Expertise

Protocol number: 46427202  
Order No. / Reference: 26739835  
Inspection date: 8 Jul 2026

Manufacturer: Volkswagen

Model: Caddy Cargo 2.0 TDI BMT

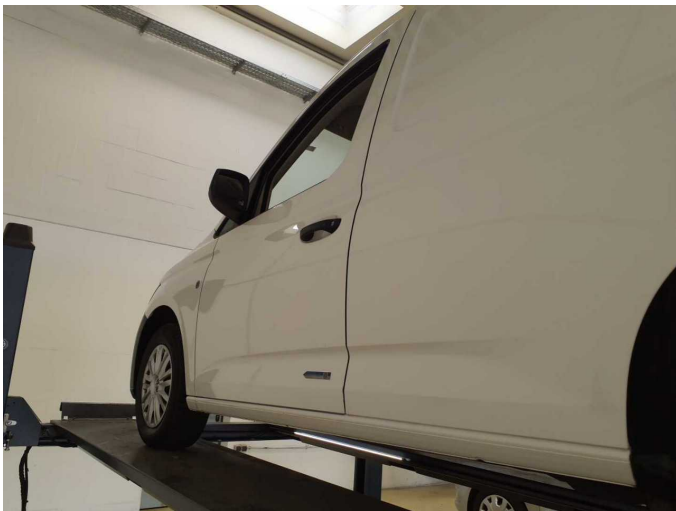
| No. | Component group | Description |
|---|---|---|
| 2 | Door - front left side | Door - dent(s) - Smart repair |

**Damage 2:** Door - front left side: Door - dent(s) - Smart repair

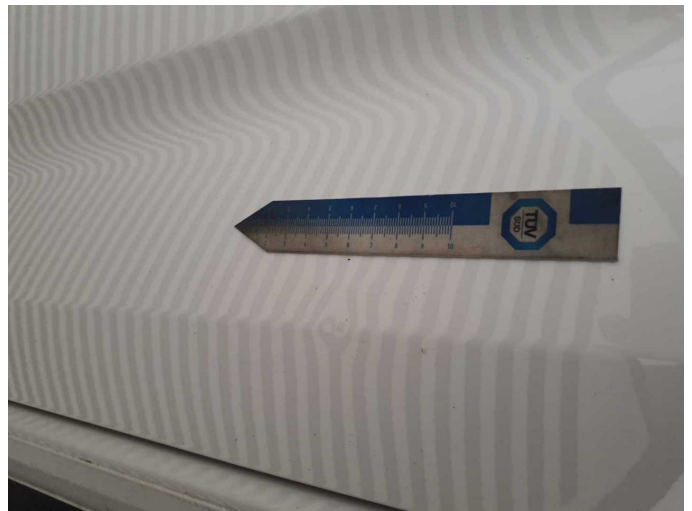
**Damage 2:** Door - front left side: Door - dent(s) - Smart repair

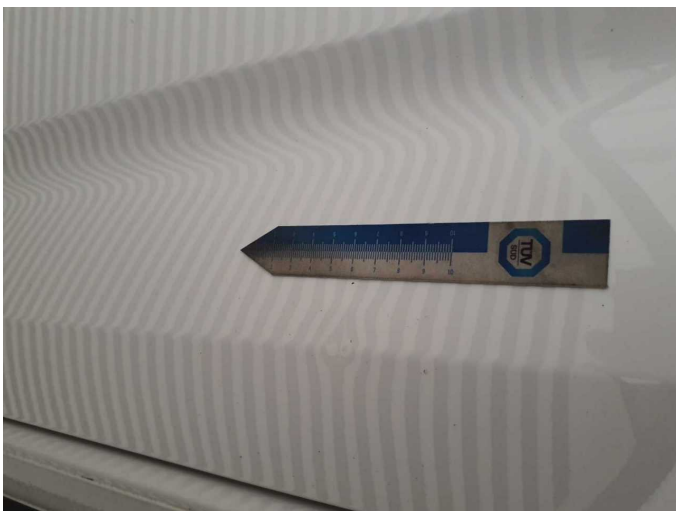
**Damage 2:** Door - front left side: Door - dent(s) - Smart repair

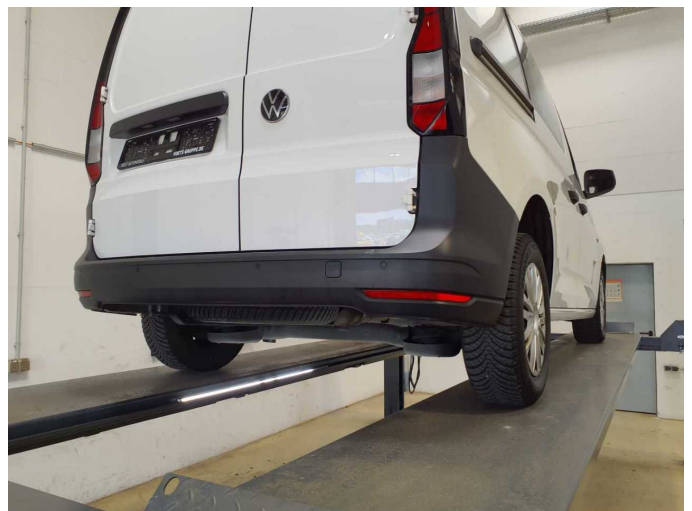
| No. | Component group | Description |
|---|---|---|
| 3 | Rear bumper | Rear bumper (Zusätzlich lose) - dent(s) - Loss in value |

**Damage 3:** Rear bumper: Rear bumper (Zusätzlich lose) - dent(s) - Loss in value

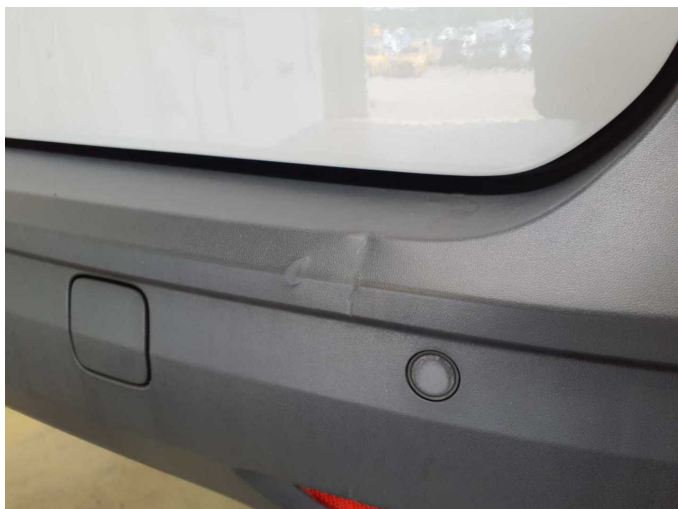
**Damage 3:** Rear bumper: Rear bumper (Zusätzlich lose) - dent(s) - Loss in value

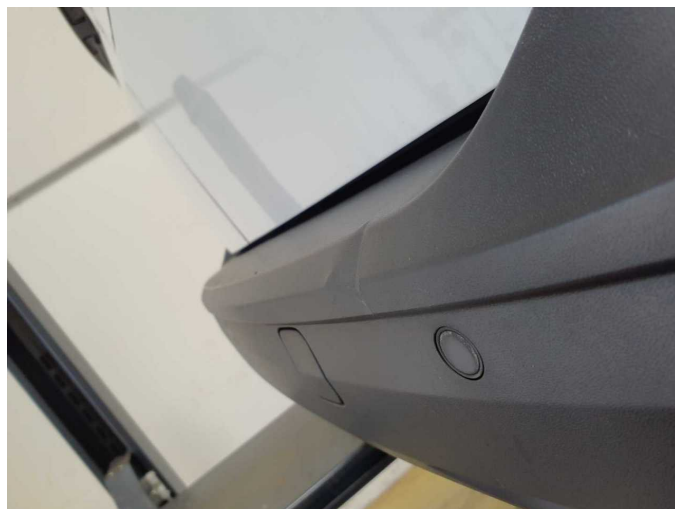
**Damage 3:** Rear bumper: Rear bumper (Zusätzlich lose) - dent(s) - Loss in value

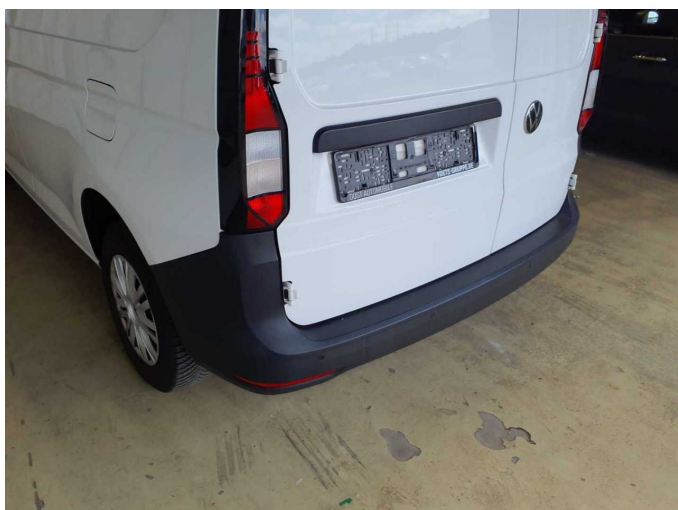
**Damage 3:** Rear bumper: Rear bumper (Zusätzlich lose) - dent(s) - Loss in value

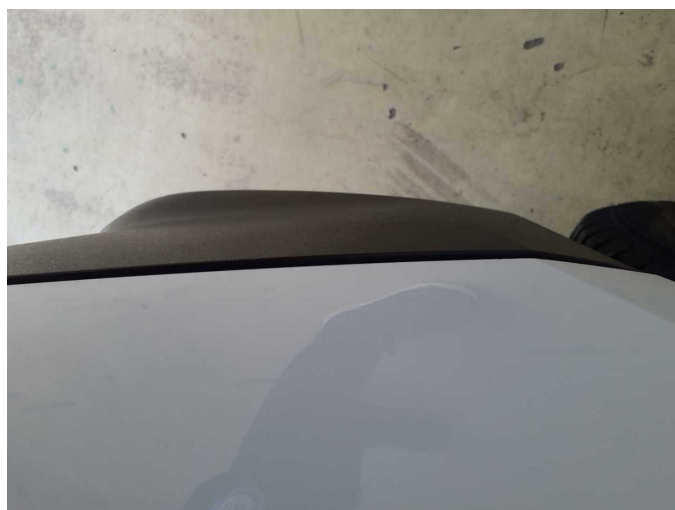
**Damage 3:** Rear bumper: Rear bumper (Zusätzlich lose) - dent(s) - Loss in value

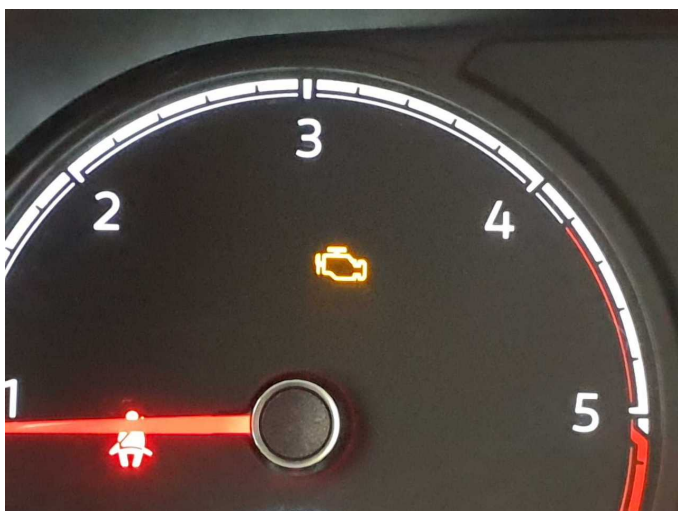
| Engine function test | An engine test run was performed, problem has been detected<br>This is due to the following reason.:<br>Motorkontrolleuchte |

| No. | Component group | Description |
|---|---|---|
| 4 | Instrument panel | Indicator light (Motorkontrolleuchte, nicht fahrbereit) - on - Perform diagnosis |

**Damage 4:** Instrument panel: Indicator light (Motorkontrolleuchte, nicht fahrbereit) - on - Perform diagnosis

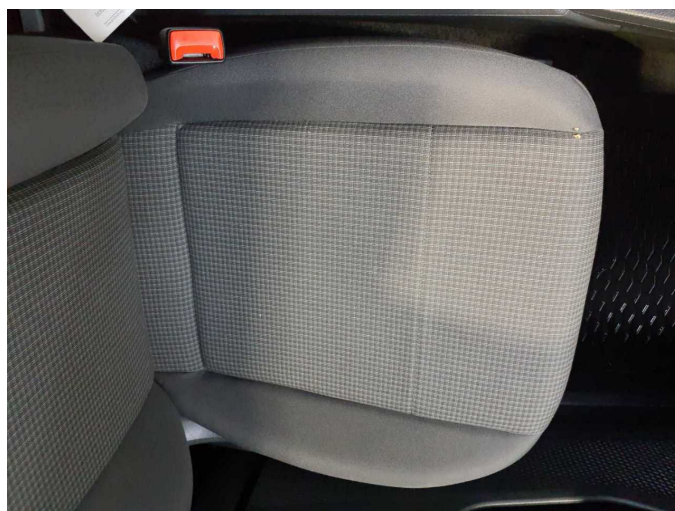
| No. | Component group | Description |
|---|---|---|
| 5 | Seat - front | Seat cover - right side - Holes - Replace |

**Damage 5:** Seat - front: Seat cover - right side - Holes - Replace

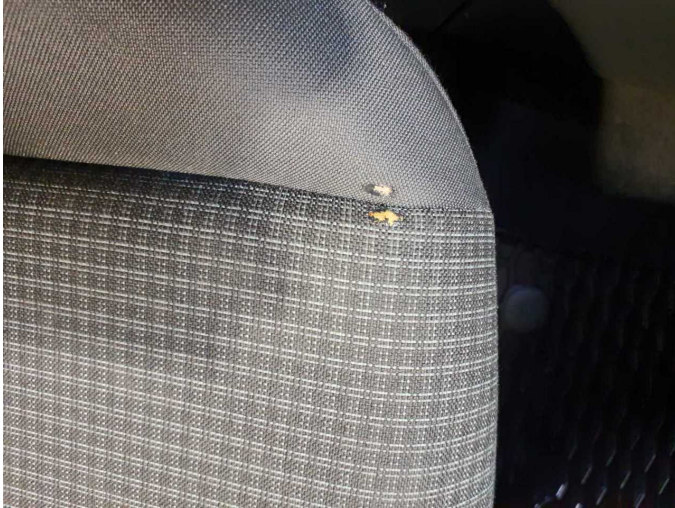
**Damage 5:** Seat - front: Seat cover - right side - Holes - Replace

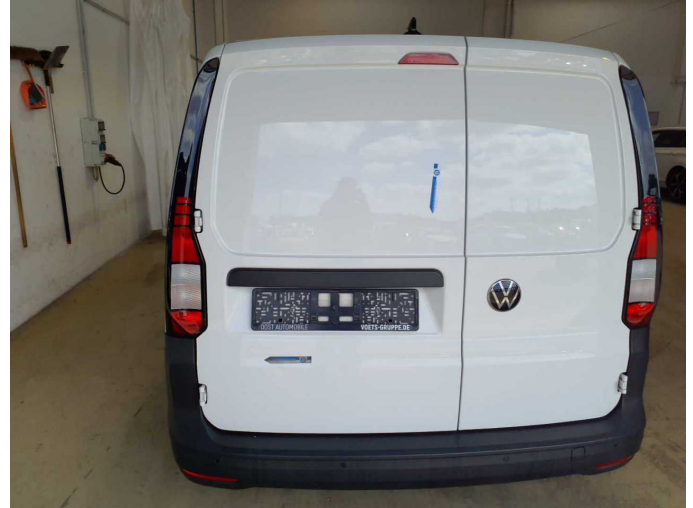
| No. | Component group | Description |
|---|---|---|
| 7 | Boot lid / rear door | Rear door - left side - Deformed - Repair and paint |

**Damage 7:** Boot lid / rear door: Rear door - left side - Deformed - Repair and paint

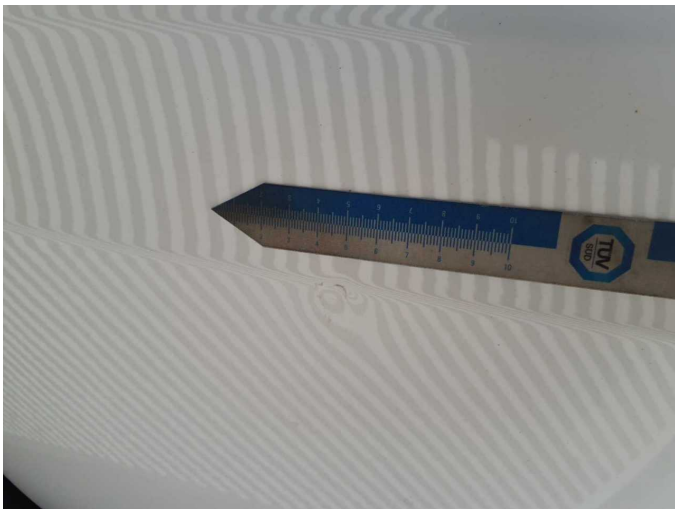
**Damage 7:** Boot lid / rear door: Rear door - left side - Deformed - Repair and paint

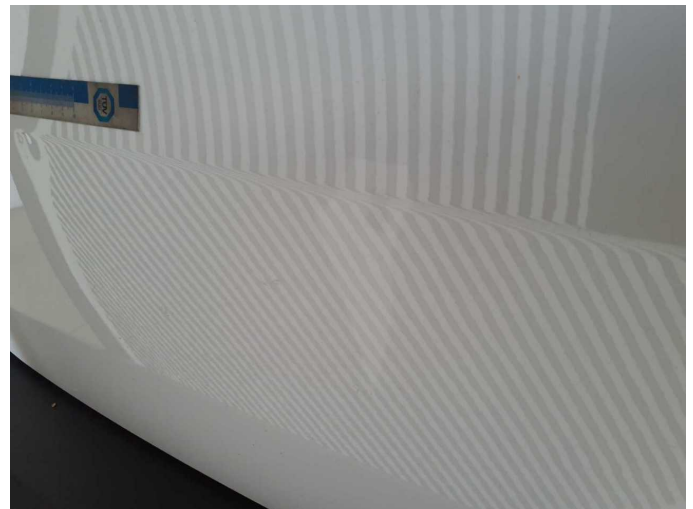
**Damage 7:** Boot lid / rear door: Rear door - left side - Deformed - Repair and paint

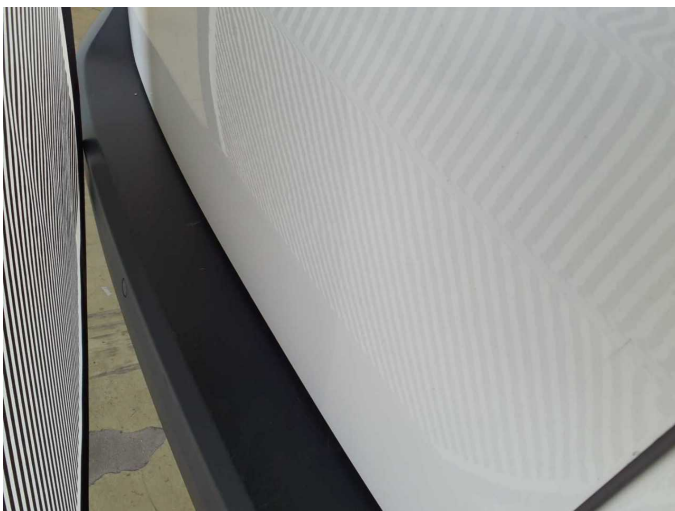
**Damage 7:** Boot lid / rear door: Rear door - left side - Deformed - Repair and paint

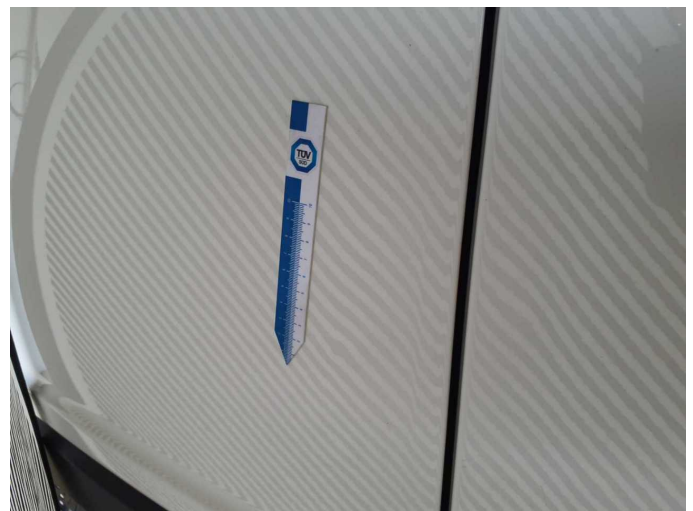
**Damage 7:** Boot lid / rear door: Rear door - left side - Deformed - Repair and paint

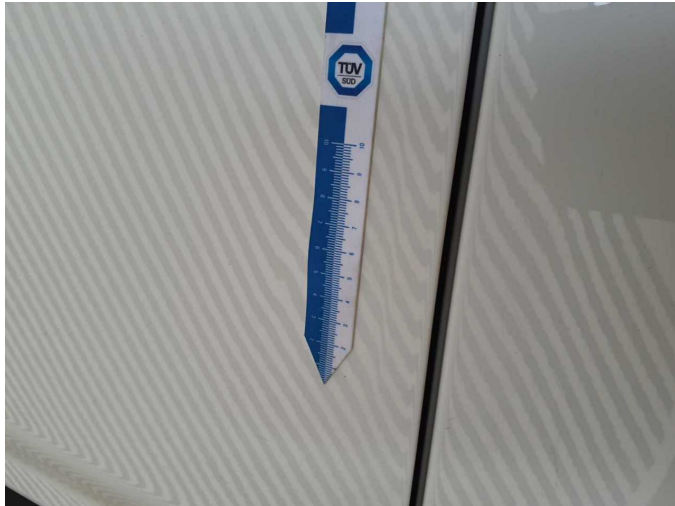
**Damage 7:** Boot lid / rear door: Rear door - left side - Deformed - Repair and paint

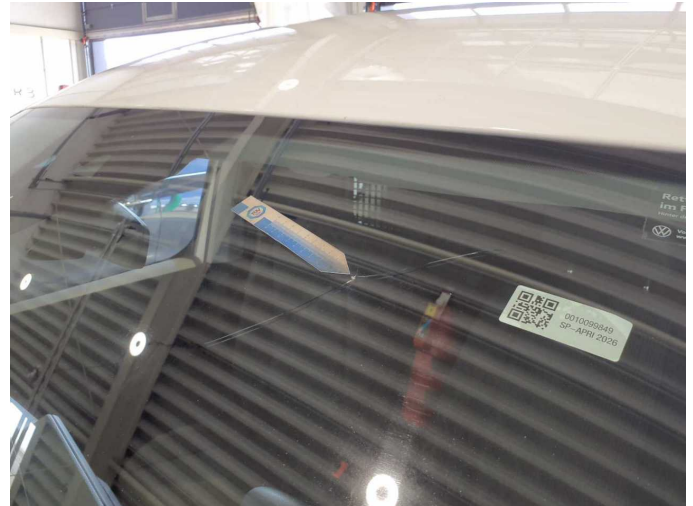
| No. | Component group | Description |
|---|---|---|
| 8 | Vehicle glazing | Windscreen - Broken / torn - Replace |

**Damage 8:** Vehicle glazing: Windscreen - Broken / torn - Replace

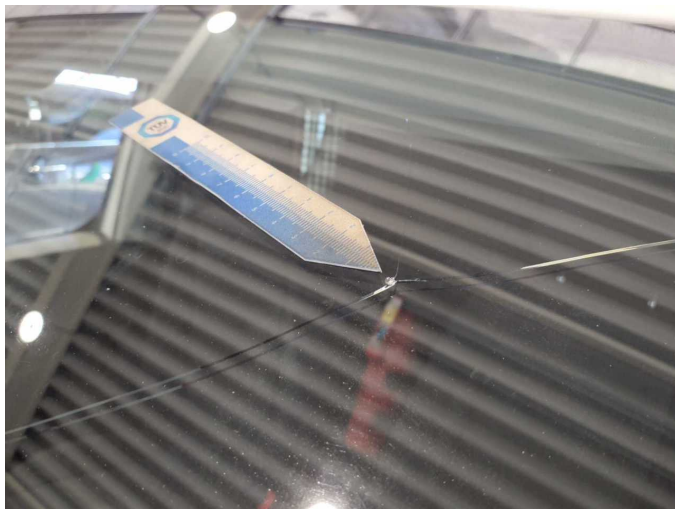
**Damage 8:** Vehicle glazing: Windscreen - Broken / torn - Replace

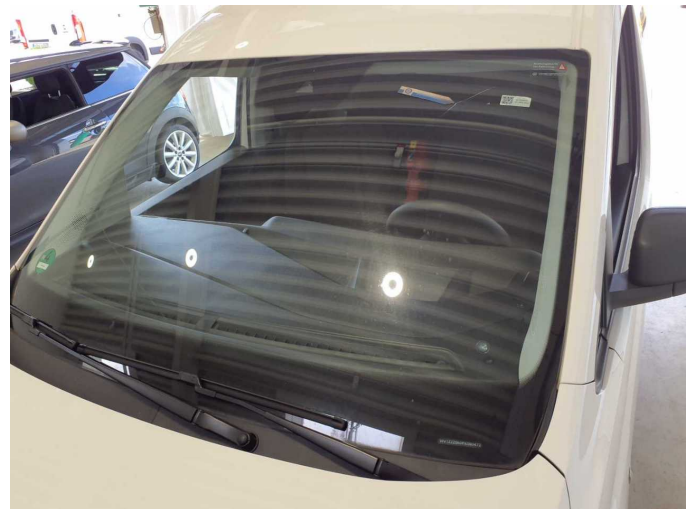
**Damage 8:** Vehicle glazing: Windscreen - Broken / torn - Replace
