Expertise

Protocol number: 46273969  
Order No. / Reference: 26631105  
Inspection date: 30 Jun 2026

Manufacturer: Skoda  
VIN: TMBJG7NX4MY121653

Model: Octavia Combi 2.0 TDI Style

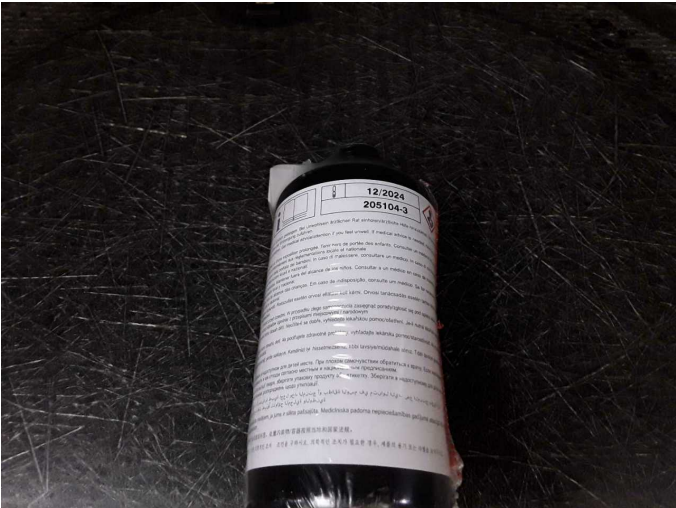
| No. | Component group | Description |
|---|---|---|
| 1 | Equipment | Tirefit filler - Expired - Replace |

Damage 1: Equipment: Tirefit filler - Expired - Replace

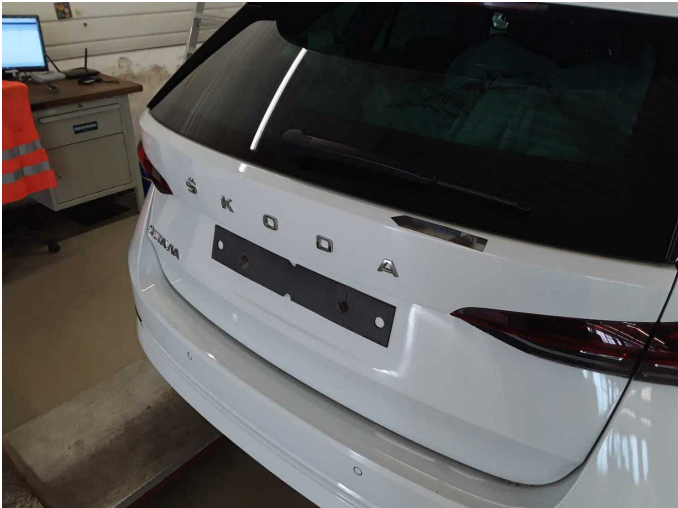
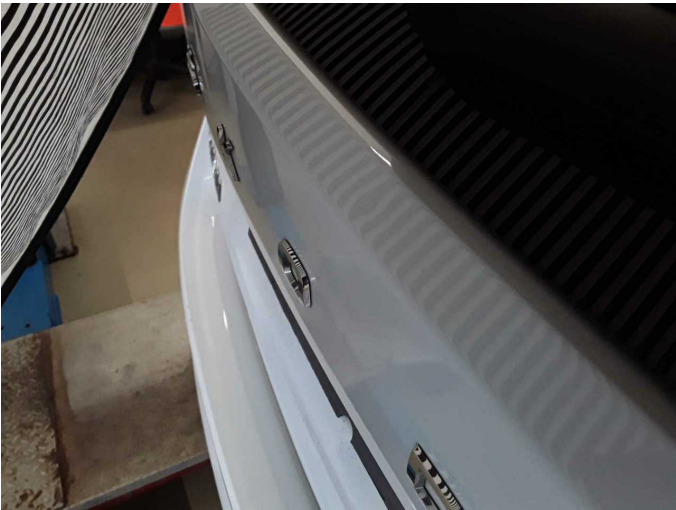
| No. | Component group | Description |
|---|---|---|
| 2 | Boot lid / rear door | Boot lid - dent(s) - Smooth repair work |

Damage 2: Boot lid / rear door: Boot lid - dent(s) - Smooth repair work

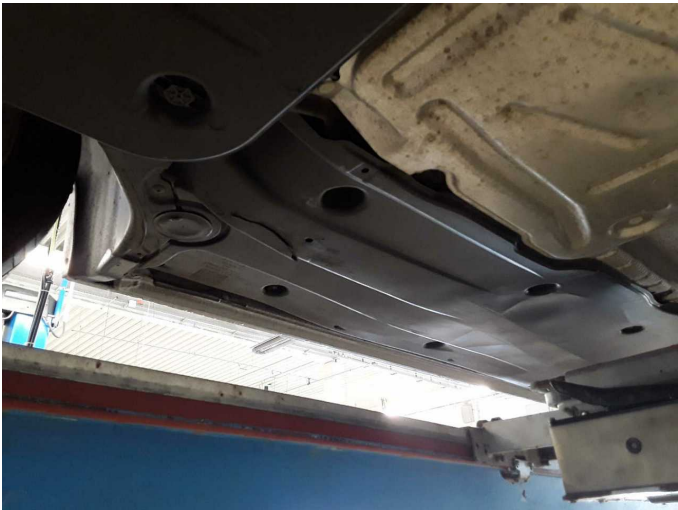
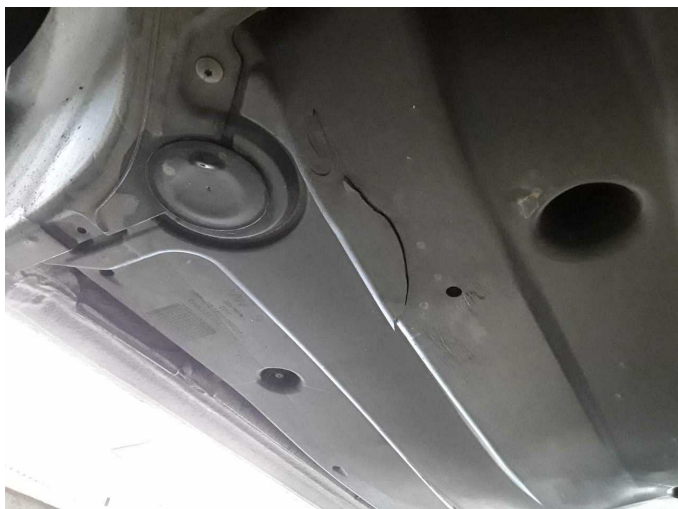
| No. | Component group | Description |
|---|---|---|
| 3 | Body | Underbody panelling (rechts) - Broken / torn - Replace |

Damage 3: Body: Underbody panelling (rechts) - Broken / torn - Replace

**Damage 3:** Body: Underbody panelling (rechts) - Broken / torn - Replace

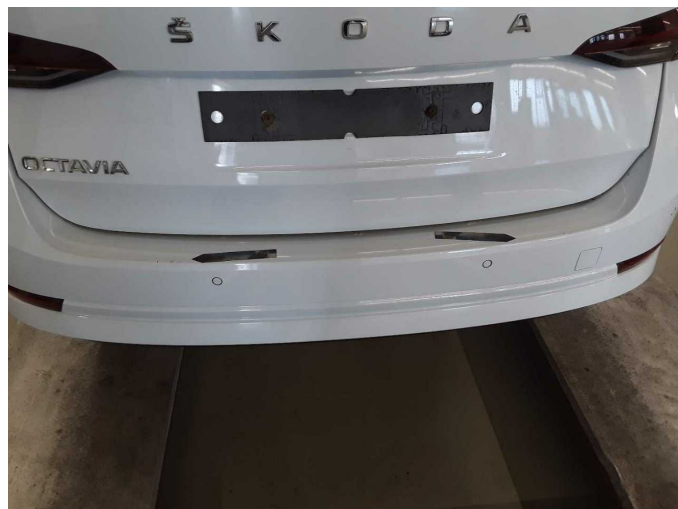
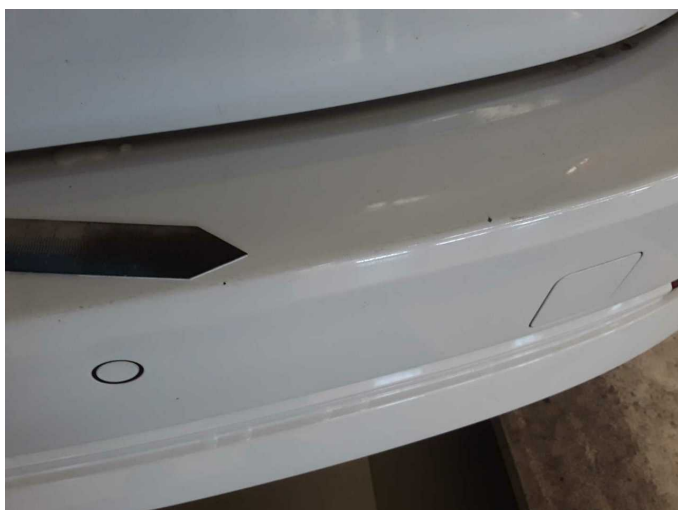
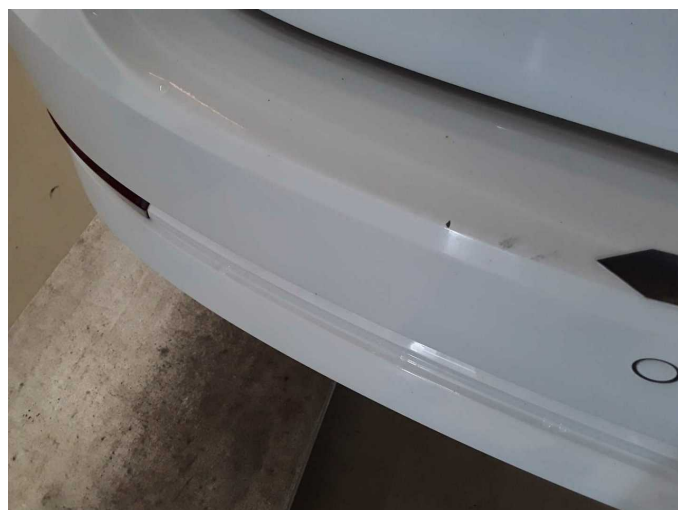
| No. | Component group | Description |
|---|---|---|
| 4 | Rear bumper | Rear bumper - Scratch(es) - Smart repair |

**Damage 4:** Rear bumper: Rear bumper - Scratch(es) - Smart repair

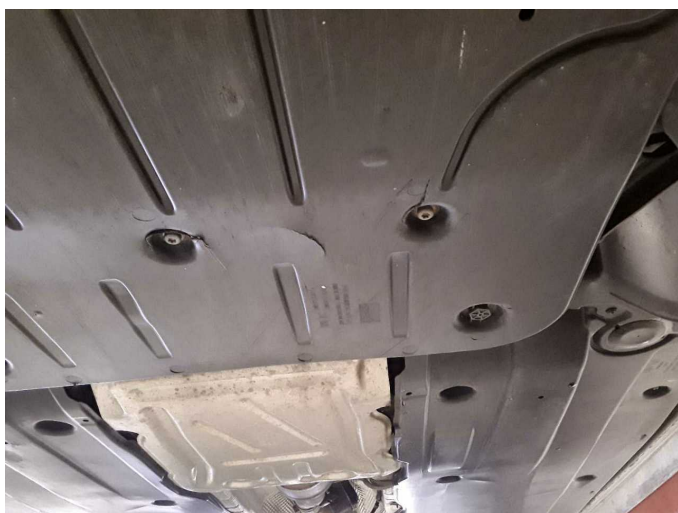
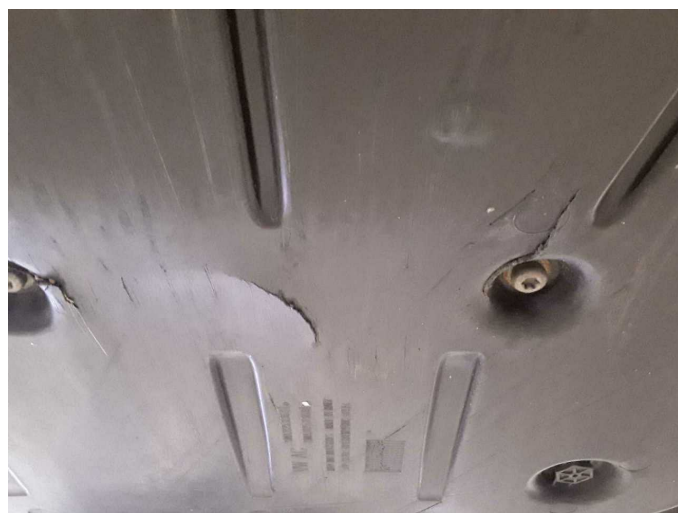
| No. | Component group | Description |
|---|---|---|
| 6 | Engine | Engine cowling - lower - Broken / torn - Replace |

**Damage 6:** Engine: Engine cowling - lower - Broken / torn - Replace

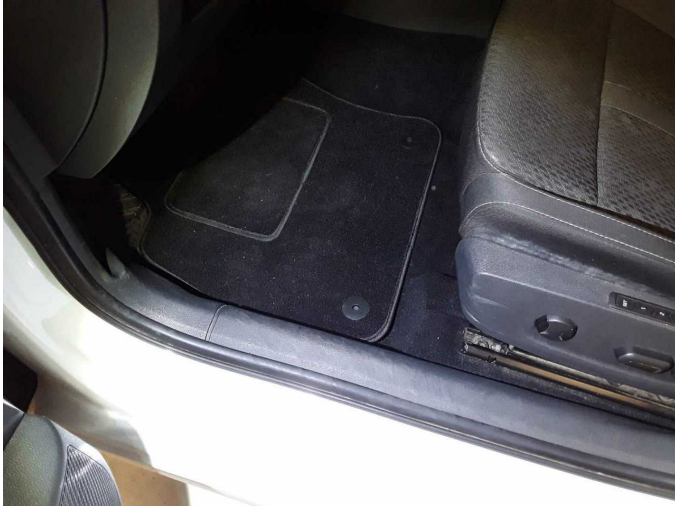
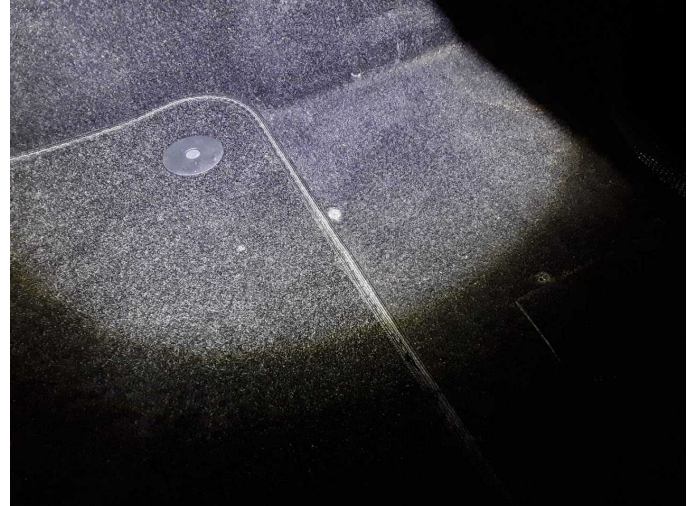
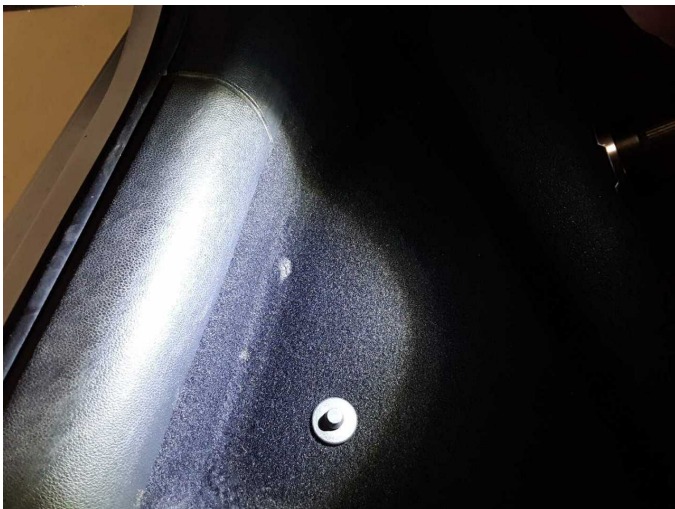
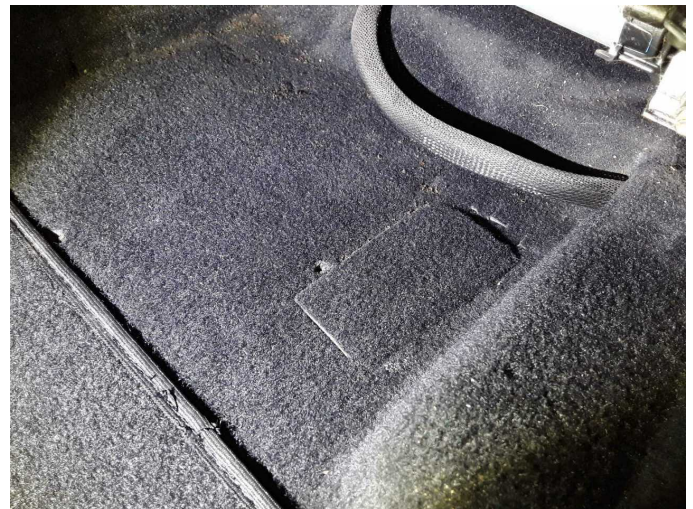
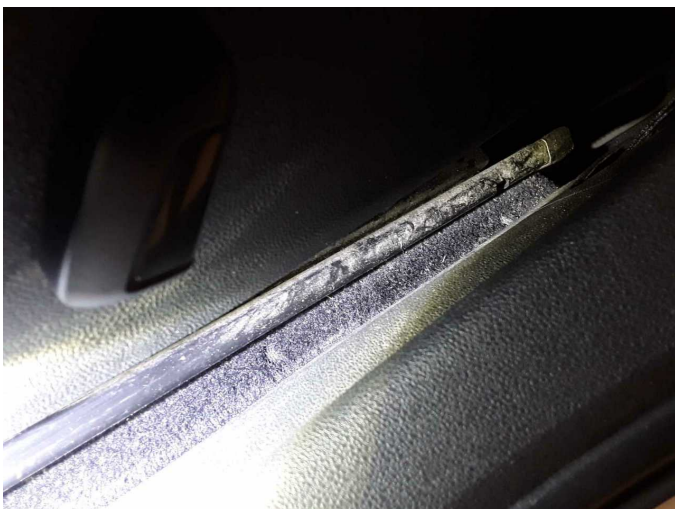
| No. | Component group | Description |
|---|---|---|
| 7 | Trim / covers | Floor covering - front left side - Burn hole (cigarettes) - Loss in value |

**Damage 7:** Trim / covers: Floor covering - front left side - Burn hole (cigarettes) - Loss in value

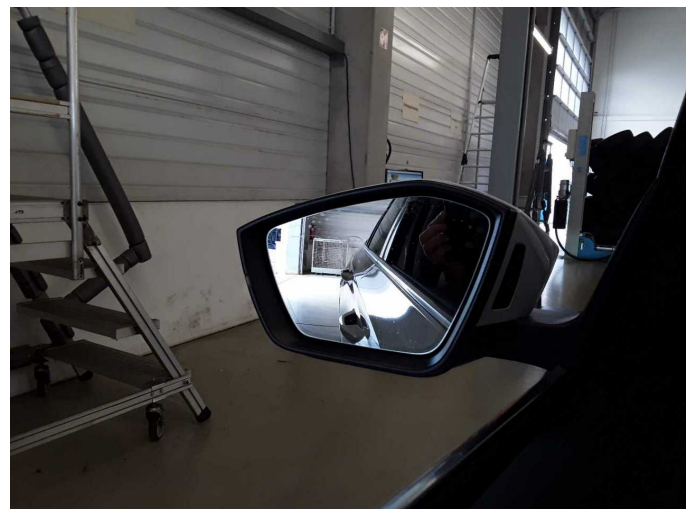
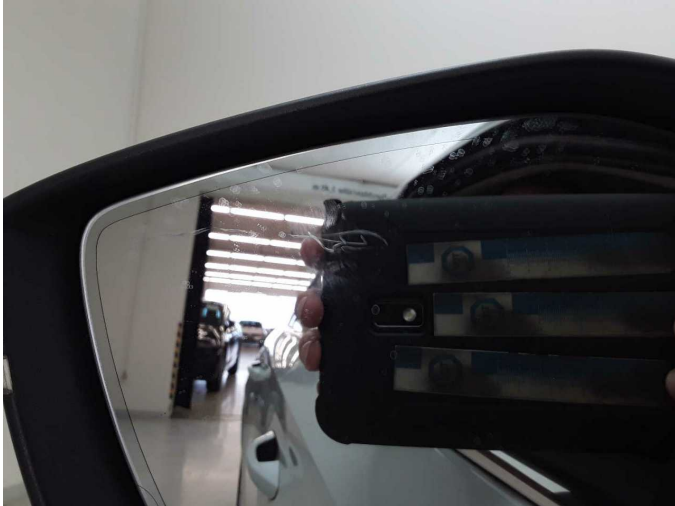
| No. | Component group | Description |
|---|---|---|
| 8 | Wing mirror - left side | Mirror glass - Scratch(es) - Replace |

**Damage 8:** Wing mirror - left side: Mirror glass - Scratch(es) - Replace

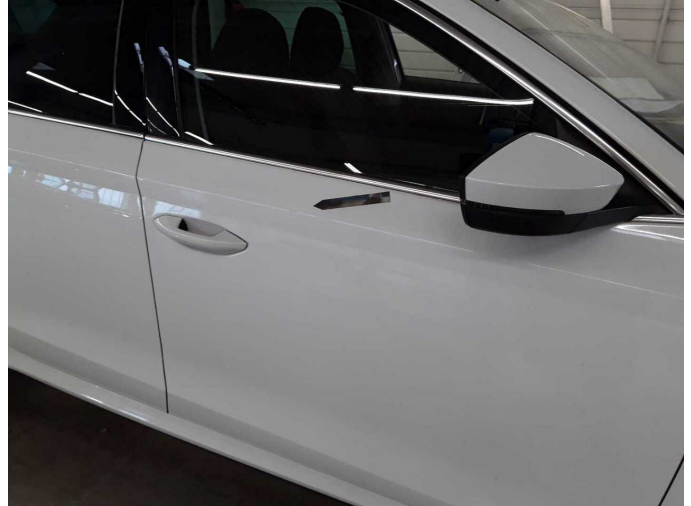
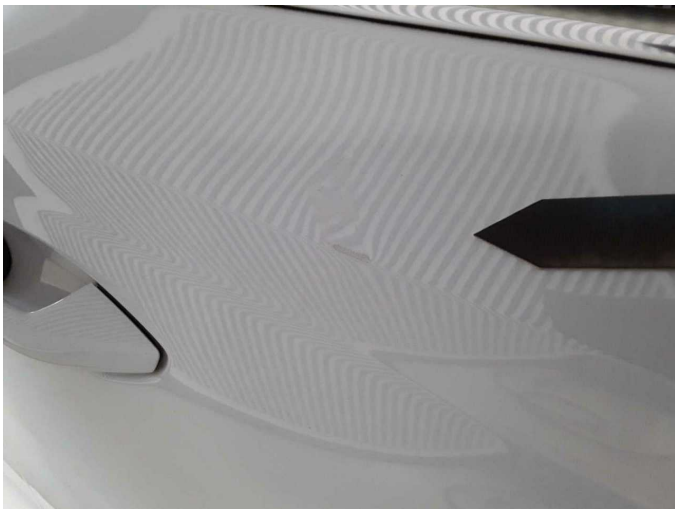
| No. | Component group | Description |
|---|---|---|
| 9 | Door - front right side | Door - Dent / paintcoat damage - Repair and paint |

**Damage 9:** Door - front right side: Door - Dent / paintcoat damage - Repair and paint

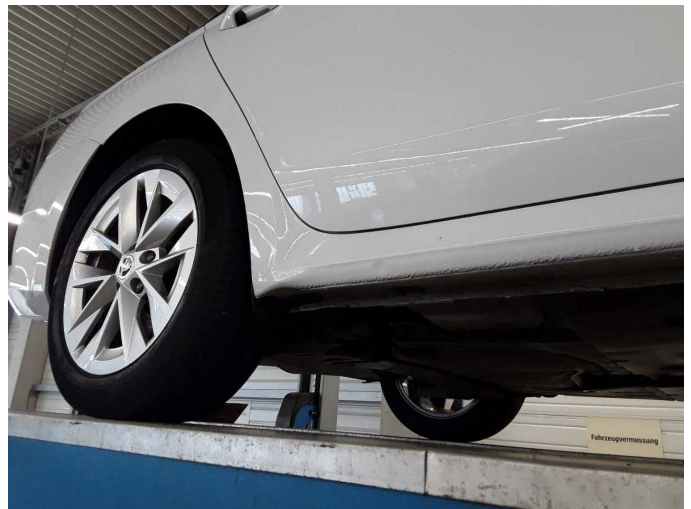
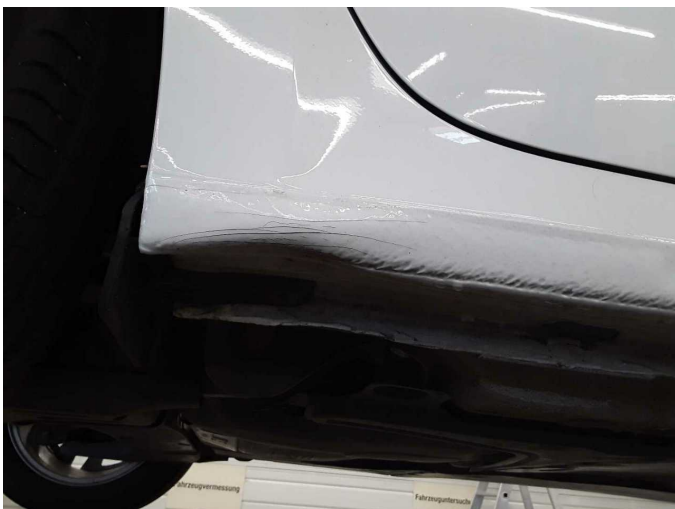
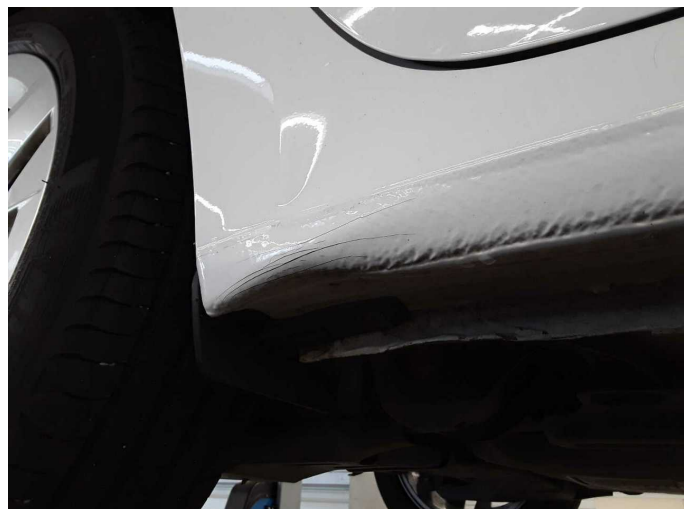
| No. | Component group | Description |
|---|---|---|
| 10 | Sill - right side | Sill - Deformed - Repair and paint |

**Damage 10:** Sill - right side: Sill - Deformed - Repair and paint

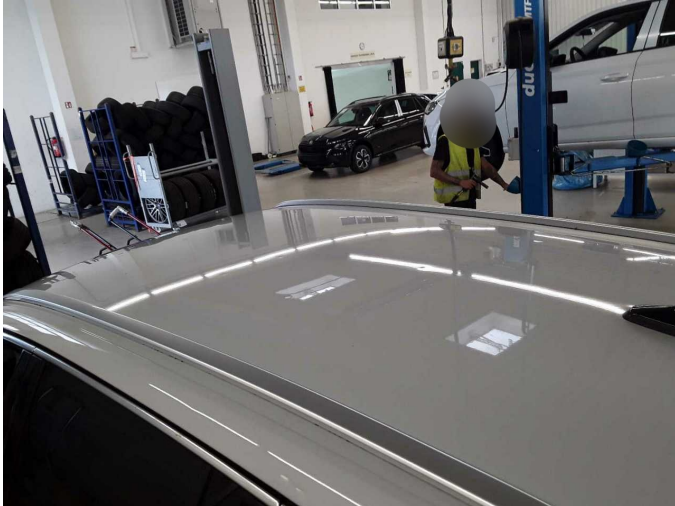
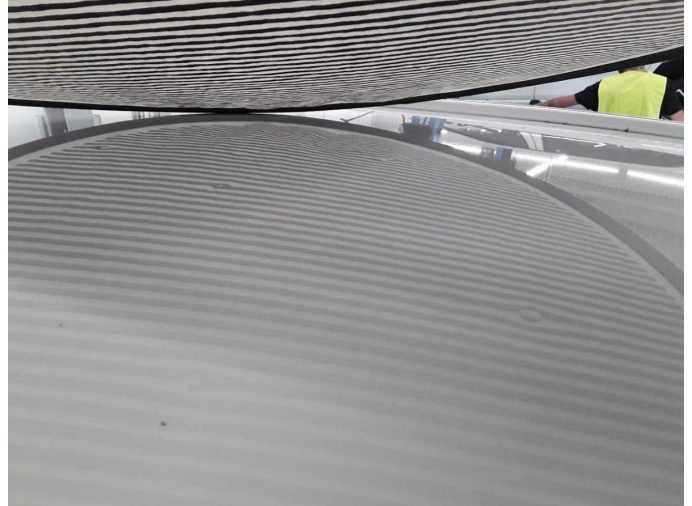
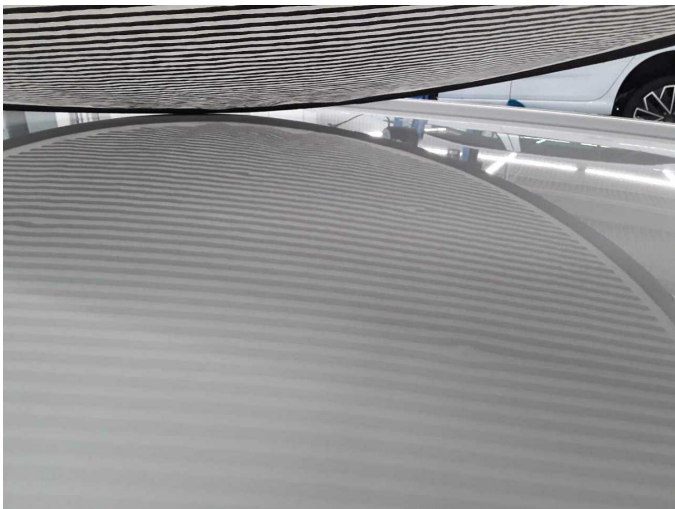
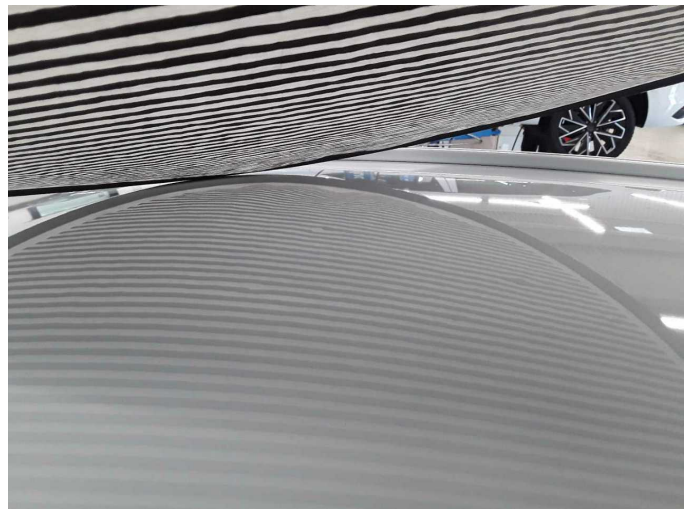
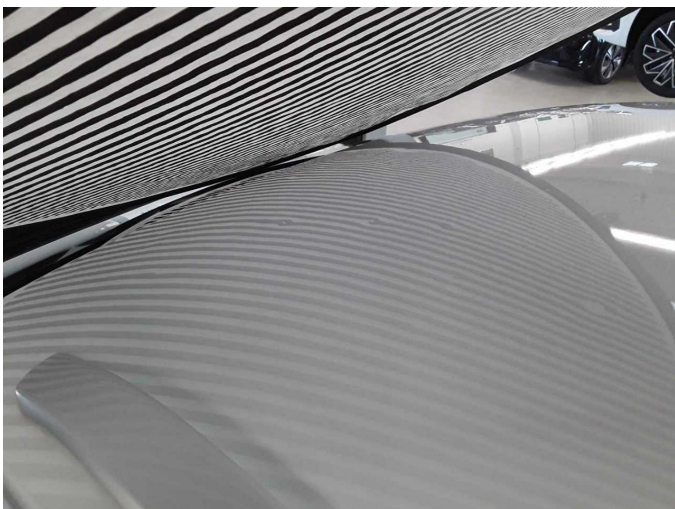
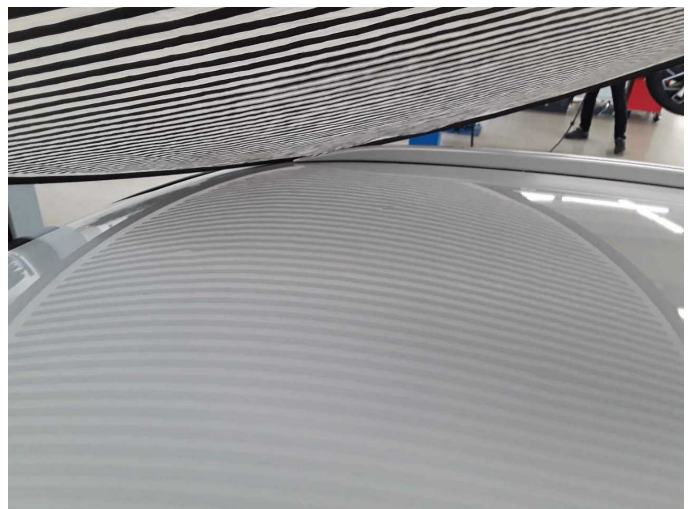
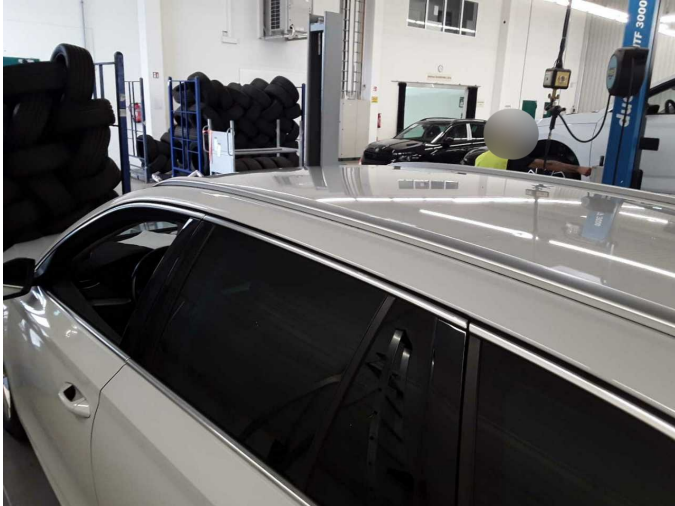
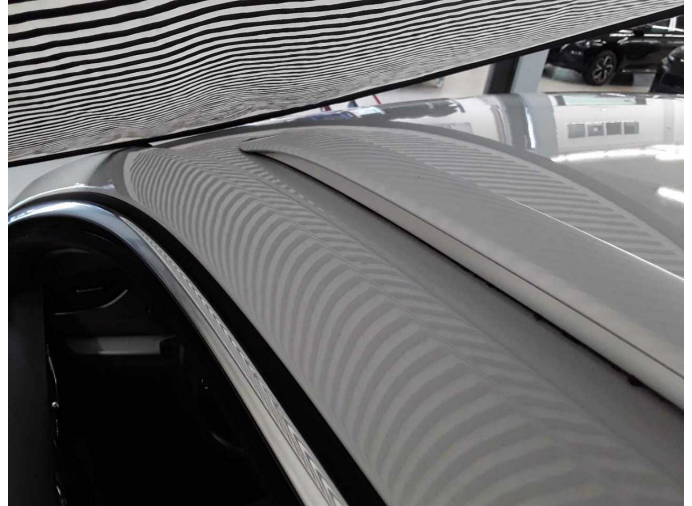
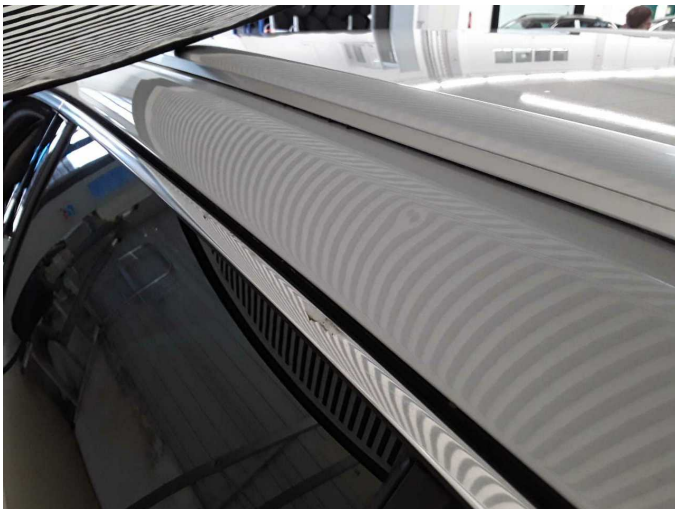
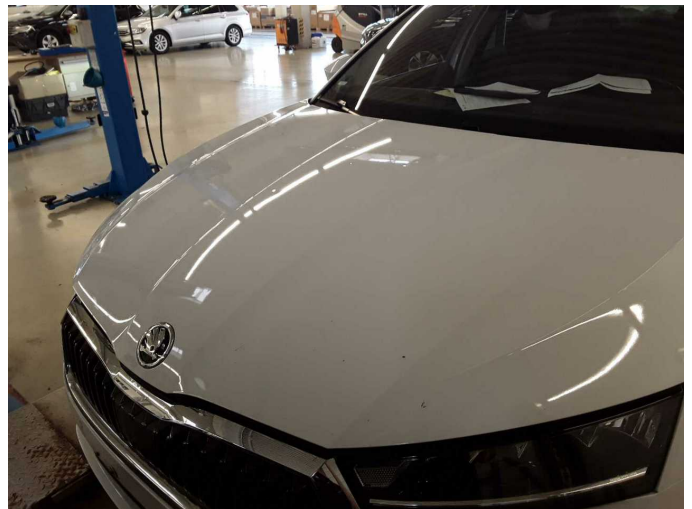
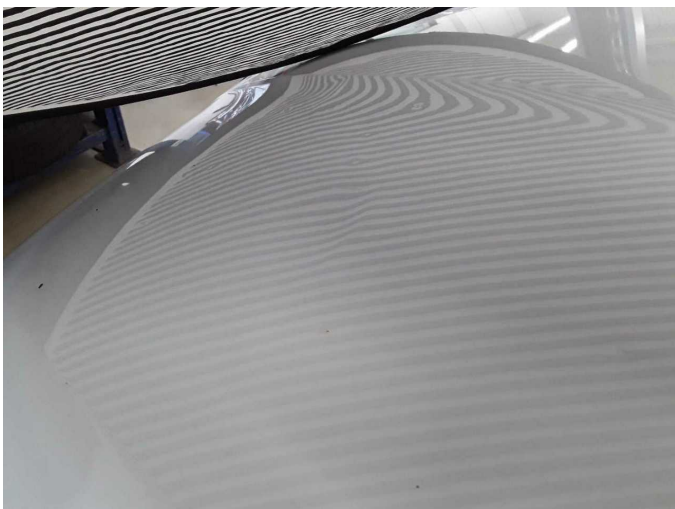
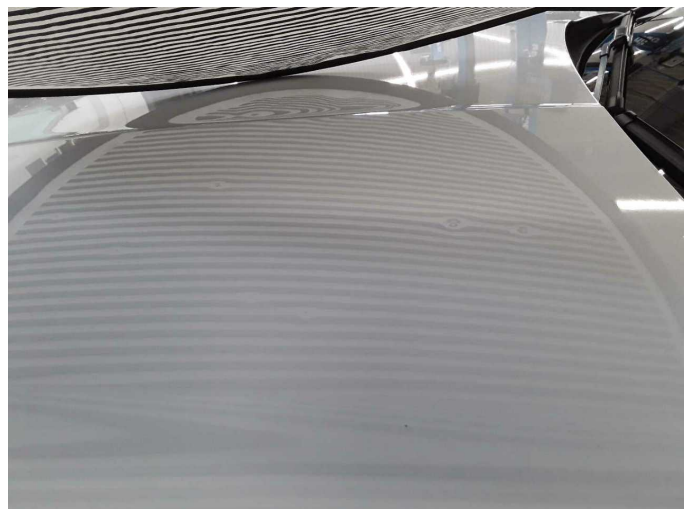
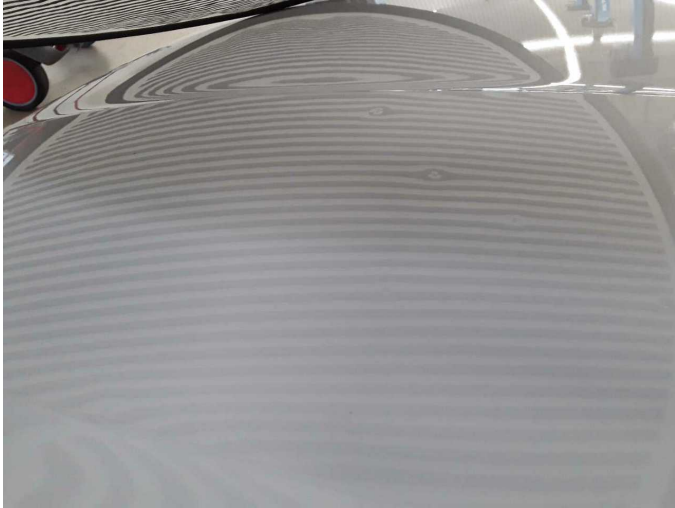
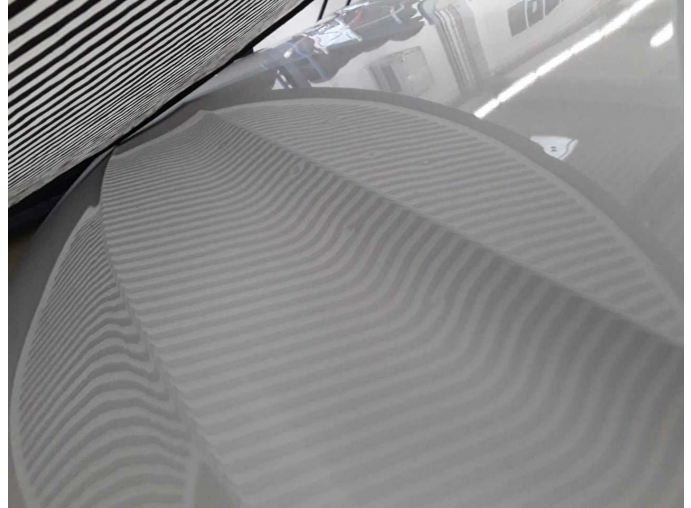
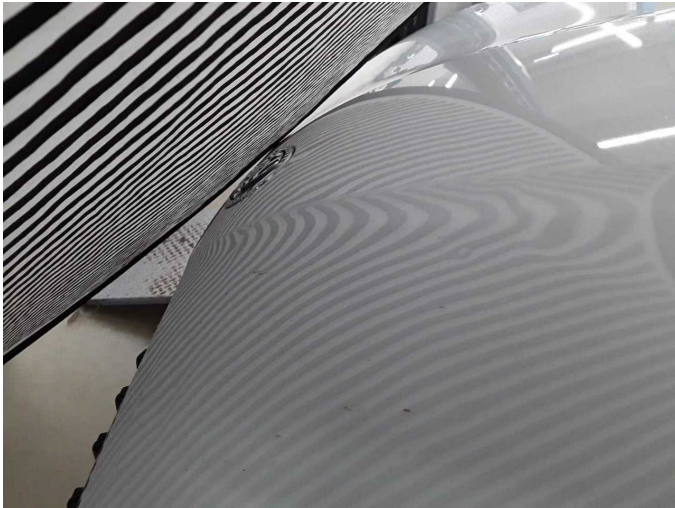
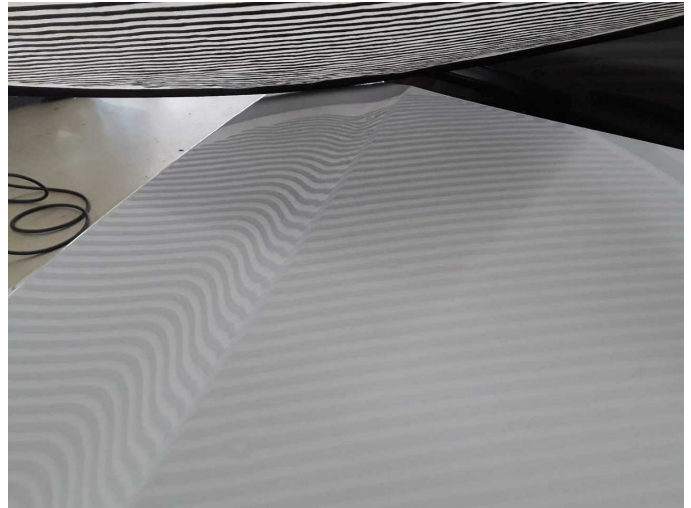
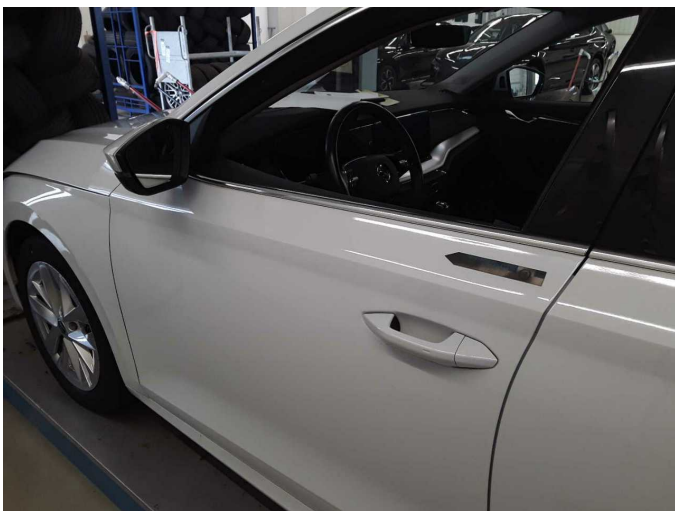
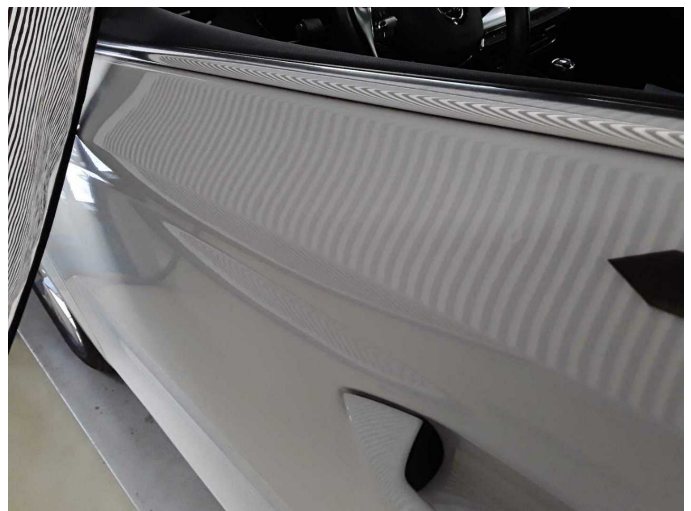
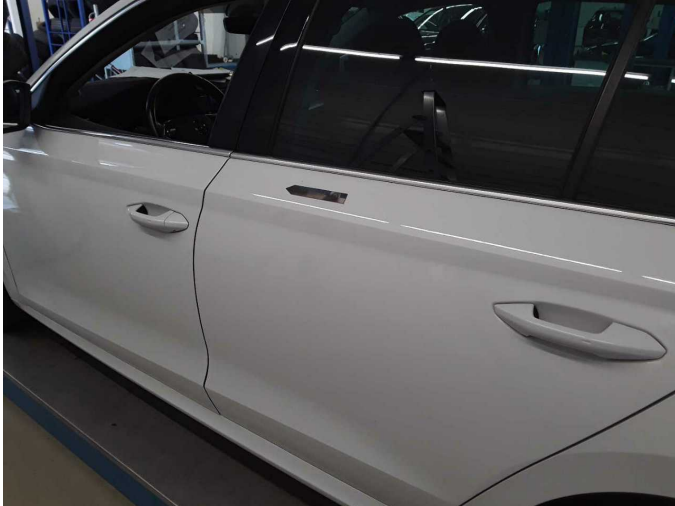
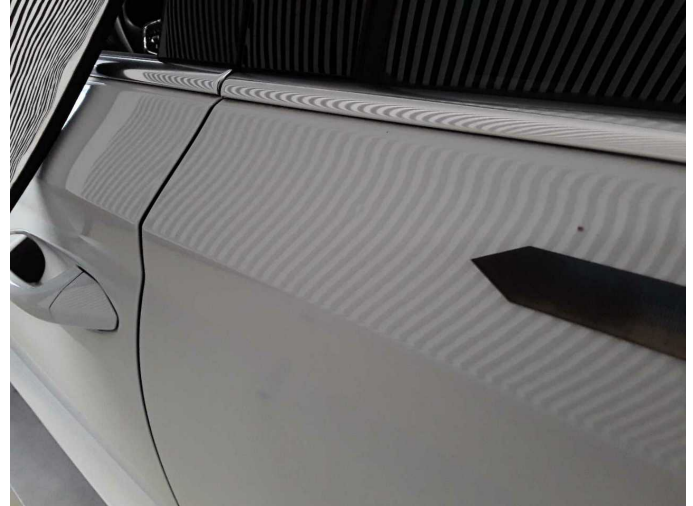
| No. | Component group | Description |
|---|---|---|
| 11 | Body | Body - Damage by hail - repair according to calculation |

**Damage 11:** Body: Body - Damage by hail - repair according to calculation

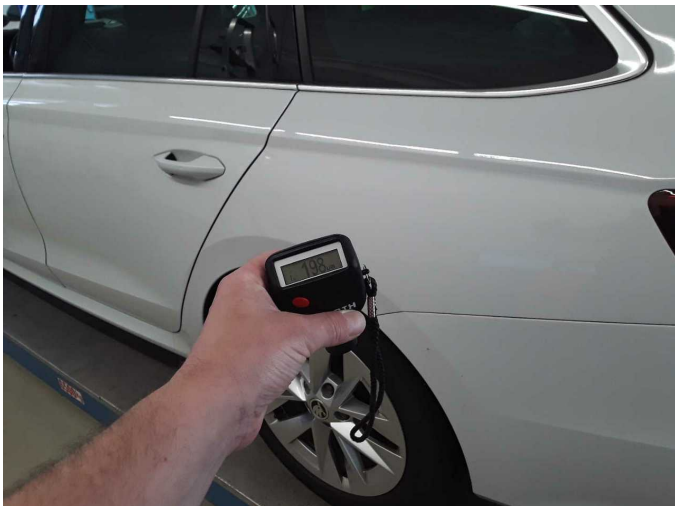
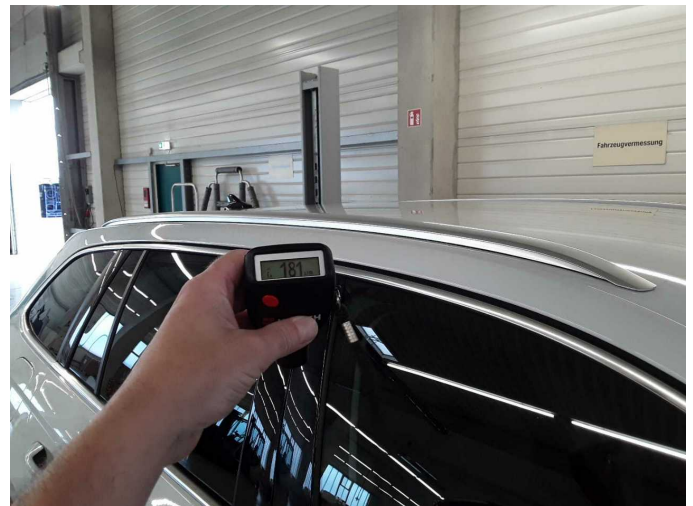
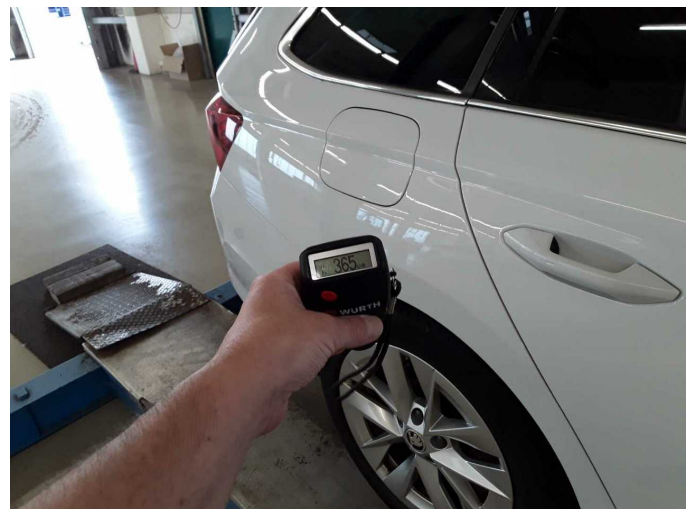
- 1 Roof rail - right side, Side panel - rear left side, Side panel - rear right side, Door - rear right side, Professionally carried out, Invoice of repair done Non-existent

**Repainting 1:** Roof rail - right side, Side panel - rear left side, Side panel - rear right side, Door - rear right side

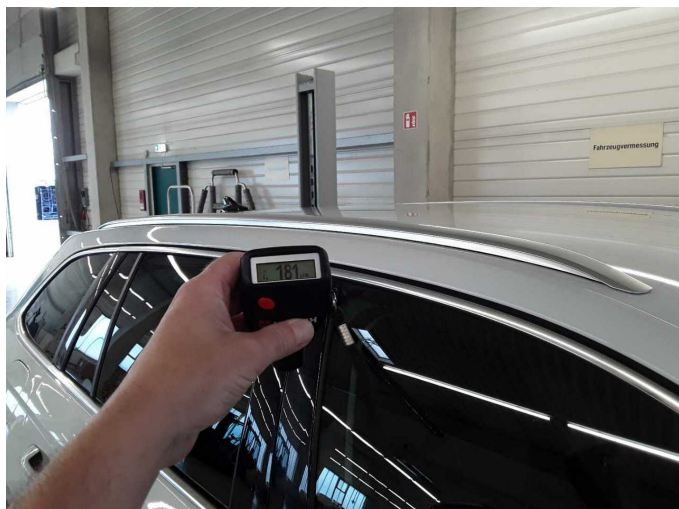
**Roof rail - right side: 181  $\mu\text{m}$**

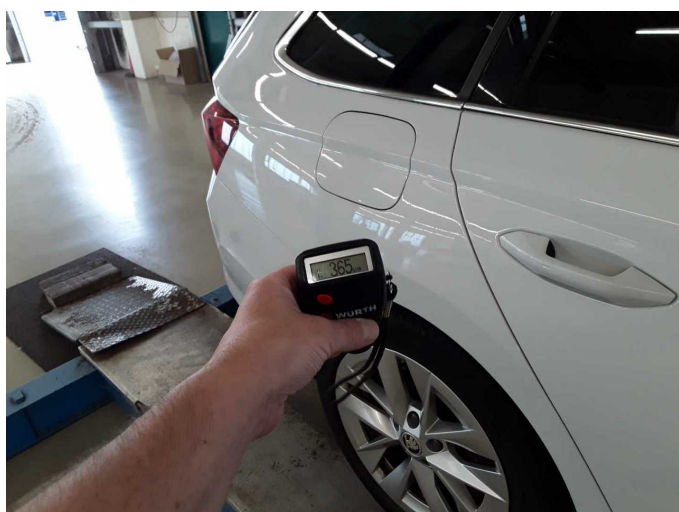
**Side panel - rear right side: 365  $\mu\text{m}$**

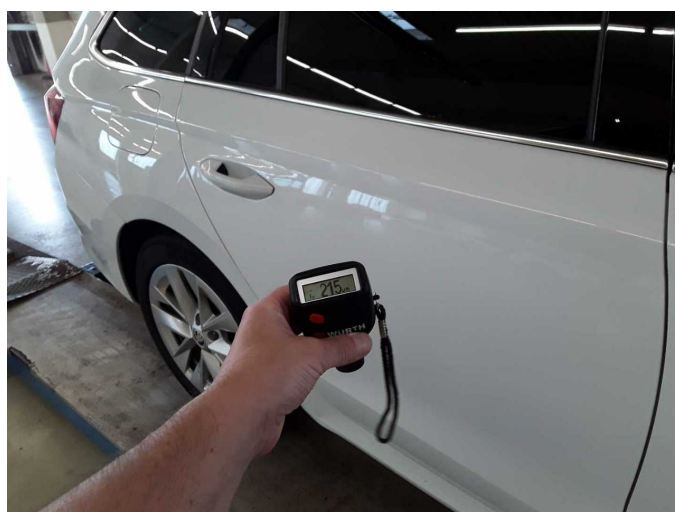
**Door - rear right side: 215  $\mu\text{m}$**
