Expertise

Protocol number: 46598464  
Order No. / Reference: 26694602  
Inspection date: 13 Jul 2026

| Manufacturer: Opel | Model: Insignia Sports Tourer 2.0 Diesel Business Elegance |

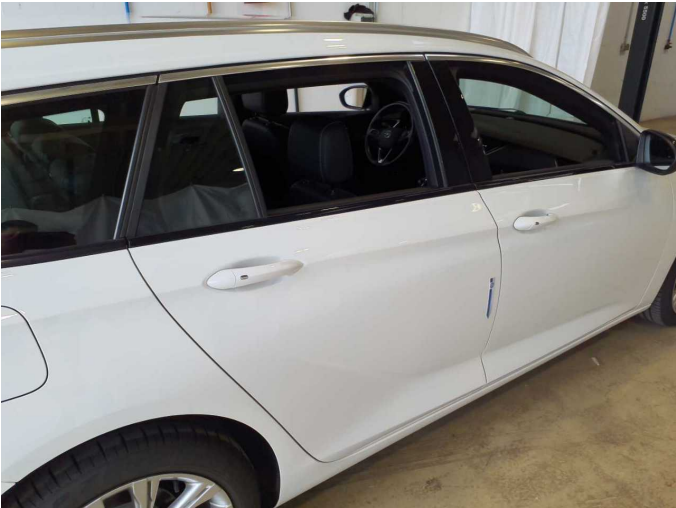
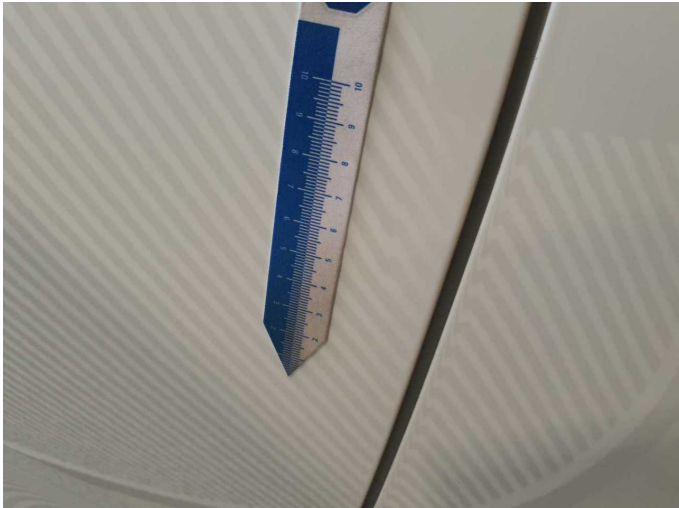
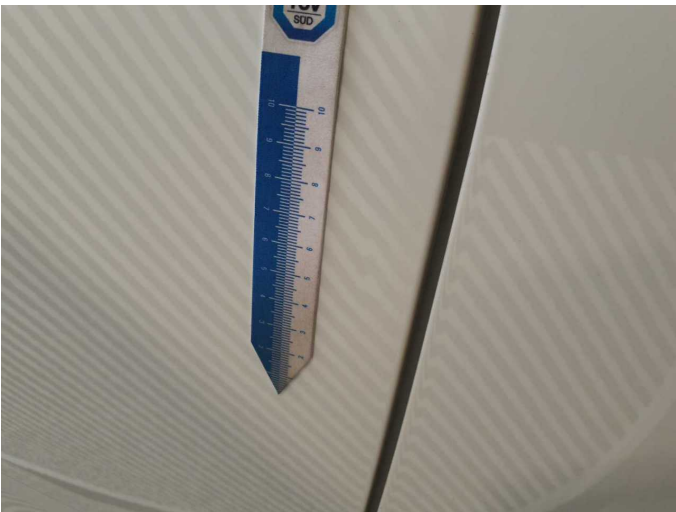
| No. | Component group | Description |
|---|---|---|
| 2 | Door - rear right side | Door - dent(s) - Smart repair |

Damage 2: Door - rear right side: Door - dent(s) - Smart repair

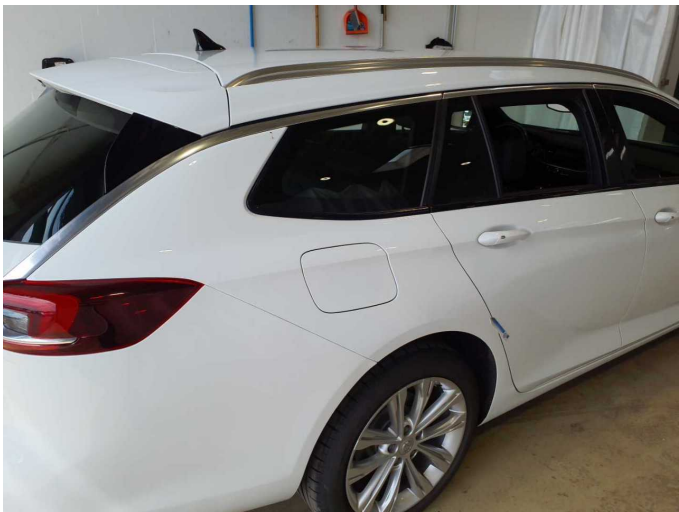
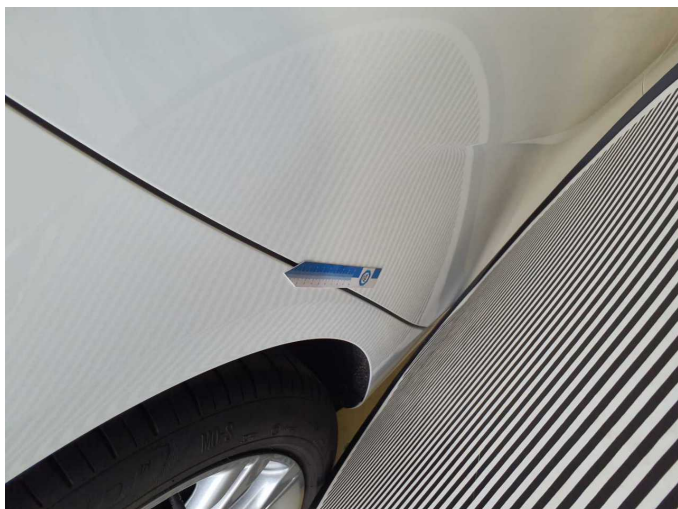
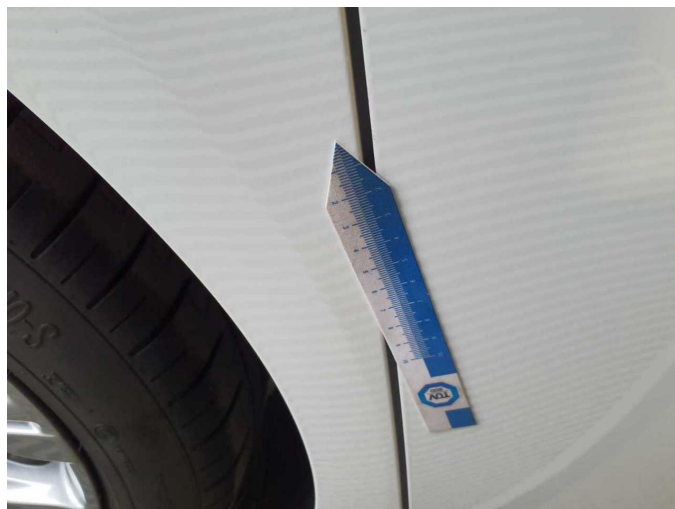
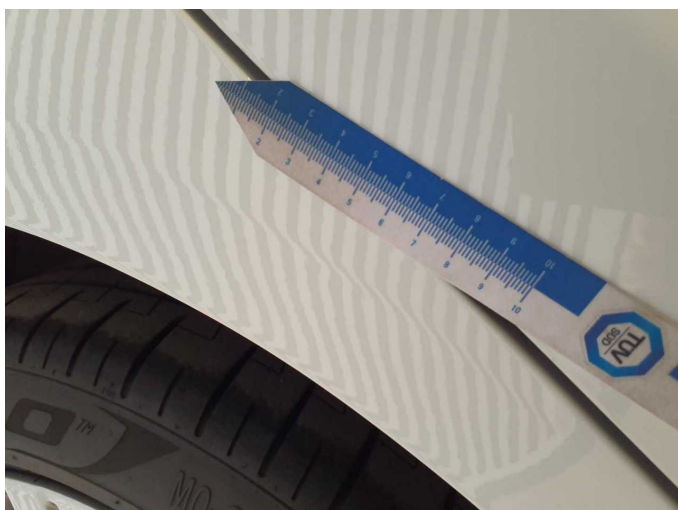
| No. | Component group | Description |
|---|---|---|
| 3 | Side panel - rear right side | Side panel - dent(s) - Smart repair |

Damage 3: Side panel - rear right side: Side panel - dent(s) - Smart repair

**Damage 3:** Side panel - rear right side: Side panel - dent(s) - Smart repair

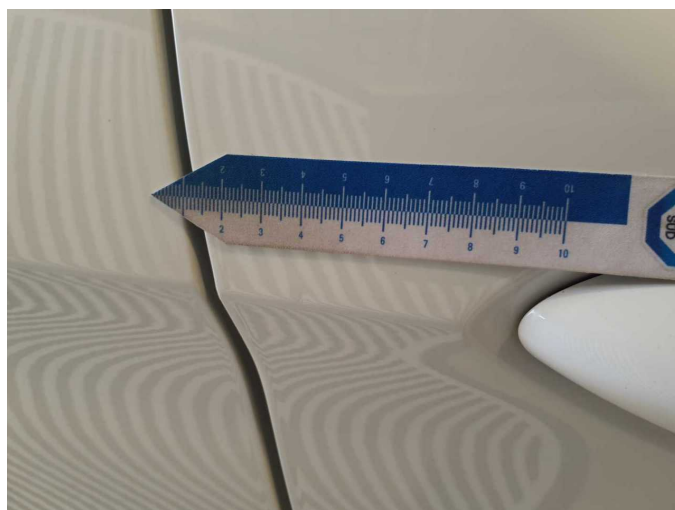
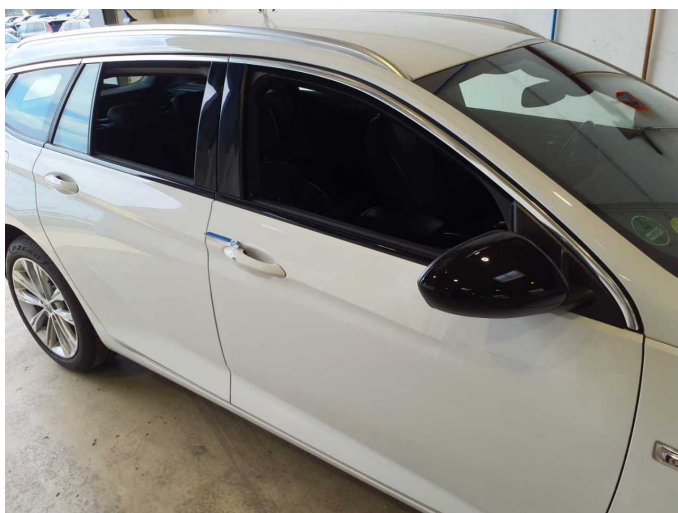
| No. | Component group | Description |
|---|---|---|
| 4 | Door - front right side | Door - dent(s) - Smart repair |

**Damage 4:** Door - front right side: Door - dent(s) - Smart repair

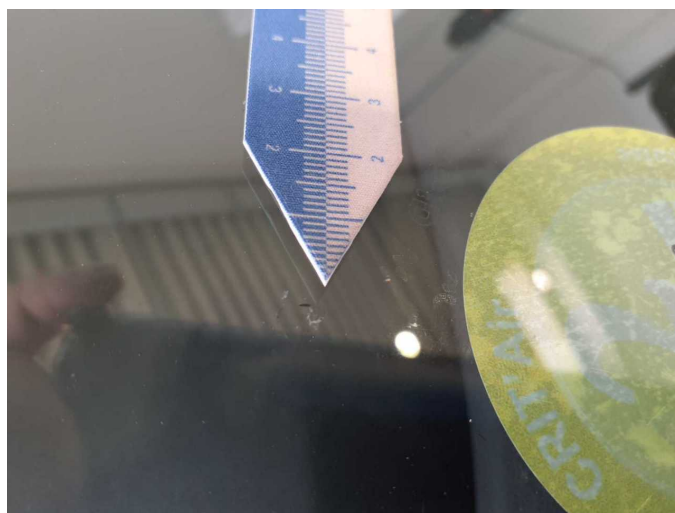
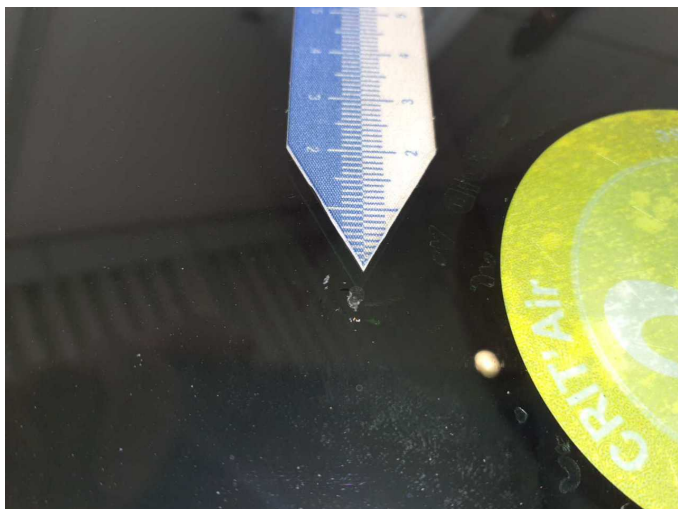
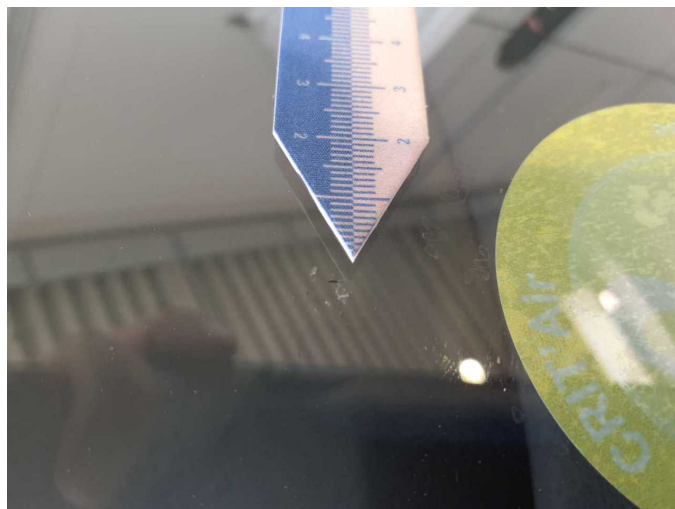
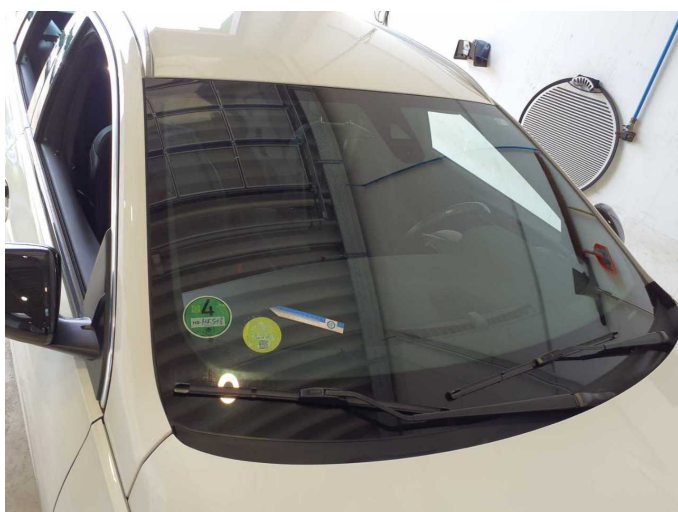
| No. | Component group | Description |
|---|---|---|
| 5 | Vehicle glazing | Windscreen - Stone chips - Replace |

**Damage 5:** Vehicle glazing: Windscreen - Stone chips - Replace

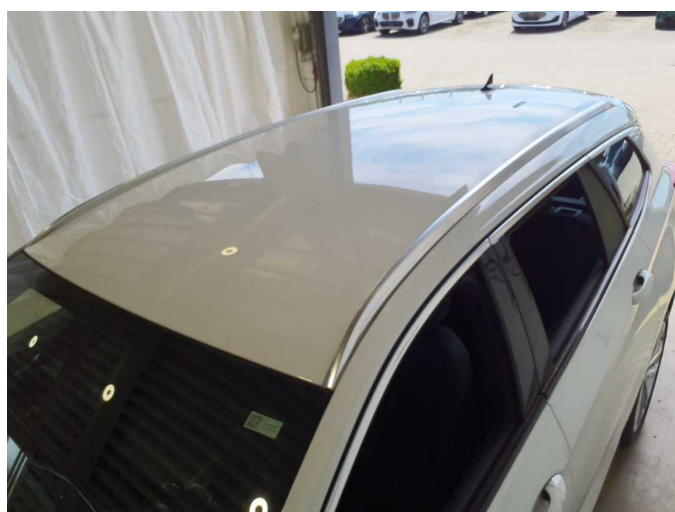
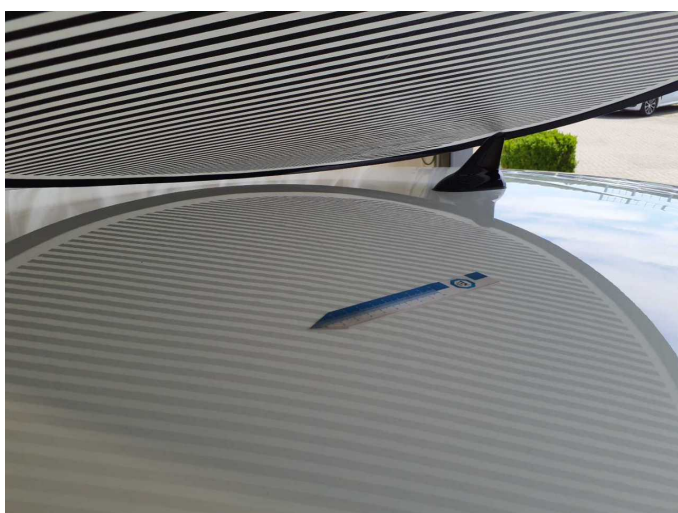
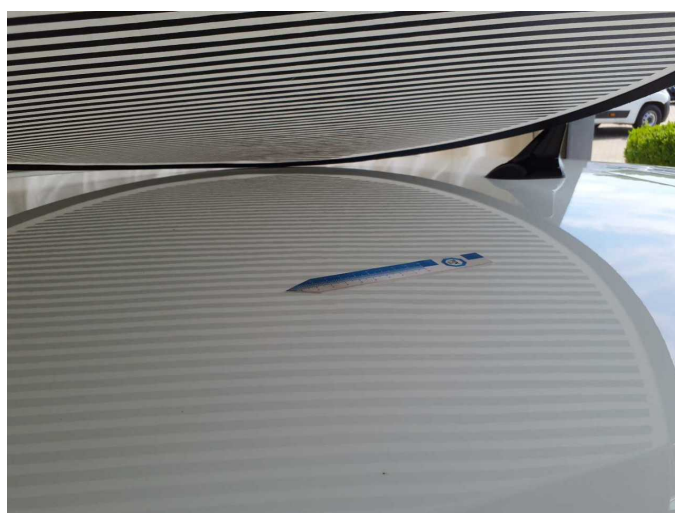
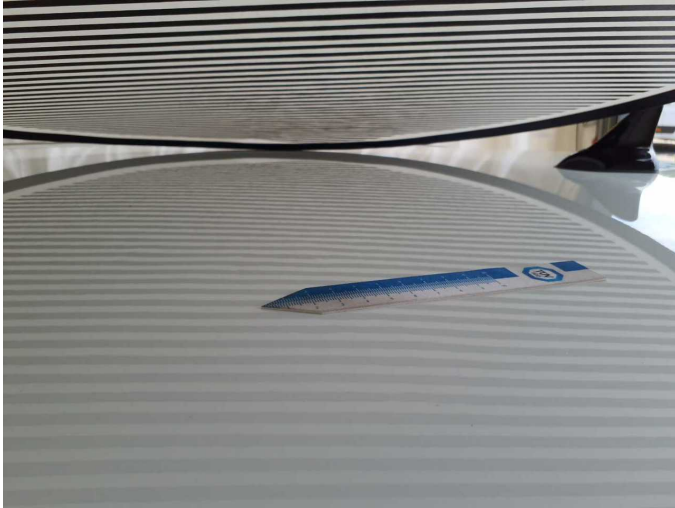
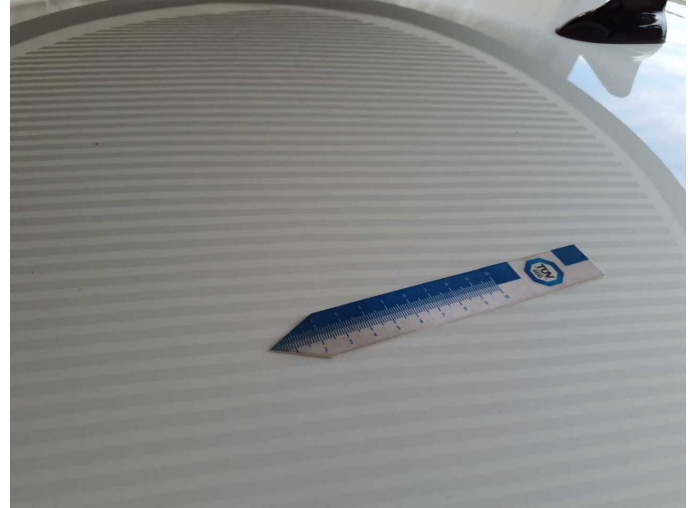
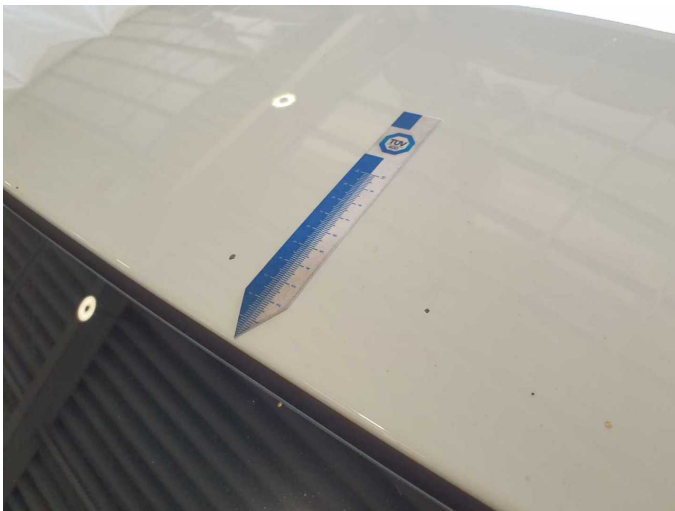
| No. | Component group | Description |
|---|---|---|
| 6 | Roof | Roof (Wellig) - Paint defect - Repair and paint |

**Damage 6:** Roof: Roof (Wellig) - Paint defect - Repair and paint
