Expertise

Protocol number: 46106675
Order No. / Reference: 26558607
Inspection date: 23 Jun 2026

Manufacturer: Renault

Model: Twingo Electric ZEN

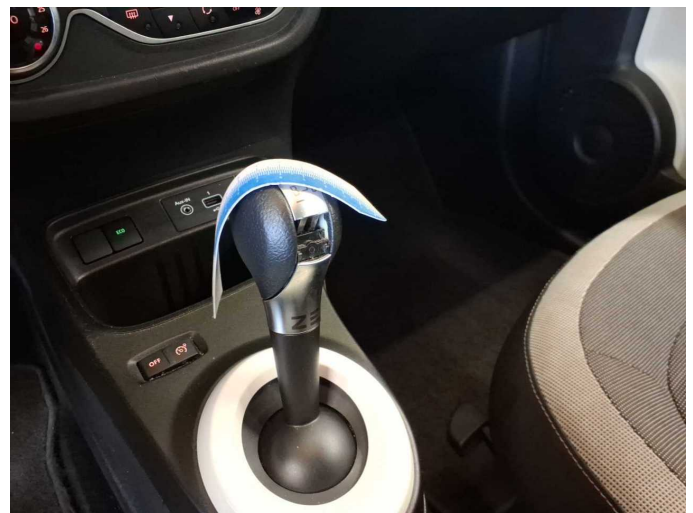
Damage 1: Gearbox: Gear knob - Damaged - Replace

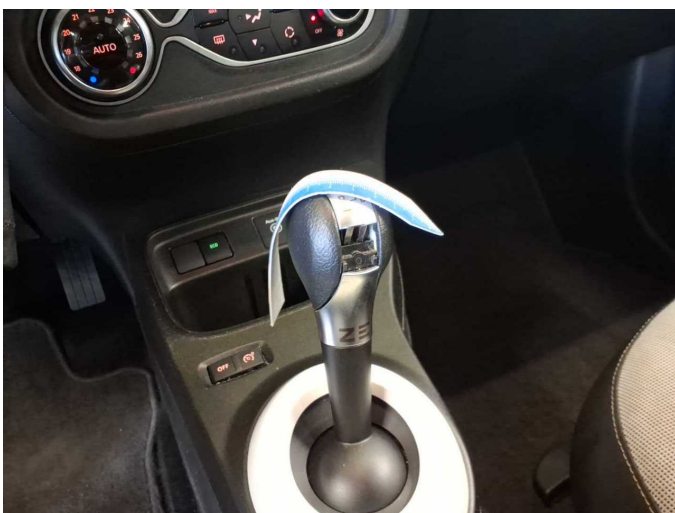
Damage 1: Gearbox: Gear knob - Damaged - Replace

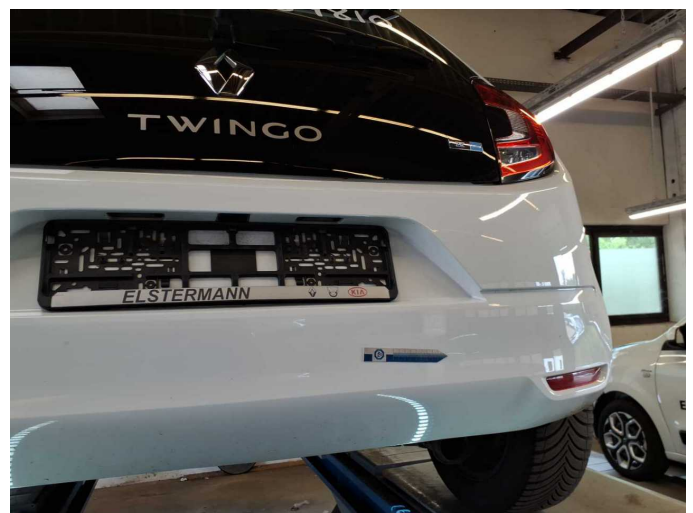
Damage 2: Rear bumper: Rear bumper - Scratch(es) - Smart repair

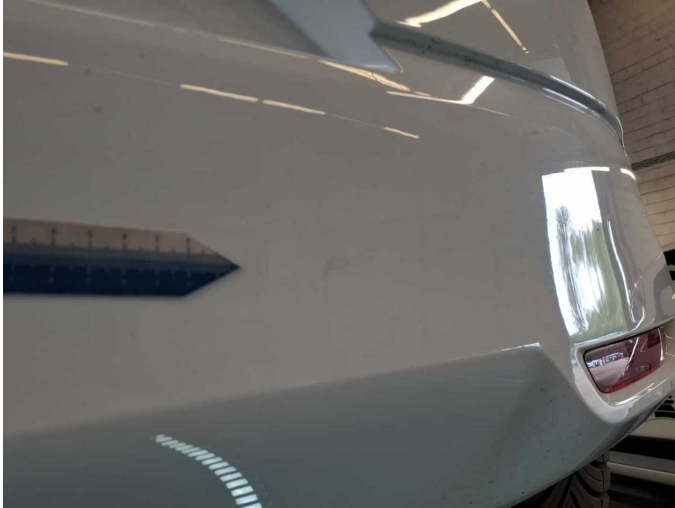
Damage 2: Rear bumper: Rear bumper - Scratch(es) - Smart repair

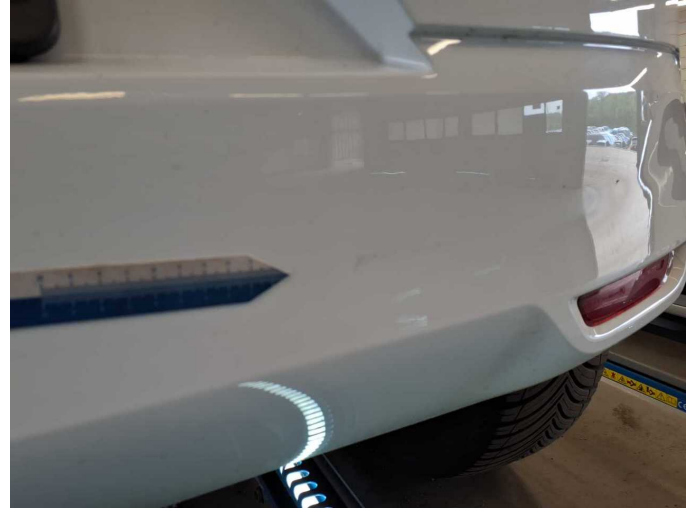
Damage 2: Rear bumper: Rear bumper - Scratch(es) - Smart repair

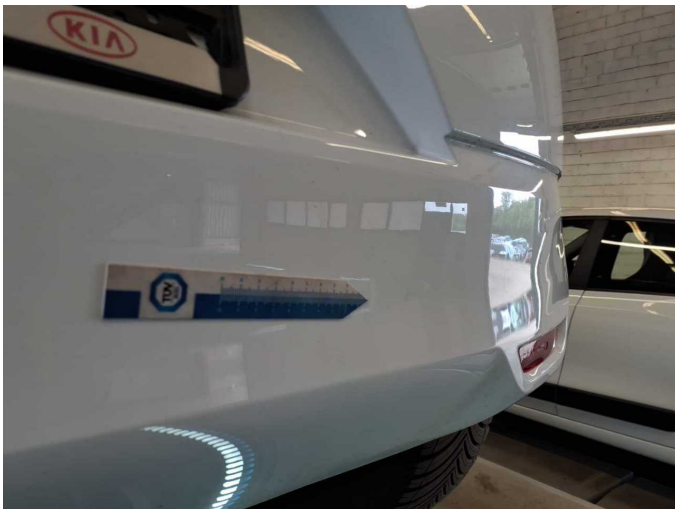
Damage 2: Rear bumper: Rear bumper - Scratch(es) - Smart repair

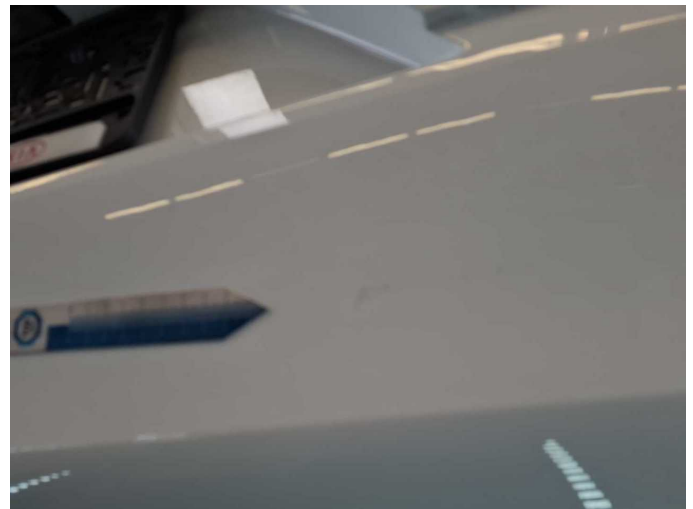
Damage 2: Rear bumper: Rear bumper - Scratch(es) - Smart repair

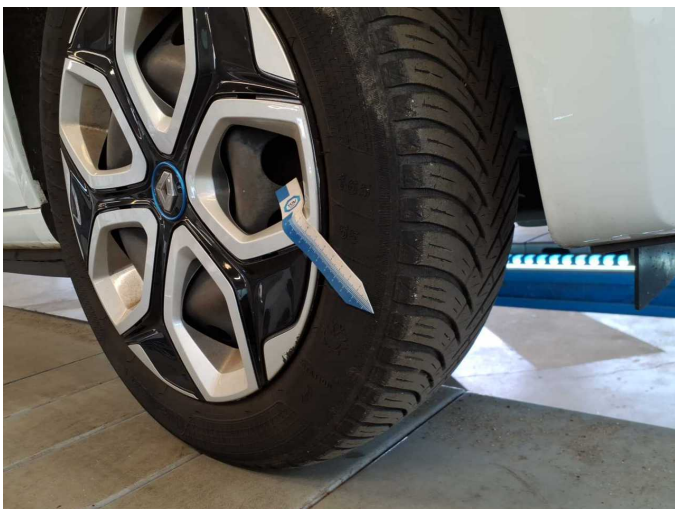
Damage 3: Wheel / tyres: Tyre - front (Rechts und links) - Does not meet the leasing specifications - Replace

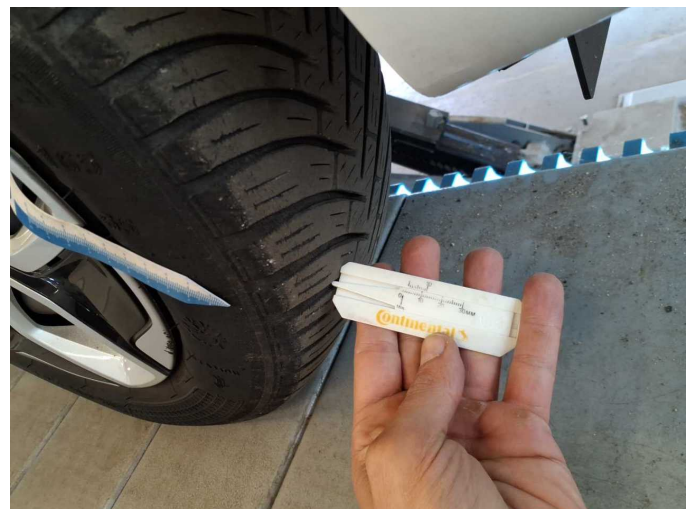
Damage 3: Wheel / tyres: Tyre - front (Rechts und links) - Does not meet the leasing specifications - Replace

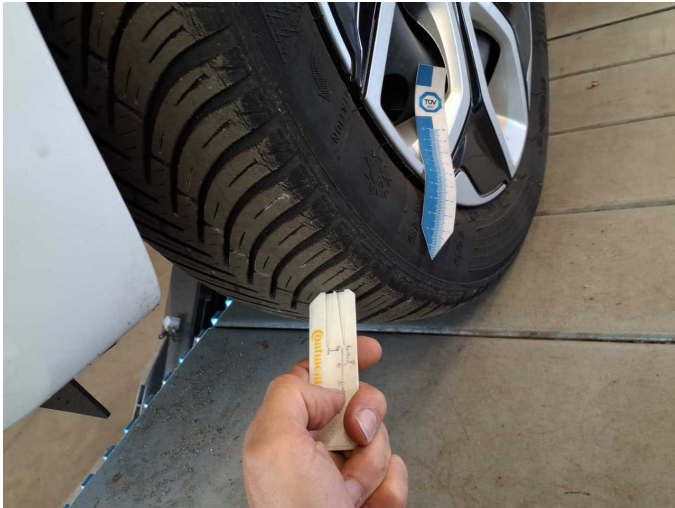
Damage 3: Wheel / tyres: Tyre - front (Rechts und links) - Does not meet the leasing specifications - Replace

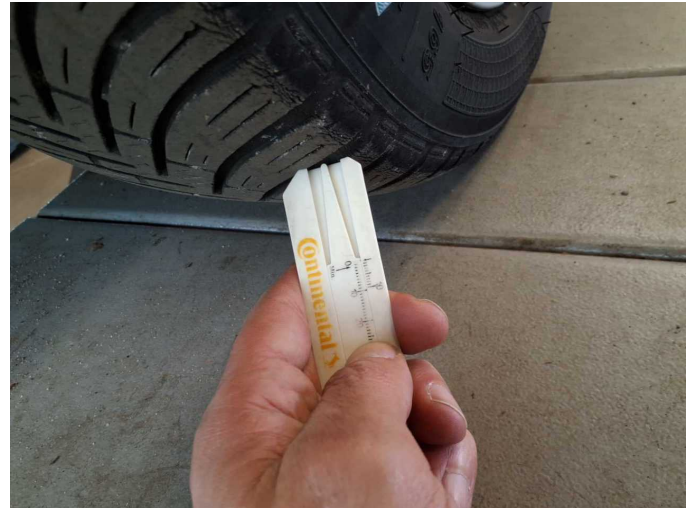
Damage 3: Wheel / tyres: Tyre - front (Rechts und links) - Does not meet the leasing specifications - Replace

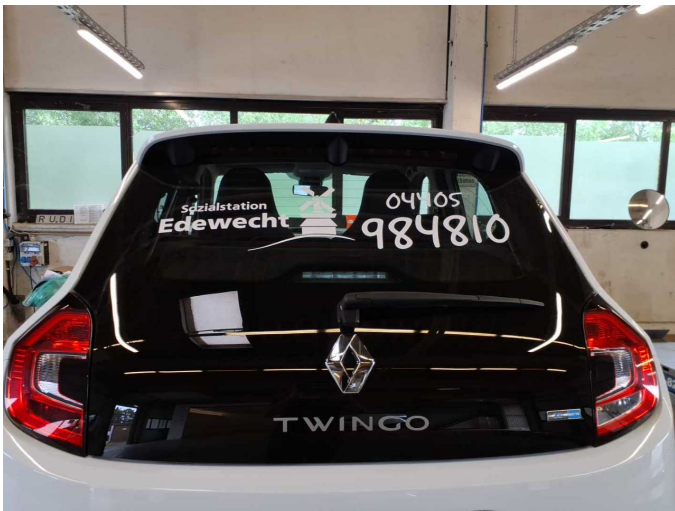
Damage 4: Body: Body - Glued / labelled - De-glug / neutralise

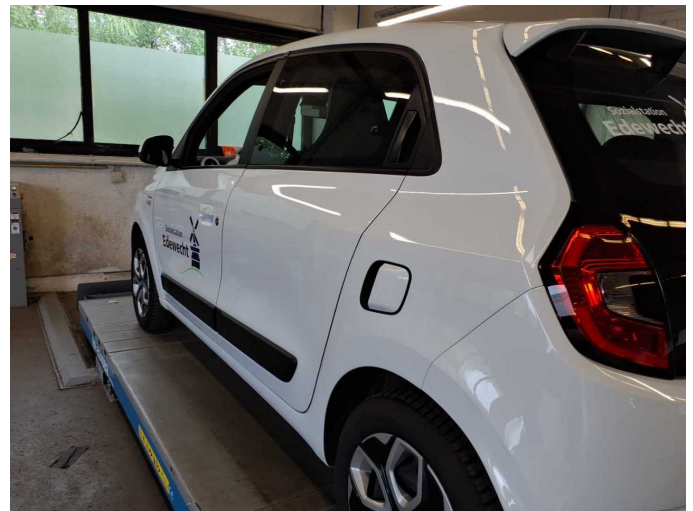
Damage 4: Body: Body - Glued / labelled - De-glug / neutralise

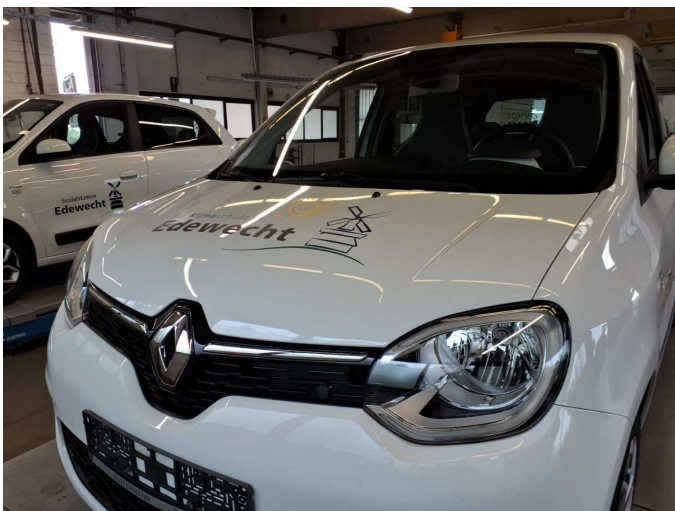
Damage 4: Body: Body - Glued / labelled - De-glug / neutralise

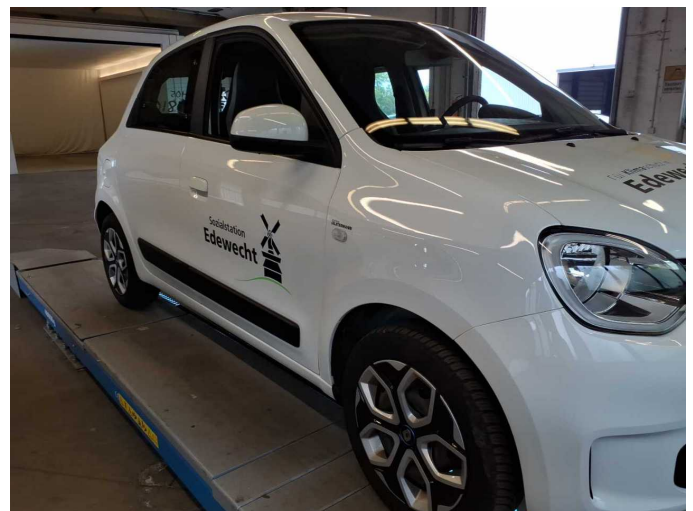
Damage 4: Body: Body - Glued / labelled - De-glug / neutralise

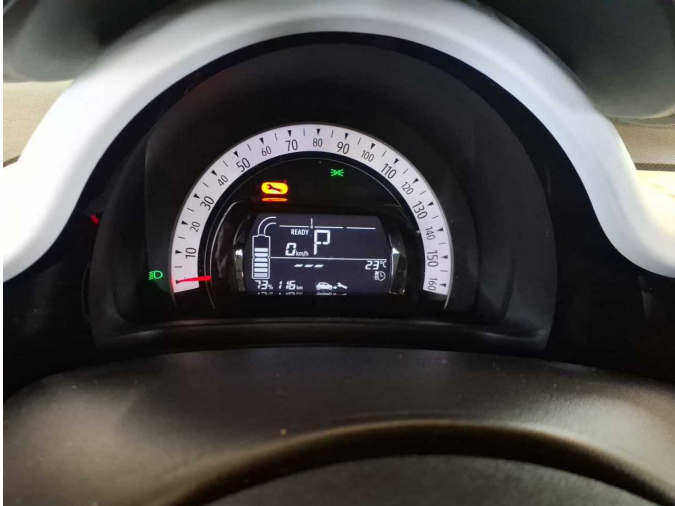
Damage 5: Misc.: Inspection / maintenance - Due - Perform

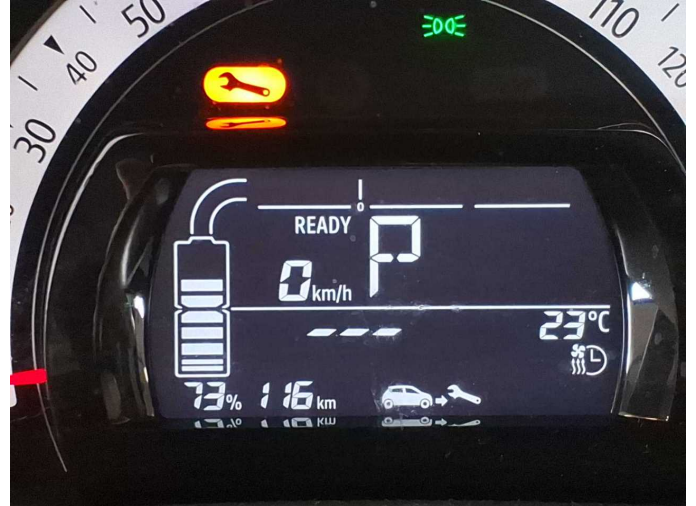
Damage 5: Misc.: Inspection / maintenance - Due - Perform

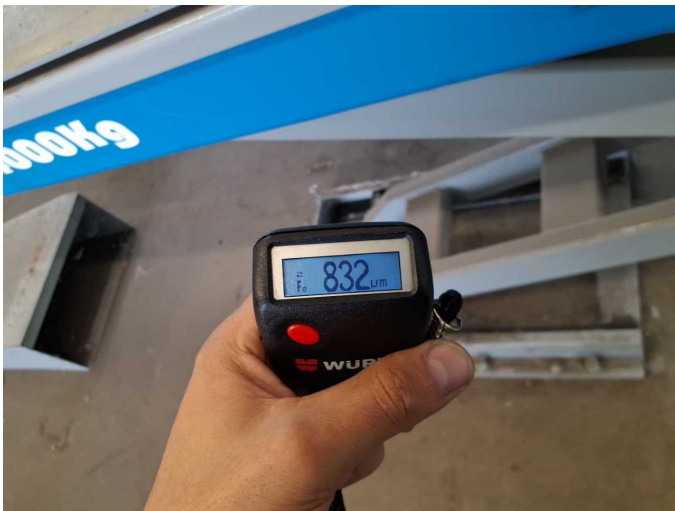
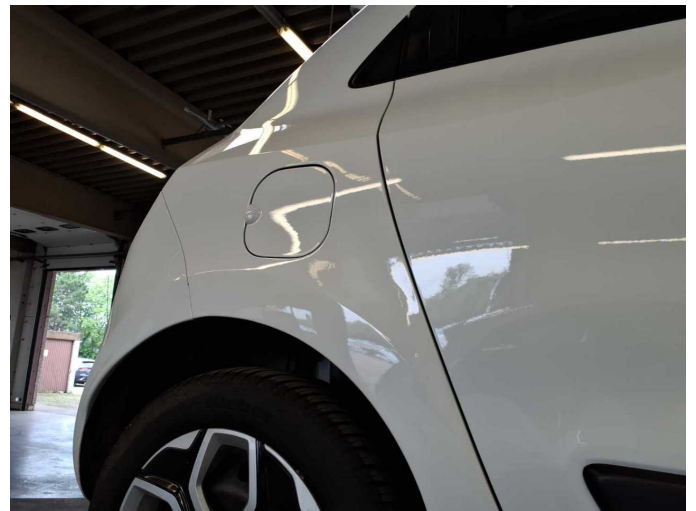
Repainting 1: Side panel - rear right side

No.	Repainting
1	Side panel - rear right side, Professionally carried out, Invoice of repair done Non-existent

Side panel - rear right side	832 µm
------------------------------	--------
