Expertise

Protocol number: 45799602
Order No. / Reference: 26327123
Inspection date: 22 May 2026

Manufacturer: Volkswagen

Model: Passat Variant 2.0 TDI SCR DSG Business

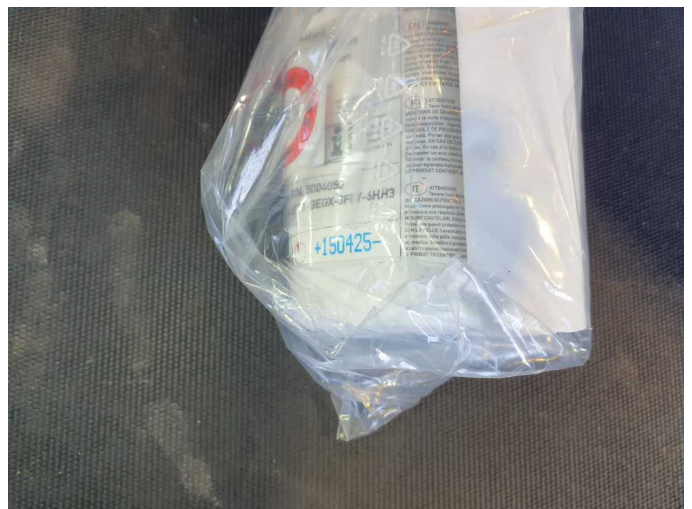
Damage 1: Equipment: Tirefit filler - Expired - Replace

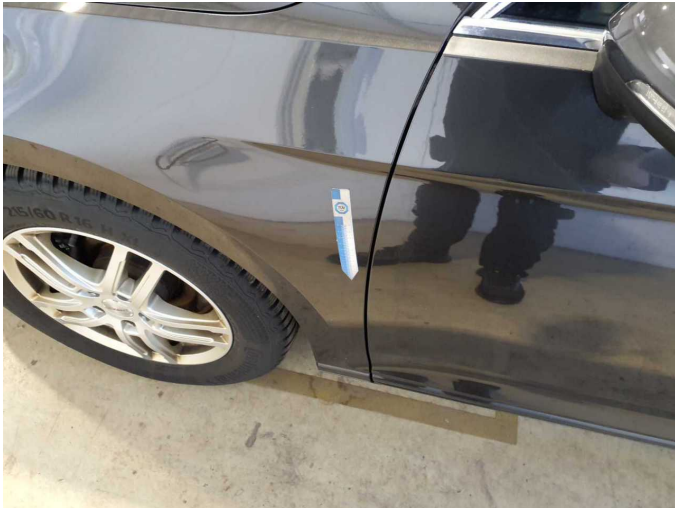
Damage 2: Mudguard - left side: Mudguard - left side - dent(s) - Smooth repair work

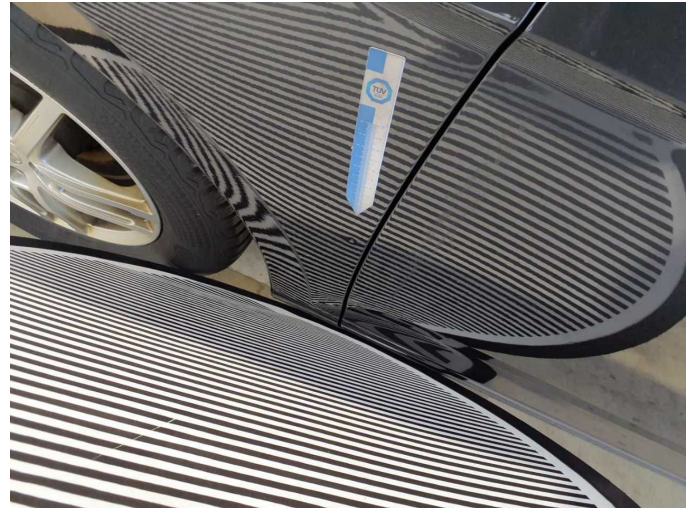
Damage 2: Mudguard - left side: Mudguard - left side - dent(s) - Smooth repair work

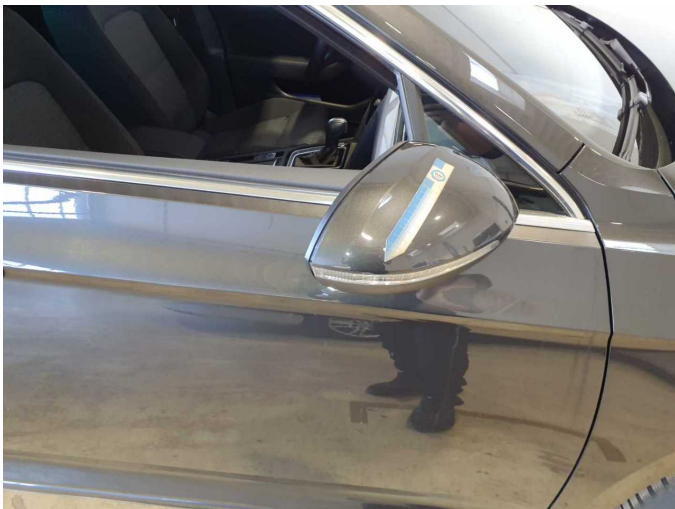
Damage 3: Indicator - front: Mirror - right side - Scratch(es) - Replace

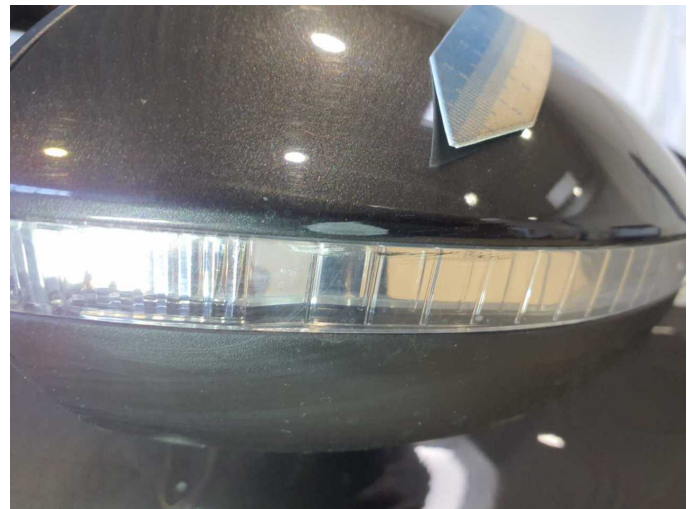
Damage 3: Indicator - front: Mirror - right side - Scratch(es) - Replace

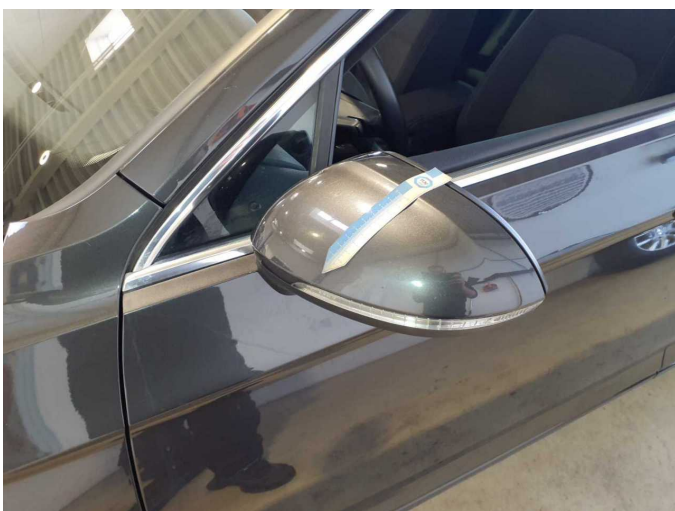
Damage 4: Wing mirror - left side: Cap - Scratch(es) - Paint

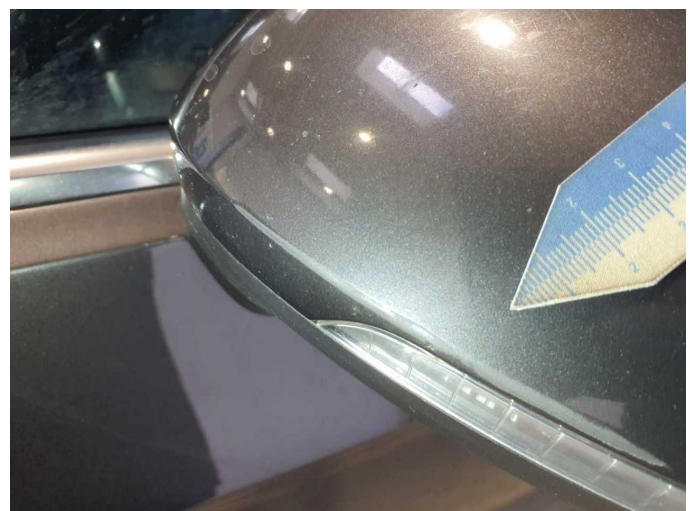
Damage 4: Wing mirror - left side: Cap - Scratch(es) - Paint

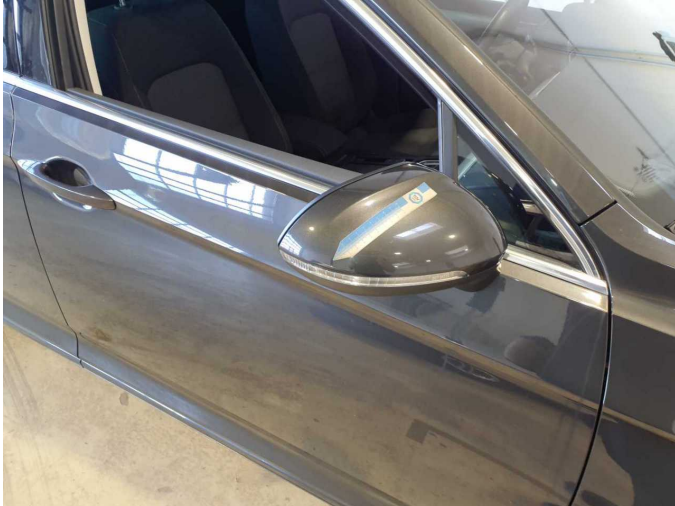
Damage 5: Wing mirror - right side: Cap - Scratch(es) - Paint

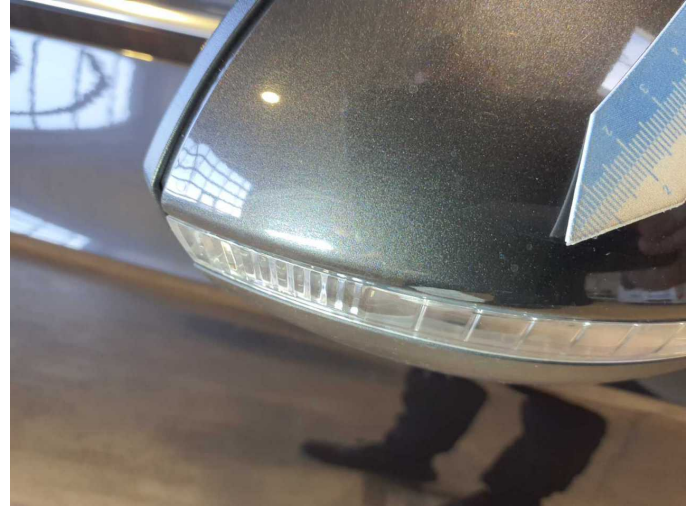
Damage 5: Wing mirror - right side: Cap - Scratch(es) - Paint

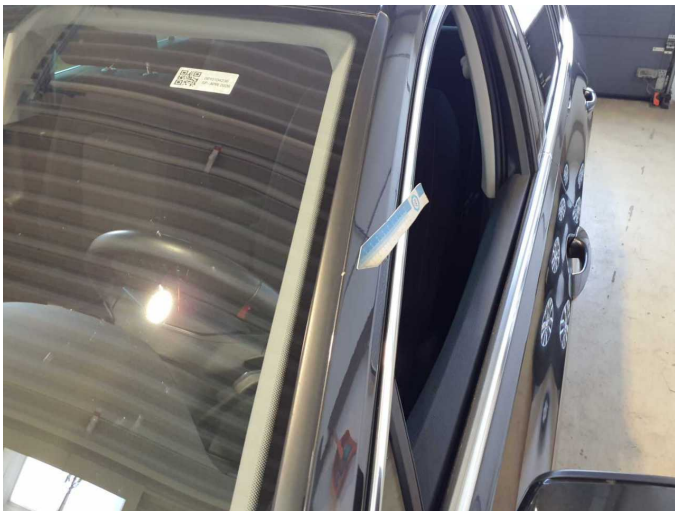
Damage 6: Body: A-pillar - left side - Stone chips - Smart repair

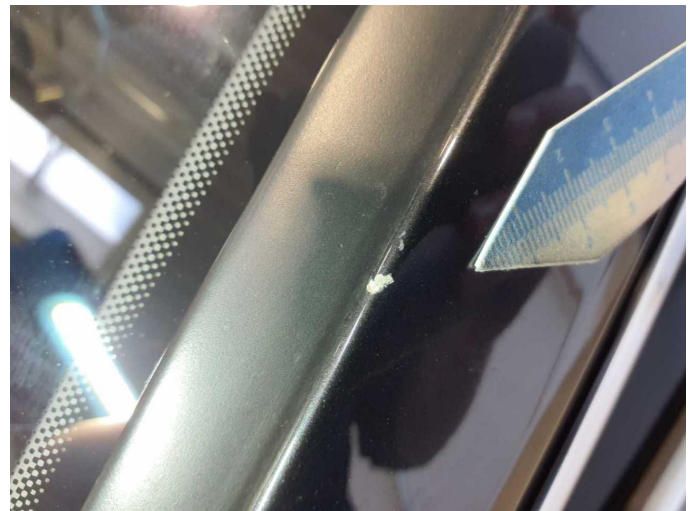
Damage 6: Body: A-pillar - left side - Stone chips - Smart repair

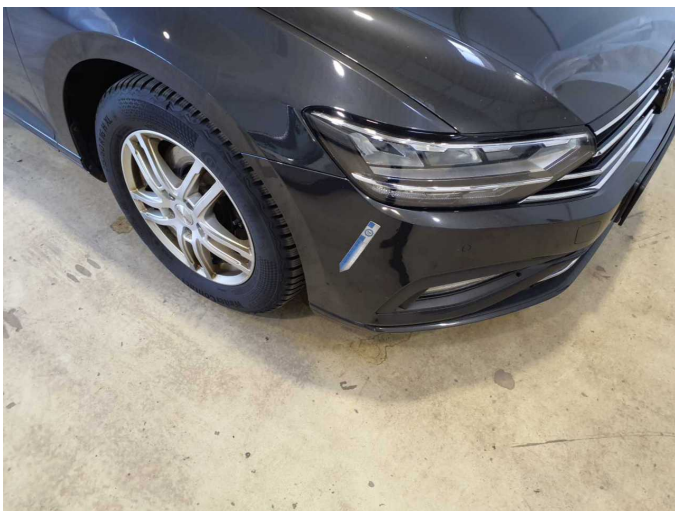
Damage 7: Front bumper: Front bumper - Scratch(es) - Smart repair

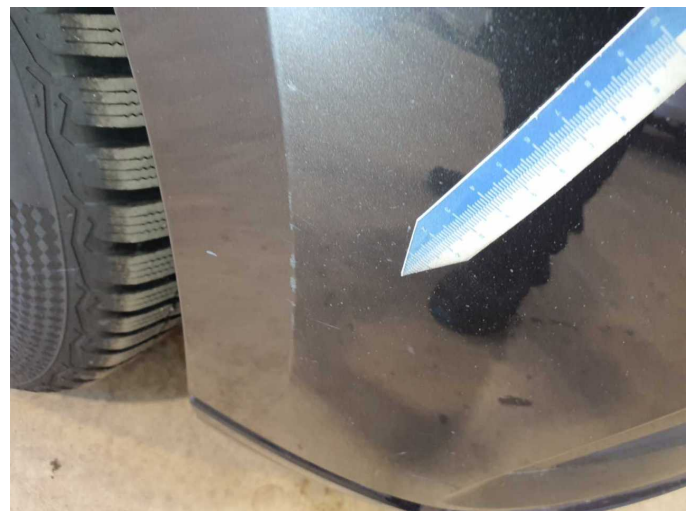
Damage 7: Front bumper: Front bumper - Scratch(es) - Smart repair

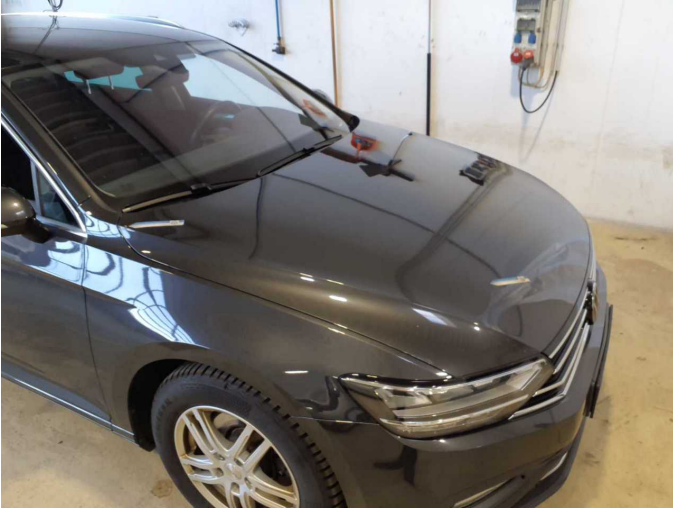
Damage 8: Bonnet: Bonnet - Dent / paintcoat damage - Repair and paint

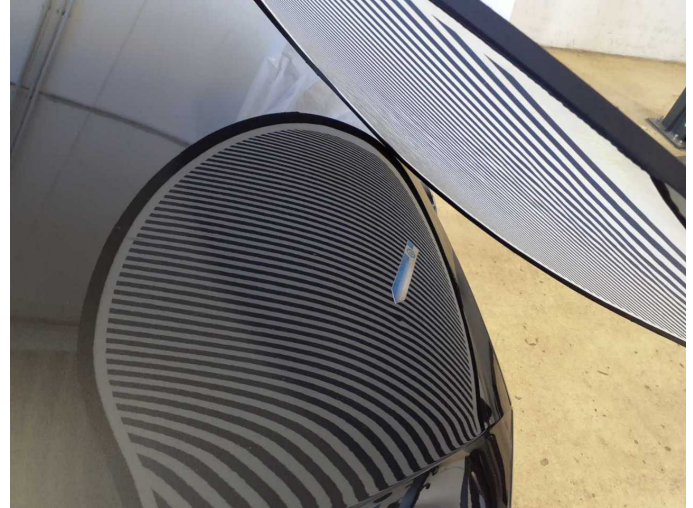
Damage 8: Bonnet: Bonnet - Dent / paintcoat damage - Repair and paint

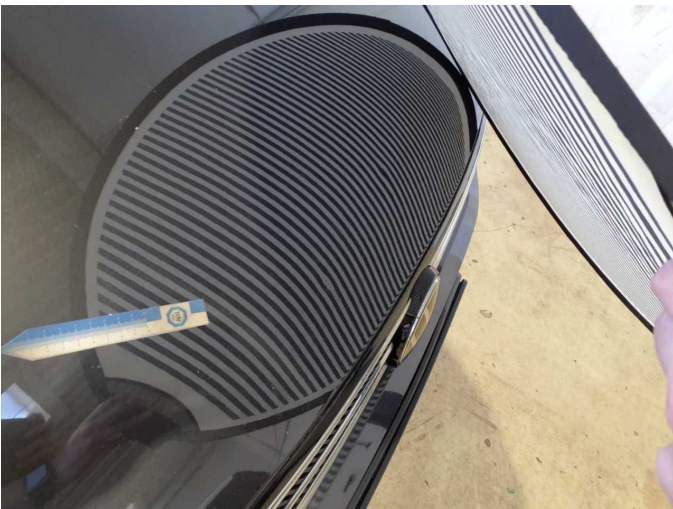
Damage 8: Bonnet: Bonnet - Dent / paintcoat damage - Repair and paint

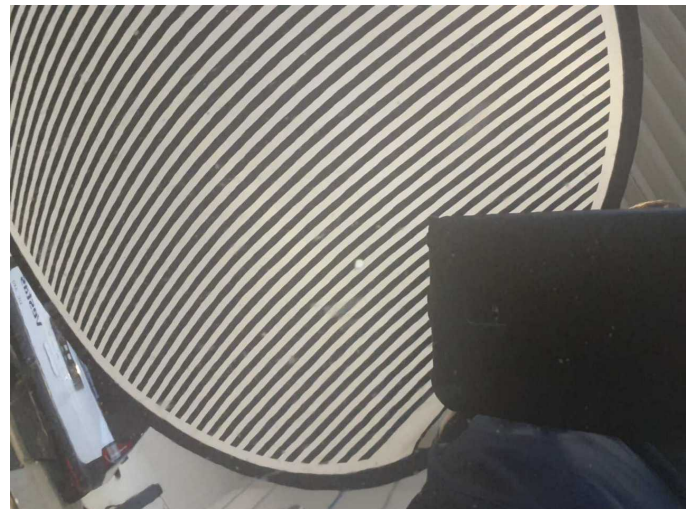
Damage 8: Bonnet: Bonnet - Dent / paintcoat damage - Repair and paint

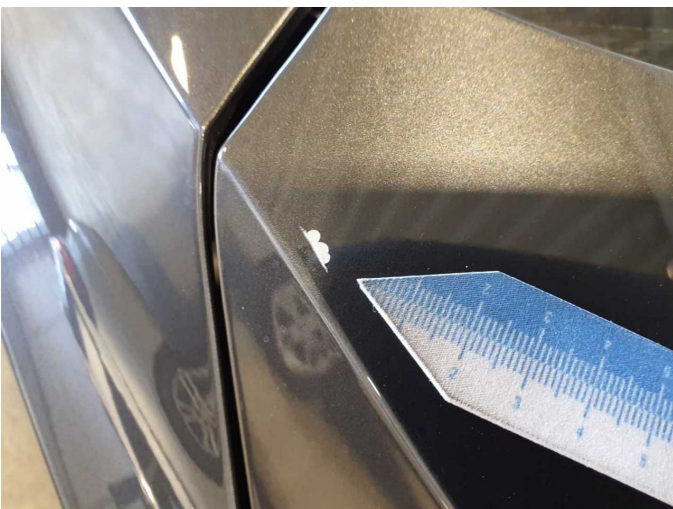
Damage 8: Bonnet: Bonnet - Dent / paintcoat damage - Repair and paint

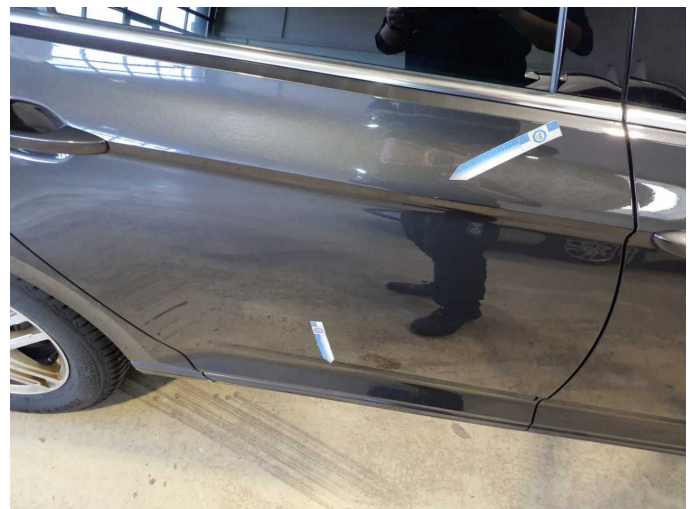
Damage 9: Door - rear right side: Door - Scratch(es) - Paint

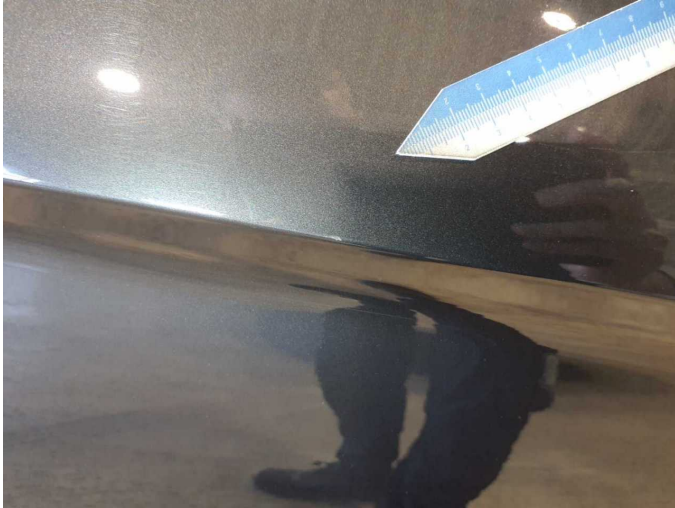
Damage 9: Door - rear right side: Door - Scratch(es) - Paint

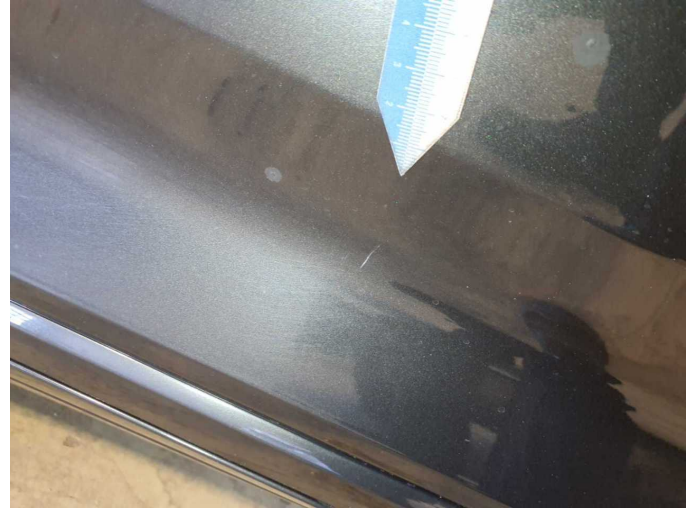
Damage 9: Door - rear right side: Door - Scratch(es) - Paint

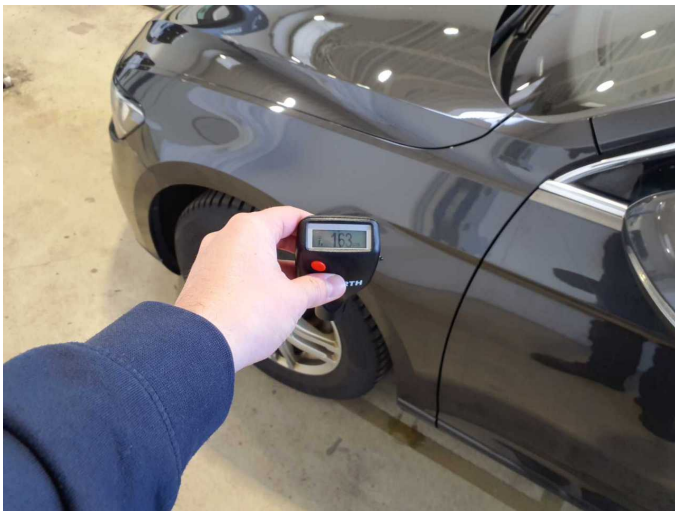
Mudguard - left side	163 µm	Door - rear left side	170 µm
----------------------	--------	-----------------------	--------

Repainting 1: Mudguard - left side

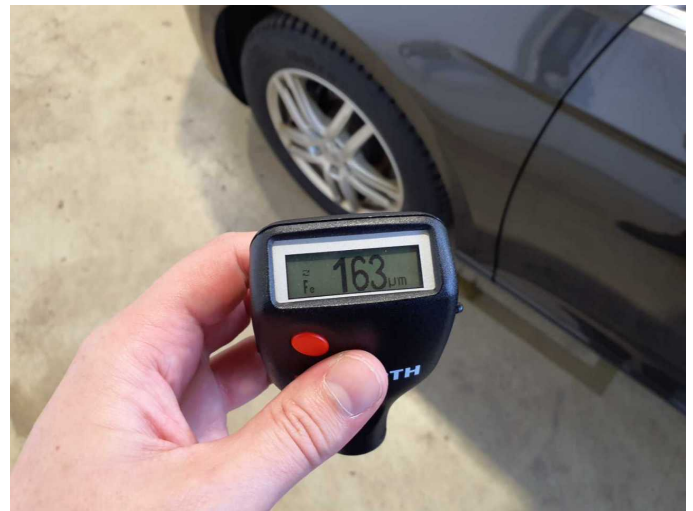
Repainting 1: Mudguard - left side

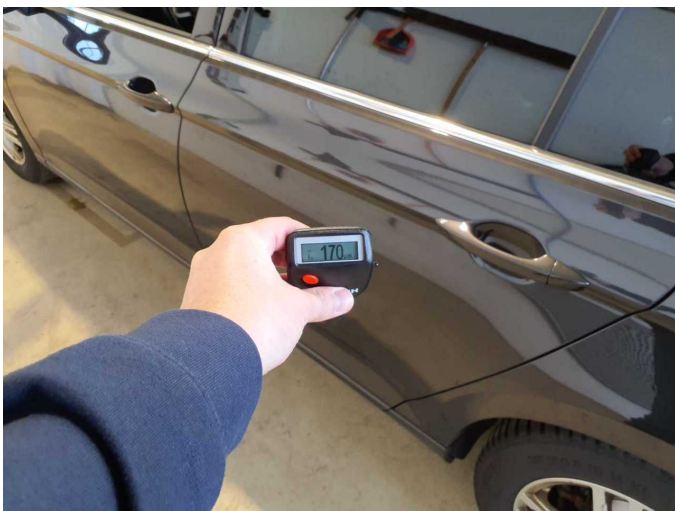
Repainting 2: Door - rear left side

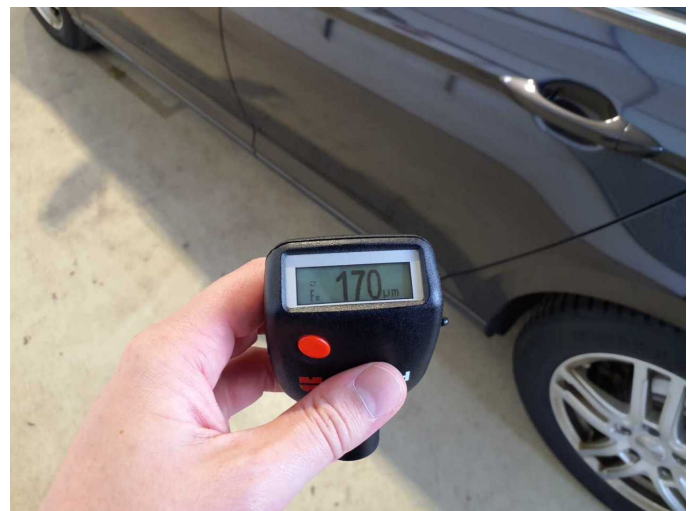
Repainting 2: Door - rear left side
