Expertise

Protocol number: 45990728
Order No. / Reference: 26603802
Inspection date: 17 Jun 2026

Model: Caddy 2.0 TDI BMT (5-Si.) 4MOTION Caddy

VIN: WV2ZZZSKZNX058822

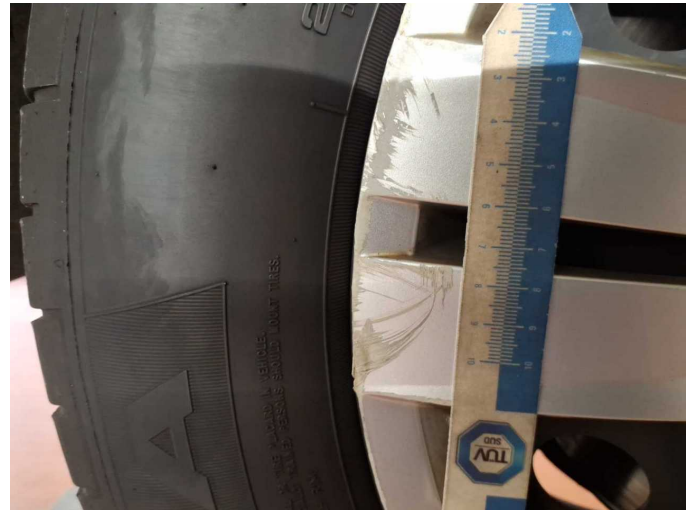
| No. | Component group | Description |
|---|---|---|
| 1 | Wheel / tyres | Wheel cover - front right side - Scratched - Replace |

Damage 1: Wheel / tyres: Wheel cover - front right side - Scratched - Replace

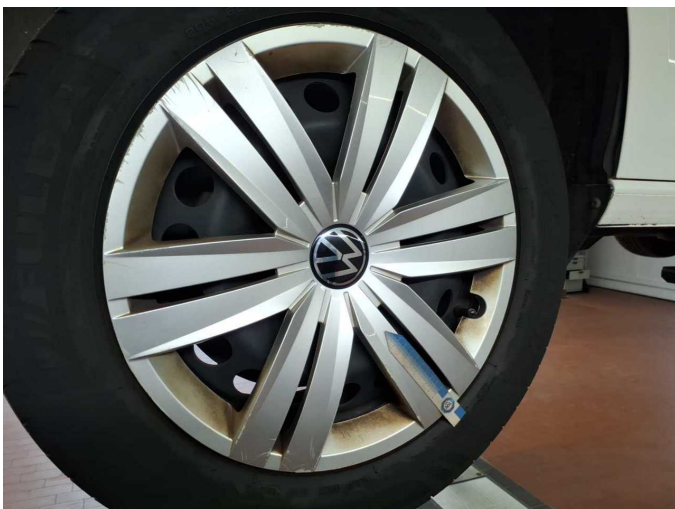
Damage 1: Wheel / tyres: Wheel cover - front right side - Scratched - Replace

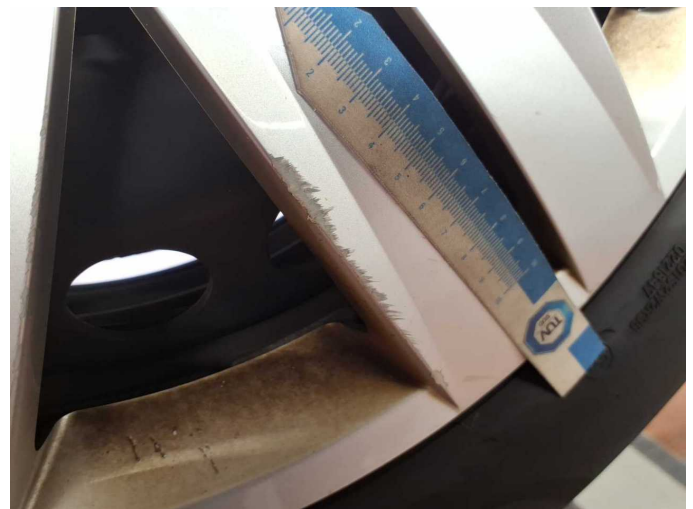
| No. | Component group | Description |
|---|---|---|
| 2 | Wheel / tyres | Wheel cover - rear right side - Scratched - Replace |

Damage 2: Wheel / tyres: Wheel cover - rear right side - Scratched - Replace

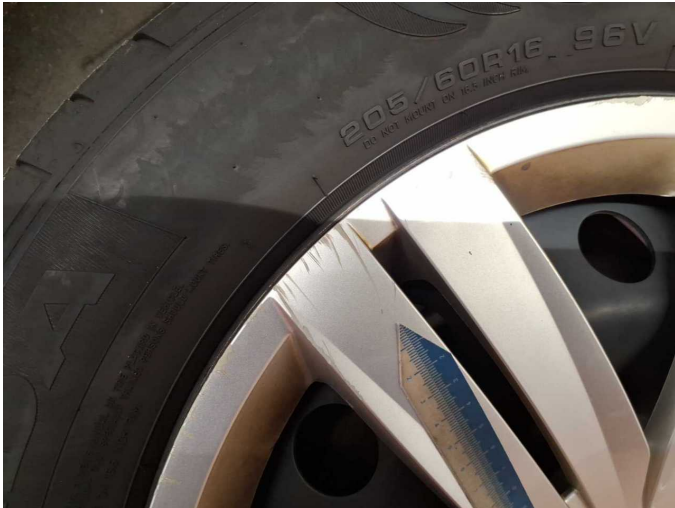
Damage 2: Wheel / tyres: Wheel cover - rear right side - Scratched - Replace

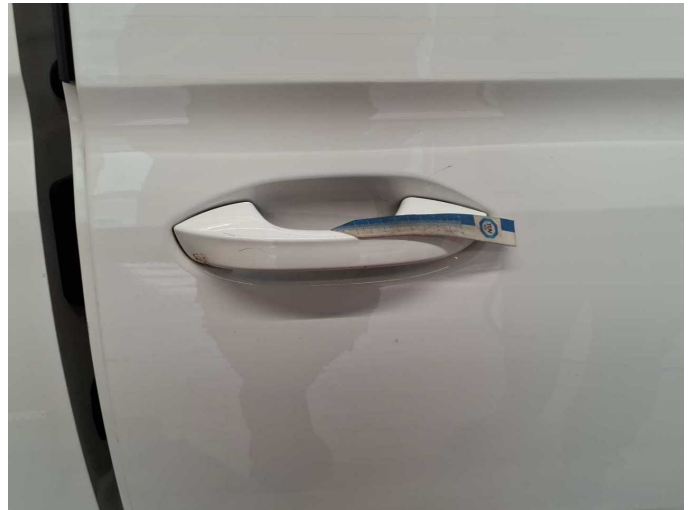
| No. | Component group | Description |
|---|---|---|
| 4 | Door - rear left side | Door handle - outside - Scratch(es) - Smart repair |

Damage 4: Door - rear left side: Door handle - outside - Scratch(es) - Smart repair

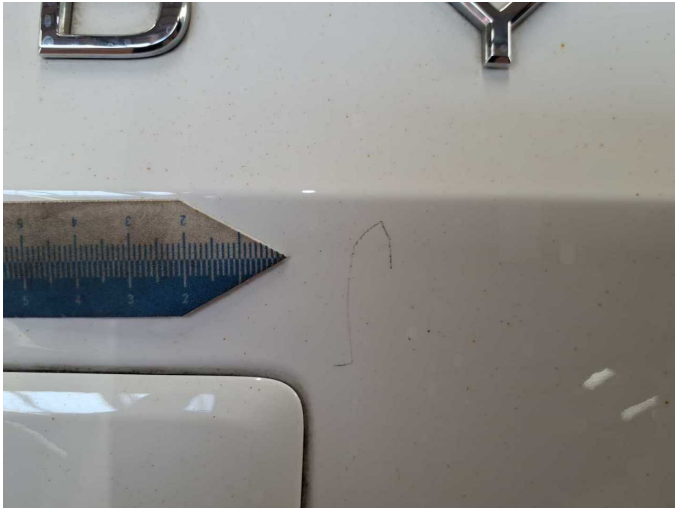
| No. | Component group | Description |
|---|---|---|
| 6 | Boot lid / rear door | Boot lid - Scratch(es) - Smart repair |

Damage 6: Boot lid / rear door: Boot lid - Scratch(es) - Smart repair

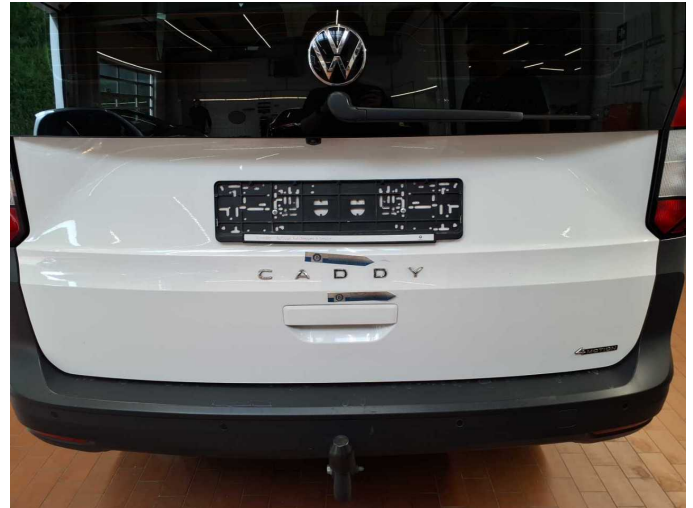
Damage 6: Boot lid / rear door: Boot lid - Scratch(es) - Smart repair

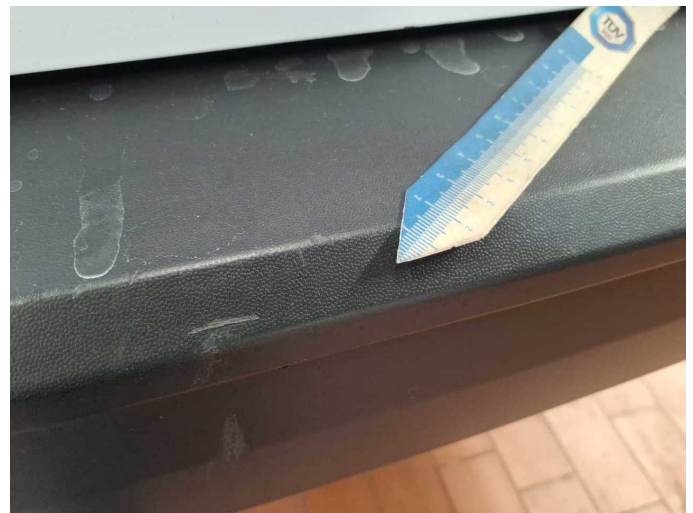
| No. | Component group | Description |
|---|---|---|
| 7 | Rear bumper | Rear bumper (unpainted) - Scratch(es) - Loss in value |

Damage 7: Rear bumper: Rear bumper (unpainted) - Scratch(es) - Loss in value

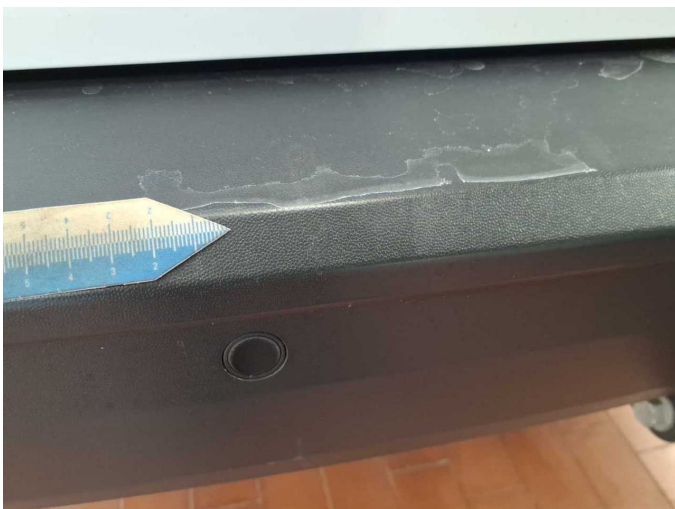
Damage 7: Rear bumper: Rear bumper (unpainted) - Scratch(es) - Loss in value

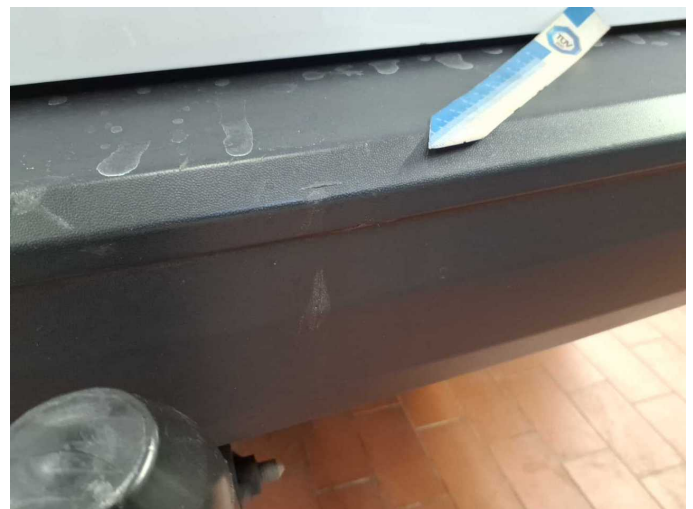
Damage 7: Rear bumper: Rear bumper (unpainted) - Scratch(es) - Loss in value

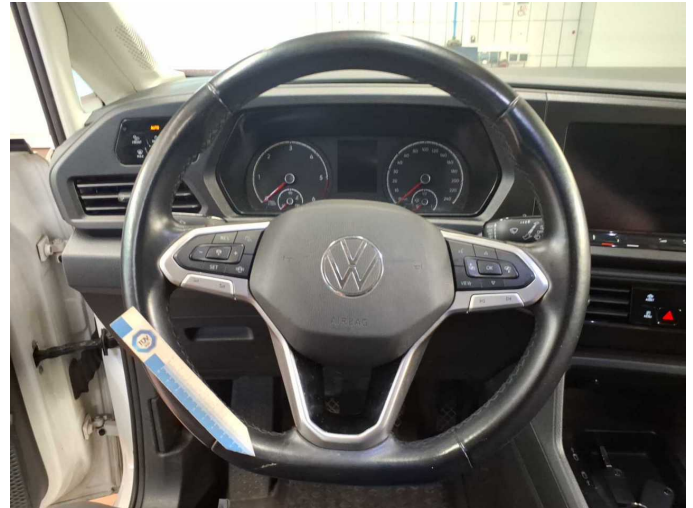
| No. | Component group | Description |
|---|---|---|
| 8 | Steering system | Steering wheel - Scratch(es) - Loss in value |

Damage 8: Steering system: Steering wheel - Scratch(es) - Loss in value

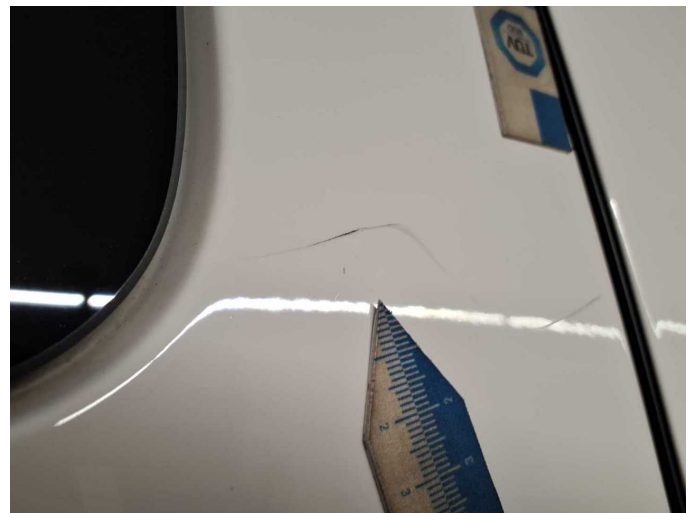
| No. | Component group | Description |
|---|---|---|
| 9 | Sliding door, right | Sliding door with glass panel - Scratch(es) - Smart repair |

Damage 9: Sliding door, right: Sliding door with glass panel - Scratch(es) - Smart repair

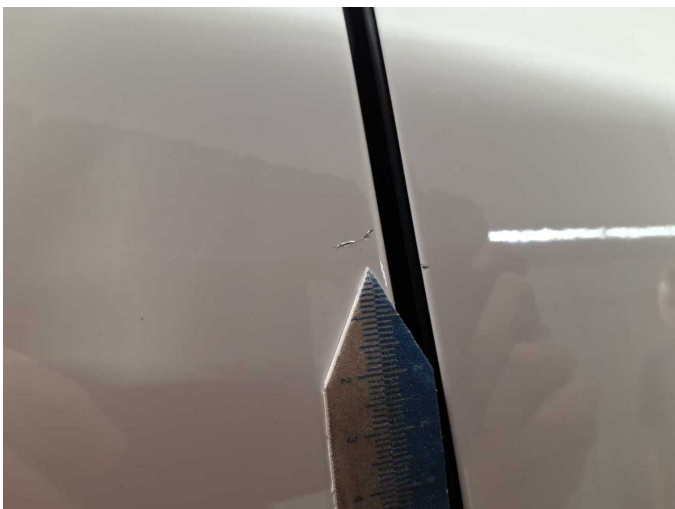
Damage 9: Sliding door, right: Sliding door with glass panel - Scratch(es) - Smart repair

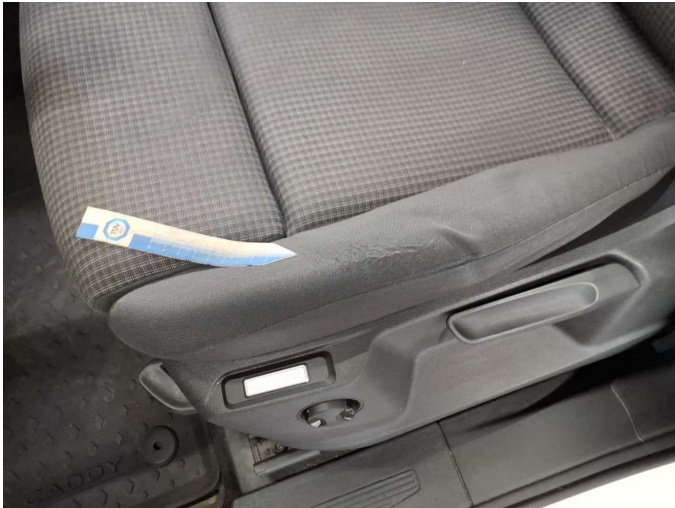
| No. | Component group | Description |
|---|---|---|
| 10 | Seat - front | Seat cover - left side - Broken / torn - Replace |

Damage 10: Seat - front: Seat cover - left side - Broken / torn - Replace

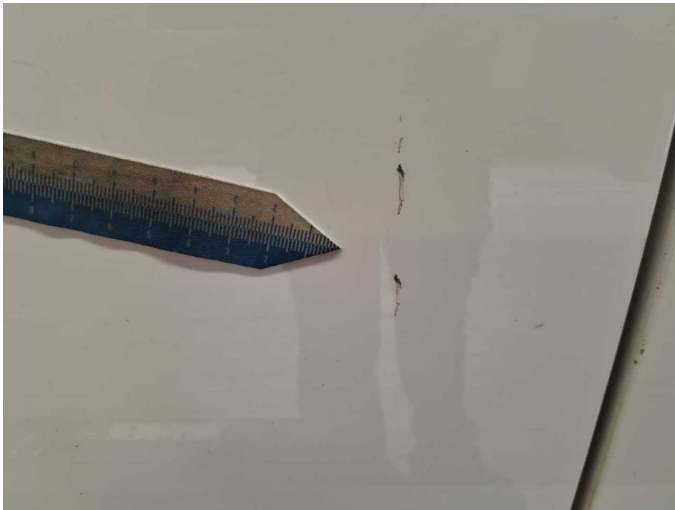
| No. | Component group | Description |
|---|---|---|
| 11 | Door - front left side | Door - Scratch(es) - Paint |

Damage 11: Door - front left side: Door - Scratch(es) - Paint

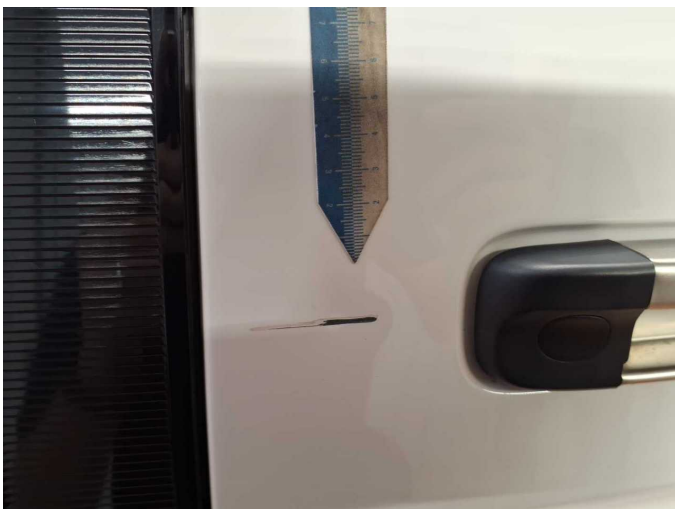
| No. | Component group | Description |
|---|---|---|
| 12 | Side panel - rear right side | Side panel - Dent / paintcoat damage - Repair and paint |

Damage 12: Side panel - rear right side: Side panel - Dent / paintcoat damage - Repair and paint

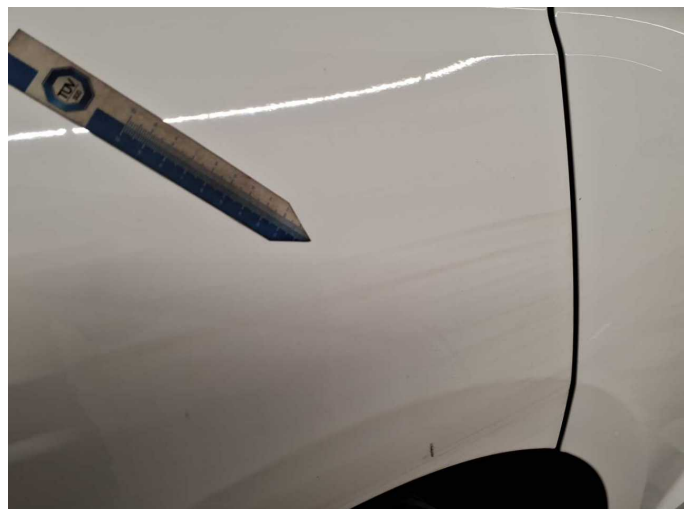
Damage 12: Side panel - rear right side: Side panel - Dent / paintcoat damage - Repair and paint

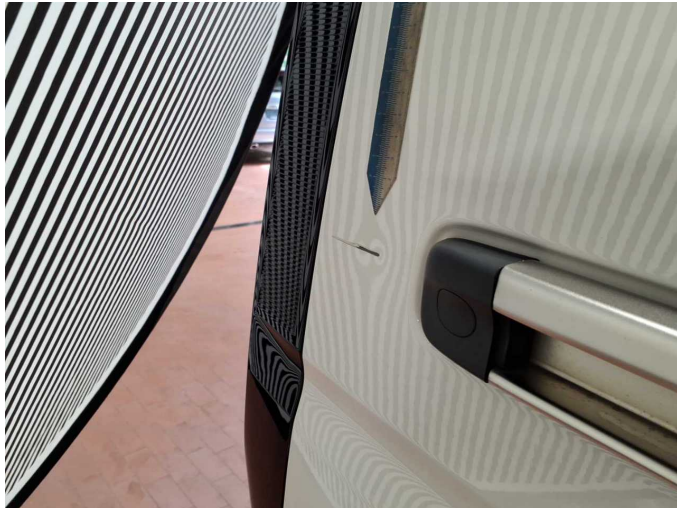
Damage 12: Side panel - rear right side: Side panel - Dent / paintcoat damage - Repair and paint

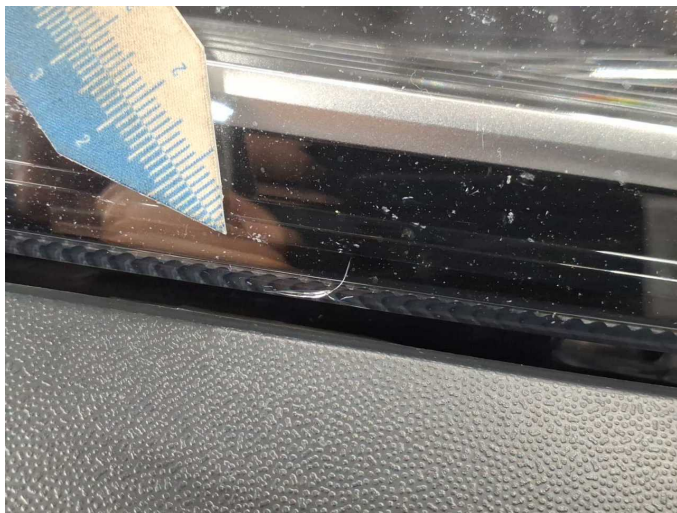
| No. | Component group | Description |
|---|---|---|
| 13 | Headlight | Headlight - right side - Broken / torn - Replace |

Damage 13: Headlight: Headlight - right side - Broken / torn - Replace

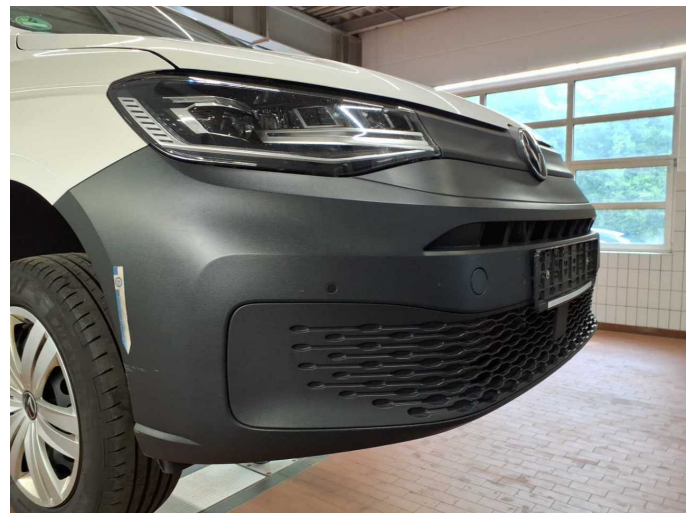
Damage 13: Headlight: Headlight - right side - Broken / torn - Replace

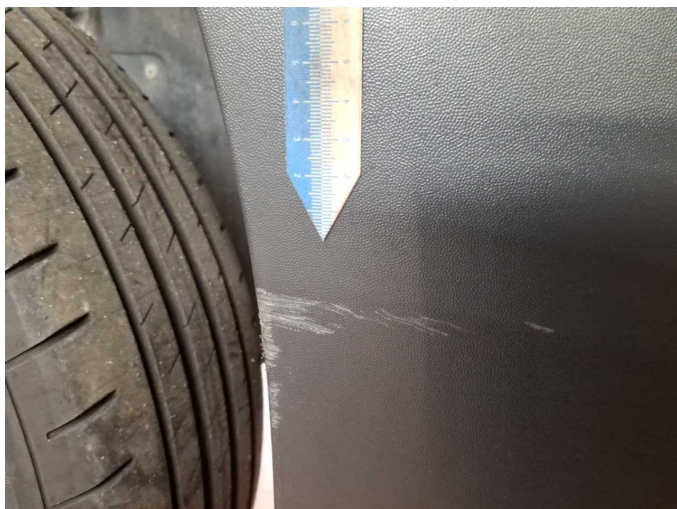
| No. | Component group | Description |
|---|---|---|
| 14 | Front bumper | Front bumper (unpainted) - Scratched - Replace |

Damage 14: Front bumper: Front bumper (unpainted) - Scratched - Replace

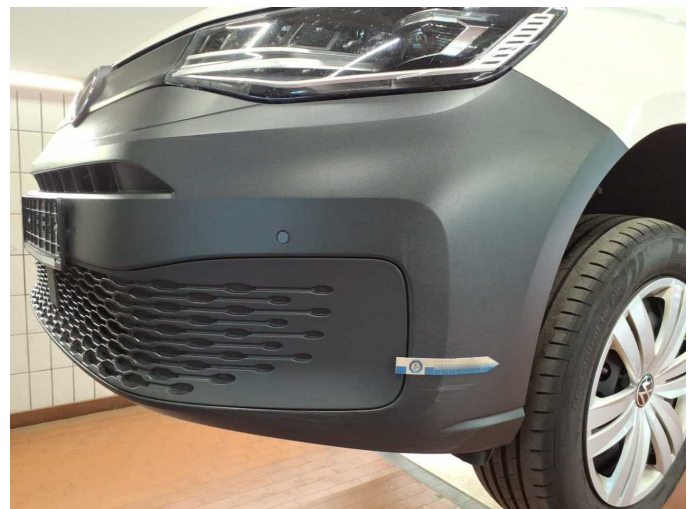
Damage 14: Front bumper: Front bumper (unpainted) - Scratched - Replace

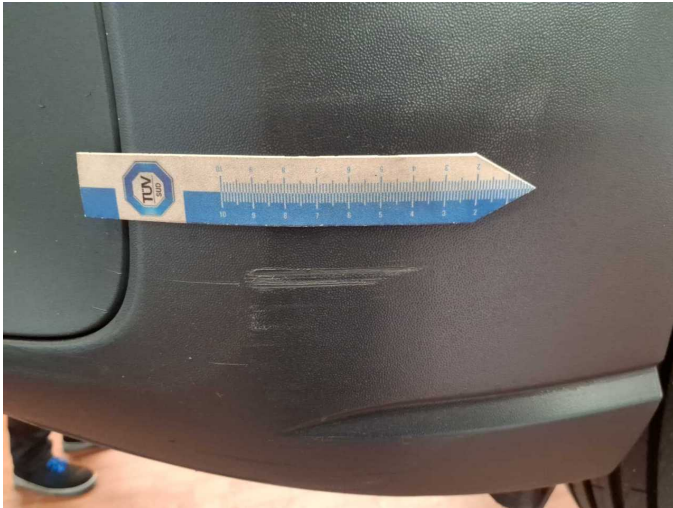
Damage 14: Front bumper: Front bumper (unpainted) - Scratched - Replace

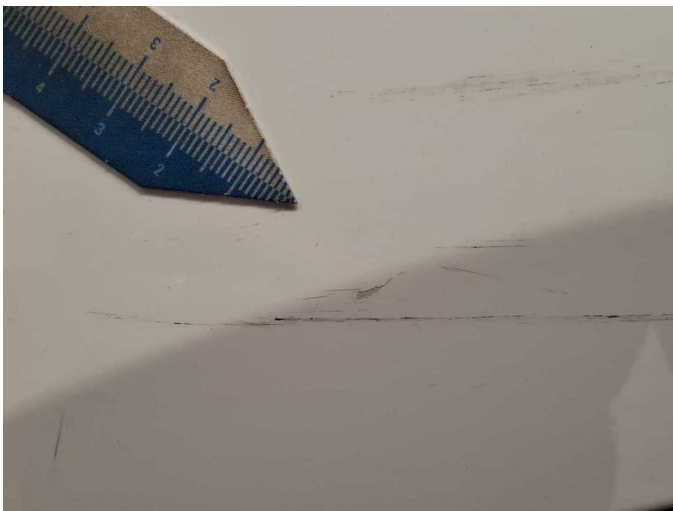
| No. | Component group | Description |
|---|---|---|
| 15 | Mudguard - left side | Mudguard - left side - Scratch(es) - Paint |

Damage 15: Mudguard - left side: Mudguard - left side - Scratch(es) - Paint

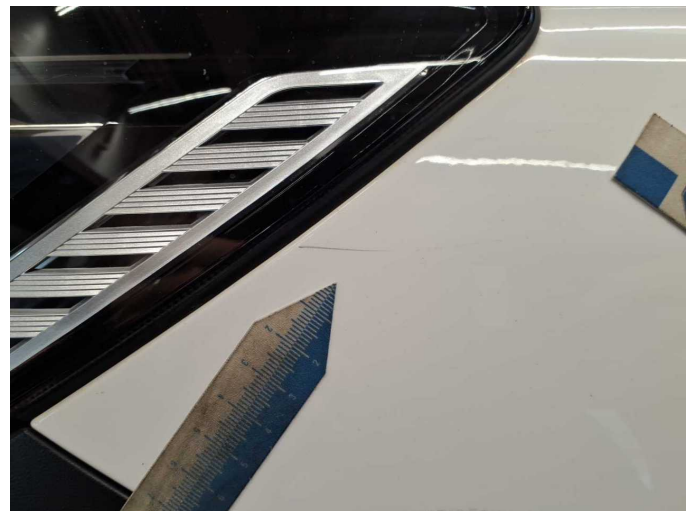
Damage 15: Mudguard - left side: Mudguard - left side - Scratch(es) - Paint

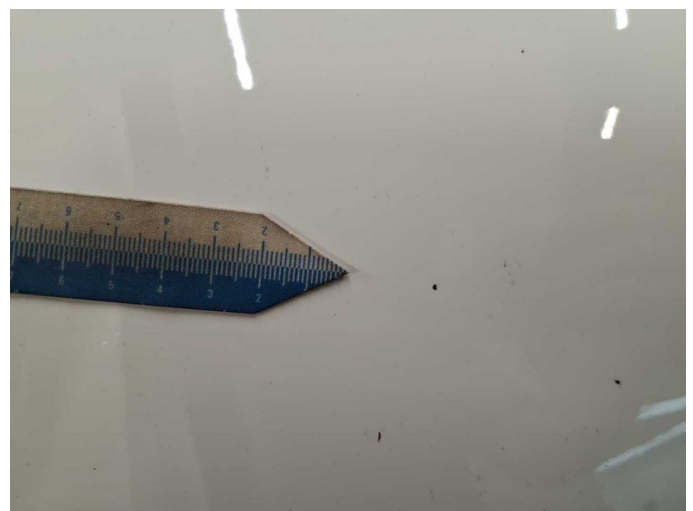
| No. | Component group | Description |
|---|---|---|
| 2 | Bonnet | Bonnet - Stone chips - No deduction |

Wear and tear 2: Bonnet: Bonnet - Stone chips - No deduction

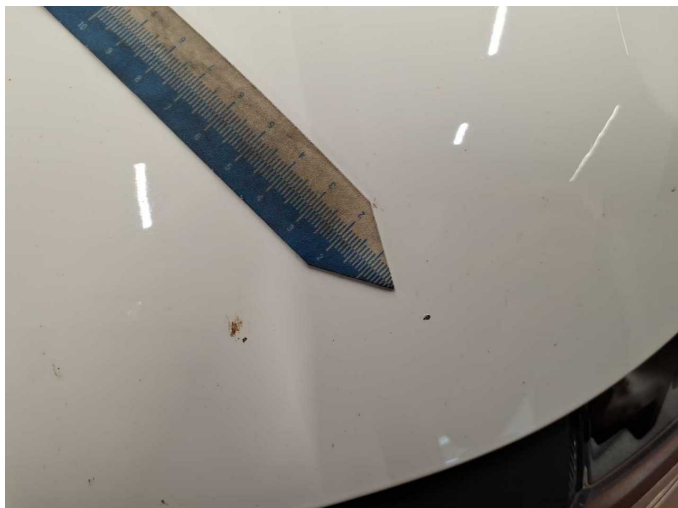
Wear and tear 2: Bonnet: Bonnet - Stone chips - No deduction

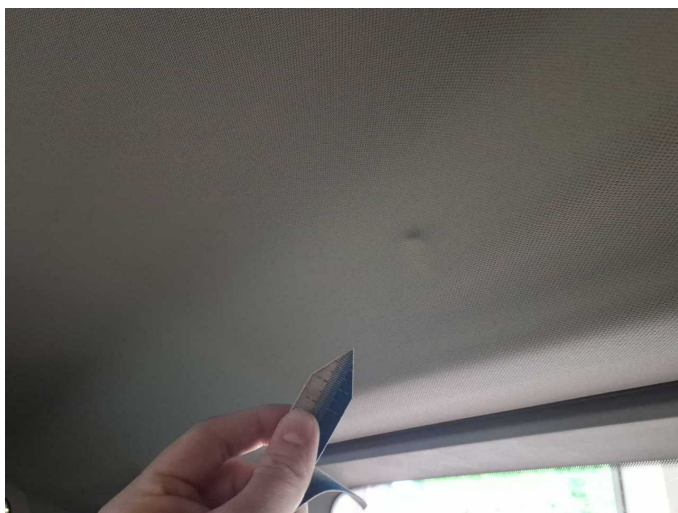
| No. | Component group | Description |
|---|---|---|
| 4 | Trim / covers | Roof lining - dent(s) - No deduction |

Wear and tear 4: Trim / covers: Roof lining - dent(s) - No deduction
