Expertise

Protocol number: 46175682
Order No. / Reference: 26495226
Inspection date: 25 Jun 2026

Manufacturer: Ford

Model: Transit Custom 320 L1H1 LKW VA Trend Kasten

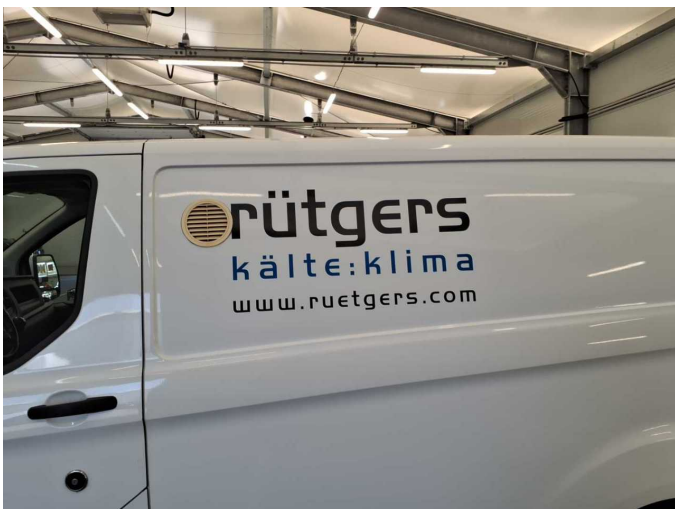
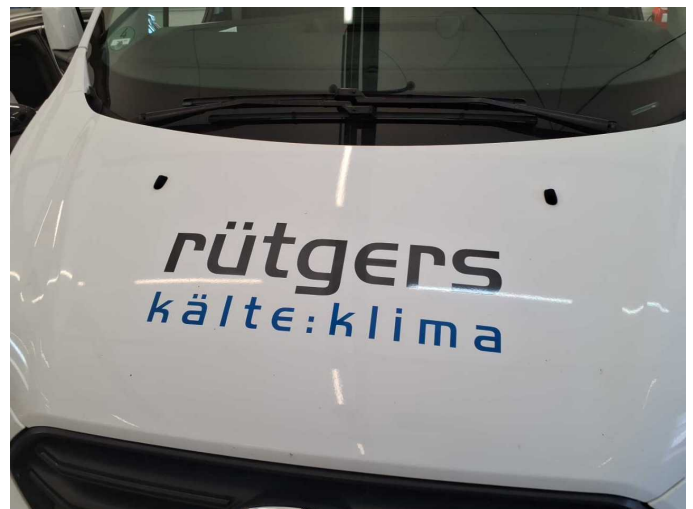
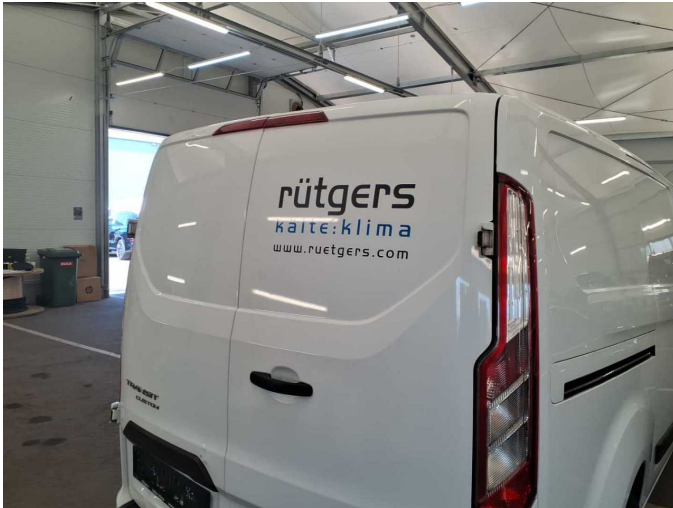
Damage 2: Body: Body - Glued / labelled - De-glue / neutralise

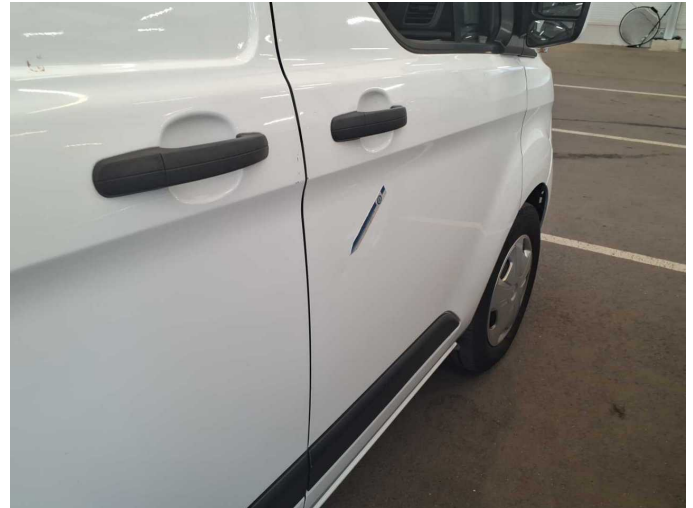
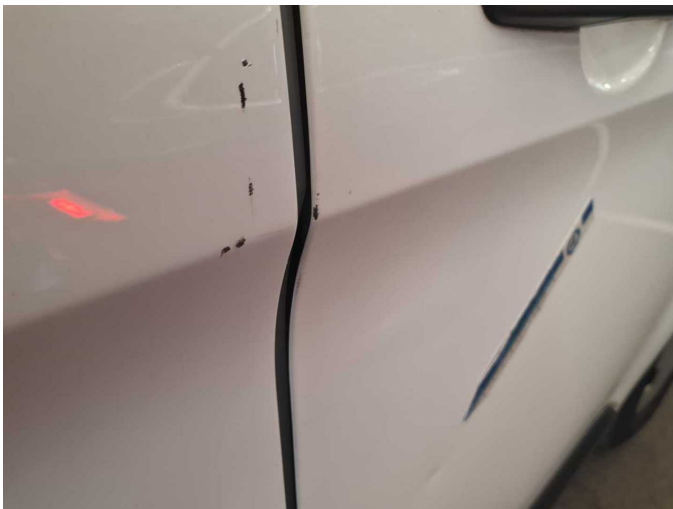
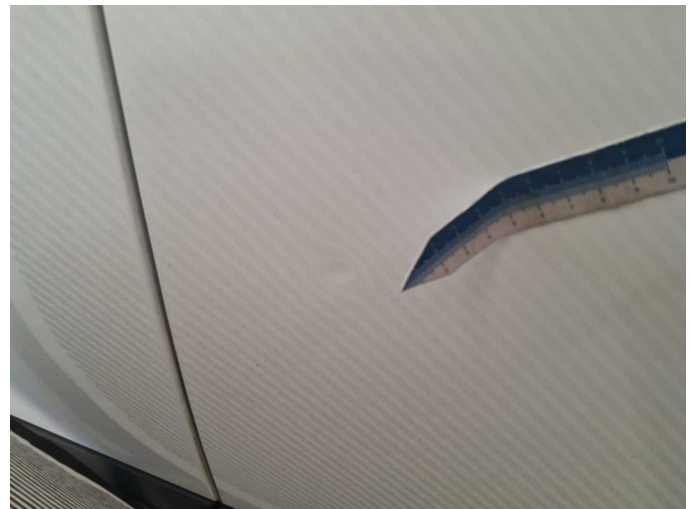
Damage 3: Door - front right side: Door - Dent / paintcoat damage - Repair and paint

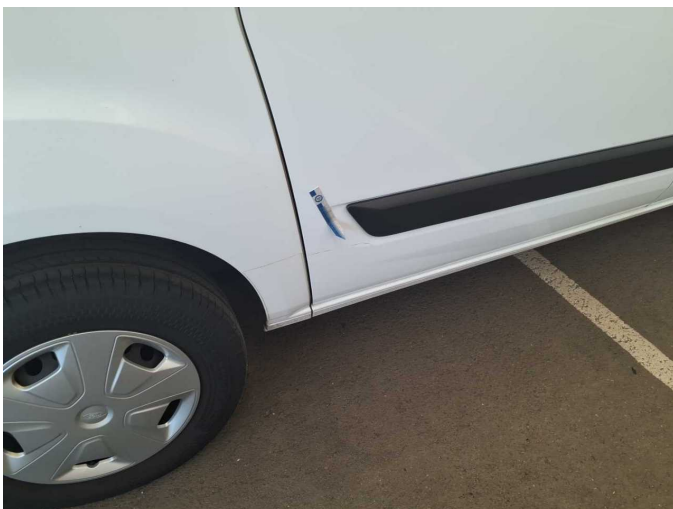
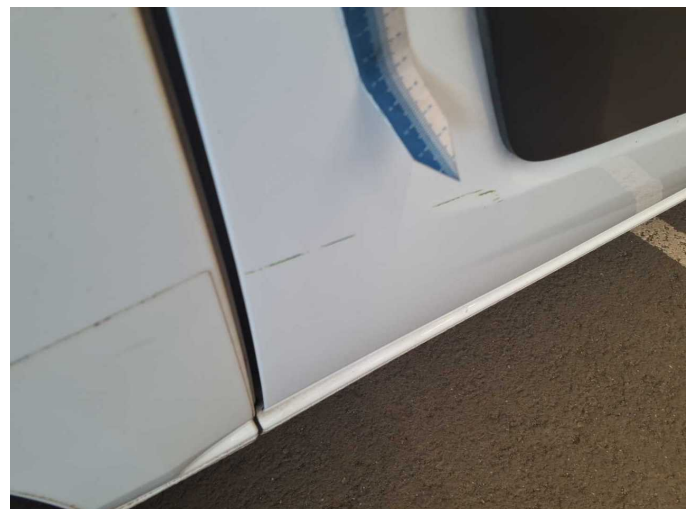
Damage 4: Sliding door, right: Sliding door - Scratched - Paint

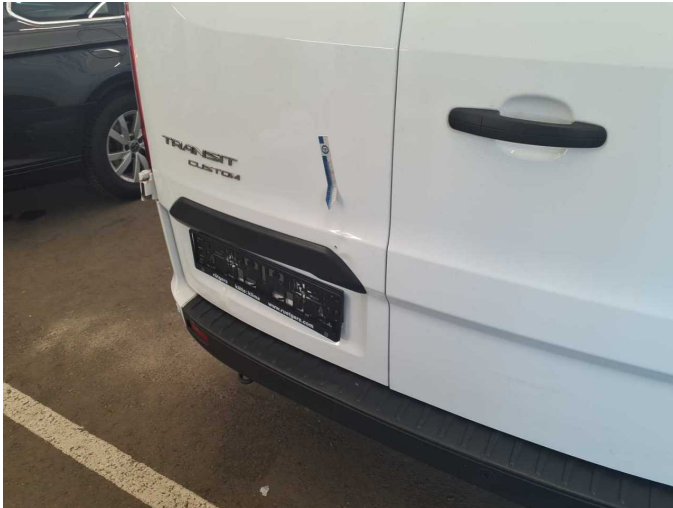
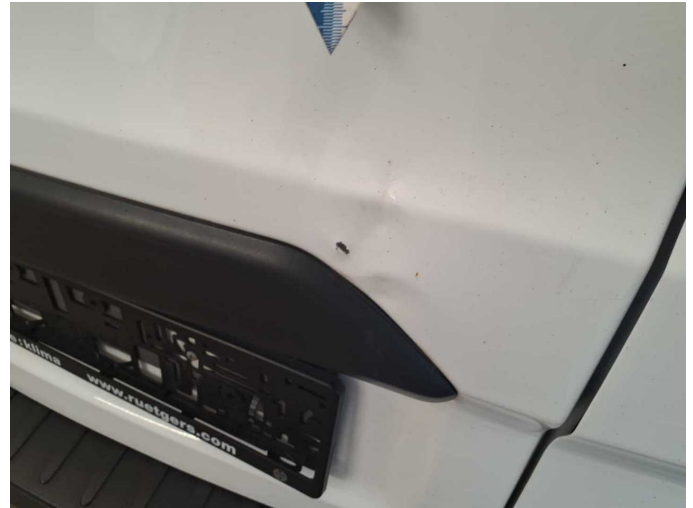
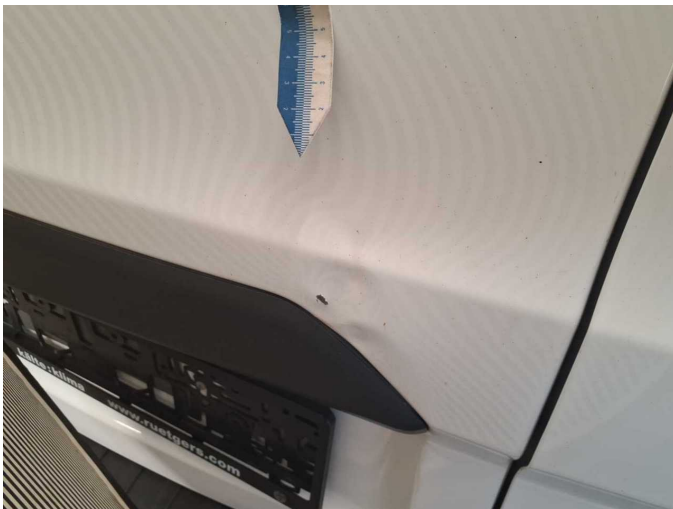
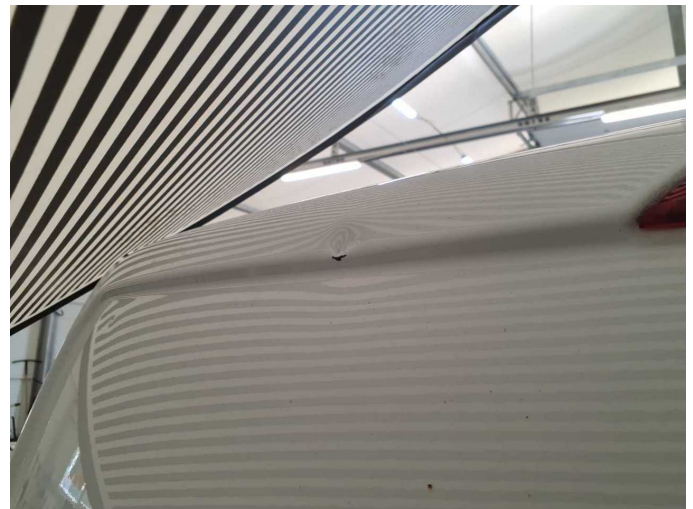
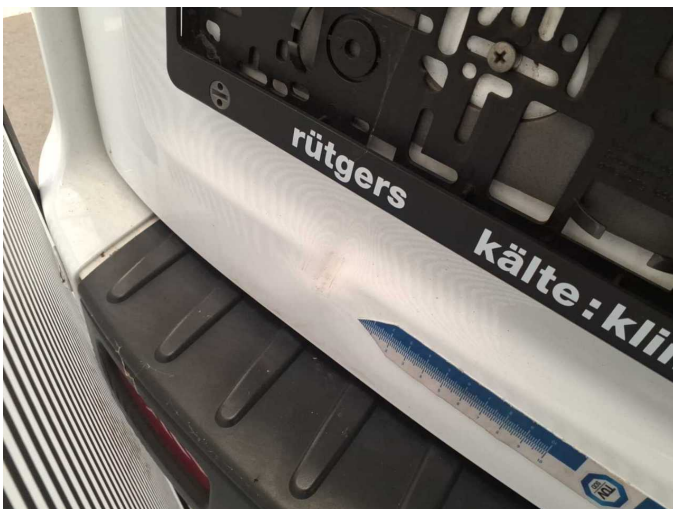
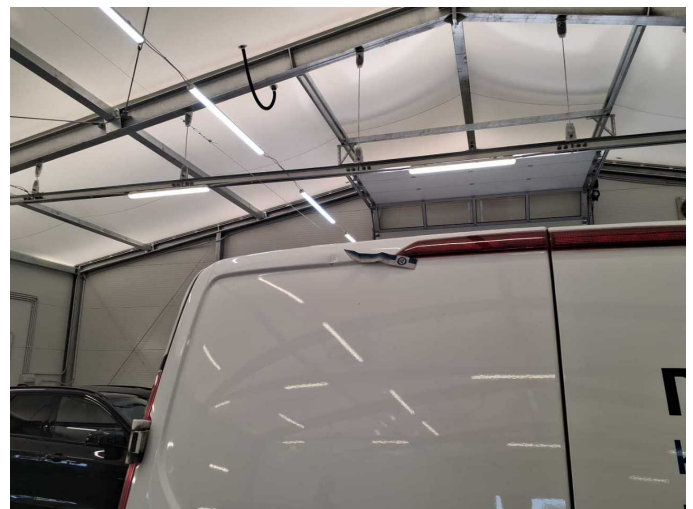
Damage 5: Boot lid / rear door: Rear door - left side (& Lackschaden) - Deformed - Repair and paint
