Expertise

Protocol number: 46044692
Order No. / Reference: 26522295
Inspection date: 17 Jun 2026

Model: Focus Turnier 1.5 EcoBlue Start-Stopp-System Aut. TITANIUM

VIN: WF0PXXGCHPPD66254

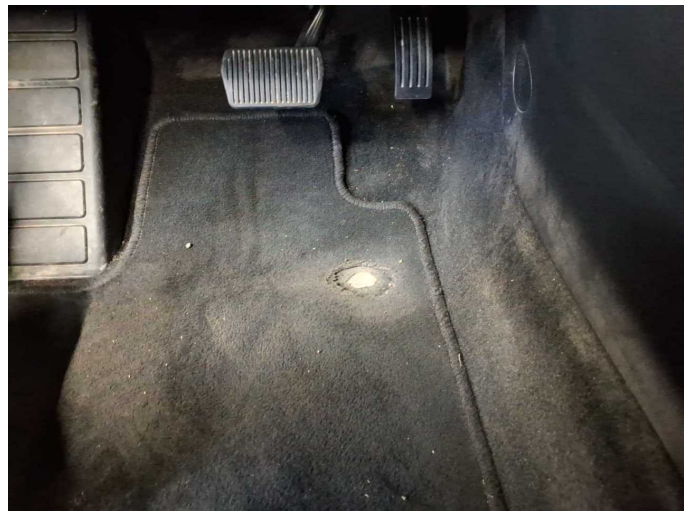
Damage 2: Trim / covers: Floor mats - Broken / torn - Replace

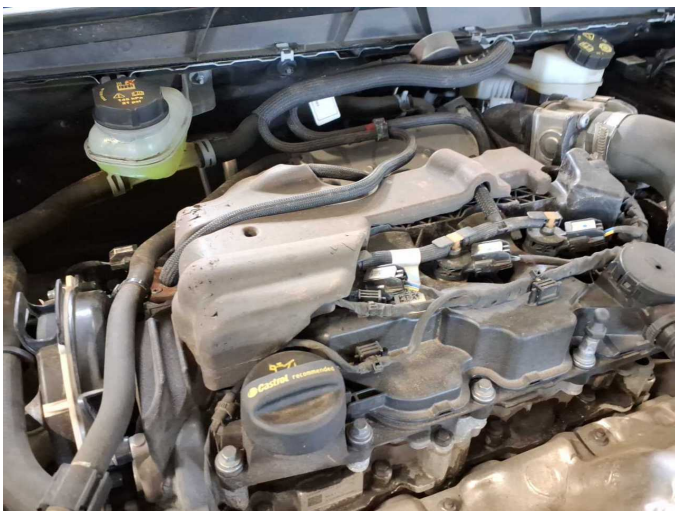
Damage 3: Engine: Engine cover (Dämmung) - Damage caused by marten / rodent - Replace

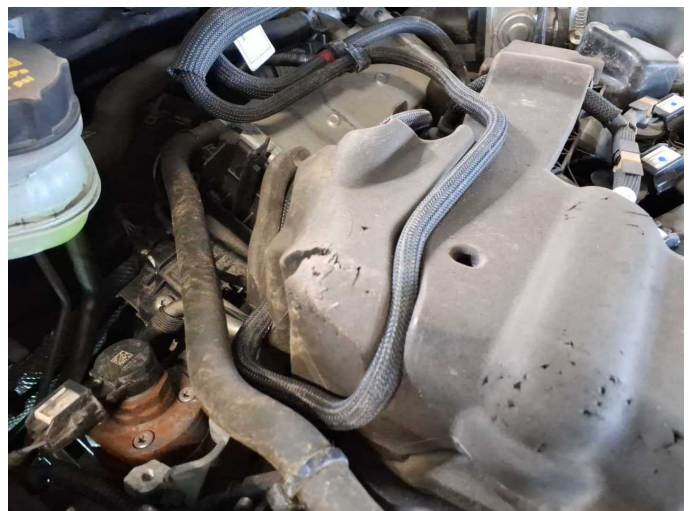
Damage 3: Engine: Engine cover (Dämmung) - Damage caused by marten / rodent - Replace

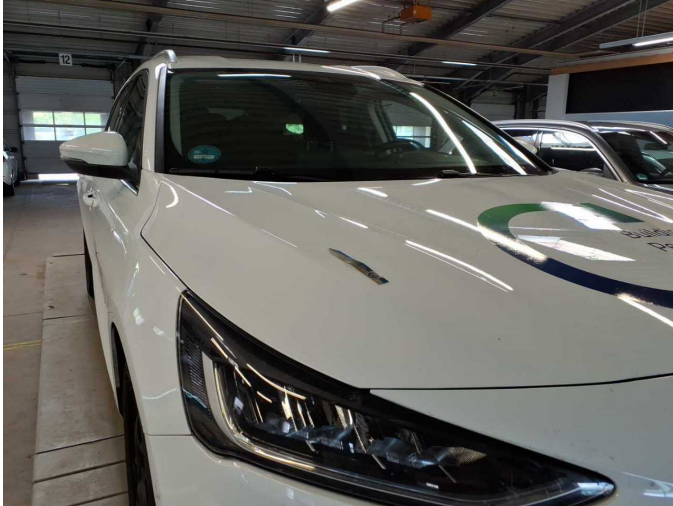
Damage 4: Bonnet: Bonnet - dent(s) - Smooth repair work

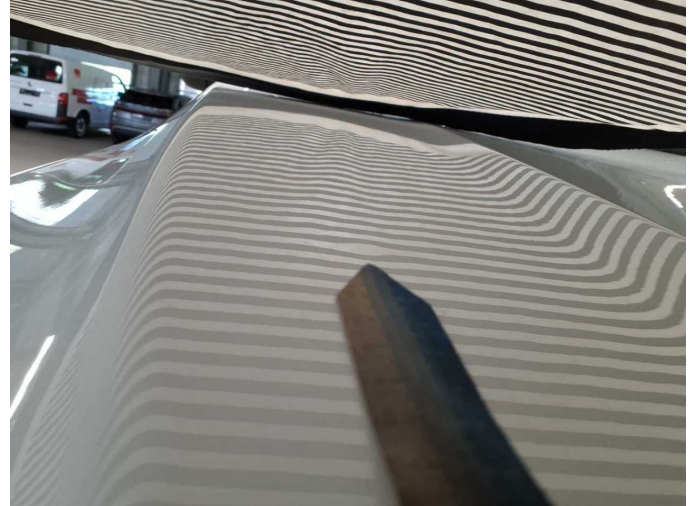
Damage 4: Bonnet: Bonnet - dent(s) - Smooth repair work

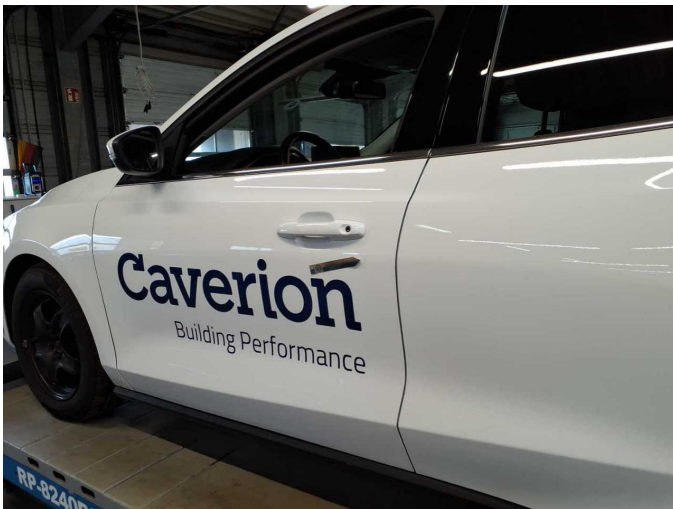
Damage 5: Door - front left side: Door - dent(s) - Smooth repair work

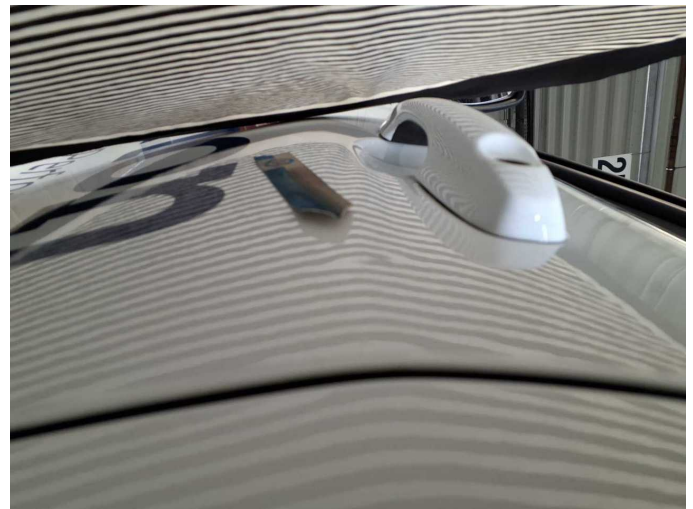
Damage 5: Door - front left side: Door - dent(s) - Smooth repair work

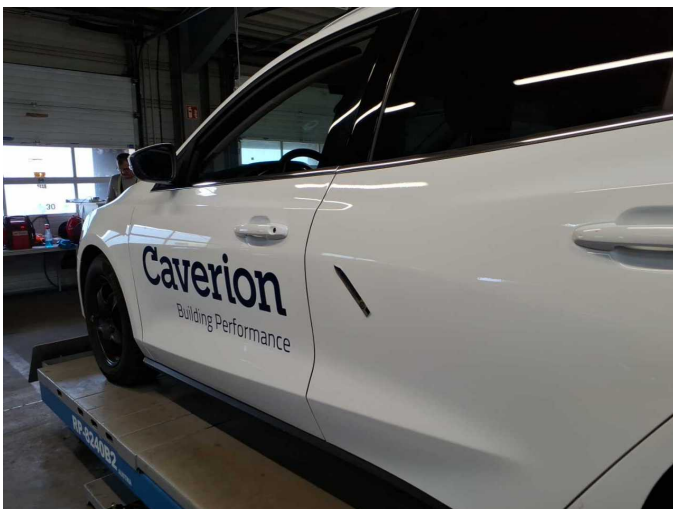
Damage 6: Door - rear left side: Door - dent(s) - Smooth repair work

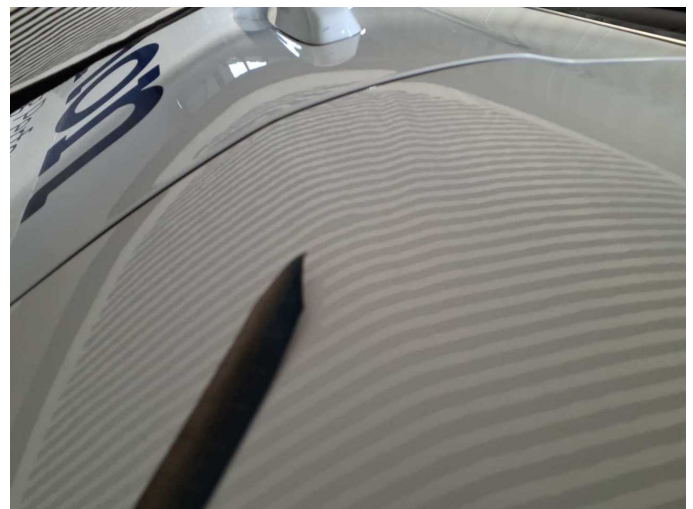
Damage 6: Door - rear left side: Door - dent(s) - Smooth repair work

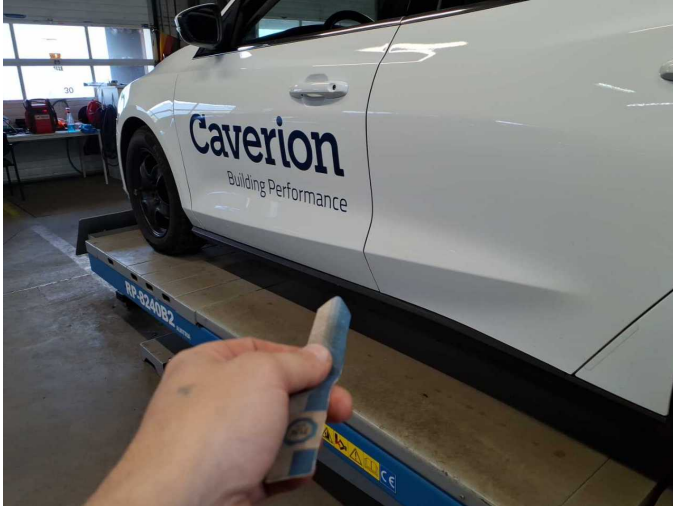
Damage 7: Sill - left side: Trim (Materialabtrag) - Scratched - Replace

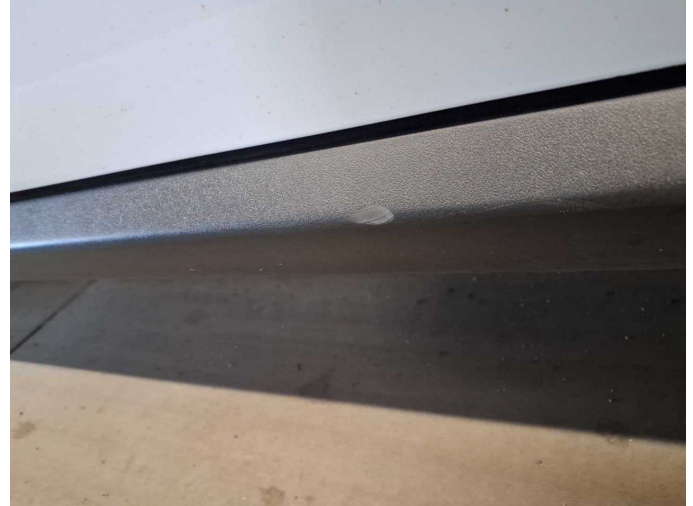
Damage 7: Sill - left side: Trim (Materialabtrag) - Scratched - Replace

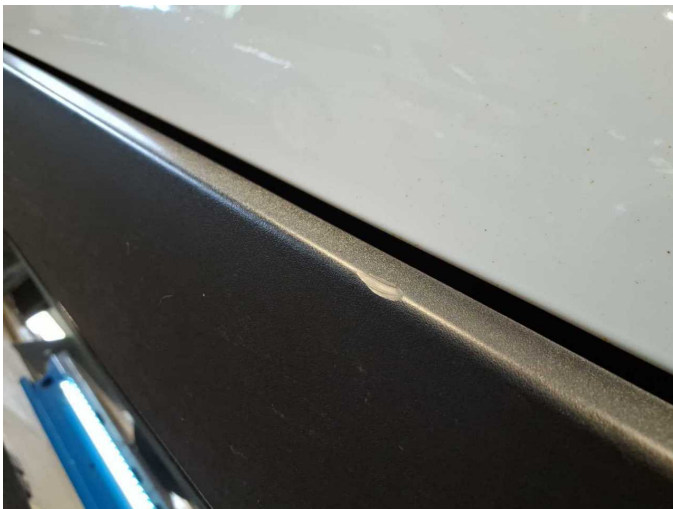
Damage 7: Sill - left side: Trim (Materialabtrag) - Scratched - Replace

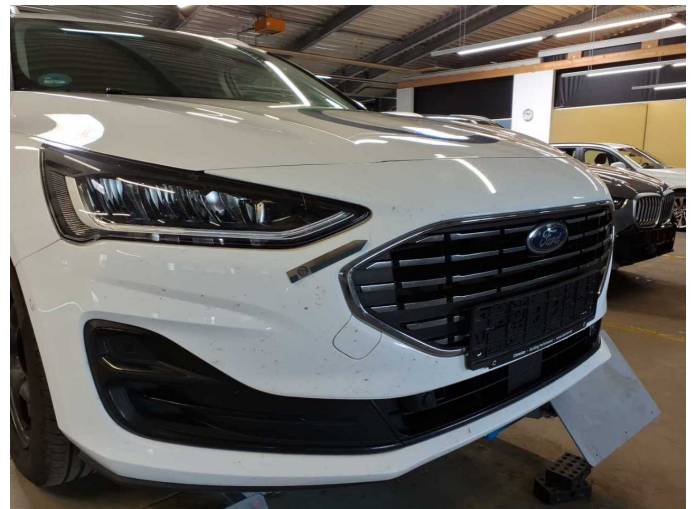
Damage 8: Front bumper: Front bumper - Scratch(es) - Smart repair

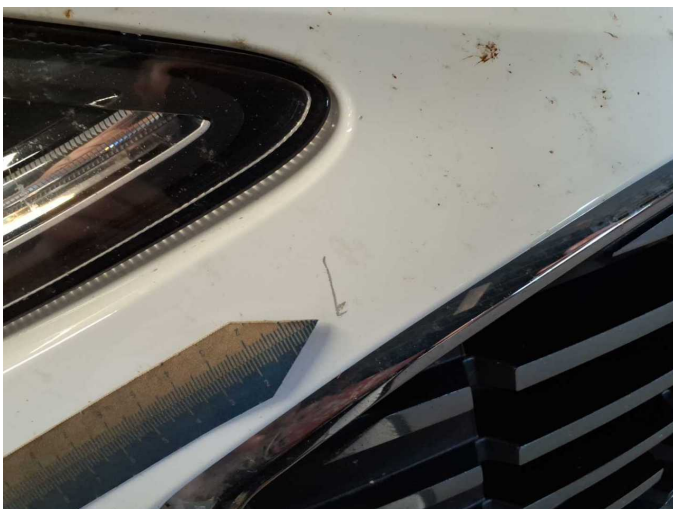
Damage 8: Front bumper: Front bumper - Scratch(es) - Smart repair

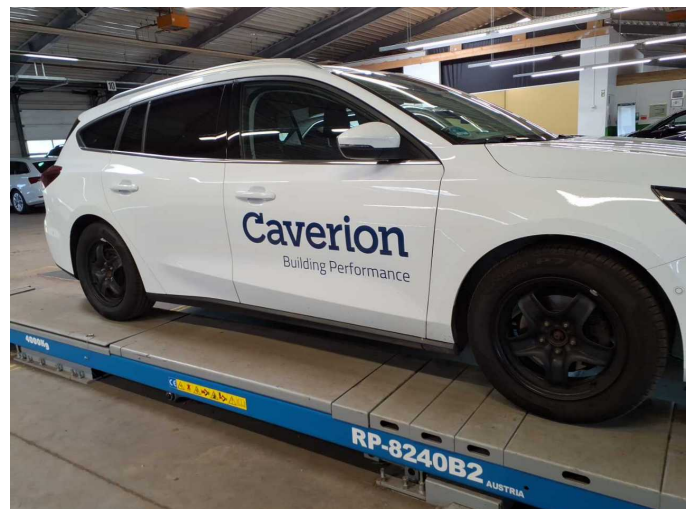
Damage 10: Body: Body - Glued / labelled - De-glug / neutralise

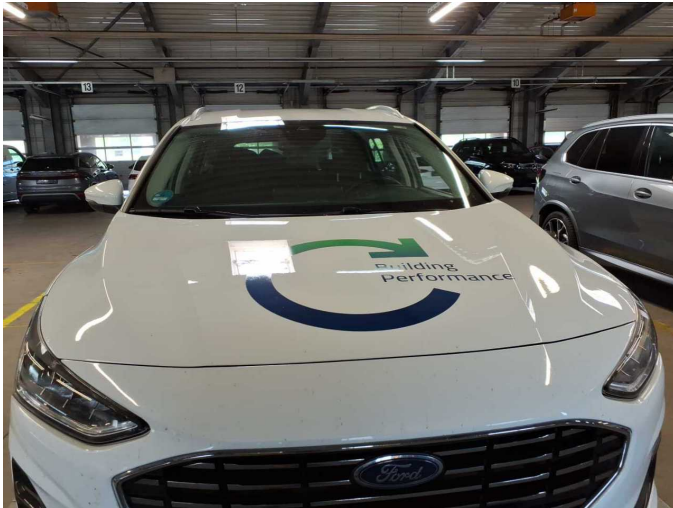
Damage 10: Body: Body - Glued / labelled - De-glue / neutralise

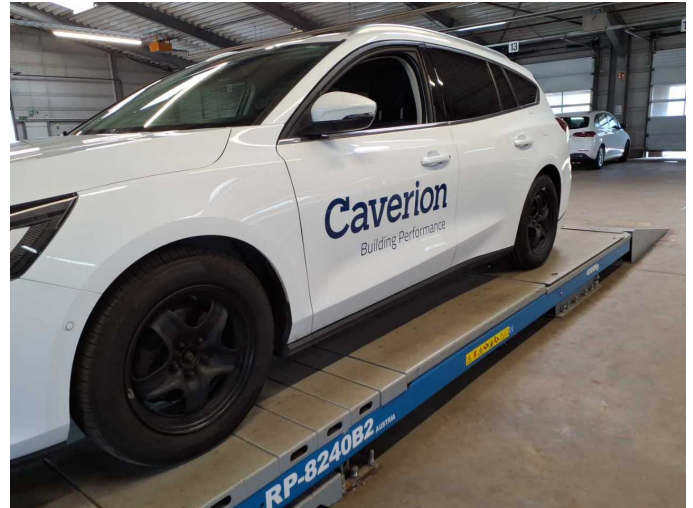
Damage 10: Body: Body - Glued / labelled - De-glue / neutralise

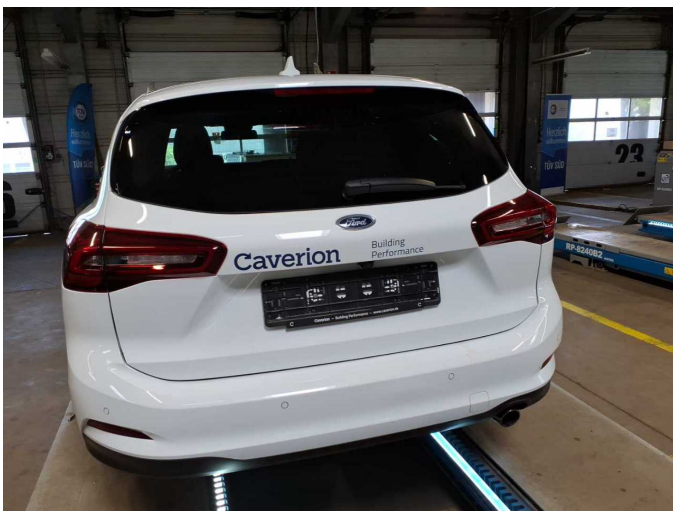
Damage 10: Body: Body - Glued / labelled - De-glue / neutralise

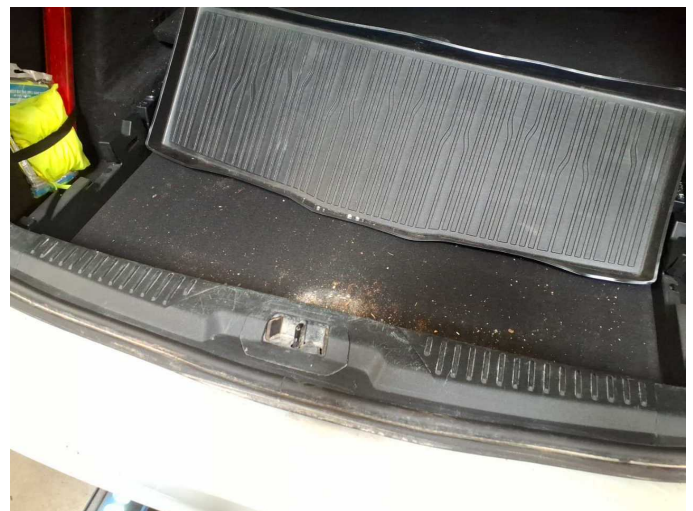
Damage 11: Interior: Interior - Soiled - Clean

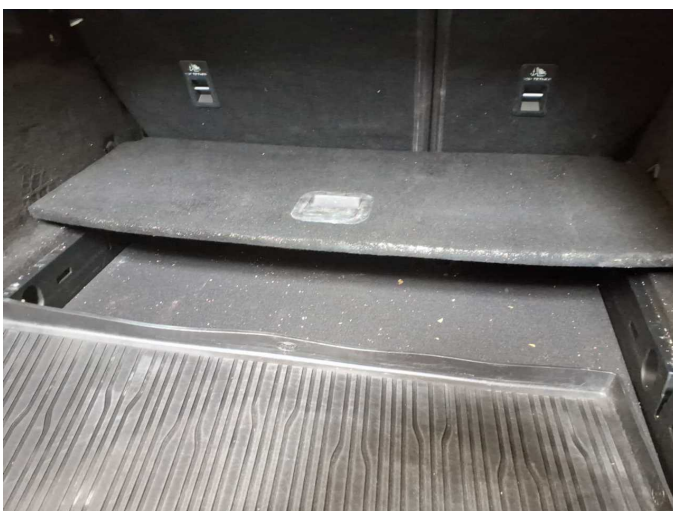
Damage 11: Interior: Interior - Soiled - Clean

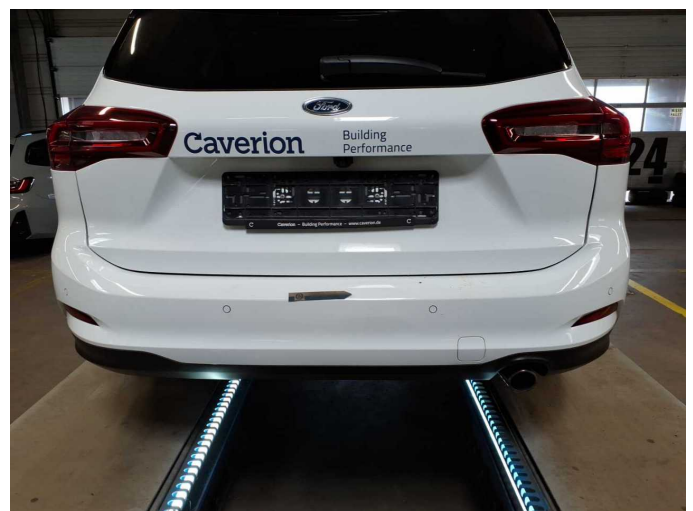
Damage 12: Rear bumper: Rear bumper - Deformed - Repair and paint

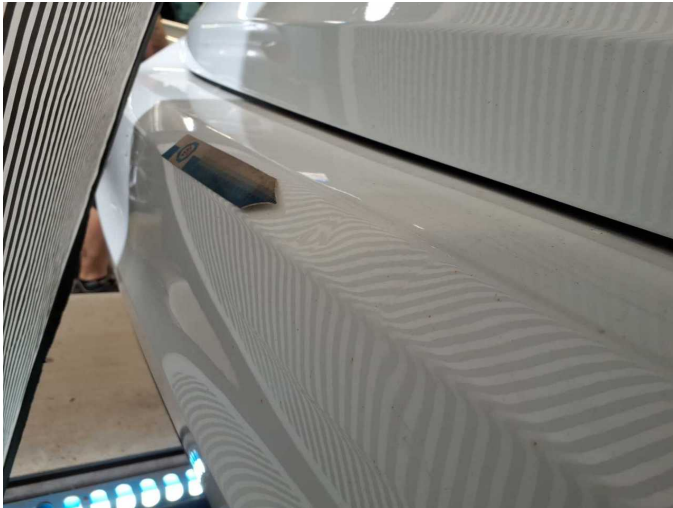
Damage 12: Rear bumper: Rear bumper - Deformed - Repair and paint

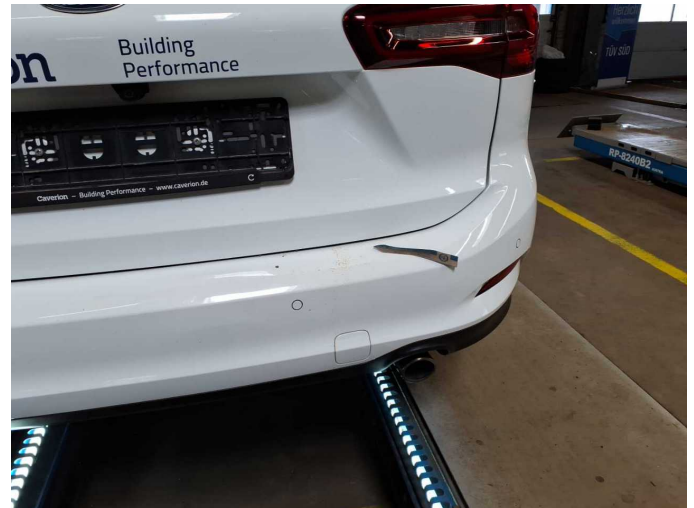
Damage 12: Rear bumper: Rear bumper - Deformed - Repair and paint

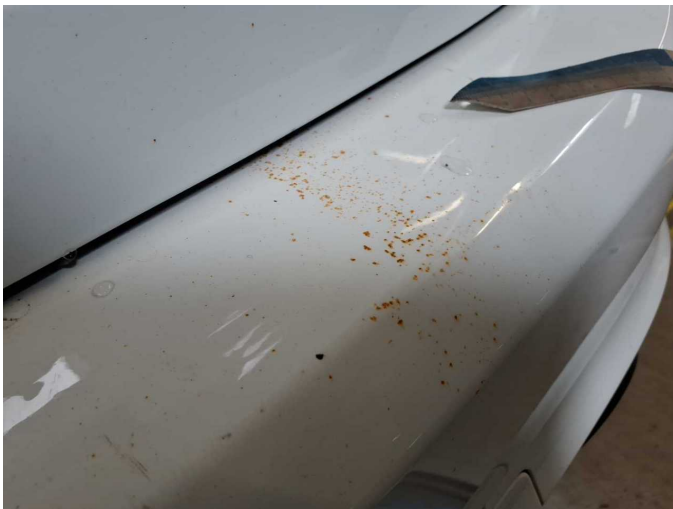
Damage 12: Rear bumper: Rear bumper - Deformed - Repair and paint

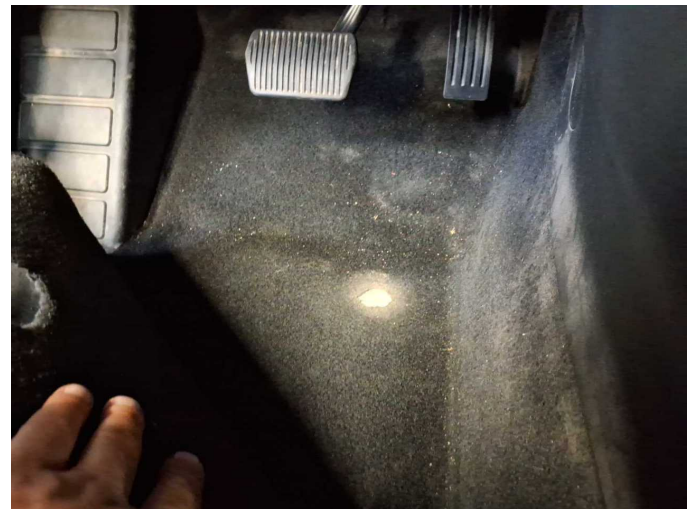
Damage 13: Trim / covers: Floor covering - front left side - Broken / torn - Replace

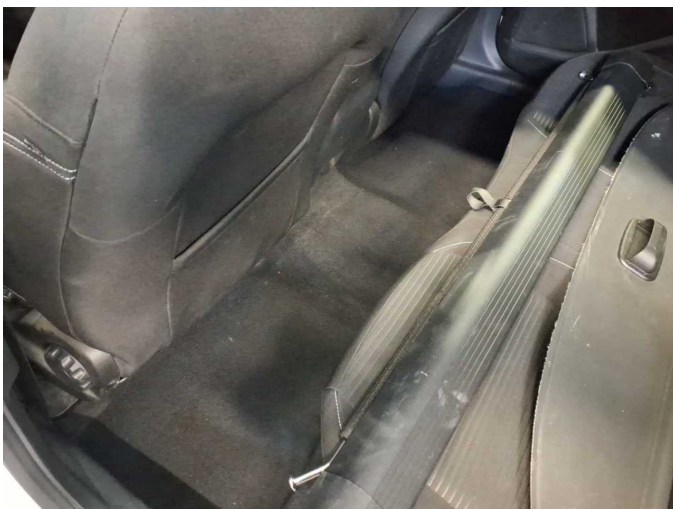
Missing part 1: Trim / covers: Floor mats (Hinten beide) - Missing - Replace

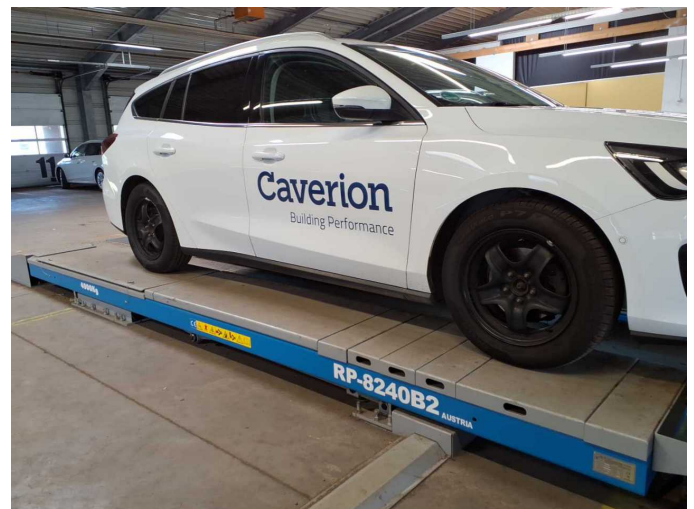
Missing part 2: Wheel / tyres: Wheel cover set - complete - Missing - Replace

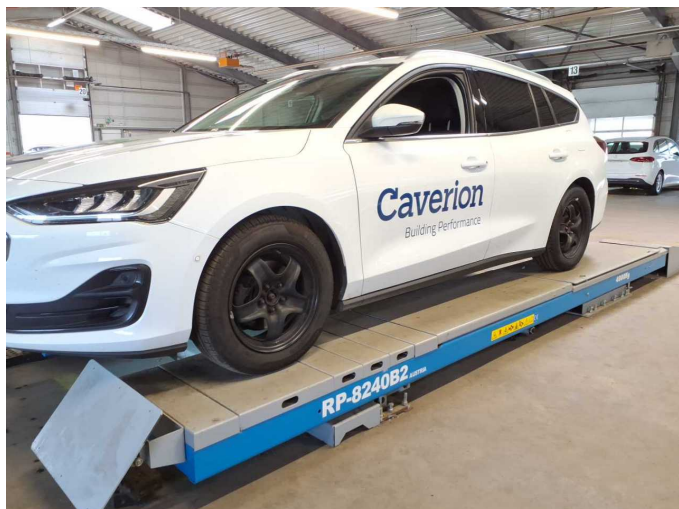
Missing part 2: Wheel / tyres: Wheel cover set - complete - Missing - Replace

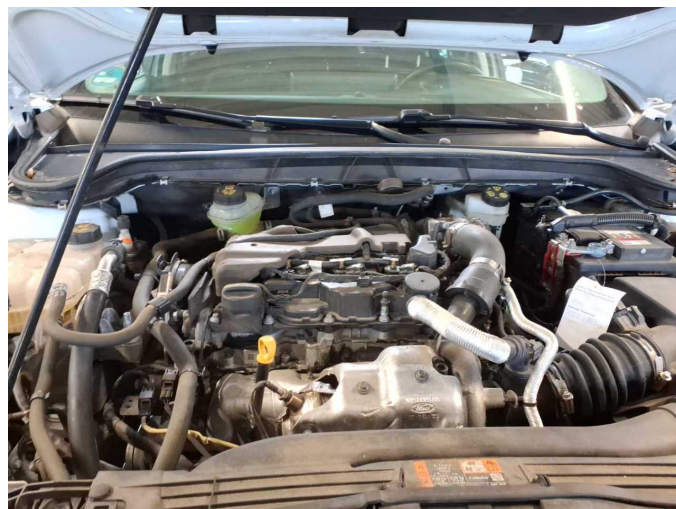
Missing part 3: Engine: Engine cover - Missing - Replace
