Expertise

Protocol number: 46445222  
Order No. / Reference: 26673515  
Inspection date: 10 Jul 2026

Manufacturer: MAN  
VIN: WMA03VUYXP9019944

Model: TGE 3.140 4X2F SB

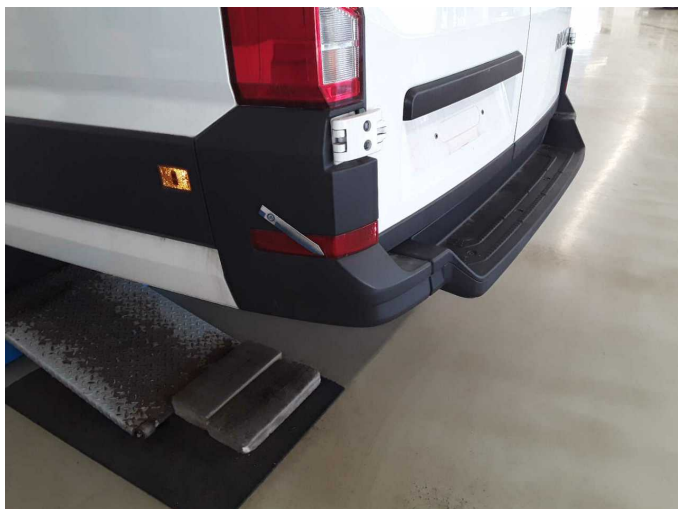
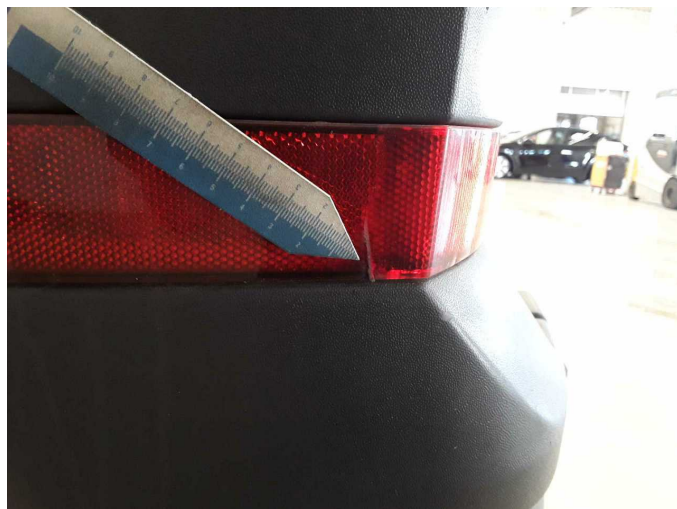
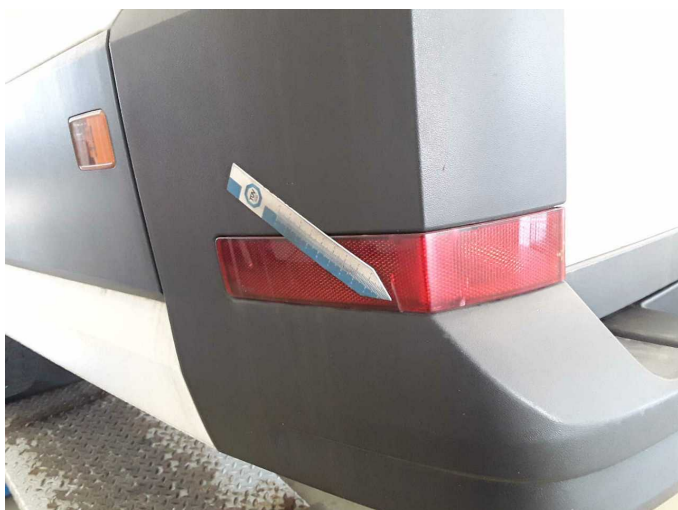
| No. | Component group | Description |
|---|---|---|
| 1 | Rear bumper | Reflector - left side - Broken / torn - Replace |

**Damage 1:** Rear bumper: Reflector - left side - Broken / torn - Replace

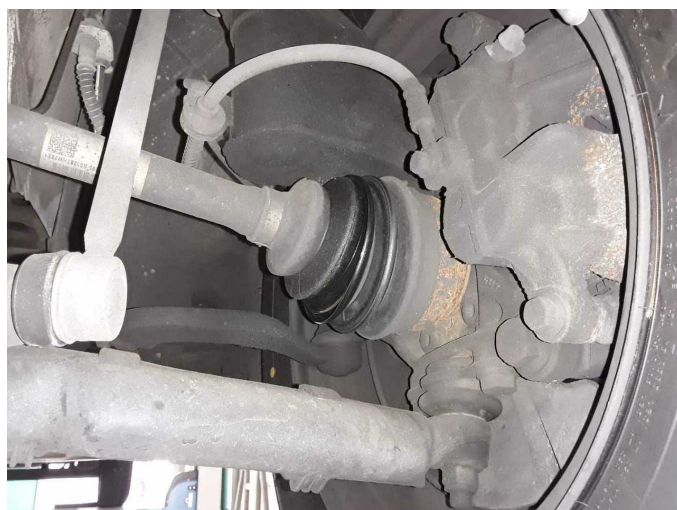
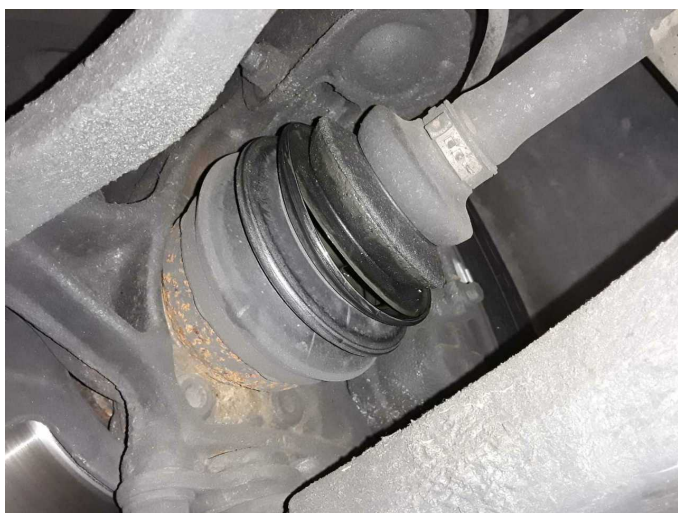
| No. | Component group | Description |
|---|---|---|
| 2 | Drive train | Sleeve prop shaft - front left side - Broken / torn - Replace |

**Damage 2:** Drive train: Sleeve prop shaft - front left side - Broken / torn - Replace

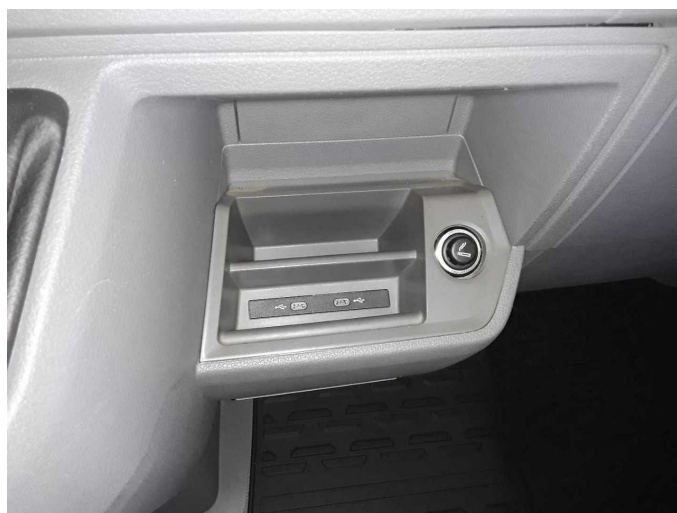
Interior - Ashtray - front

**Missing part 1:** Interior: Ashtray - front - Missing - Replace

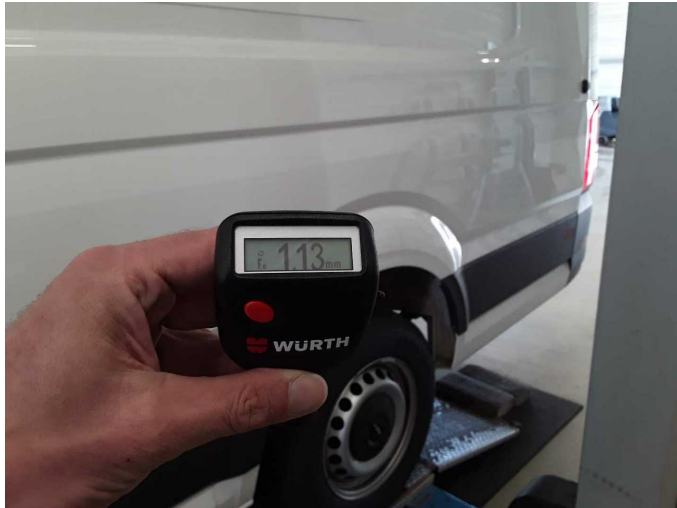
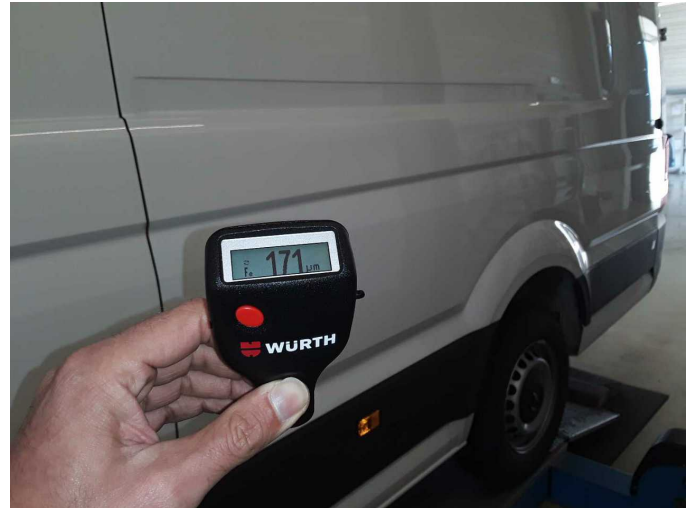
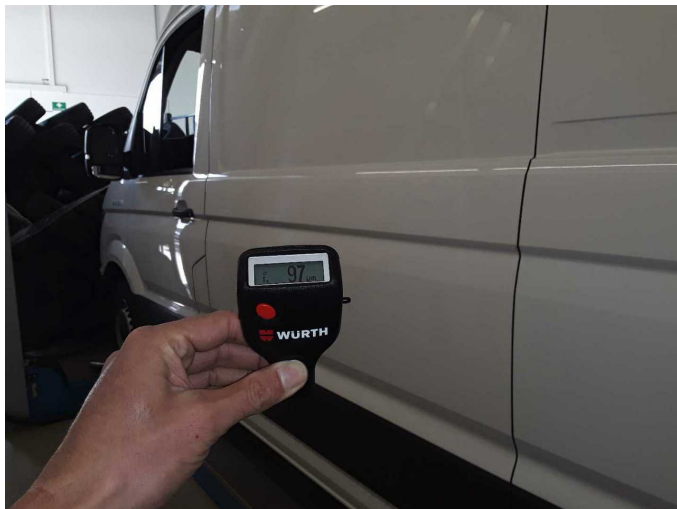
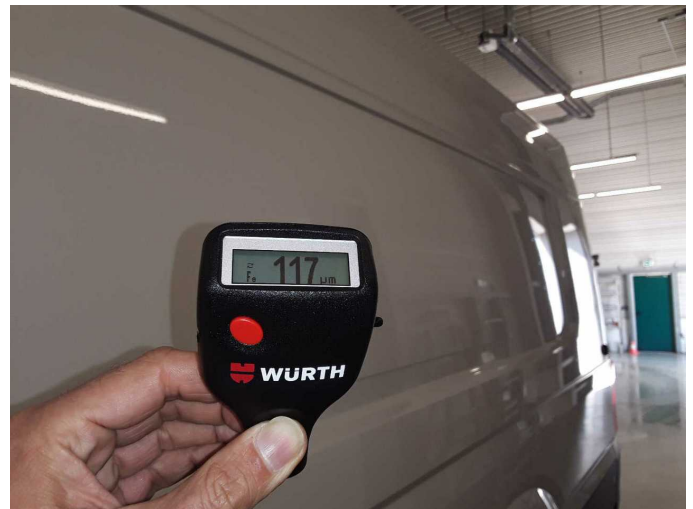
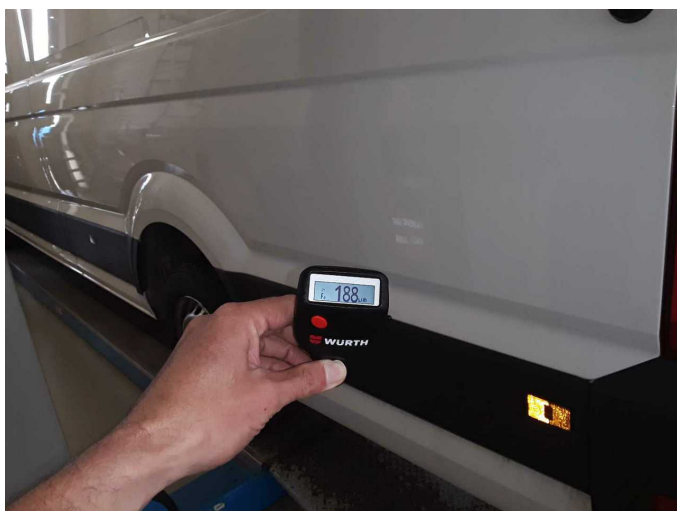
| 1 | Side panel - rear left side, Professionally carried out |

| Side panel - rear left side | 1,130<br>µm |

Side panel - rear left side: 1,130 µm
