## Expertise

Protocol number: 46077339  
Order No. / Reference: 26471920  
Inspection date: 19 Jun 2026

Model: Astra 1.5 D Start/Stop Sports Tourer Automatik Edition

VIN: W0VBD8EV7N8041000

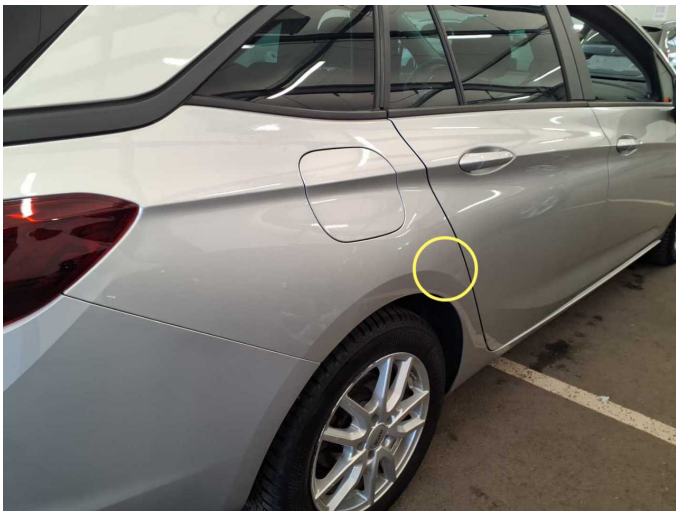
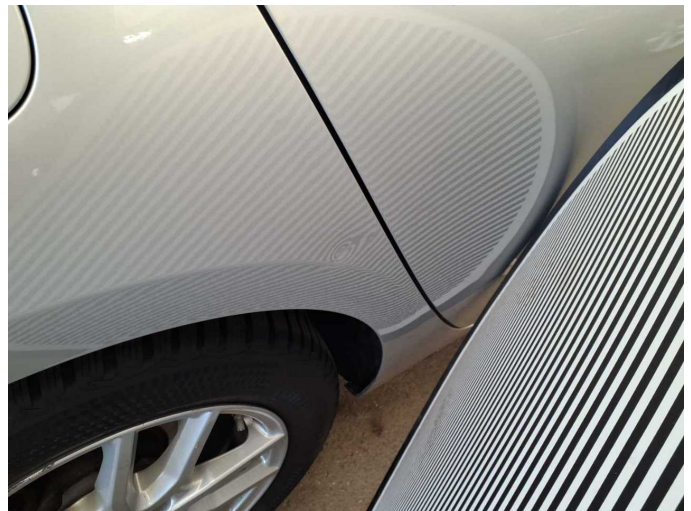
Damage 1: Side panel - rear right side: Side panel - dent(s) - Smart repair

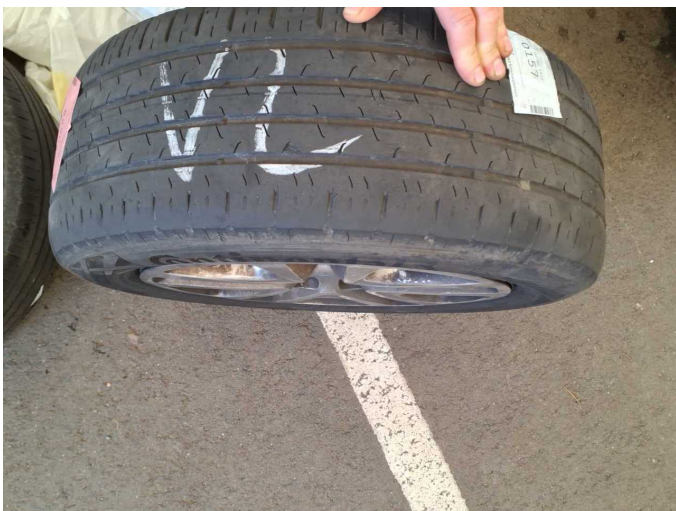
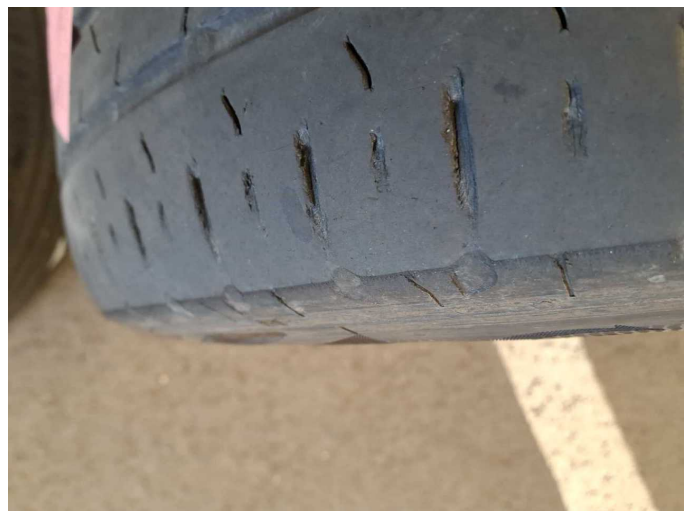
#	Tyre size	Type of tyre	Manufacturer	Tread depth
1)	205/55 R16 91V	Summer tyres on Steel rim with wheel cover	Continental	0mm / 3mm
2)	205/55 R16 91V	Summer tyres on Steel rim with wheel cover	Continental	4mm / 4mm

Damage 2: 2nd wheel set: 1 tyre - Worn - Replace

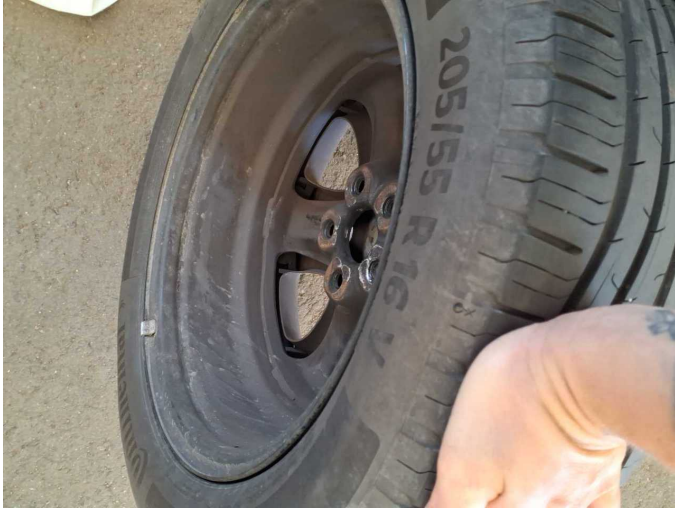
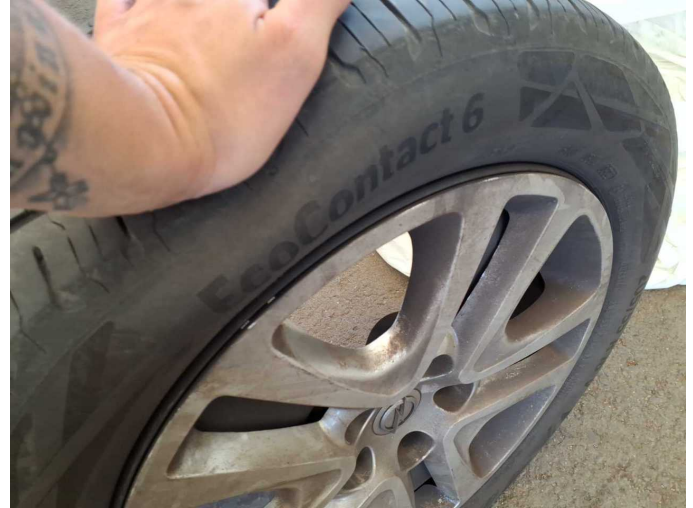
**Damage 3:** 2nd wheel set: 1 tyre - Empty - Replace

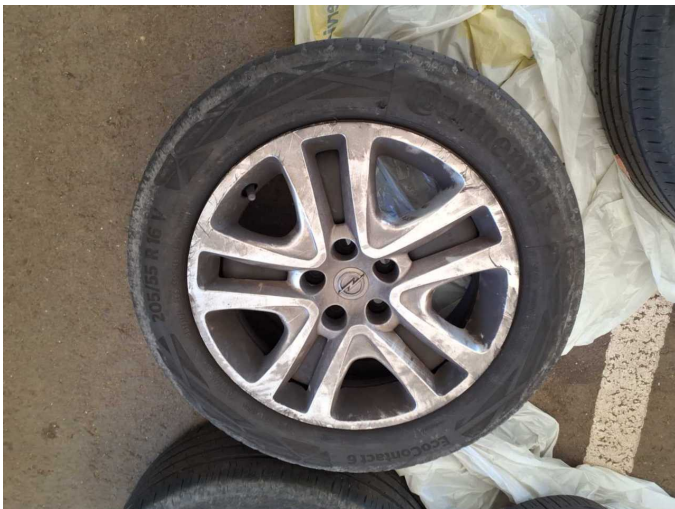
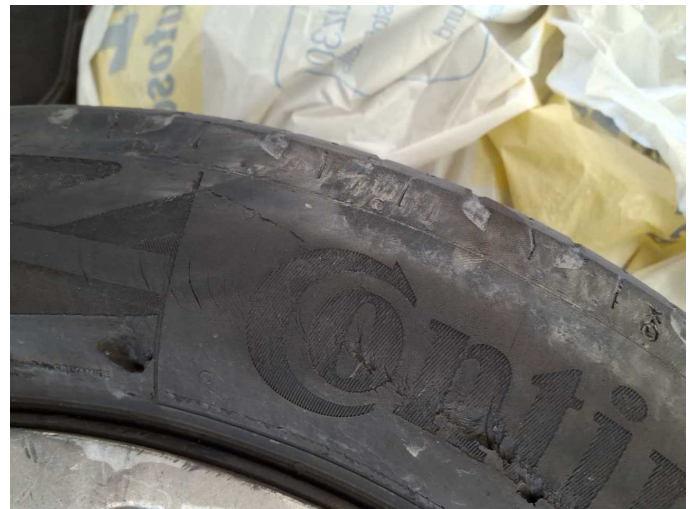
**Damage 4:** 2nd wheel set: 1 tyre - Broken / torn - Replace

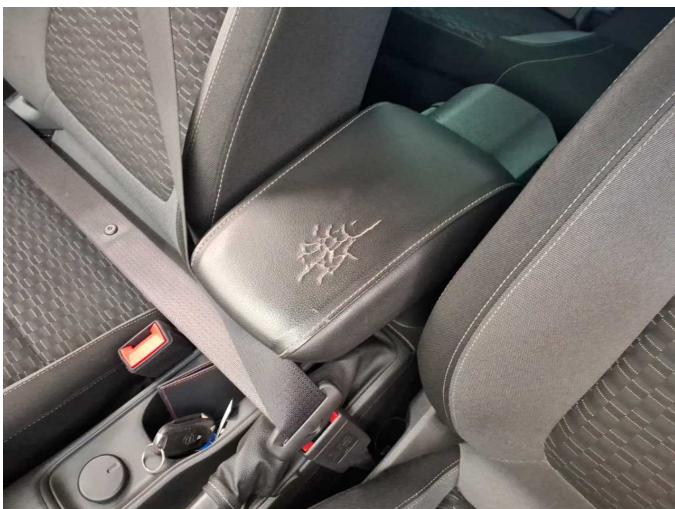
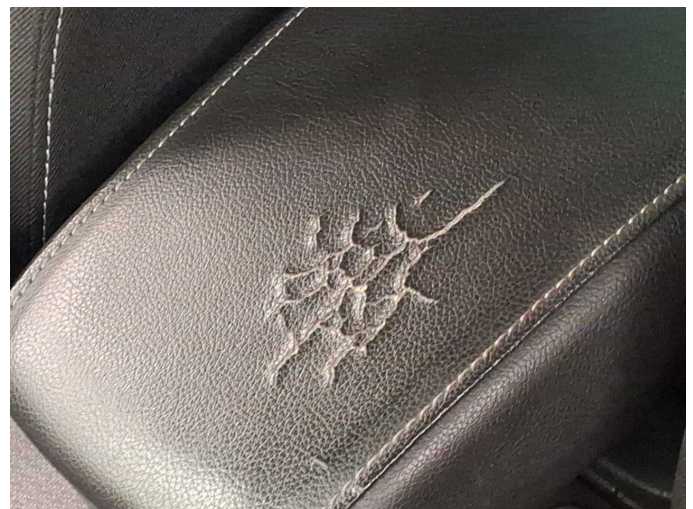
**Damage 5:** Seat - rear: Armrest - centre - Broken / torn - Replace

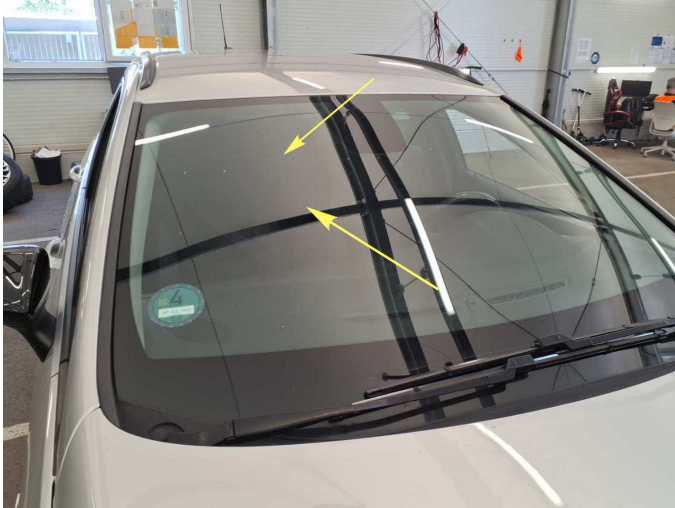
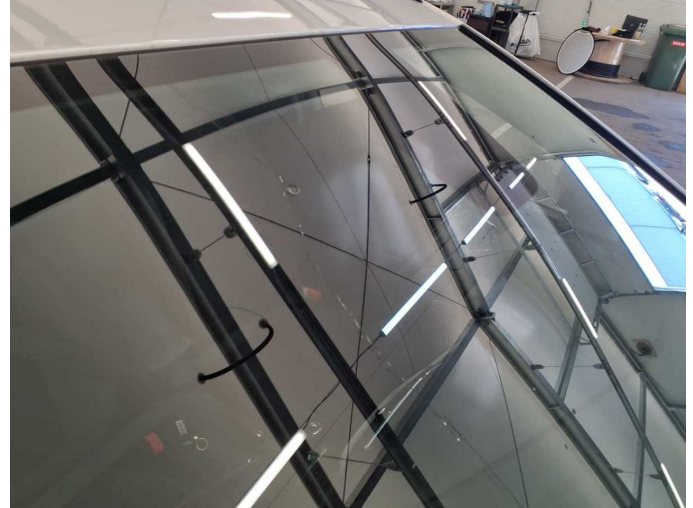
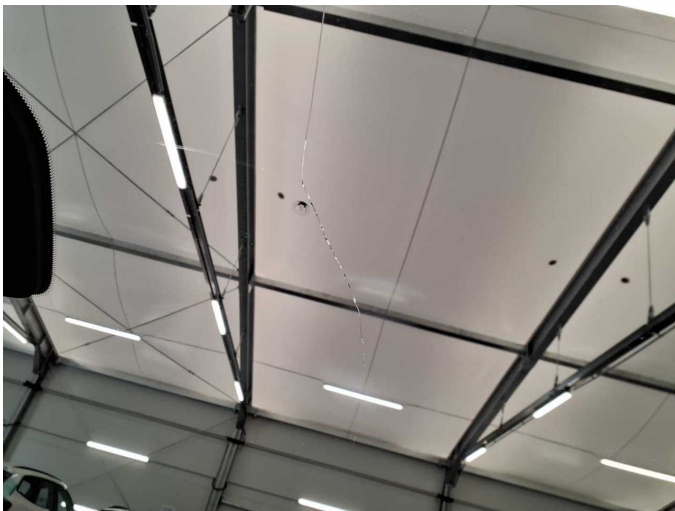
**Damage 6:** Vehicle glazing: Windscreen - Broken / torn - Replace

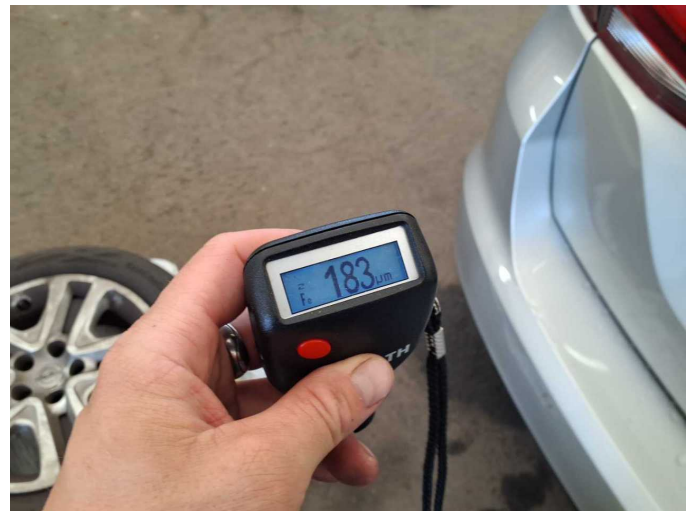
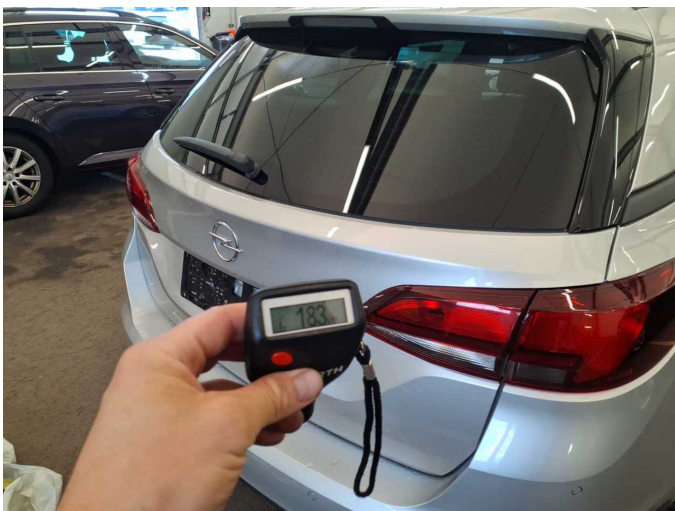
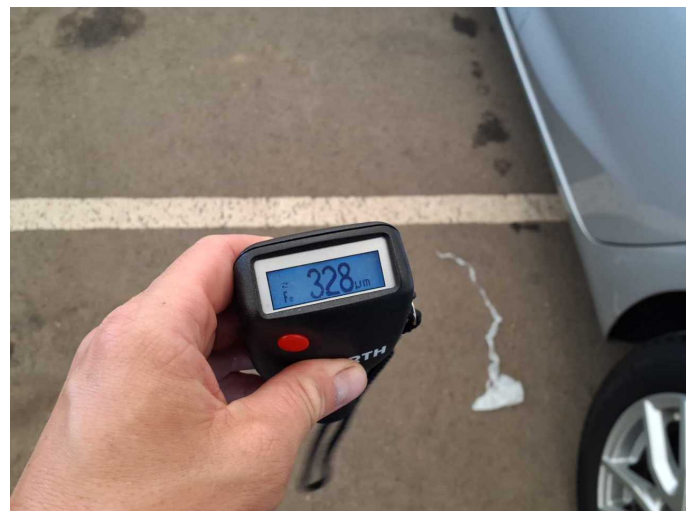
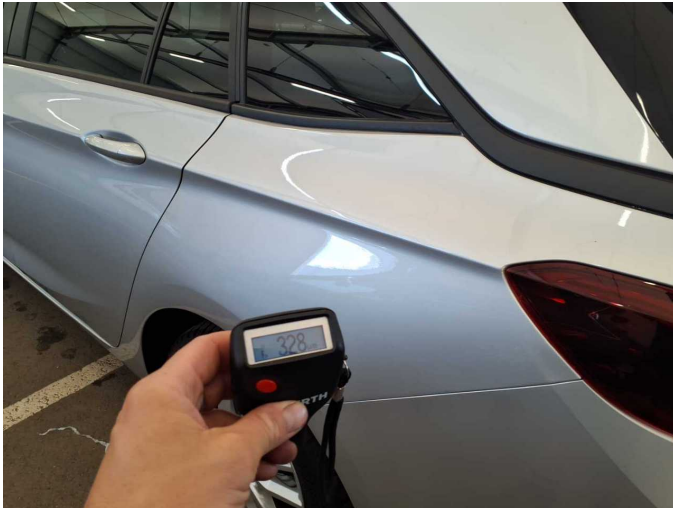
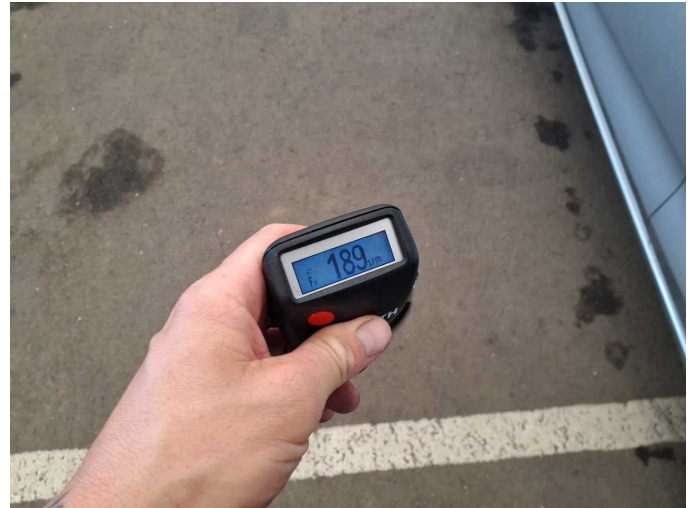
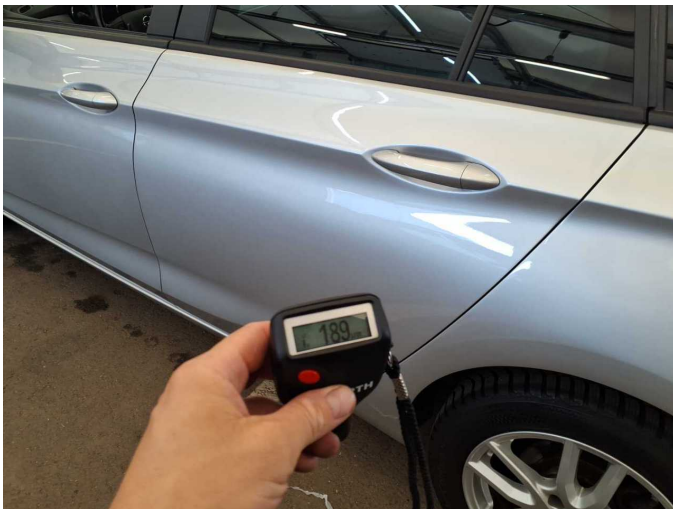
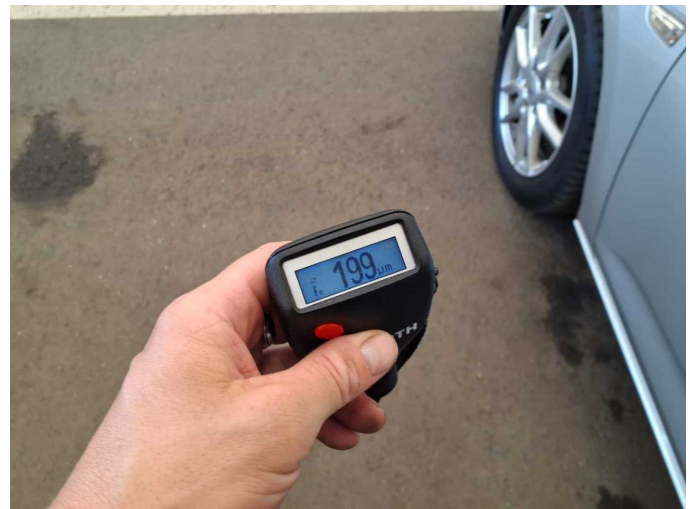
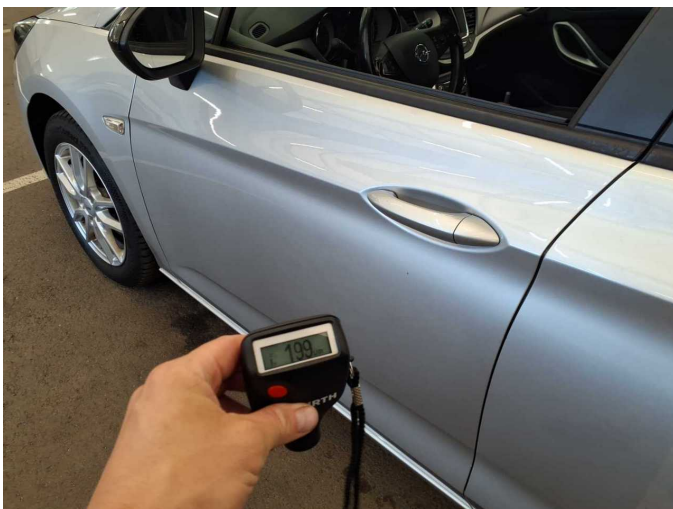
1	Boot lid / rear door, Side panel - rear left side, Door - rear left side, Door - front left side, Professionally carried out, Invoice of repair done Non-existent
---	---

Boot lid / rear door	183 µm	Side panel - rear left side	328 µm
Door - rear left side	189 µm	Door - front left side	199 µm

**Repainting 1:** Boot lid / rear door, Side panel - rear left side, Door - rear left side, Door - front left side
