Expertise

Protocol number: 47188246  
Order No. / Reference: 26765966  
Inspection date: 20 Aug 2026

Model: Touran 2.0 TDI SCR DSG Comfortline

VIN: WVGZZZ1T4PW011600

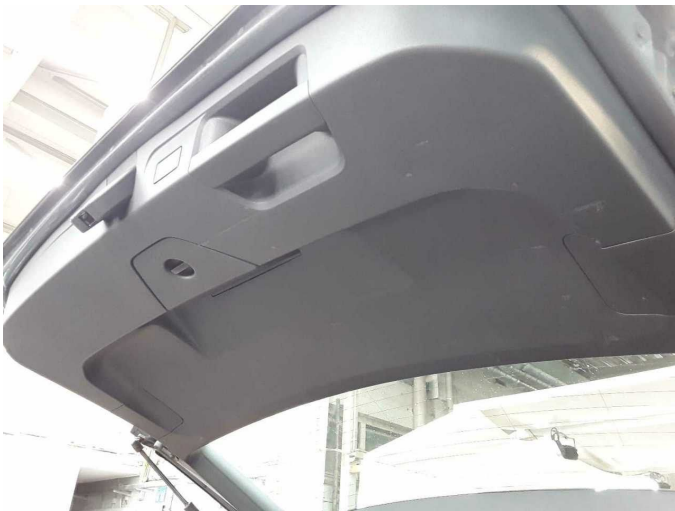
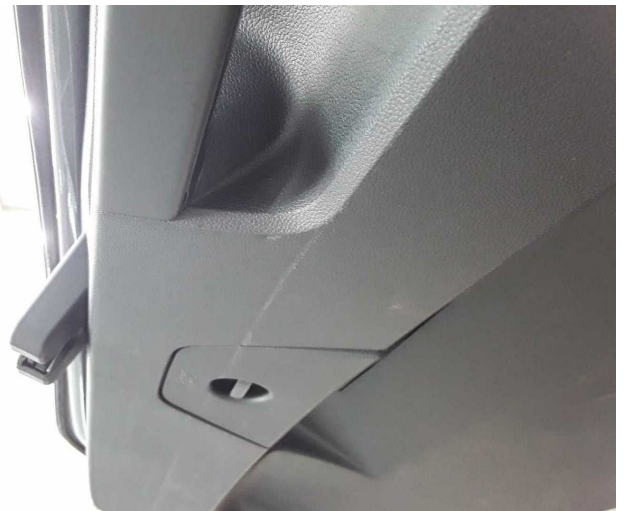
| No. | Component group | Description |
|---|---|---|
| 1 | Trim / covers | Boot lid - interior trim - Scratched - Loss in value |

**Damage 1:** Trim / covers: Boot lid - interior trim - Scratched - Loss in value

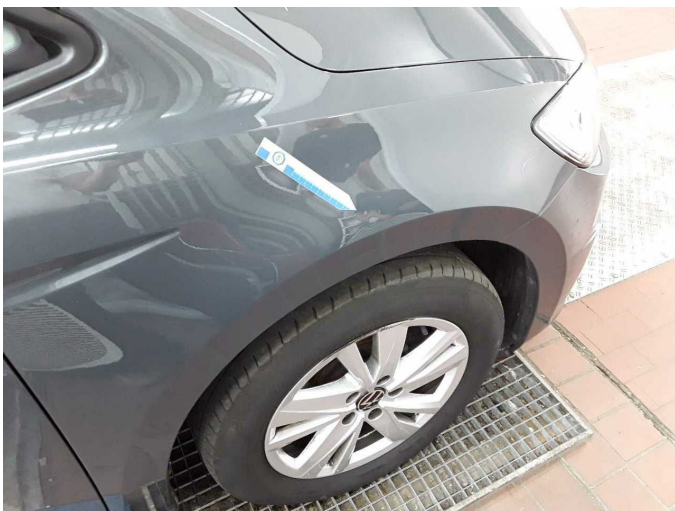
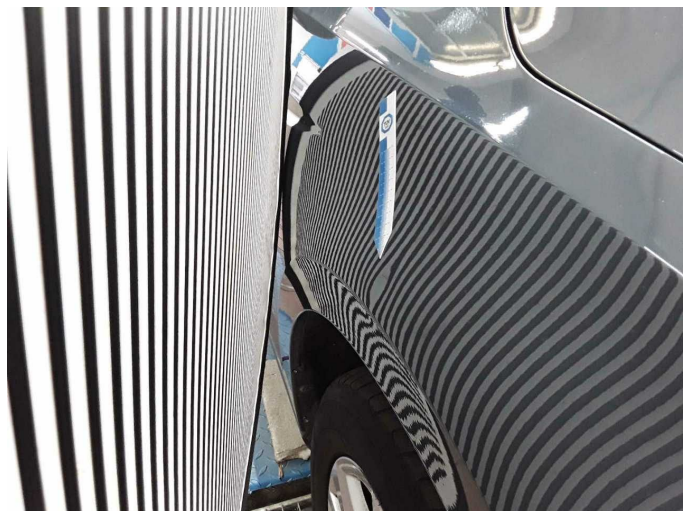
| No. | Component group | Description |
|---|---|---|
| 2 | Mudguard - right side | Mudguard - right side - dent(s) - Smooth repair work |

**Damage 2:** Mudguard - right side: Mudguard - right side - dent(s) - Smooth repair work

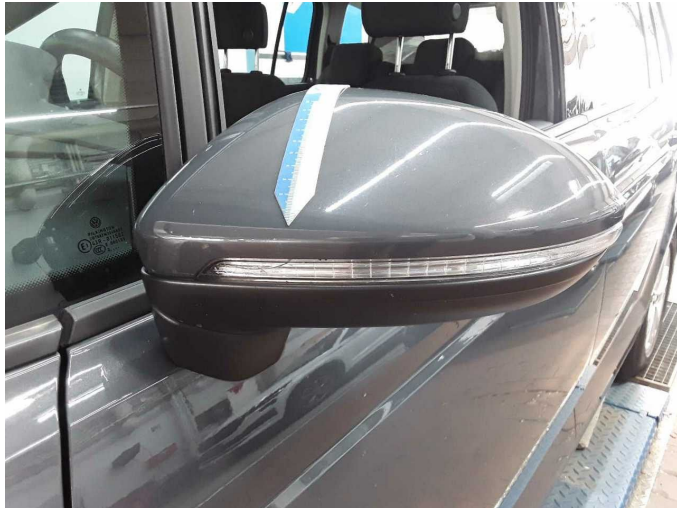
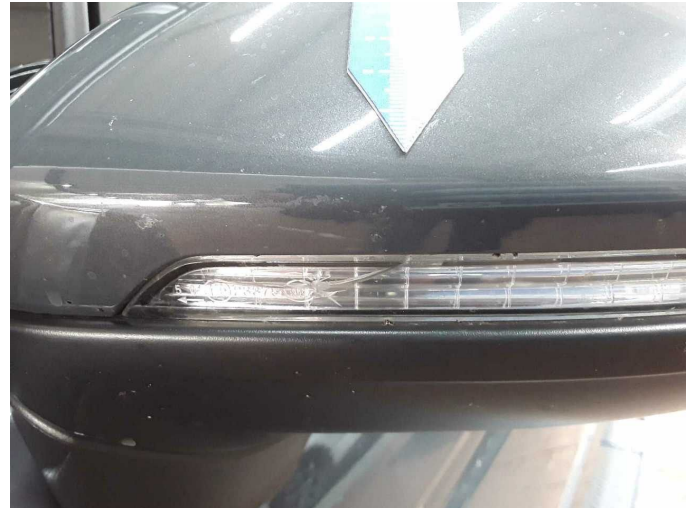
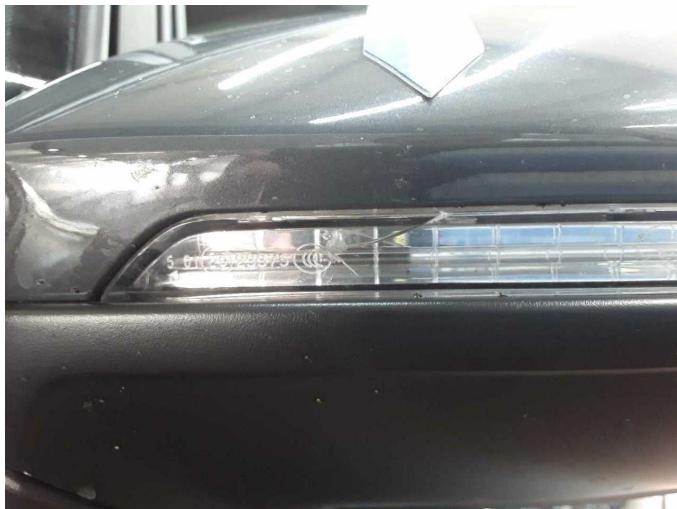
| No. | Component group | Description |
|---|---|---|
| 3 | Indicator - front | Mirror - left side - Broken / torn - Replace |

**Damage 3:** Indicator - front: Mirror - left side - Broken / torn - Replace

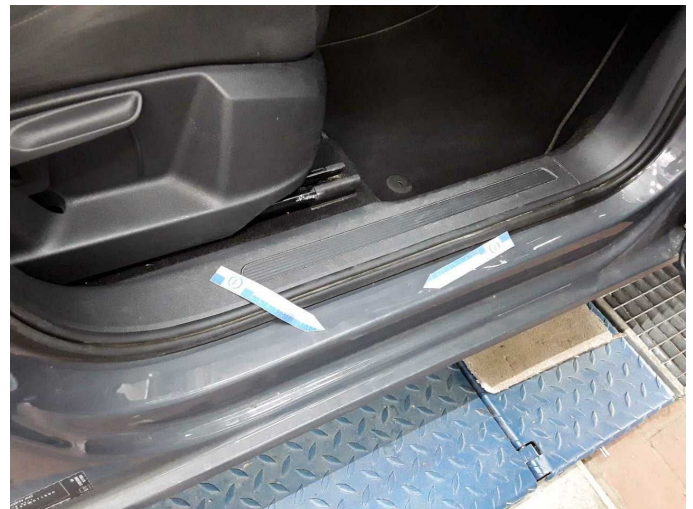
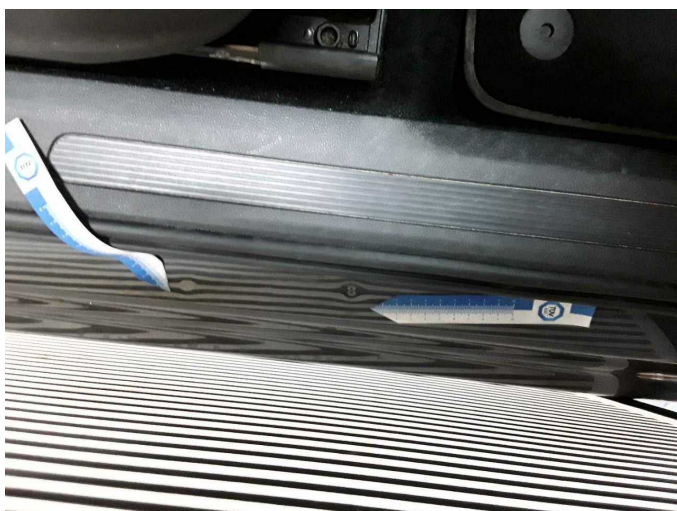
| No. | Component group | Description |
|---|---|---|
| 4 | Sill - right side | Sill - Dent / paintcoat damage - Smart repair |

**Damage 4:** Sill - right side: Sill - Dent / paintcoat damage - Smart repair

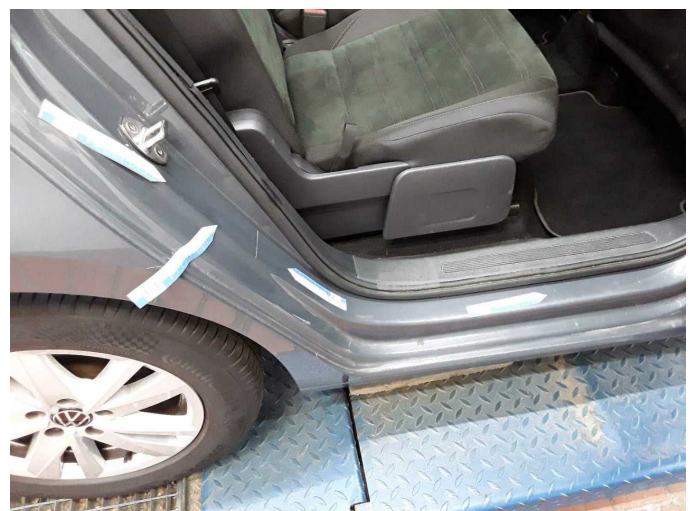
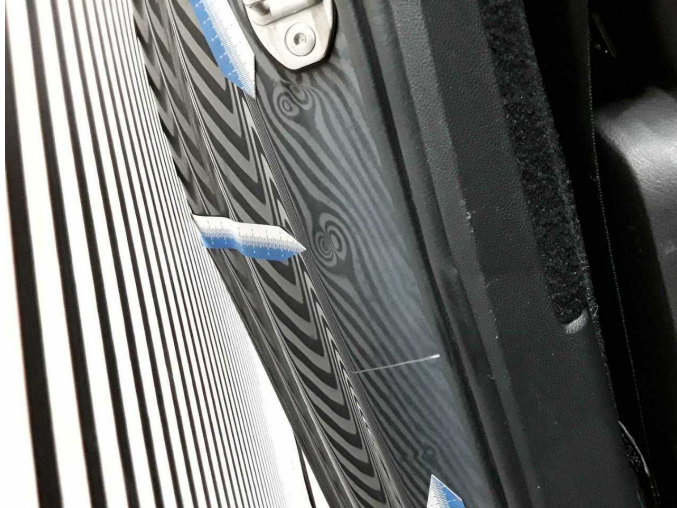
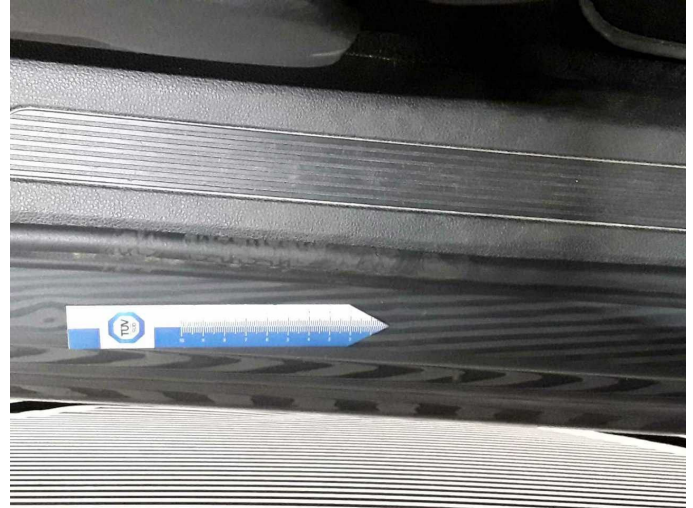
| No. | Component group | Description |
|---|---|---|
| 5 | Side panel - rear right side | Sill - Dent / paintcoat damage - Smart repair |

**Damage 5:** Side panel - rear right side: Sill - Dent / paintcoat damage - Smart repair

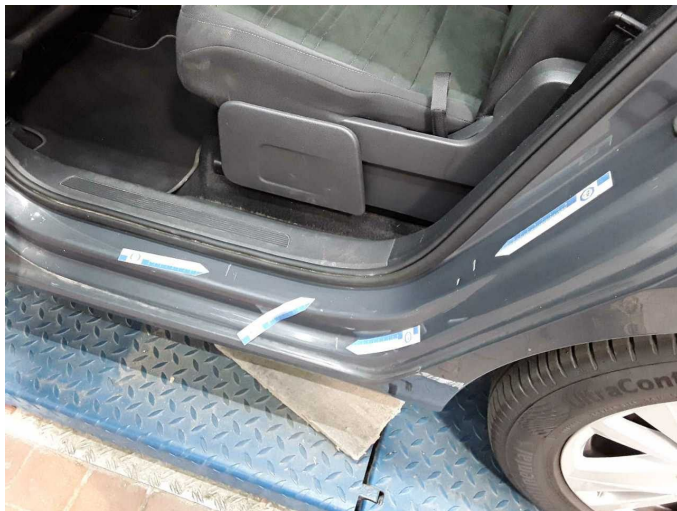
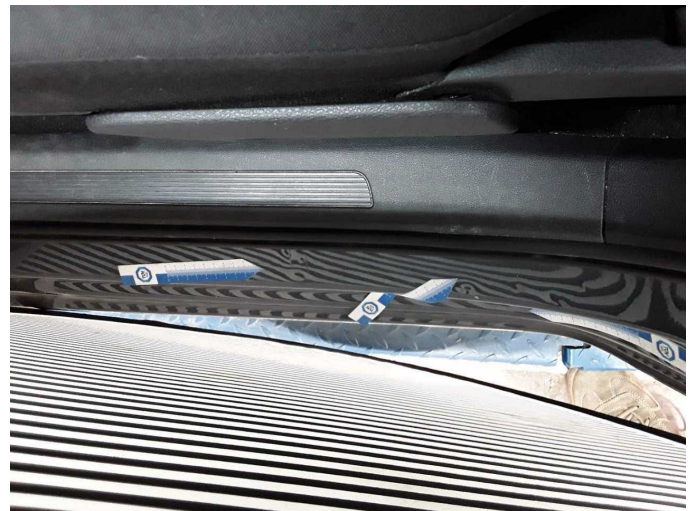
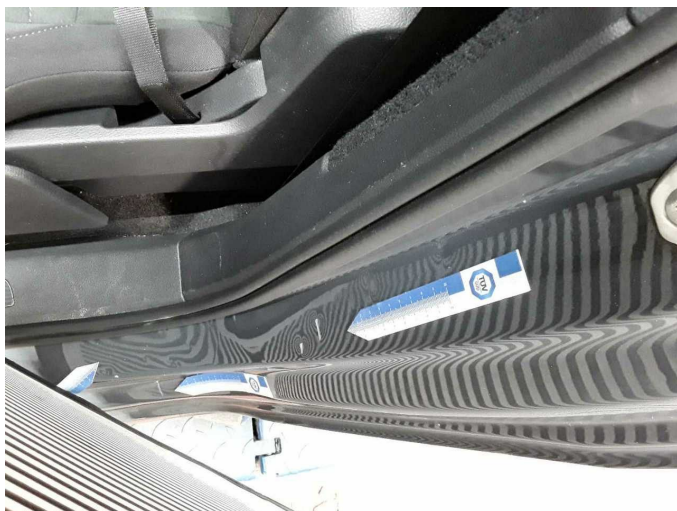
| No. | Component group | Description |
|---|---|---|
| 6 | Side panel - rear left side | Sill - Dent / paintcoat damage - Smart repair |

**Damage 6:** Side panel - rear left side: Sill - Dent / paintcoat damage - Smart repair

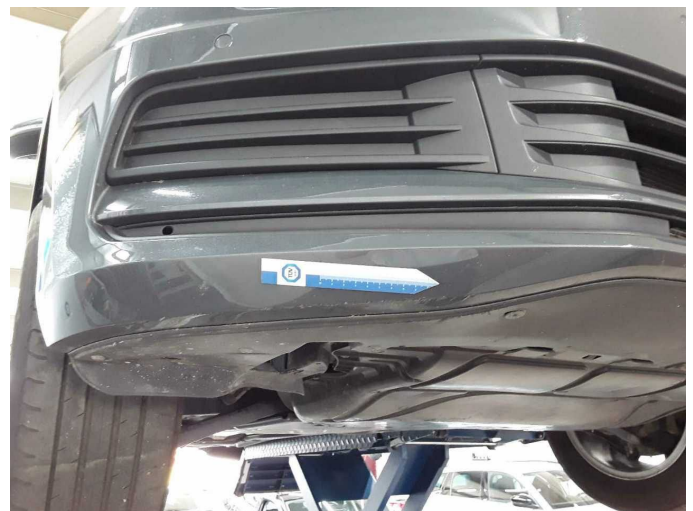
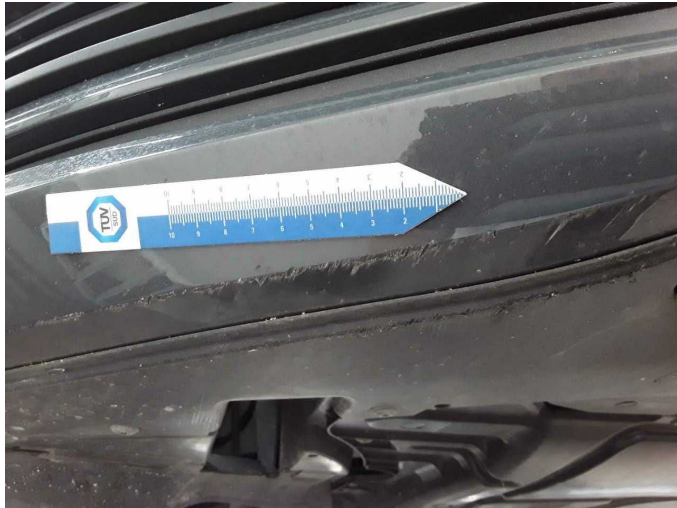
| No. | Component group | Description |
|---|---|---|
| 7 | Front bumper | Front bumper - Scratch(es) - Smart repair |

**Damage 7:** Front bumper: Front bumper - Scratch(es) - Smart repair

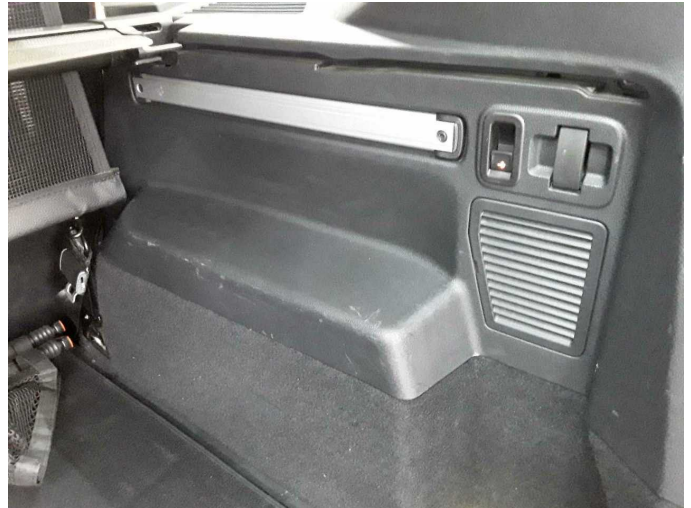
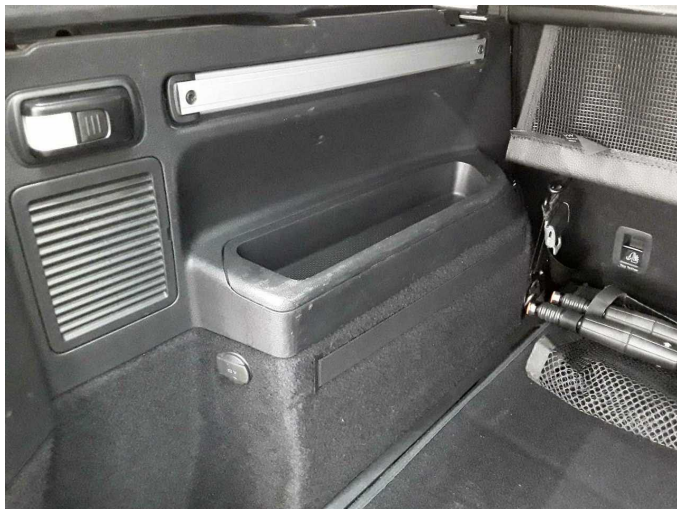
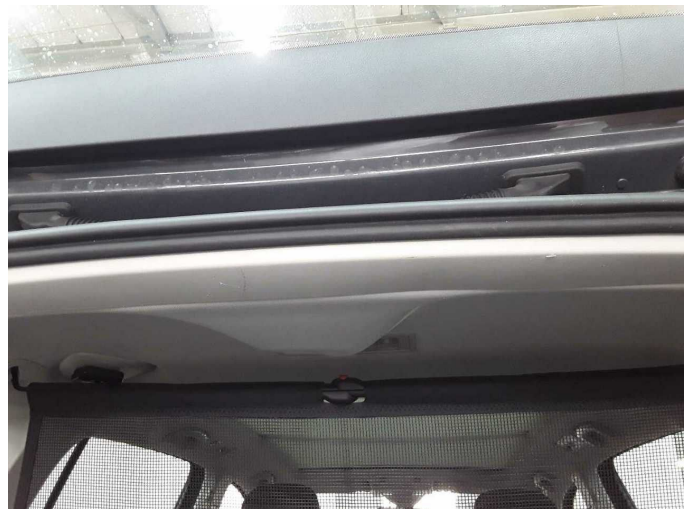
| No. | Component group | Description |
|---|---|---|
| 8 | Interior | Interior (Laderaum Verkleidung) - Scratch(es) - Loss in value |

**Damage 8:** Interior: Interior (Laderaum Verkleidung) - Scratch(es) - Loss in value

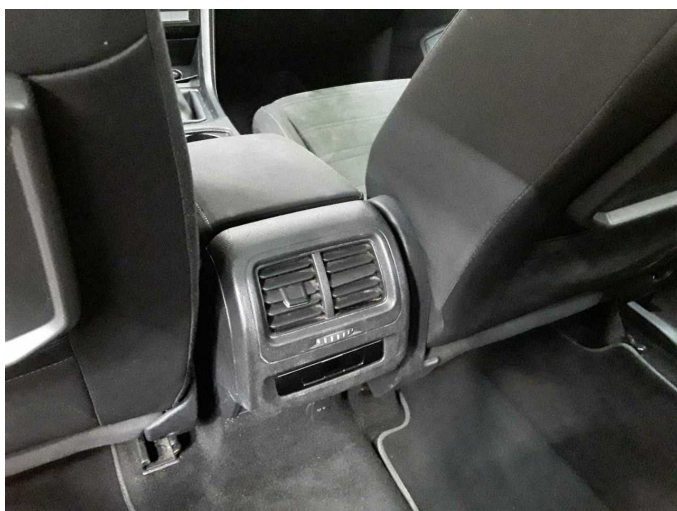
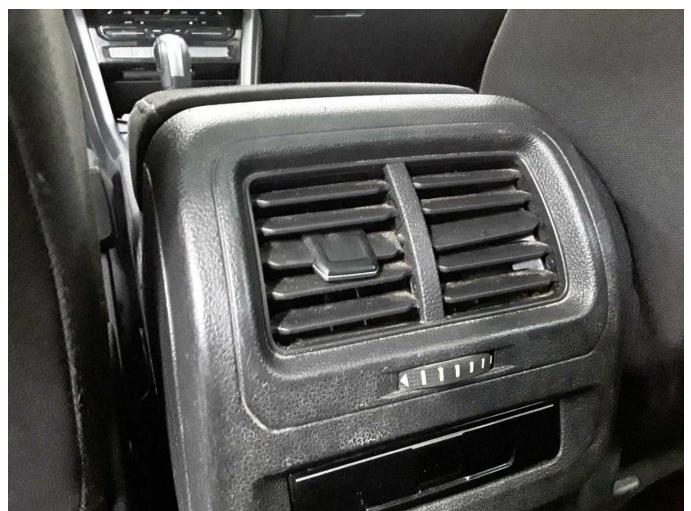
| No. | Component group | Description |
|---|---|---|
| 9 | Instrument panel | Air nozzle - centre (Hinten/Einsteller fehlt) - Broken / torn - Replace |

**Damage 9:** Instrument panel: Air nozzle - centre (Hinten/Einsteller fehlt) - Broken / torn - Replace

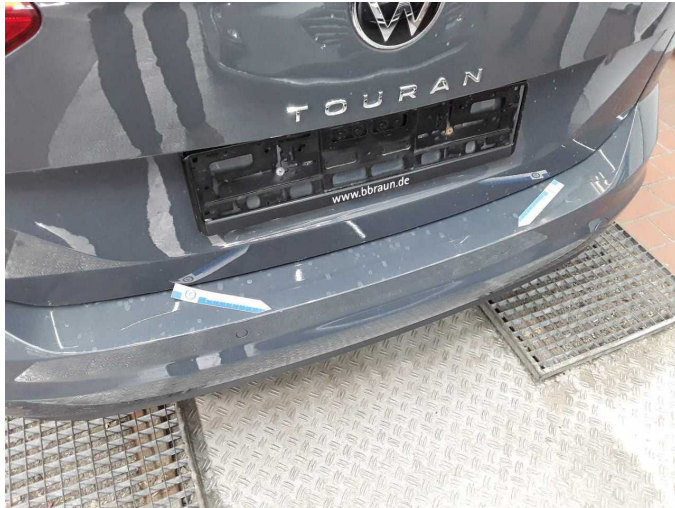
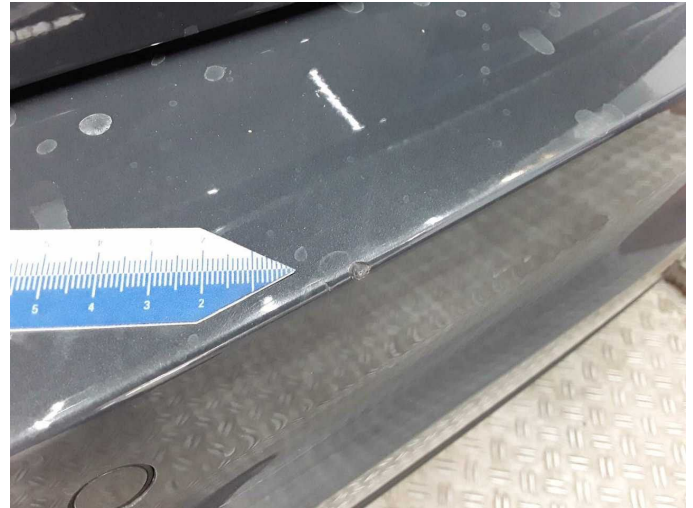
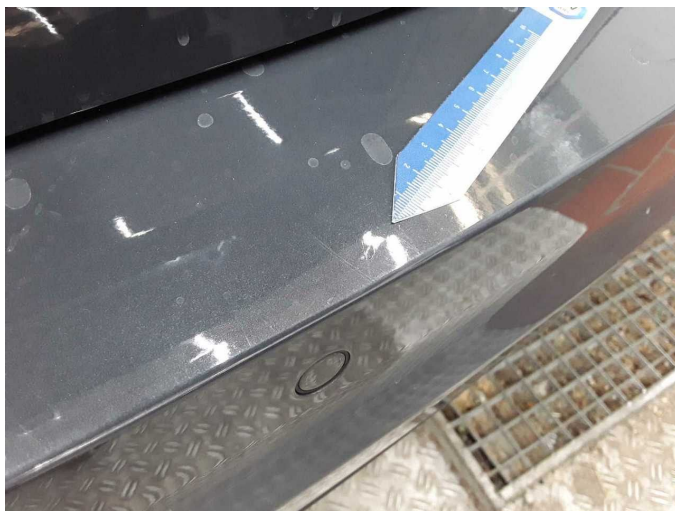
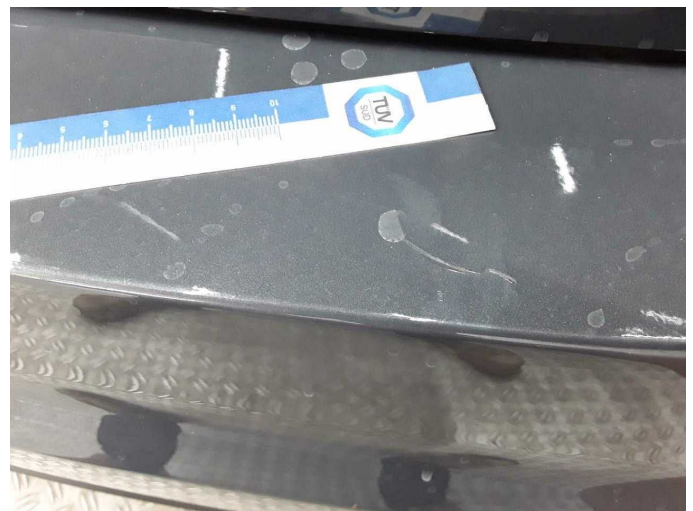
| No. | Component group | Description |
|---|---|---|
| 10 | Rear bumper | Rear bumper (Ladekante) - Scratched - Repair and paint |

**Damage 10:** Rear bumper: Rear bumper (Ladekante) - Scratched - Repair and paint

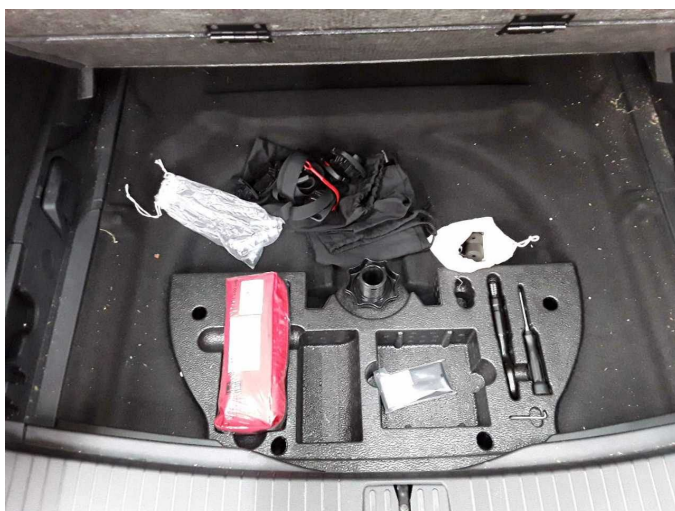
Equipment - Tirefit complete

**Missing part 1:** Equipment: Tirefit complete - Missing - Replace

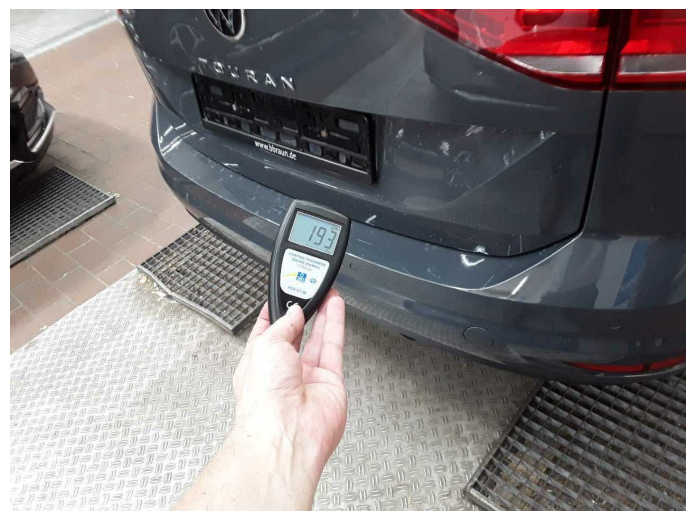
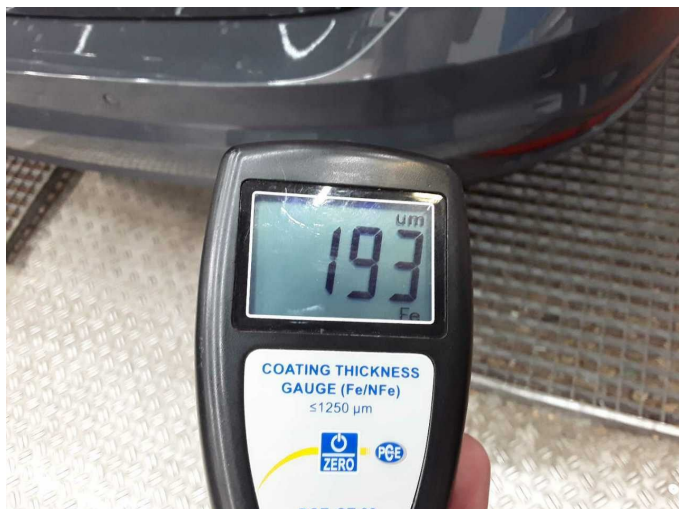
- 1 Boot lid / rear door, Professionally carried out, Invoice of repair done Non-existent

Boot lid / rear door 193  $\mu\text{m}$  |

**Repainting 1:** Boot lid / rear door
