MACDAM

Skoda Enyaq '21 BEV

Vehicle information

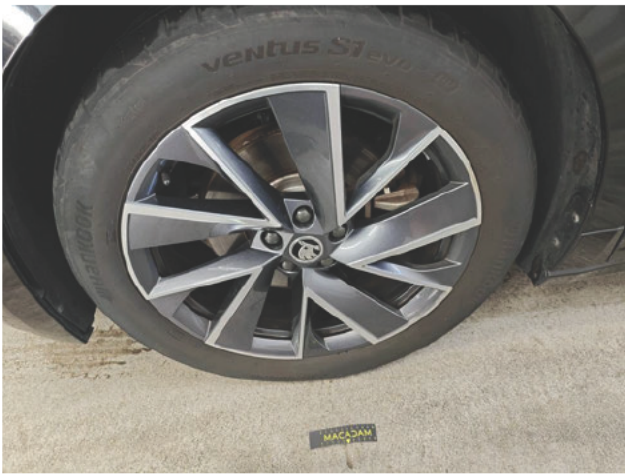
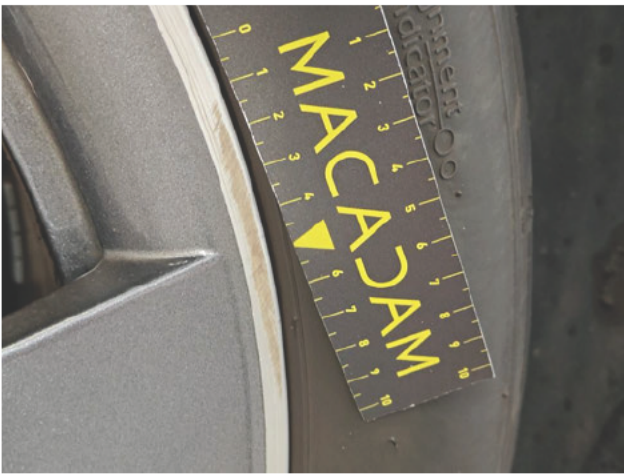
**Alloy rim FL**  
Scratch(es)  
Repair and paint (complete)  
Left

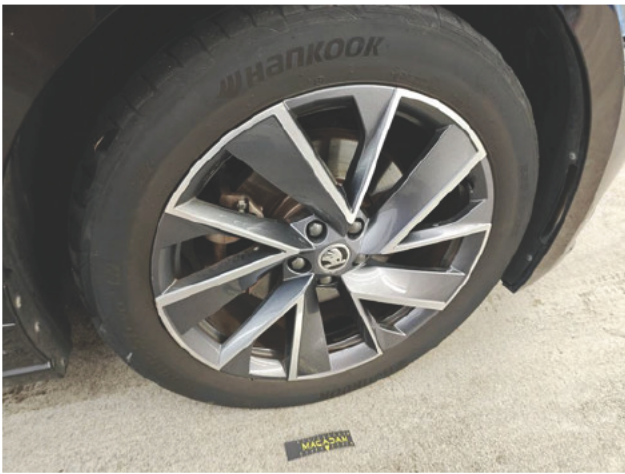
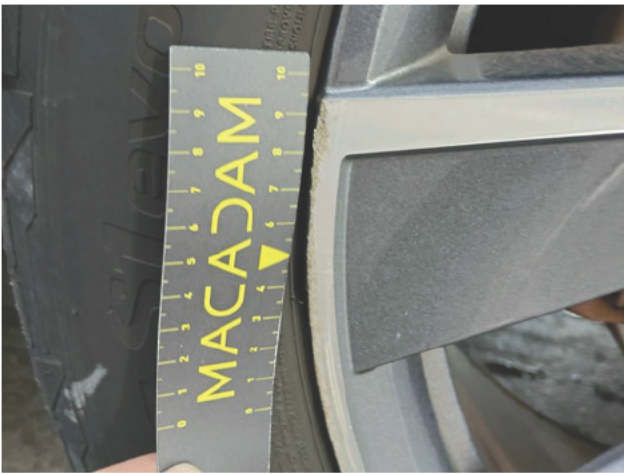
Scratch(es)  
Repair and paint (complete)  
Right

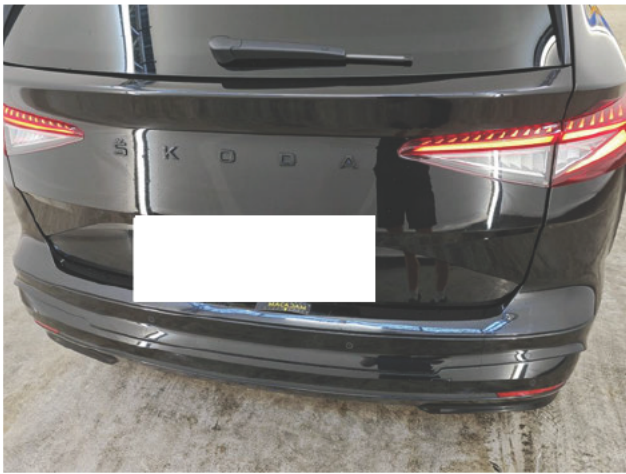
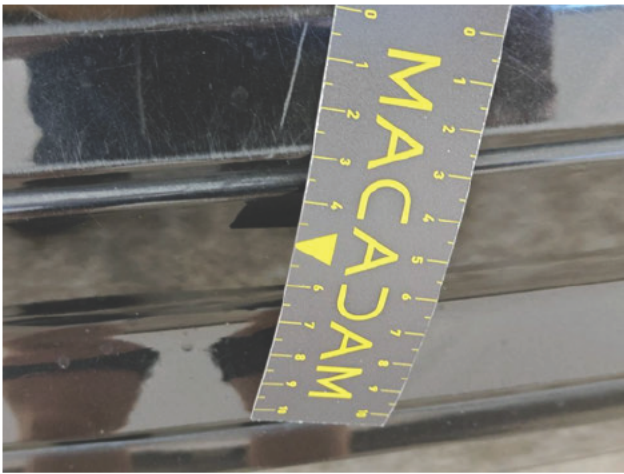
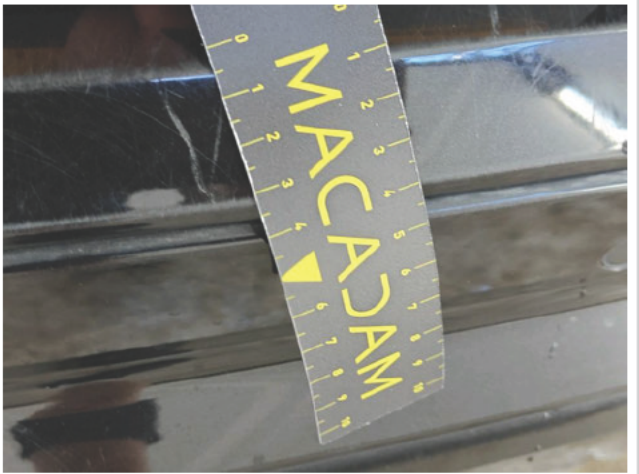
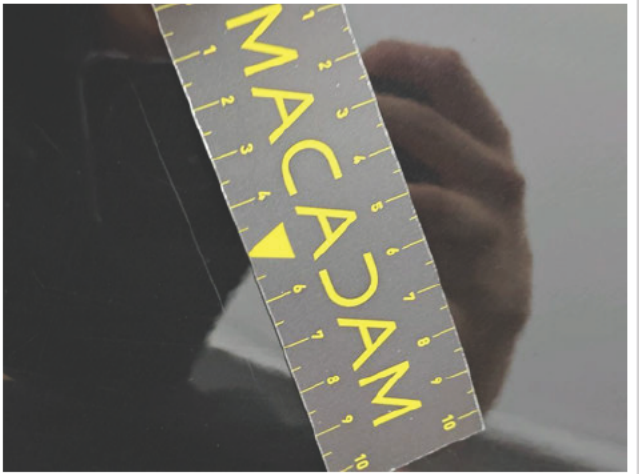
Scratch(es)  
Repair and paint (complete)  
Rear

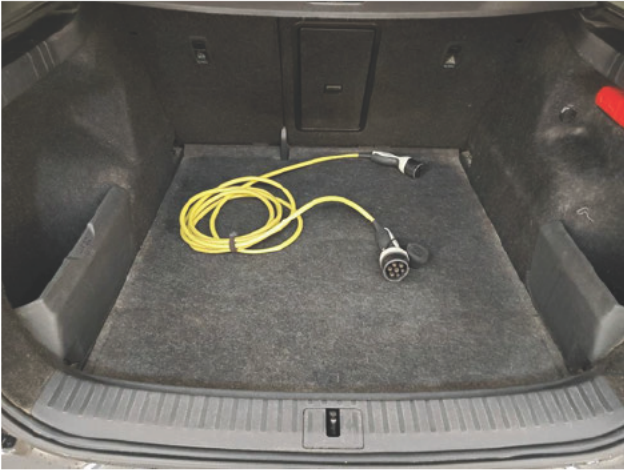
Charging cable (normal)

Missing  
Replace  
Rear

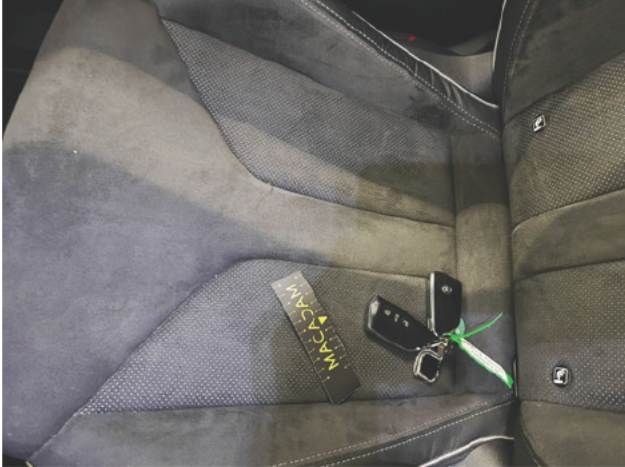
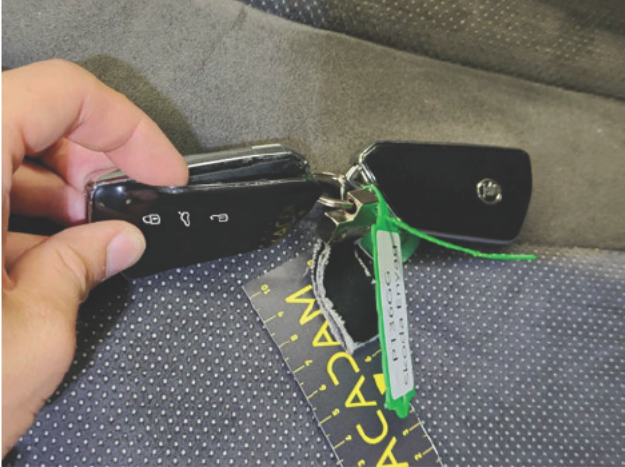
Ignition key

Broken  
Replace  
Interior

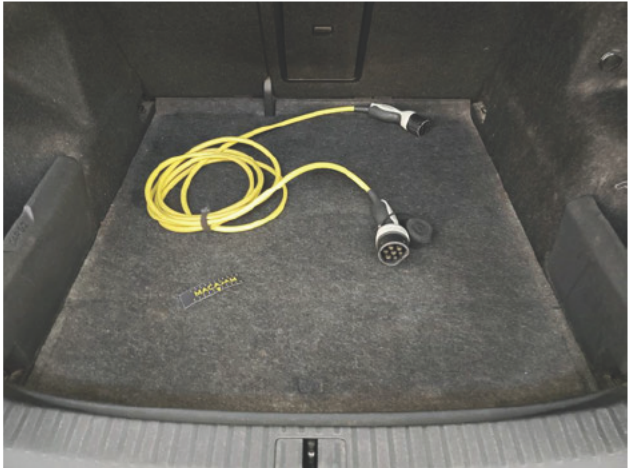
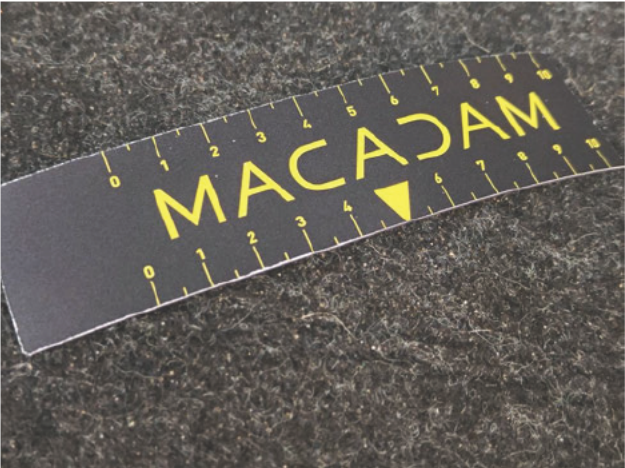
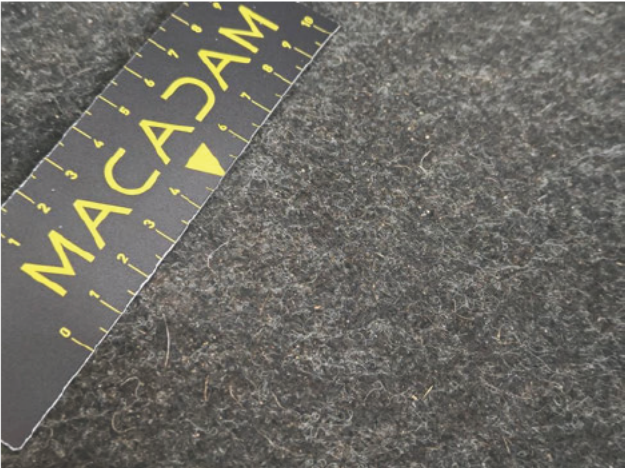
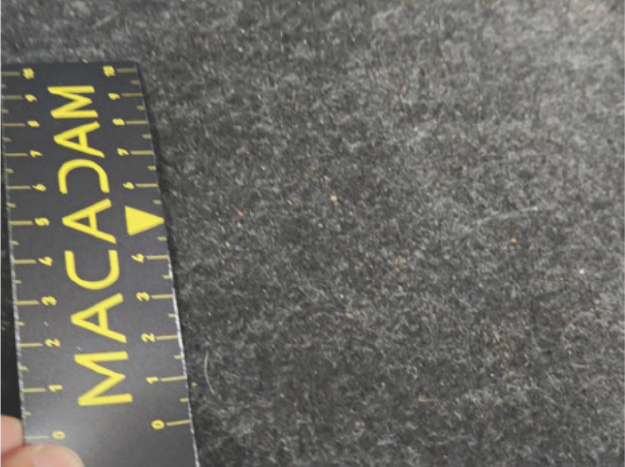
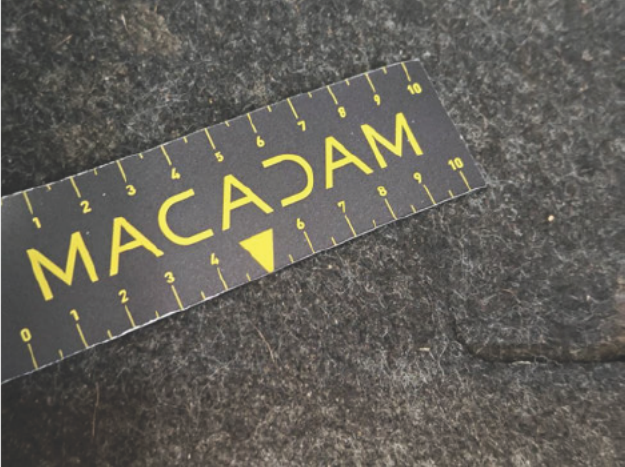
Dirty  
Chemical cleaning  
Interior

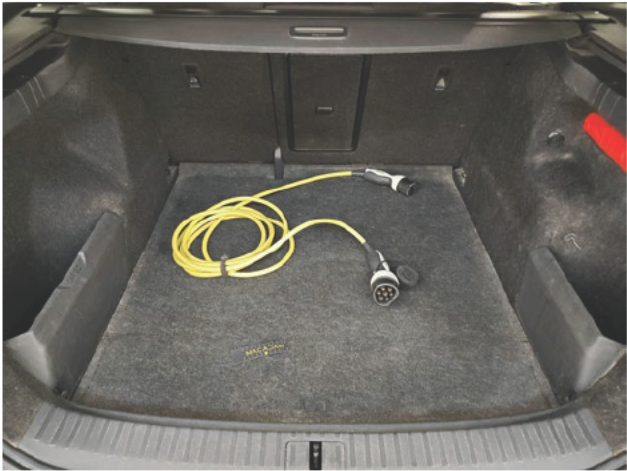
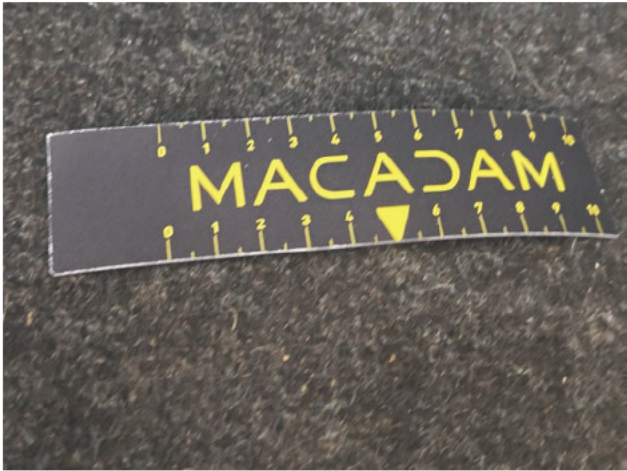
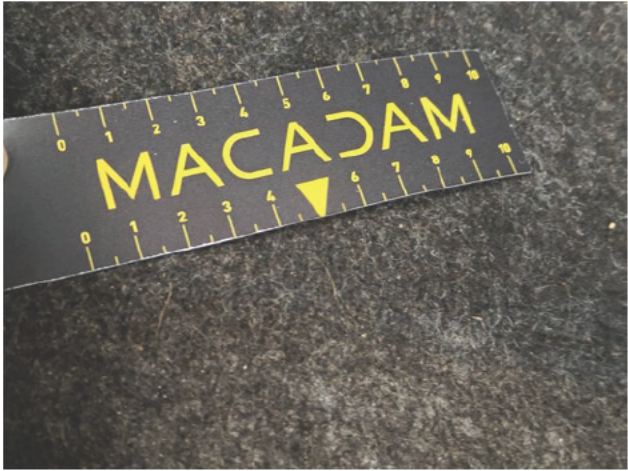
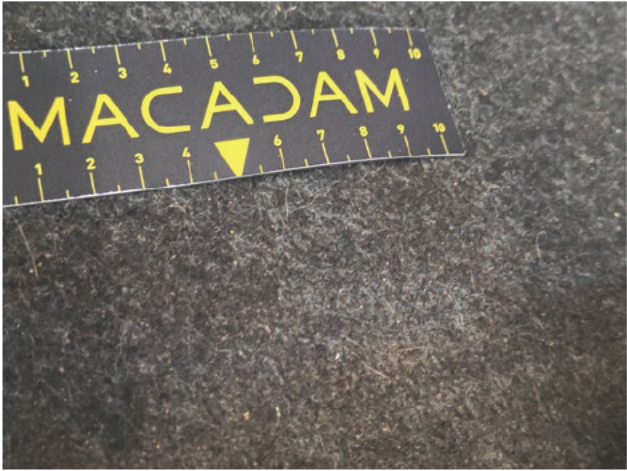
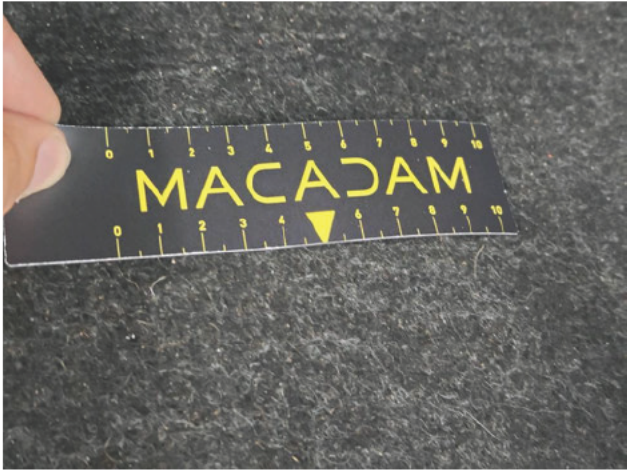
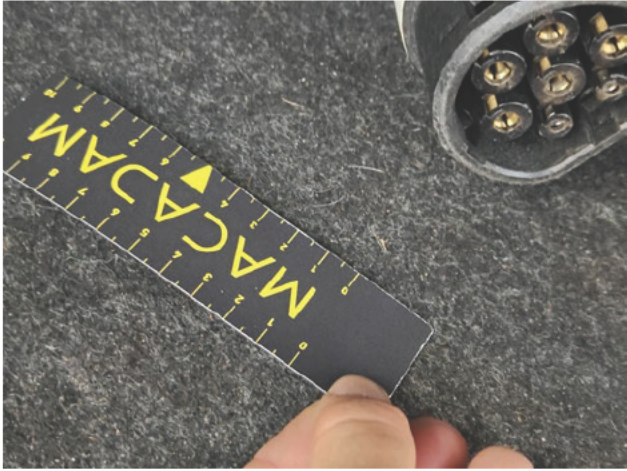
Smell  
Ozone treatment (Animal smell)  
Interior

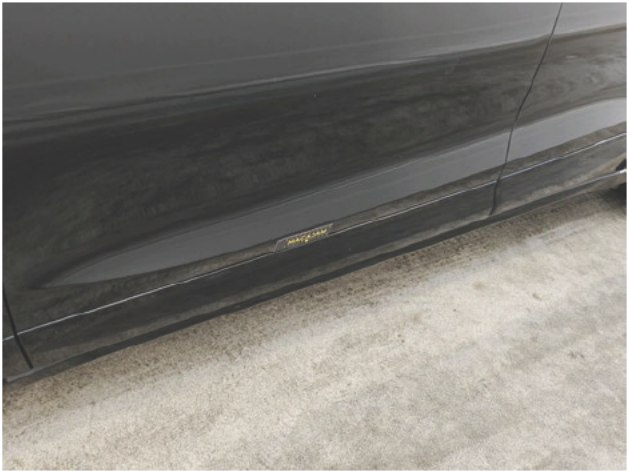
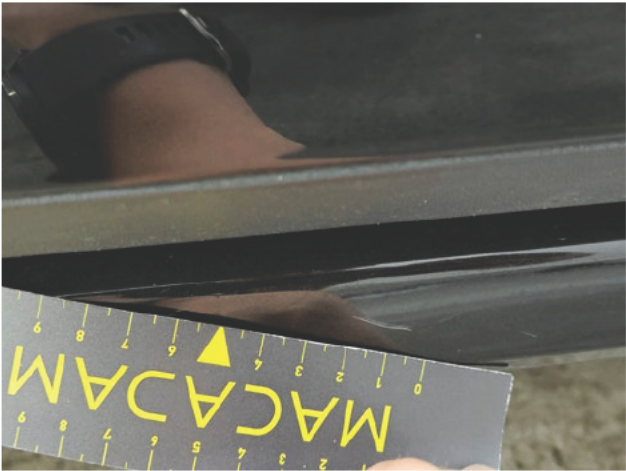
Sill trim L

Scratch(es)  
Repair and paint (complete)  
Left

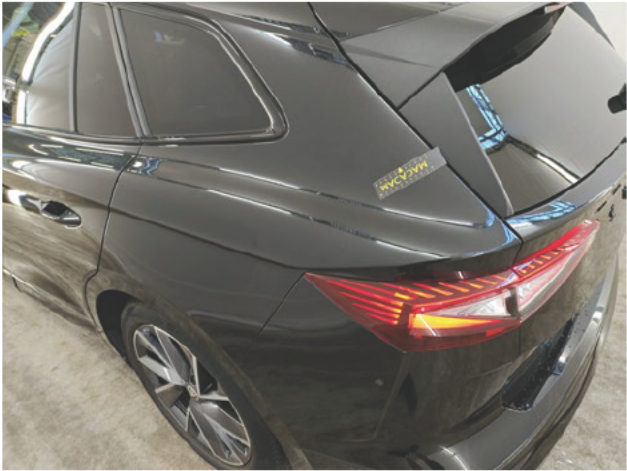
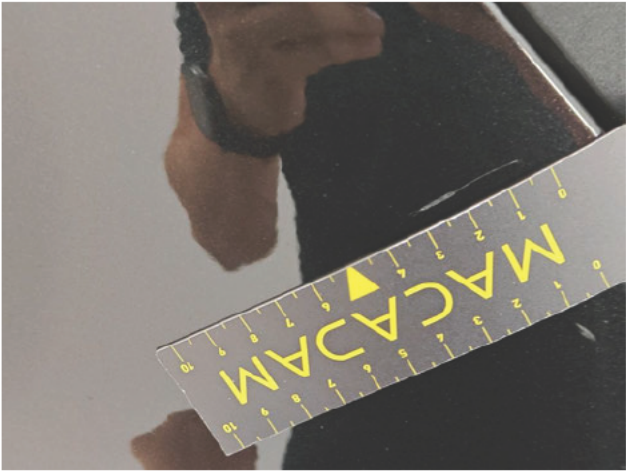
Wing RL

Scratch(es)  
Repair and paint (complete)  
Left

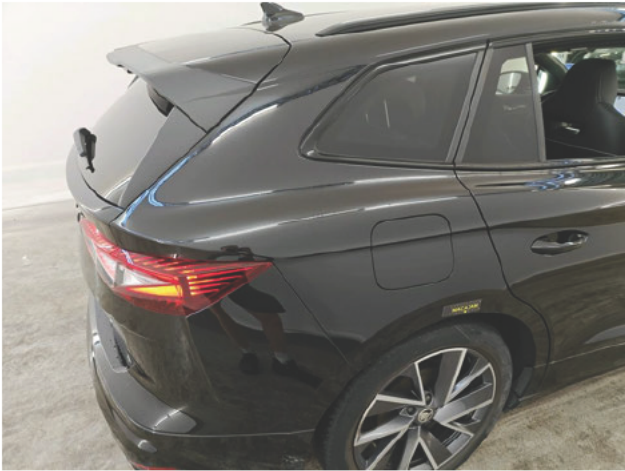
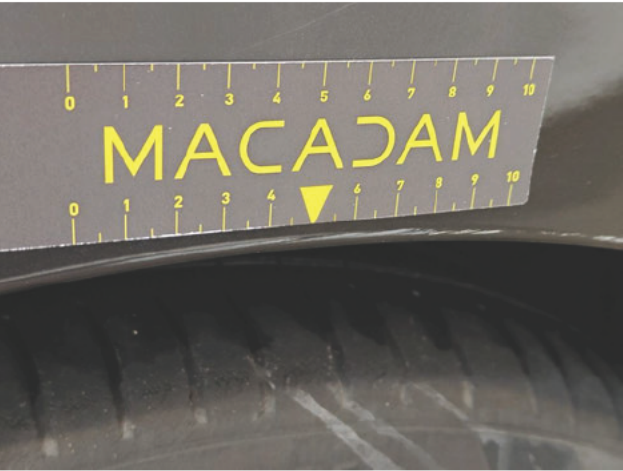
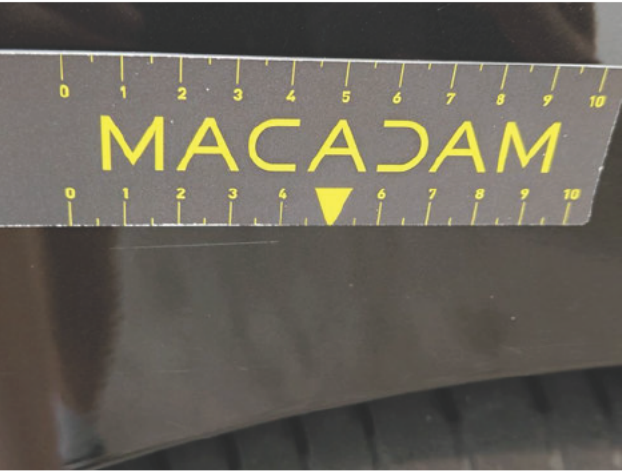
Wing RR

Scratch(es)

Repair and paint (partial)
