Expertise

Protocol number: 46288369  
Order No. / Reference: 26642218  
Inspection date: 1 Jul 2026

Manufacturer: MAN  
VIN: WMA03VUY2P9009506

Model: TGE 3.140 4X2F SB

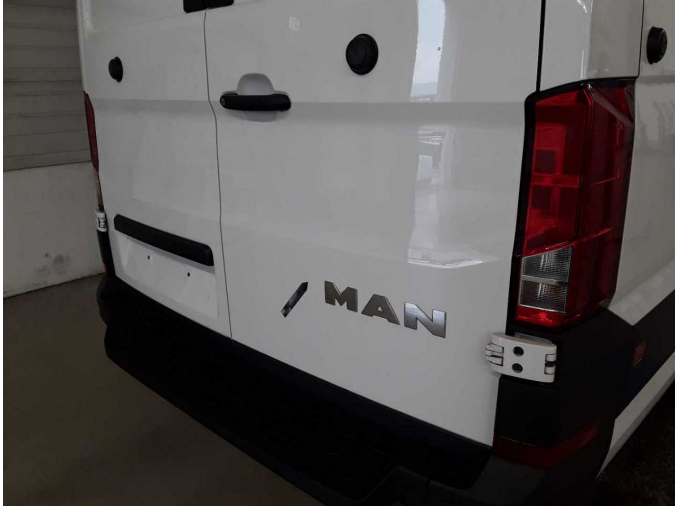
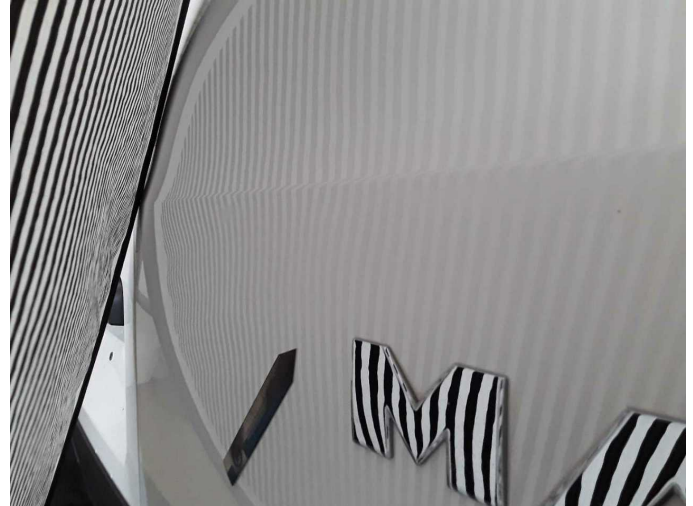
| No. | Component group | Description |
|---|---|---|
| 1 | Boot lid / rear door | Rear door - right side - dent(s) - Smart repair |

**Damage 1:** Boot lid / rear door: Rear door - right side - dent(s) - Smart repair

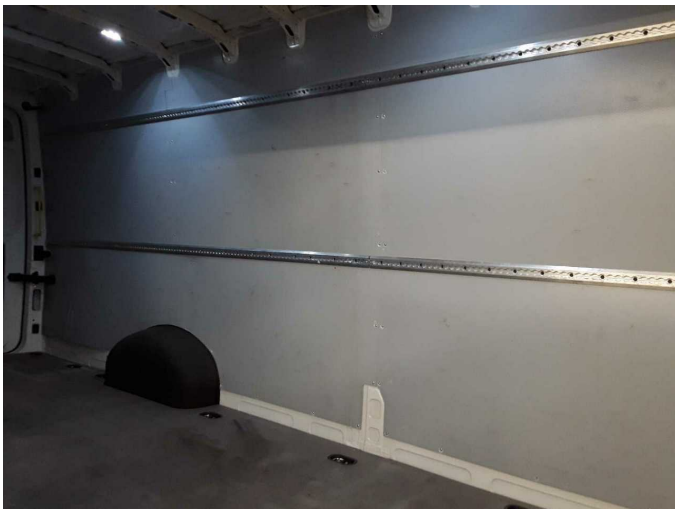
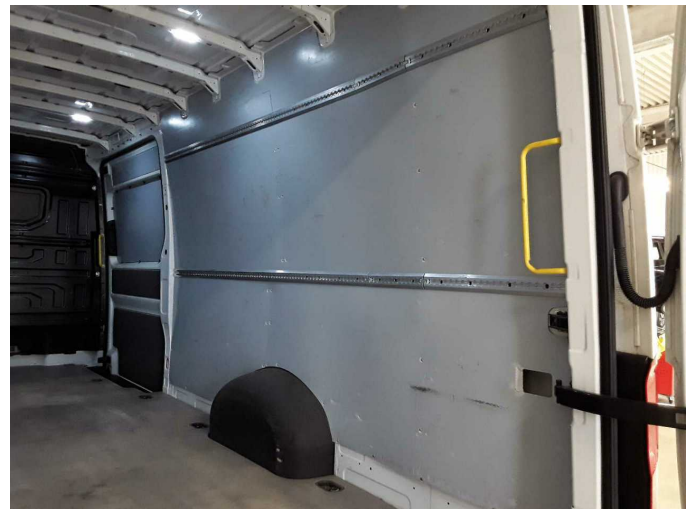
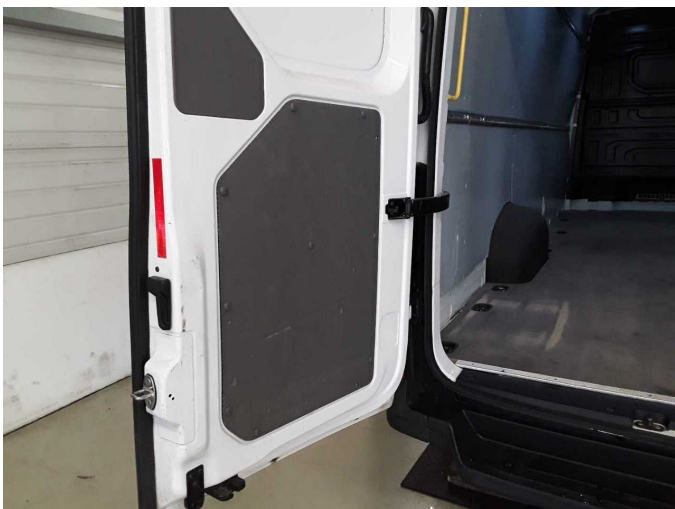
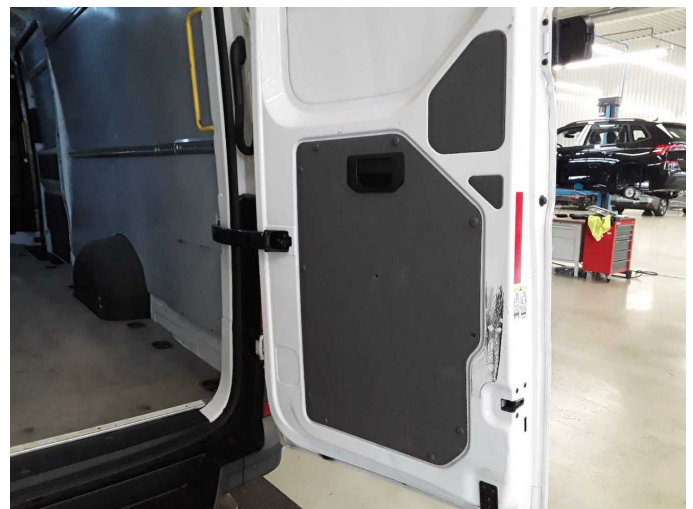
| No. | Component group | Description |
|---|---|---|
| 2 | Interior | Interior (Laderaumverkleidungen) - Differs from the original configuration - Loss in value |

**Damage 2:** Interior: Interior (Laderaumverkleidungen) - Differs from the original configuration - Loss in value

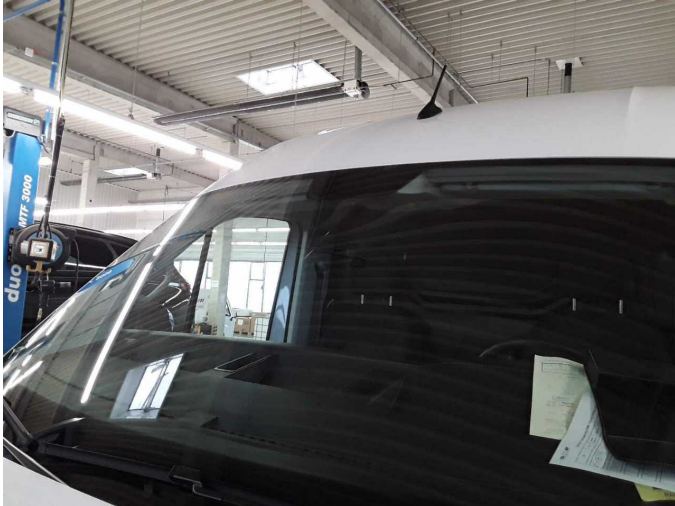
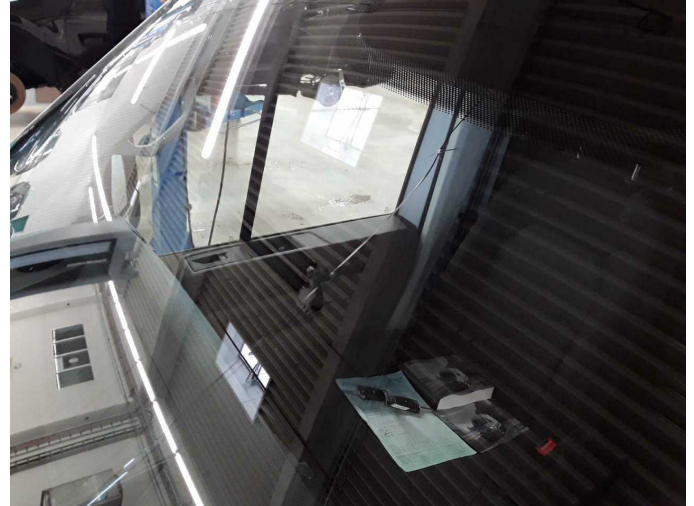
| No. | Component group | Description |
|---|---|---|
| 3 | Vehicle glazing | Windscreen - Broken / torn - Replace |

**Damage 3:** Vehicle glazing: Windscreen - Broken / torn - Replace
