- Vehicle Inspection Report -

Number: 10506447
From: 28.04.2026

Vehicle category:	Passenger Car
Vehicle type:	SUV
Make:	Volkswagen
Model:	Tiguan
Manufacturers and type code:	0603 / CIR
Date of first registration:	24.03.2025
Mileage:	33,643 km
Proof of mileage:	ReadOff
Exterior colour:	Pyritsilber Metallic
Roof colour:	Pyritsilber Metallic
Propulsion:	Front
Fuel:	Petrol
Engine size (cc):	1,500 ccm
Performance:	110 kW (150 PS)
Length:	
Height:	
Width:	
Permitted total weight:	
Wheelbase:	
Number of powered axles:	2
Cylinders:	4
Euronorm:	Euro 6
Number of doors:	4
Number of seats:	7
Gearbox:	Automatic 7-speed
Upholstery type:	Lining fabrics
Interior colour:	Titanschwarz/Titanschwarz/Schwarz/ Stormgrey
Number of keys:	1

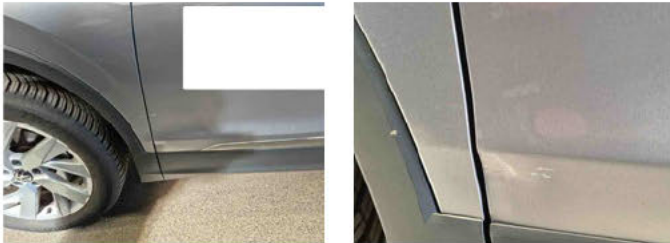
1 - Door FL - Dent(s) and scratch(es) - Repair and paint (complete)

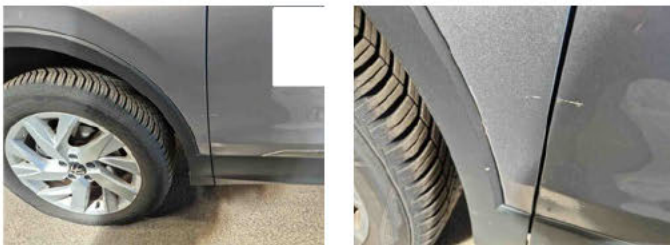
3 - Wing FL - Scratch(es) - Paint

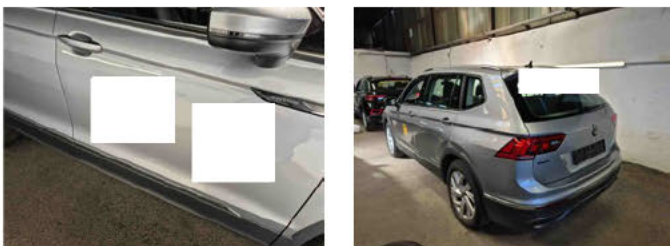
5 - Bodywork - Lettering - Remove lettering

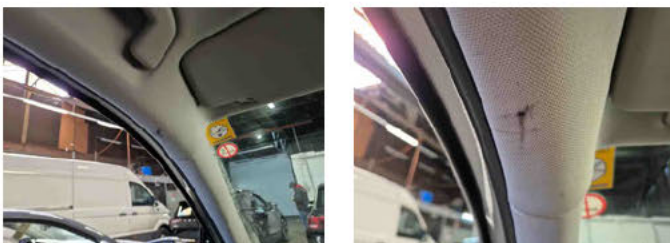
6 - Roof liner - Stain - Cleaning

Comment	Reparaturkostenausweitung möglich.
---------	------------------------------------
