Expertise

Protocol number: 46347032
Order No. / Reference: 26503803
Inspection date: 2 Jul 2026

Model: Captur TCe Mild Hybrid 140 EDC GPF TECHNO

VIN: VF1RJB00570183615

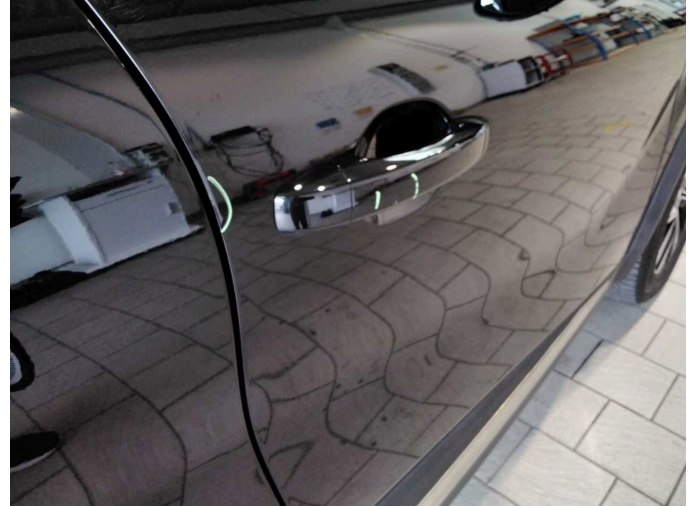
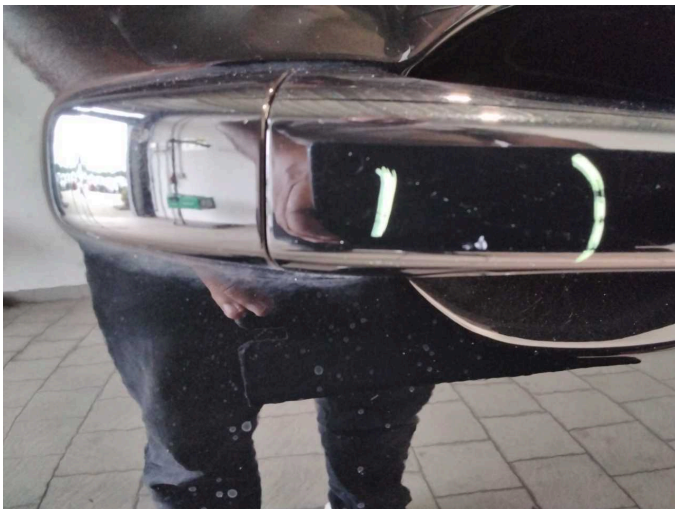
No.	Component group	Description
1	Door - front right side	Door handle - outside - Scratch(es) - Smart repair
2	Door - front right side	Door edge - Scratch(es) - Smart repair
3	Door - front left side	Door edge - Scratch(es) - Smart repair
4	Side panel - rear left side	Sill - Scratch(es) - Smart repair
5	Door - rear left side	Door edge - Scratch(es) - Smart repair
6	Sill - right side	Sill - Scratch(es) - Smart repair
7	Rear bumper	Bumper - rear right side - Scratch(es) - Smart repair
8	Rear bumper	Bumper - rear left side - Scratch(es) - Smart repair
9	Bonnet	Bonnet - dent(s) - Smooth repair work
10	Roof	Roof - dent(s) - Smooth repair work
11	Side panel - rear right side	Side panel - dent(s) - Smooth repair work
12	Side panel - rear right side	Sill - Dent / paintcoat damage - Smart repair

Damage 1: Door - front right side: Door handle - outside - Scratch(es) - Smart repair

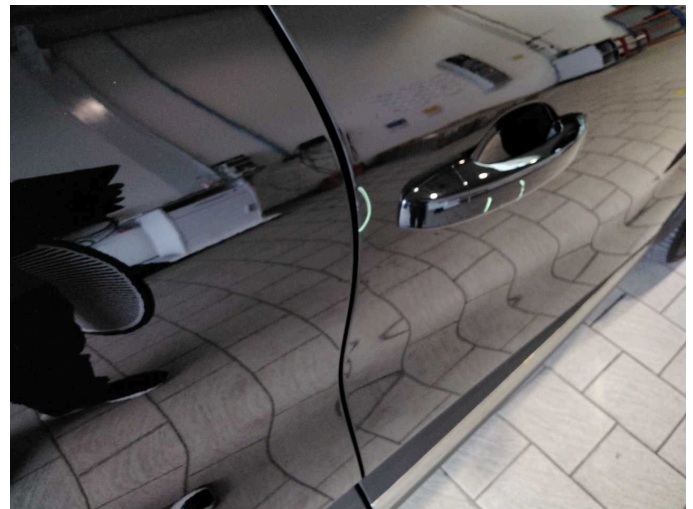
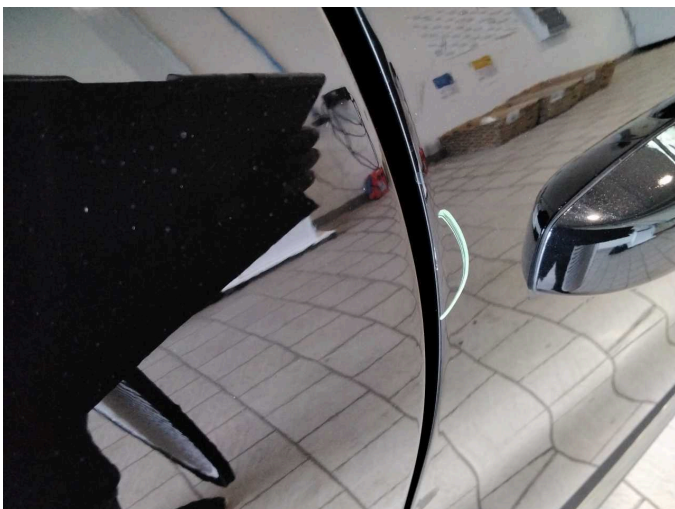
Damage 2: Door - front right side: Door edge - Scratch(es) - Smart repair

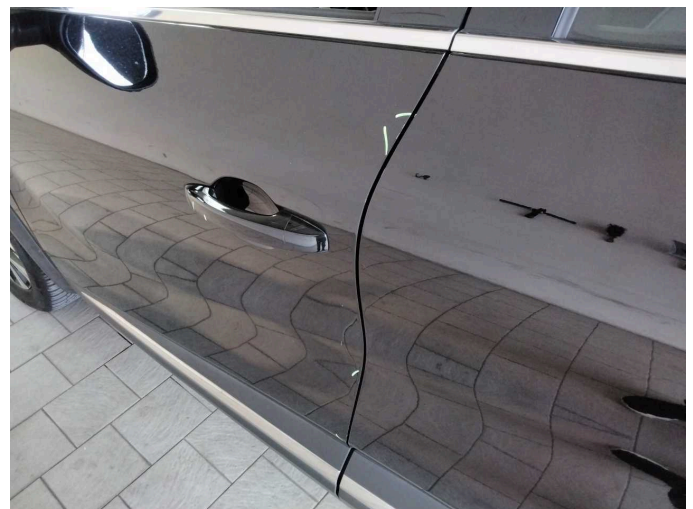
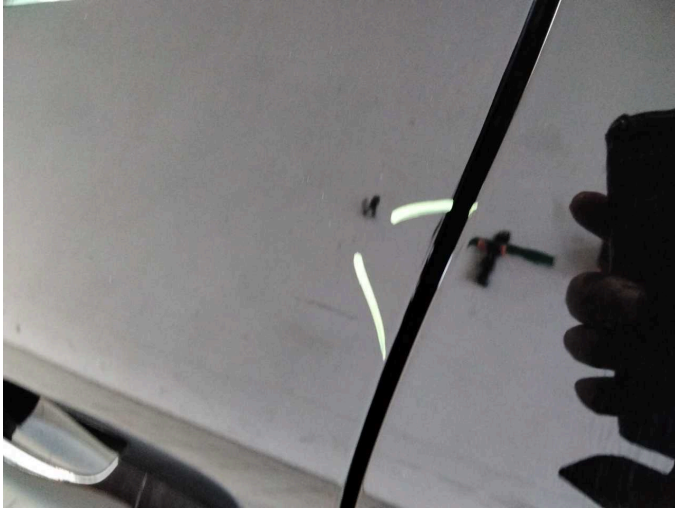
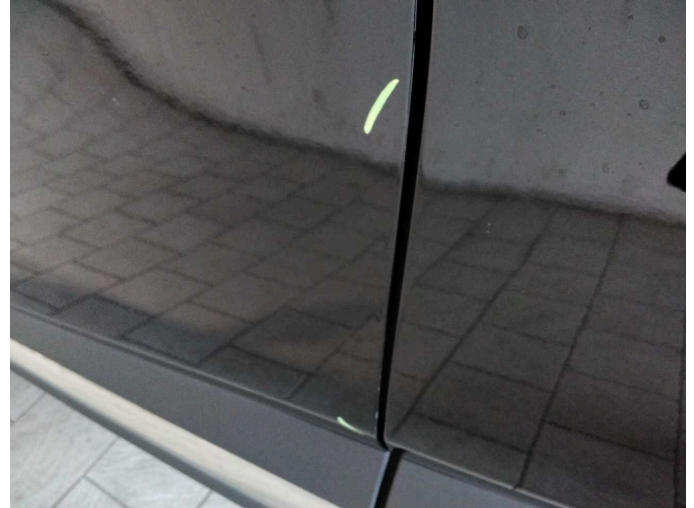
Damage 3: Door - front left side: Door edge - Scratch(es) - Smart repair

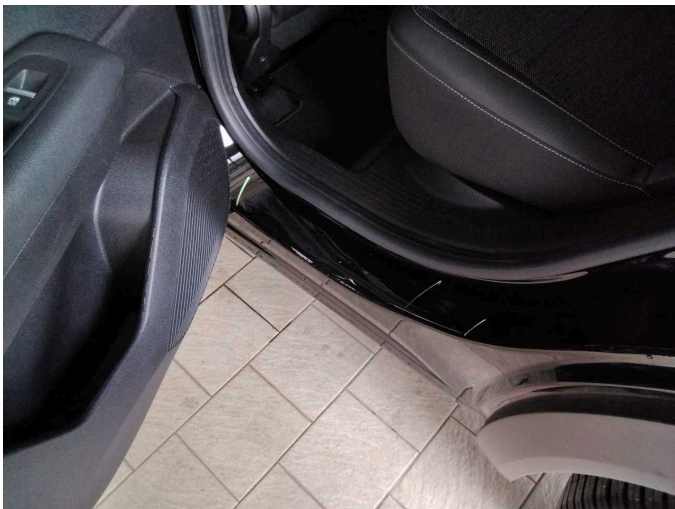
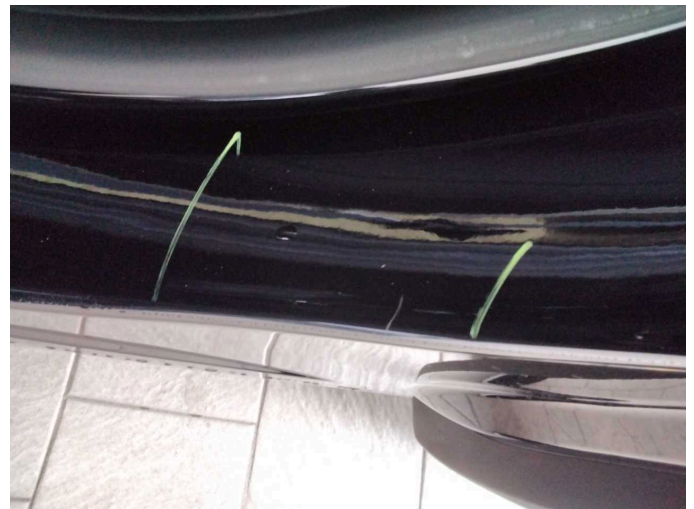
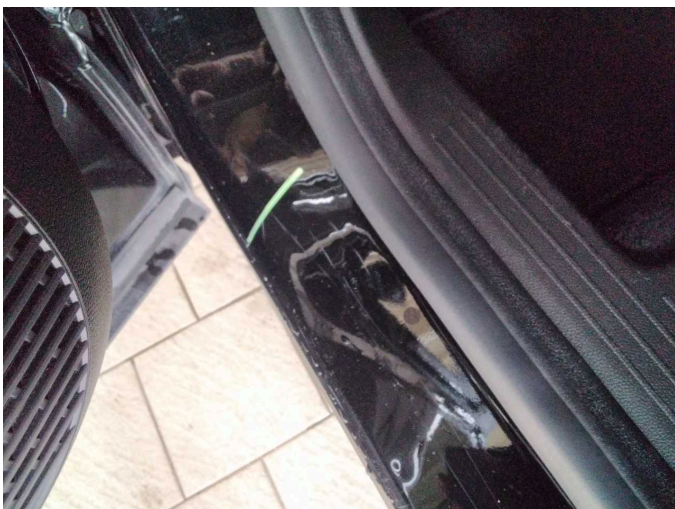
Damage 4: Side panel - rear left side: Sill - Scratch(es) - Smart repair

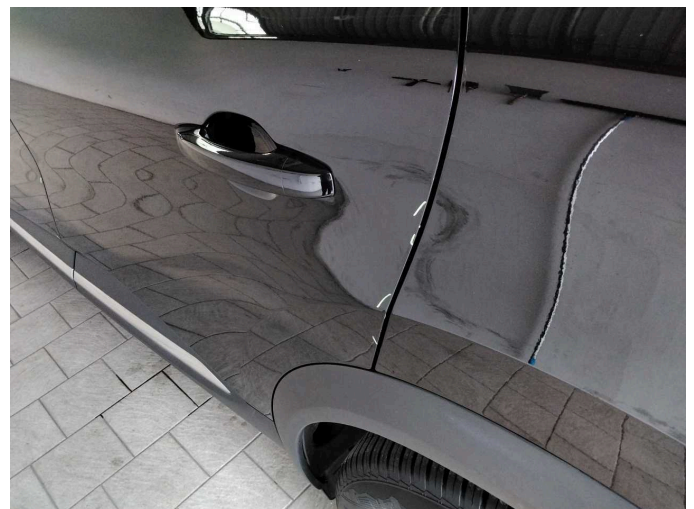
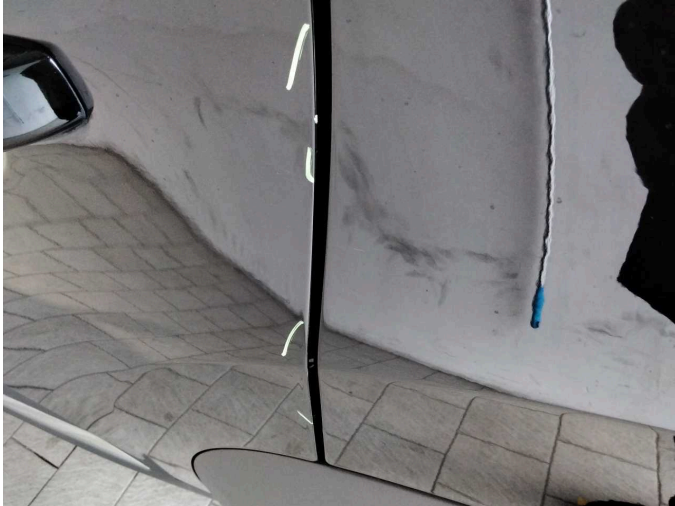
Damage 5: Door - rear left side: Door edge - Scratch(es) - Smart repair

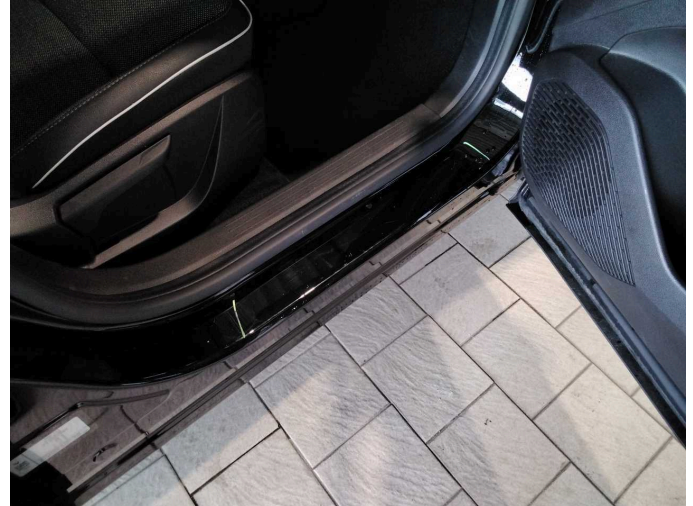
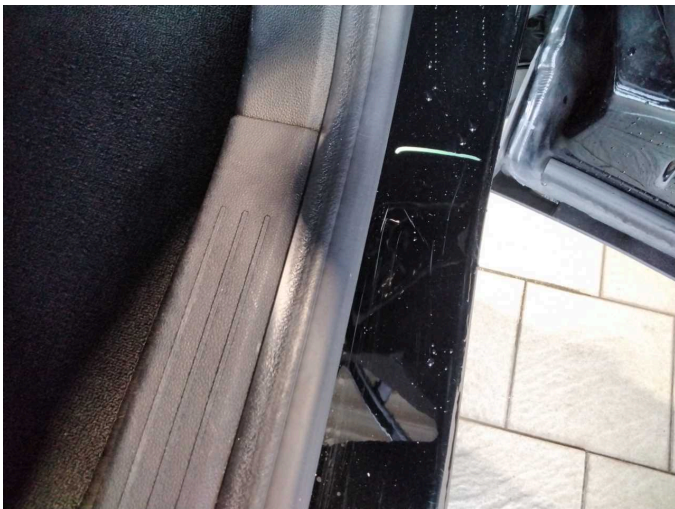
Damage 6: Sill - right side: Sill - Scratch(es) - Smart repair

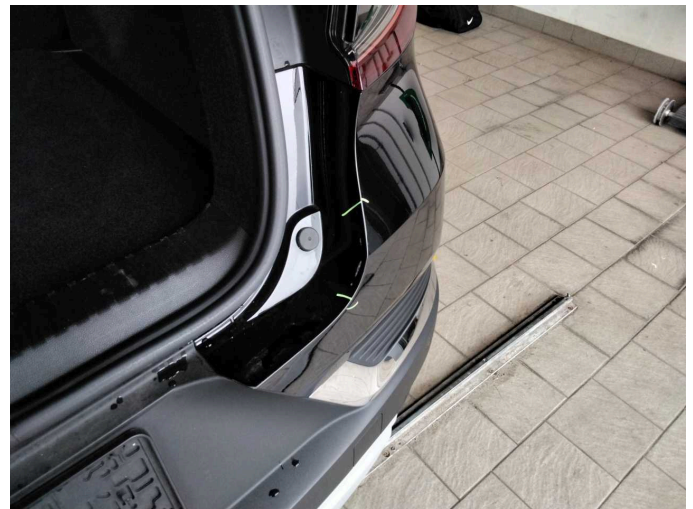
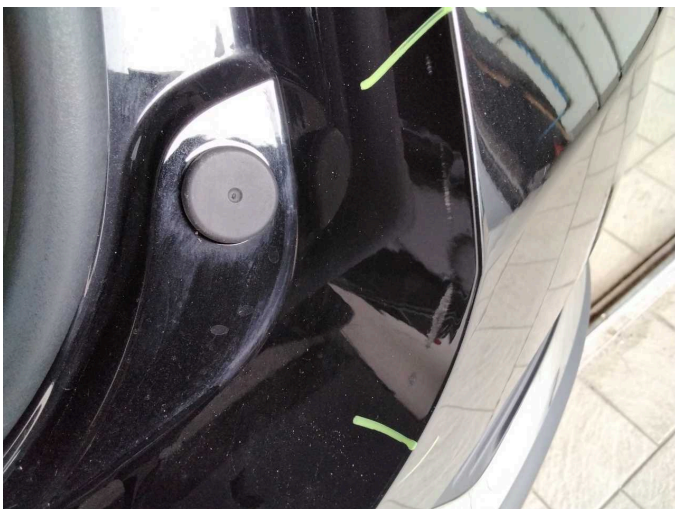
Damage 7: Rear bumper: Bumper - rear right side - Scratch(es) - Smart repair

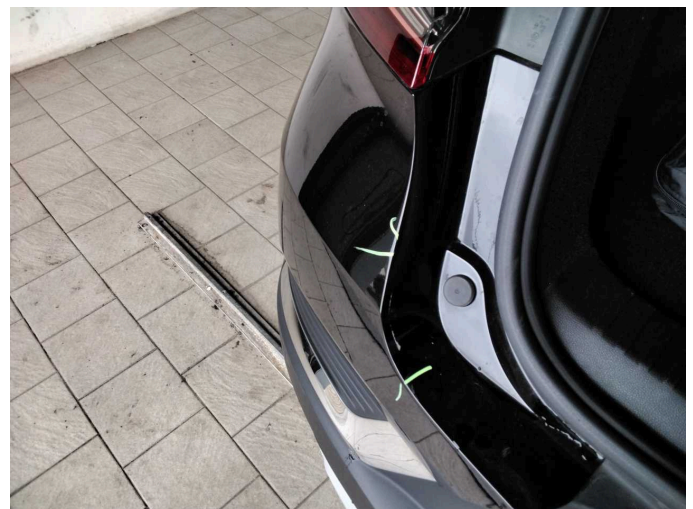
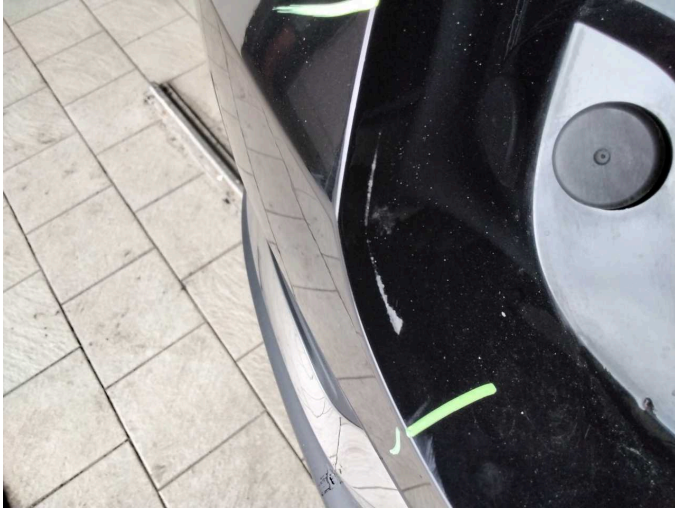
Damage 8: Rear bumper: Bumper - rear left side - Scratch(es) - Smart repair

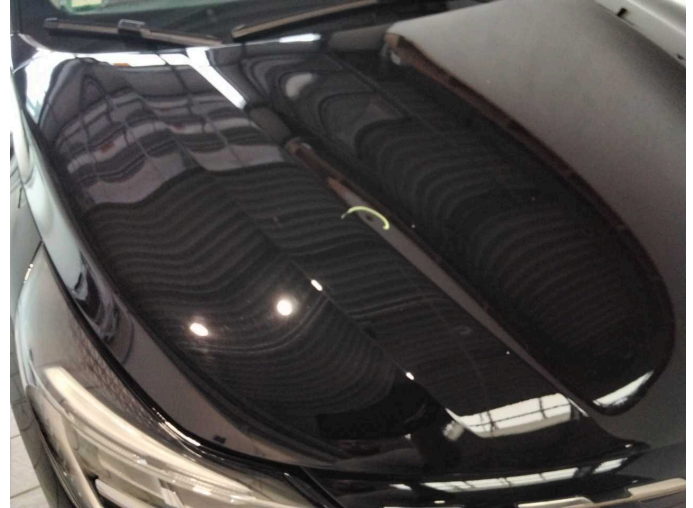
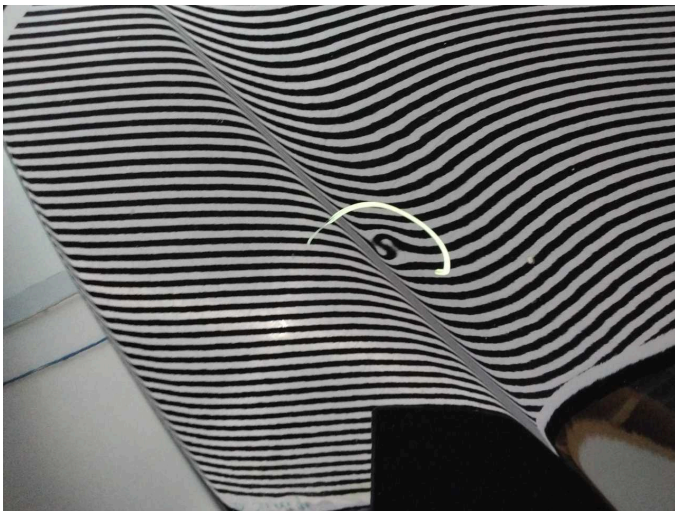
Damage 9: Bonnet: Bonnet - dent(s) - Smooth repair work

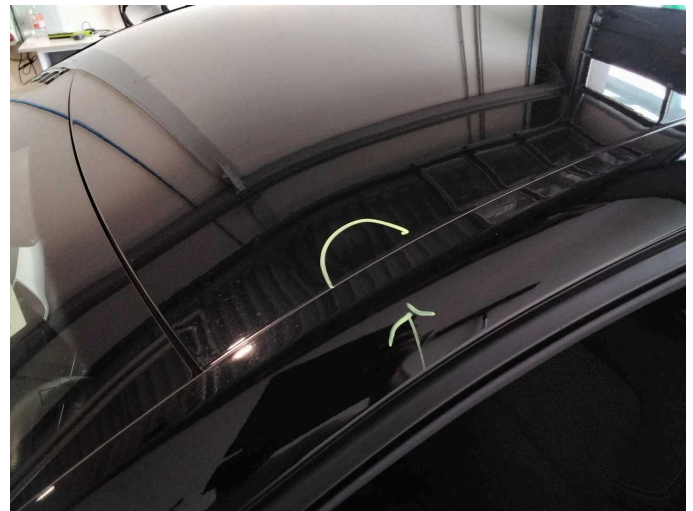
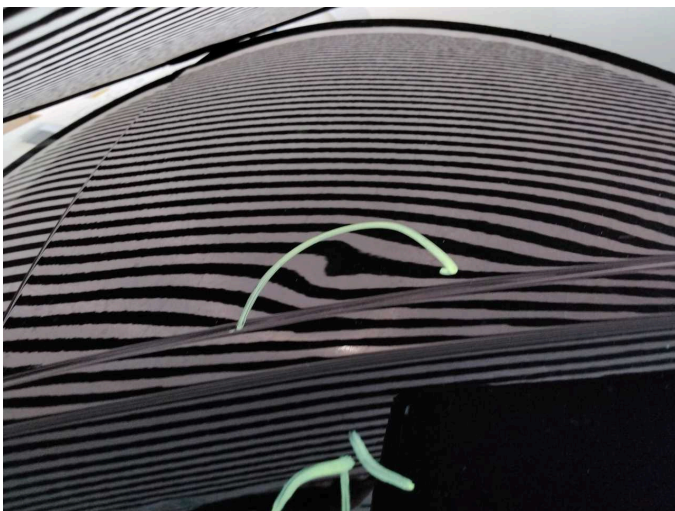
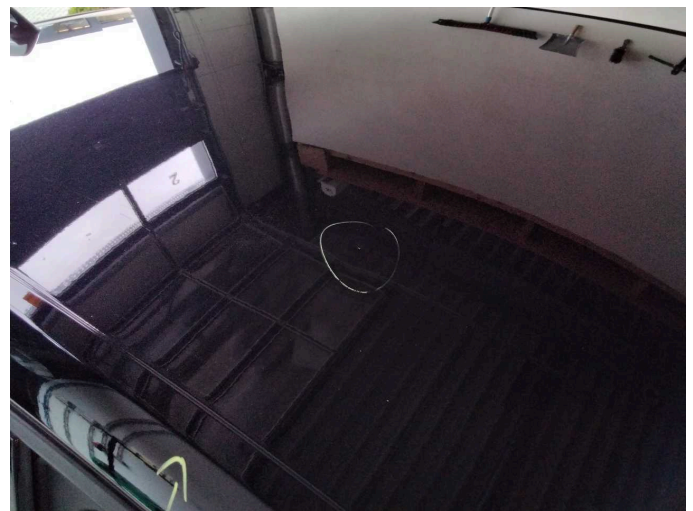
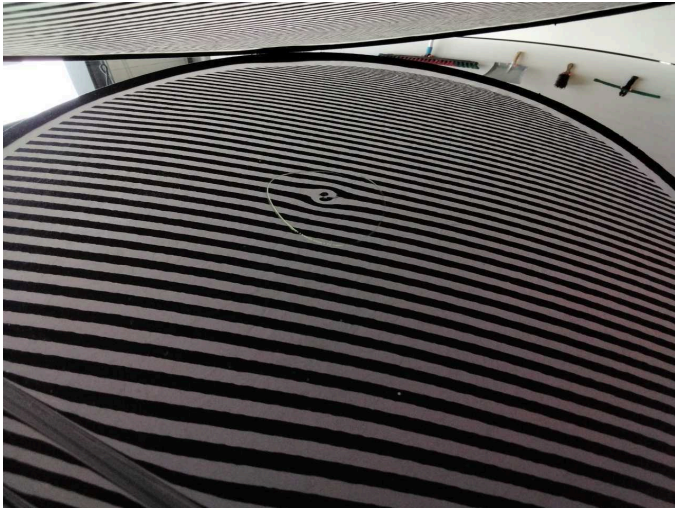
Damage 10: Roof: Roof - dent(s) - Smooth repair work

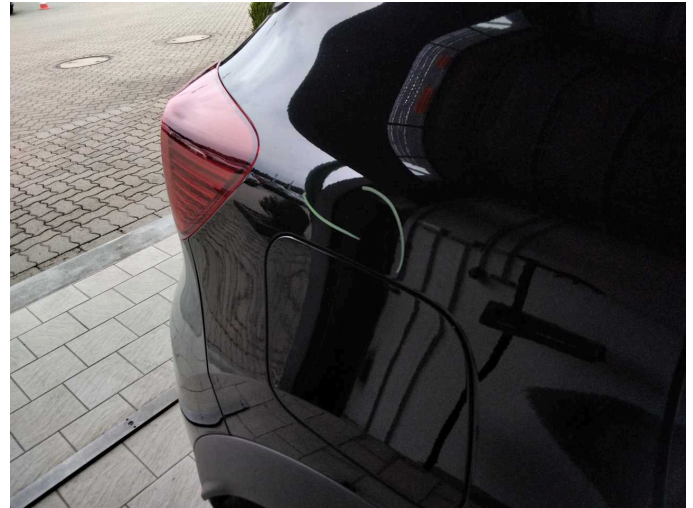
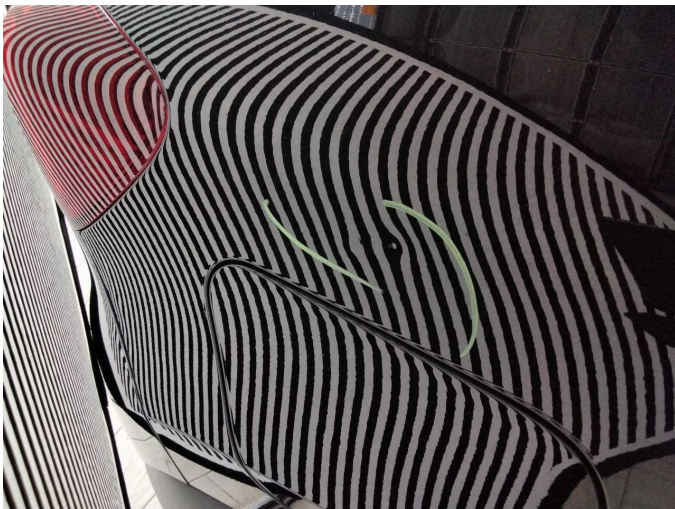
Damage 11: Side panel - rear right side: Side panel - dent(s) - Smooth repair work

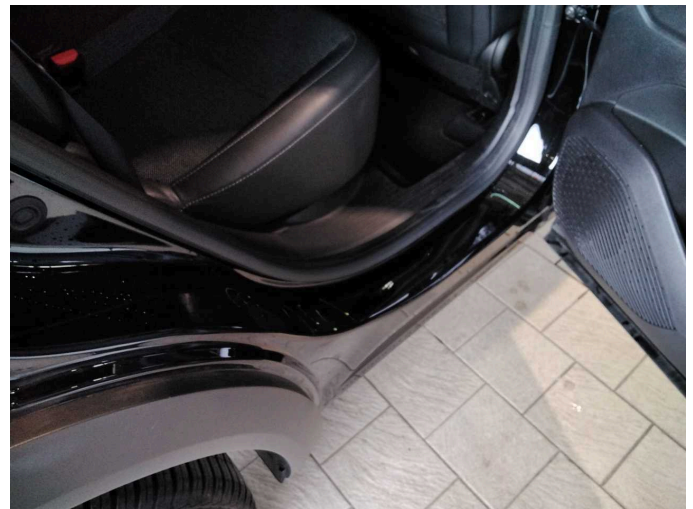
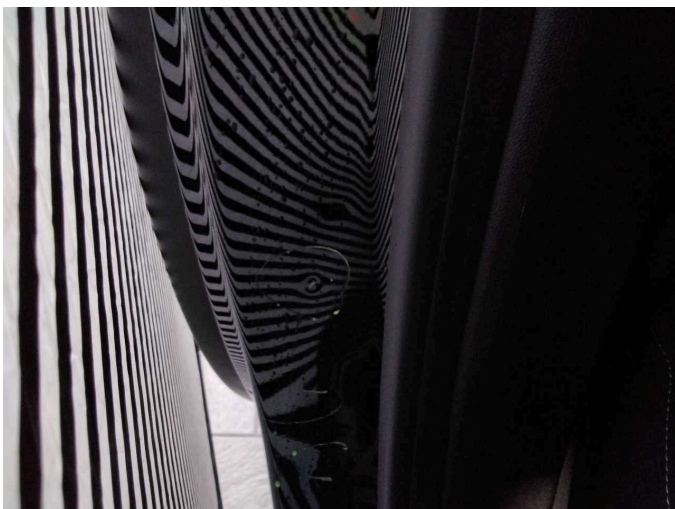
Damage 12: Side panel - rear right side: Sill - Dent / paintcoat damage - Smart repair

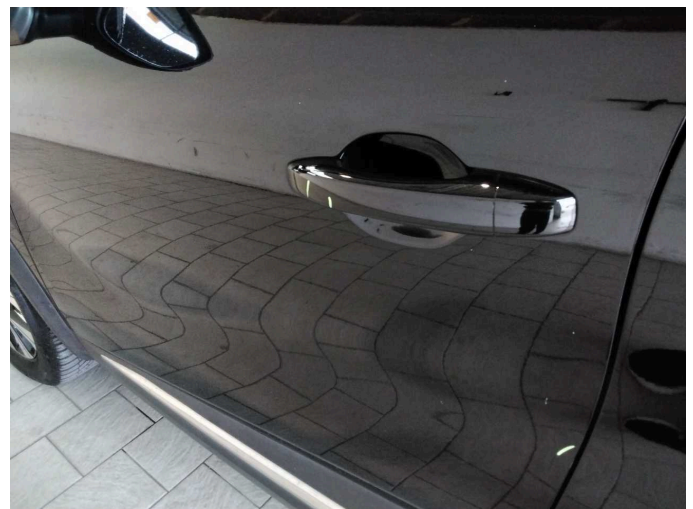
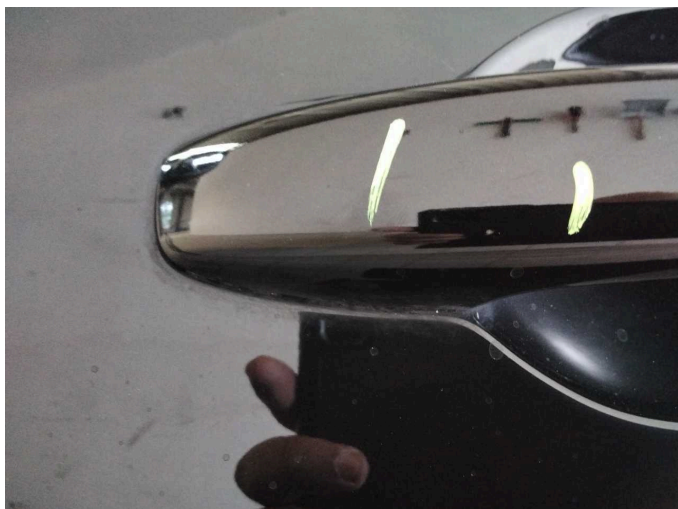
No.	Component group	Description
1	Door - front left side	Door handle - outside - Scratch(es) - No deduction
2	Wing mirror - left side	Cap - Scratch(es) - No deduction
3	Vehicle glazing	Windscreen - Stone chips - No deduction

Wear and tear 1: Door - front left side: Door handle - outside - Scratch(es) - No deduction

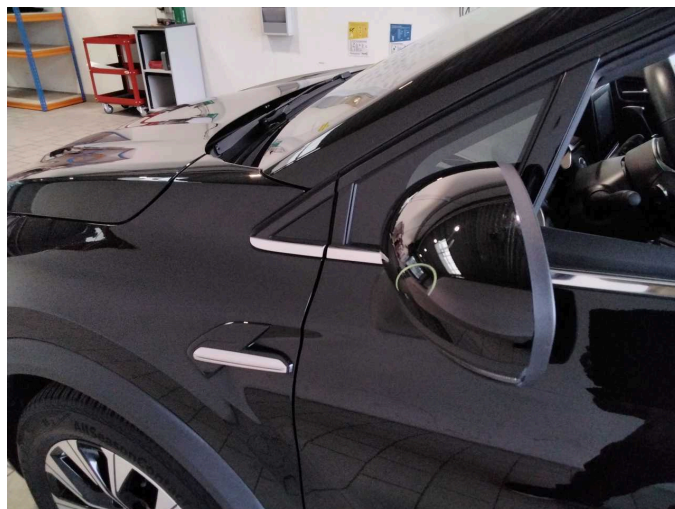
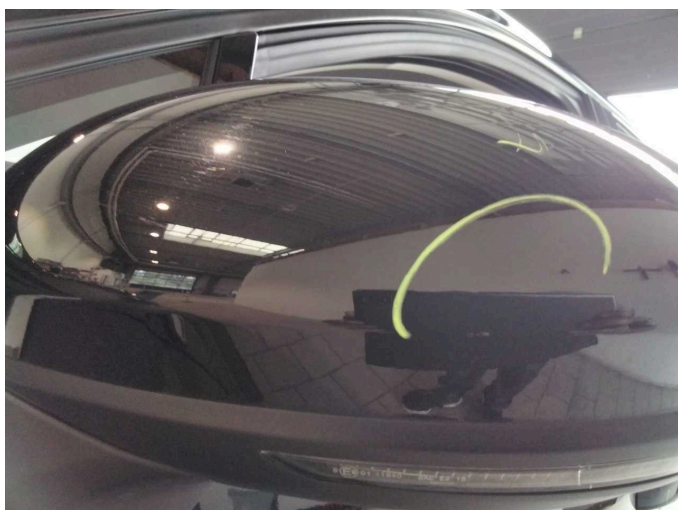
Wear and tear 2: Wing mirror - left side: Cap - Scratch(es) - No deduction

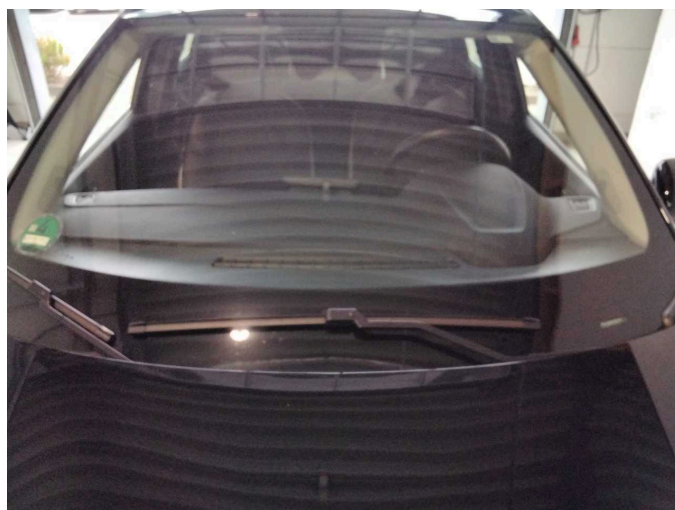
Wear and tear 3: Vehicle glazing: Windscreen - Stone chips - No deduction
