Expertise

Protocol number: 46766366  
Order No. / Reference: 26566844  
Inspection date: 28 Jul 2026

| Manufacturer: Seat | Model: Cupra Born 150kW/58kWh |
| VIN: VSSZZK10RP024390 | |

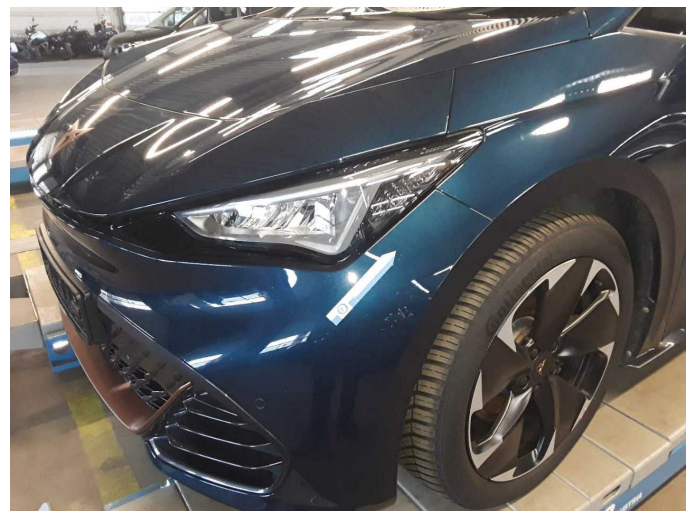
| No. | Component group | Description |
|---|---|---|
| 1 | Front bumper | Front bumper - Scratch(es) - Smart repair |

Damage 1: Front bumper: Front bumper - Scratch(es) - Smart repair

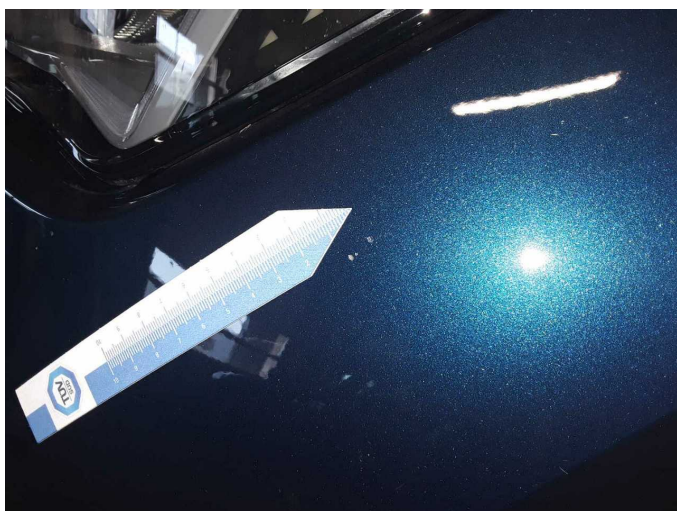
Damage 1: Front bumper: Front bumper - Scratch(es) - Smart repair

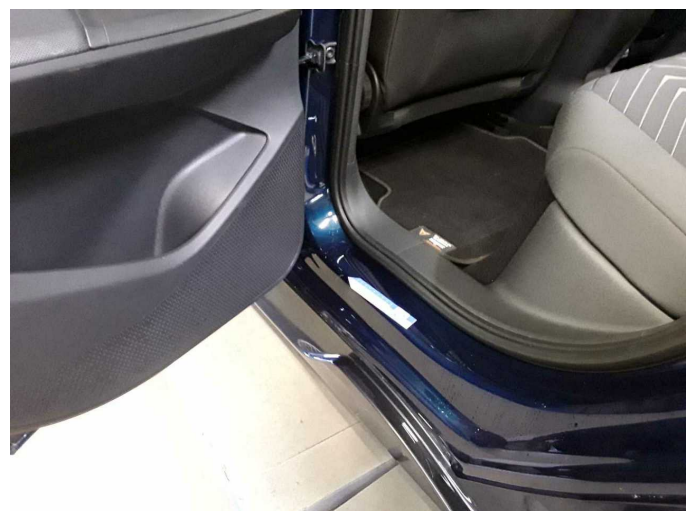
| No. | Component group | Description |
|---|---|---|
| 2 | Sill - left side | Sill - Scratch(es) - Smart repair |

Damage 2: Sill - left side: Sill - Scratch(es) - Smart repair

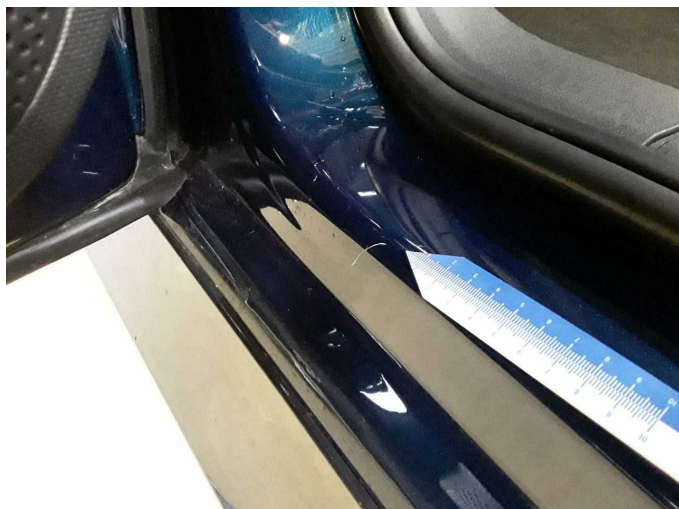
**Damage 2:** Sill - left side: Sill - Scratch(es) - Smart repair

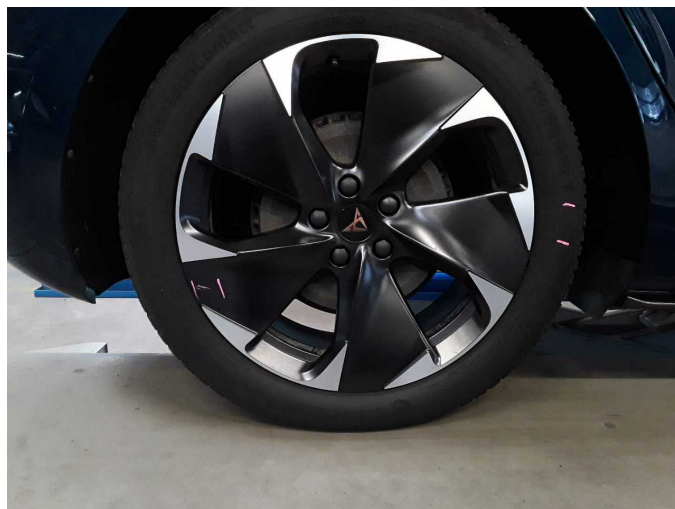
| No. | Component group | Description |
|---|---|---|
| 3 | Wheel / tyres | Alloy rim - rear right side - Scratched - Loss in value |

**Damage 3:** Wheel / tyres: Alloy rim - rear right side - Scratched - Loss in value

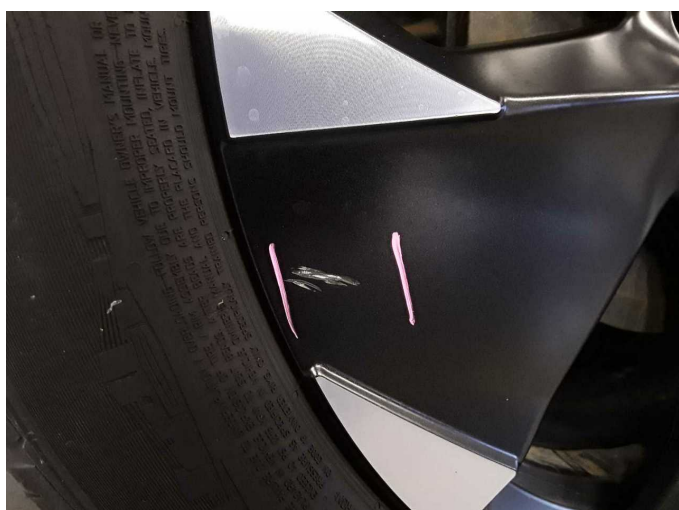
**Damage 3:** Wheel / tyres: Alloy rim - rear right side - Scratched - Loss in value

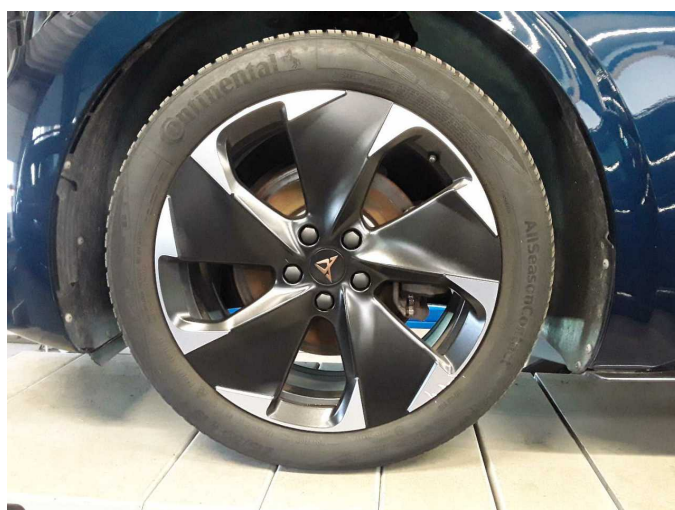
| No. | Component group | Description |
|---|---|---|
| 4 | Wheel / tyres | Alloy rim - front left side - Scratched - Loss in value |

**Damage 4:** Wheel / tyres: Alloy rim - front left side - Scratched - Loss in value

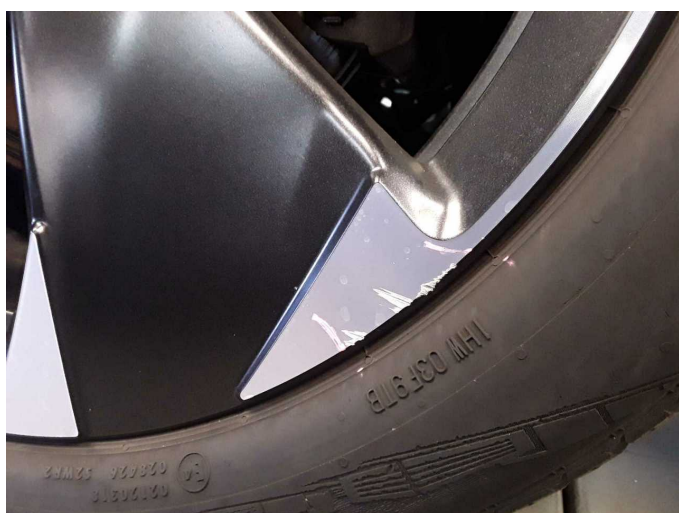
**Damage 4:** Wheel / tyres: Alloy rim - front left side - Scratched - Loss in value

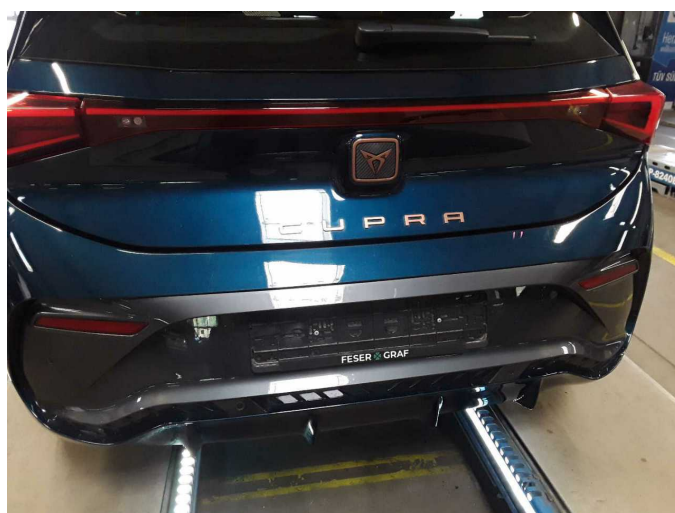
| No. | Component group | Description |
|---|---|---|
| 5 | Rear bumper | Rear bumper - Scratch(es) - Paint |

**Damage 5:** Rear bumper: Rear bumper - Scratch(es) - Paint

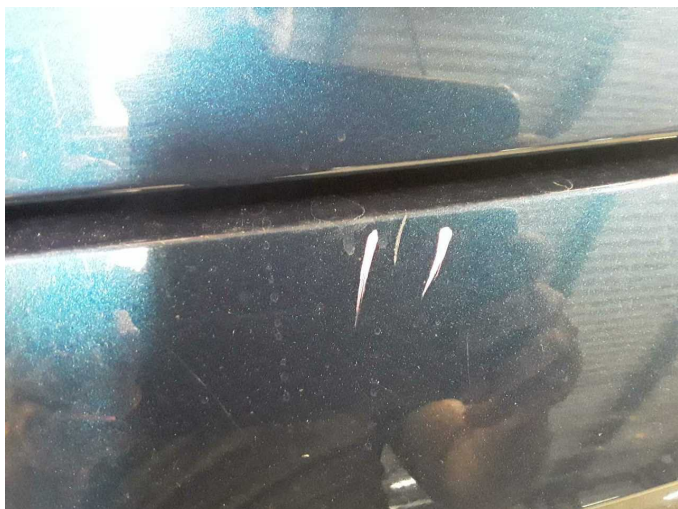
**Damage 5:** Rear bumper: Rear bumper - Scratch(es) - Paint

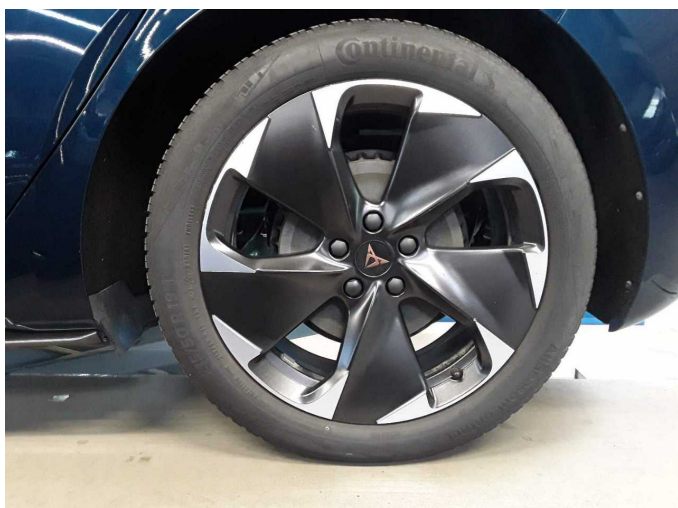
| No. | Component group | Description |
|---|---|---|
| 6 | Wheel / tyres | Alloy rim - rear left side (Materialabtrag) - Scratched - Replace |

**Damage 6:** Wheel / tyres: Alloy rim - rear left side (Materialabtrag) - Scratched - Replace

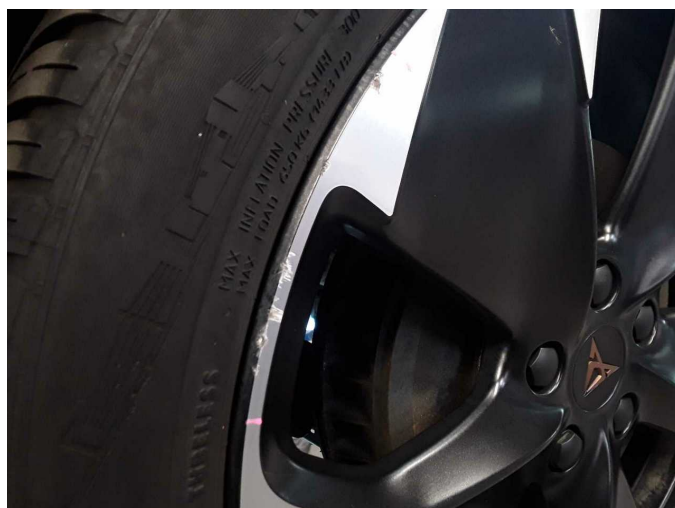
**Damage 6:** Wheel / tyres: Alloy rim - rear left side (Materialabtrag) - Scratched - Replace

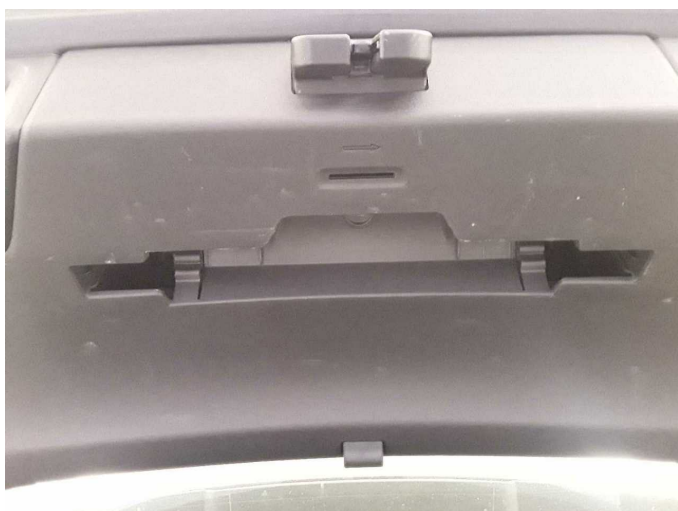
Equipment - Warning triangle

**Missing part 1:** Equipment: Warning triangle - Missing - Replace
