## Expertise

Protocol number: 46149460  
Order No. / Reference: 26539630  
Inspection date: 24 Jun 2026

Manufacturer: Opel

Model: Grandland 1.5 D Automatik Business Edition

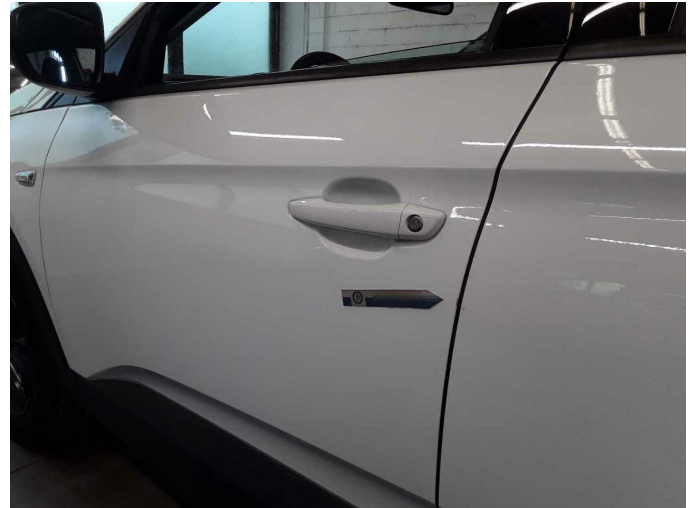
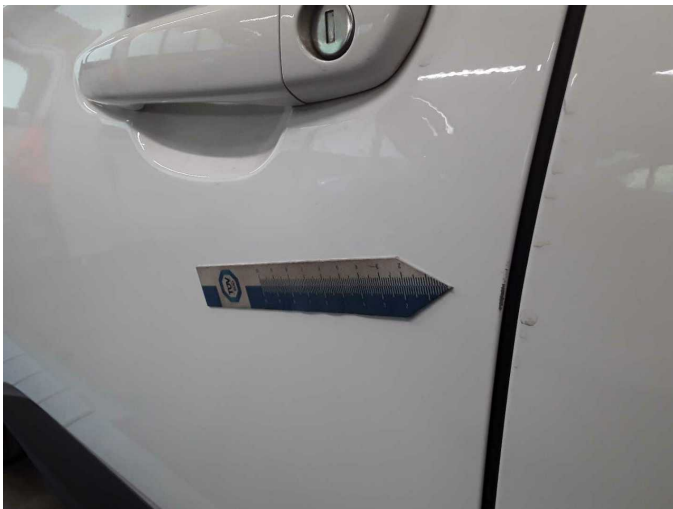
Damage 1: Door - front left side: Door - Scratch(es) - Smart repair

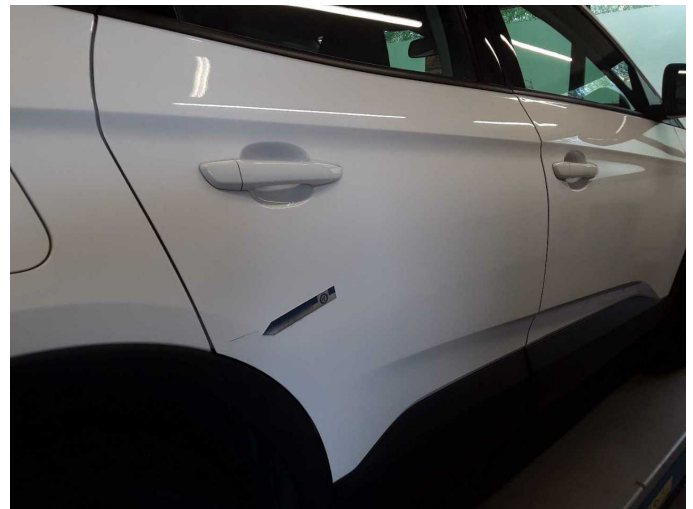
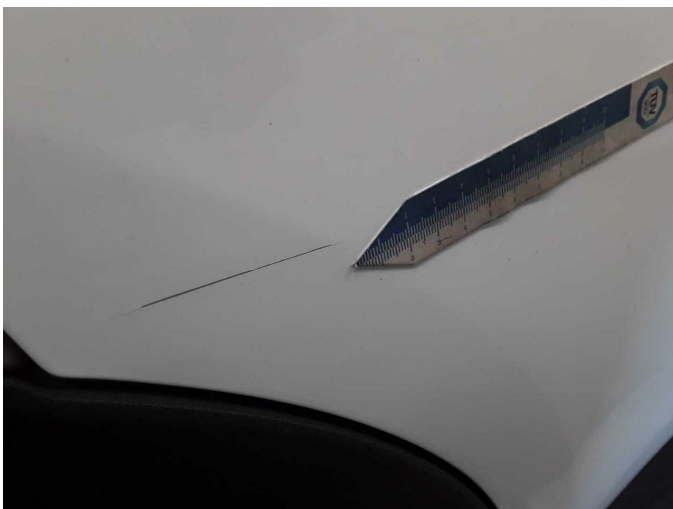
Damage 2: Door - rear right side: Door - Scratch(es) - Paint

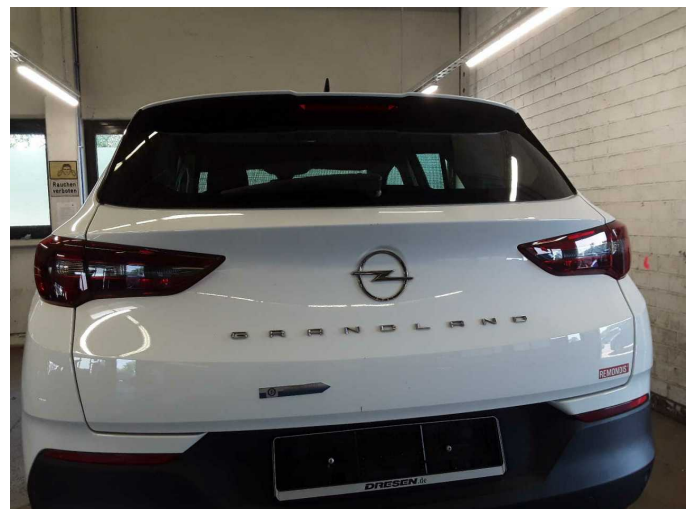
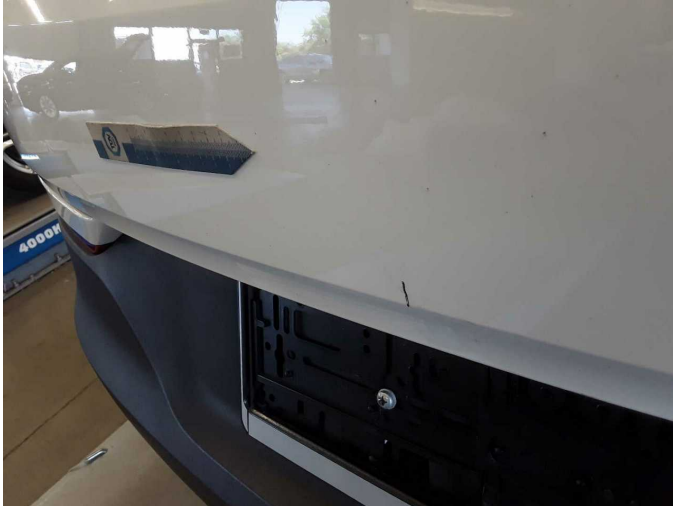
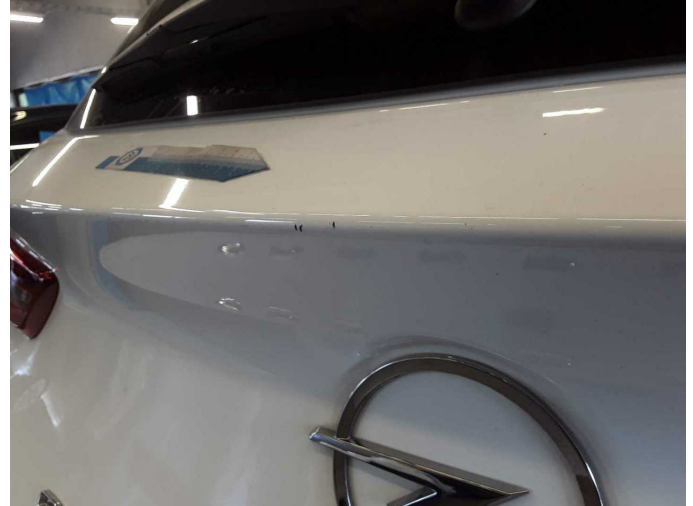
Damage 3: Boot lid / rear door: Boot lid - Scratch(es) - Paint

**Damage 3:** Boot lid / rear door: Boot lid - Scratch(es) - Paint

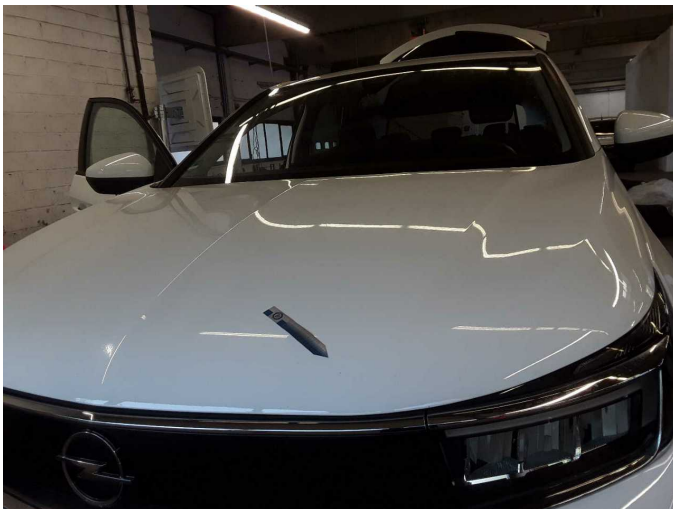
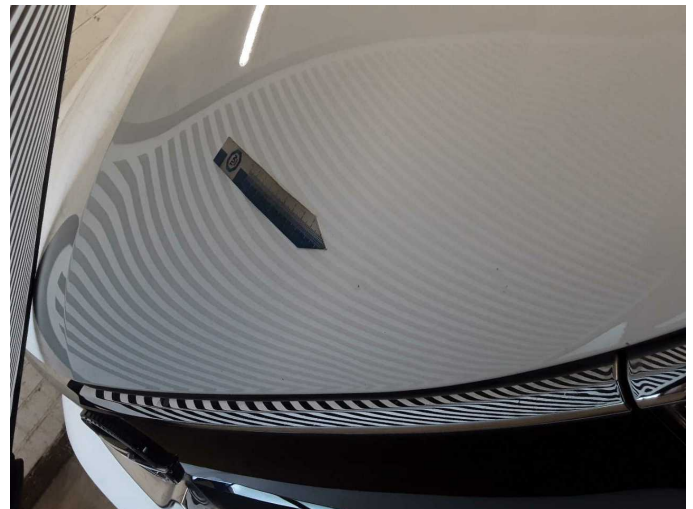
**Damage 4:** Bonnet: Bonnet - Dent / paintcoat damage - Repair and paint

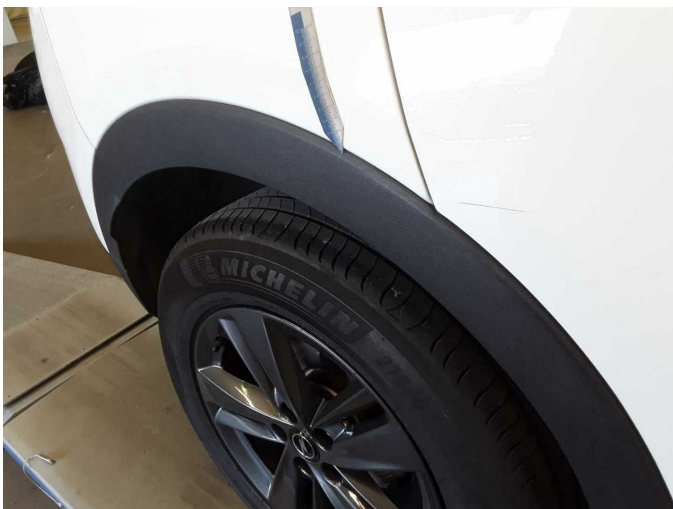
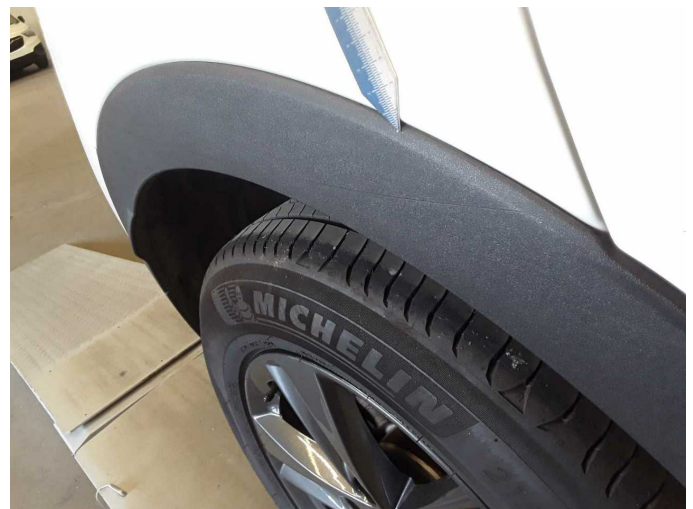
**Wear and tear 1:** Side panel - rear right side: Wheel arch - Scratch(es) - No deduction

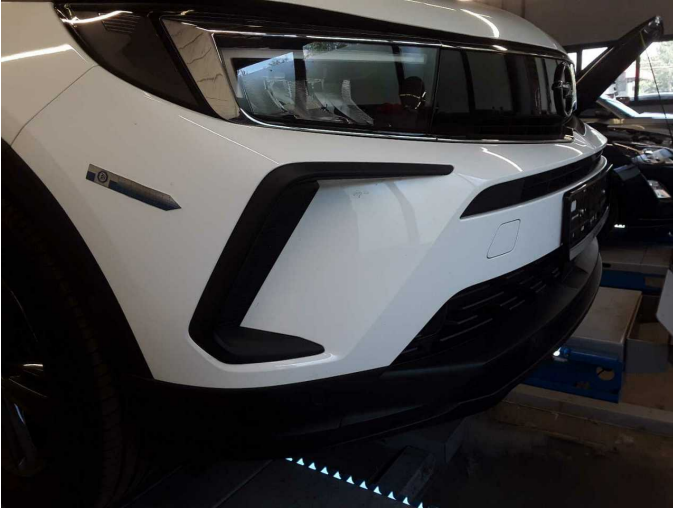
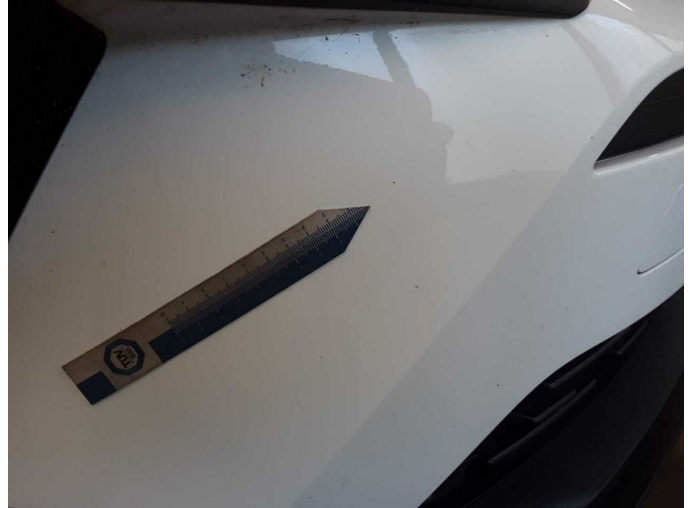
**Wear and tear 2:** Front bumper: Front bumper - Stone chips - No deduction

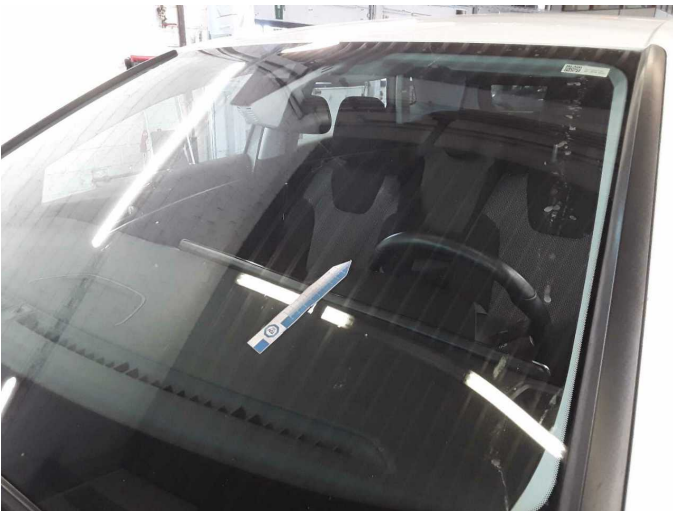
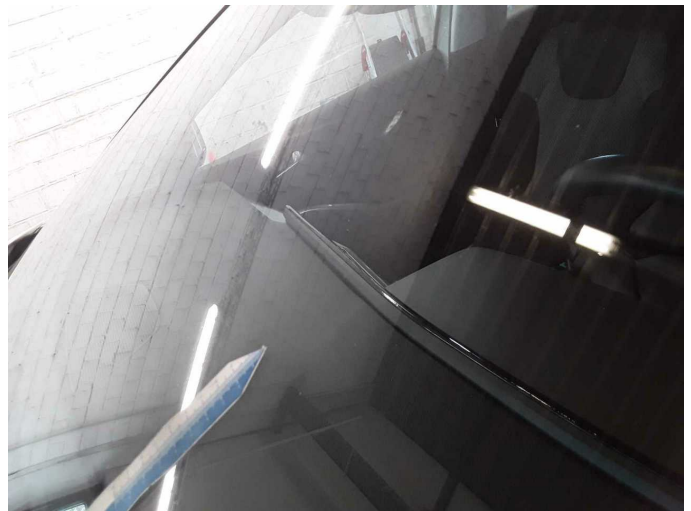
**Wear and tear 3:** Vehicle glazing: Windscreen - Stone chips - No deduction
