## Expertise

Protocol number: 45911002  
Order No. / Reference: 26397913  
Inspection date: 8 Jun 2026

Model: Superb Combi 1.4 TSI iV DSG Style

VIN: TMBJW7NP8M7050689

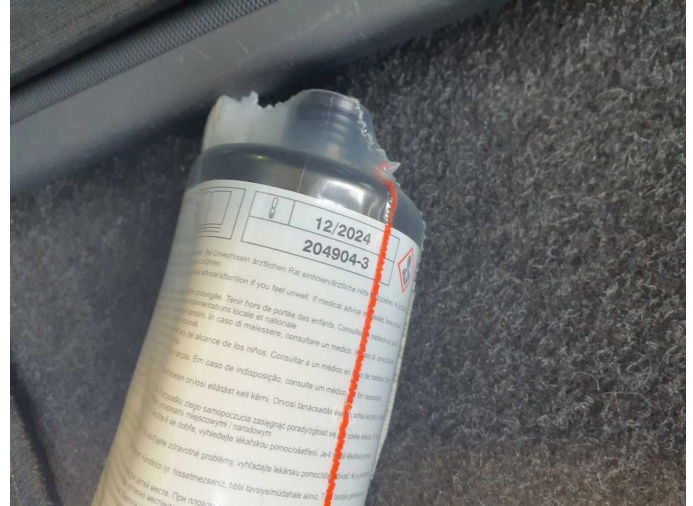
| No. | Component group | Description |
|---|---|---|
| 1 | Equipment | Tirefit filler - Expired - Replace |

Damage 1: Equipment: Tirefit filler - Expired - Replace

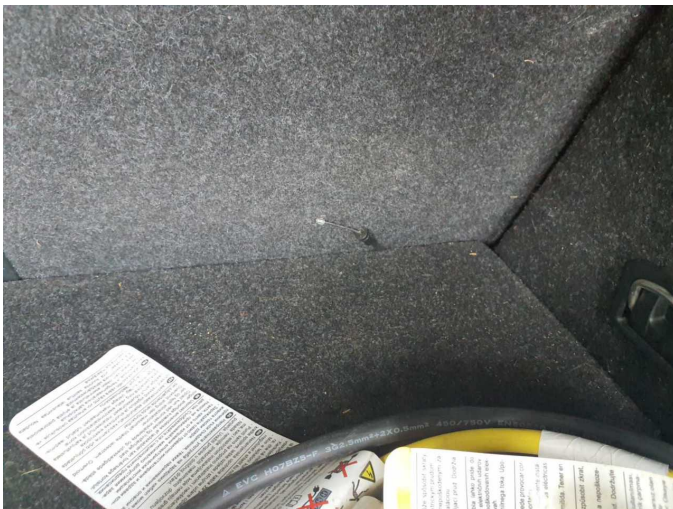
| No. | Component group | Description |
|---|---|---|
| 2 | Seat - rear | Lever seat adjustment - Specify findings - Perform diagnosis |

Damage 2: Seat - rear: Lever seat adjustment - Specify findings - Perform diagnosis

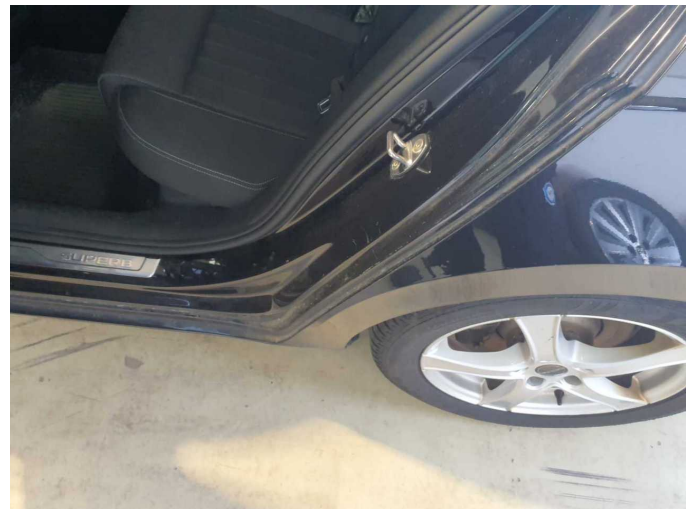
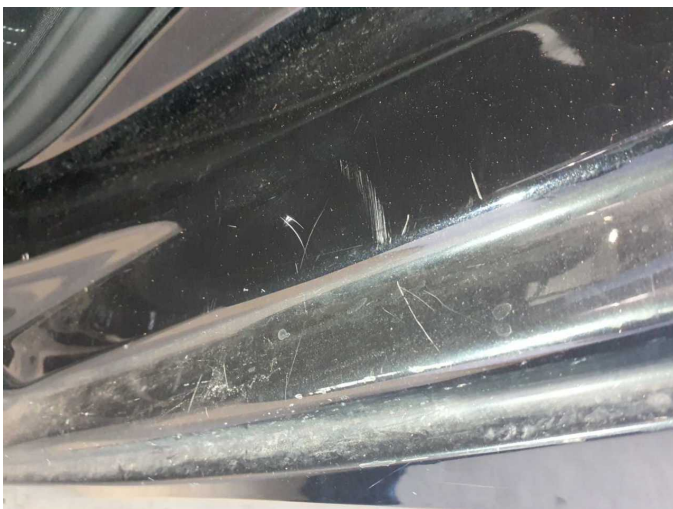
| No. | Component group | Description |
|---|---|---|
| 3 | Side panel - rear left side | Sill - Scratch(es) - Smart repair |

Damage 3: Side panel - rear left side: Sill - Scratch(es) - Smart repair

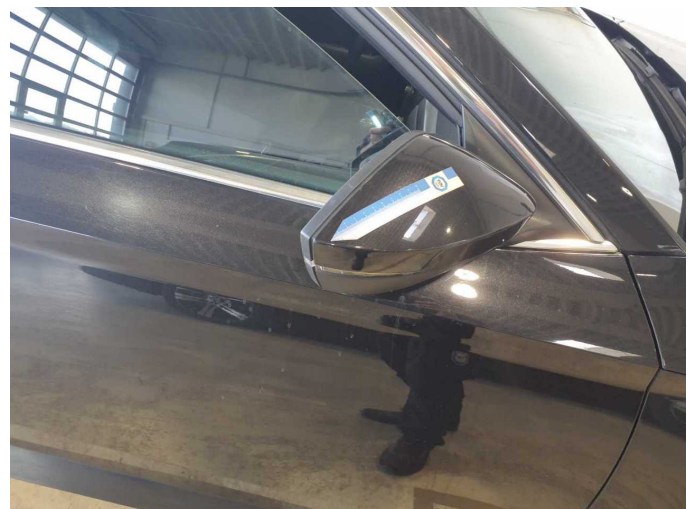
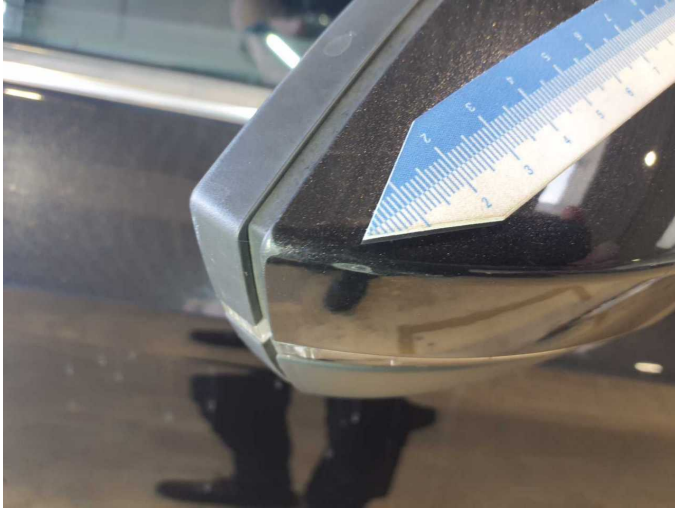
| No. | Component group | Description |
|---|---|---|
| 4 | Wing mirror - right side | Cap - Scratch(es) - Paint |

Damage 4: Wing mirror - right side: Cap - Scratch(es) - Paint

**Damage 4:** Wing mirror - right side: Cap - Scratch(es) - Paint

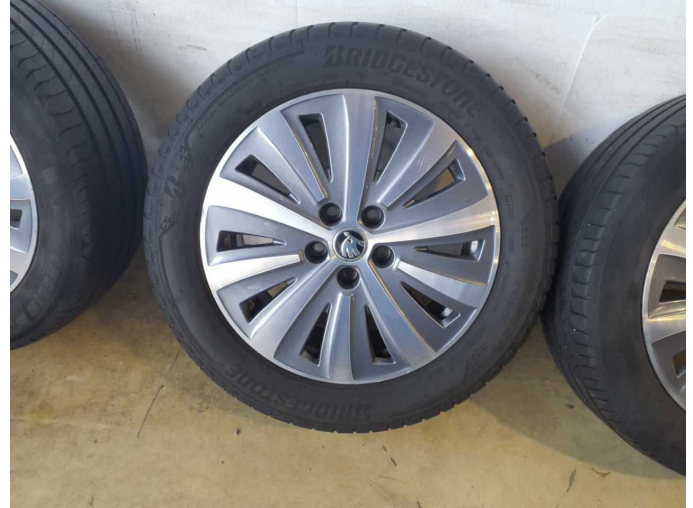
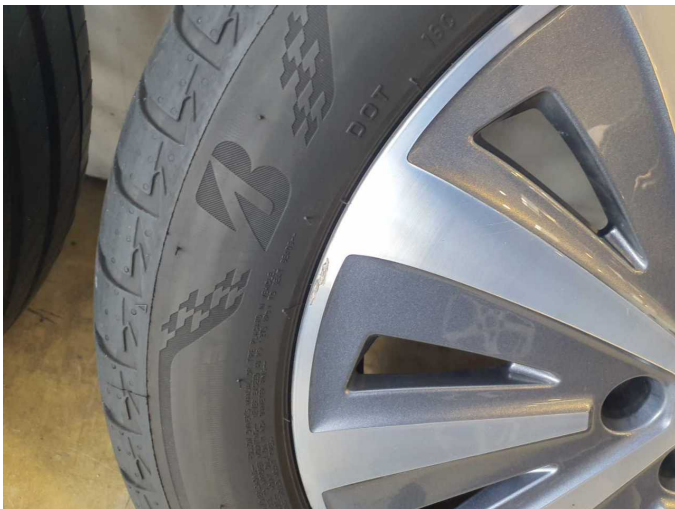
| No. | Component group | Description |
|---|---|---|
| 5 | 2nd wheel set | 1 alloy rim - Scratch(es) - Loss in value |

**Damage 5:** 2nd wheel set: 1 alloy rim - Scratch(es) - Loss in value

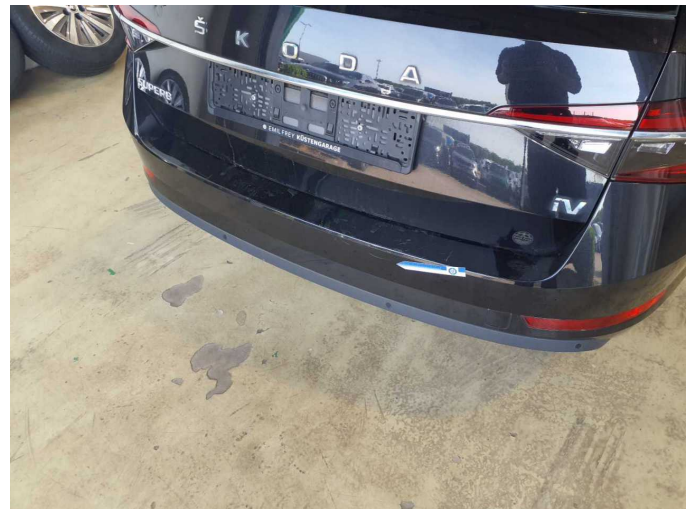
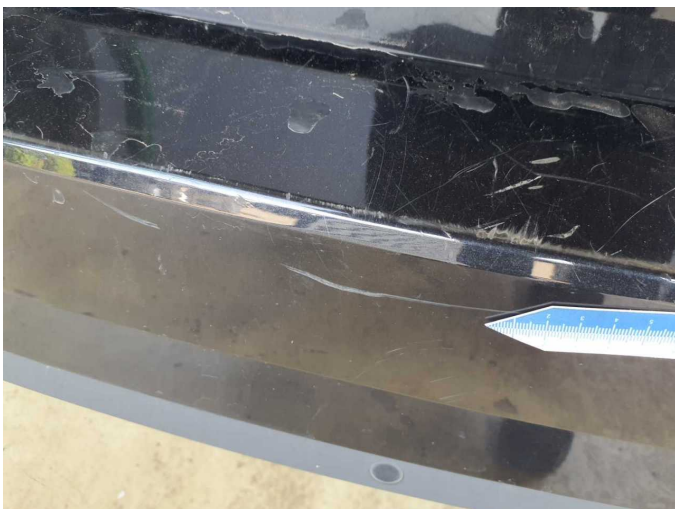
| No. | Component group | Description |
|---|---|---|
| 6 | Rear bumper | Rear bumper - Scratch(es) - Paint |

**Damage 6:** Rear bumper: Rear bumper - Scratch(es) - Paint

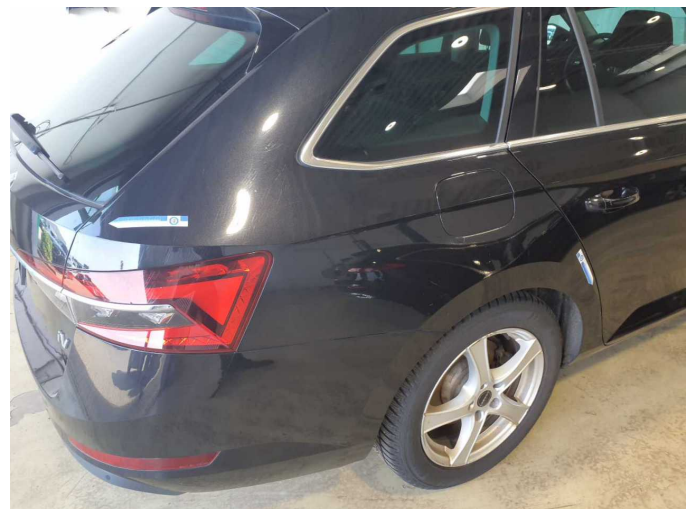
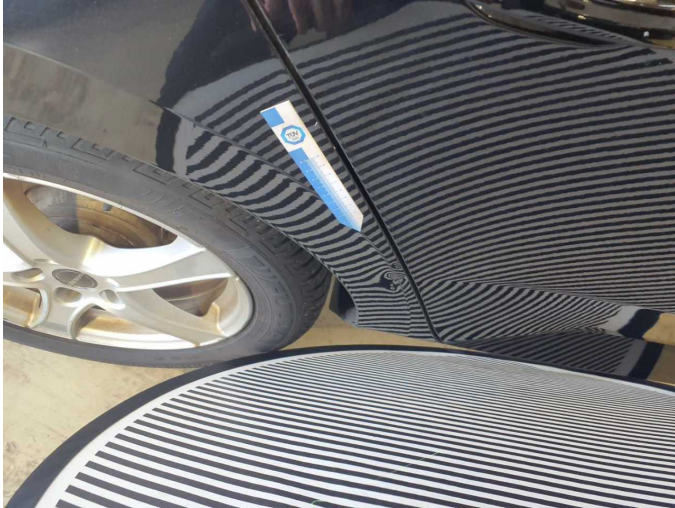
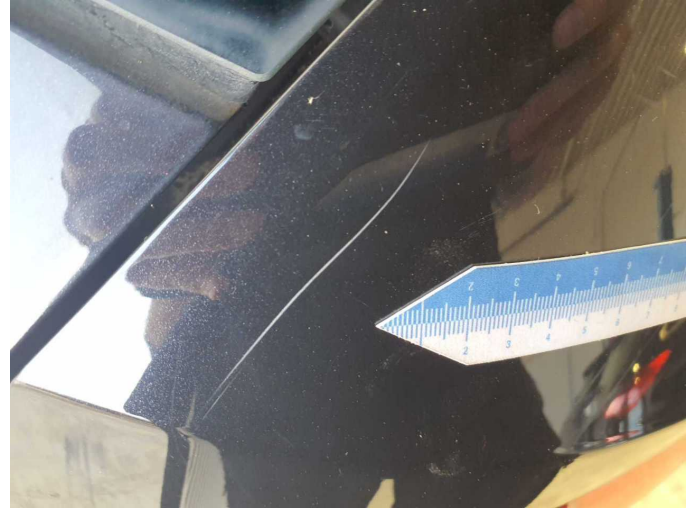
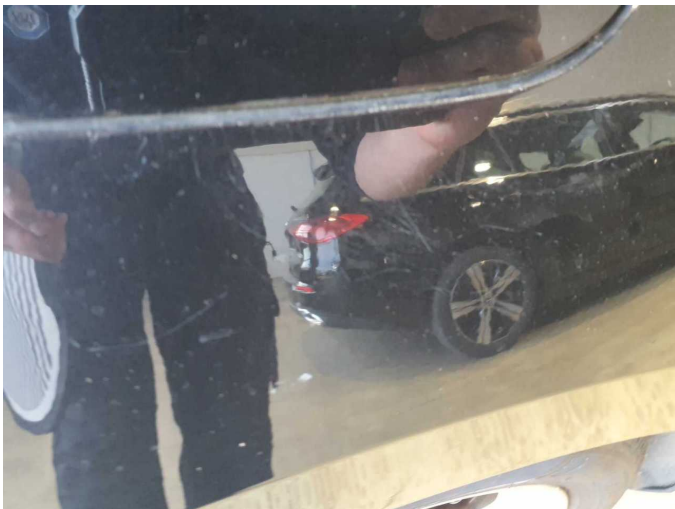
| No. | Component group | Description |
|---|---|---|
| 7 | Side panel - rear right side | Side panel - Dent / paintcoat damage - Repair and paint |

**Damage 7:** Side panel - rear right side: Side panel - Dent / paintcoat damage - Repair and paint

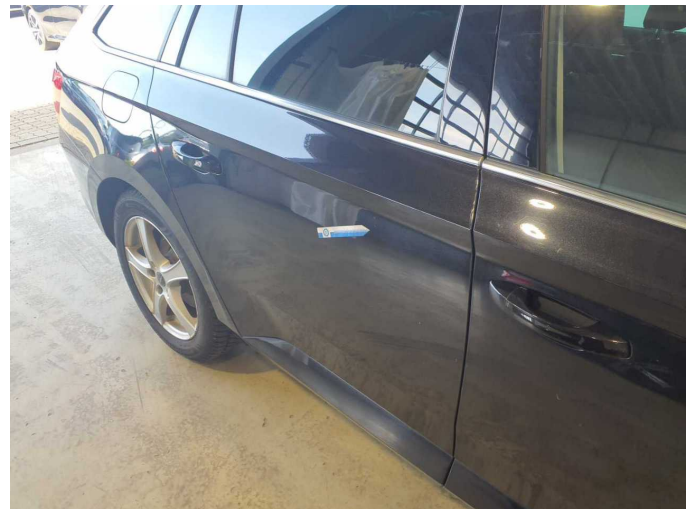
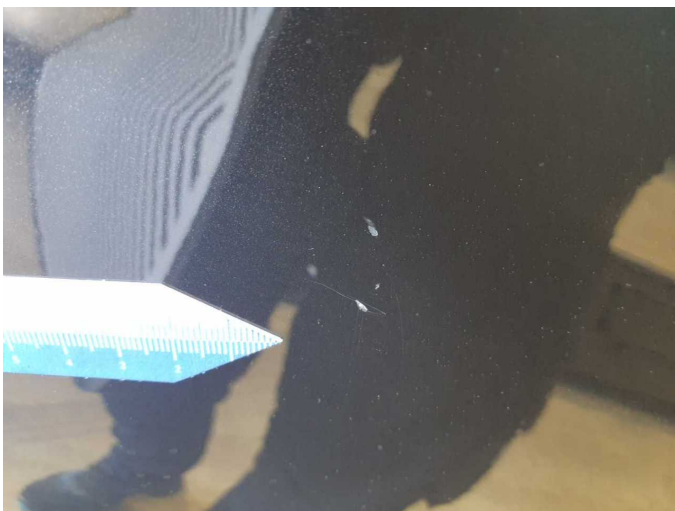
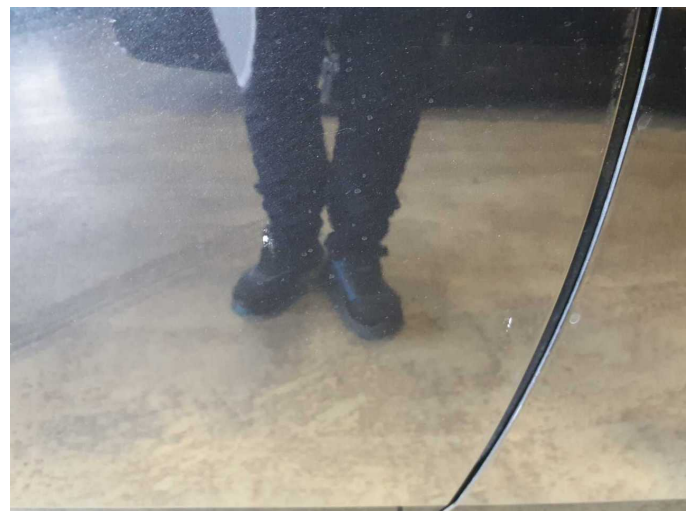
| No. | Component group | Description |
|---|---|---|
| 8 | Door - rear right side | Door - Dent / paintcoat damage - Paint |

**Damage 8:** Door - rear right side: Door - Dent / paintcoat damage - Paint

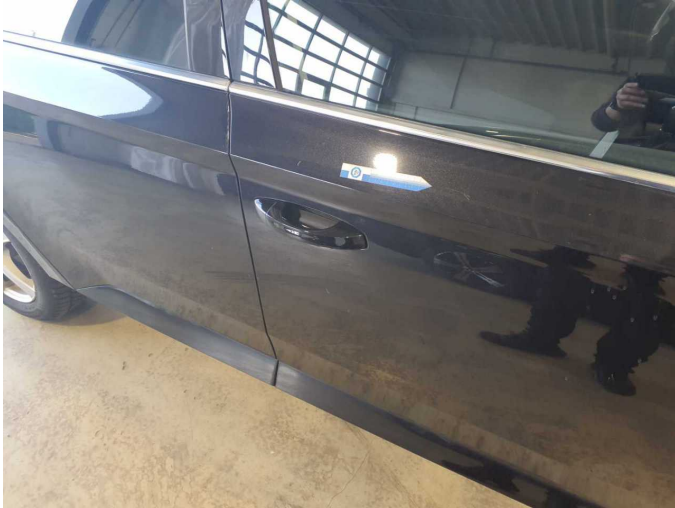
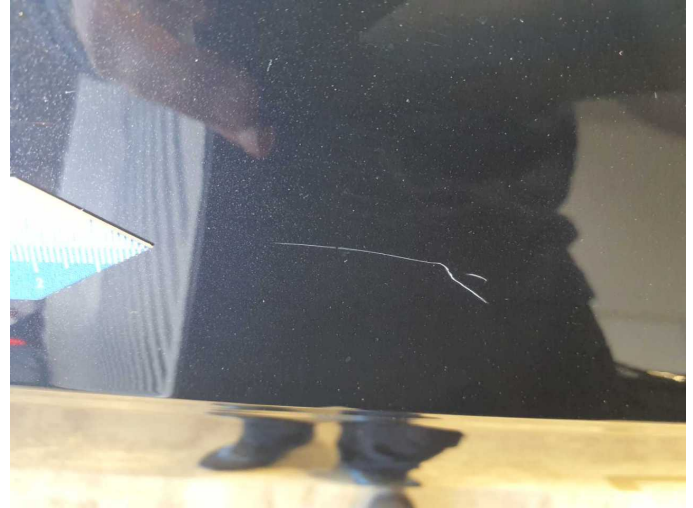
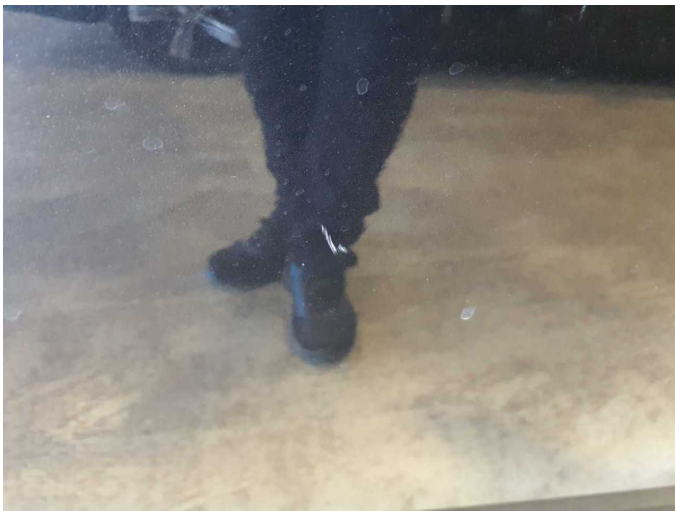
| No. | Component group | Description |
|---|---|---|
| 9 | Door - front right side | Door - Scratch(es) - Paint |

**Damage 9:** Door - front right side: Door - Scratch(es) - Paint

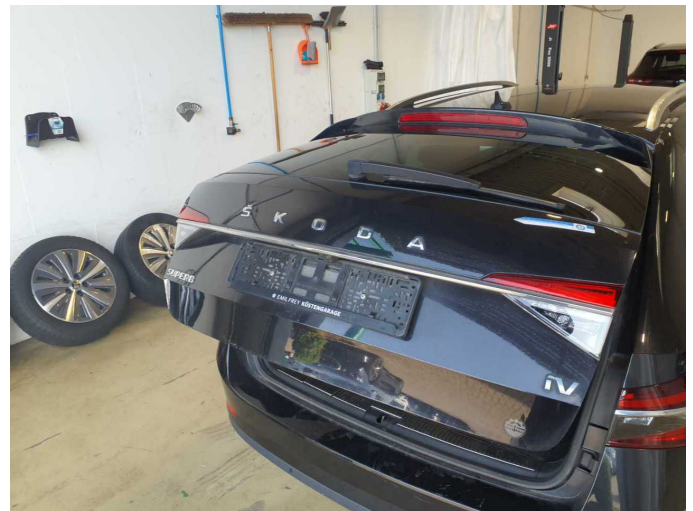
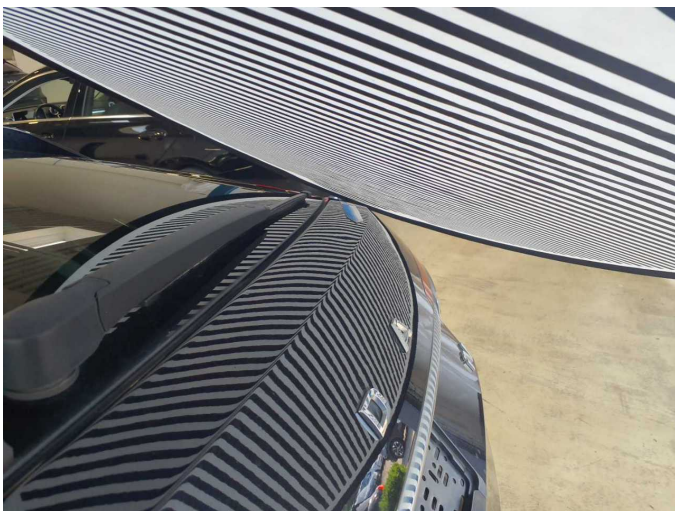
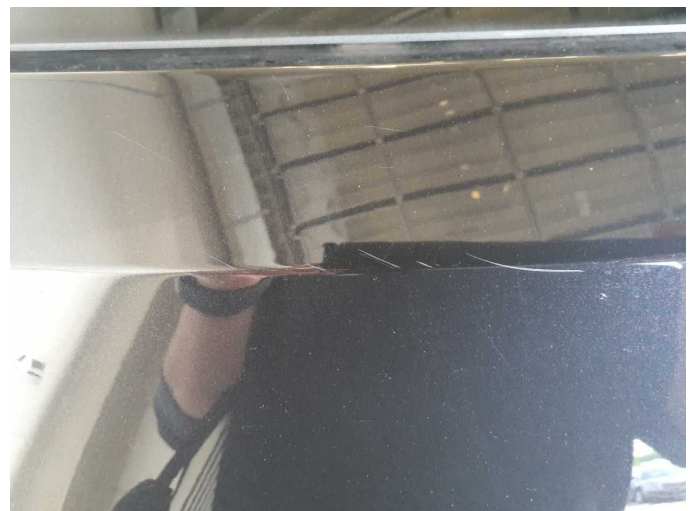
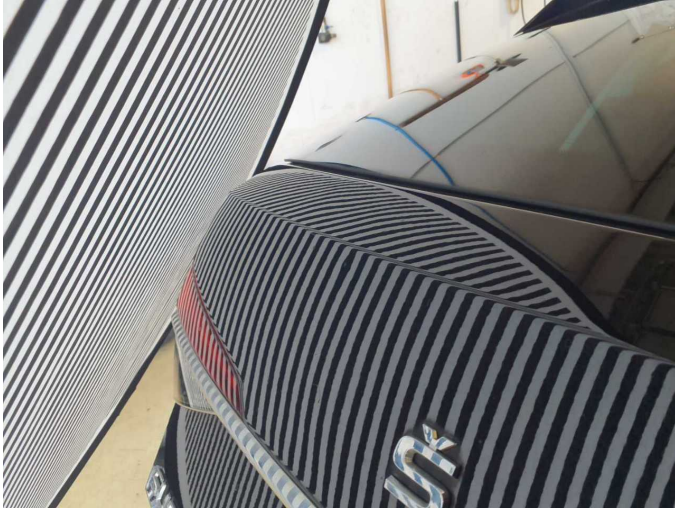
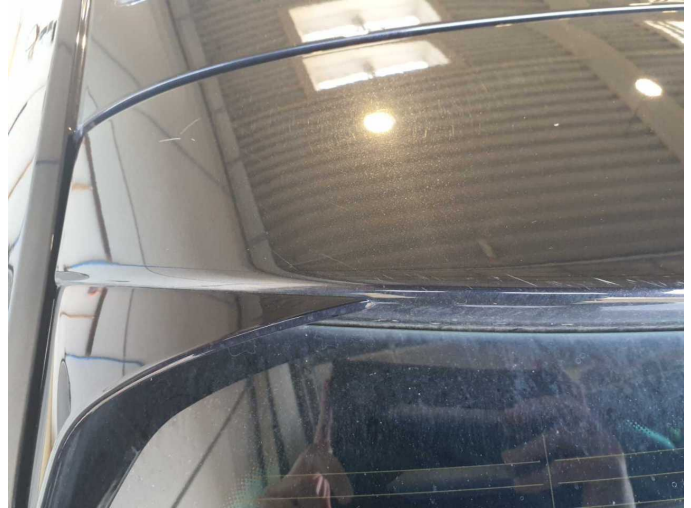
| No. | Component group | Description |
|---|---|---|
| 10 | Boot lid / rear door | Boot lid - Dent / paintcoat damage - Paint |

**Damage 10:** Boot lid / rear door: Boot lid - Dent / paintcoat damage - Paint

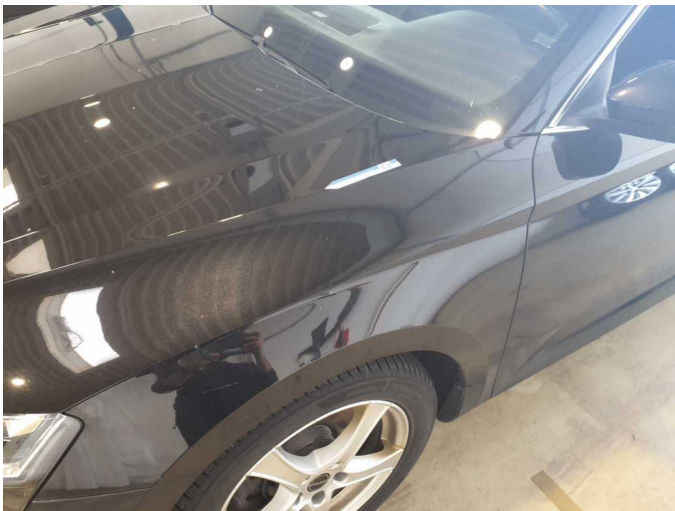
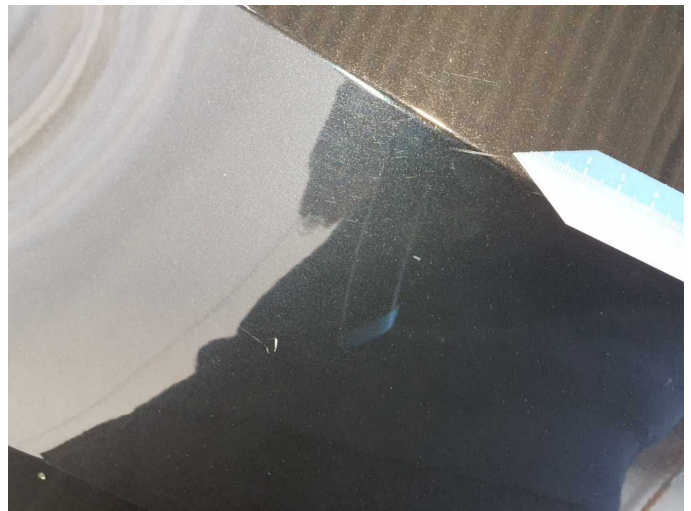
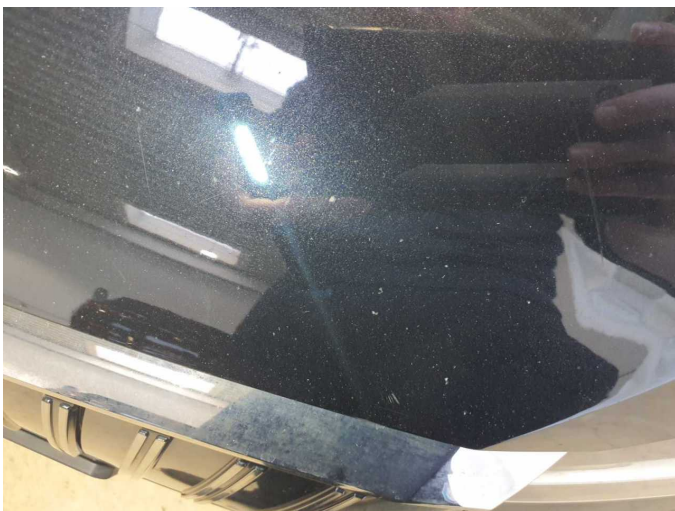
| No. | Component group | Description |
|---|---|---|
| 11 | Bonnet | Bonnet - Scratch(es) - Paint |

**Damage 11:** Bonnet: Bonnet - Scratch(es) - Paint

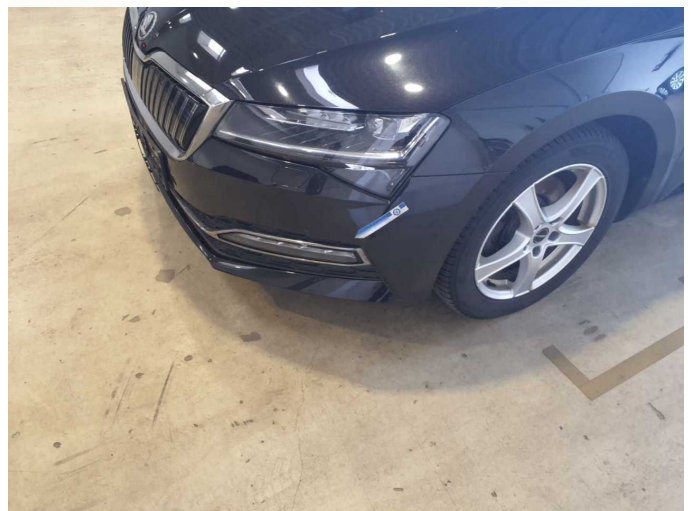
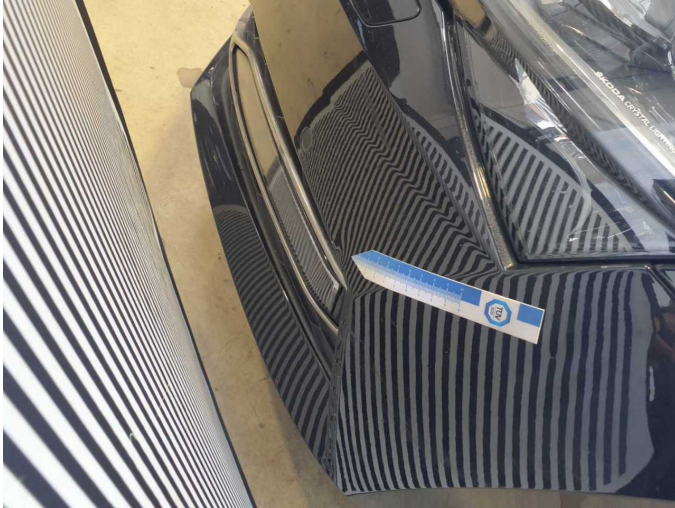
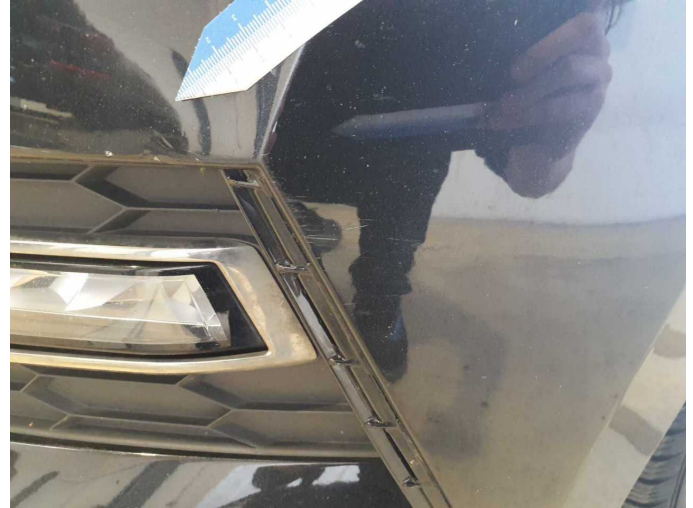
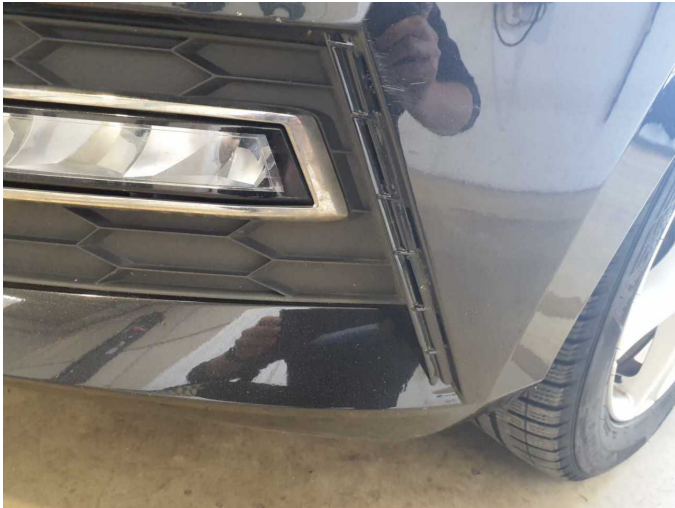
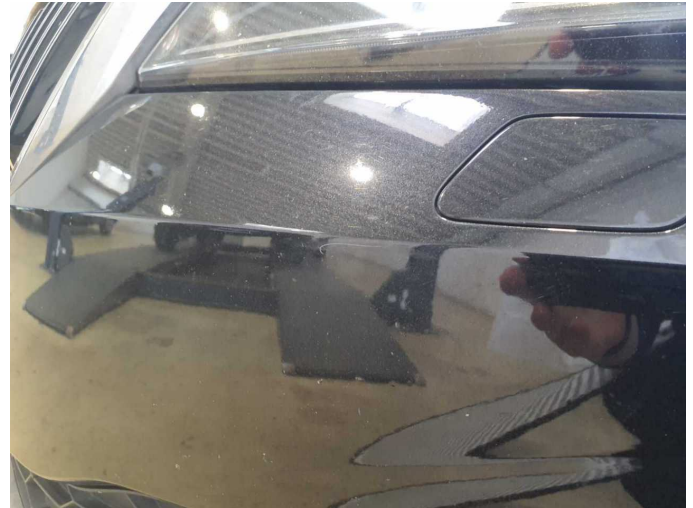
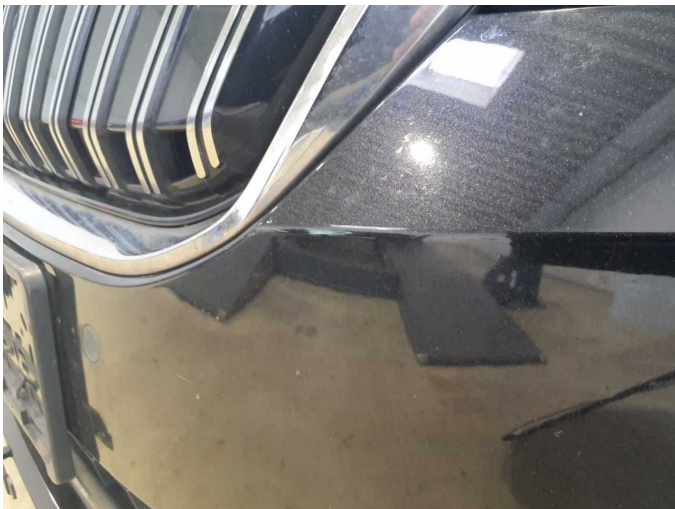
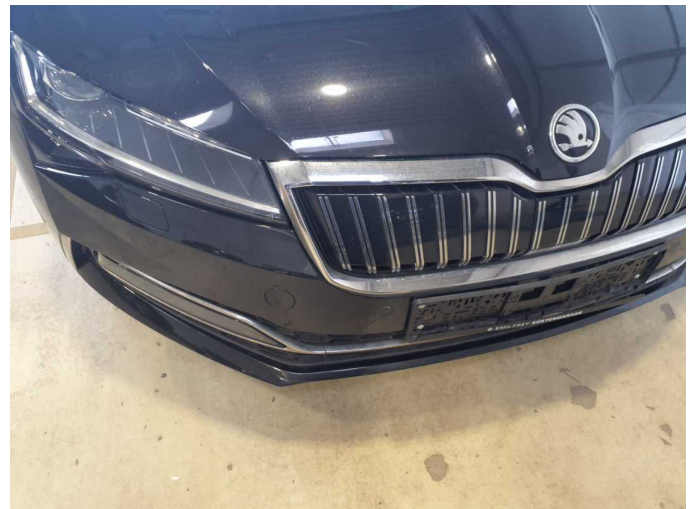
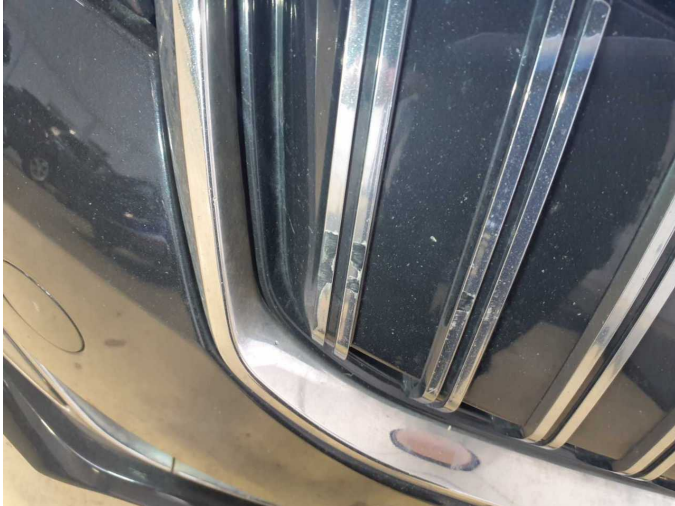
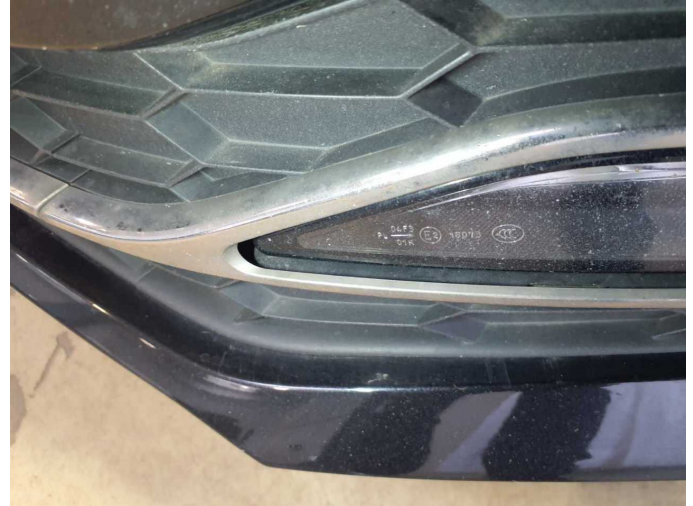
| No. | Component group | Description |
|---|---|---|
| 12 | Front bumper | Front bumper (Inklusive Anbauteile, Nebelleuchte links gebrochen) - Dent / paintcoat damage - repair according to calculation |

**Damage 12:** Front bumper: Front bumper (Inklusive Anbauteile, Nebelleuchte links gebrochen) - Dent / paintcoat damage - repair according to calculation

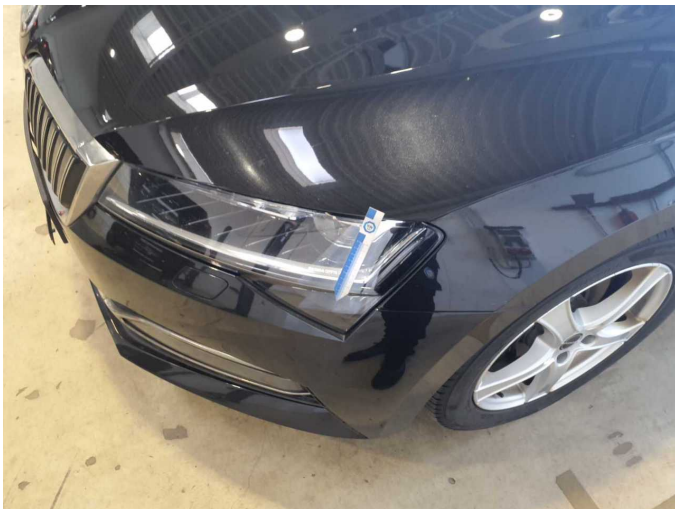
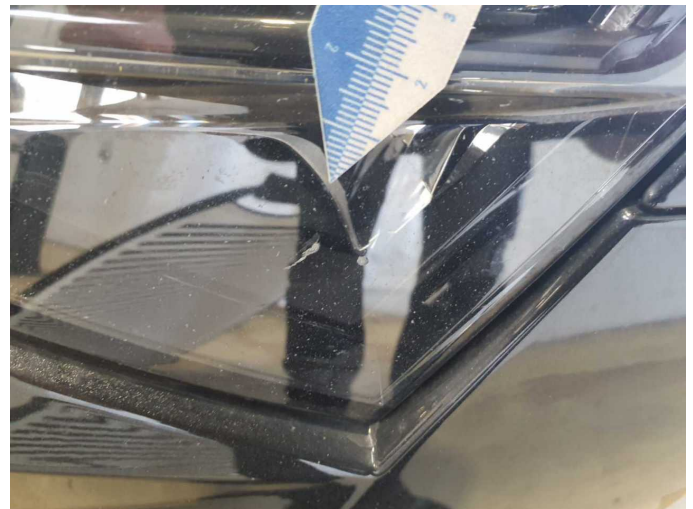
| No. | Component group | Description |
|---|---|---|
| 13 | Headlight | Headlight - left side (Randbereich) - Stone chips - repair according to calculation |

**Damage 13:** Headlight: Headlight - left side (Randbereich) - Stone chips - repair according to calculation

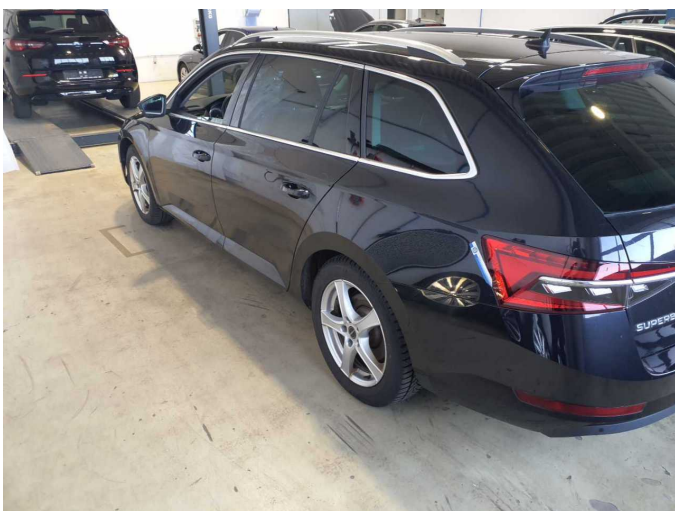
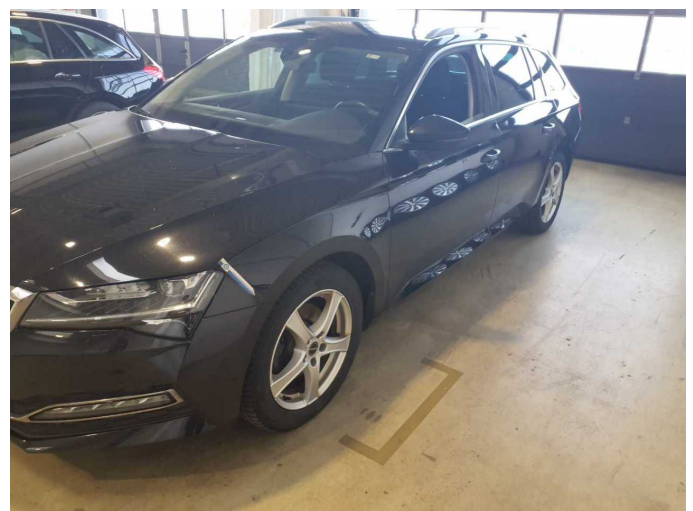
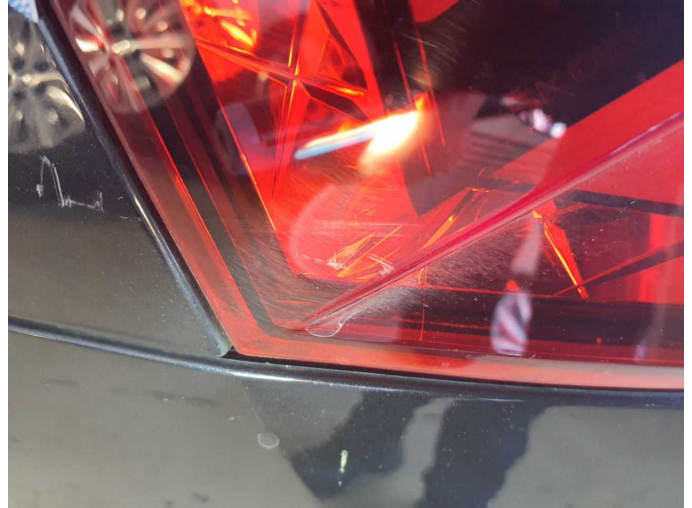
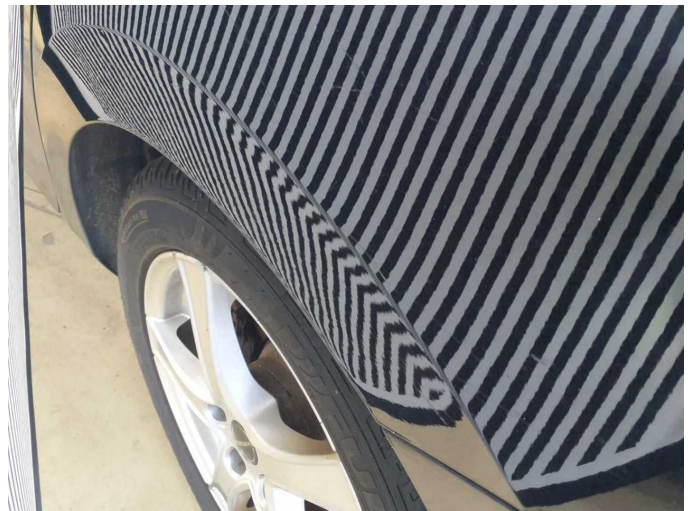
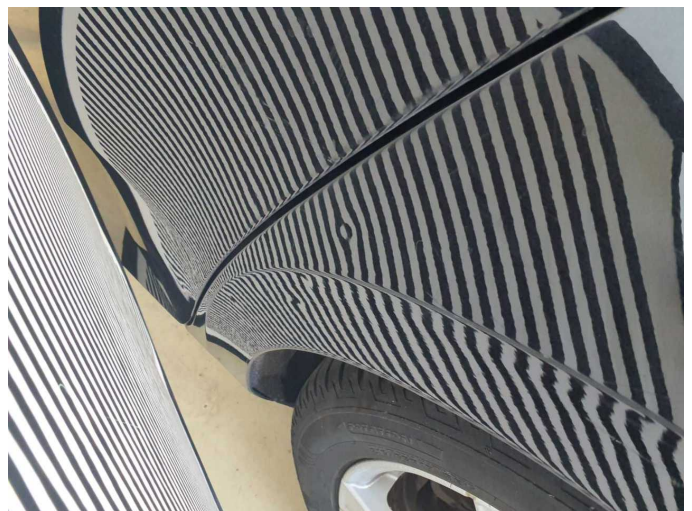
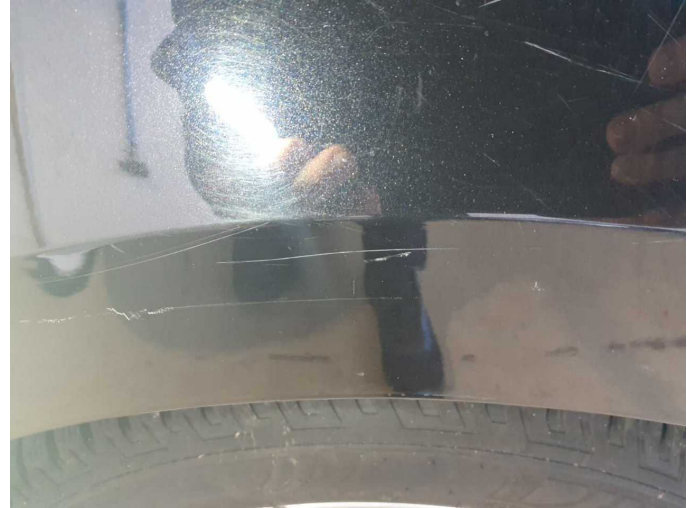
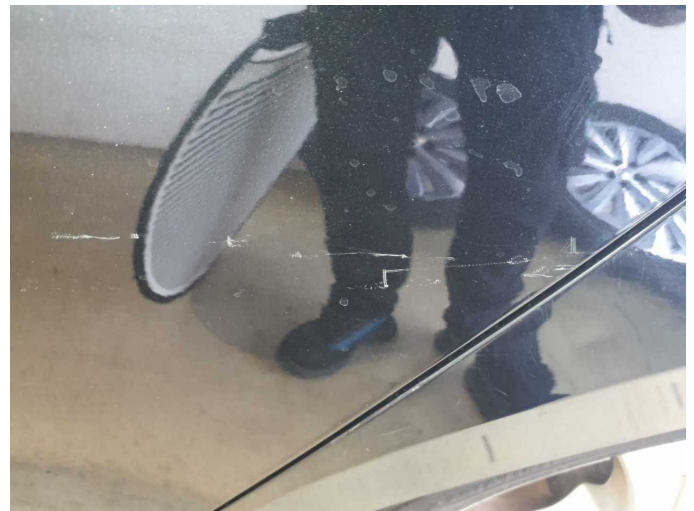
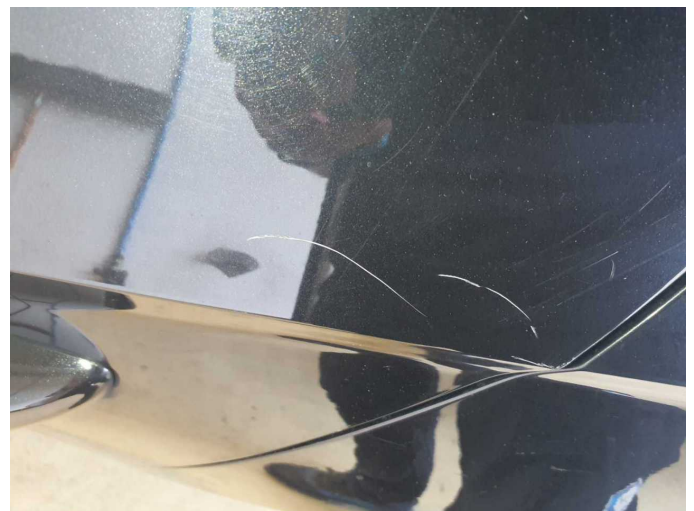
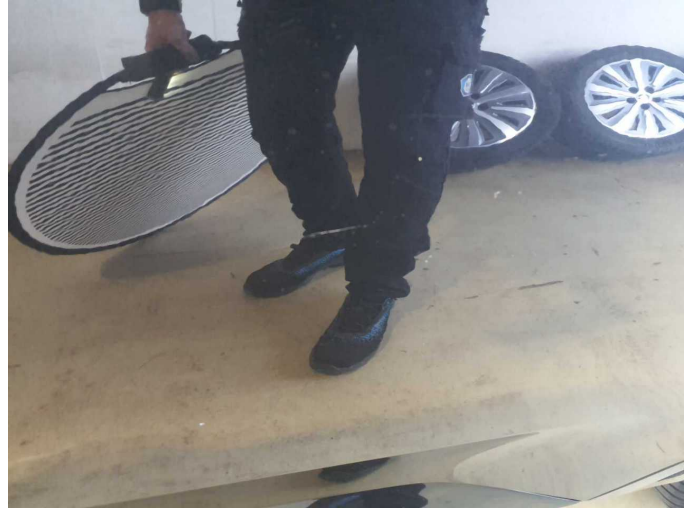
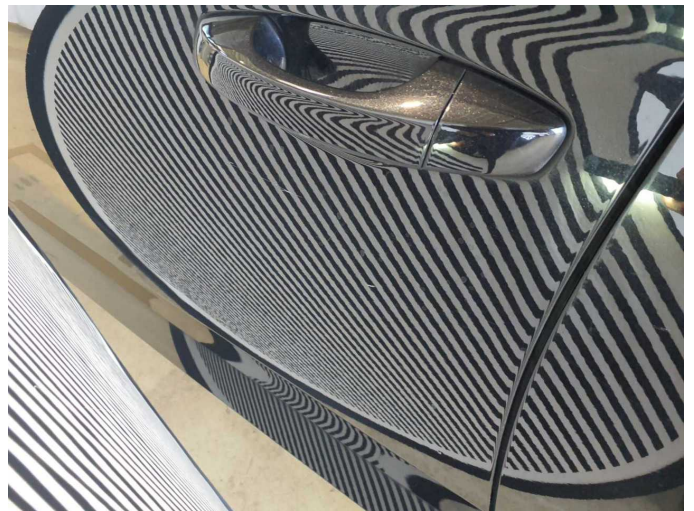
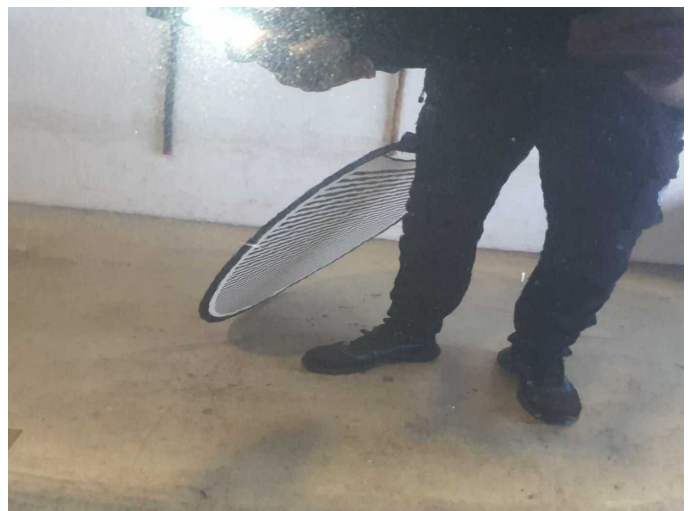
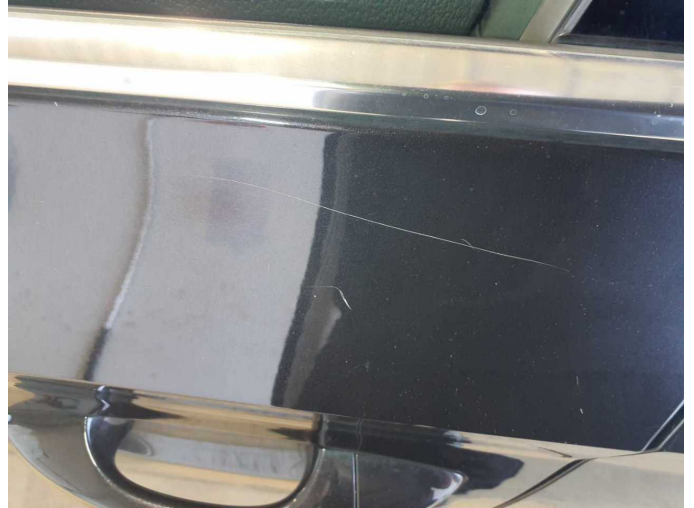
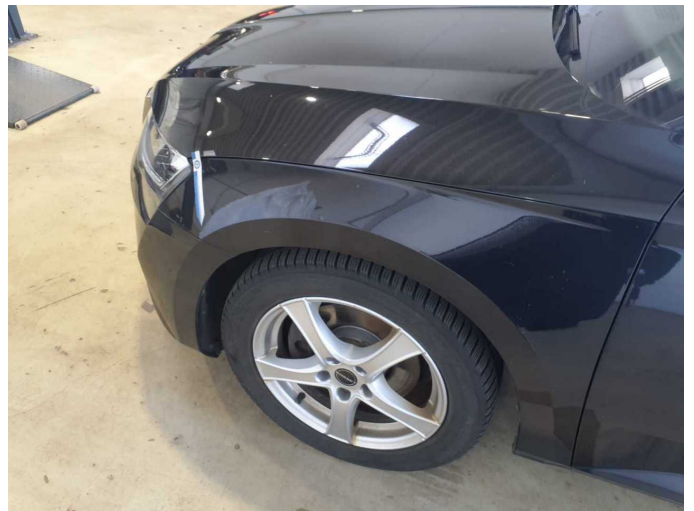
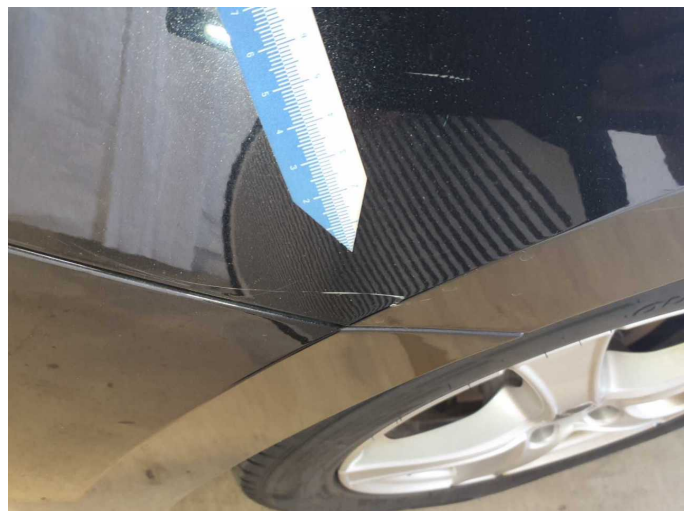
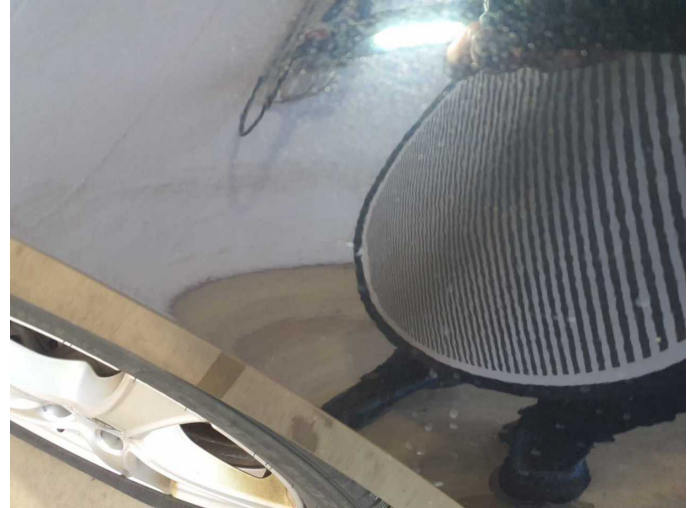
1 Side - left

**Accident 1:** Side - left
