# Assessment

- Vehicle Inspection Report -

Number: 10606329  
From: 13.05.2026

**Order number:** 1002423842  
**Order completed:** 13.05.2026 07:48  
**Report number:** 10606329  
**VIN:** TMBJG8NX5RY148048

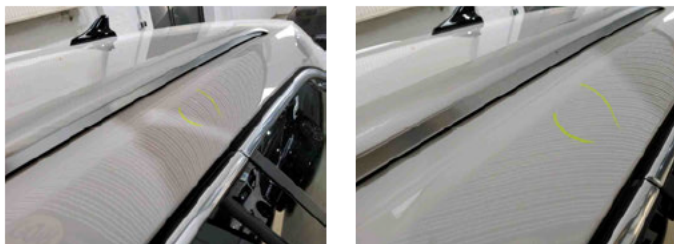
## 6 - Roof pillar L - Dent(s) - Spot repair

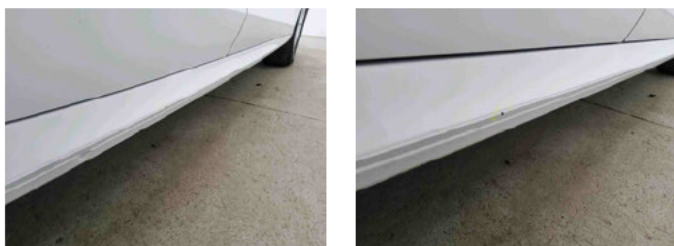
## 7 - Outer sill R - Scratch(es) - Smart repair

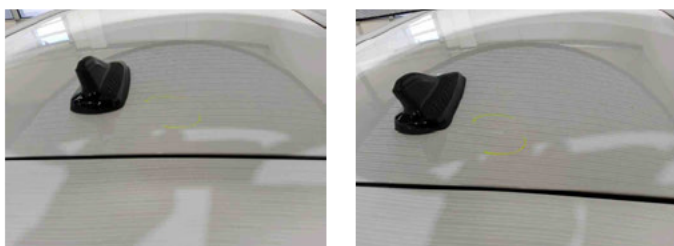
## 8 - Roof - Dent(s) - Paintless dent repair

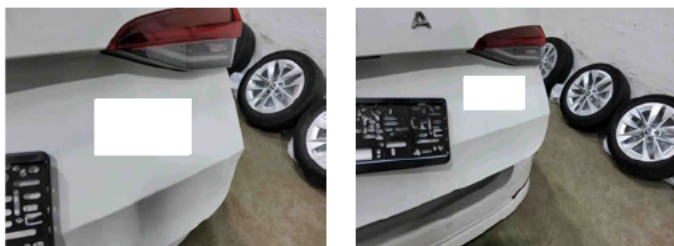
## 9 - Bodywork - Lettering - Remove lettering
