Expertise

Protocol number: 45512998
Order No. / Reference: 26384463
Inspection date: 19 May 2026

Model: Astra 1.5 D Automatik Ultimate

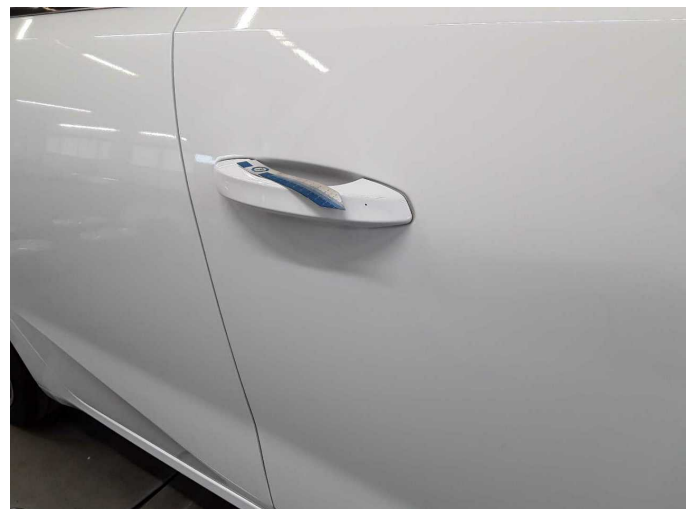
Damage 2: Door - front right side: Door handle - outside - Stone chips - Smart repair

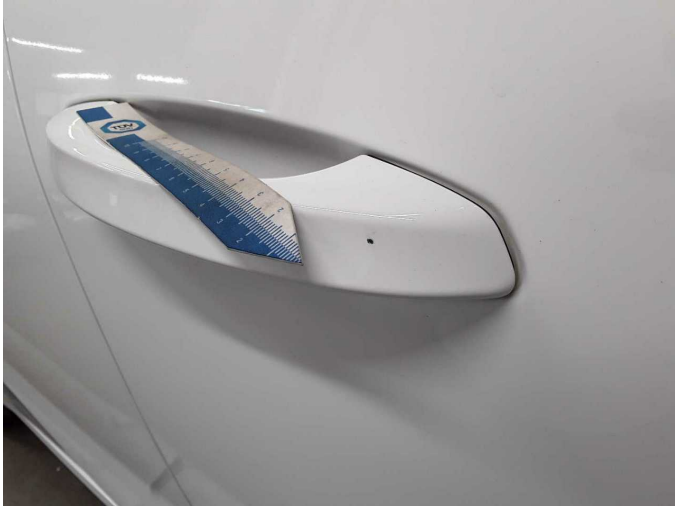
Damage 2: Door - front right side: Door handle - outside - Stone chips - Smart repair

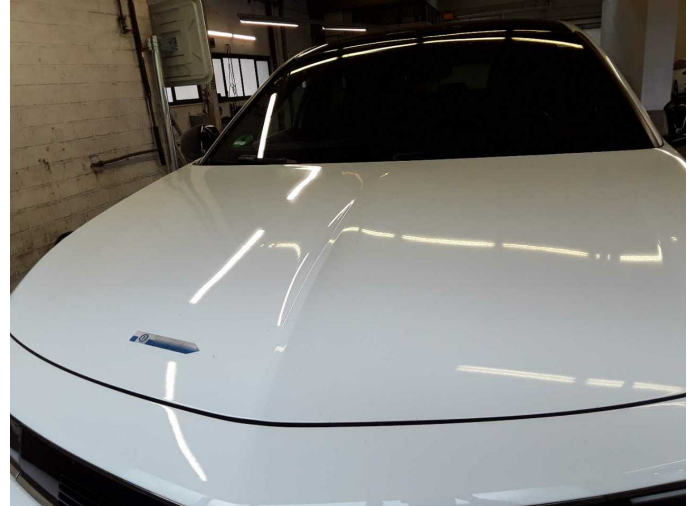
Damage 3: Bonnet: Bonnet - dent(s) - Smooth repair work

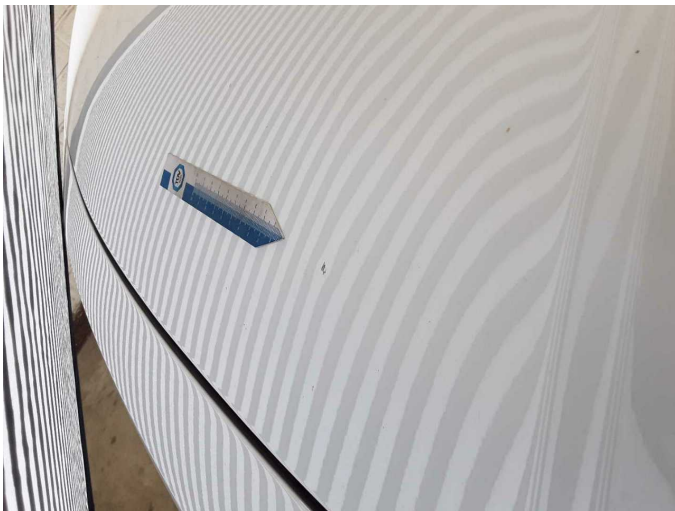
Damage 3: Bonnet: Bonnet - dent(s) - Smooth repair work

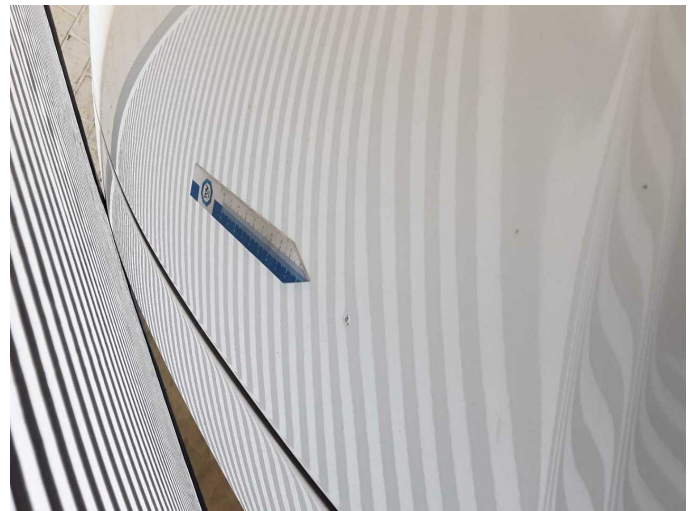
Damage 3: Bonnet: Bonnet - dent(s) - Smooth repair work

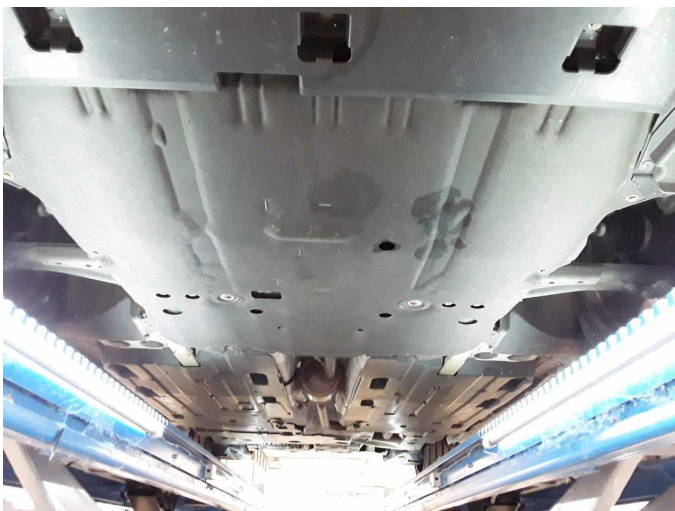
Damage 4: Engine: Engine - Leaking - Diagnosed and repair if necessary

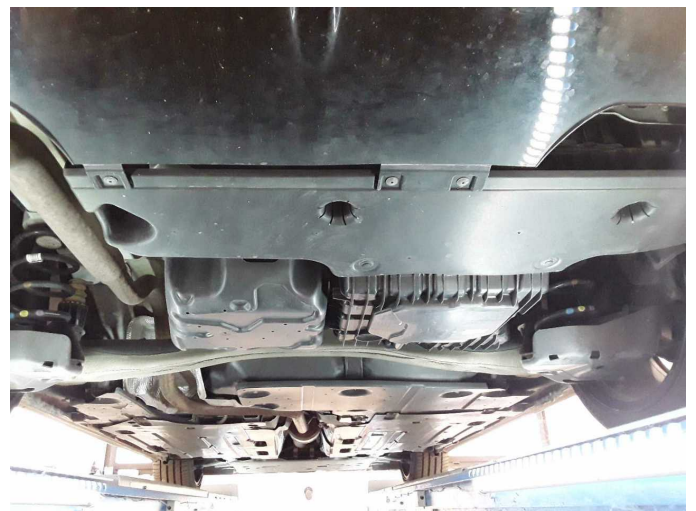
Damage 4: Engine: Engine - Leaking - Diagnosed and repair if necessary

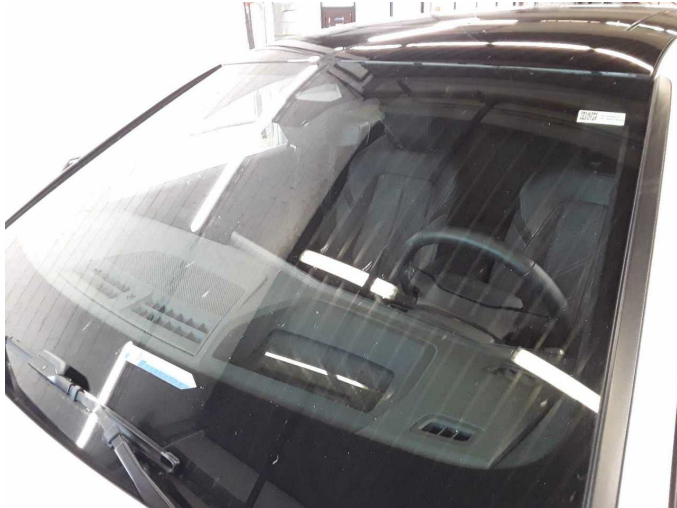
Damage 5: Vehicle glazing: Windscreen (Rissbildung) - Stone chips - Replace

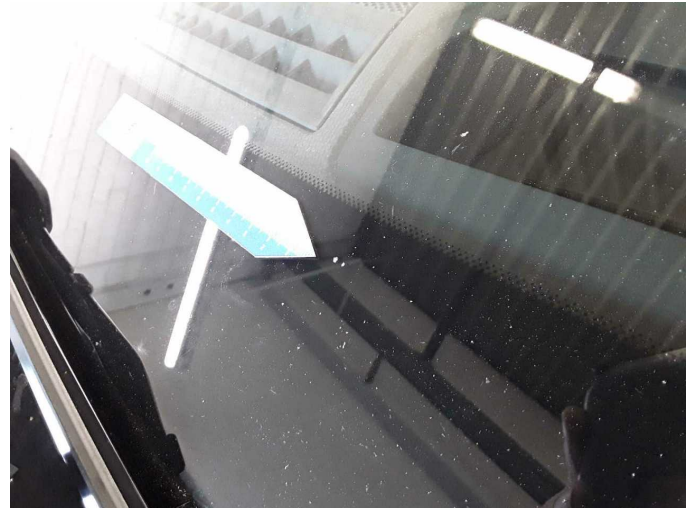
Damage 5: Vehicle glazing: Windscreen (Rissbildung) - Stone chips - Replace

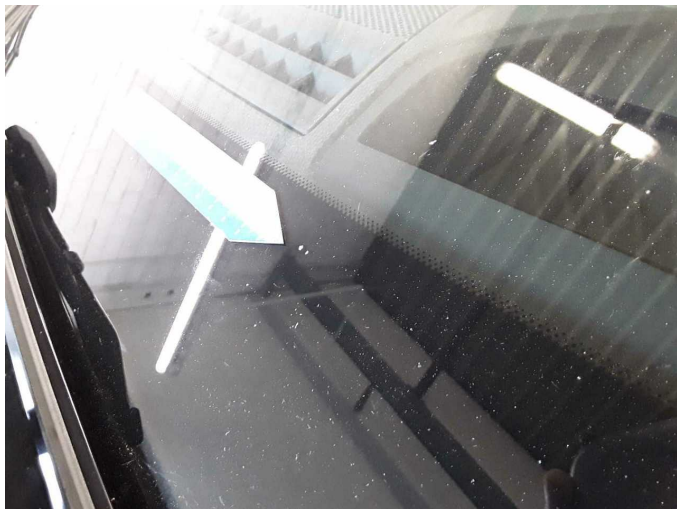
Damage 5: Vehicle glazing: Windscreen (Rissbildung) - Stone chips - Replace

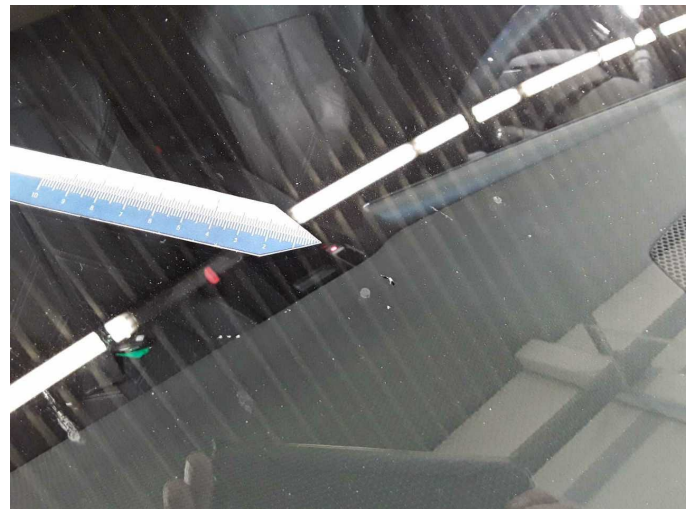
Damage 5: Vehicle glazing: Windscreen (Rissbildung) - Stone chips - Replace

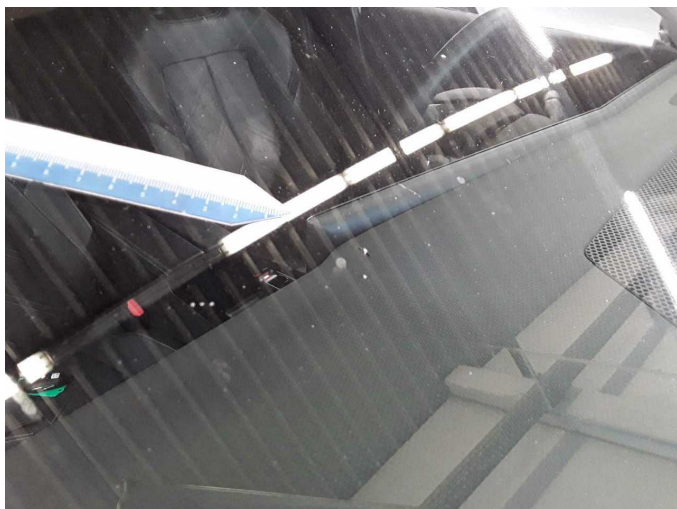
Damage 5: Vehicle glazing: Windscreen (Rissbildung) - Stone chips - Replace

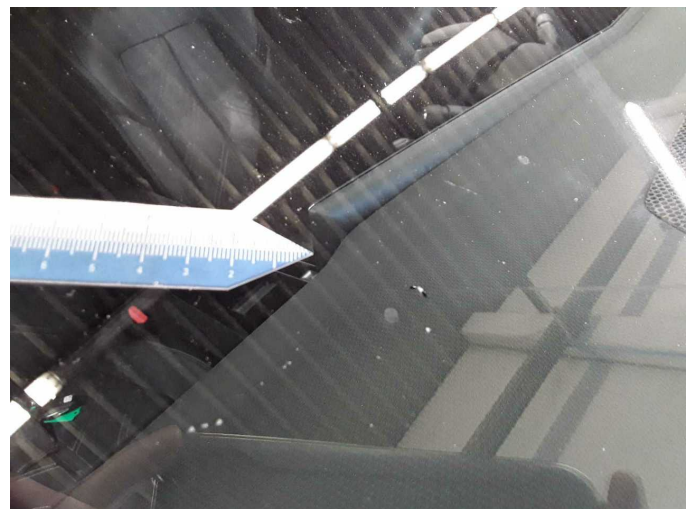
Damage 5: Vehicle glazing: Windscreen (Rissbildung) - Stone chips - Replace

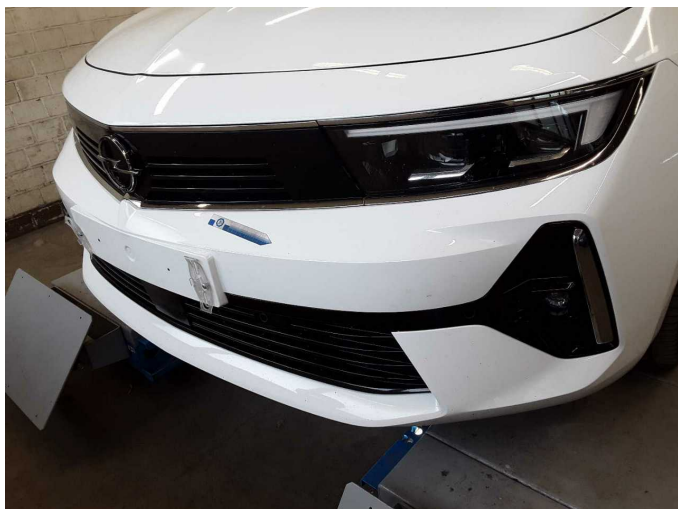
Wear and tear 1: Front bumper: Front bumper - Stone chips - No deduction

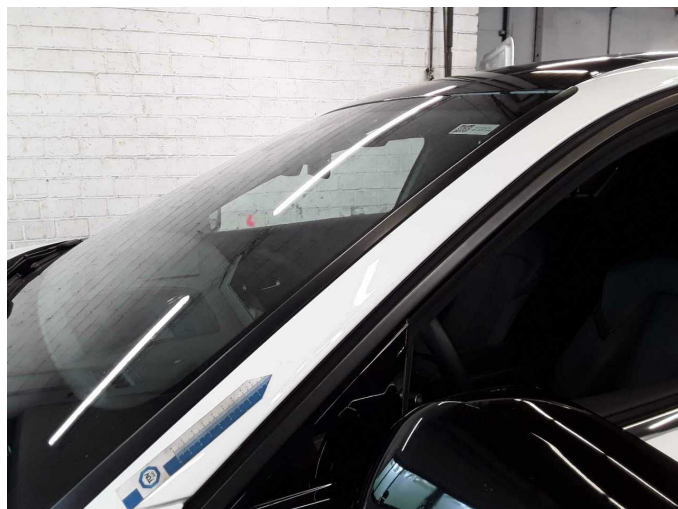
Wear and tear 2: Body: A-pillar - left side - Stone chips - No deduction
