Expertise

Protocol number: 46520478  
Order No. / Reference: 26513140  
Inspection date: 15 Jul 2026

| Manufacturer: Opel | Model: Astra 1.5 D Start/Stop Sports Tourer Business Edition |
| VIN: W0VBD8EV1N8028632 | |

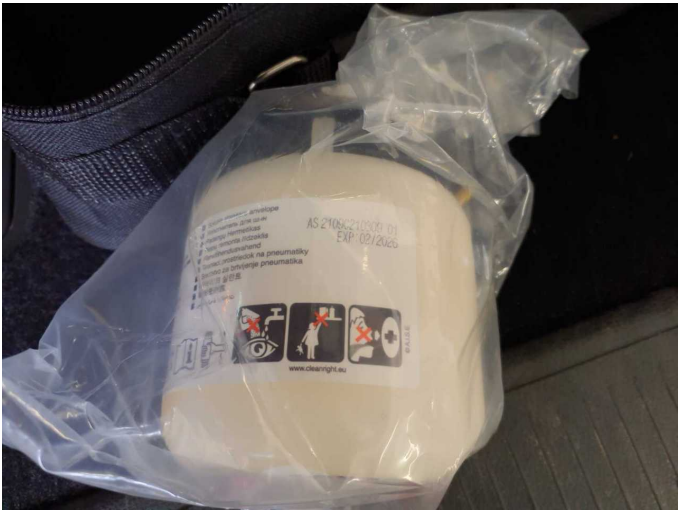
| No. | Component group | Description |
|---|---|---|
| 1 | Equipment | Tirefit filler - Expired - Replace |

Damage 1: Equipment: Tirefit filler - Expired - Replace

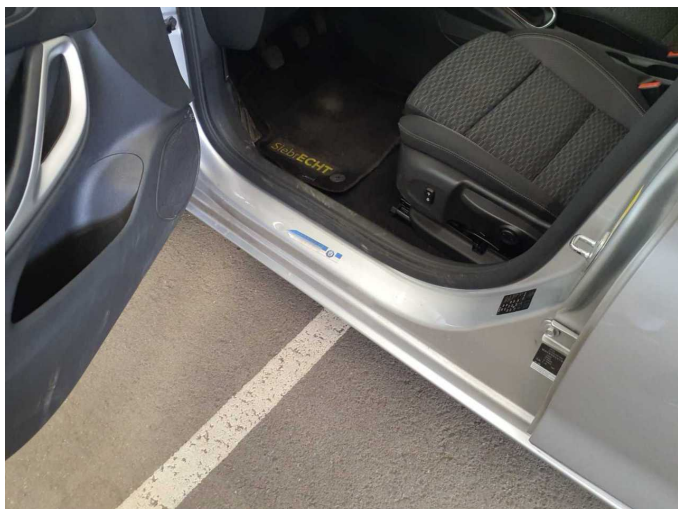
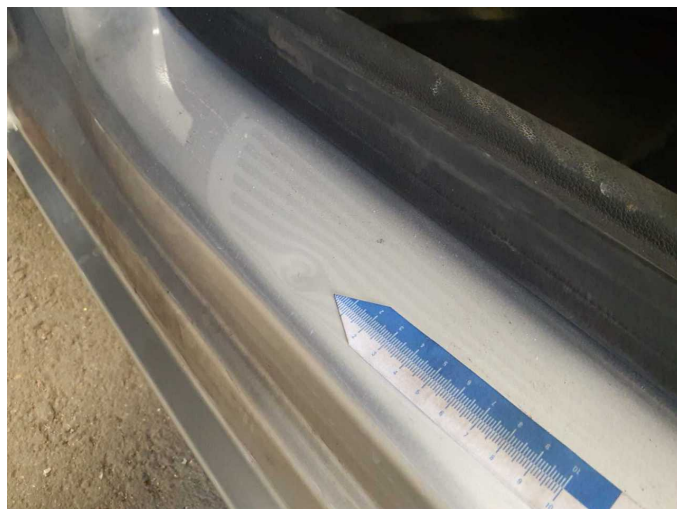
| No. | Component group | Description |
|---|---|---|
| 2 | Sill - left side | Sill - dent(s) - Smart repair |

**Damage 2:** Sill - left side: Sill - dent(s) - Smart repair

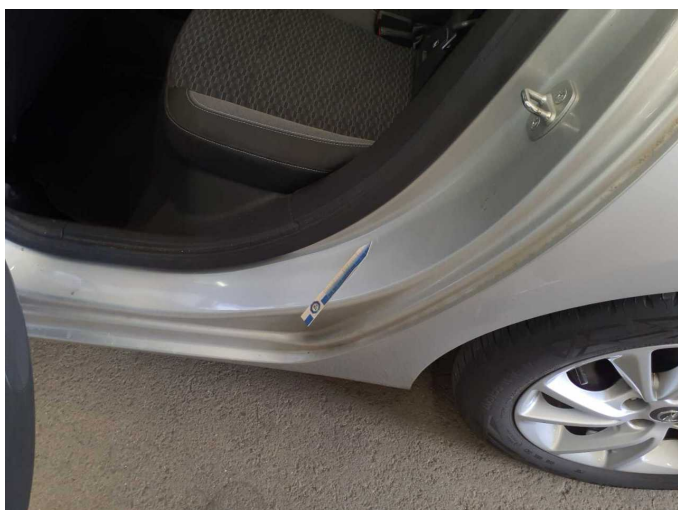
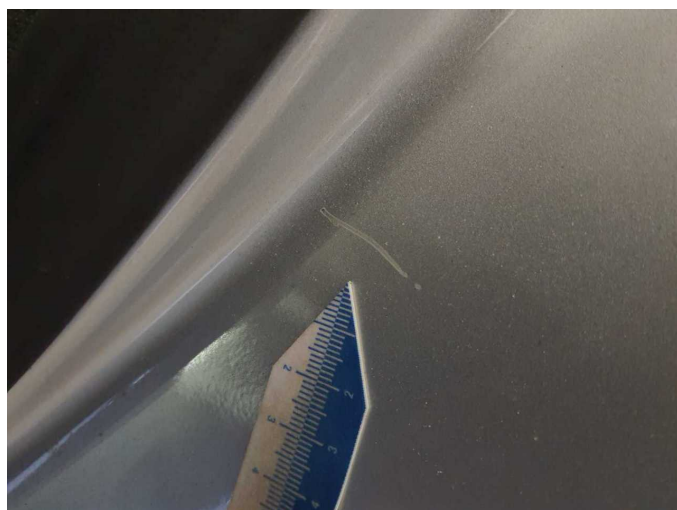
| No. | Component group | Description |
|---|---|---|
| 3 | Side panel - rear left side | Sill - Scratch(es) - Smart repair |

**Damage 3:** Side panel - rear left side: Sill - Scratch(es) - Smart repair

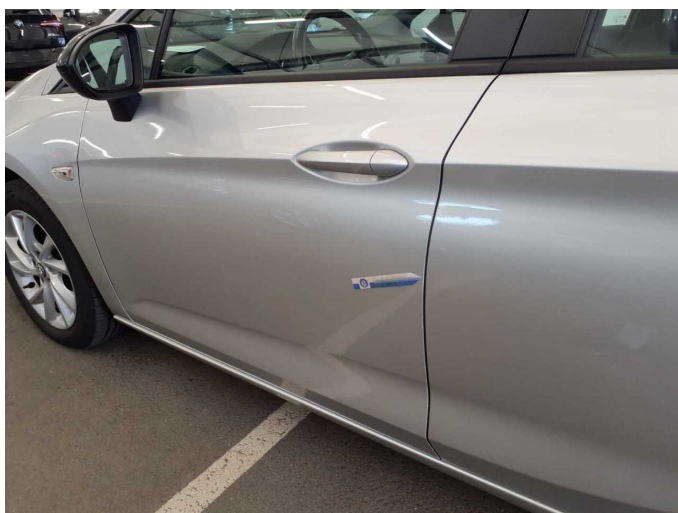
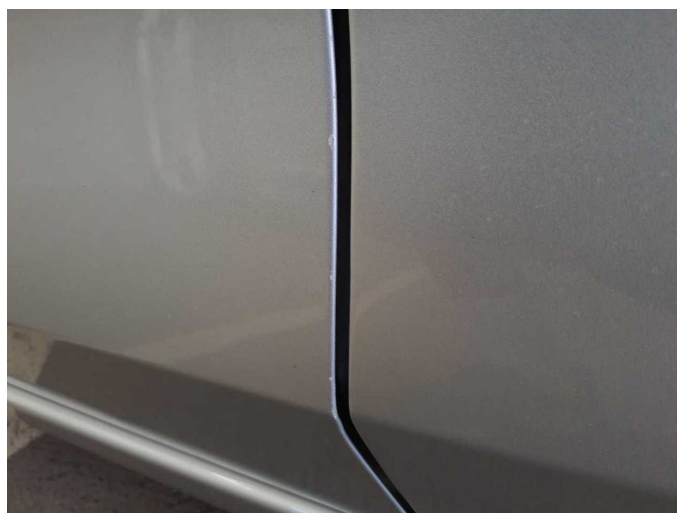
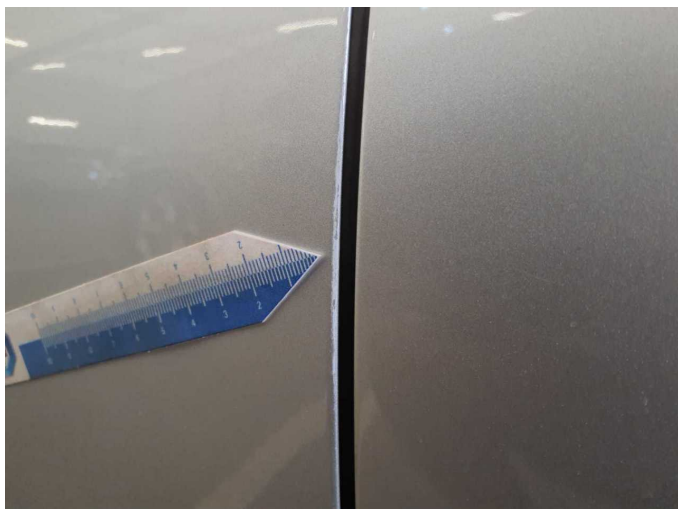
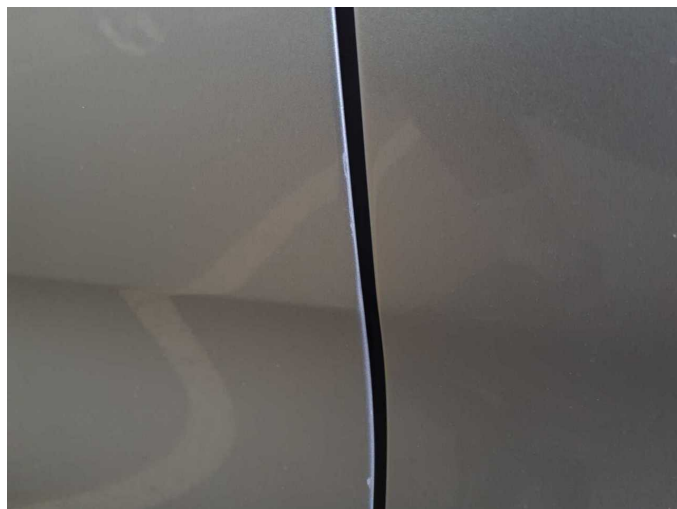
| No. | Component group | Description |
|---|---|---|
| 4 | Door - front left side | Door edge - Scratch(es) - Smart repair |

**Damage 4:** Door - front left side: Door edge - Scratch(es) - Smart repair

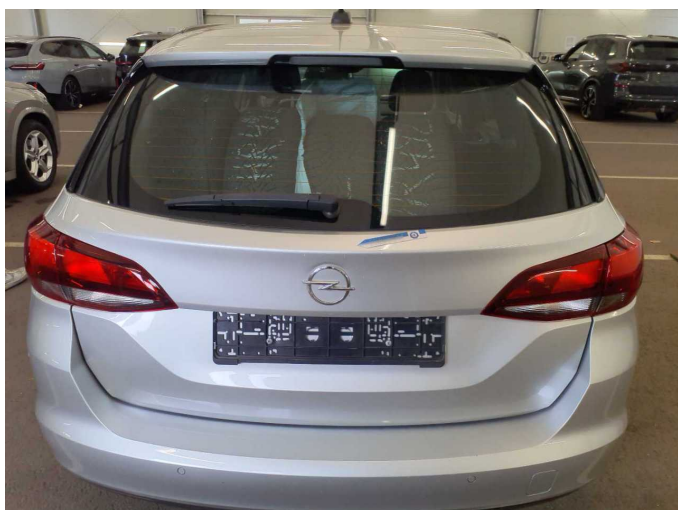
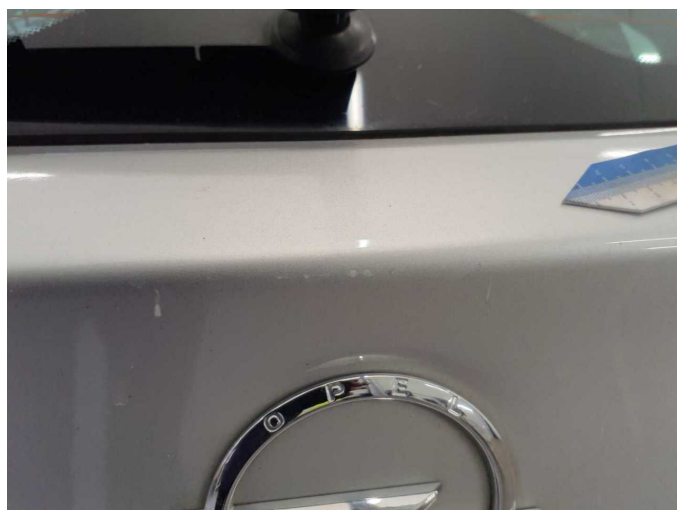
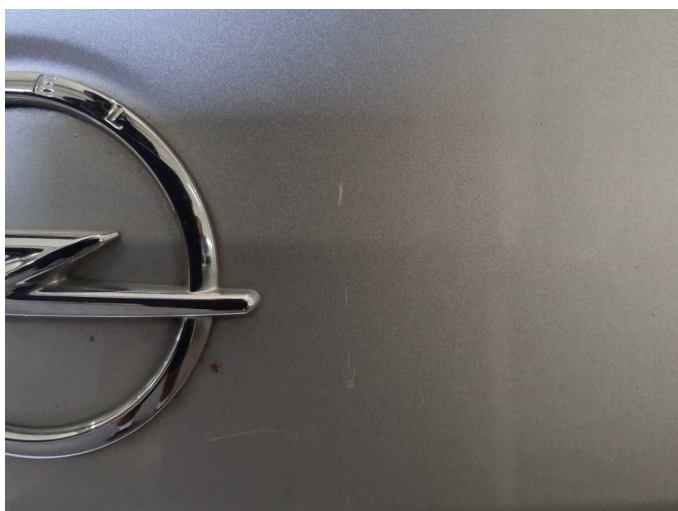
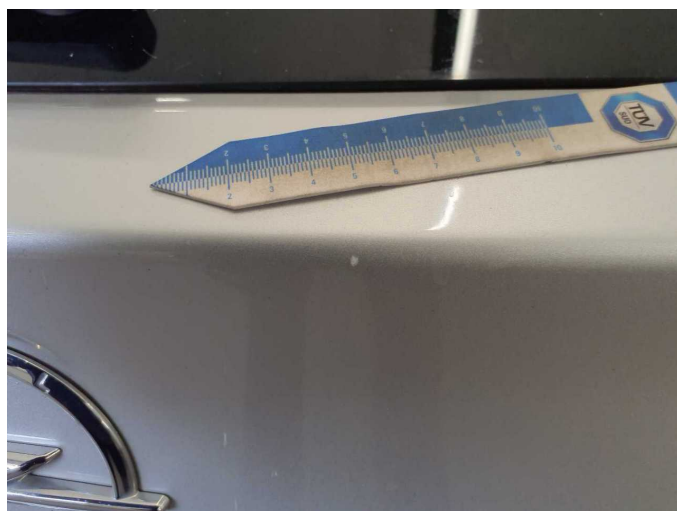
| No. | Component group | Description |
|---|---|---|
| 5 | Boot lid / rear door | Boot lid - Scratch(es) - Smart repair |

**Damage 5:** Boot lid / rear door: Boot lid - Scratch(es) - Smart repair

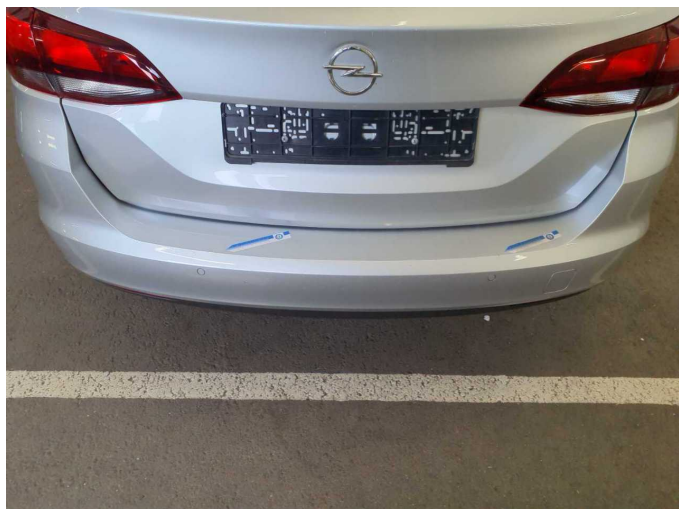
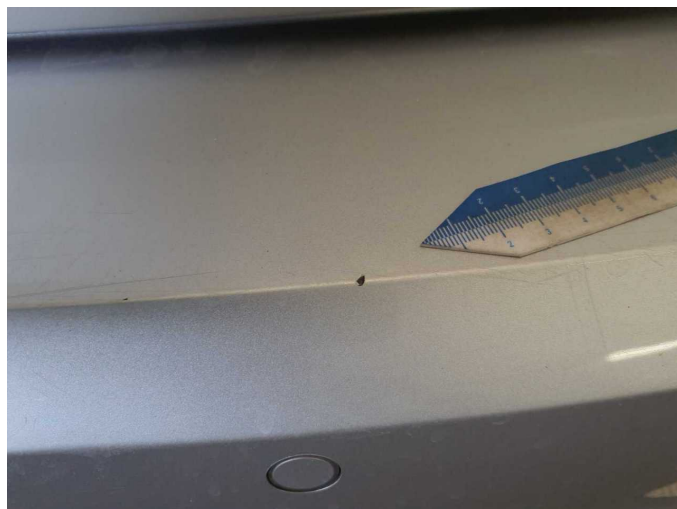
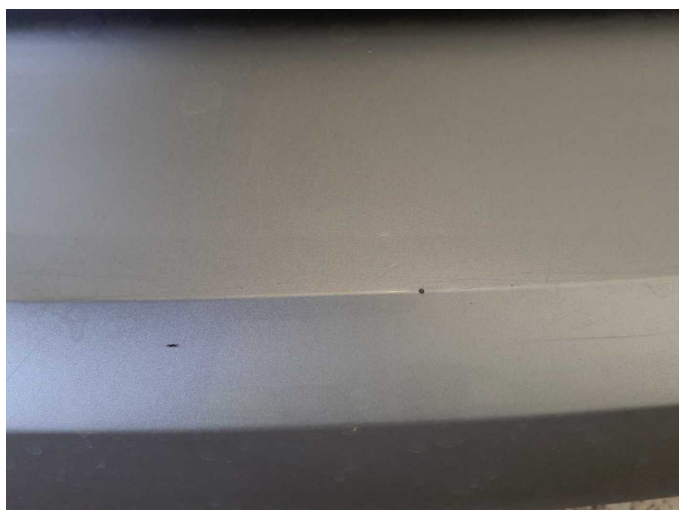
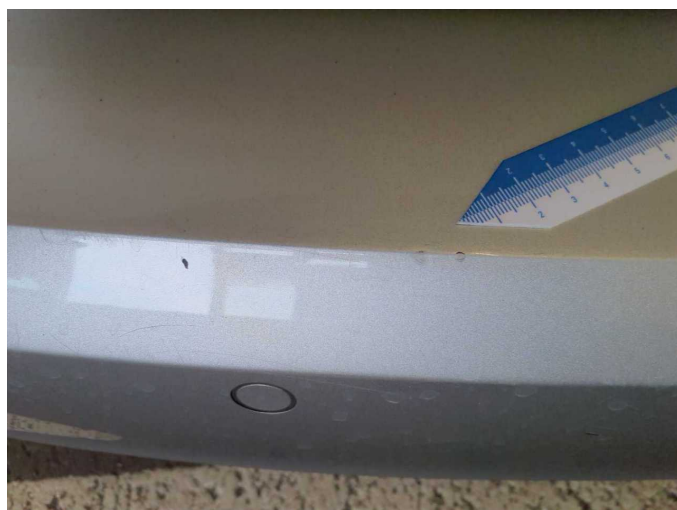
| No. | Component group | Description |
|---|---|---|
| 6 | Rear bumper | Rear bumper - Scratch(es) - Smart repair |

**Damage 6:** Rear bumper: Rear bumper - Scratch(es) - Smart repair

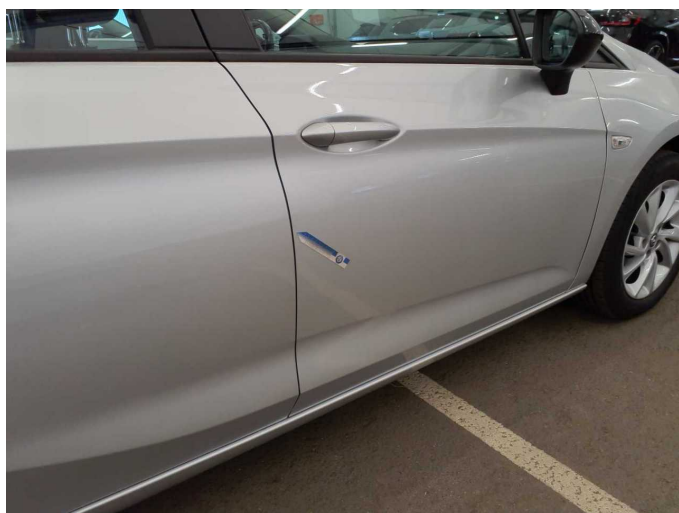
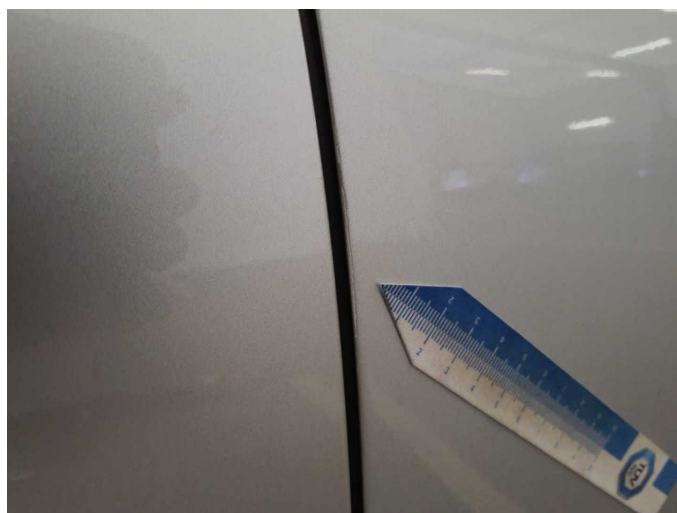
| No. | Component group | Description |
|---|---|---|
| 7 | Door - front right side | Door edge - Scratch(es) - Smart repair |

**Damage 7:** Door - front right side: Door edge - Scratch(es) - Smart repair

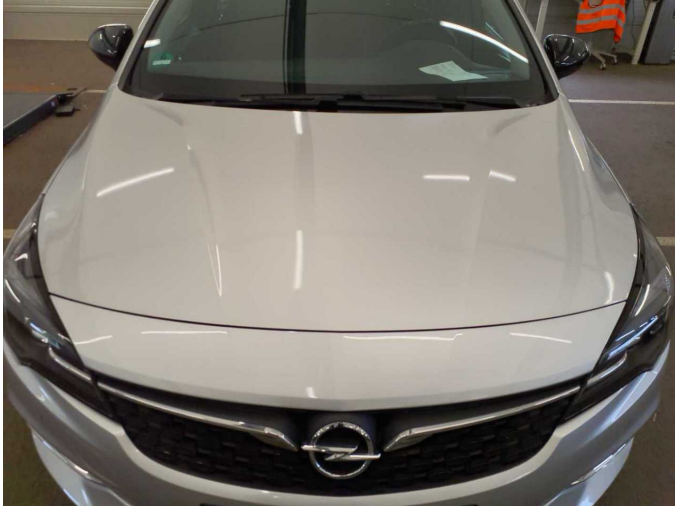
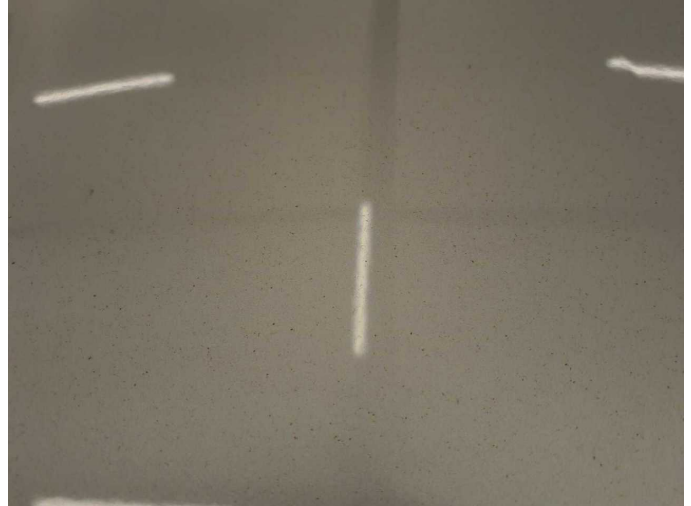
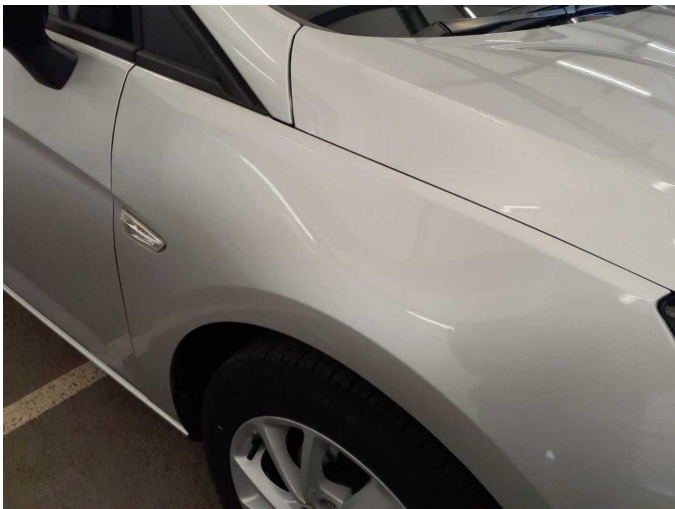
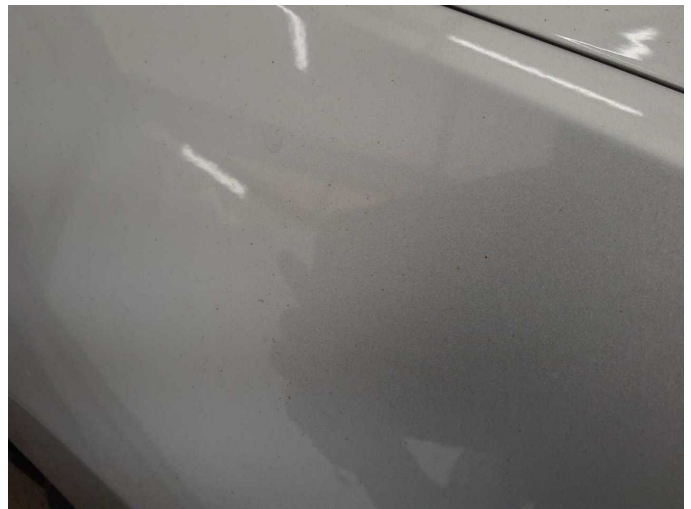
| No. | Component group | Description |
|---|---|---|
| 8 | Body | Body (Flugrost) - Soiled - Clean |

**Damage 8:** Body: Body (Flugrost) - Soiled - Clean

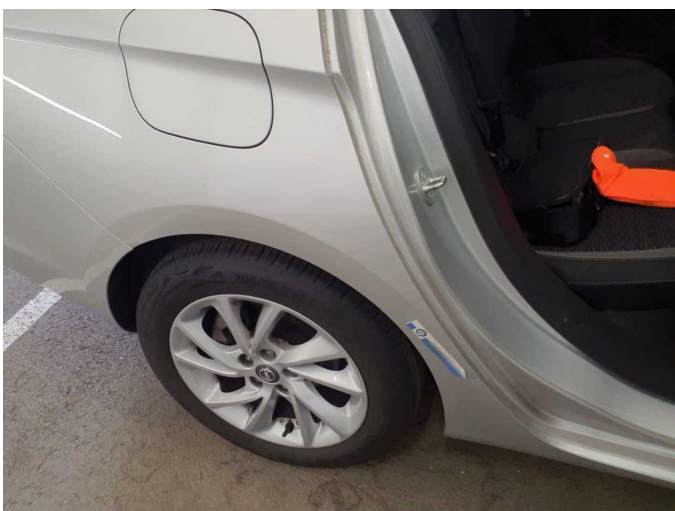
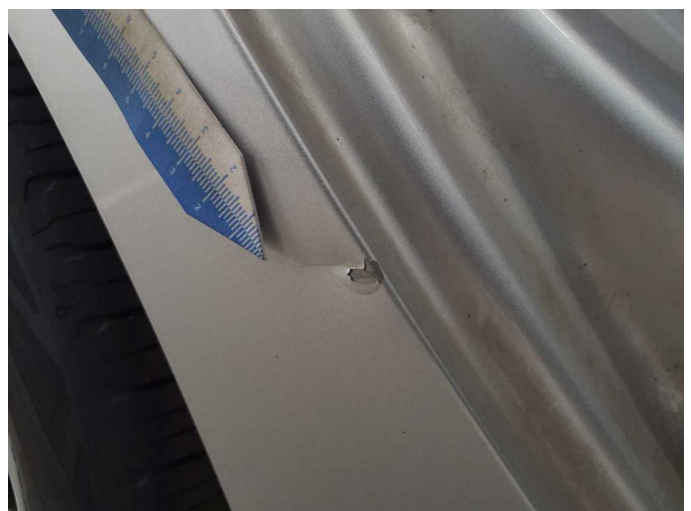
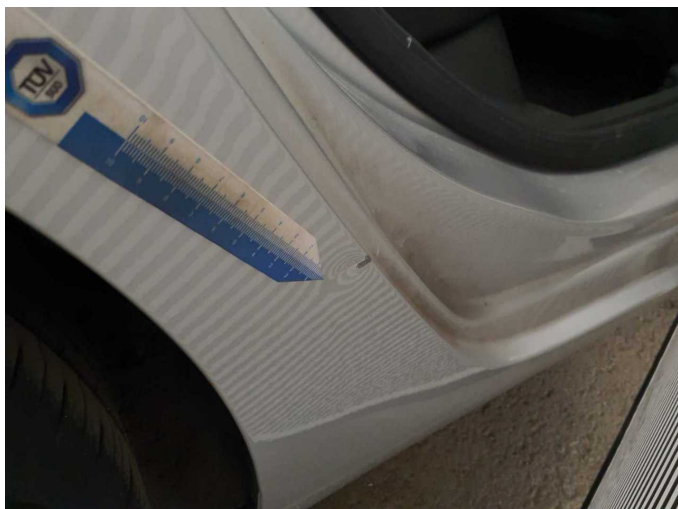
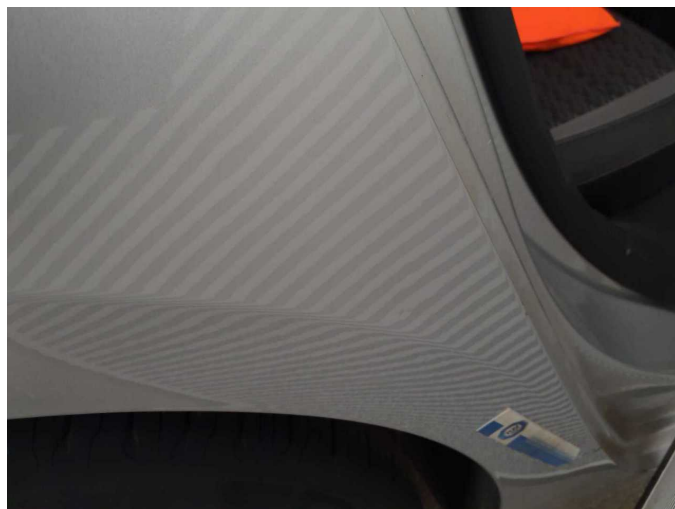
| No. | Component group | Description |
|---|---|---|
| 9 | Side panel - rear right side | Elbow - Dent / paintcoat damage - Repair and paint |

**Damage 9:** Side panel - rear right side: Elbow - Dent / paintcoat damage  
- Repair and paint

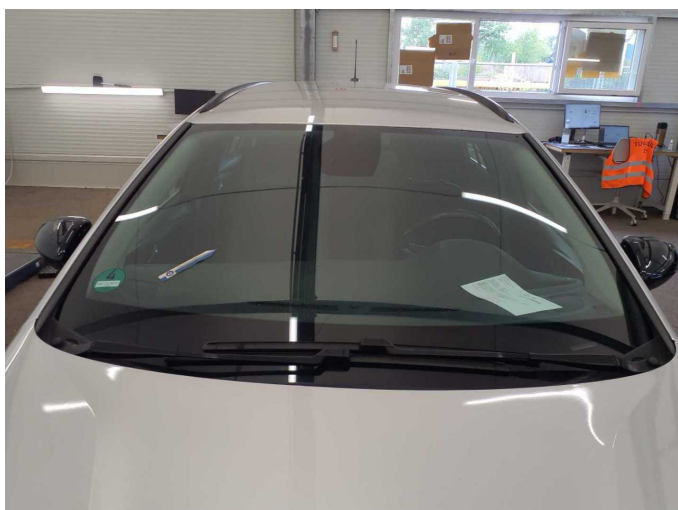
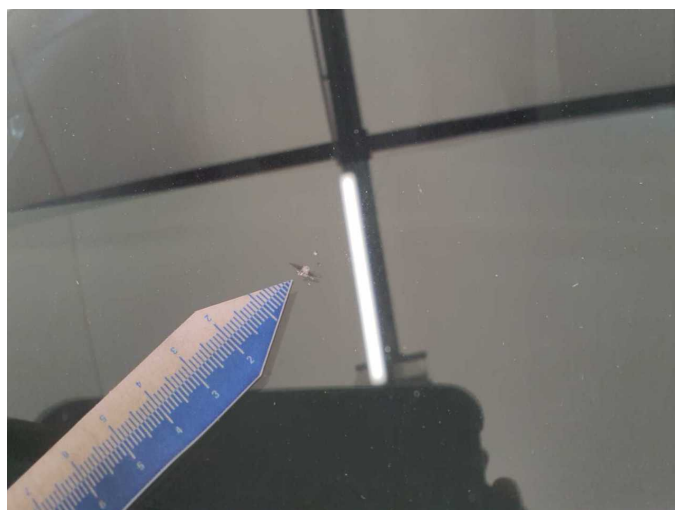
| No. | Component group | Description |
|---|---|---|
| 10 | Vehicle glazing | Windscreen with rain sensor - Stone chips - Replace |

**Damage 10:** Vehicle glazing: Windscreen with rain sensor - Stone chips -  
Replace
