Expertise

Protocol number: 46139819  
Order No. / Reference: 26484122  
Inspection date: 16 Jun 2026

Manufacturer: Skoda  
VIN: TMBJF9NU3PC213679

Model: Karoq 2.0 TDI SCR DSG Style

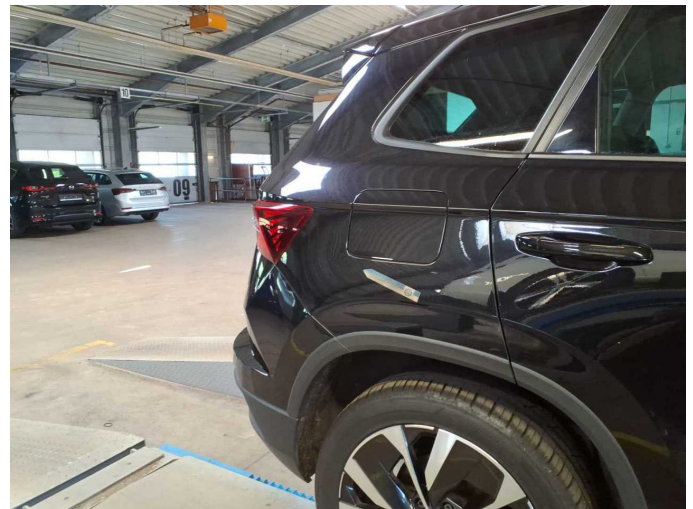
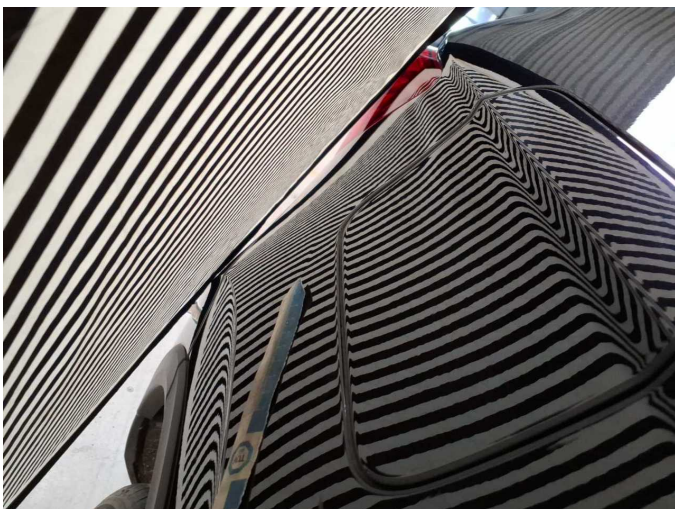
| No. | Component group | Description |
|---|---|---|
| 1 | Side panel - rear right side | Side panel - dent(s) - Smooth repair work |

**Damage 1:** Side panel - rear right side: Side panel - dent(s) - Smooth repair work

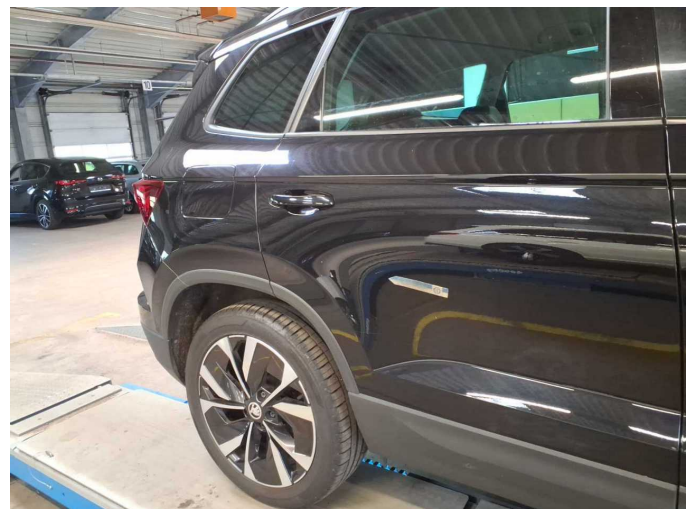
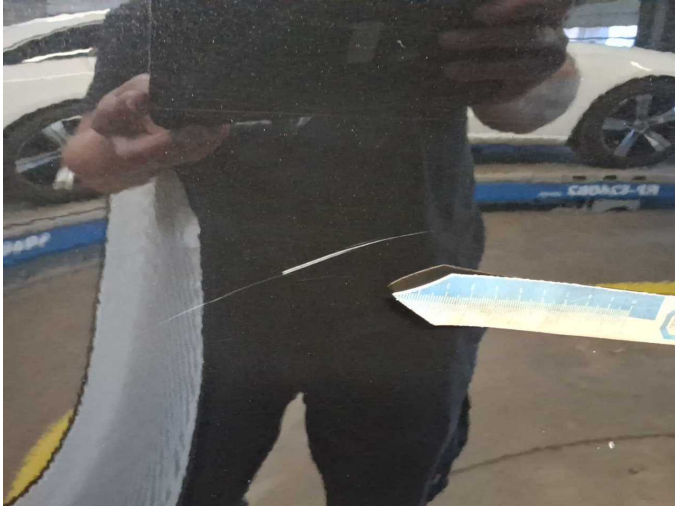
| No. | Component group | Description |
|---|---|---|
| 2 | Door - rear right side | Door - Scratch(es) - Smart repair |

**Damage 2:** Door - rear right side: Door - Scratch(es) - Smart repair

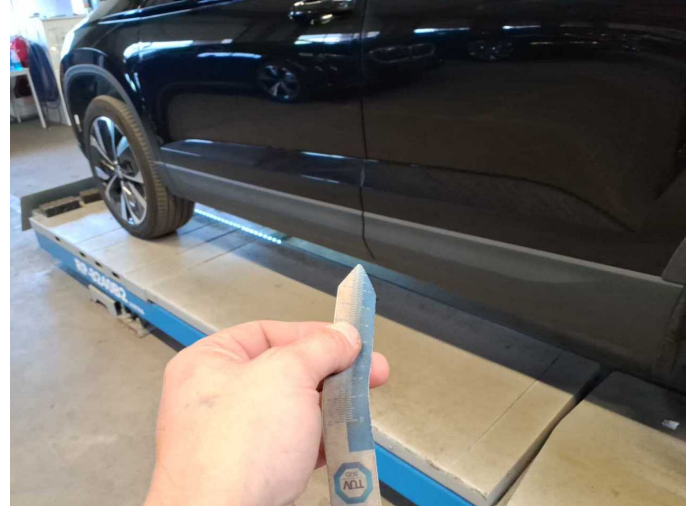
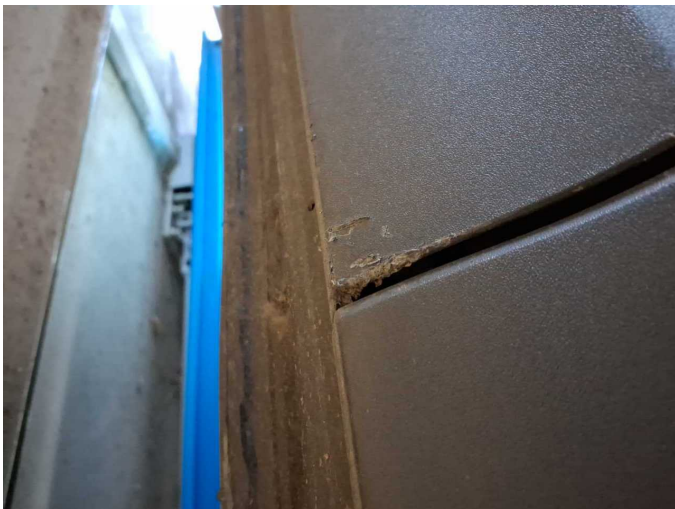
| No. | Component group | Description |
|---|---|---|
| 3 | Door - front left side | Brightware - lower - Scratched - Smart repair |

**Damage 3:** Door - front left side: Brightware - lower - Scratched - Smart repair

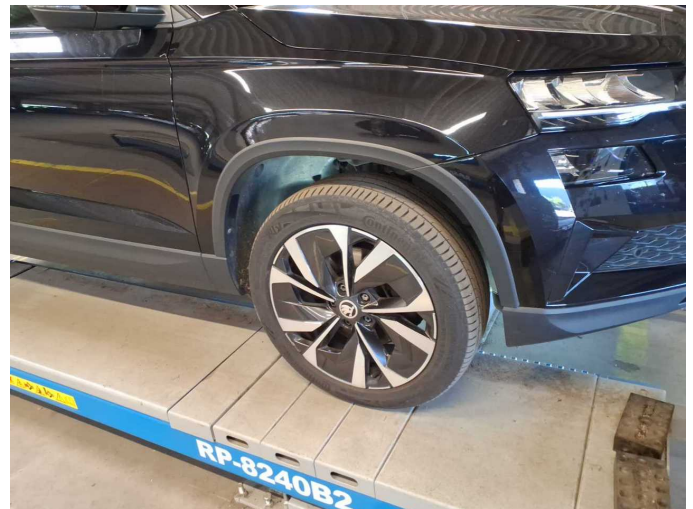
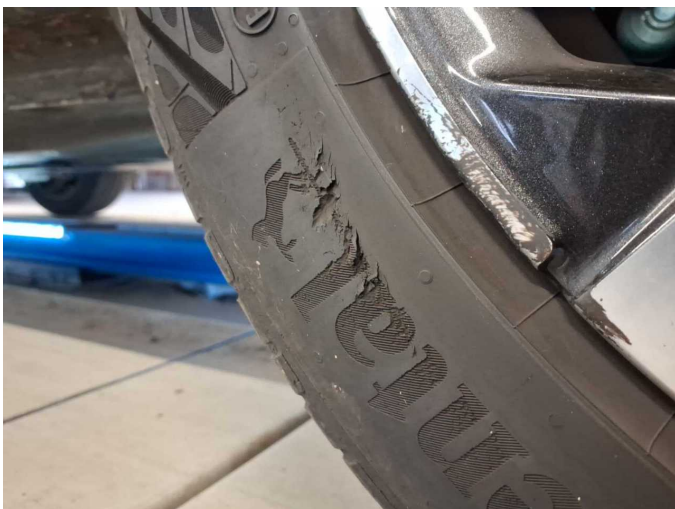
| No. | Component group | Description |
|---|---|---|
| 4 | Wheel / tyres | Tyre - front right side (Flanke) - Damaged - Replace |

**Damage 4:** Wheel / tyres: Tyre - front right side (Flanke) - Damaged - Replace

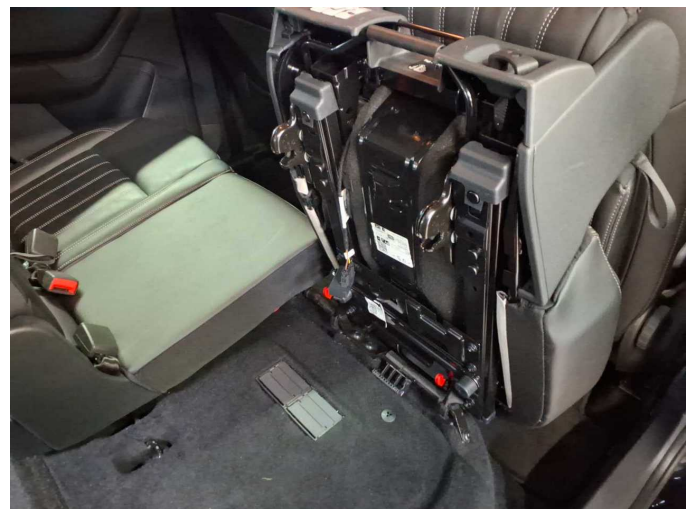
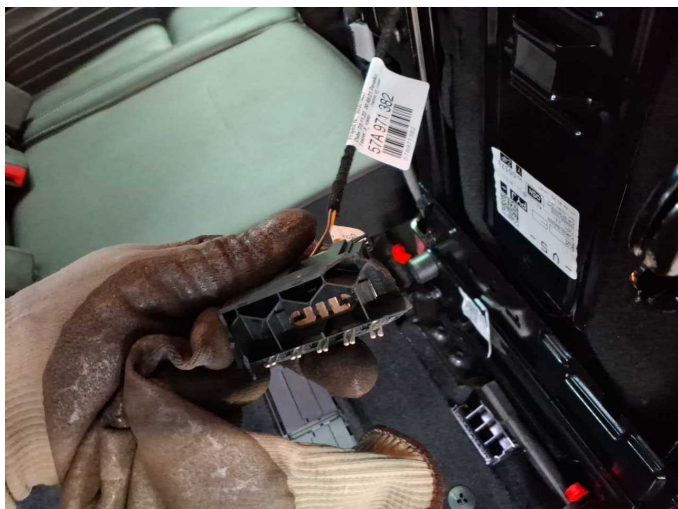
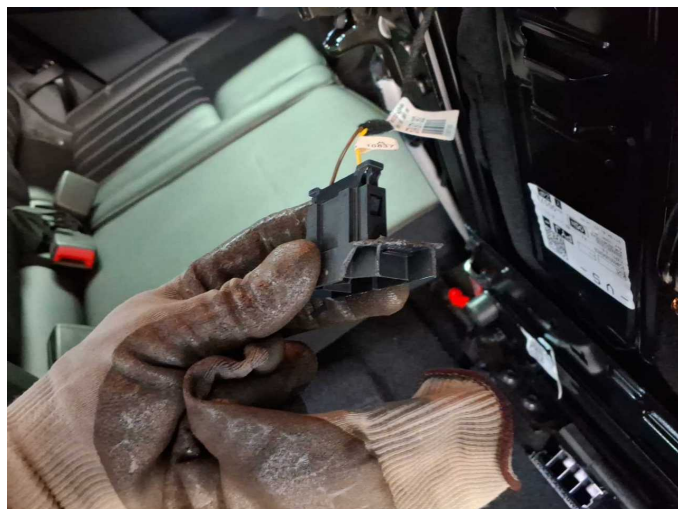
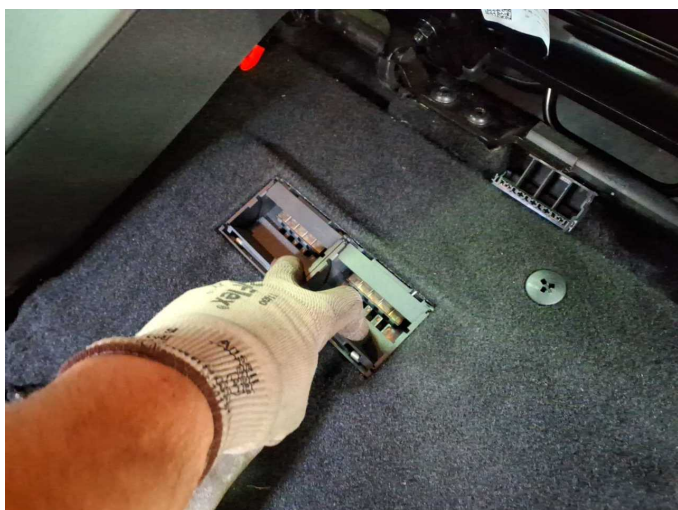
| No. | Component group | Description |
|---|---|---|
| 5 | Misc. | Misc. (Stecker Sitzheizung, Mehrkosten möglich) - Broken / torn - Replace |

**Damage 5:** Misc.: Misc. (Stecker Sitzheizung, Mehrkosten möglich) - Broken / torn - Replace

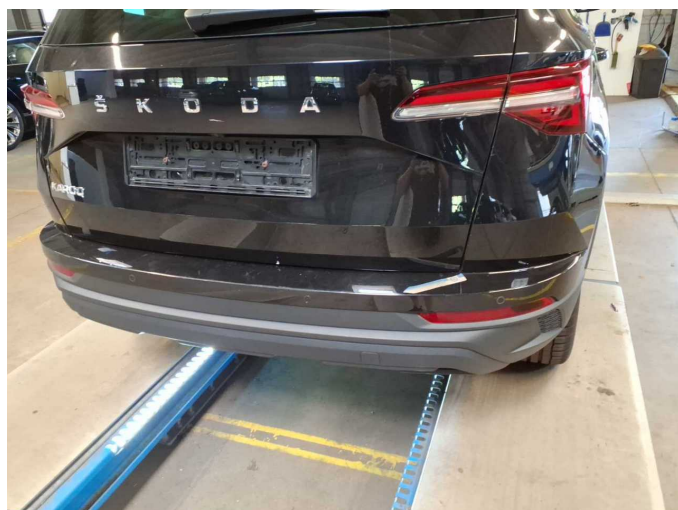
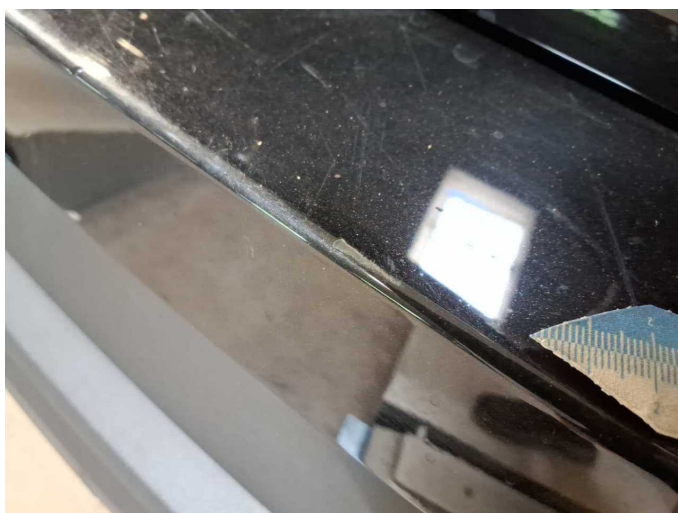
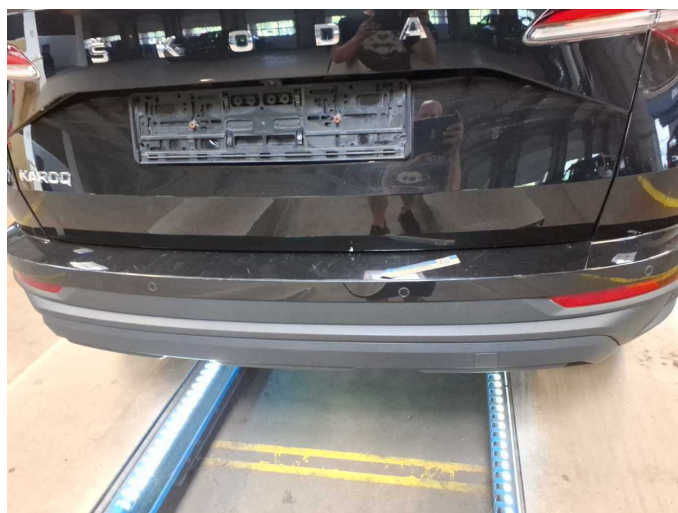
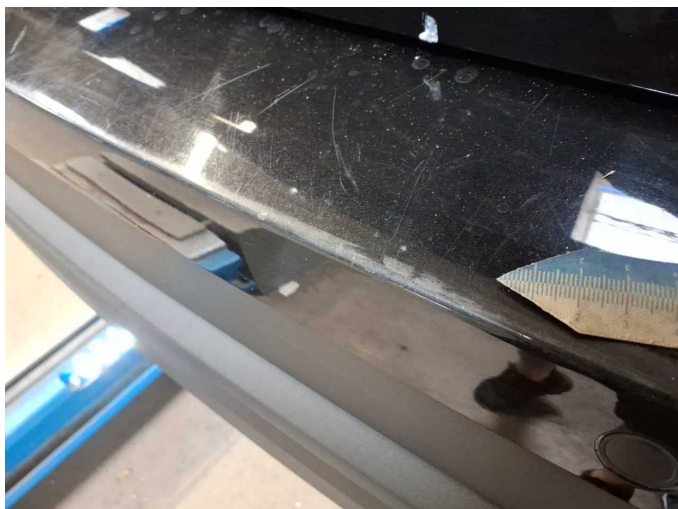
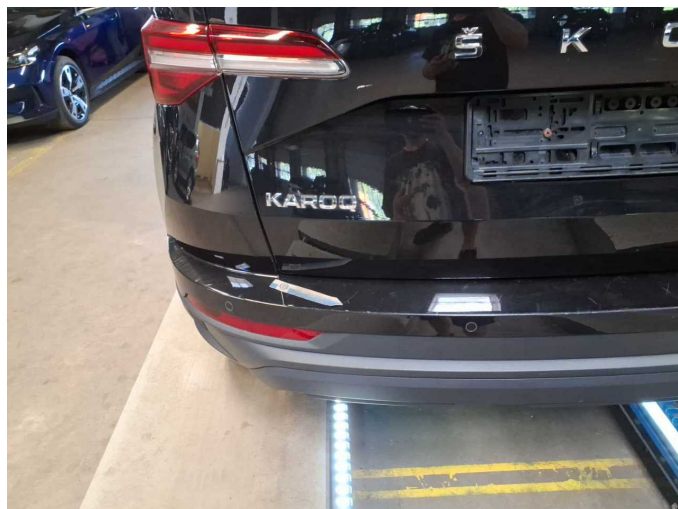
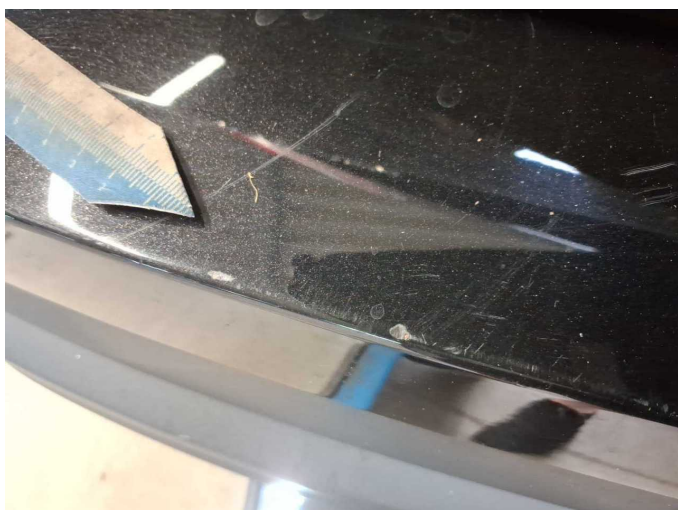
| No. | Component group | Description |
|---|---|---|
| 6 | Rear bumper | Rear bumper - Scratched - Paint |

**Damage 6:** Rear bumper: Rear bumper - Scratched - Paint

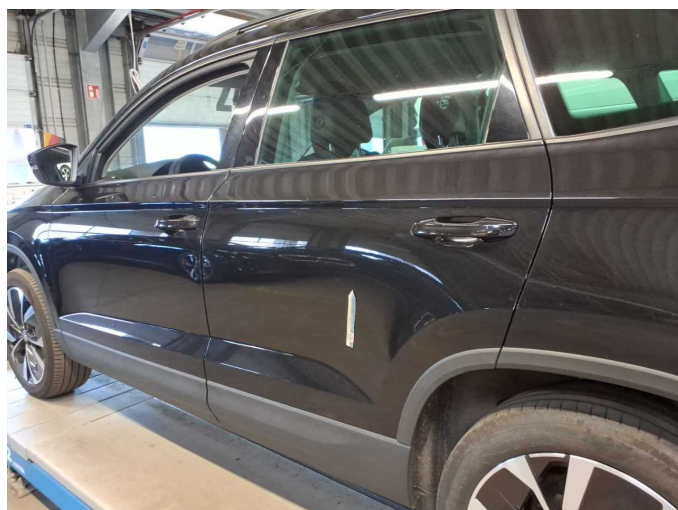
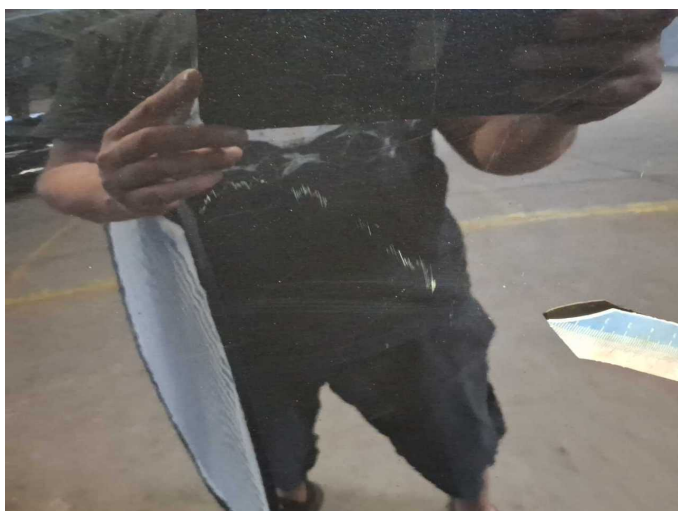
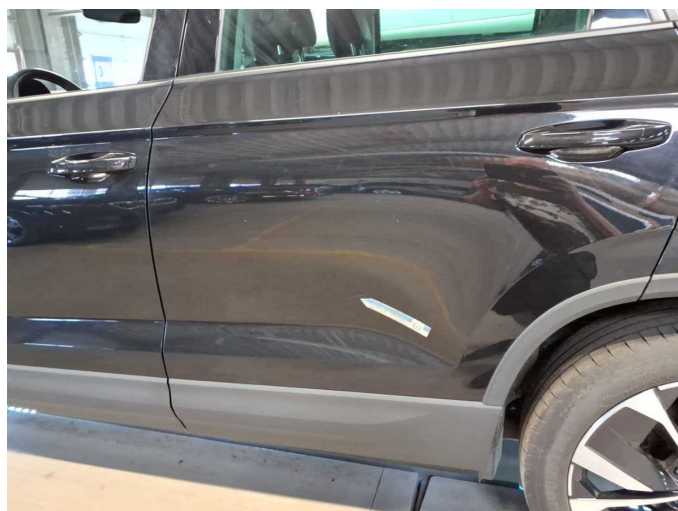
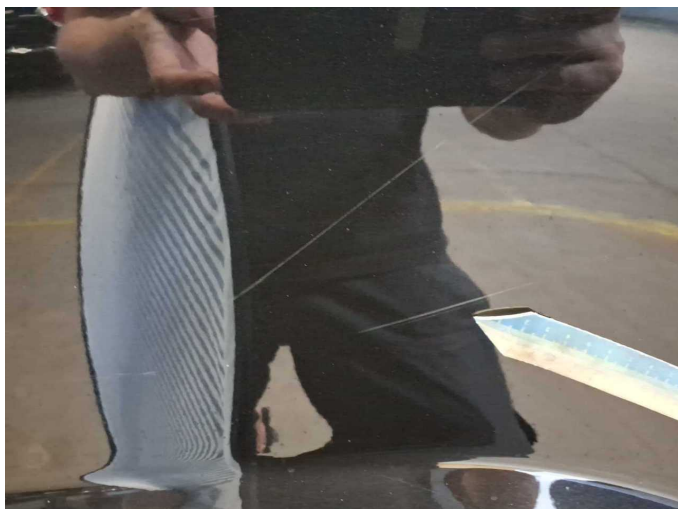
| No. | Component group | Description |
|---|---|---|
| 7 | Door - rear left side | Door - Scratch(es) - Paint |

**Damage 7:** Door - rear left side: Door - Scratch(es) - Paint

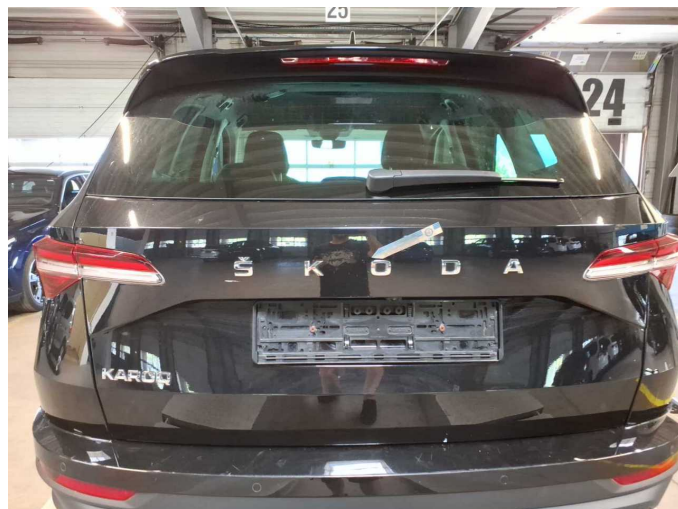
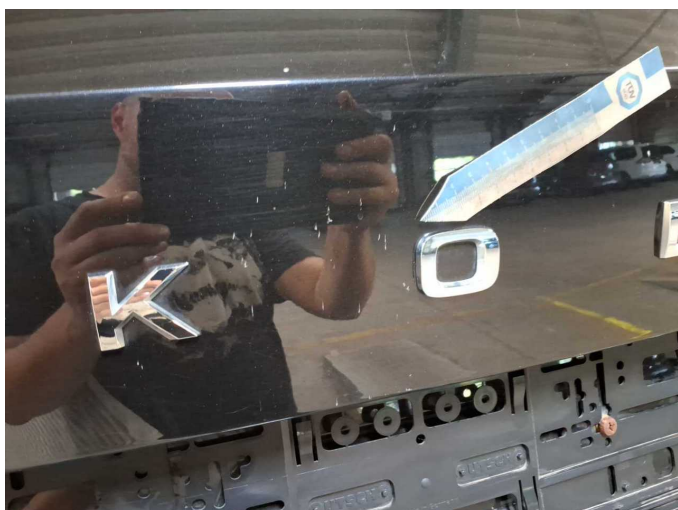
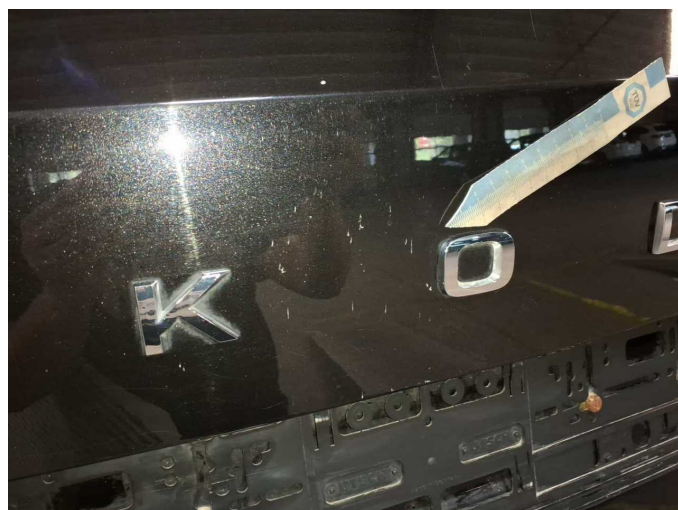
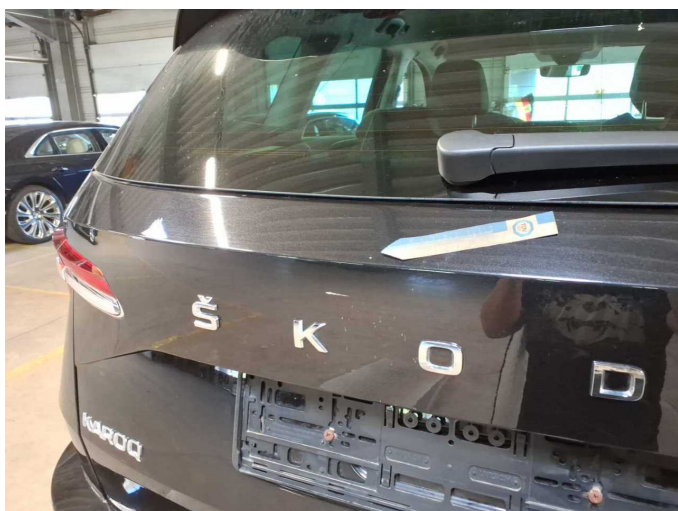
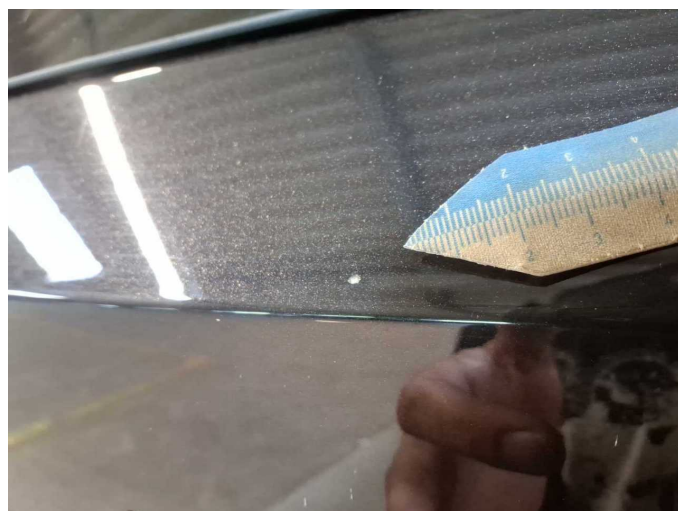
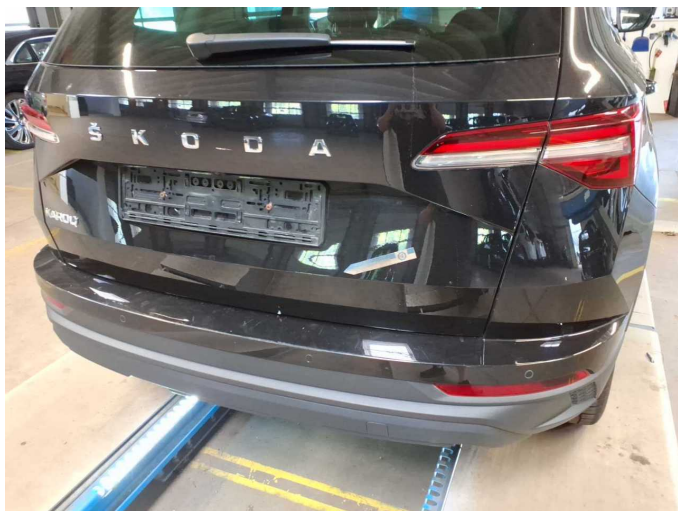
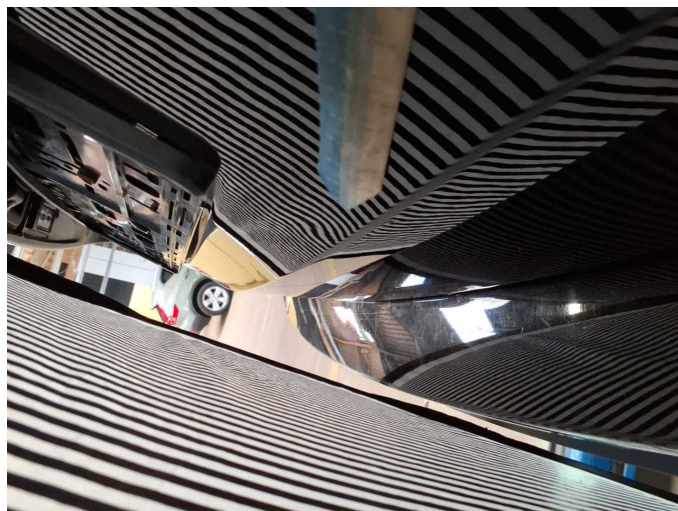
| No. | Component group | Description |
|---|---|---|
| 8 | Boot lid / rear door | Boot lid - Dent / paintcoat damage - Repair and paint |

**Damage 8:** Boot lid / rear door: Boot lid - Dent / paintcoat damage - Repair and paint

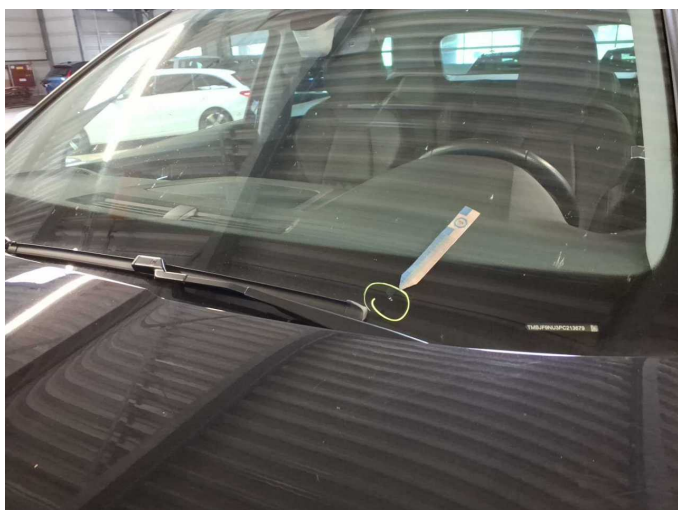
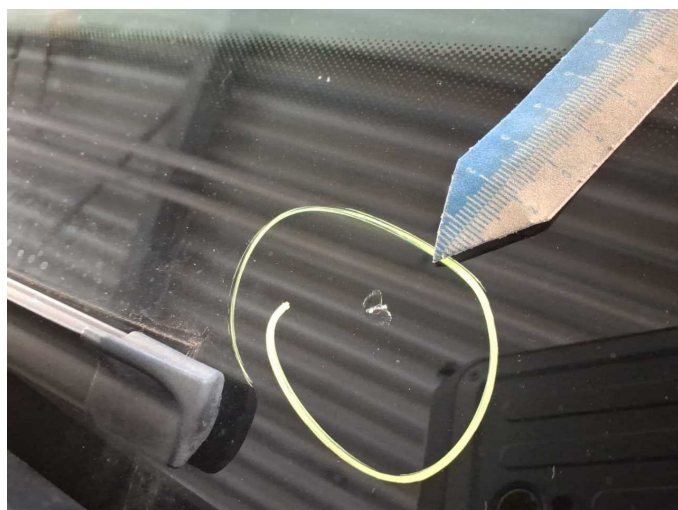
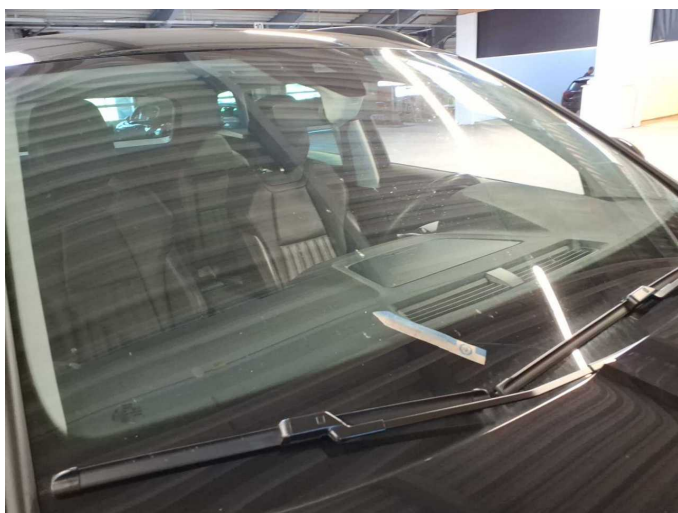
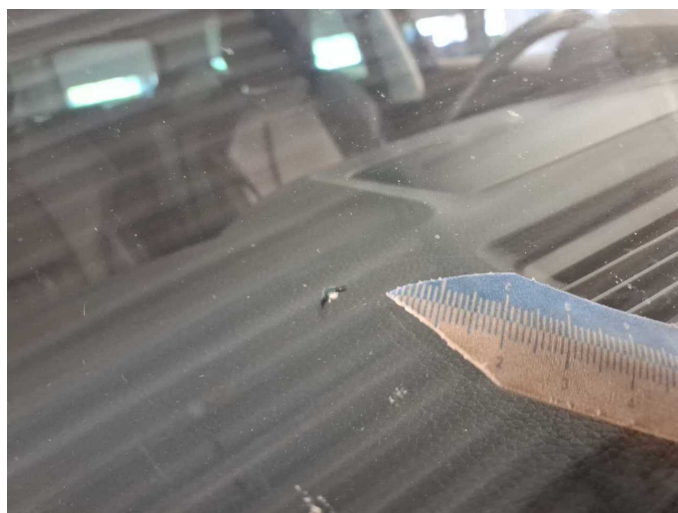
| No. | Component group | Description |
|---|---|---|
| 9 | Vehicle glazing | Windscreen - Stone chips - Replace |

**Damage 9:** Vehicle glazing: Windscreen - Stone chips - Replace

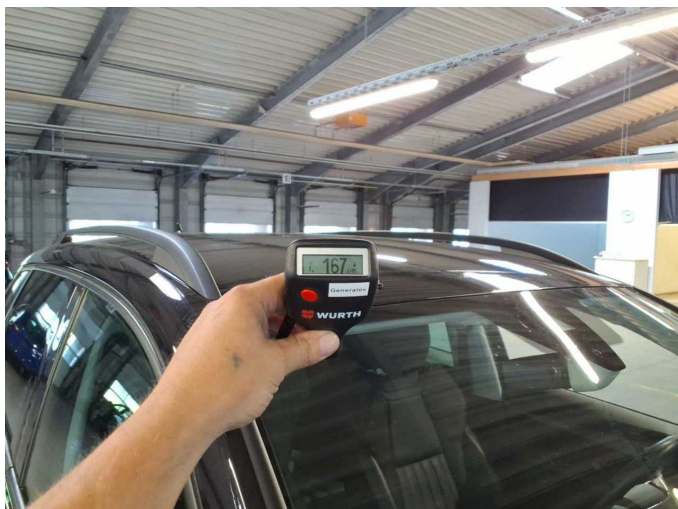
| No. | Repainting |
|---|---|
| 1 | Roof, Professionally carried out, Invoice of repair done Non-existent |

| Roof | 167 µm | Boot lid / rear door | 174 µm |

**Repainting 1: Roof**

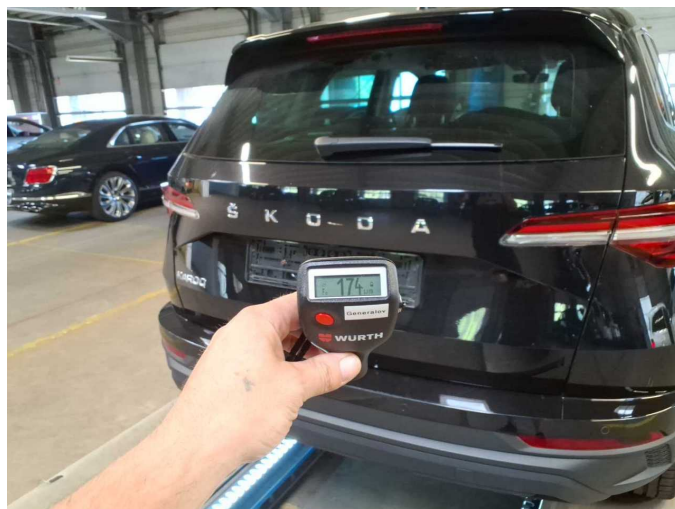
| No. | Repainting |
|---|---|
| 2 | Boot lid / rear door, Professionally carried out, Invoice of repair done Non-existent |

**Repainting 2: Boot lid / rear door**

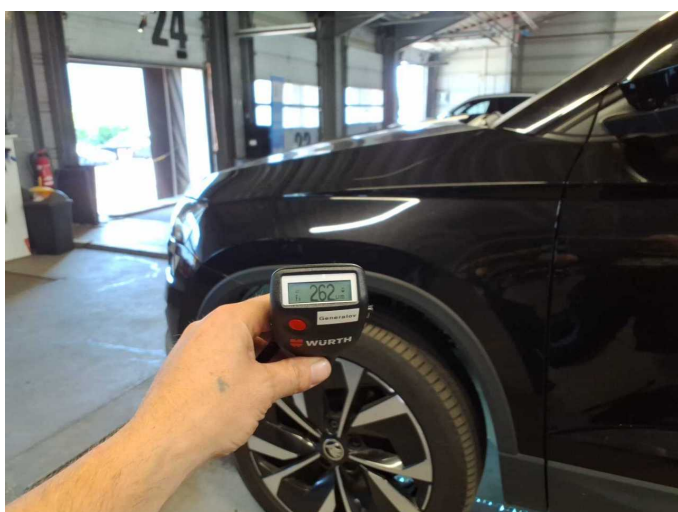
| No. | Repainting |
|---|---|
| 3 | Mudguard - left side, Professionally carried out, Invoice of repair done Non-existent |

| Mudguard - left side | 262 µm | Bonnet | 161 µm |

**Repainting 3: Mudguard - left side**

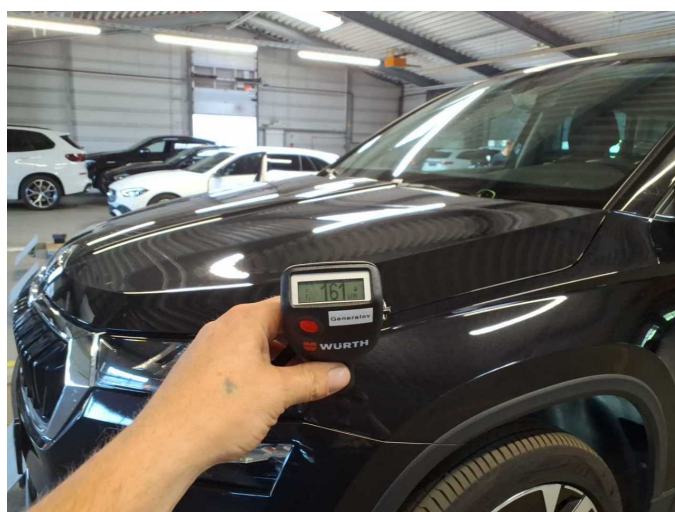
| No. | Repainting |
|---|---|
| 4 | Bonnet, Professionally carried out, Invoice of repair done Non-existent |

**Repainting 4: Bonnet**

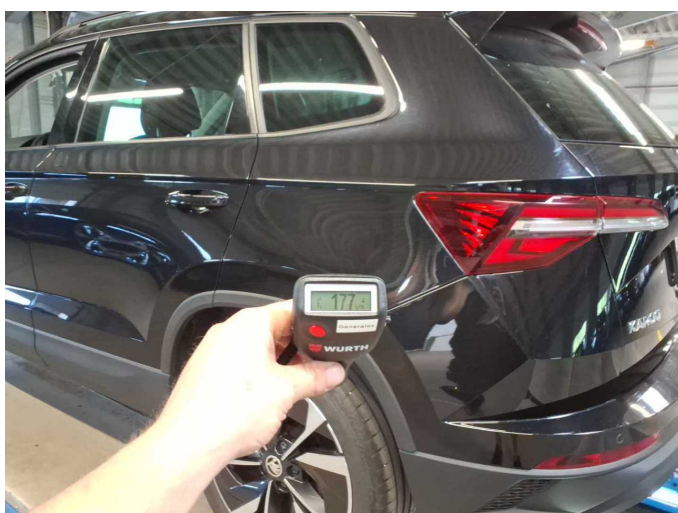
| No. | Repainting |
|---|---|
| 5 | Side panel - rear left side, Professionally carried out, Invoice of repair done Non-existent |

| Side panel - rear left side | 177 µm | Side panel - rear right side | 167 µm |

**Repainting 5: Side panel - rear left side**

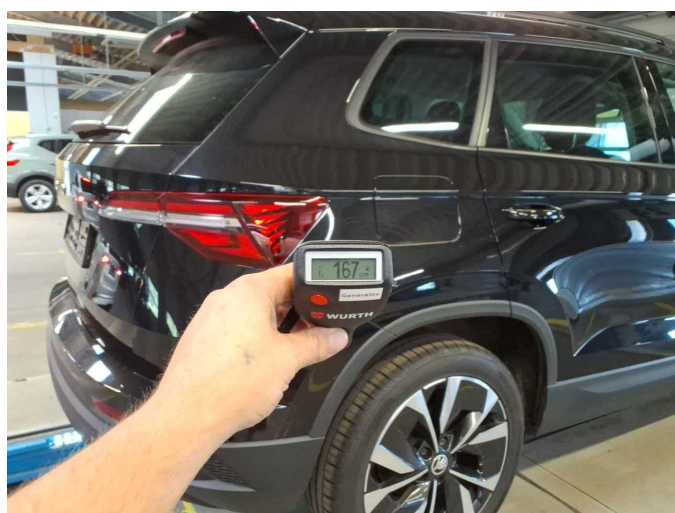
| No. | Repainting |
|---|---|
| 6 | Side panel - rear right side, Professionally carried out, Invoice of repair done Non-existent |

**Repainting 6: Side panel - rear right side**

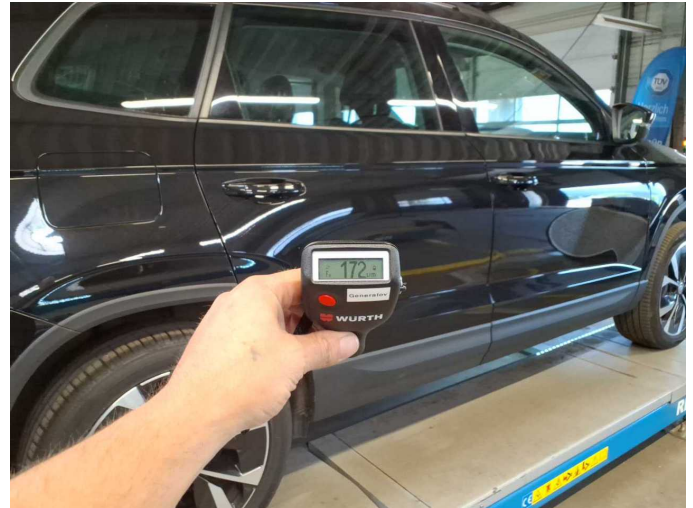
| No. | Repainting |
|---|---|
| 8 | Door - rear right side, Professionally carried out, Invoice of repair done Non-existent |

| Door - rear left side | 156 µm | Door - rear right side | 172 µm |

**Repainting 8:** Door - rear right side

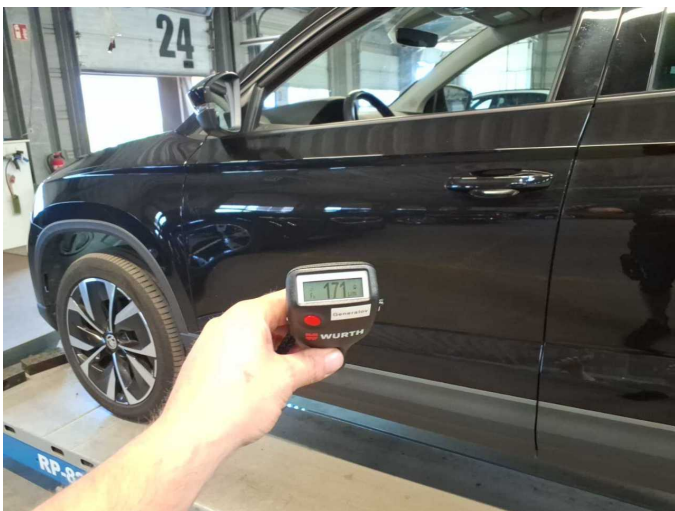
| No. | Repainting |
|---|---|
| 9 | Door - front left side, Professionally carried out, Invoice of repair done Non-existent |

| Door - front left side | 171 µm | Door - front right side | 205 µm |

**Repainting 9:** Door - front left side

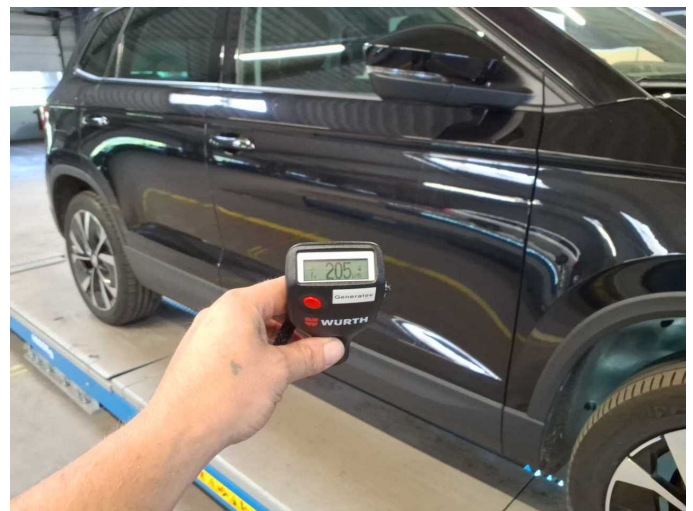
| No. | Repainting |
|---|---|
| 10 | Door - front right side, Professionally carried out, Invoice of repair done Non-existent |

**Repainting 10:** Door - front right side
