Expertise

Protocol number: 46296196
Order No. / Reference: 26611713
Inspection date: 30 Jun 2026

Manufacturer: Volkswagen

Model: Caddy Cargo 2.0 TDI BMT

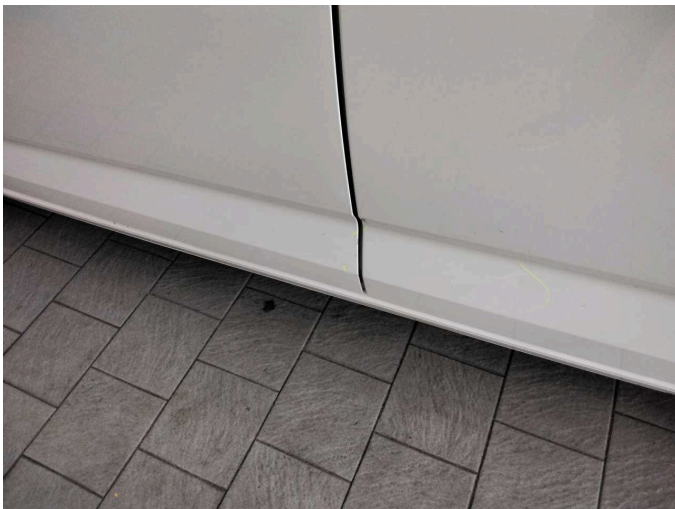
Damage 1: Door - front left side: Door edge - Scratch(es) - Smart repair

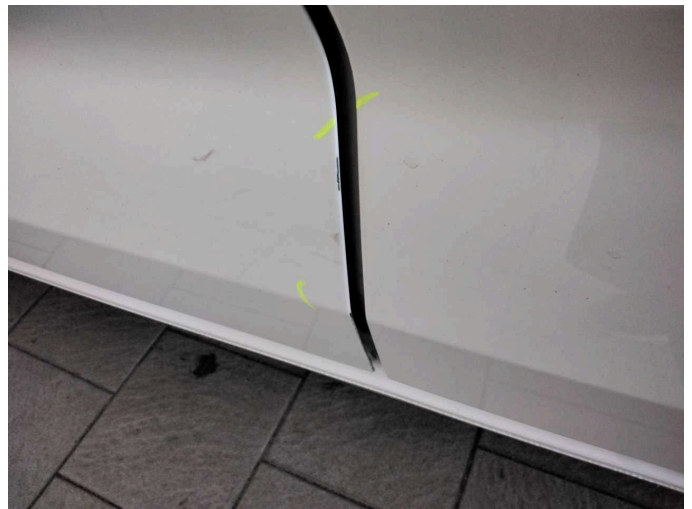
Damage 1: Door - front left side: Door edge - Scratch(es) - Smart repair

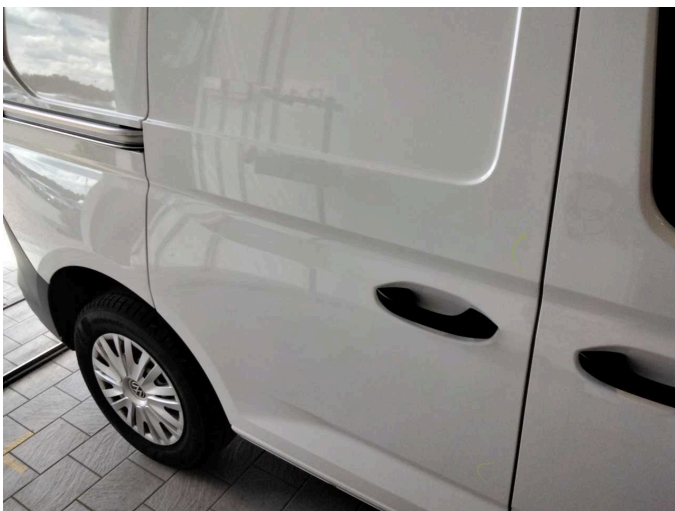
Damage 2: Sliding door, right: Sliding door - Dent / paintcoat damage - Repair and paint

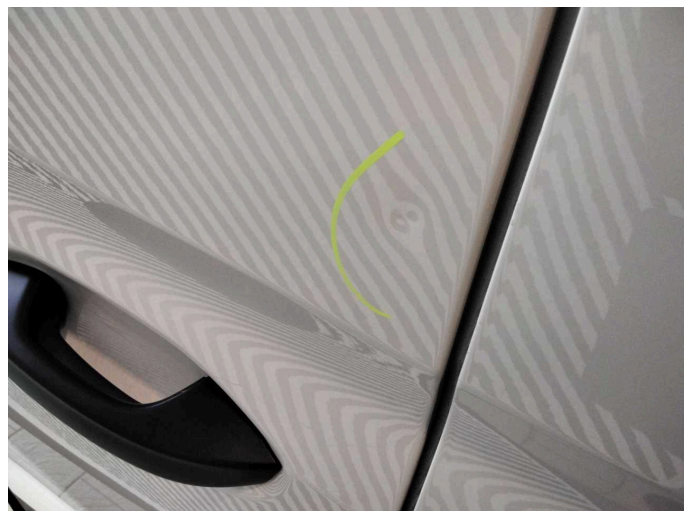
Damage 2: Sliding door, right: Sliding door - Dent / paintcoat damage - Repair and paint

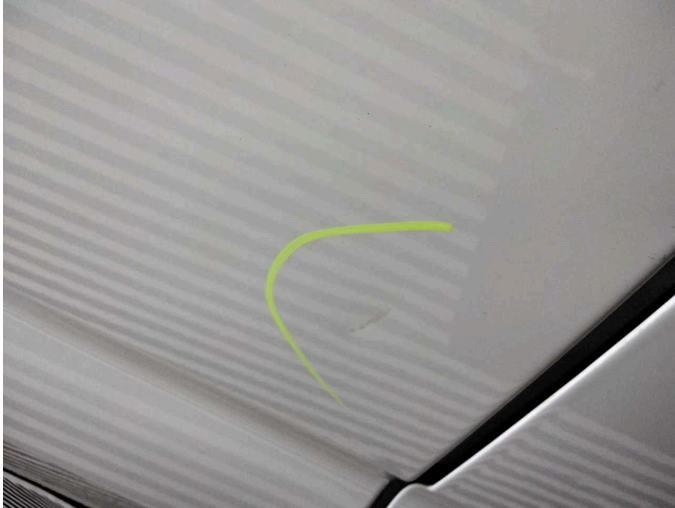
Damage 2: Sliding door, right: Sliding door - Dent / paintcoat damage - Repair and paint

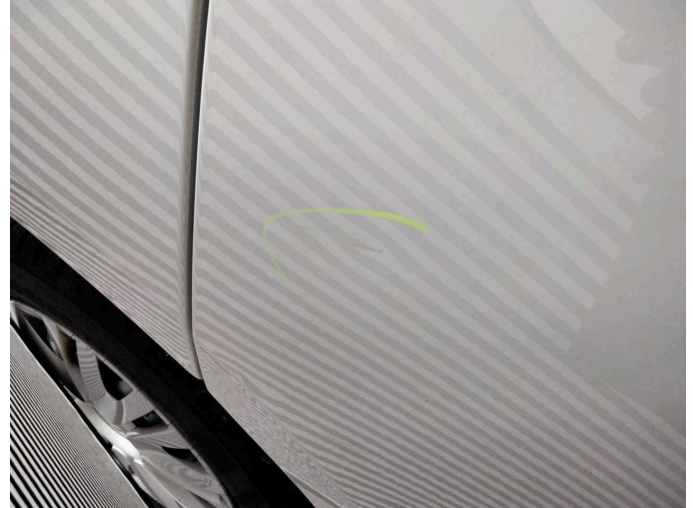
Damage 2: Sliding door, right: Sliding door - Dent / paintcoat damage - Repair and paint

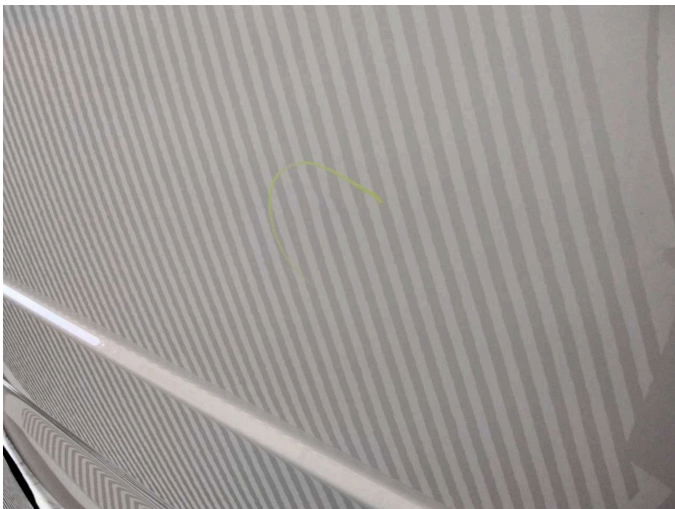
Damage 2: Sliding door, right: Sliding door - Dent / paintcoat damage - Repair and paint

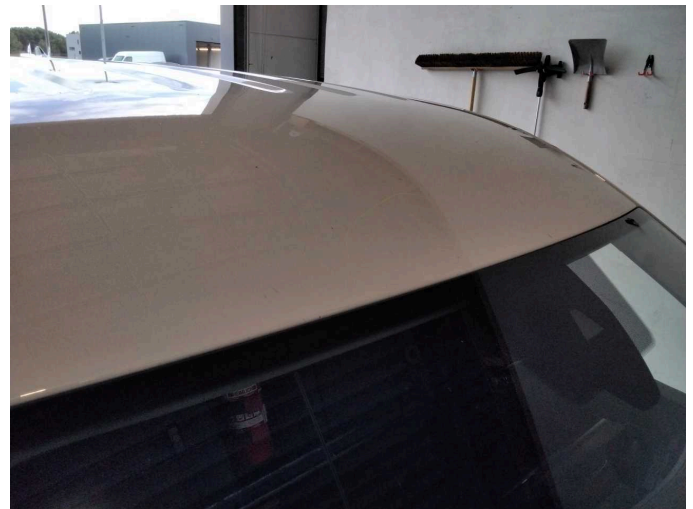
Damage 3: Roof: Roof - dent(s) - Repair and paint

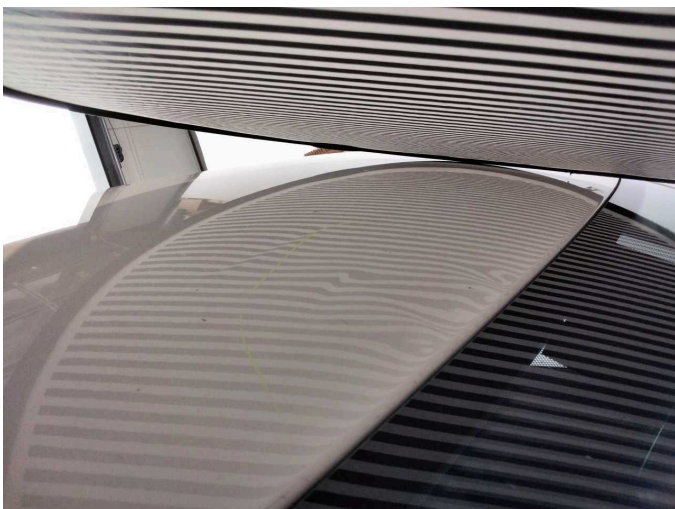
Damage 3: Roof: Roof - dent(s) - Repair and paint

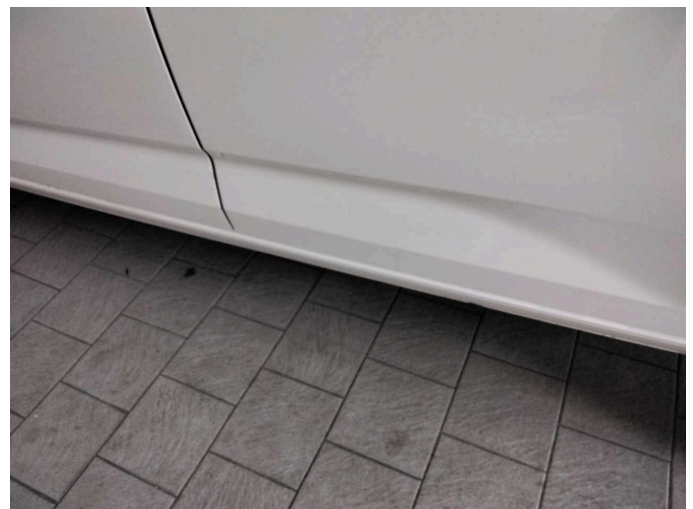
Wear and tear 1: Side panel - rear left side: Side panel - dent(s) - No deduction

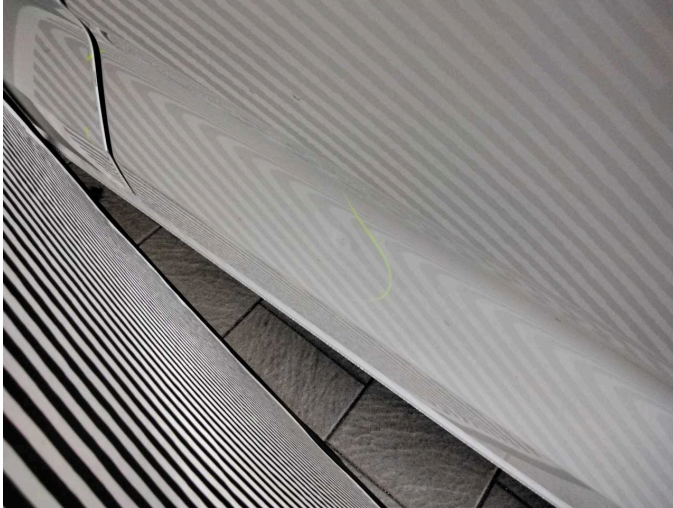
Wear and tear 1: Side panel - rear left side: Side panel - dent(s) - No deduction

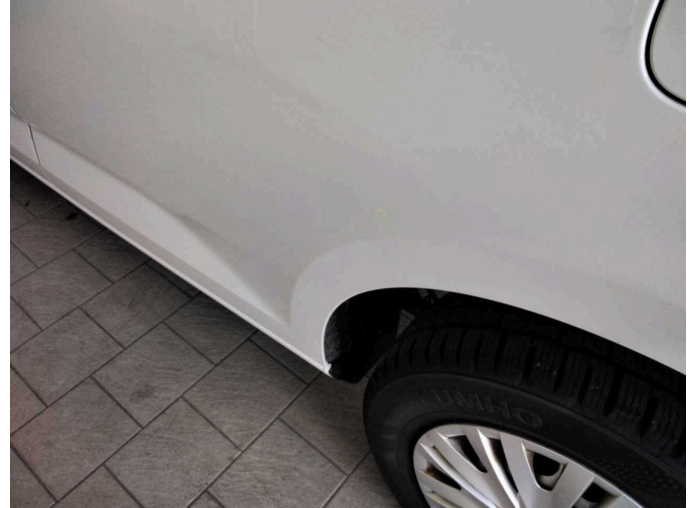
Wear and tear 1: Side panel - rear left side: Side panel - dent(s) - No deduction

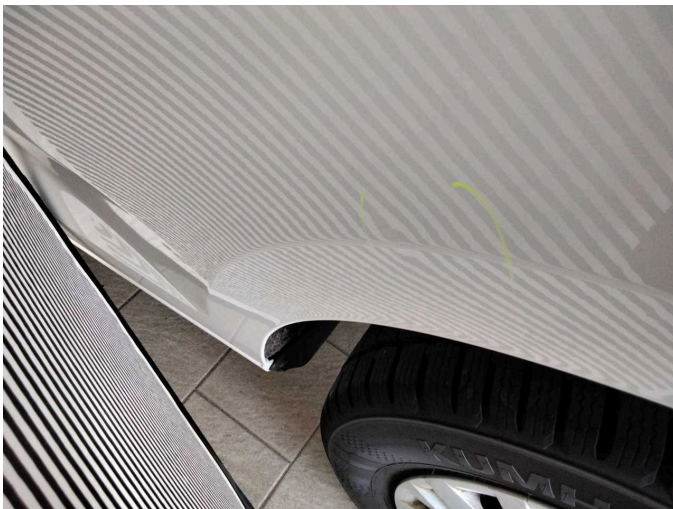
Wear and tear 1: Side panel - rear left side: Side panel - dent(s) - No deduction

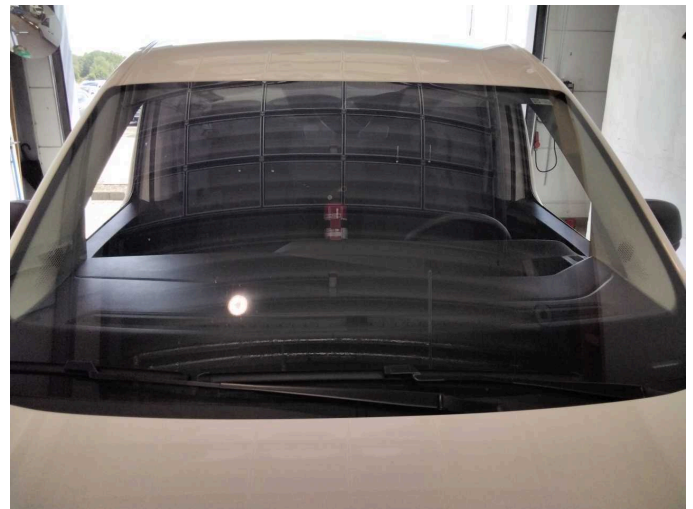
Wear and tear 2: Vehicle glazing: Windscreen - Stone chips - No deduction

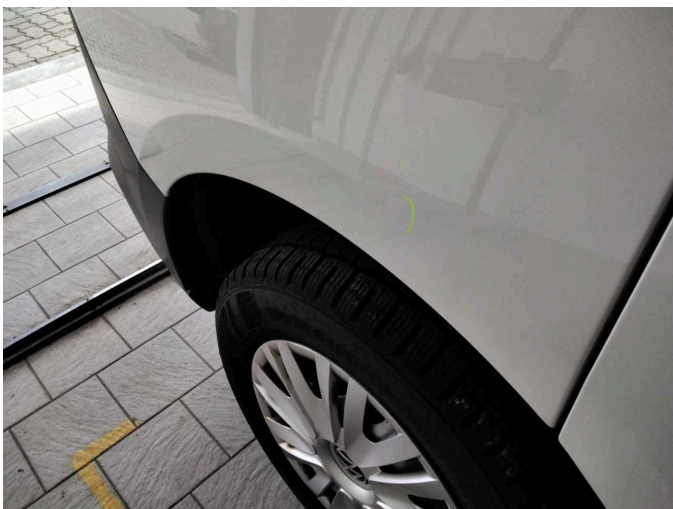
Wear and tear 5: Side panel - rear right side: Side panel - dent(s) - No deduction

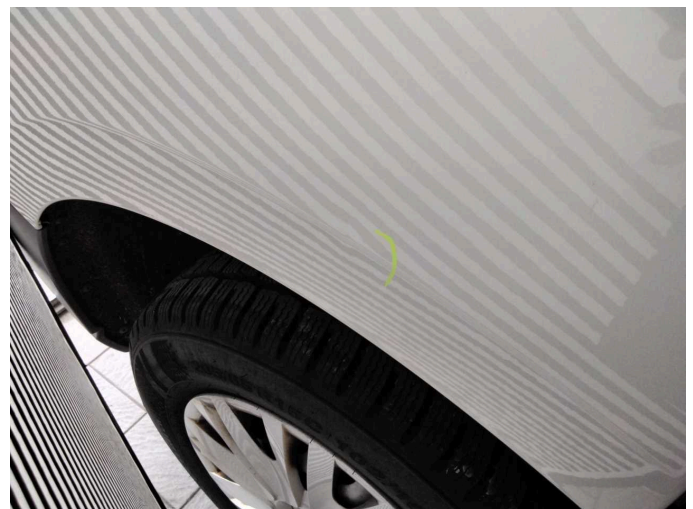
Wear and tear 5: Side panel - rear right side: Side panel - dent(s) - No deduction
