Expertise

Protocol number: 45995459
Order No. / Reference: 26412372
Inspection date: 17 Jun 2026

Model: Focus Turnier 1.5 EcoBlue Start-Stopp-System Aut. TITANIUM

An order was placed to prepare a sales report for the described vehicle. This report includes the following:

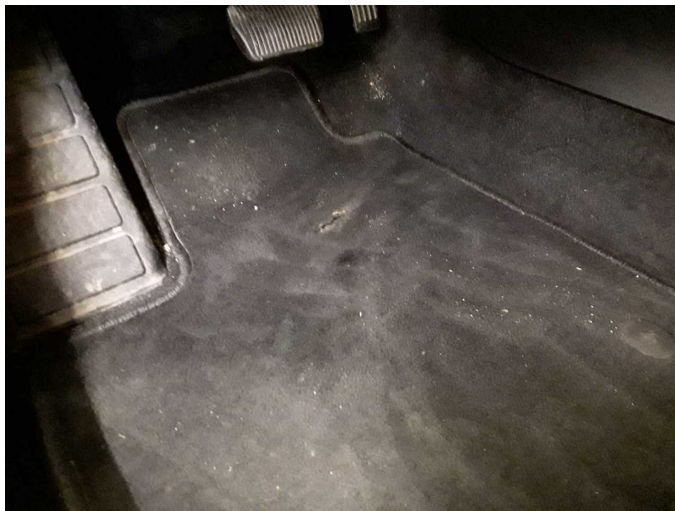
Damage 1: Trim / covers: Floor mats - Damaged - Replace

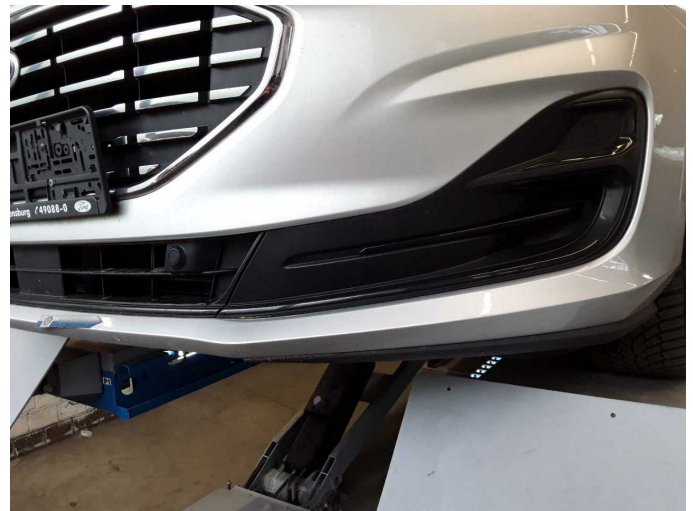
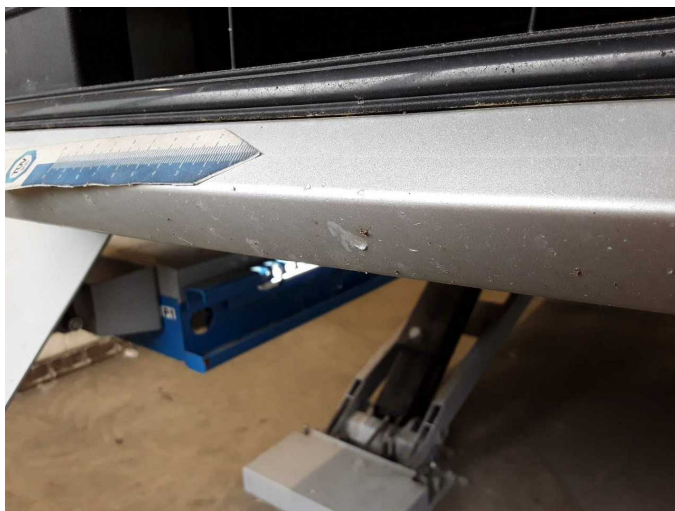
Damage 2: Front bumper: Front bumper - Scratch(es) - Smart repair

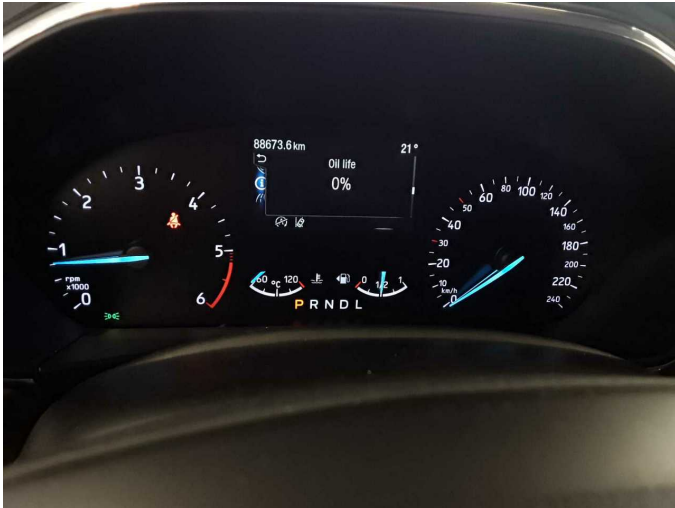
Damage 5: Misc.: Inspection / maintenance - Due - Perform

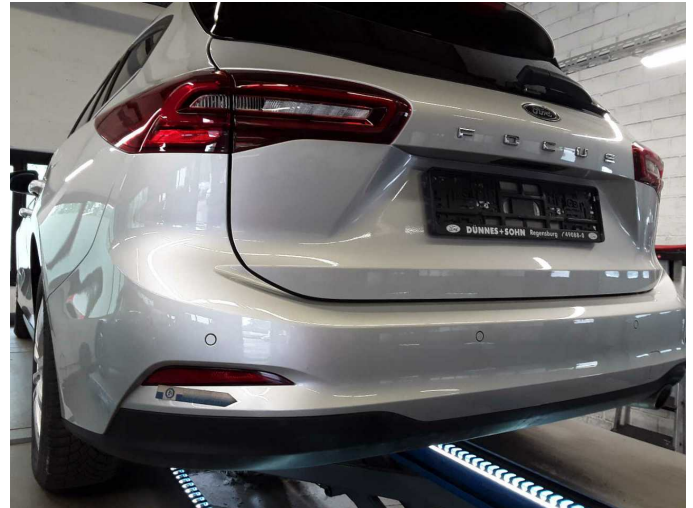
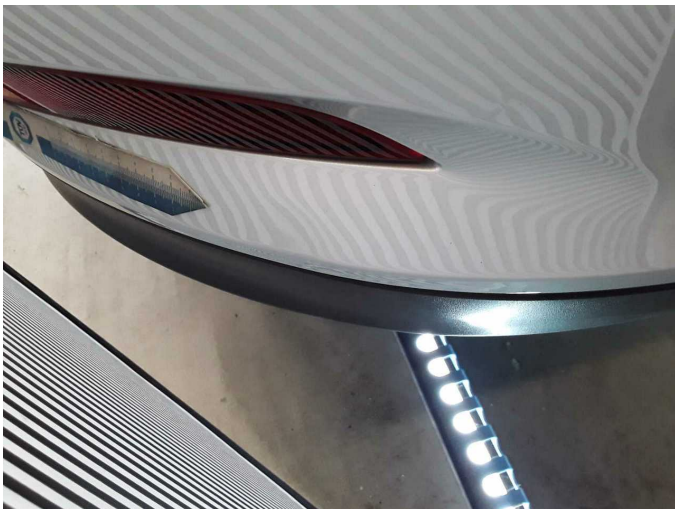
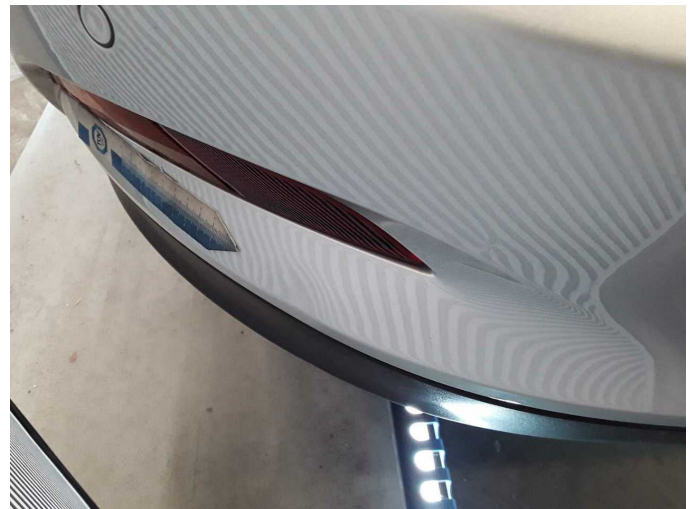
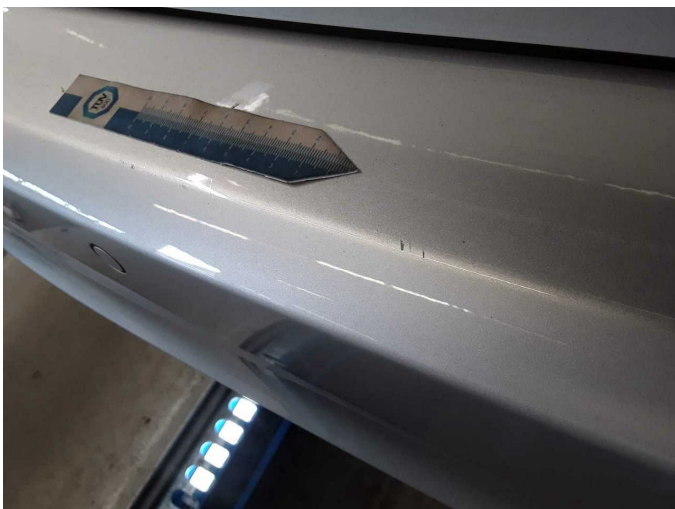
Damage 6: Rear bumper: Rear bumper - Deformed - Repair and paint

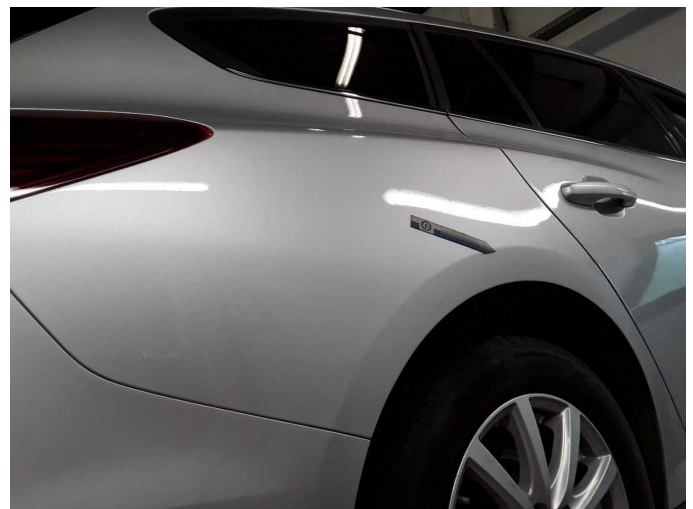
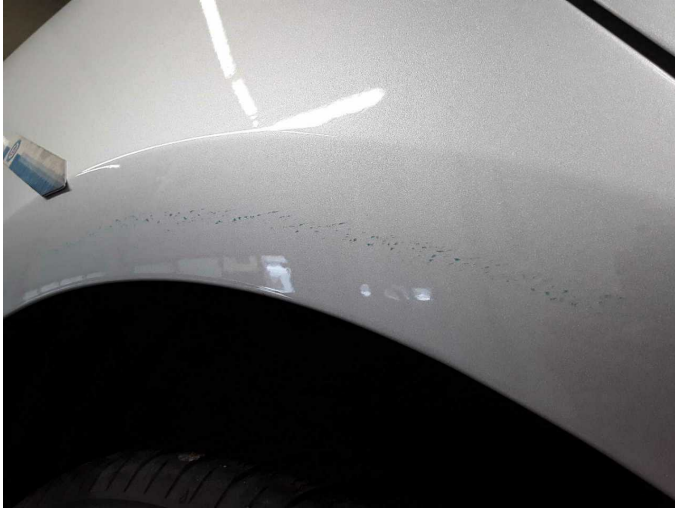
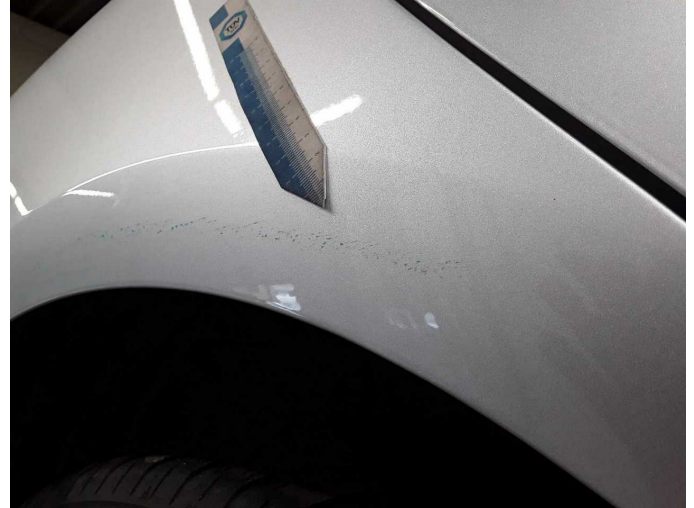
Damage 7: Side panel - rear right side: Side panel (Farbe) - Paint defect - Paint

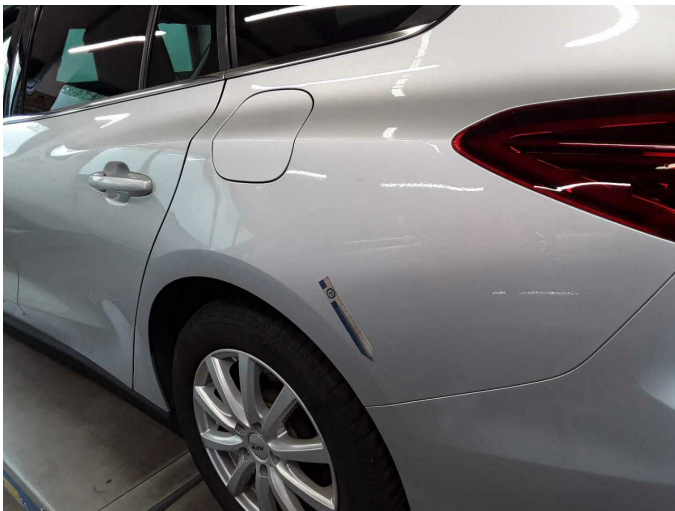
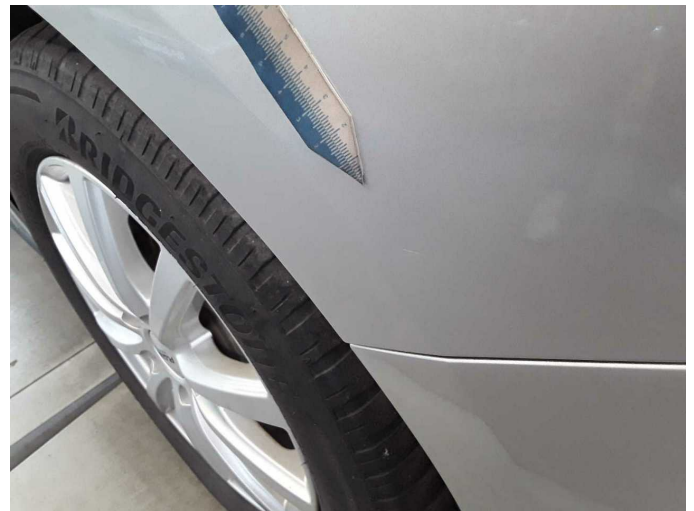
Wear and tear 1: Side panel - rear left side: Side panel - Scratch(es) - No deduction

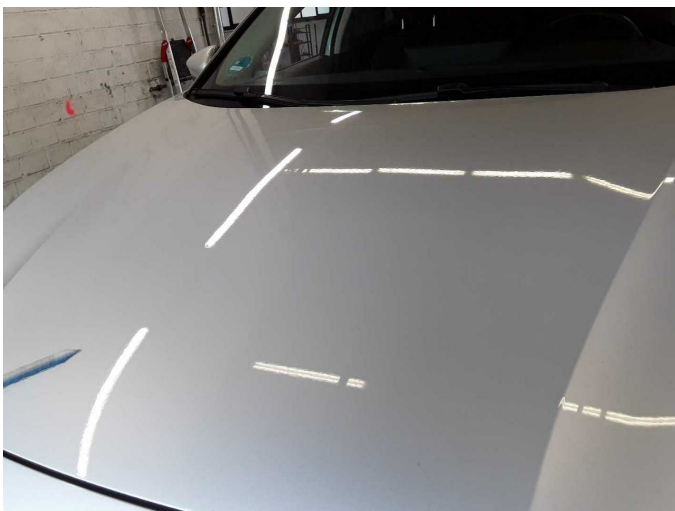
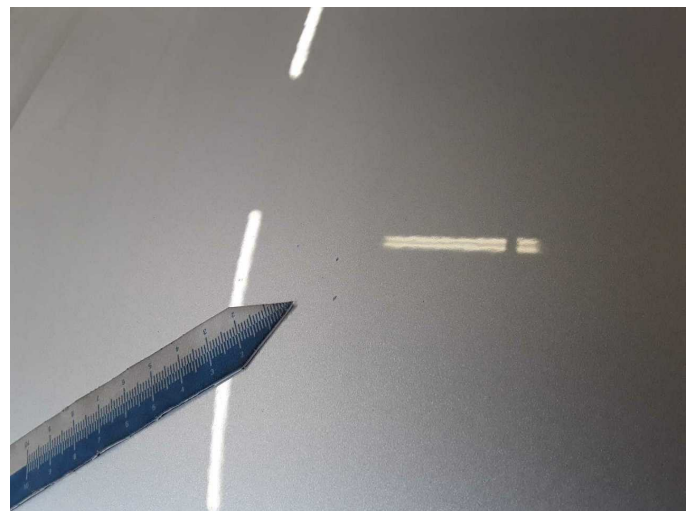
Wear and tear 2: Bonnet: Bonnet - Stone chips - No deduction

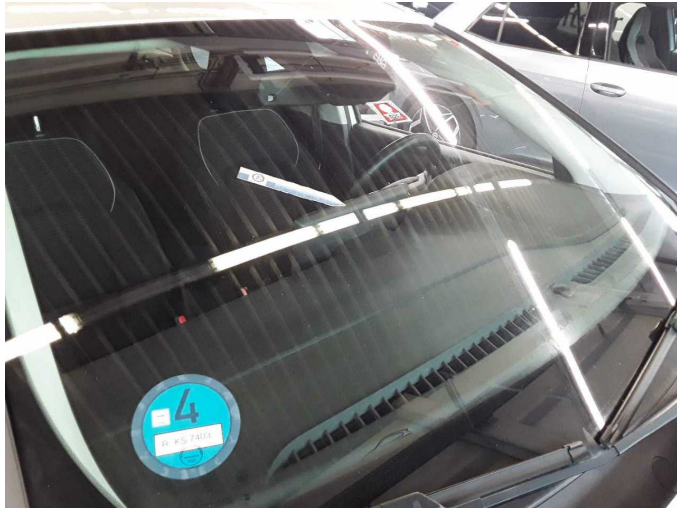
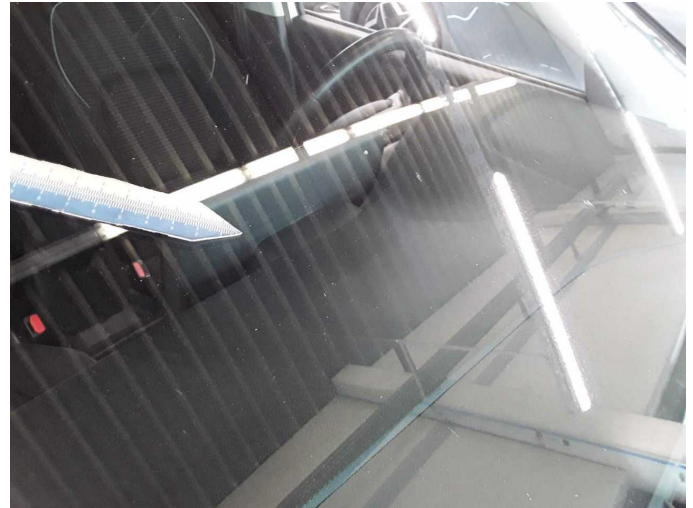
Wear and tear 3: Vehicle glazing: Windscreen - Stone chips - No deduction

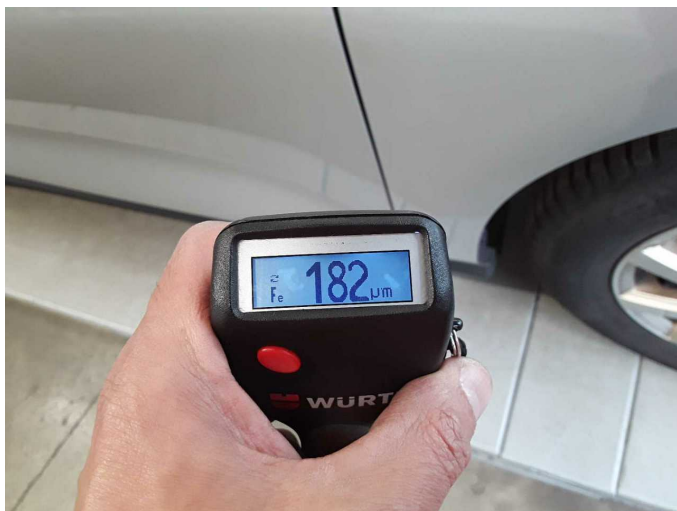
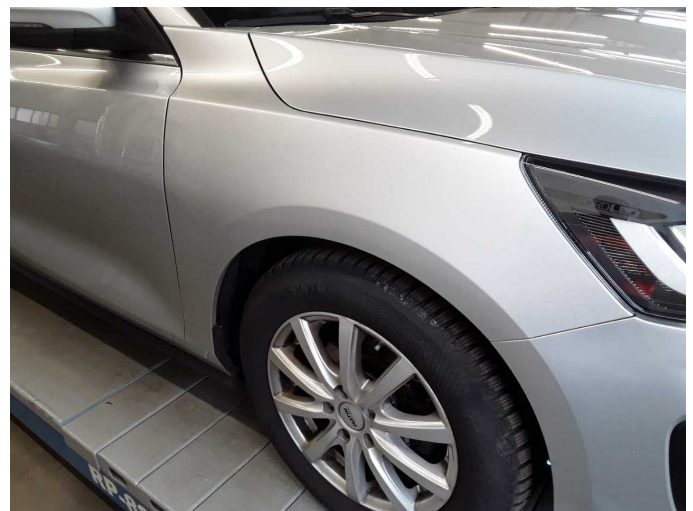
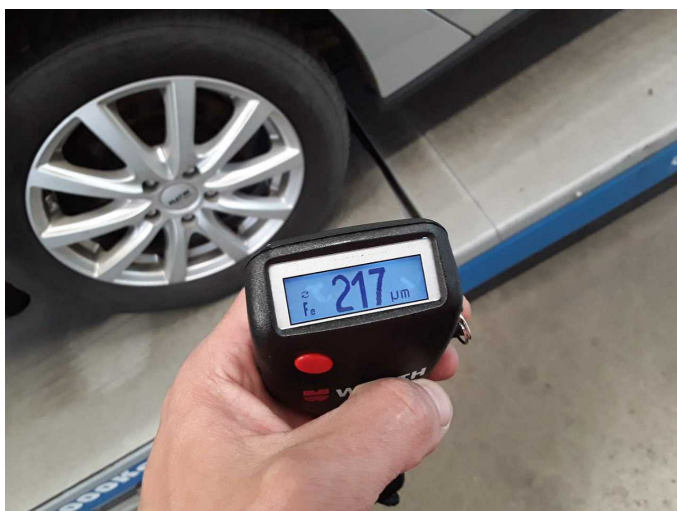
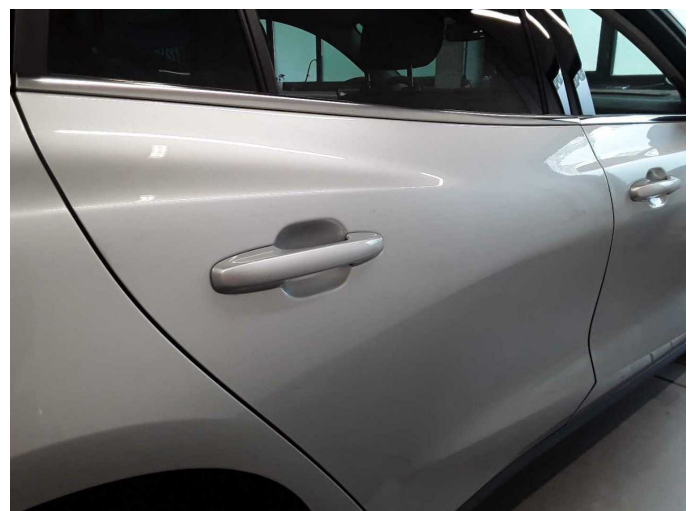
No.	Repainting
1	Mudguard - right side, Door - rear right side, Professionally carried out, Invoice of repair done

Mudguard - right side	182 µm	Door - rear right side	217 µm
-----------------------	--------	------------------------	--------

Repainting 1: Mudguard - right side, Door - rear right side
