Expertise

Protocol number: 46118952
Order No. / Reference: 26472069
Inspection date: 24 Jun 2026

Manufacturer: Peugeot

Model: 308 SW BlueHDi 130 EAT8 Allure Pack

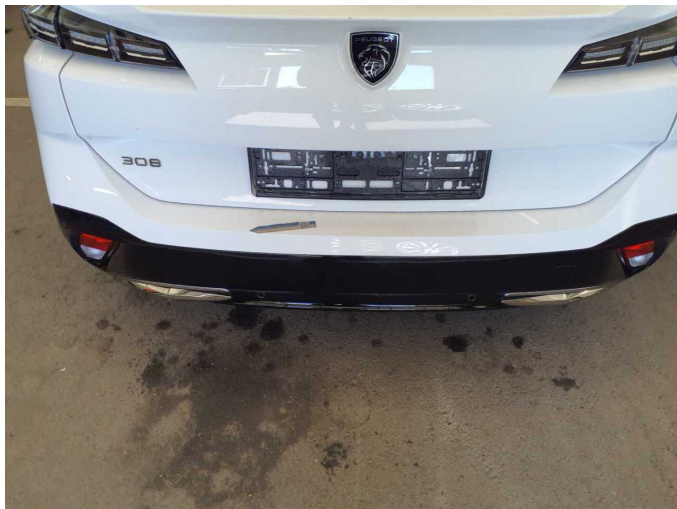
Damage 2: Rear bumper: Rear bumper - Scratch(es) - Smart repair

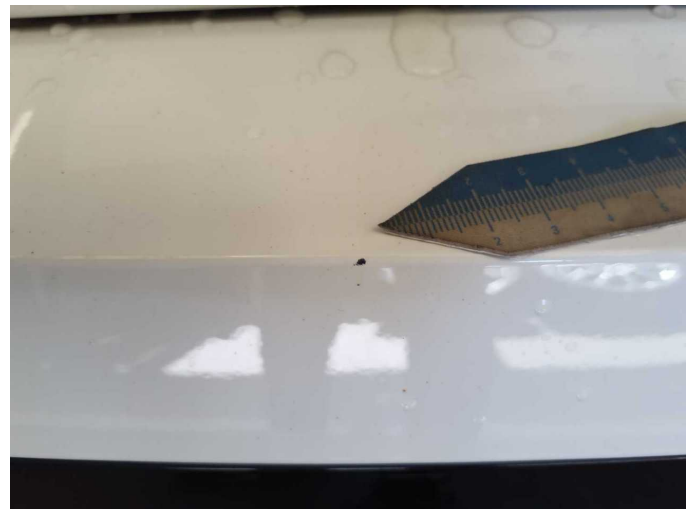
Damage 2: Rear bumper: Rear bumper - Scratch(es) - Smart repair

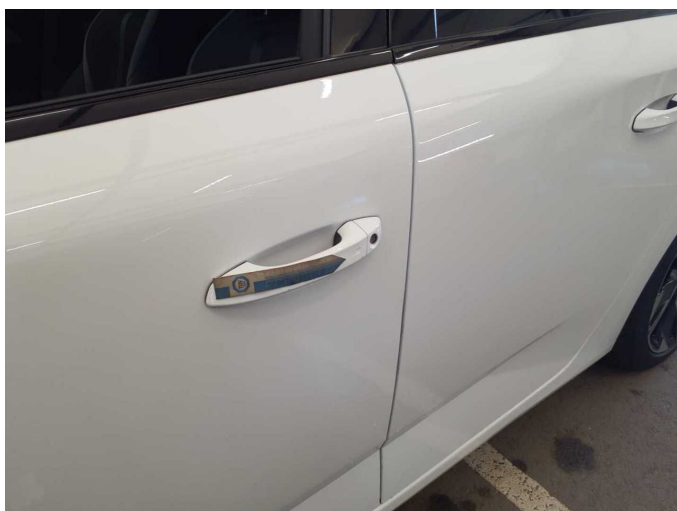
Damage 3: Door - front left side: Door handle - outside - Scratch(es) - Smart repair

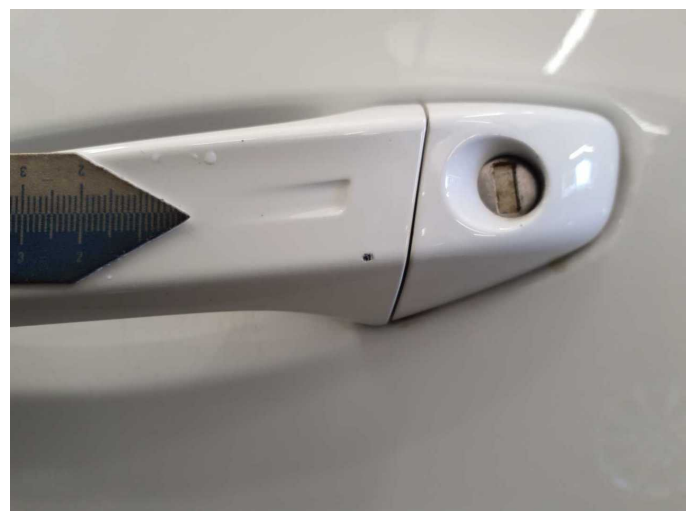
Damage 3: Door - front left side: Door handle - outside - Scratch(es) - Smart repair

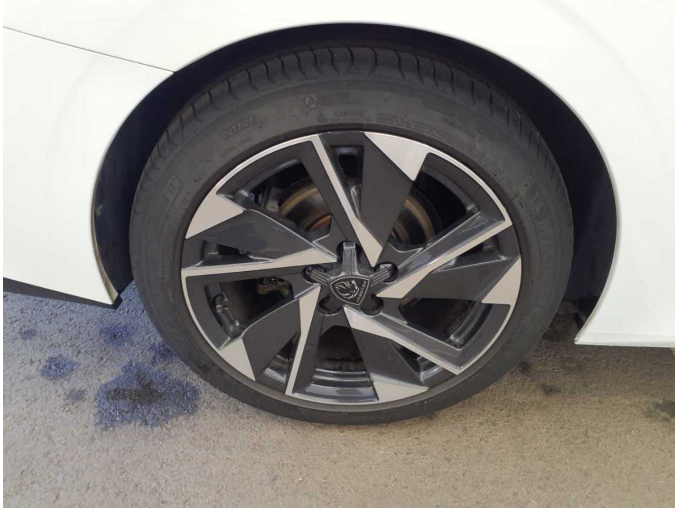
Damage 4: Wheel / tyres: Alloy rim - rear right side - Scratch(es) - Loss in value

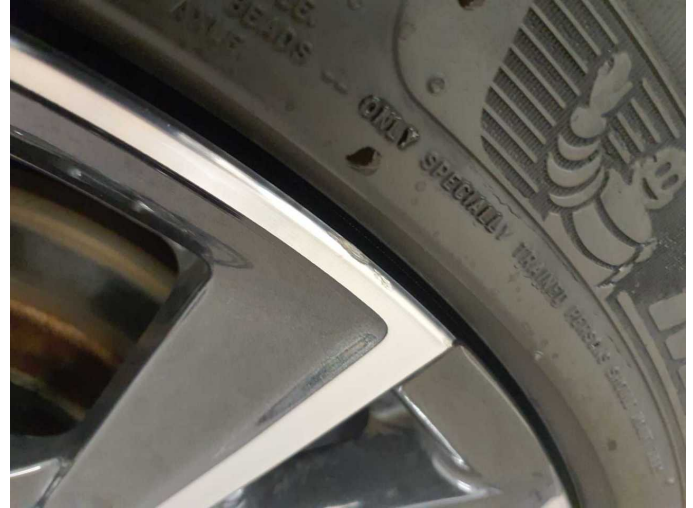
Damage 4: Wheel / tyres: Alloy rim - rear right side - Scratch(es) - Loss in value

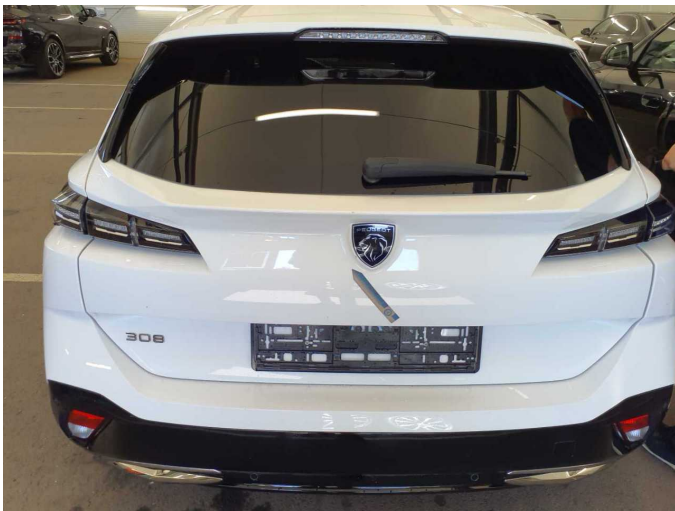
Damage 5: Boot lid / rear door: Boot lid - Scratch(es) - Smart repair

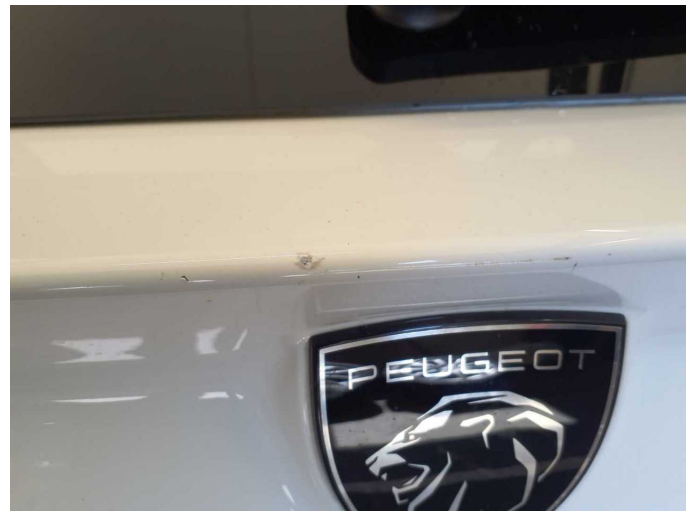
Damage 5: Boot lid / rear door: Boot lid - Scratch(es) - Smart repair

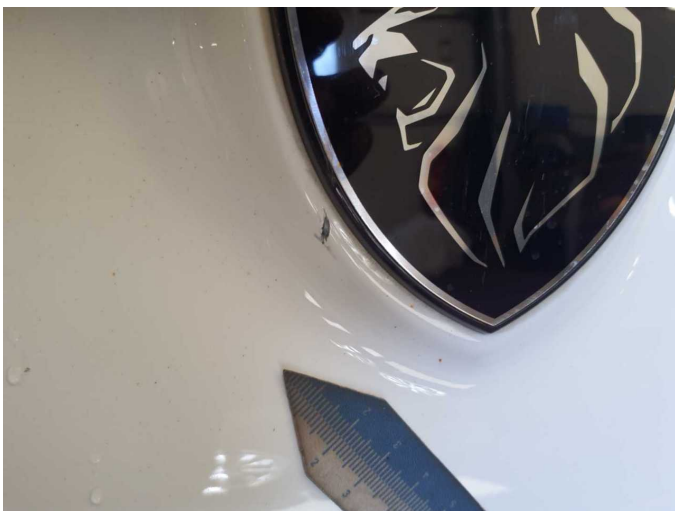
Damage 5: Boot lid / rear door: Boot lid - Scratch(es) - Smart repair

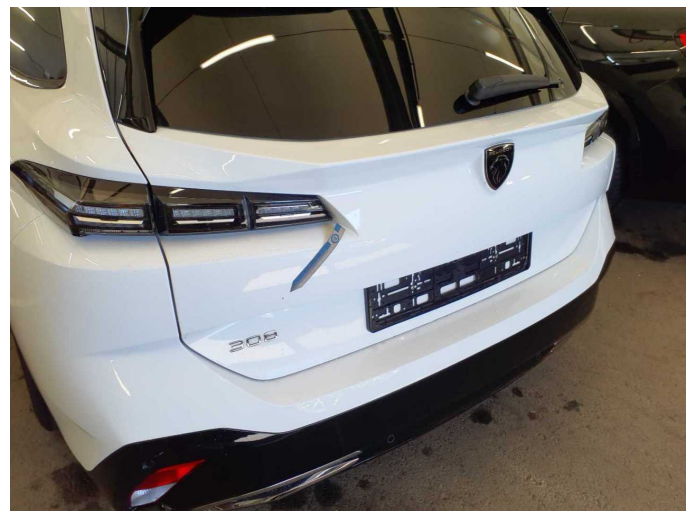
Damage 5: Boot lid / rear door: Boot lid - Scratch(es) - Smart repair

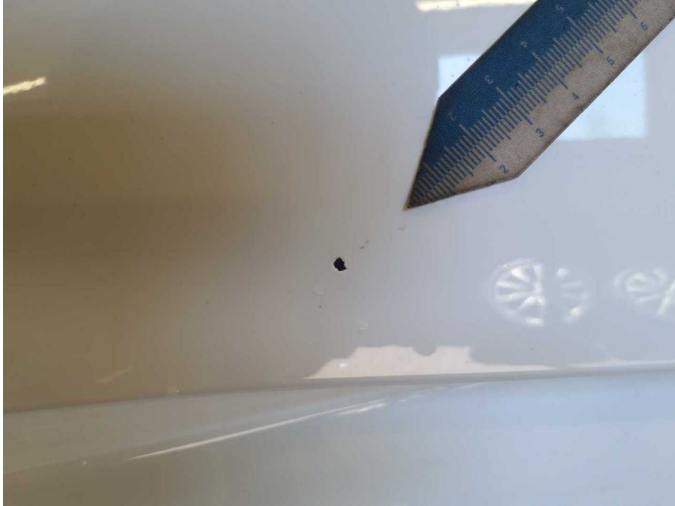
Damage 5: Boot lid / rear door: Boot lid - Scratch(es) - Smart repair

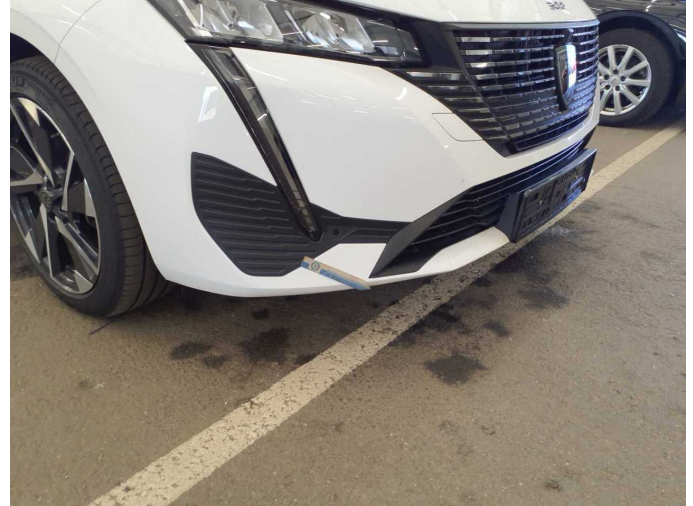
Damage 6: Front bumper: Front bumper - Scratch(es) - Smart repair

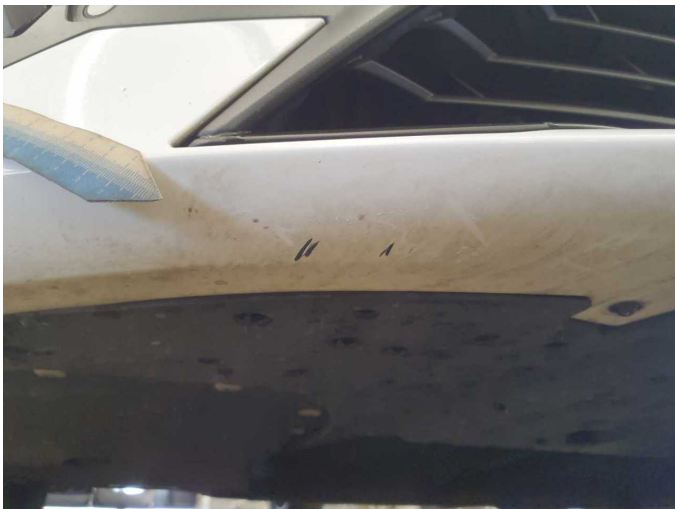
Damage 6: Front bumper: Front bumper - Scratch(es) - Smart repair

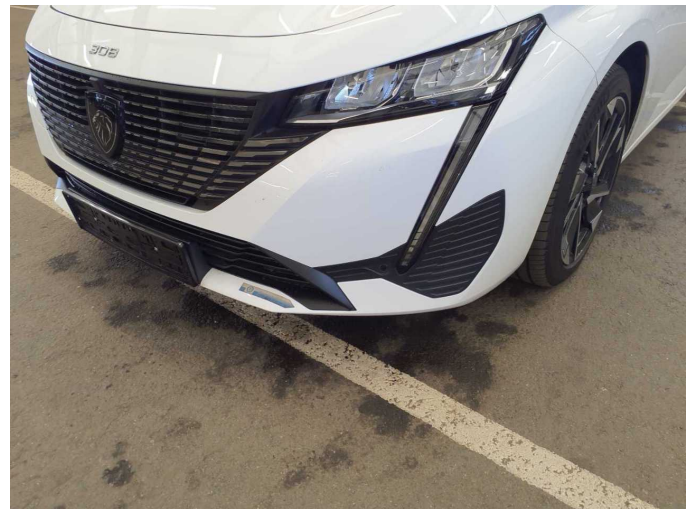
Damage 6: Front bumper: Front bumper - Scratch(es) - Smart repair

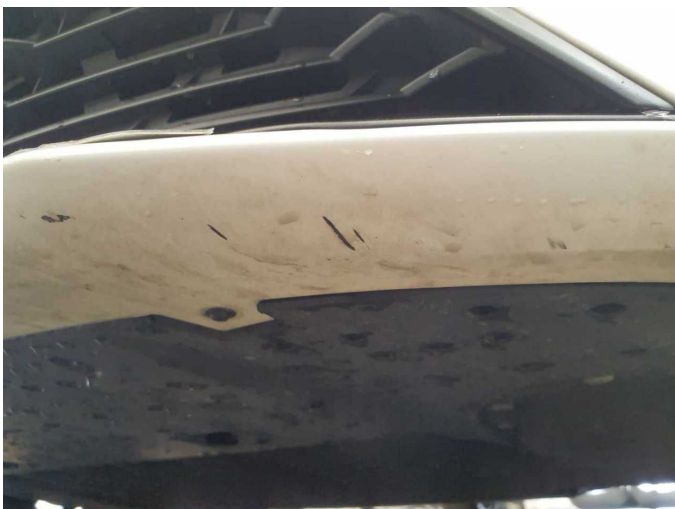
Damage 6: Front bumper: Front bumper - Scratch(es) - Smart repair

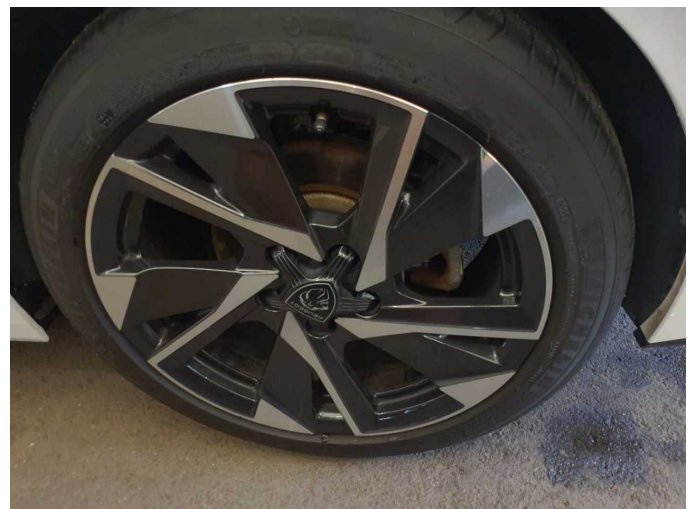
Damage 7: Wheel / tyres: Alloy rim - rear left side - Scratch(es) - Loss in value

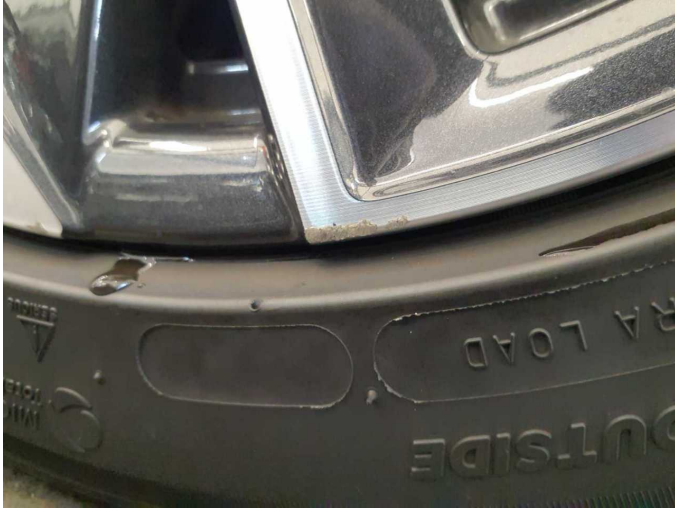
Damage 7: Wheel / tyres: Alloy rim - rear left side - Scratch(es) - Loss in value

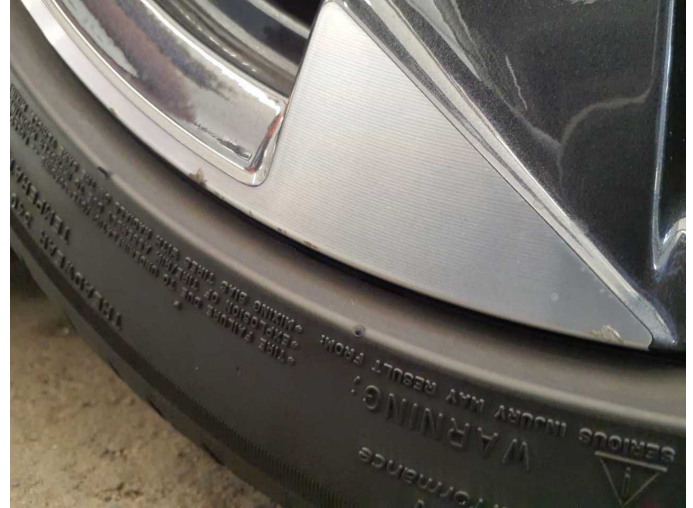
Damage 7: Wheel / tyres: Alloy rim - rear left side - Scratch(es) - Loss in value

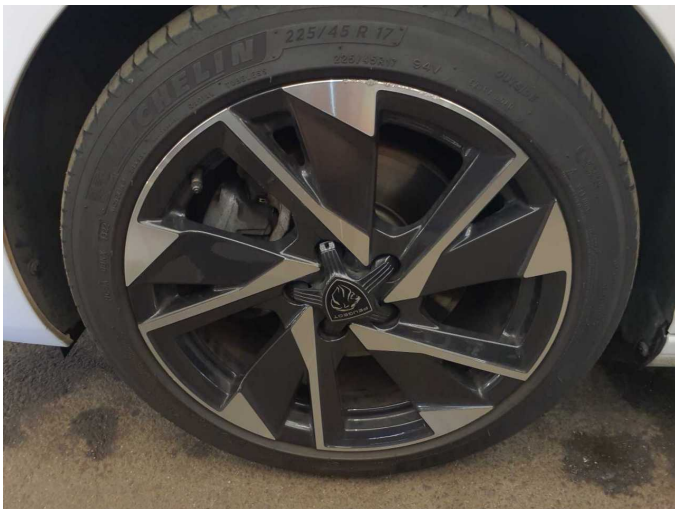
Damage 8: Wheel / tyres: Alloy rim - front left side - Scratched - Replace

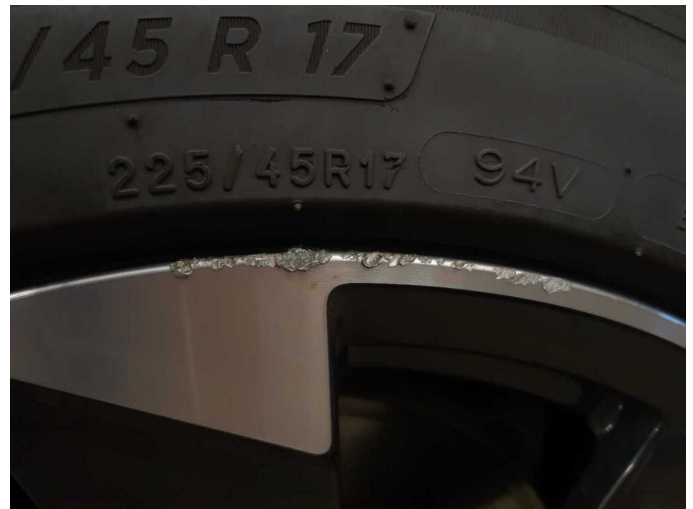
Damage 8: Wheel / tyres: Alloy rim - front left side - Scratched - Replace
