Expertise

Protocol number: 46289191
Order No. / Reference: 26627660
Inspection date: 2 Jul 2026

Manufacturer: Opel

Model: Insignia Sports Tourer 2.0 Diesel Aut. Business Edition

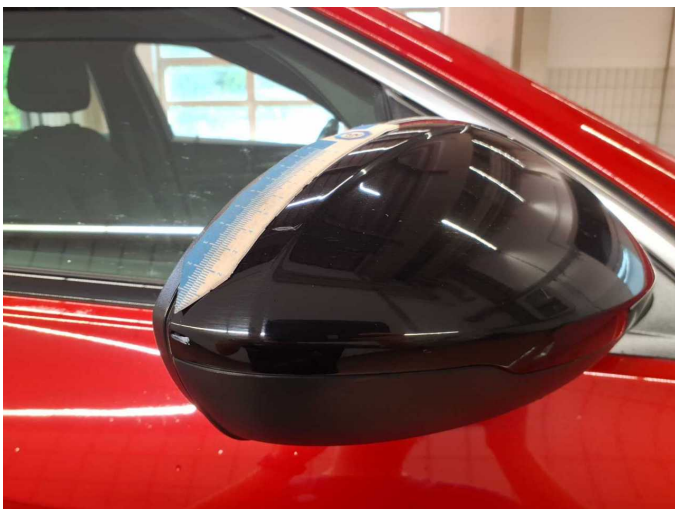
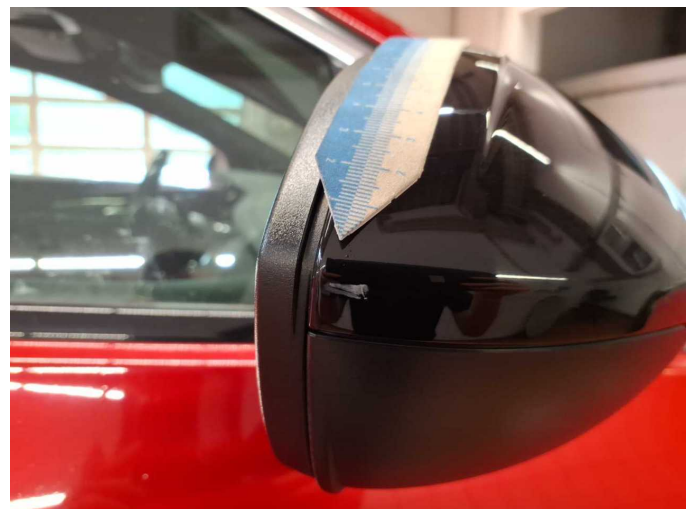
Damage 1: Wing mirror - right side: Cap - Scratch(es) - Smart repair

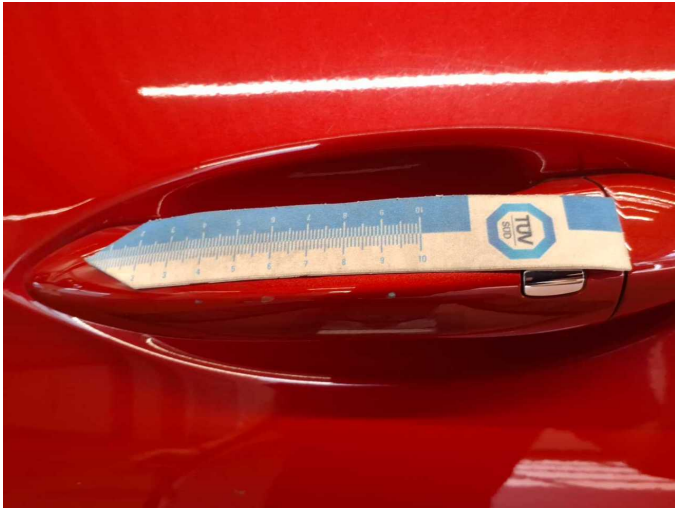
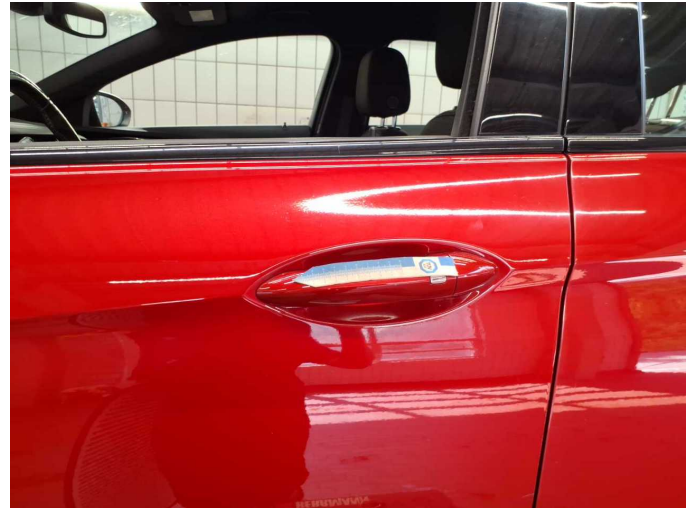
Damage 2: Door - front left side: Door handle - outside - Scratch(es) - Smart repair

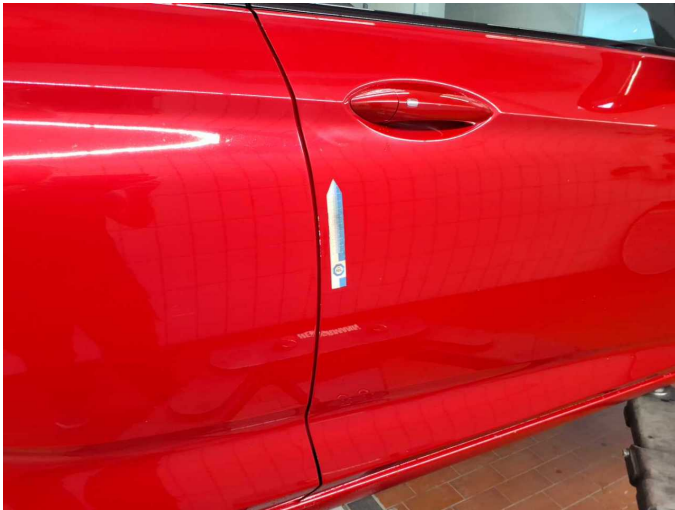
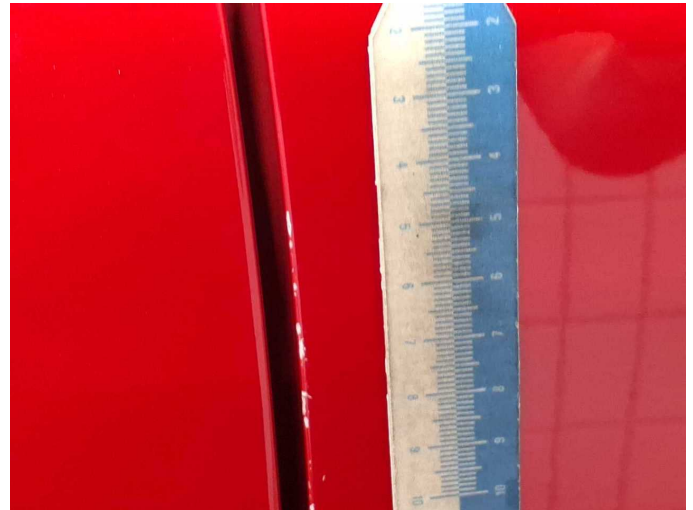
Damage 3: Door - front right side: Door edge - Scratch(es) - Smart repair

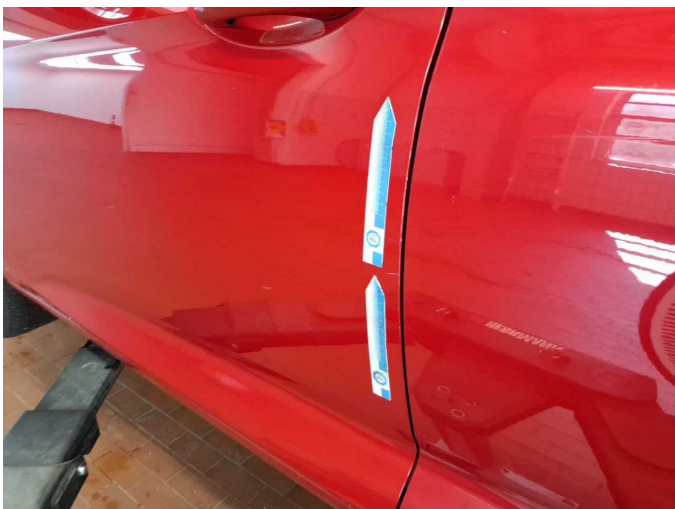
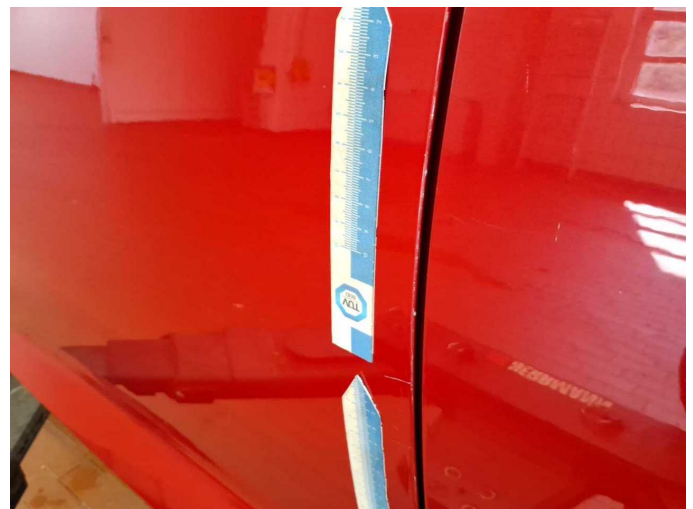
Damage 4: Door - front left side: Door edge - Scratch(es) - Smart repair

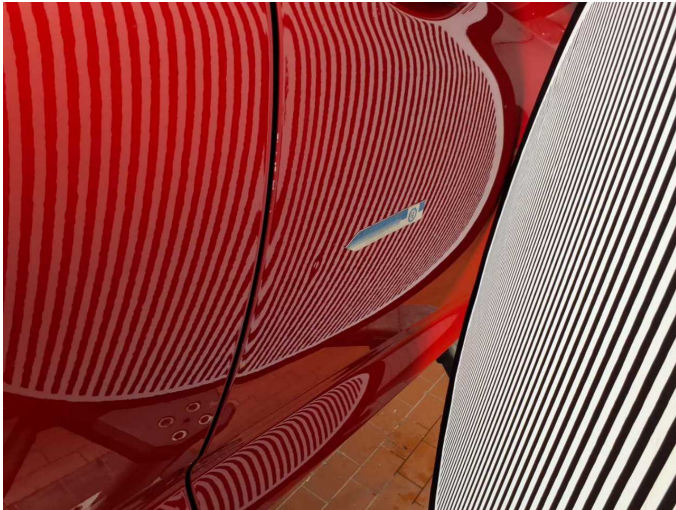
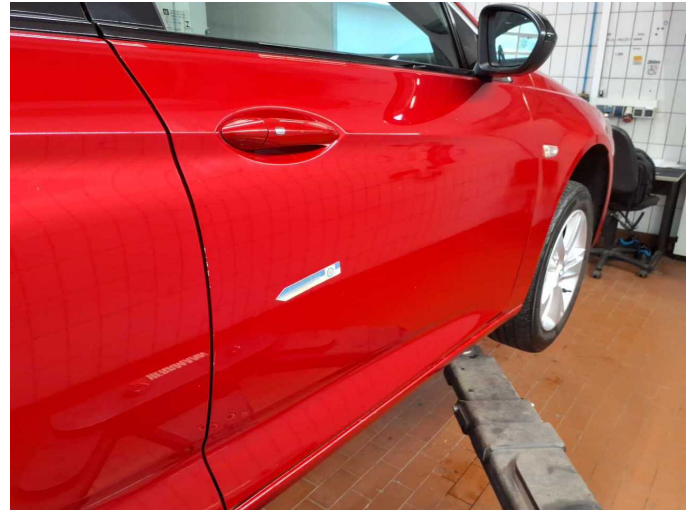
Damage 5: Door - front right side: Door - dent(s) - Smooth repair work

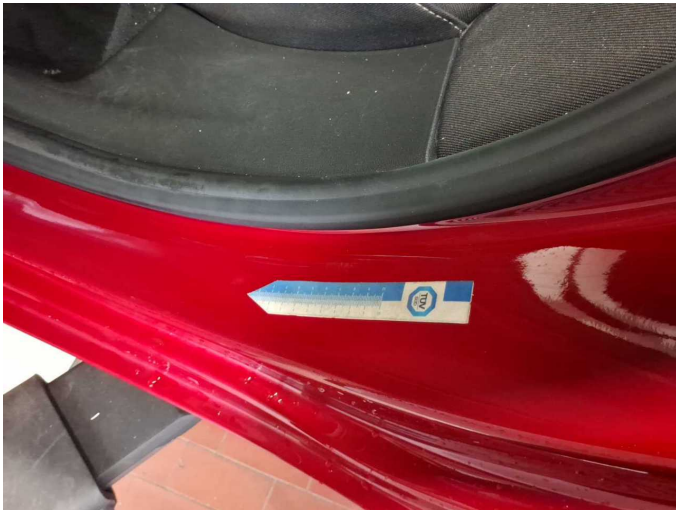
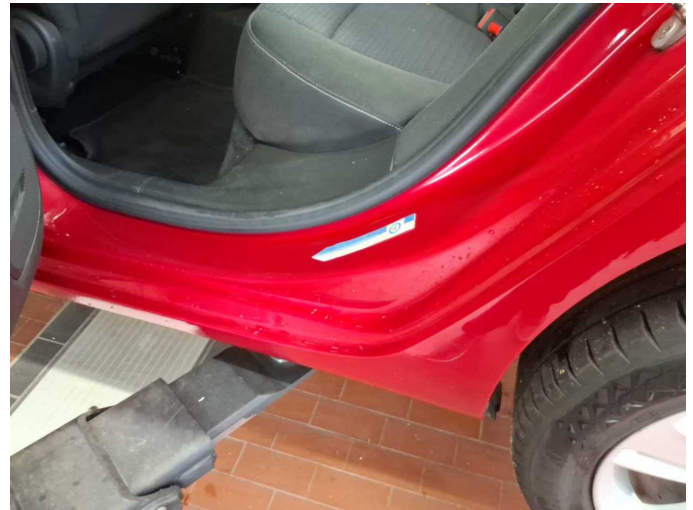
Damage 6: Side panel - rear left side: Sill - Scratch(es) - Smart repair

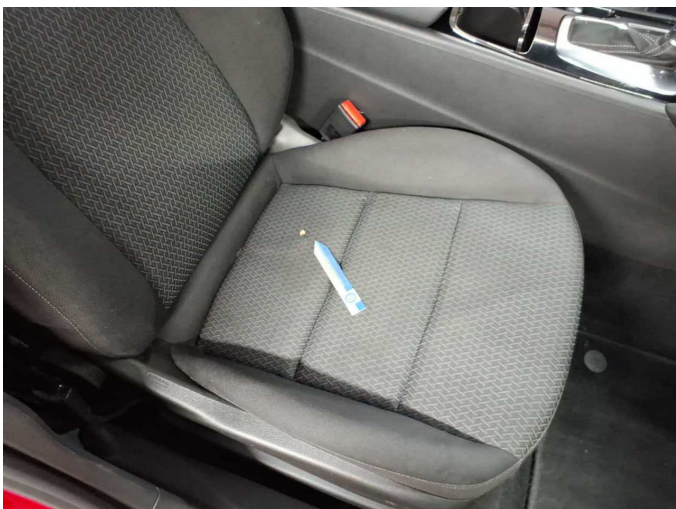
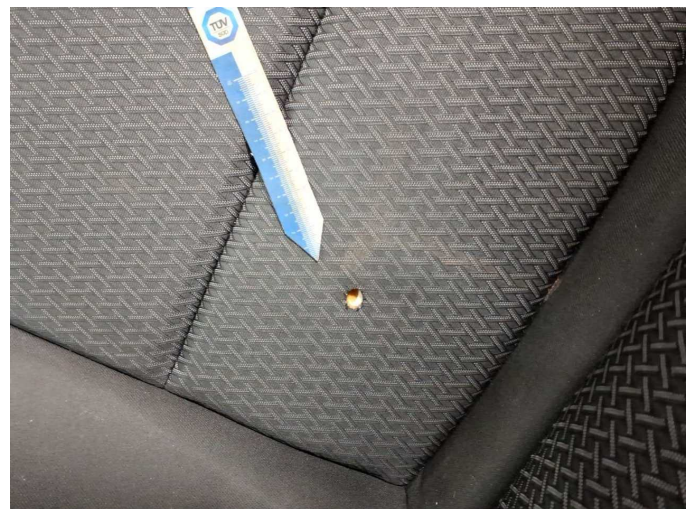
Damage 7: Seat - front: Seat cover - right side - Burn hole (cigarettes) - Smart repair

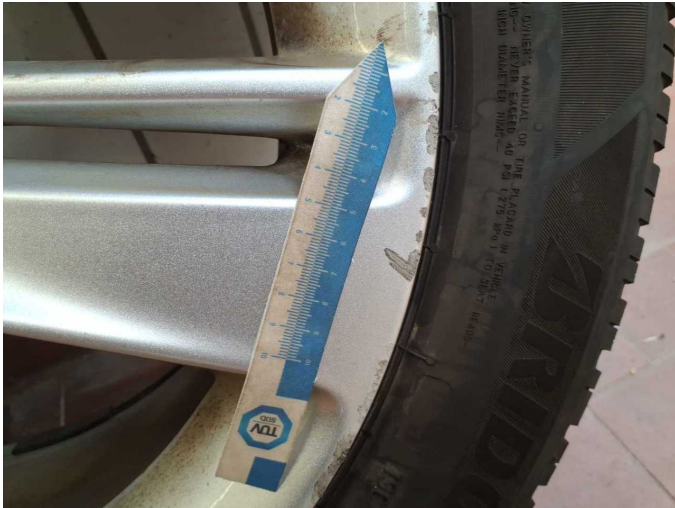
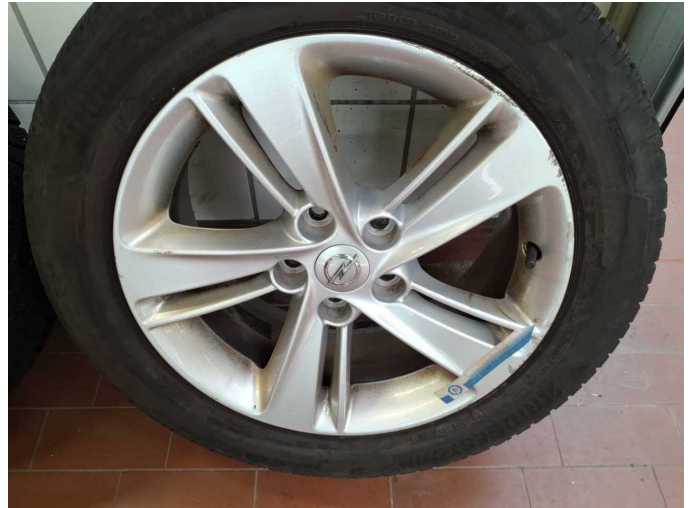
Damage 8: 2nd wheel set: 1 alloy rim - Scratch(es) - Loss in value

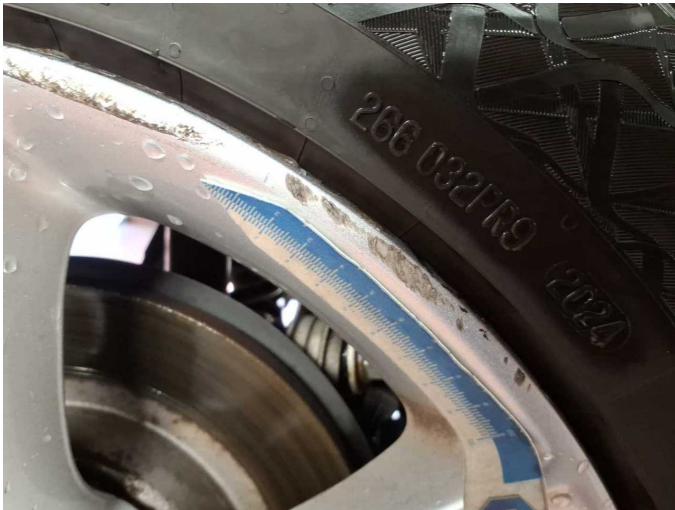
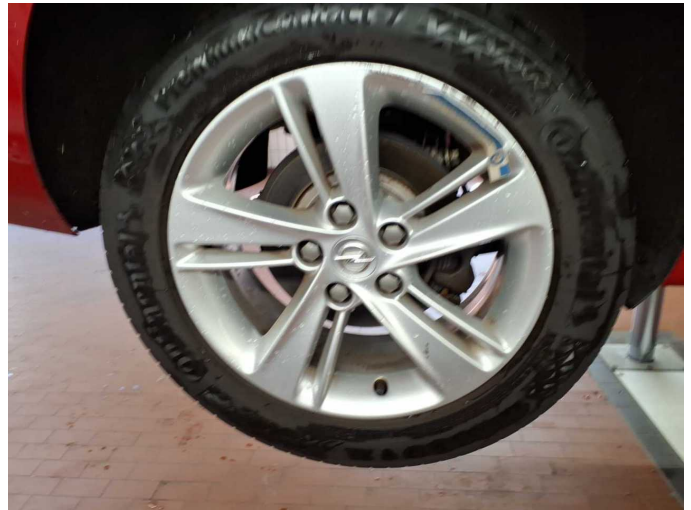
Damage 9: Wheel / tyres: Alloy rim - rear right side - Scratch(es) - Loss in value

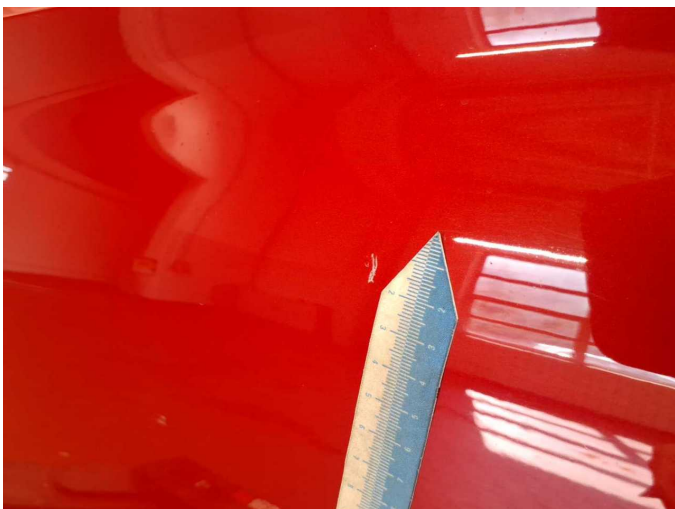
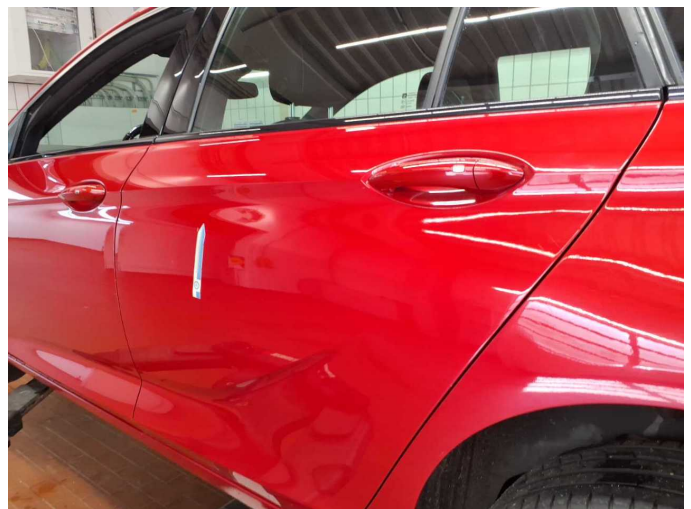
Damage 10: Door - rear left side: Door - Scratch(es) - Paint

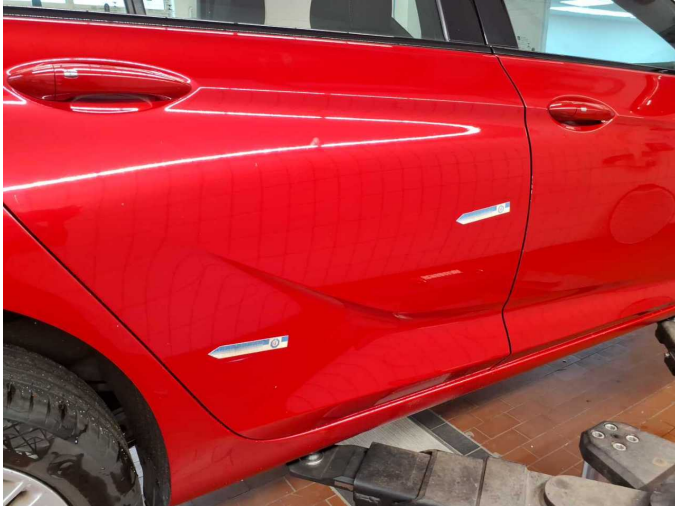
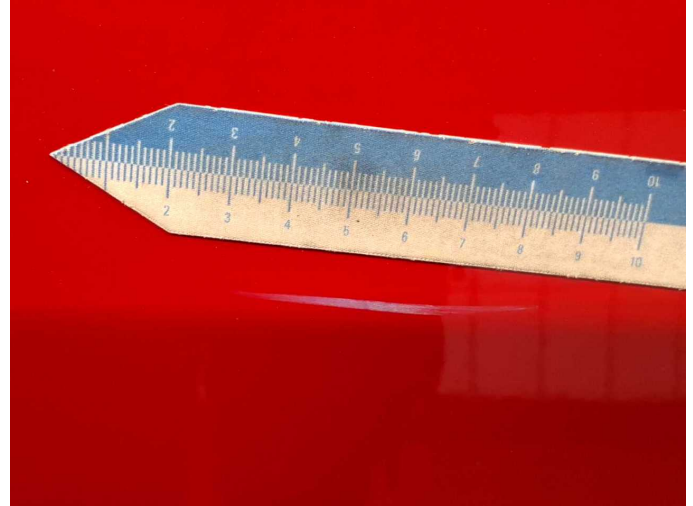
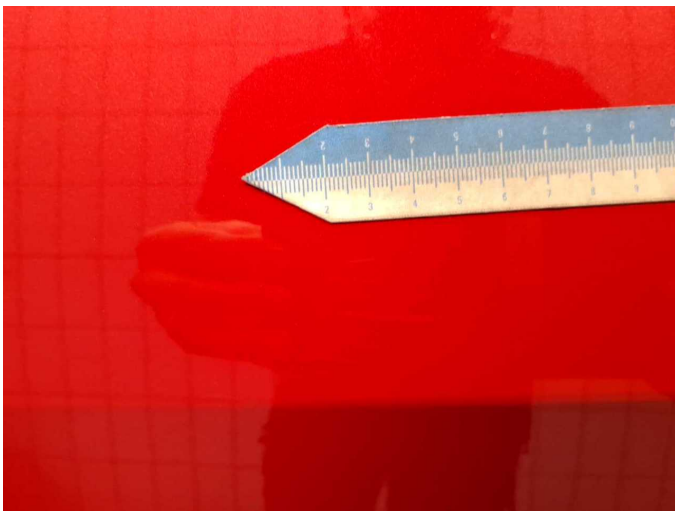
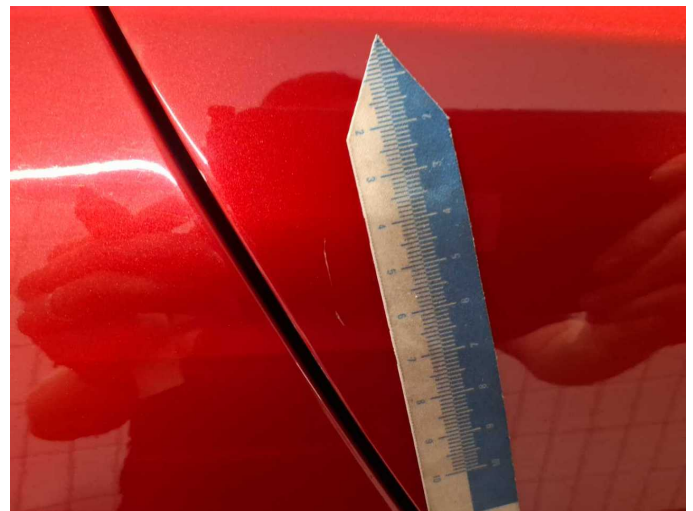
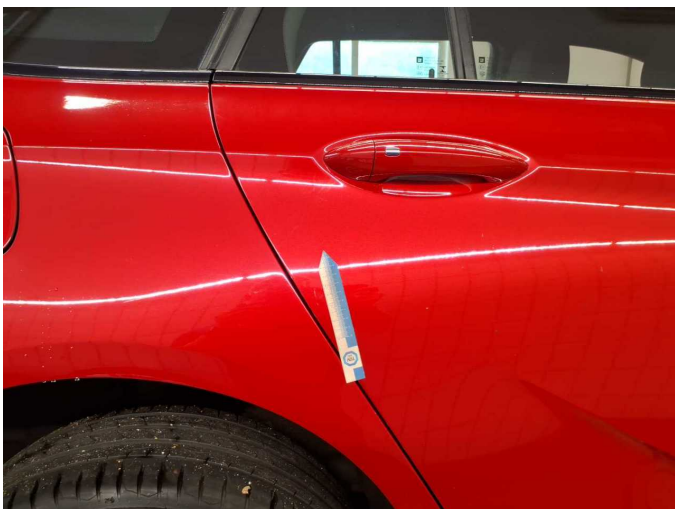
Damage 11: Door - rear right side: Door - Scratch(es) - Paint

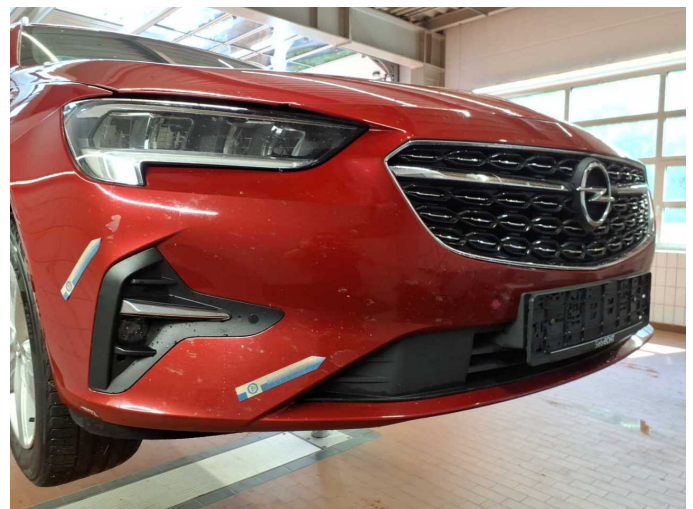
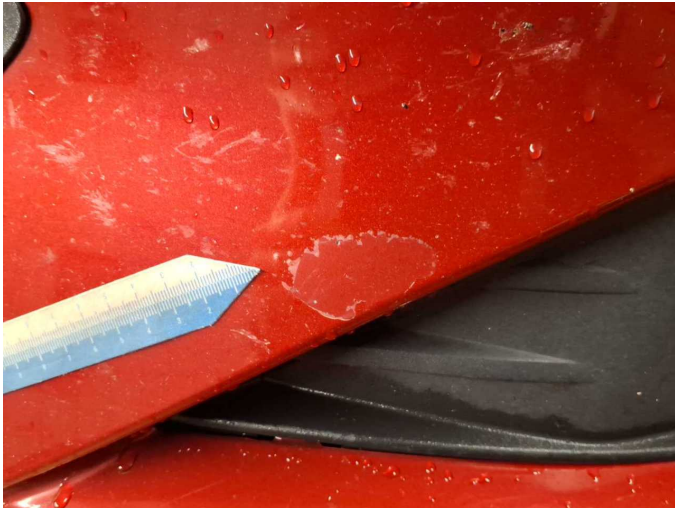
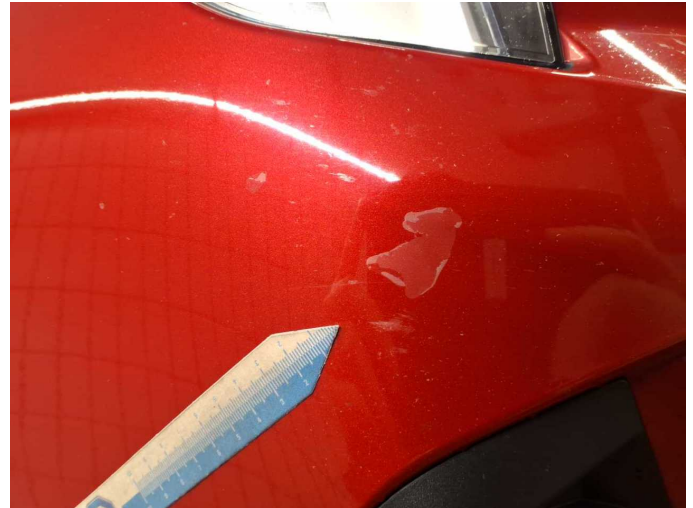
Damage 12: Front bumper: Front bumper - Paint defect - Paint

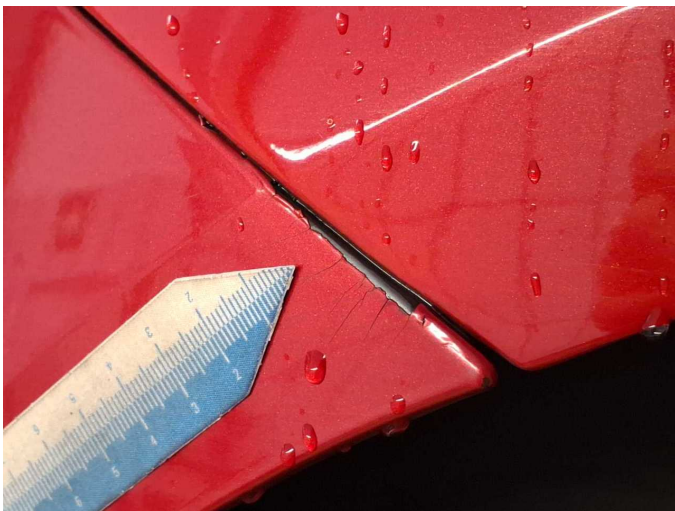
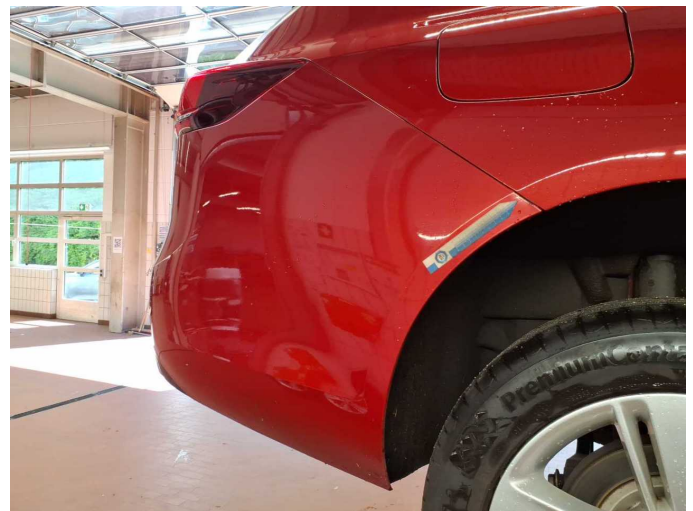
Damage 13: Rear bumper: Rear bumper - Unprofessionally repaired - Repair and paint

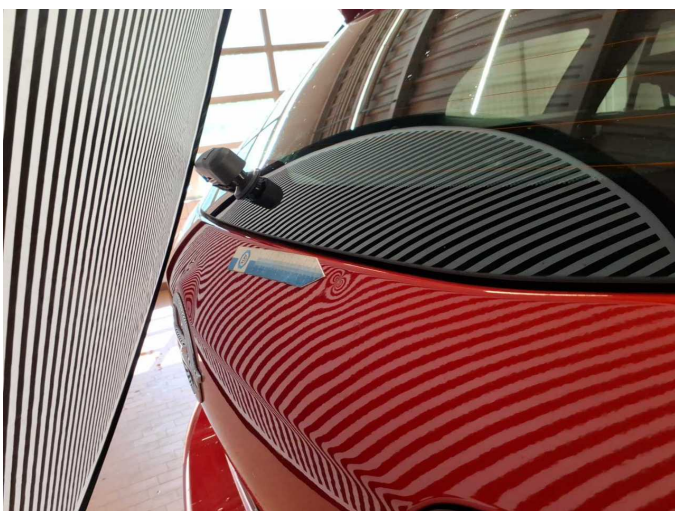
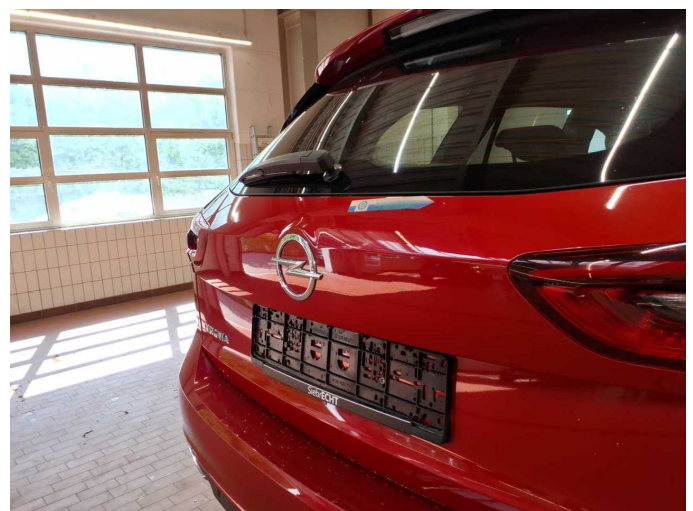
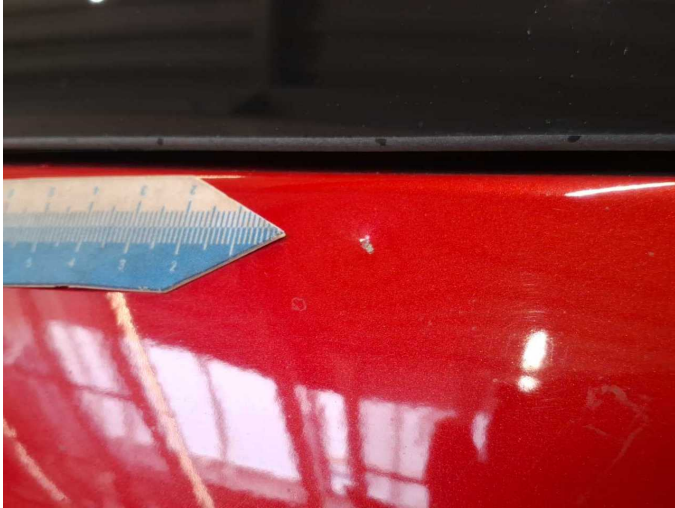
Damage 14: Boot lid / rear door: Boot lid - Dent / paintcoat damage - Repair and paint

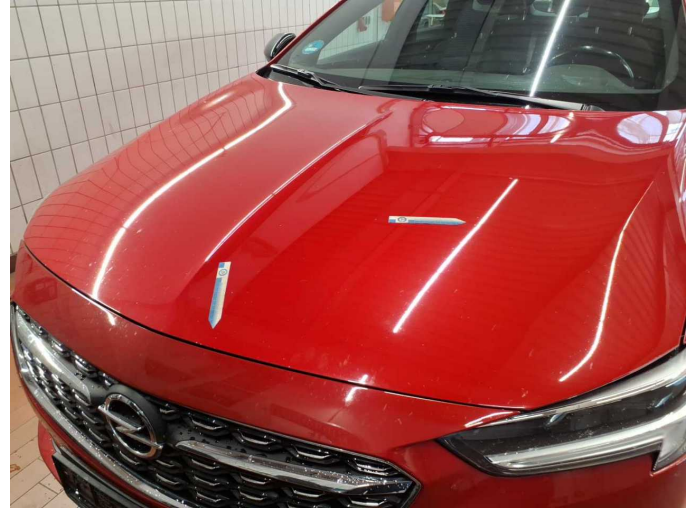
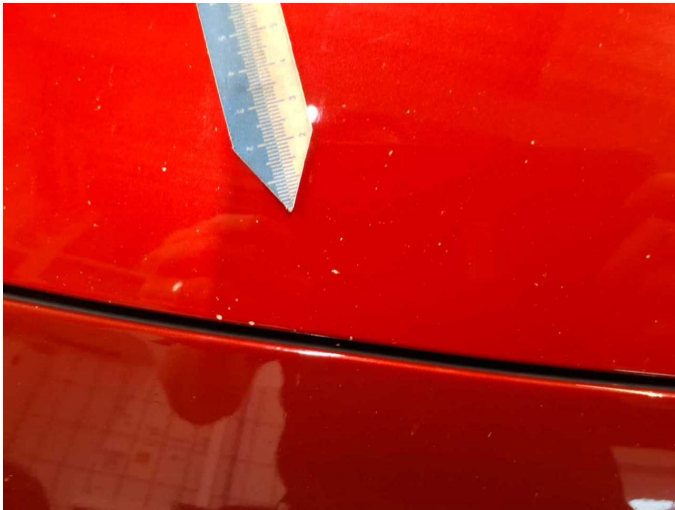
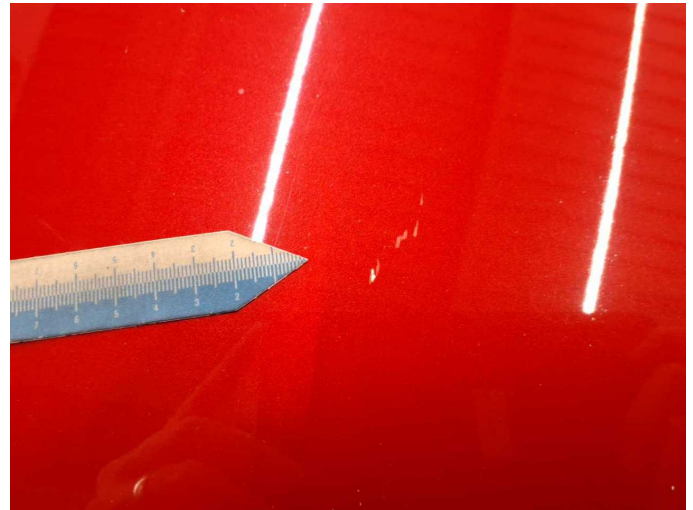
15	Bonnet	Bonnet - Stone chips - Paint

Damage 15: Bonnet: Bonnet - Stone chips - Paint

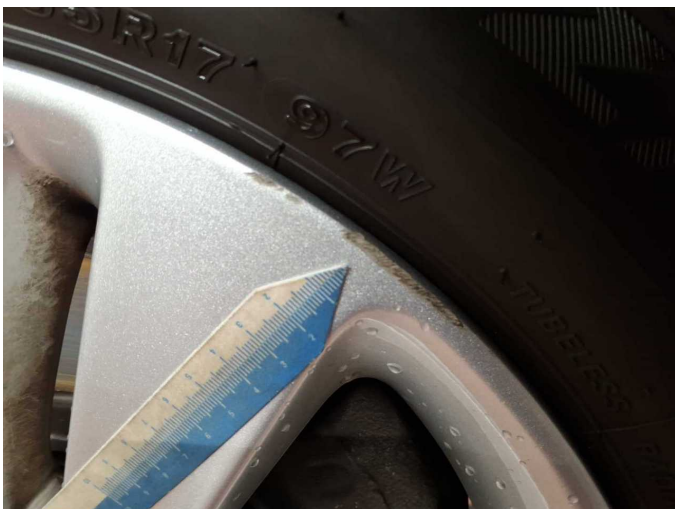
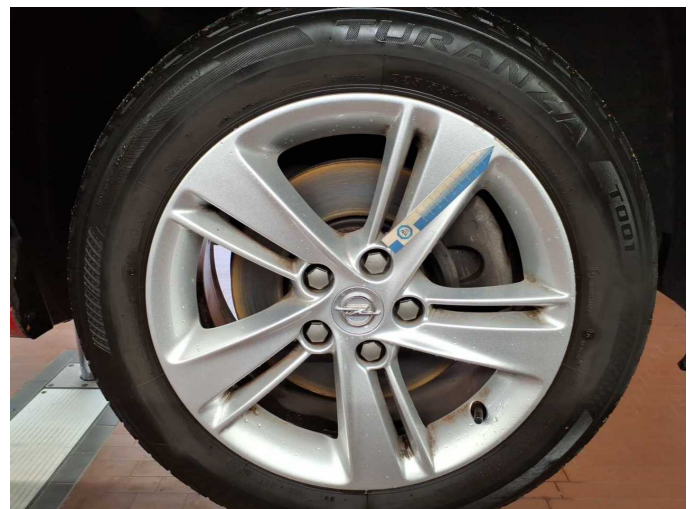
Wear and tear 1: Wheel / tyres: Alloy rim - front right side - Scratch(es) - No deduction

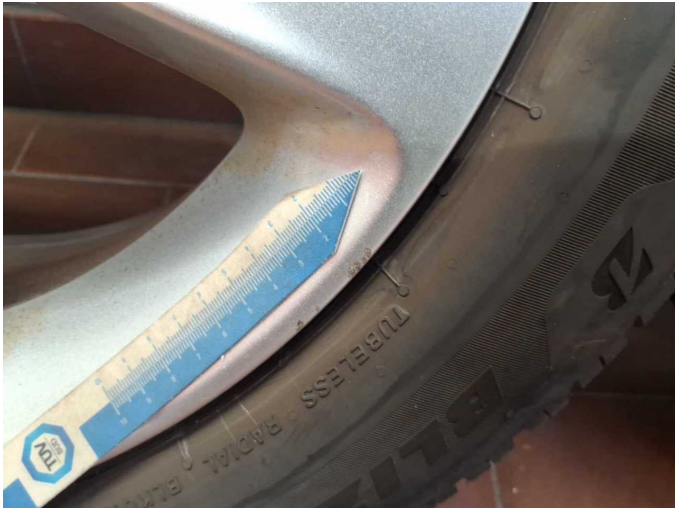
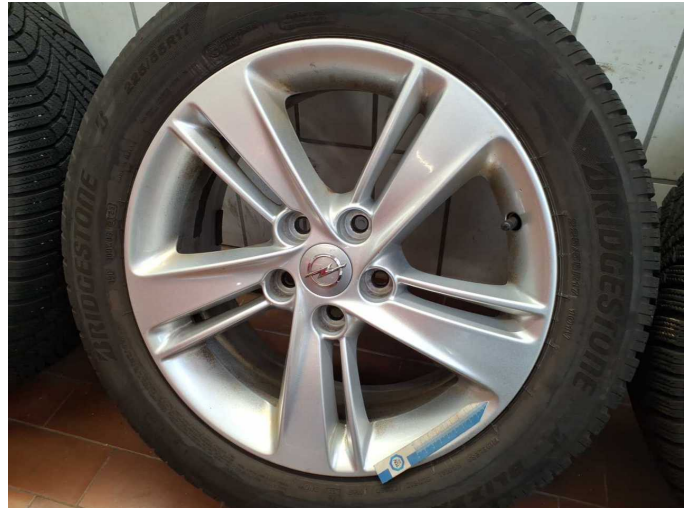
Wear and tear 2: 2nd wheel set: 1 alloy rim - Scratch(es) - No deduction
