## Expertise

Protocol number: 46187456  
Order No. / Reference: 26151940  
Inspection date: 22 Jun 2026

Manufacturer: Mercedes-Benz

Model: Vito 116 CDI Tourer Lang Aut. PRO

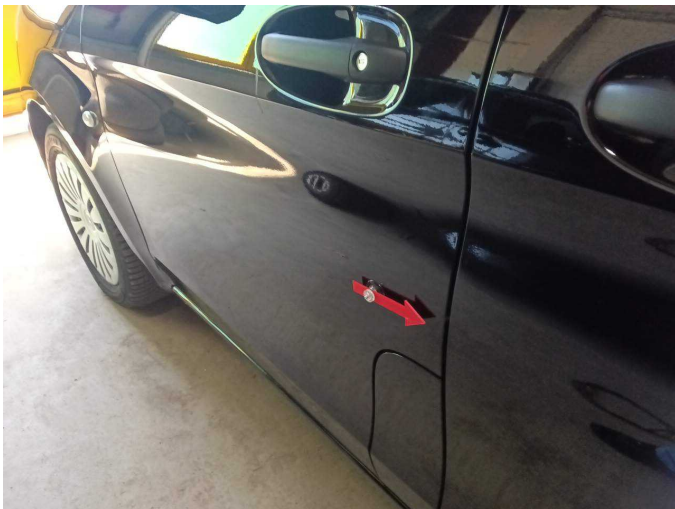
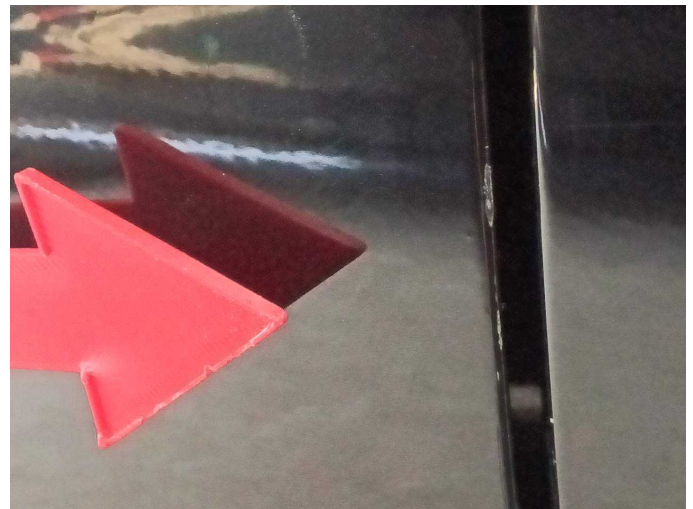
Damage 1: Door - front left side: Door edge - Scratch(es) - Smart repair

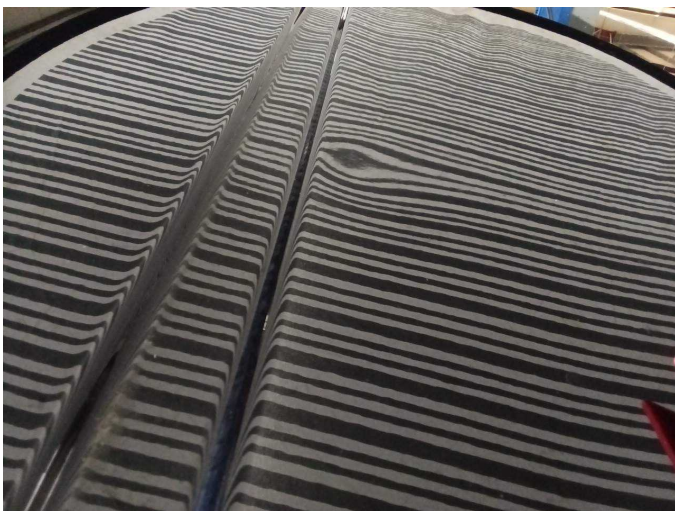
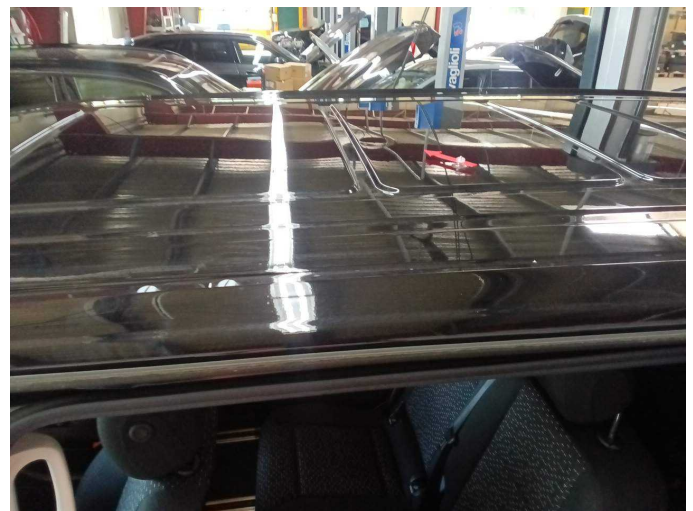
Damage 2: Roof: Roof - dent(s) - Smooth repair work

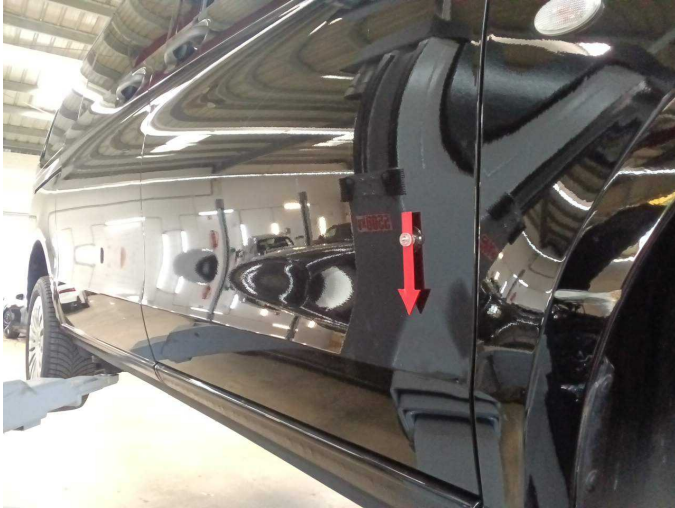
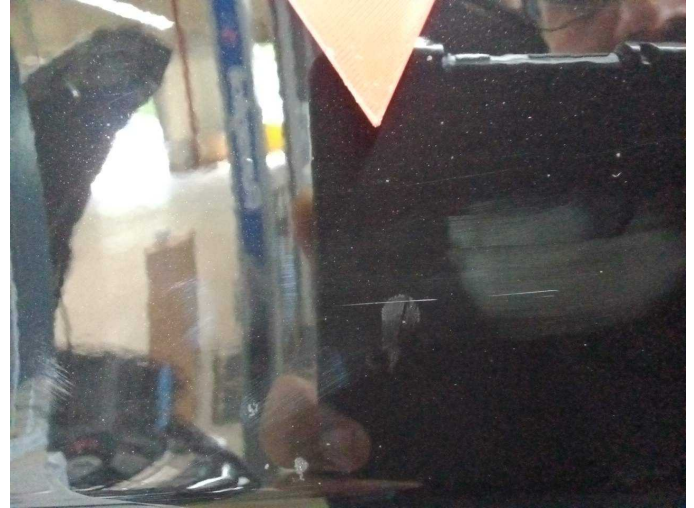
**Damage 3:** Door - front right side: Door - Scratch(es) - Smart repair

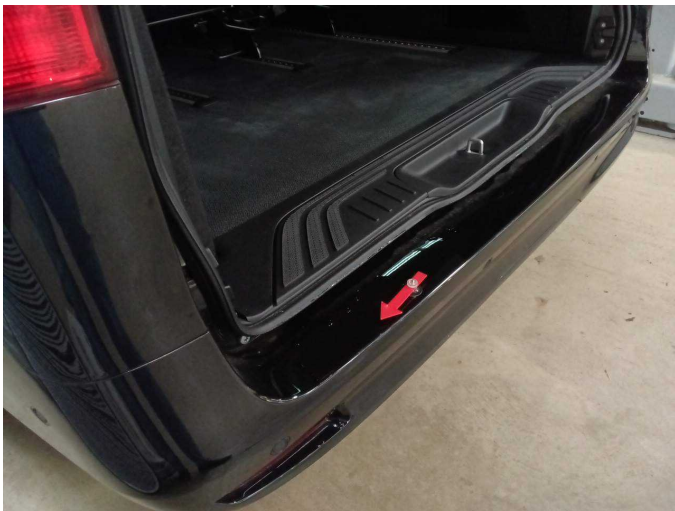
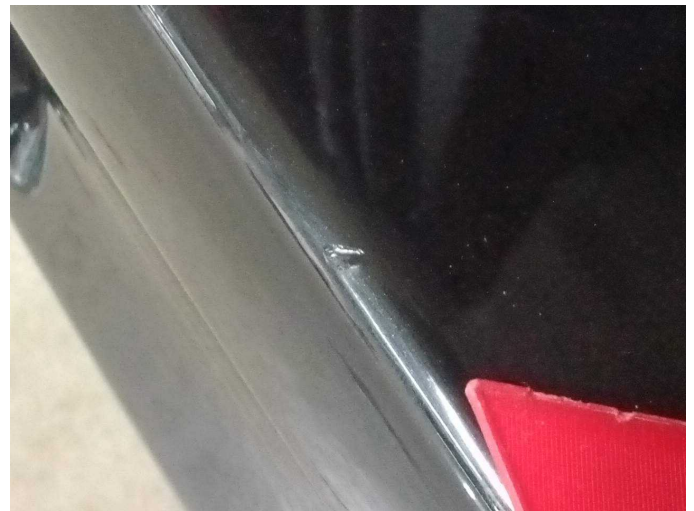
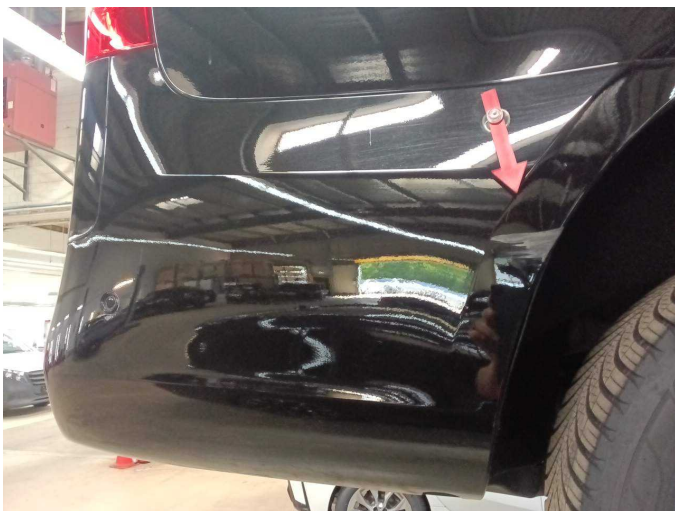
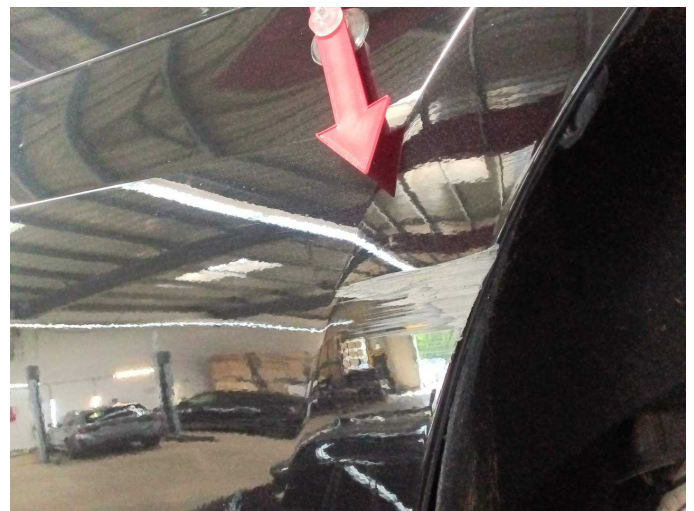
**Damage 4:** Rear bumper: Rear bumper - Scratched - Paint

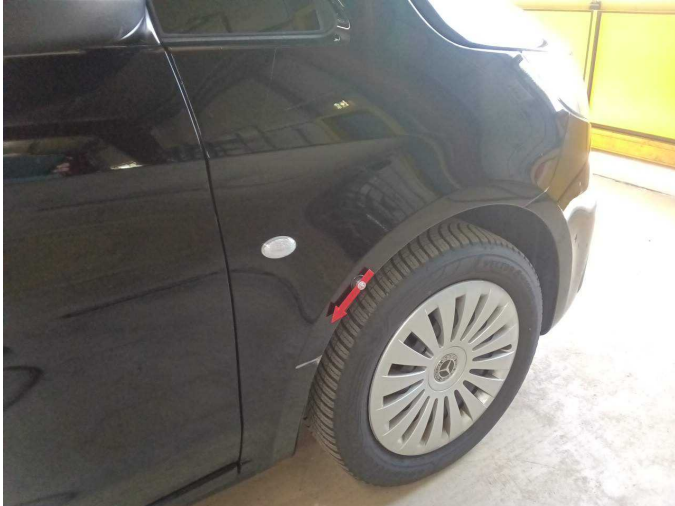
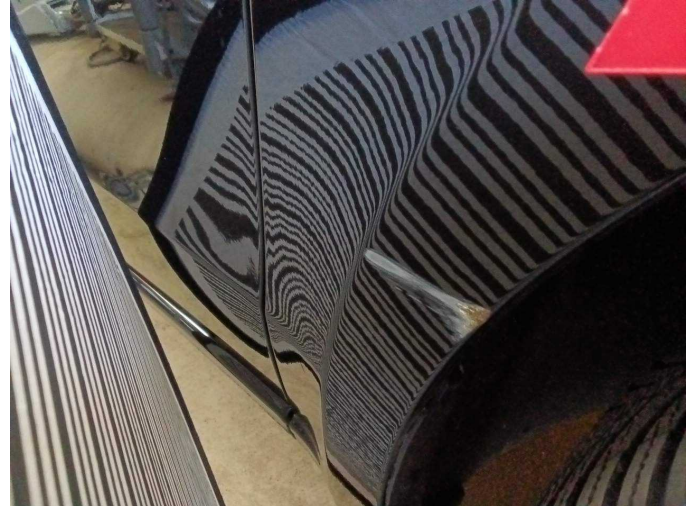
**Damage 5:** Mudguard - right side: Mudguard - right side - Dent / paintcoat damage - Repair and paint

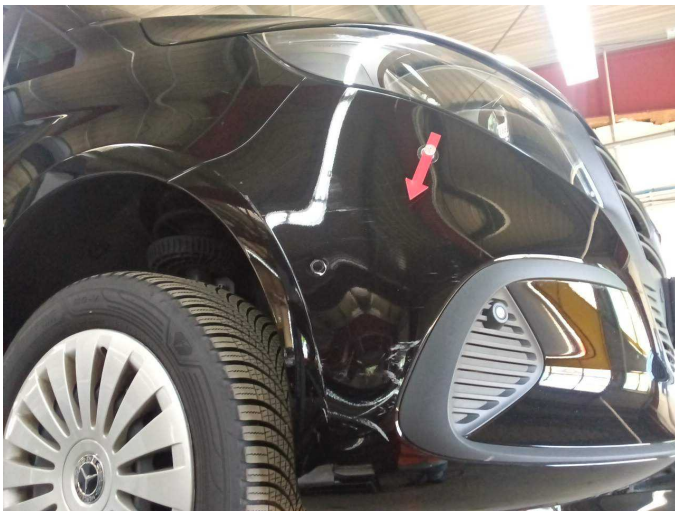
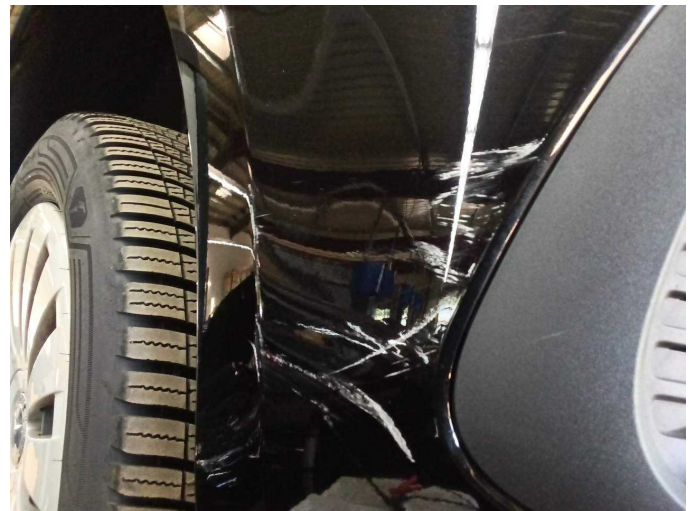
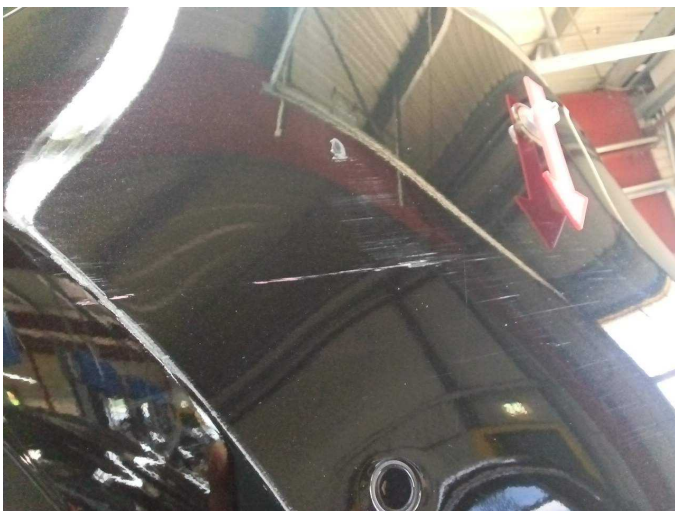
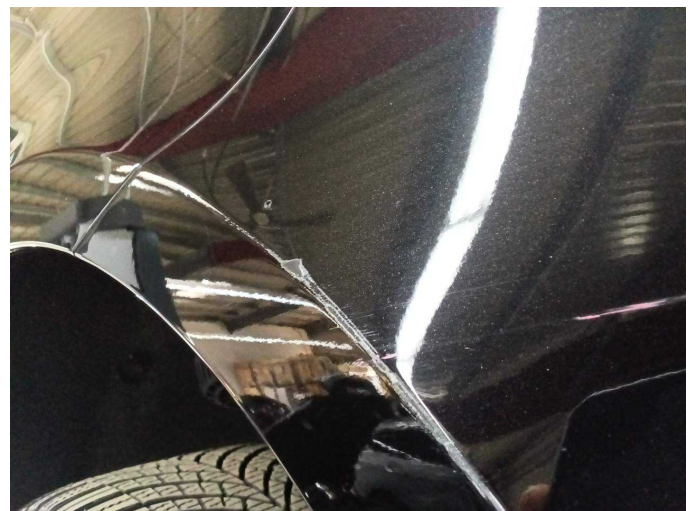
**Damage 6:** Front bumper: Front bumper - Scratched - Paint

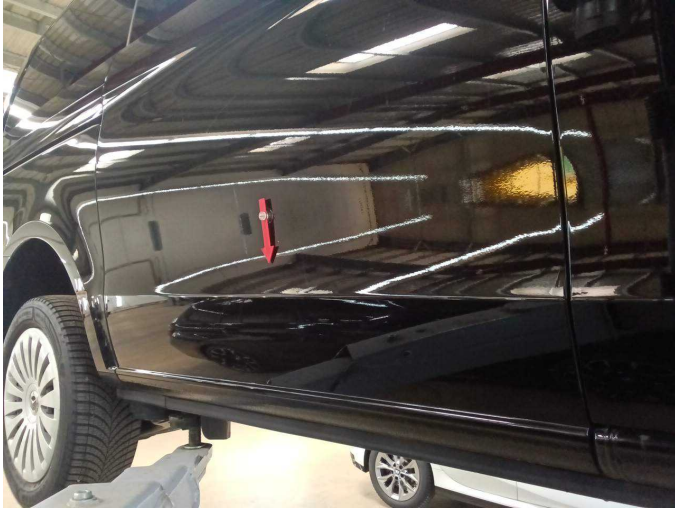
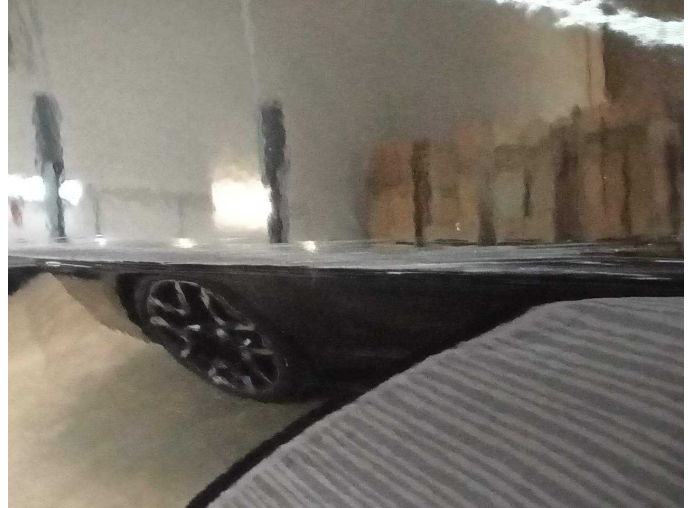
**Damage 7:** Sliding door, right: Sliding door - Scratched - Paint

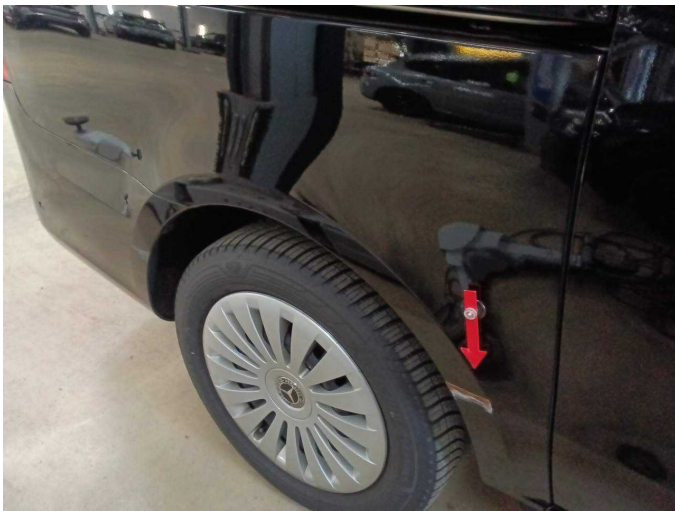
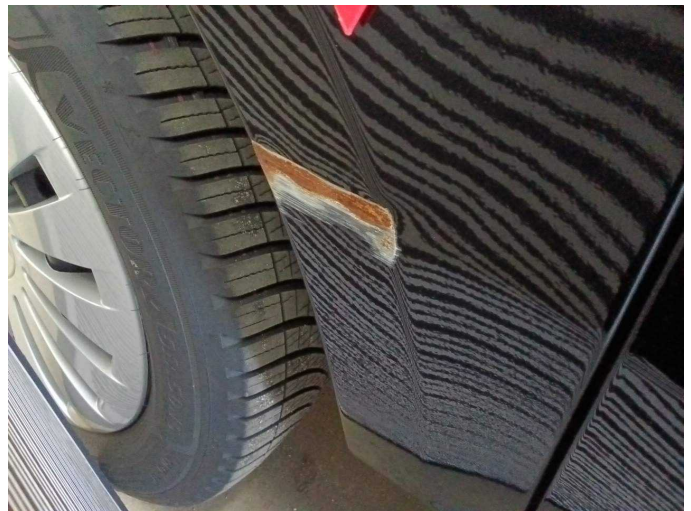
**Damage 8:** Side panel - rear right side: Side panel - Dent / paintcoat damage - Repair and paint

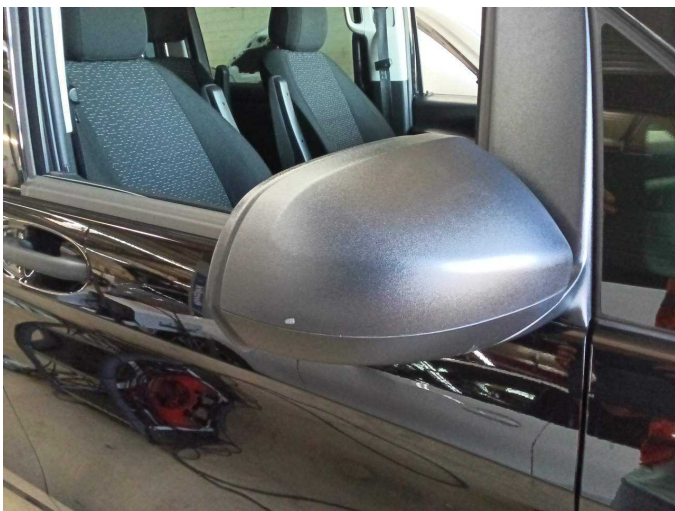
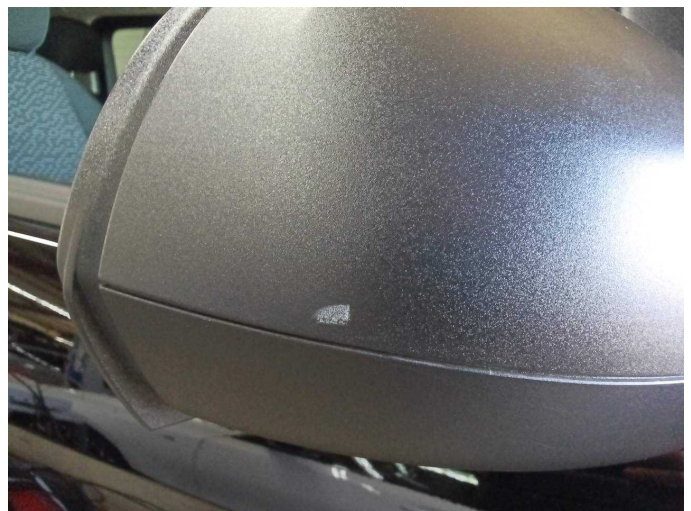
**Wear and tear 7:** Wing mirror - right side: Cap - Scratch(es) - No deduction

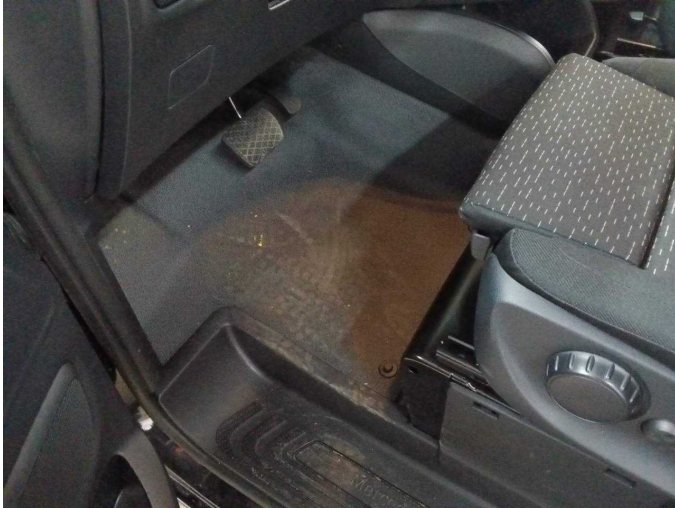
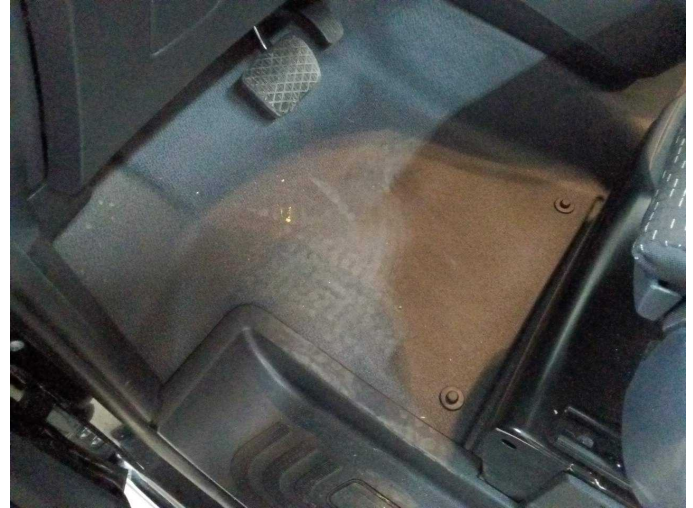
Trim / covers - Floor mats

**Missing part 1:** Trim / covers: Floor mats - Missing - Perform
