Expertise

Protocol number: 45838784
Order No. / Reference: 26358451
Inspection date: 3 Jun 2026

Model: Octavia Combi 2.0 TDI DSG Style

VIN: TMBJG8NX0PY165417

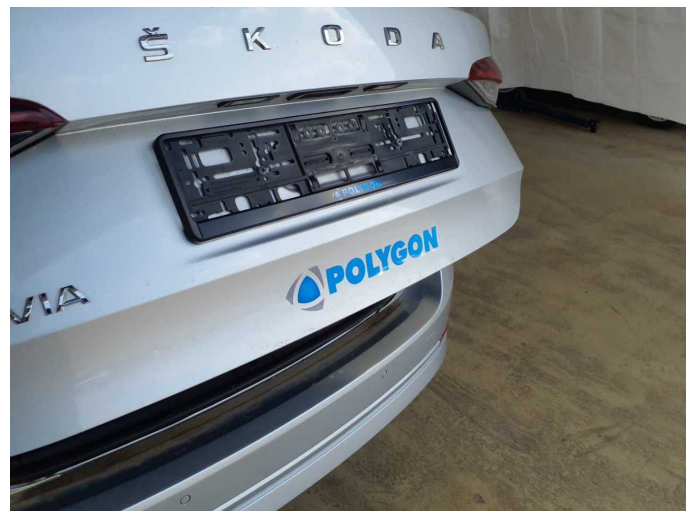
Damage 1: Boot lid / rear door: Boot lid - Glued / labelled - De-glue / neutralise

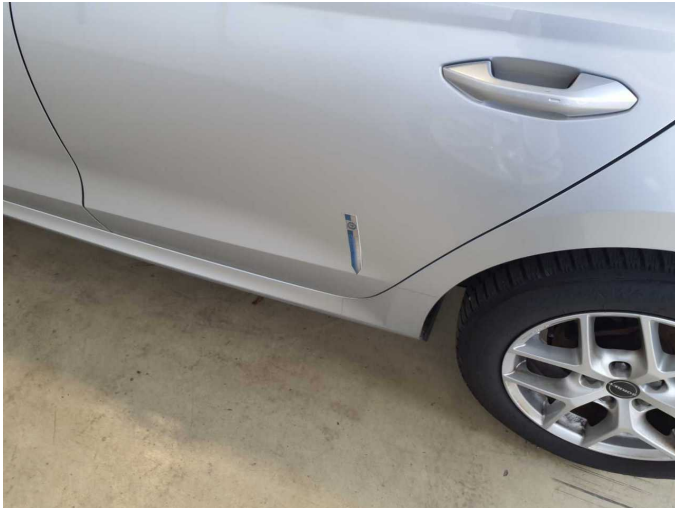
Damage 2: Door - rear left side: Door - Dent / paintcoat damage - Smart repair

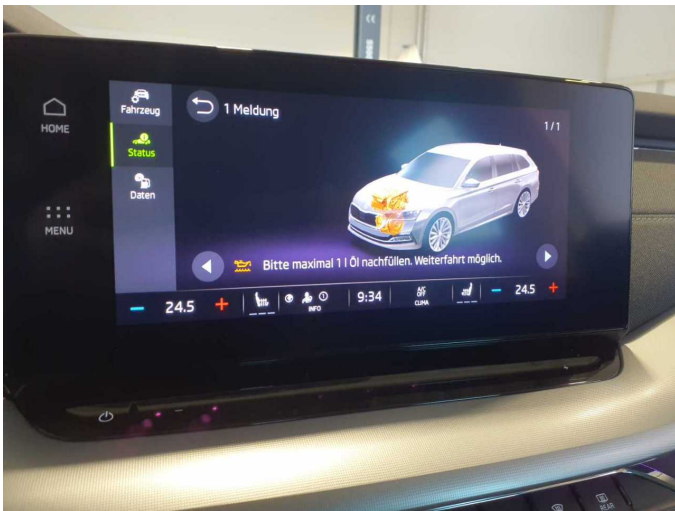
Damage 3: Instrument panel: Indicator light (Ölkontrolle, auf Undichtigkeiten prüfen) - on - Perform

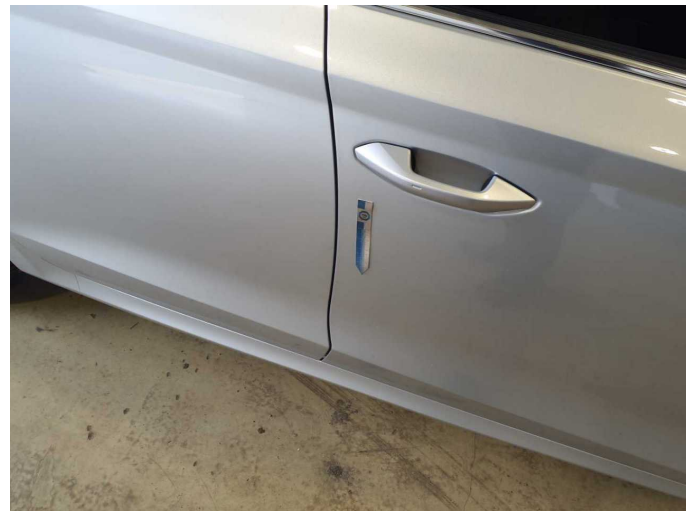
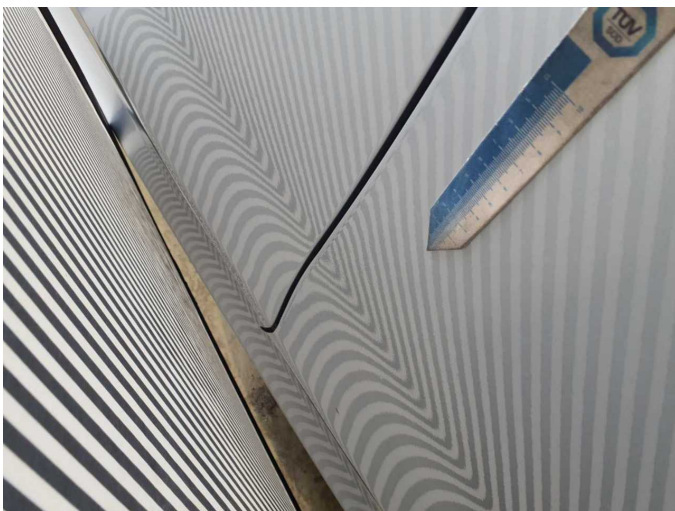
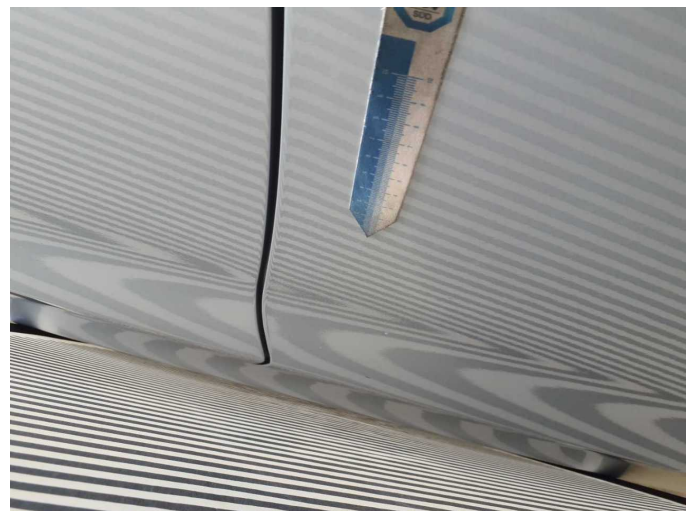
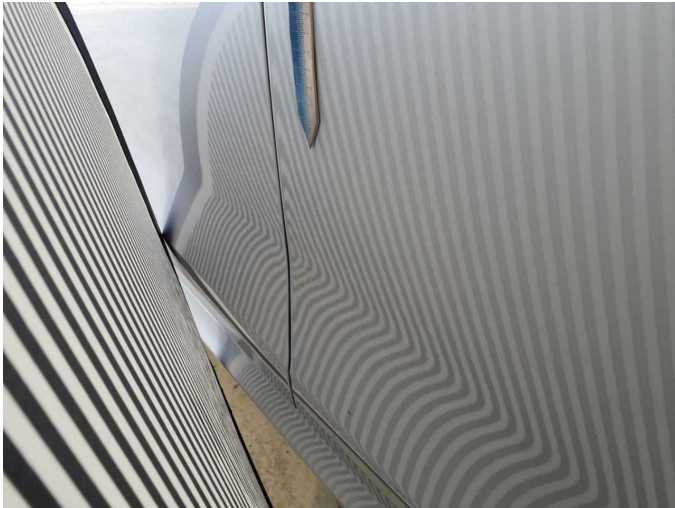
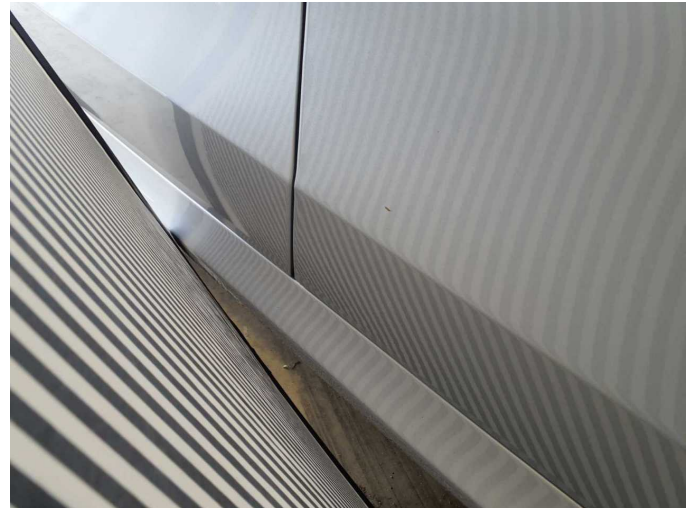
Boot lid / rear door	186 µm	Bonnet	174 µm
Side panel - rear right side	182 µm	Door - rear right side	189 µm
Door - front right side	235 µm

Damage 4: Door - front right side: Door (Orangenhaut) - Unprofessionally repaired - Paint

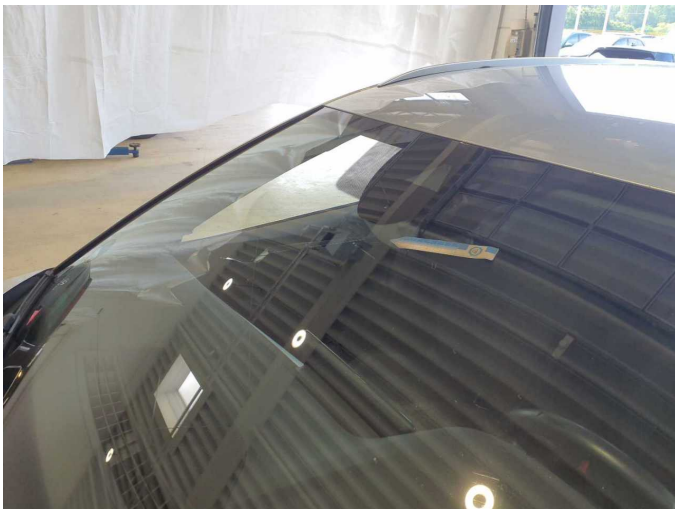
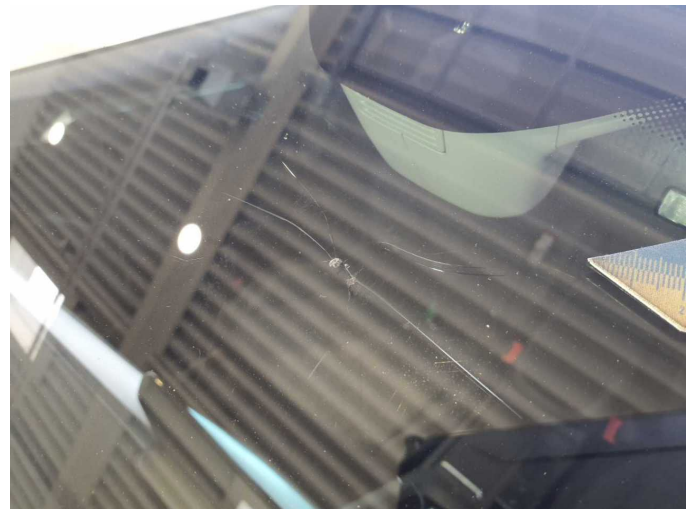
Damage 5: Vehicle glazing: Windscreen - Broken / torn - Replace

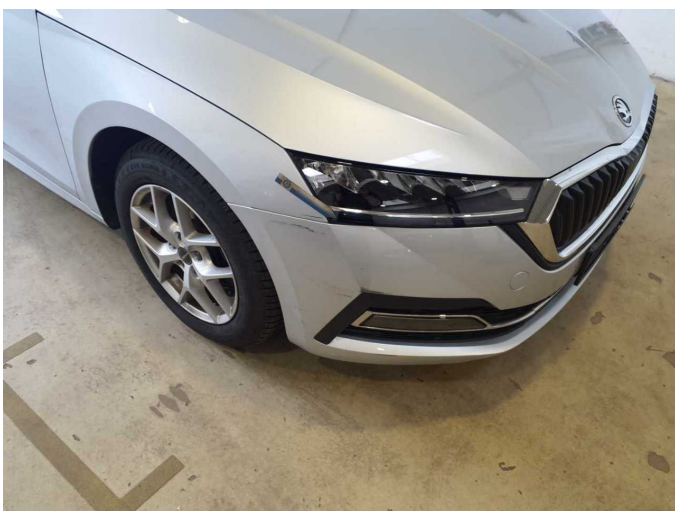
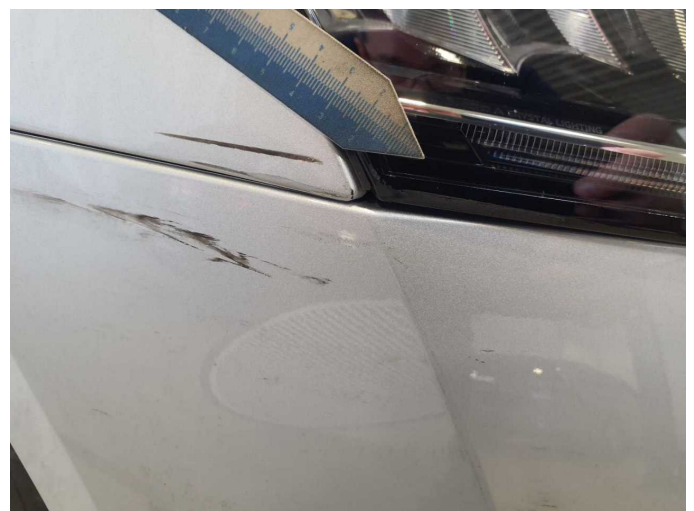
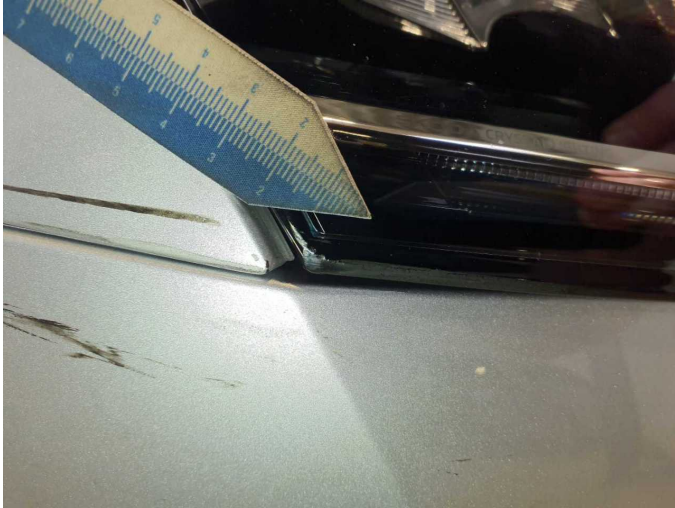
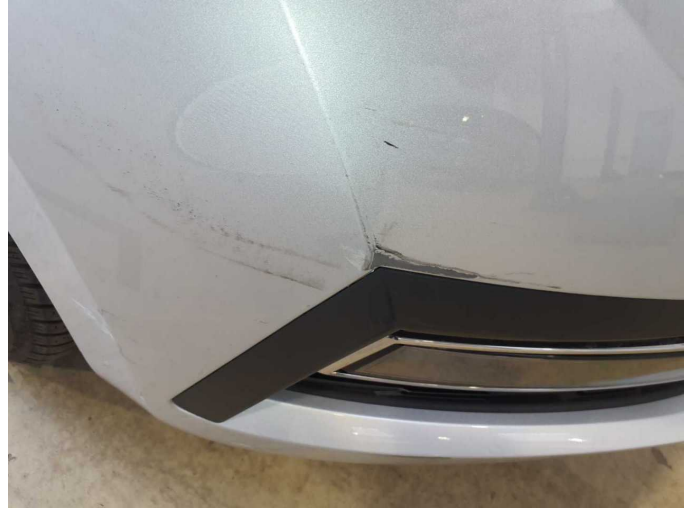
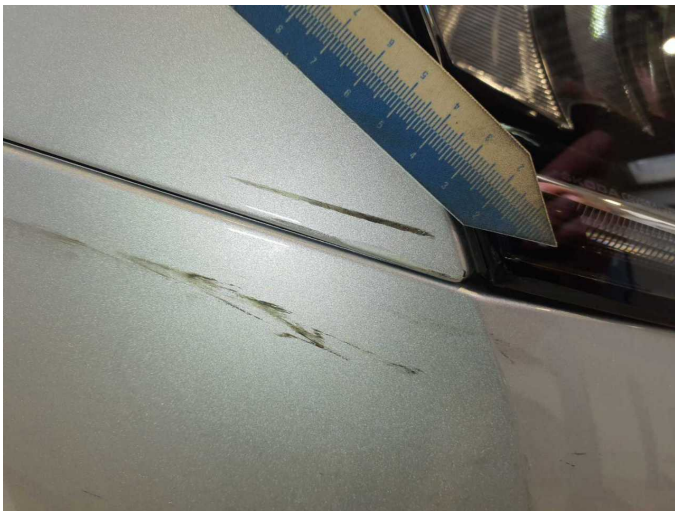
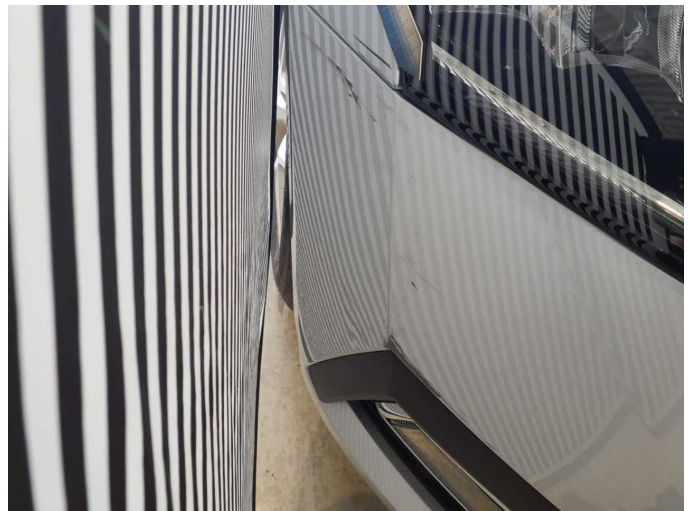
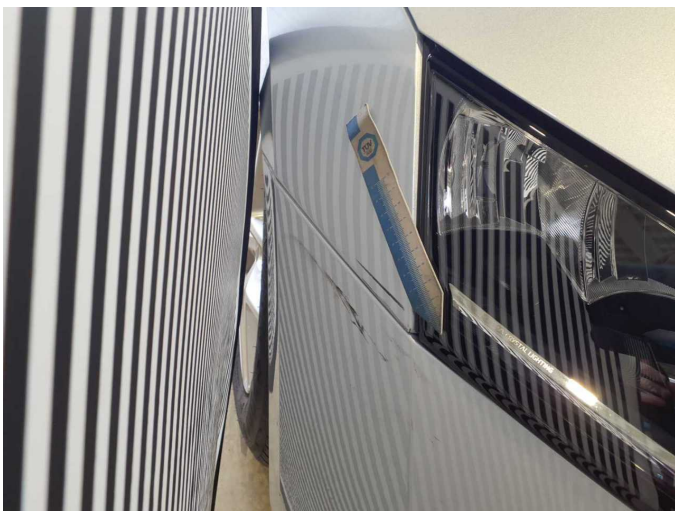
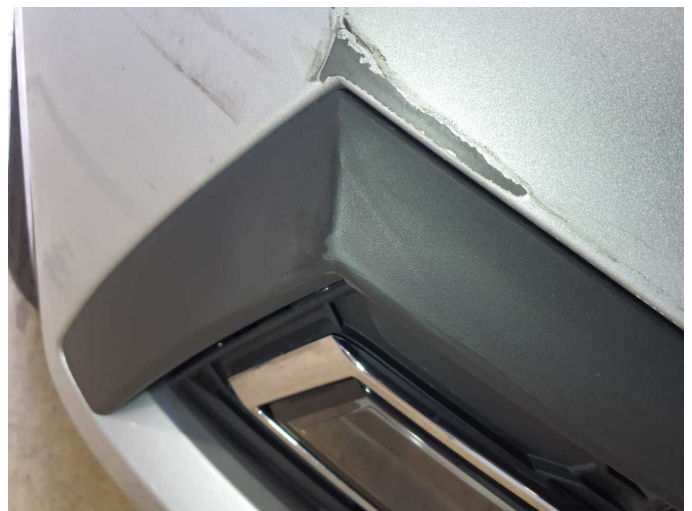
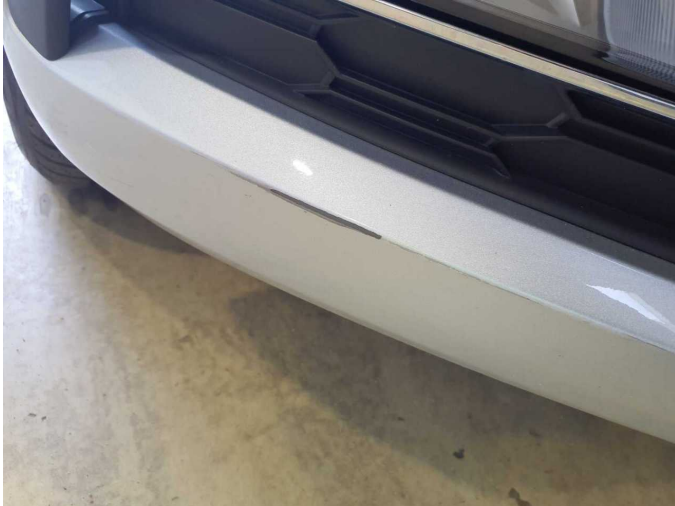
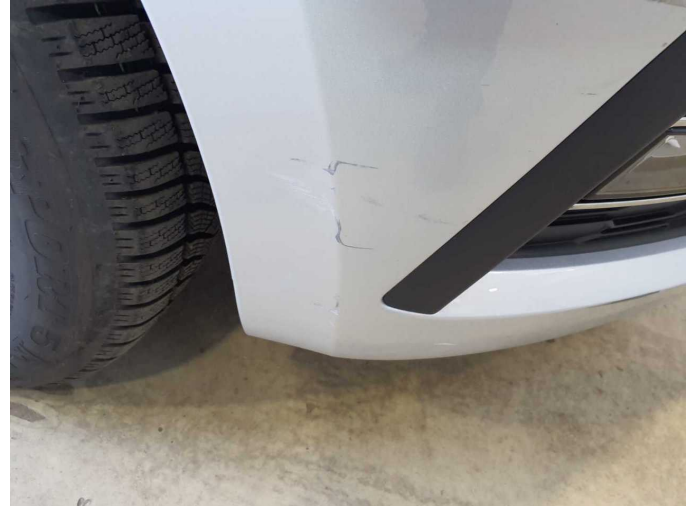
No.	Accident
1	Front, Side right

Accident 1: Front, Side right

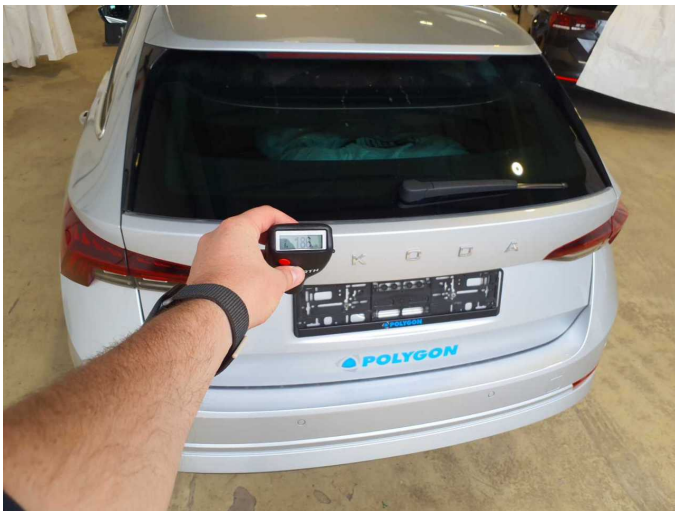
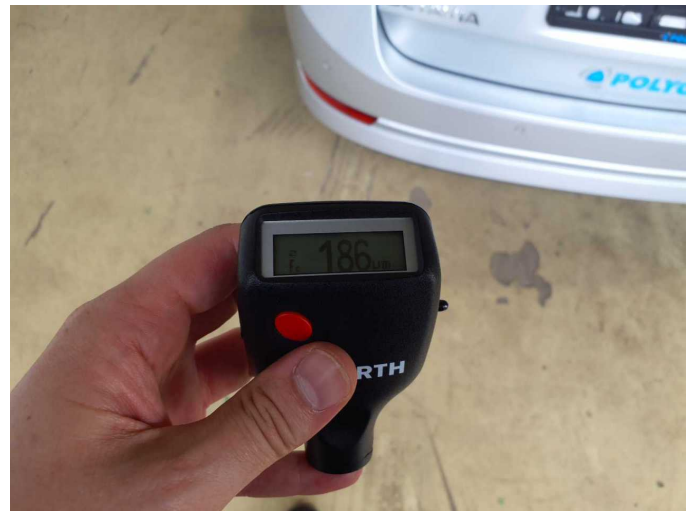
Repainting 1: Boot lid / rear door

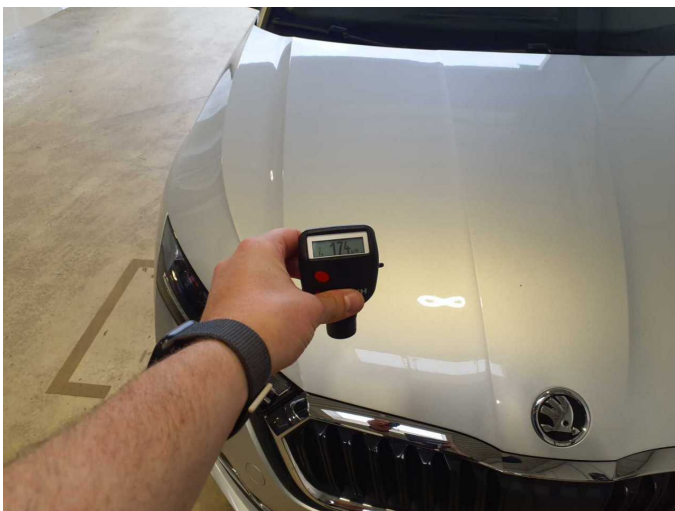
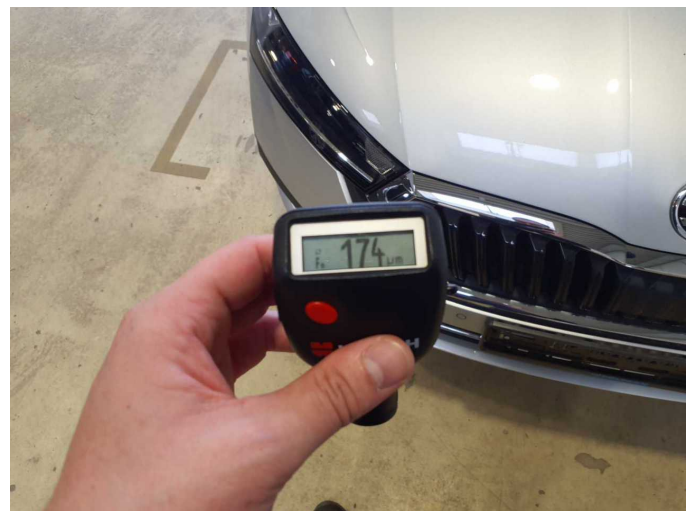
Repainting 2: Bonnet

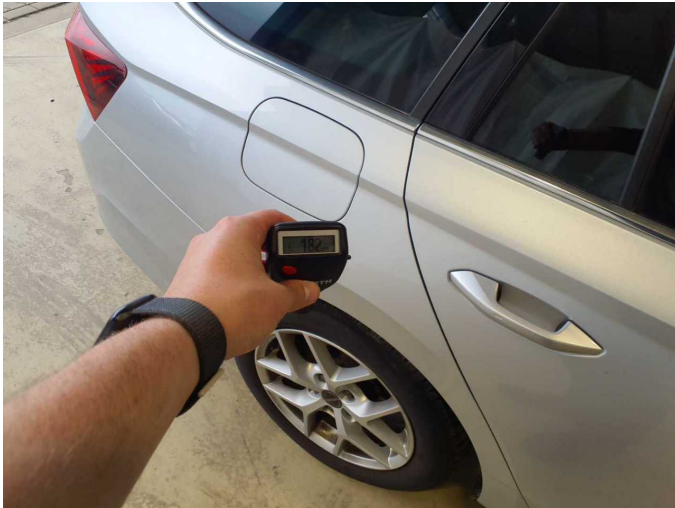
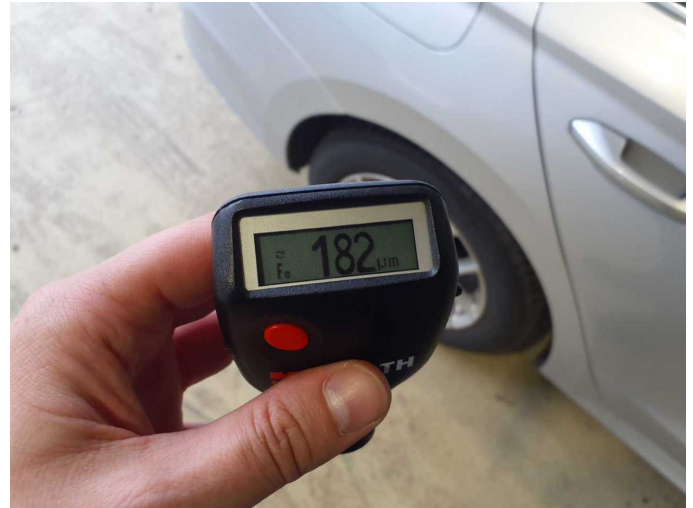
Repainting 3: Side panel - rear right side

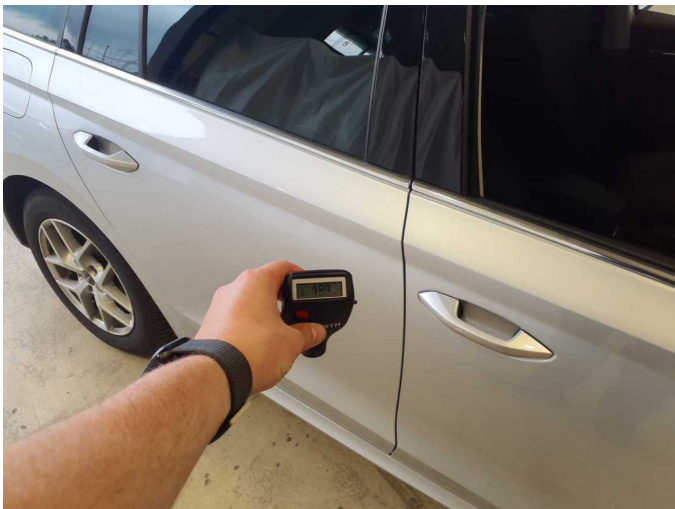
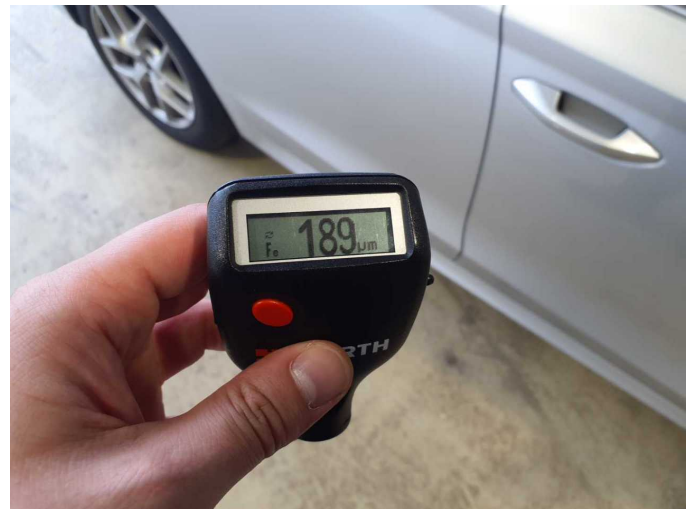
Repainting 4: Door - rear right side

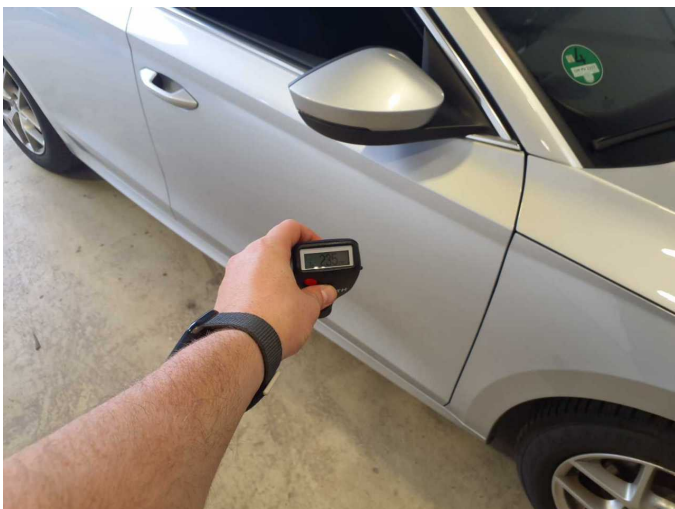
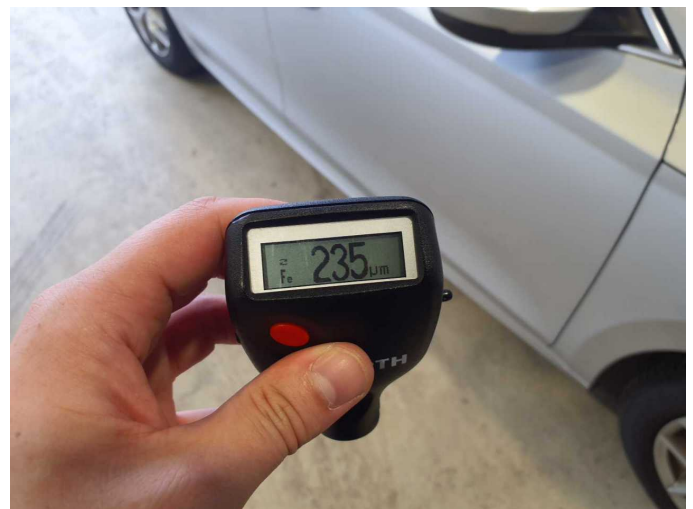
Repainting 5: Door - front right side
