Expertise

Protocol number: 46594318  
Order No. / Reference: 26740432  
Inspection date: 15 Jul 2026

Manufacturer: Mercedes-Benz  
VIN: W1KZH1CB4PB137305

Model: E 200 d T 9G-TRONIC Avantgarde

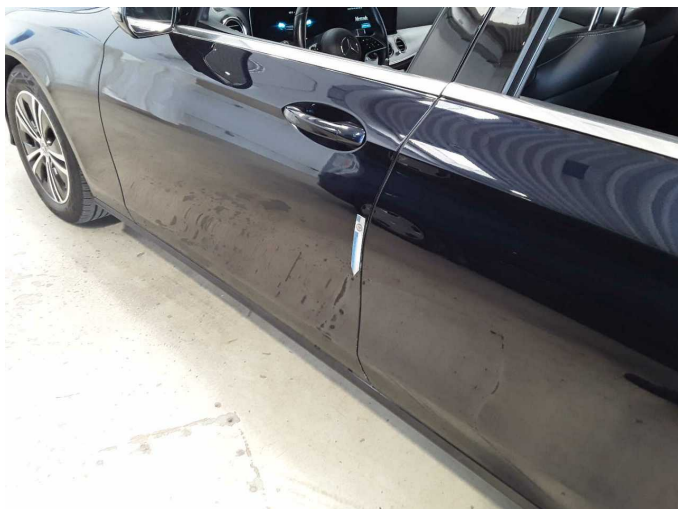
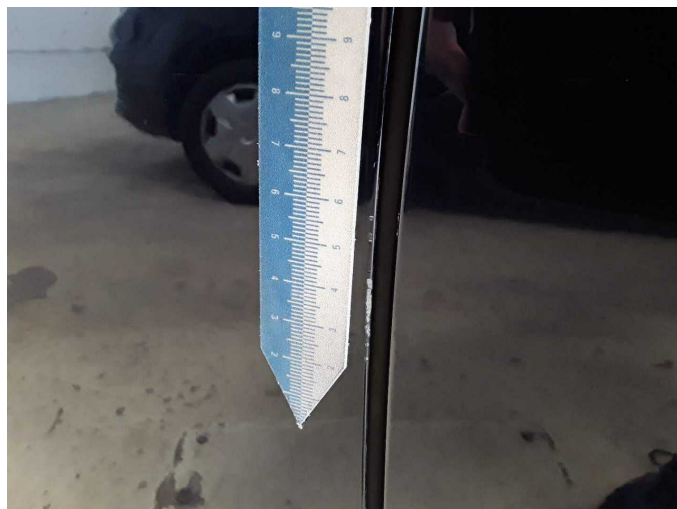
| No. | Component group | Description |
|---|---|---|
| 2 | Door - front left side | Door edge - Scratch(es) - Smart repair |

**Damage 2:** Door - front left side: Door edge - Scratch(es) - Smart repair

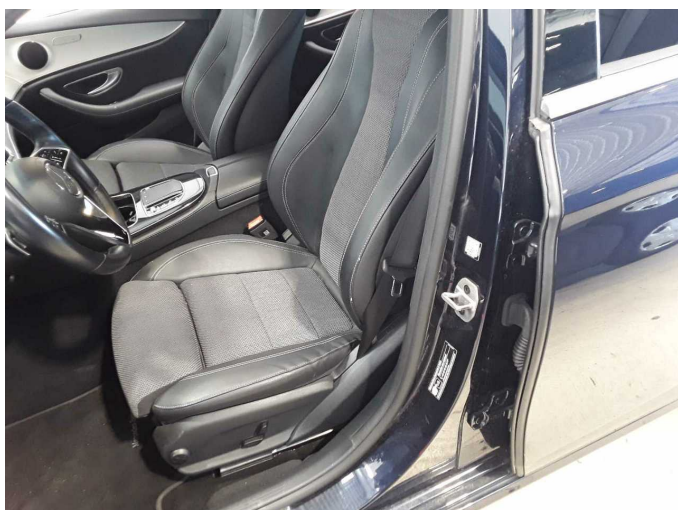
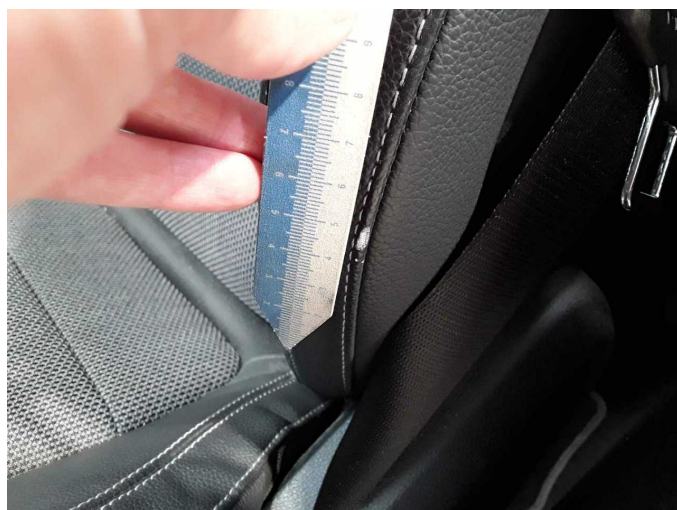
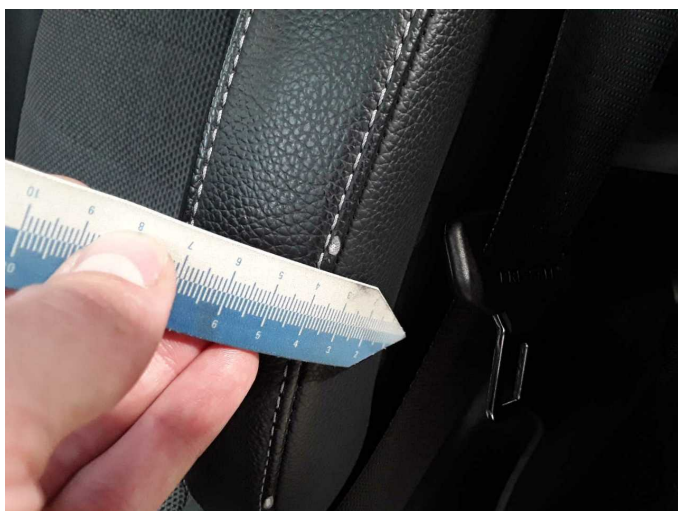
| No. | Component group | Description |
|---|---|---|
| 3 | Seat - front | Backrest cover - left side - Scratch(es) - Smart repair |

**Damage 3:** Seat - front: Backrest cover - left side - Scratch(es) - Smart repair

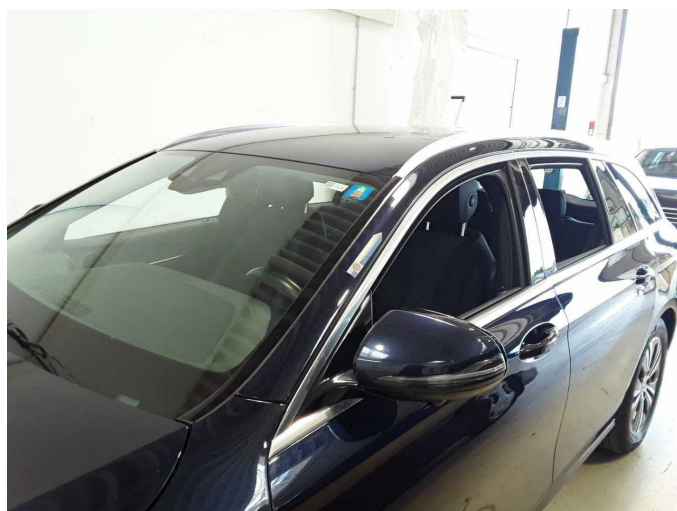
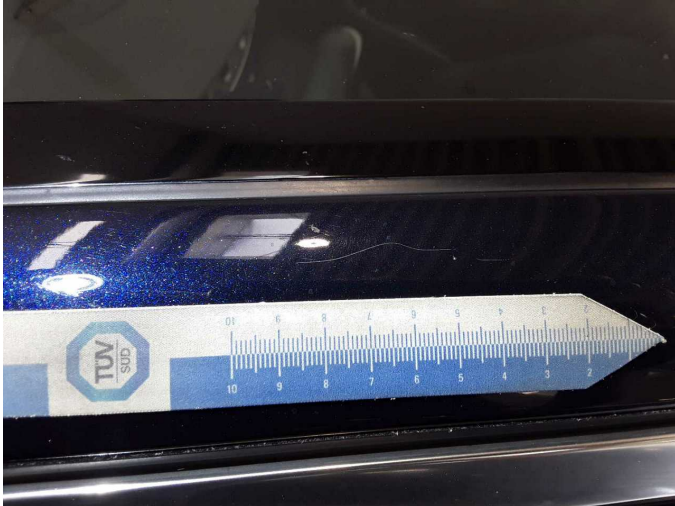
| No. | Component group | Description |
|---|---|---|
| 4 | Body | A-pillar - left side - Scratch(es) - Smart repair |

**Damage 4:** Body: A-pillar - left side - Scratch(es) - Smart repair

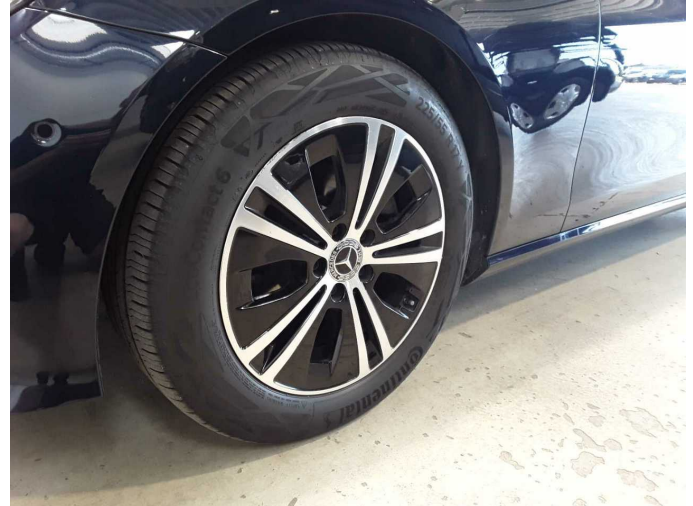
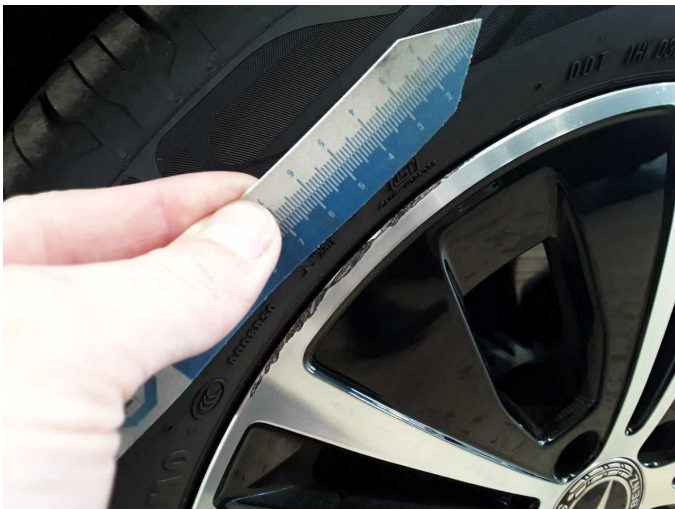
| No. | Component group | Description |
|---|---|---|
| 5 | Wheel / tyres | Alloy rim - front left side - Scratch(es) - Loss in value |

**Damage 5:** Wheel / tyres: Alloy rim - front left side - Scratch(es) - Loss in value

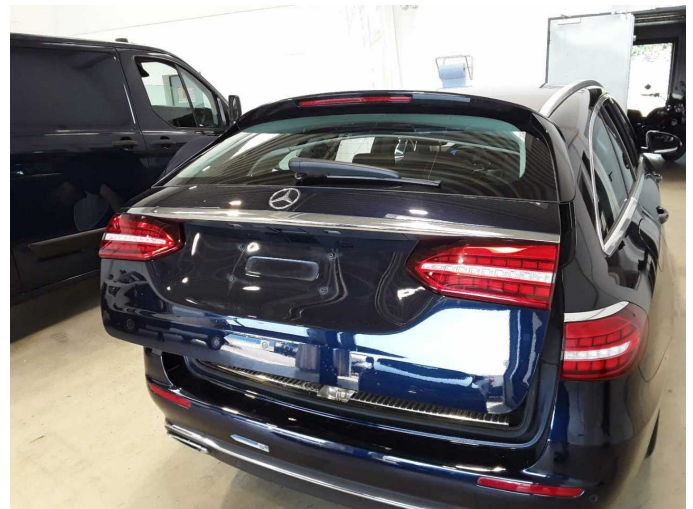
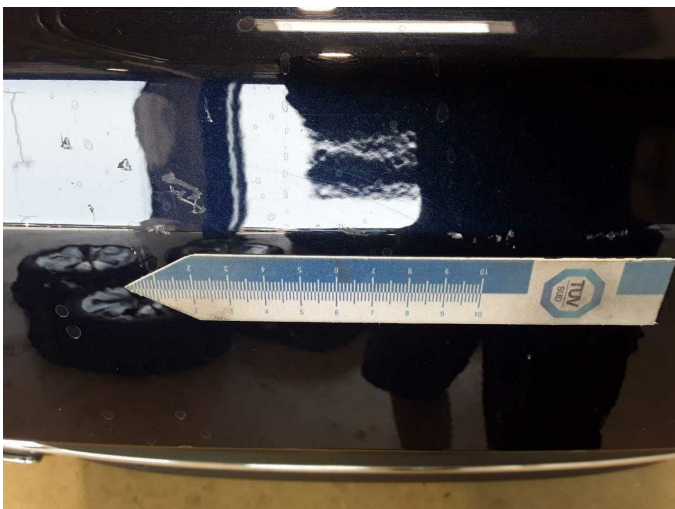
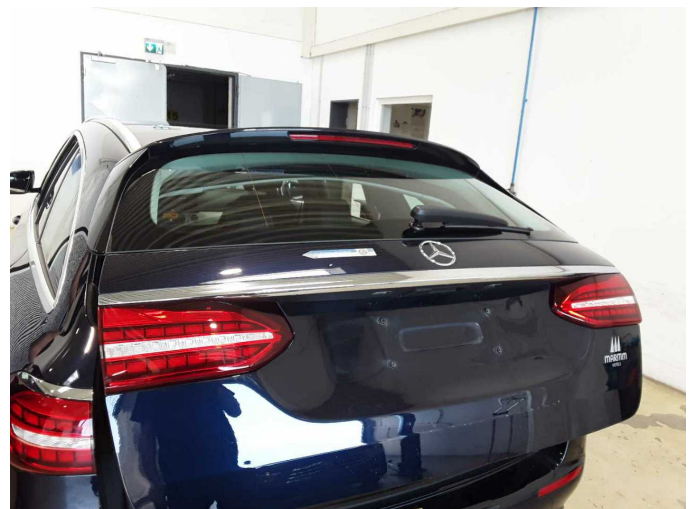
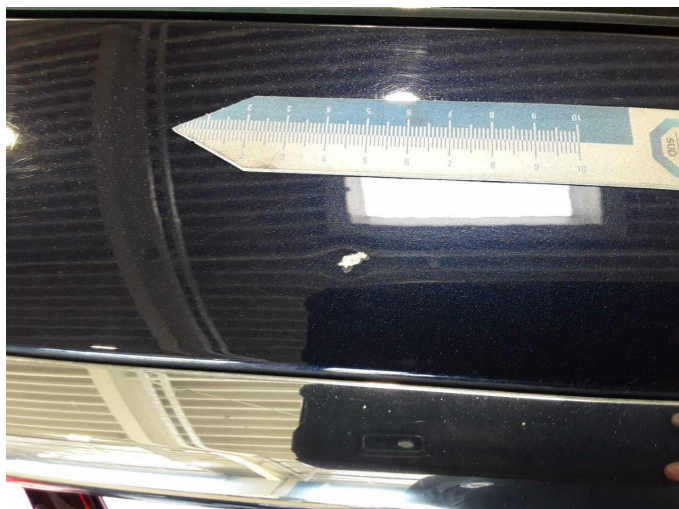
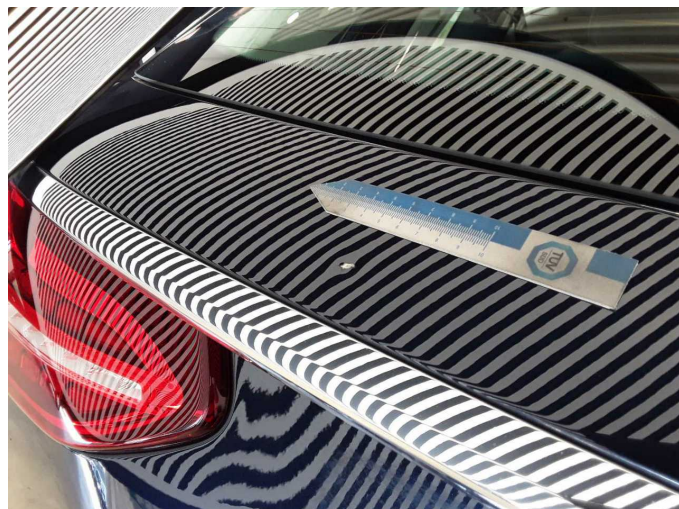
| No. | Component group | Description |
|---|---|---|
| 6 | Boot lid / rear door | Boot lid - Dent / paintcoat damage - Repair and paint |

**Damage 6:** Boot lid / rear door: Boot lid - Dent / paintcoat damage - Repair and paint

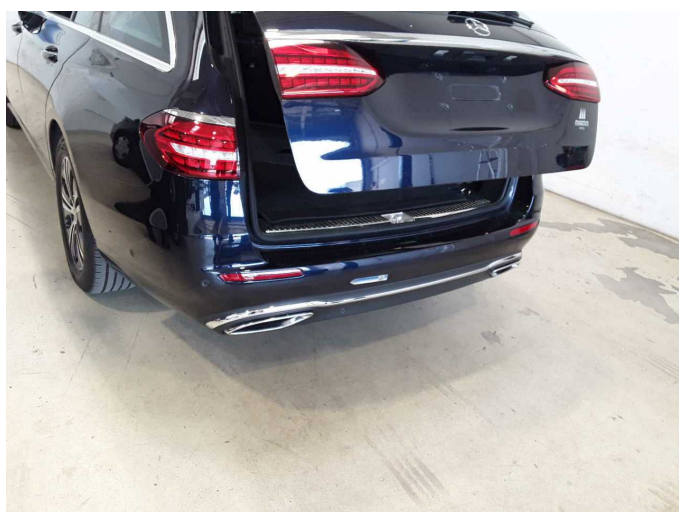
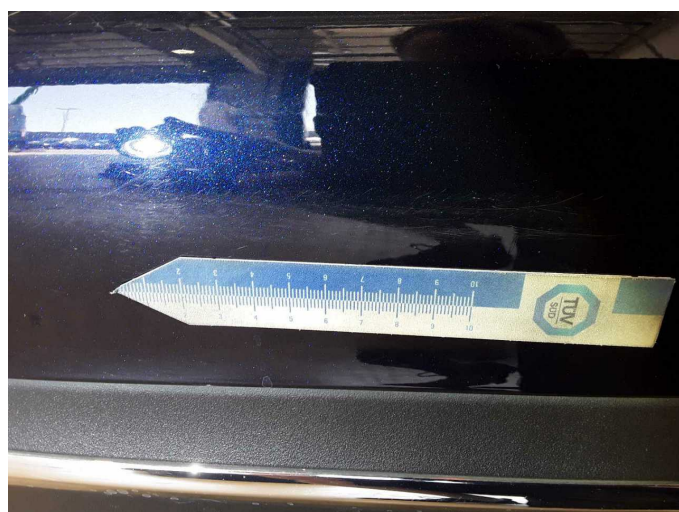
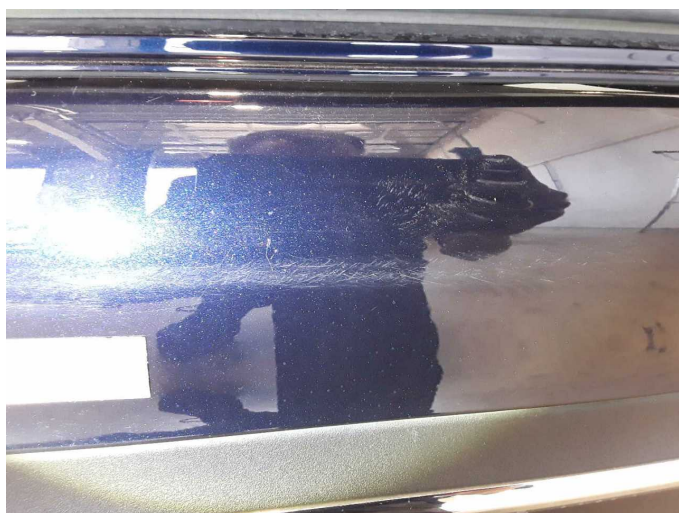
| No. | Component group | Description |
|---|---|---|
| 7 | Rear bumper | Rear bumper - Scratch(es) - Paint |

**Damage 7:** Rear bumper: Rear bumper - Scratch(es) - Paint

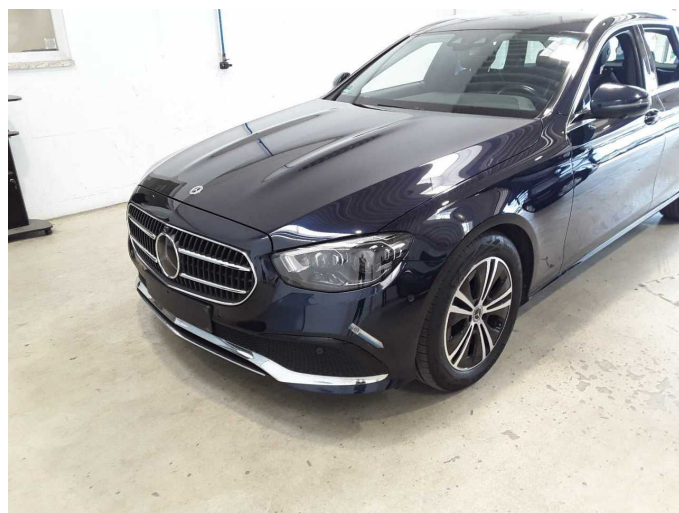
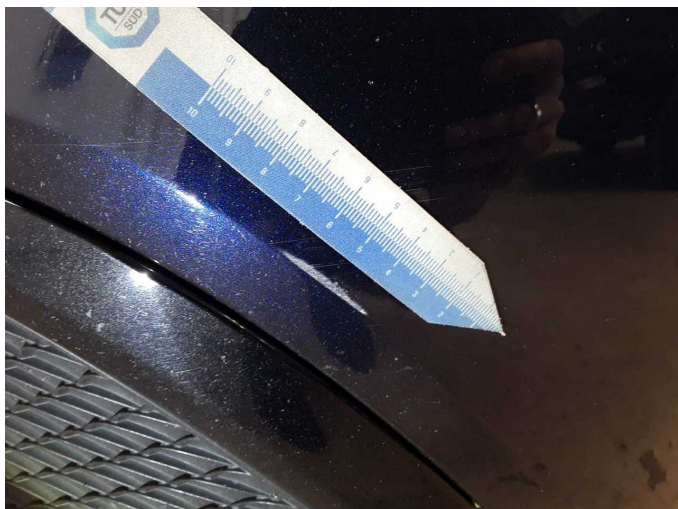
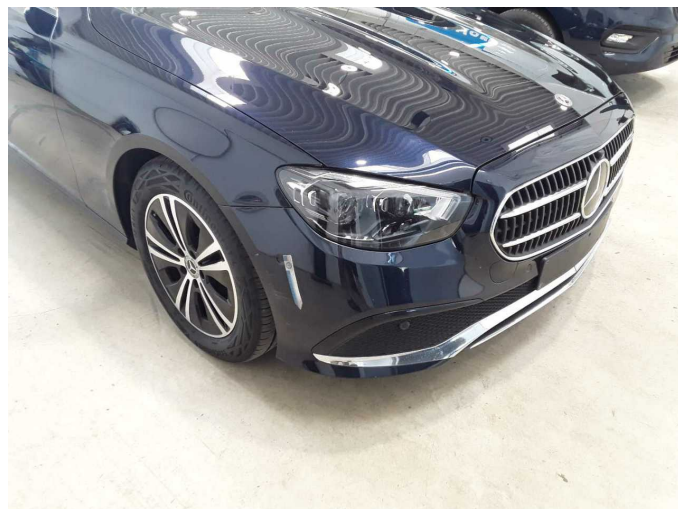
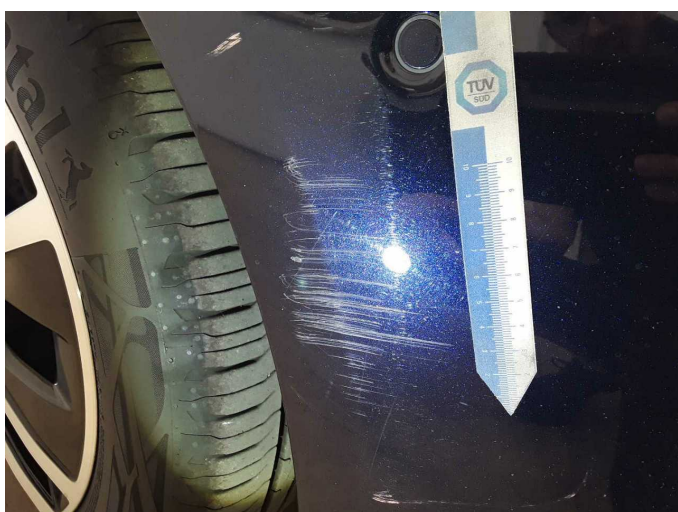
| No. | Component group | Description |
|---|---|---|
| 8 | Front bumper | Front bumper - Scratch(es) - Paint |

**Damage 8:** Front bumper: Front bumper - Scratch(es) - Paint

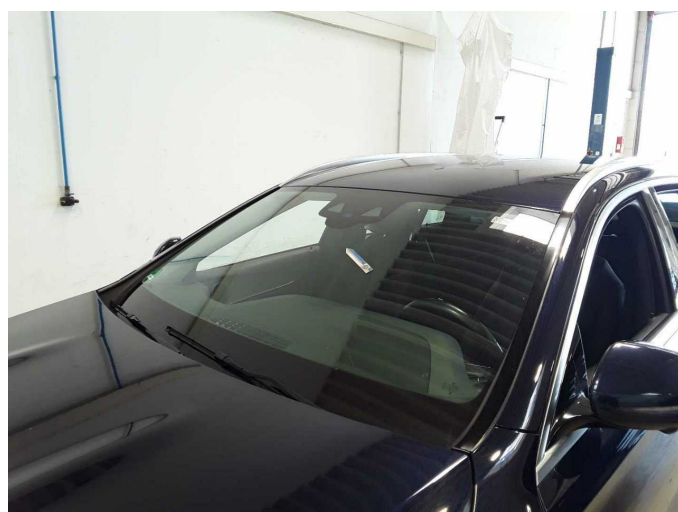
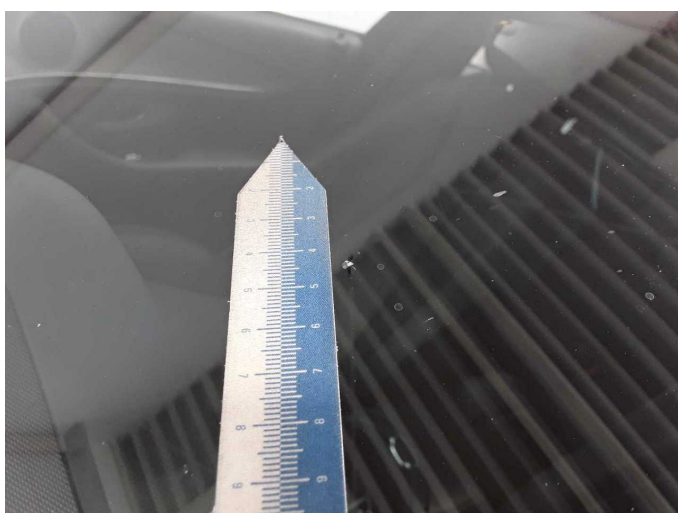
| No. | Component group | Description |
|---|---|---|
| 9 | Vehicle glazing | Windscreen - Broken / torn - Replace |

**Damage 9:** Vehicle glazing: Windscreen - Broken / torn - Replace
