Expertise

Protocol number: 46621875  
Order No. / Reference: 26653413  
Inspection date: 21 Jul 2026

Manufacturer: Volkswagen

Model: Touran 1.5 TSI ACT OPF DSG Comfortline

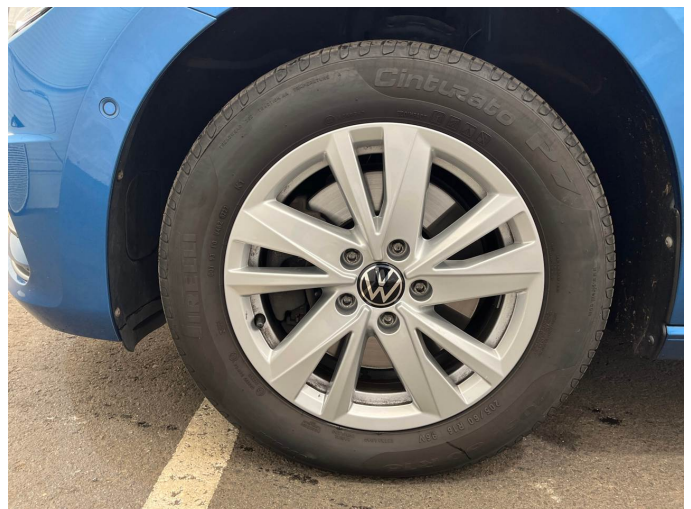
Figure 12: Mounted tyres

| # | Tyre size | Type of tyre | Manufacturer | Tread depth |
|---|---|---|---|---|
| 1) | 205/60 R16 96V | Summer tyres on Light alloy | Pirelli | 4mm / 4mm |
| 2) | 205/60 R16 96V | Summer tyres on Light alloy | Pirelli | 6mm / 6mm |

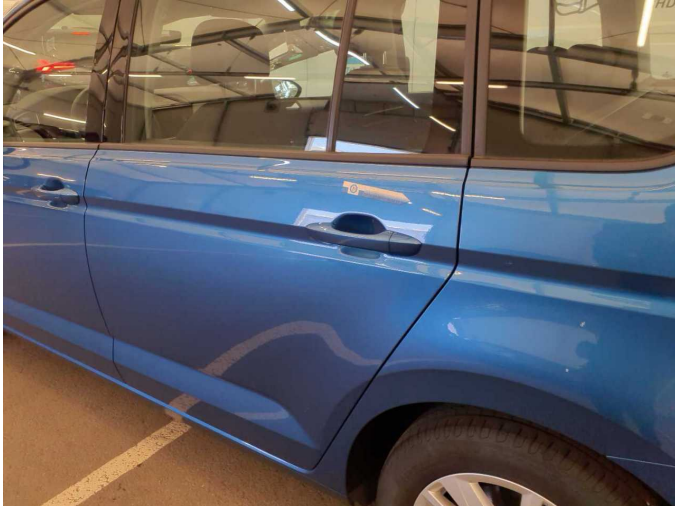
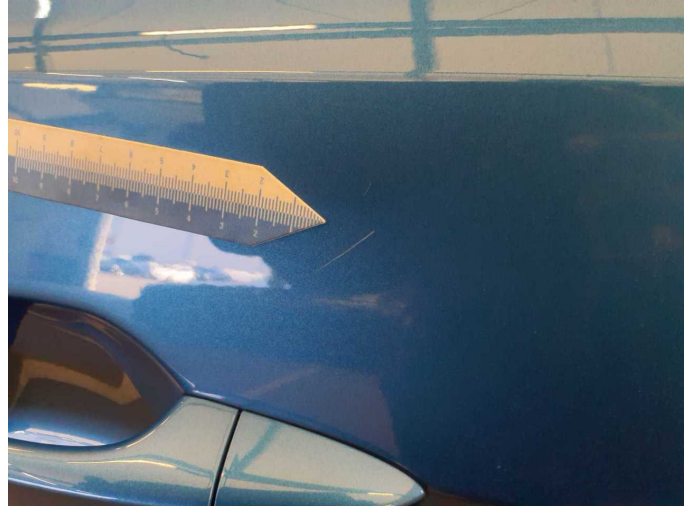
| No. | Component group | Description |
|---|---|---|
| 1 | Door - rear left side | Door - Scratch(es) - Smart repair |

**Damage 1:** Door - rear left side: Door - Scratch(es) - Smart repair

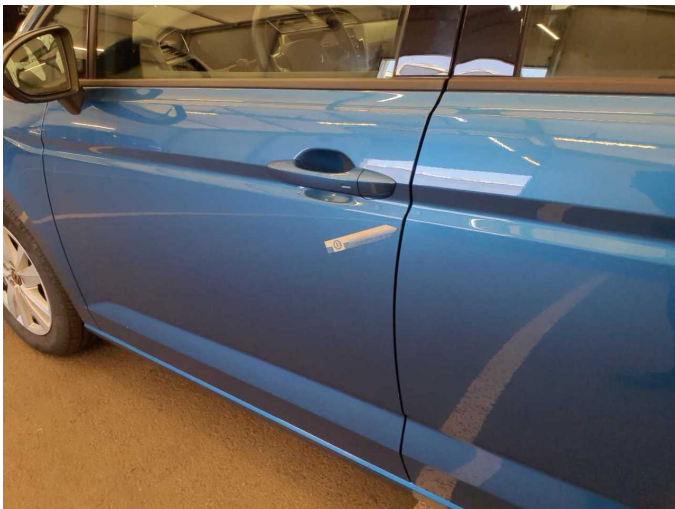
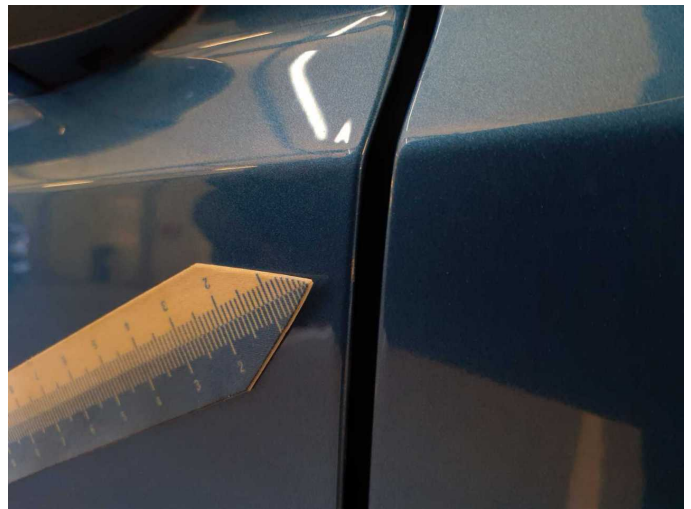
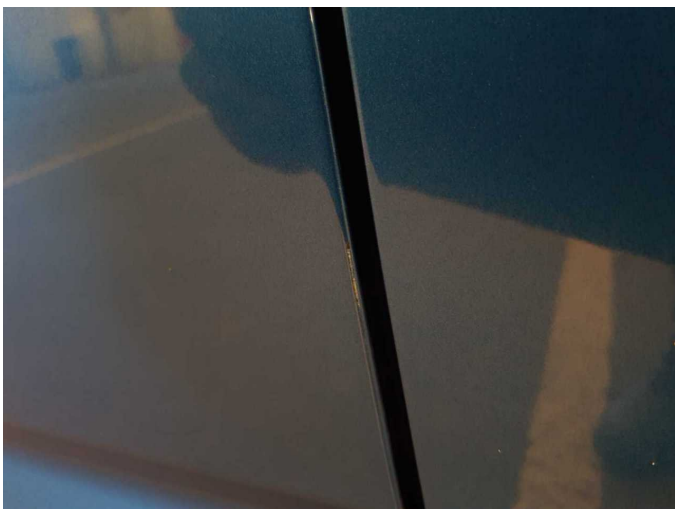
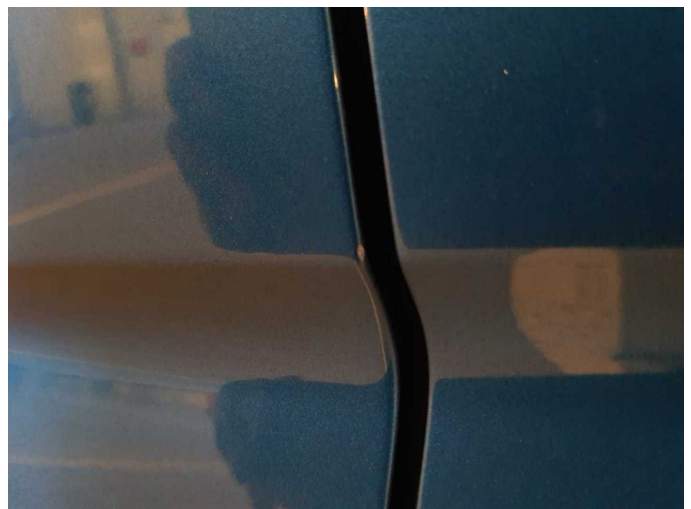
| No. | Component group | Description |
|---|---|---|
| 2 | Door - front left side | Door edge - Scratch(es) - Smart repair |

**Damage 2:** Door - front left side: Door edge - Scratch(es) - Smart repair

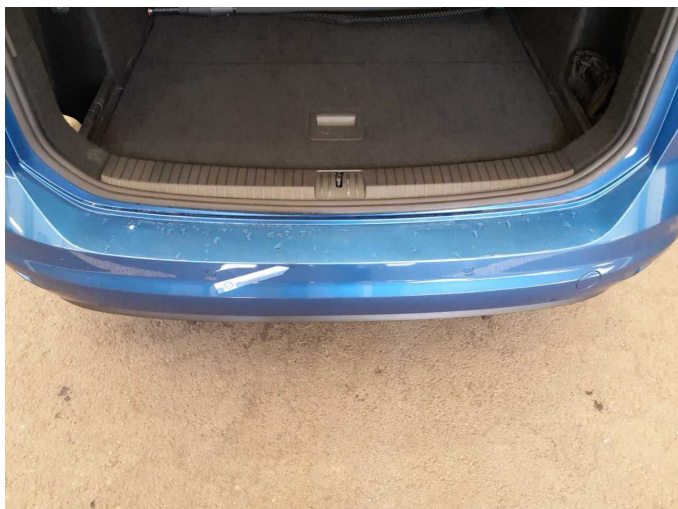
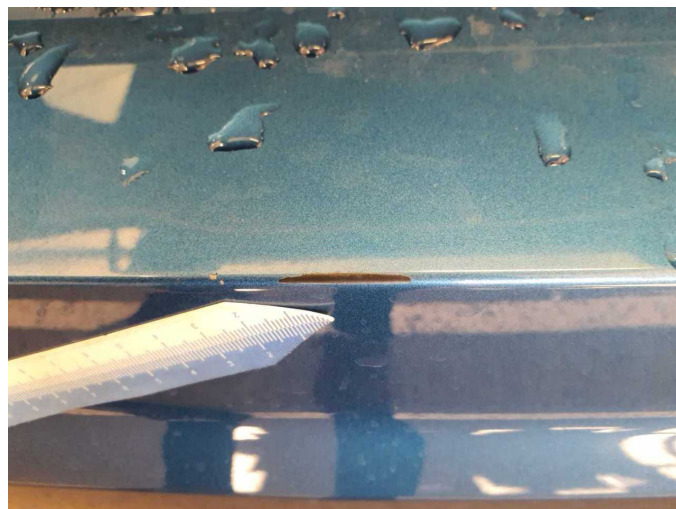
| No. | Component group | Description |
|---|---|---|
| 3 | Rear bumper | Rear bumper - Scratch(es) - Smart repair |

**Damage 3:** Rear bumper: Rear bumper - Scratch(es) - Smart repair

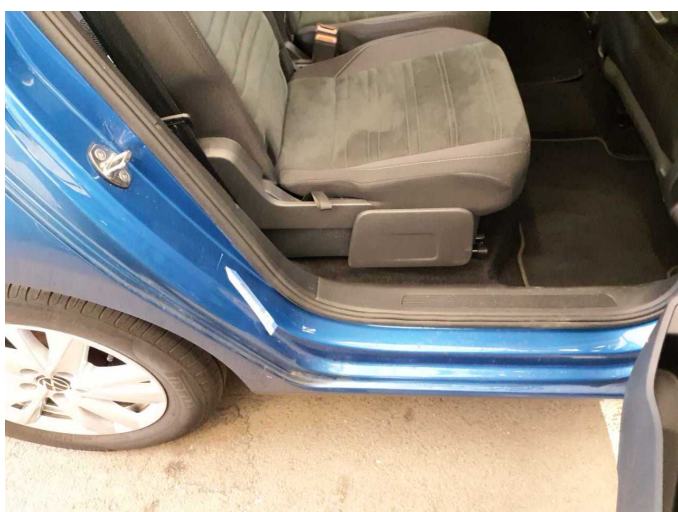
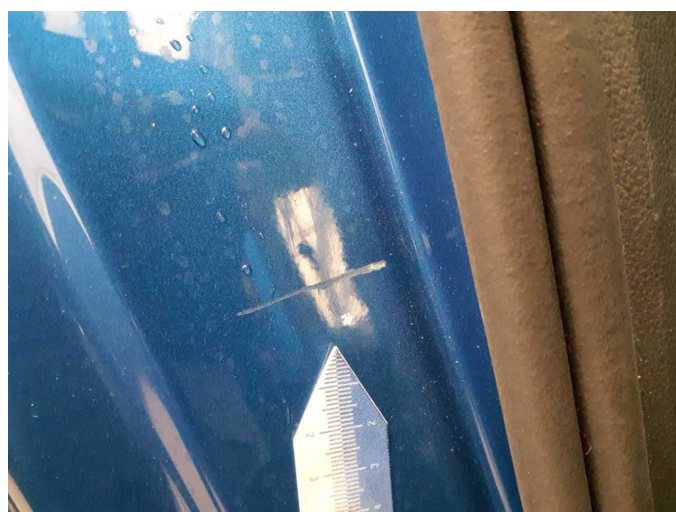
| No. | Component group | Description |
|---|---|---|
| 4 | Side panel - rear right side | Sill - Scratch(es) - Smart repair |

**Damage 4:** Side panel - rear right side: Sill - Scratch(es) - Smart repair

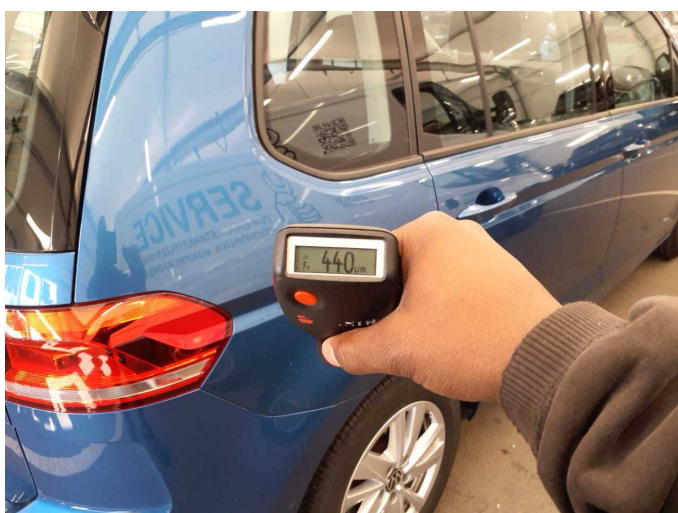
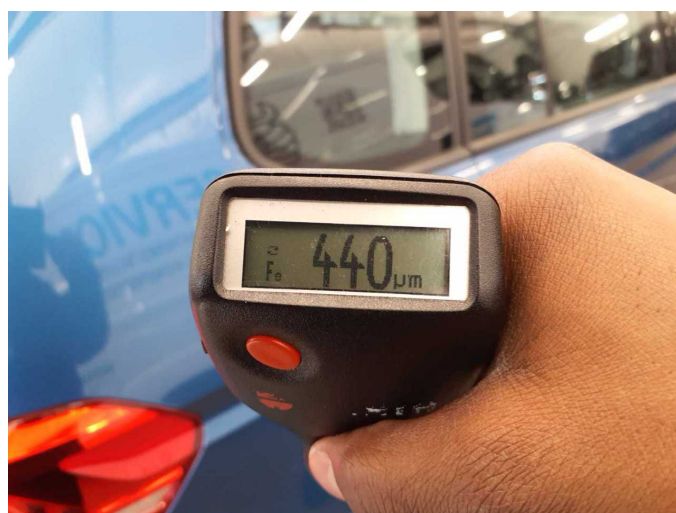
| No. | Repainting |
|---|---|
| 1 | Side panel - rear right side, Professionally carried out, Invoice of repair done Non-existent |

| Side panel - rear right side | 440 µm |

**Repainting 1:** Side panel - rear right side
