Expertise

Protocol number: 46347685
Order No. / Reference: 26042940
Inspection date: 2 Jul 2026

Manufacturer: Mercedes-Benz

Model: Vito 116 CDI Extralang HA Aut. PRO

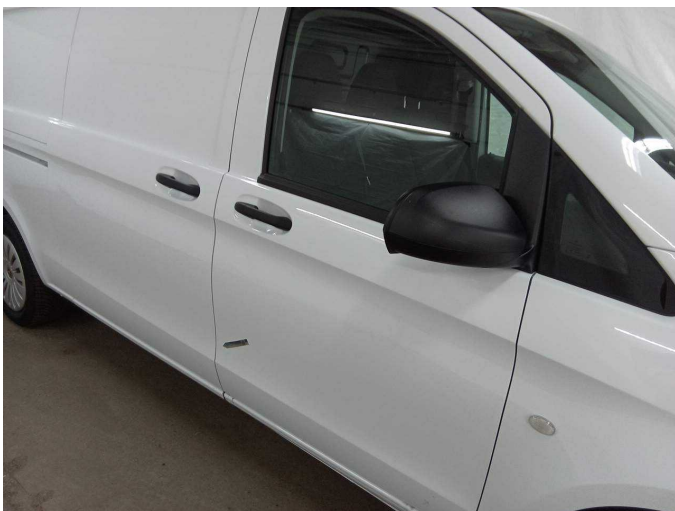
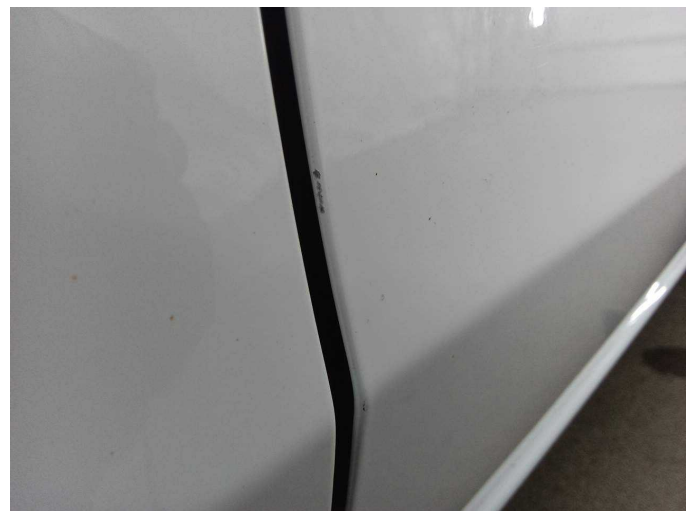
No.	Component group	Description
1	Door - front right side	Door edge - Scratch(es) - Smart repair
2	Rear bumper	Rear bumper - Scratch(es) - Smart repair
3	Front bumper	Front bumper - Scratch(es) - Smart repair

Damage 1: Door - front right side: Door edge - Scratch(es) - Smart repair

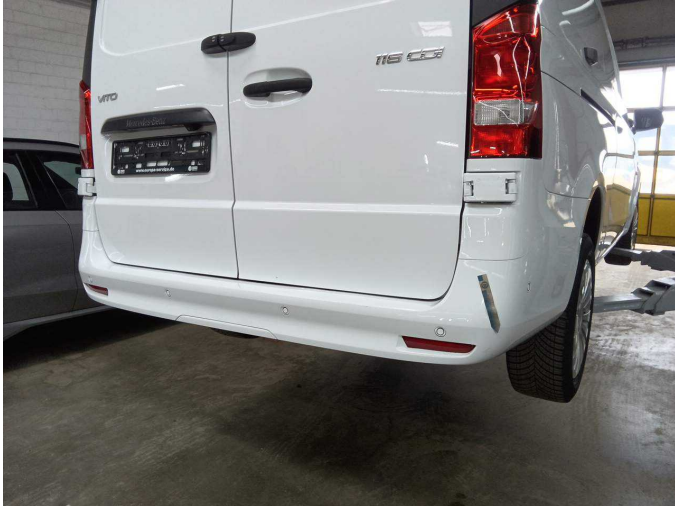
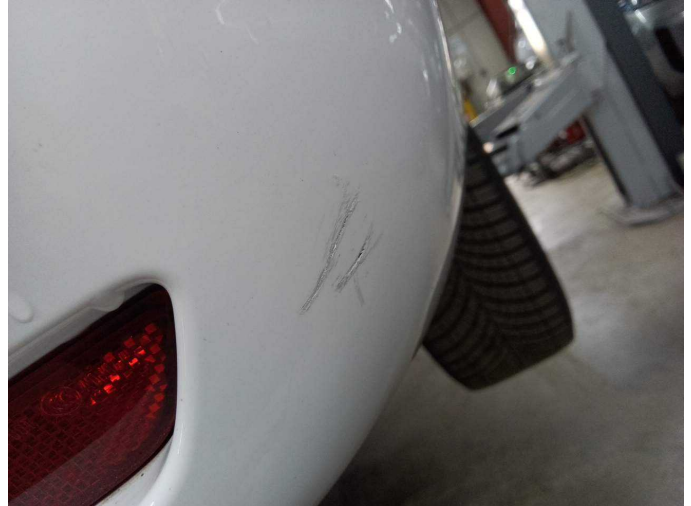
Damage 2: Rear bumper: Rear bumper - Scratch(es) - Smart repair

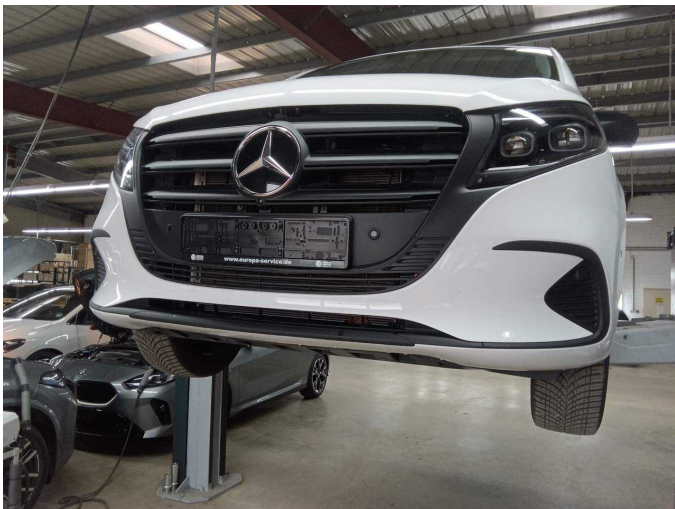
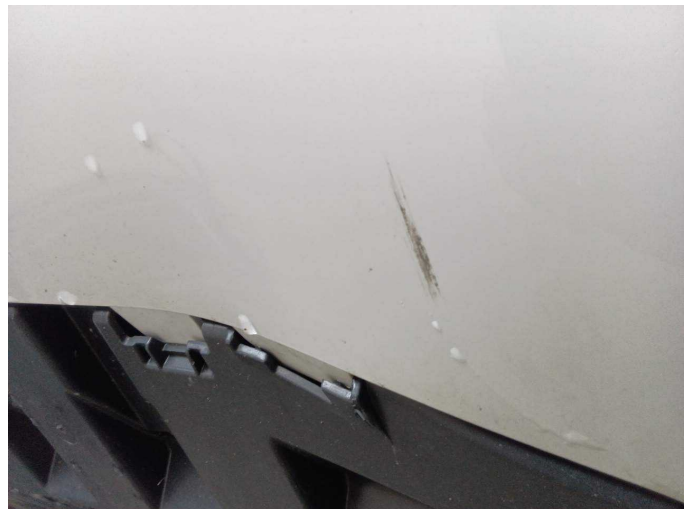
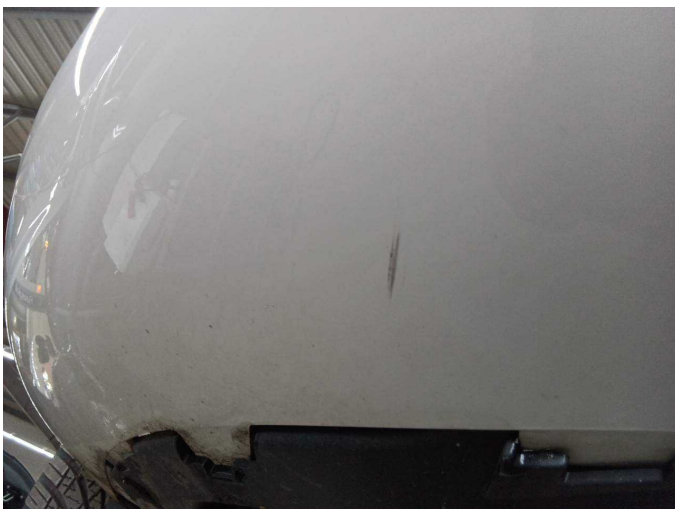
Damage 3: Front bumper: Front bumper - Scratch(es) - Smart repair

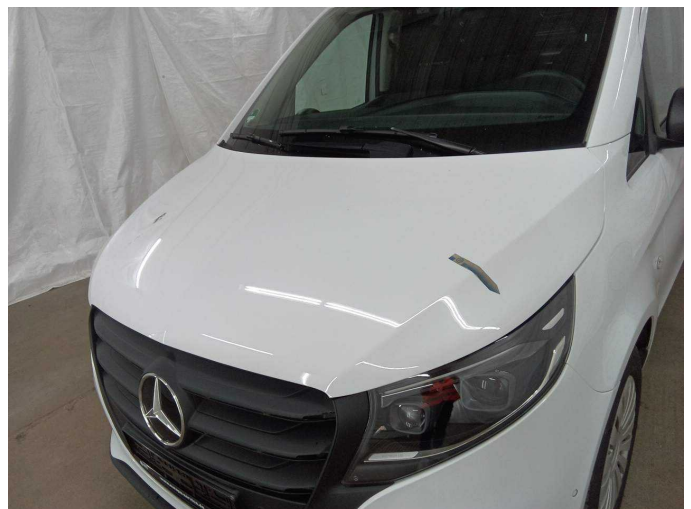
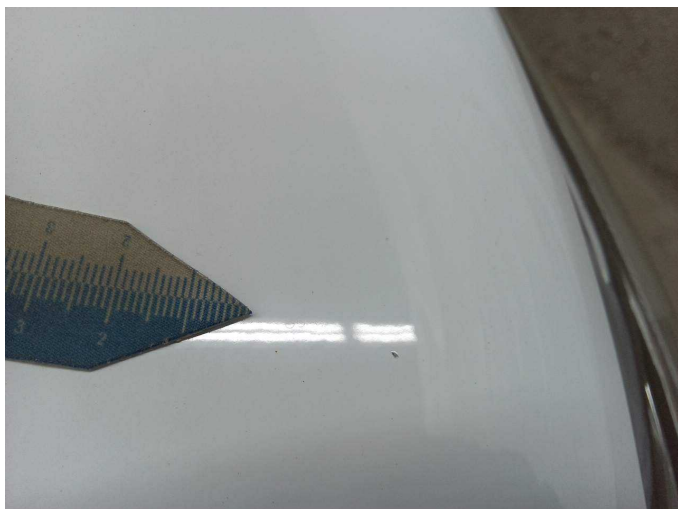
No.	Component group	Description
1	Bonnet	Bonnet - Stone chips - No deduction

Wear and tear 1: Bonnet: Bonnet - Stone chips - No deduction
