Expertise

Protocol number: 46161754
Order No. / Reference: 26485253
Inspection date: 24 Jun 2026

Model: SANTA FE 1.6 Plugin-Hybrid 4WD Signature

VIN: KMHS4812DNU044458

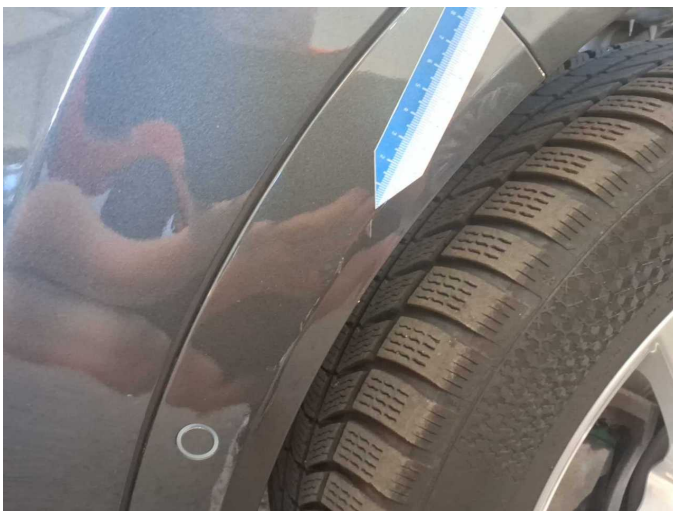
Damage 1: Mudguard - left side: Wheel well extension - Scratch(es) - Smart repair

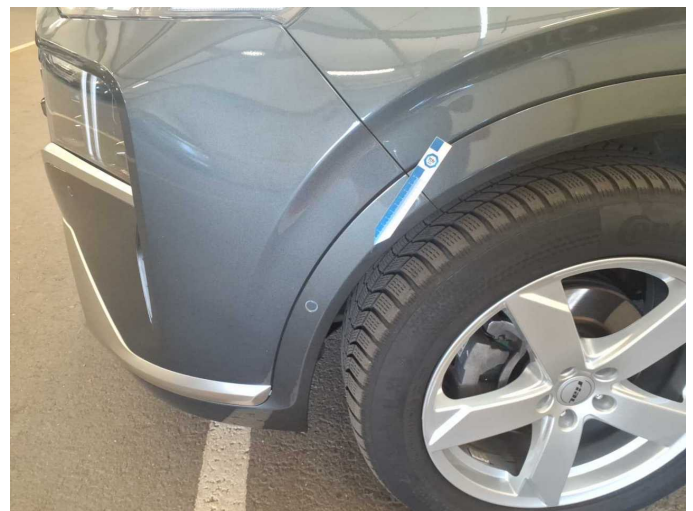
Damage 1: Mudguard - left side: Wheel well extension - Scratch(es) - Smart repair

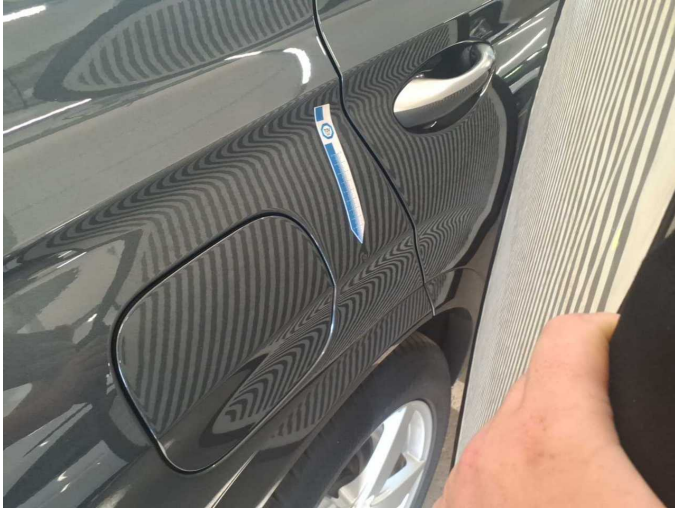
Damage 2: Side panel - rear right side: Side panel - dent(s) - Smooth repair work

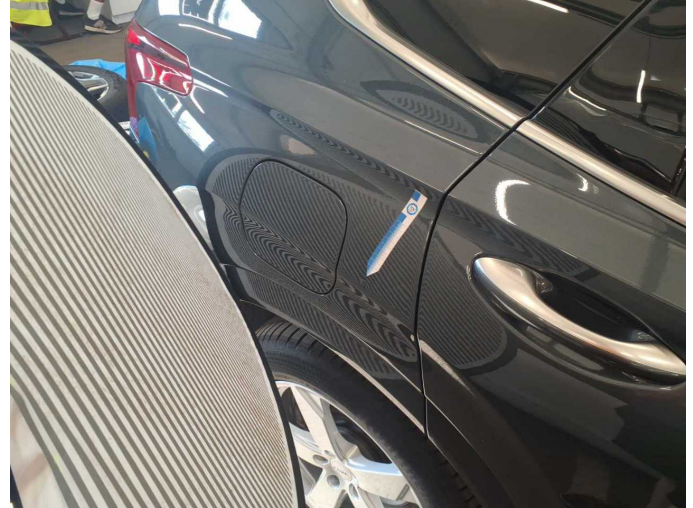
Damage 2: Side panel - rear right side: Side panel - dent(s) - Smooth repair work

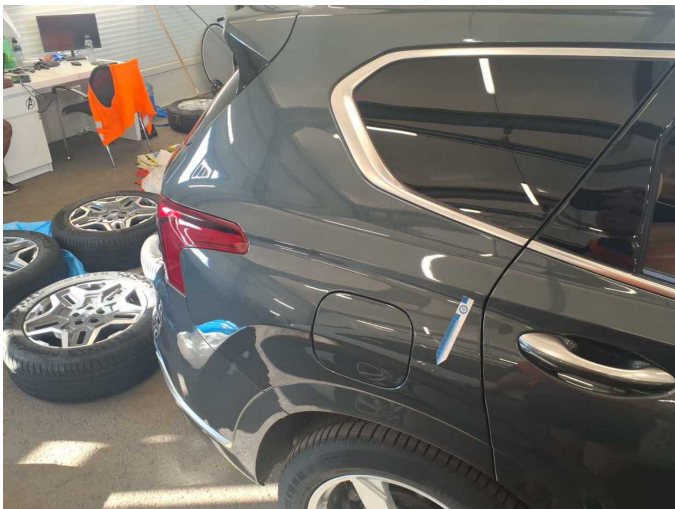
Damage 2: Side panel - rear right side: Side panel - dent(s) - Smooth repair work

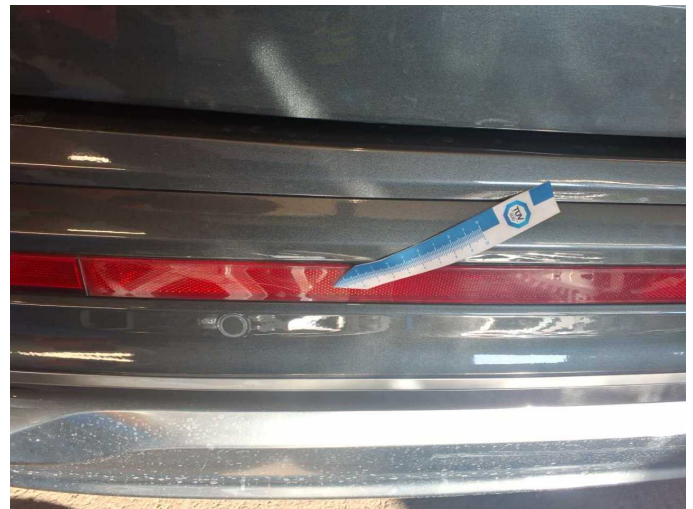
Damage 3: Boot lid / rear door: Reflectors - Scratch(es) - Replace

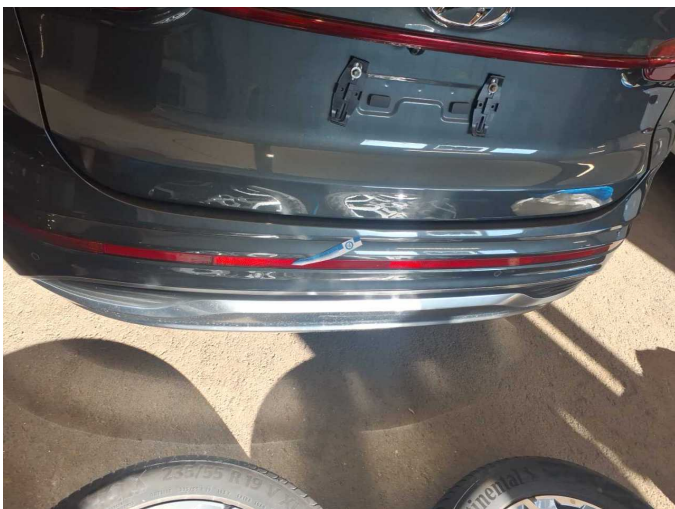
Damage 3: Boot lid / rear door: Reflectors - Scratch(es) - Replace

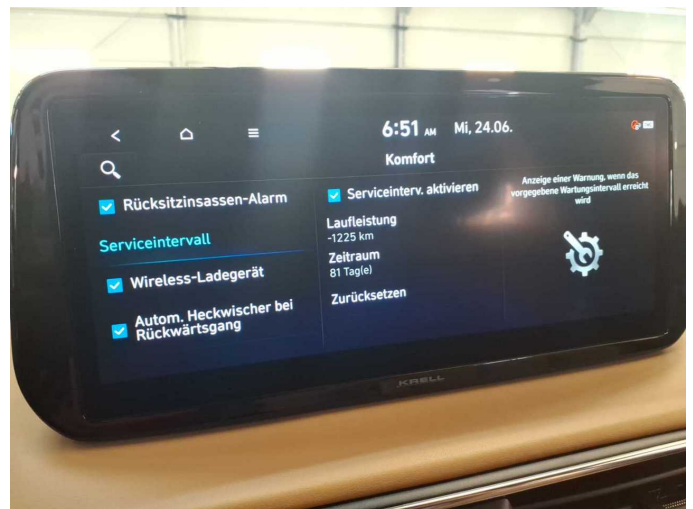
Damage 4: Misc.: Inspection / maintenance - Expired - Perform

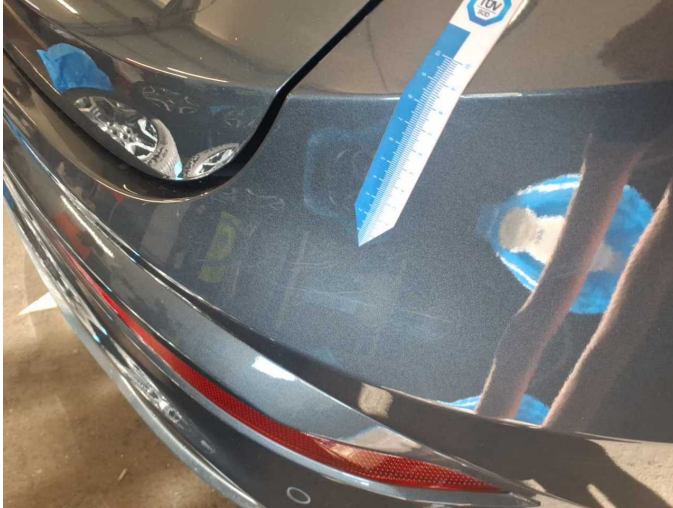
Damage 5: Rear bumper: Rear bumper - Scratch(es) - Paint

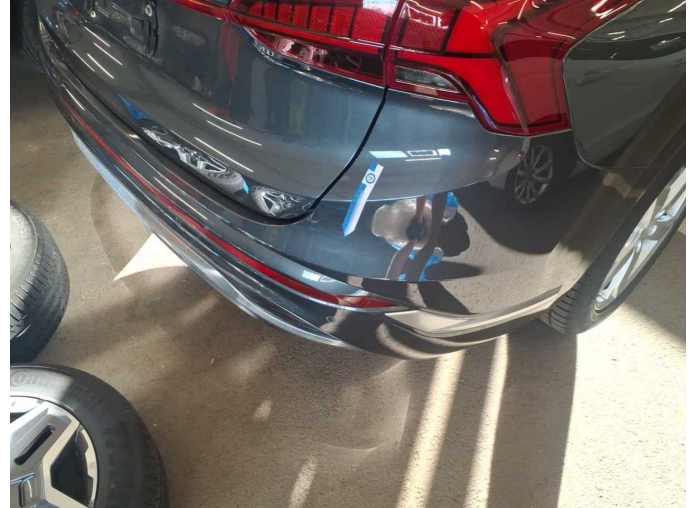
Damage 5: Rear bumper: Rear bumper - Scratch(es) - Paint

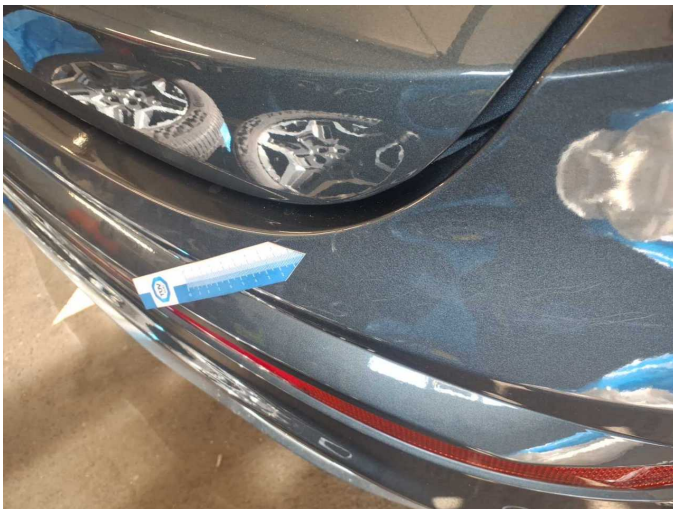
Damage 5: Rear bumper: Rear bumper - Scratch(es) - Paint

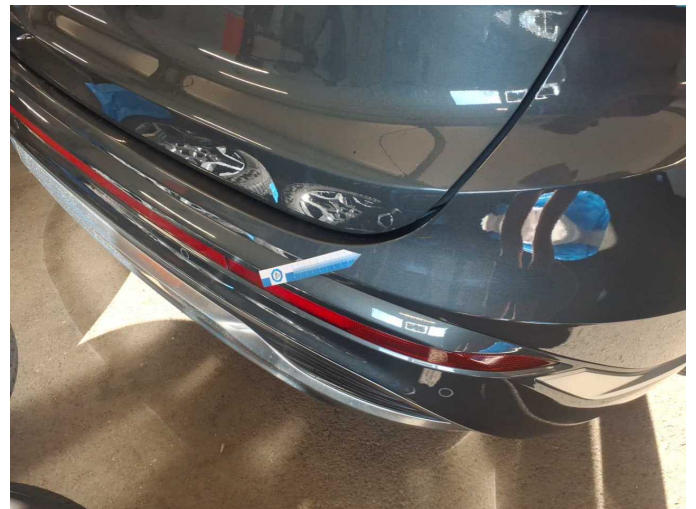
Damage 5: Rear bumper: Rear bumper - Scratch(es) - Paint

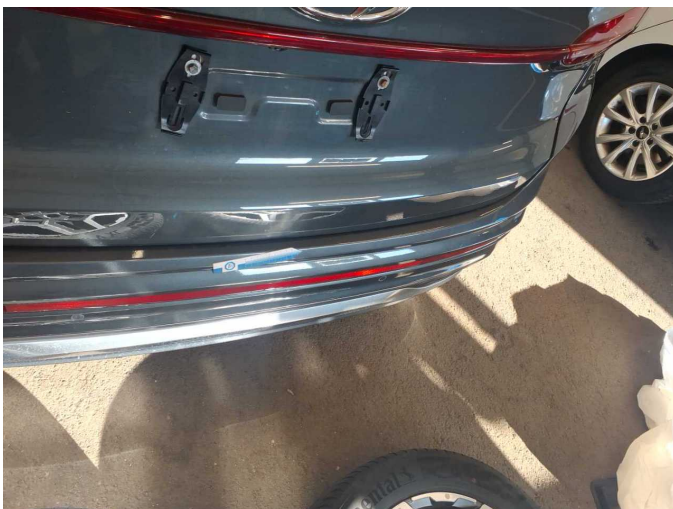
Damage 5: Rear bumper: Rear bumper - Scratch(es) - Paint

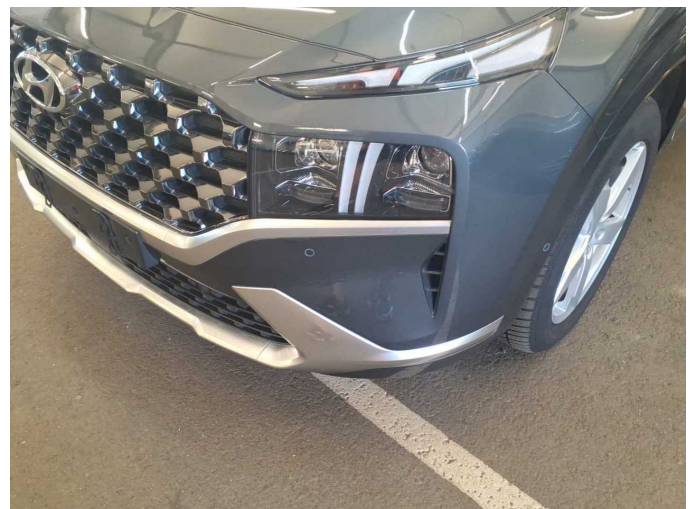
Wear and tear 1: Front bumper: Front bumper - Stone chips - No deduction

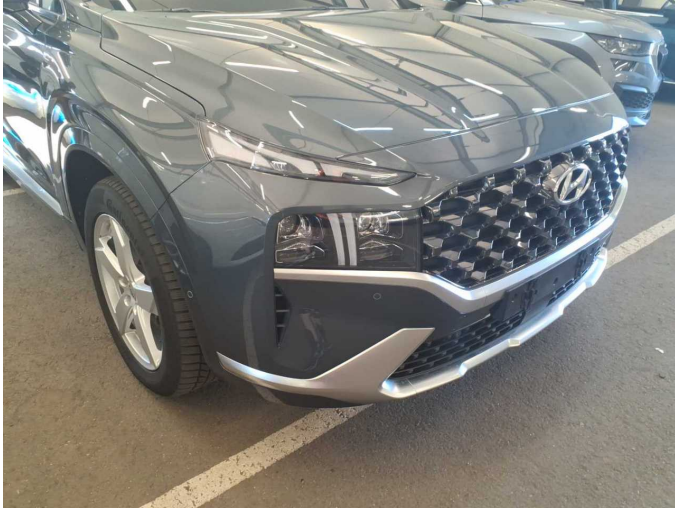
Wear and tear 1: Front bumper: Front bumper - Stone chips - No deduction

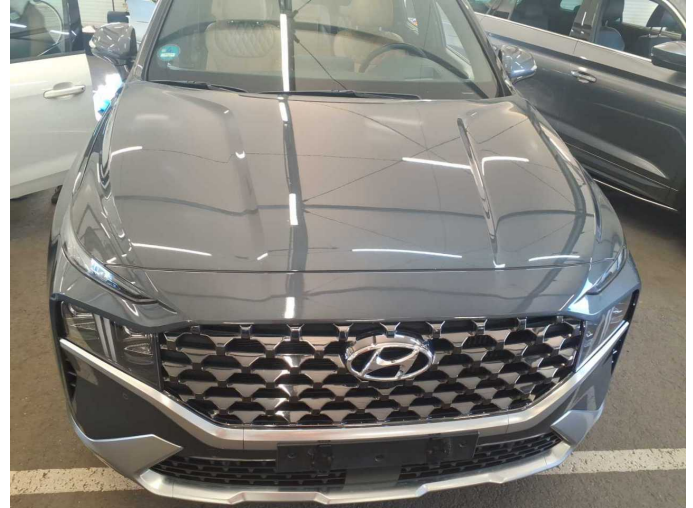
Wear and tear 2: Bonnet: Bonnet - Stone chips - No deduction

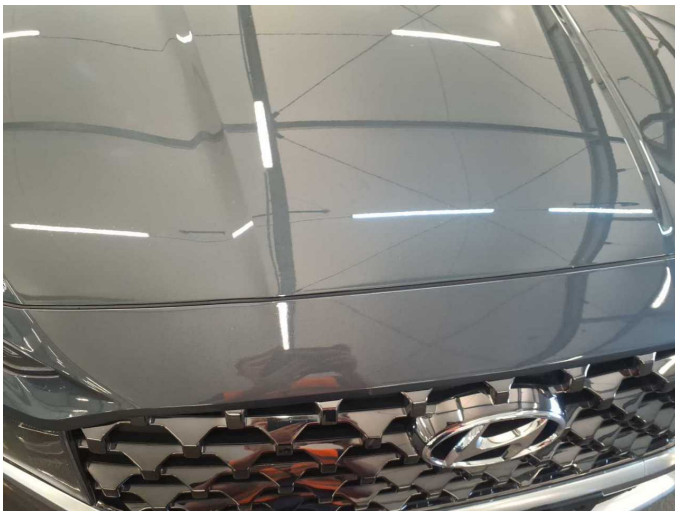
Wear and tear 2: Bonnet: Bonnet - Stone chips - No deduction

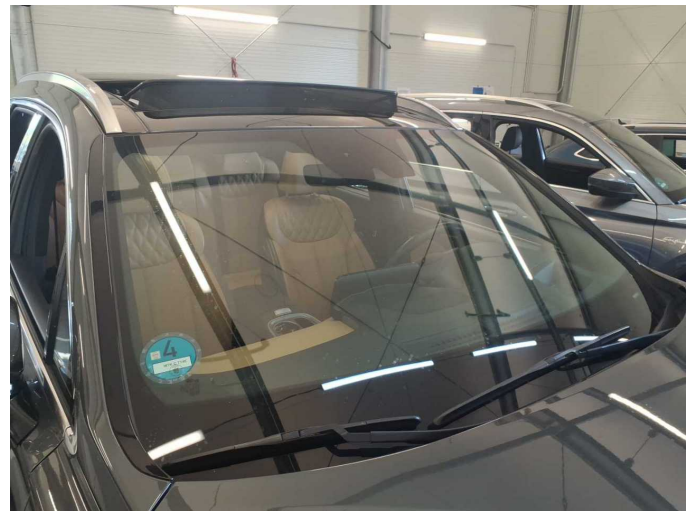
Wear and tear 3: Vehicle glazing: Windscreen - Stone chips - No deduction

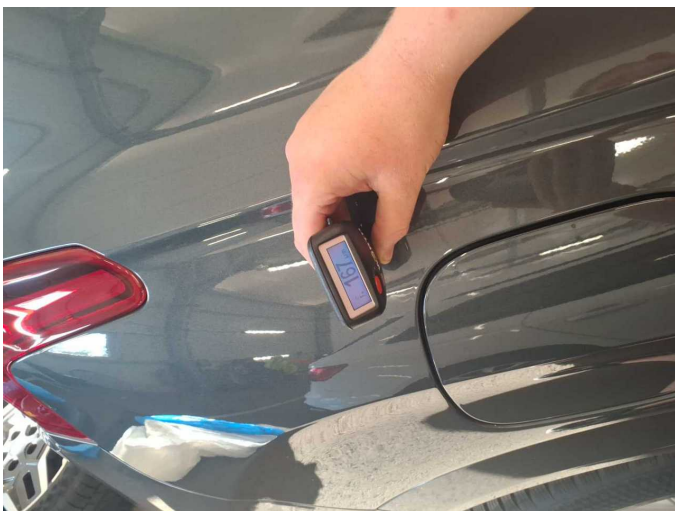
Side panel - rear right side	167 µm	Door - rear right side	176 µm
------------------------------	--------	------------------------	--------

Repainting 1: Side panel - rear right side

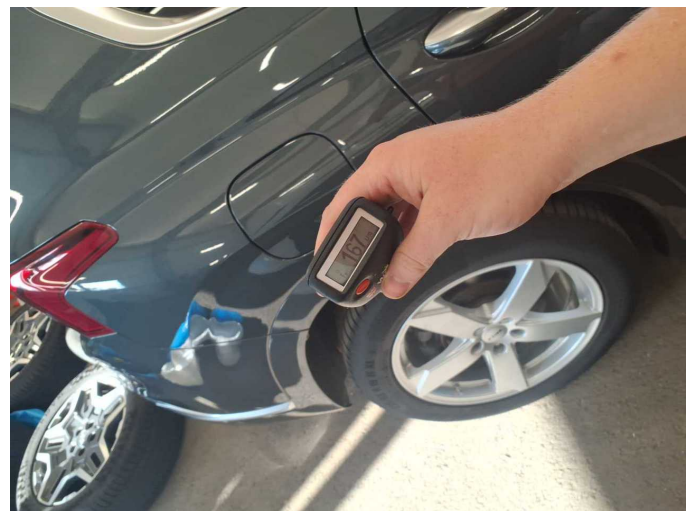
Repainting 1: Side panel - rear right side

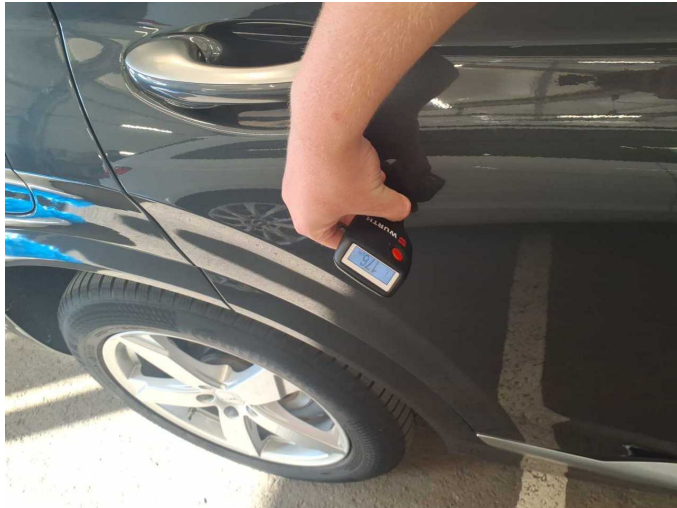
Repainting 2: Door - rear right side

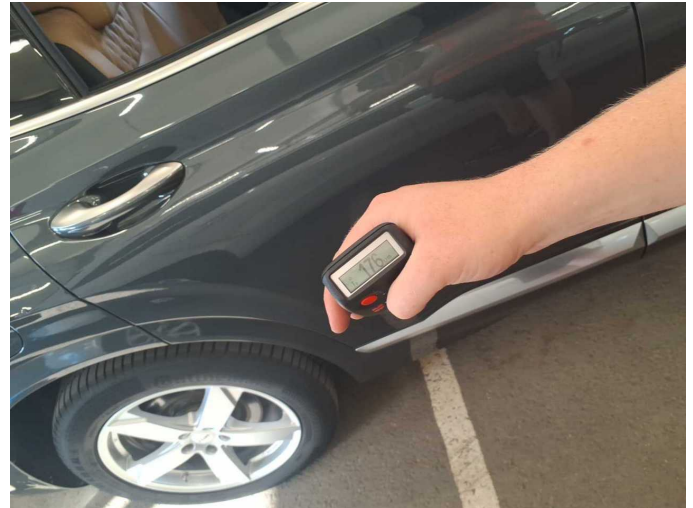
Repainting 2: Door - rear right side
