Expertise

Protocol number: 46898786  
Order No. / Reference: 26760582  
Inspection date: 5 Aug 2026

Manufacturer: Ford

Model: S-Max 2.5 Duratec FHEV (7-Sitzer) TITANIUM

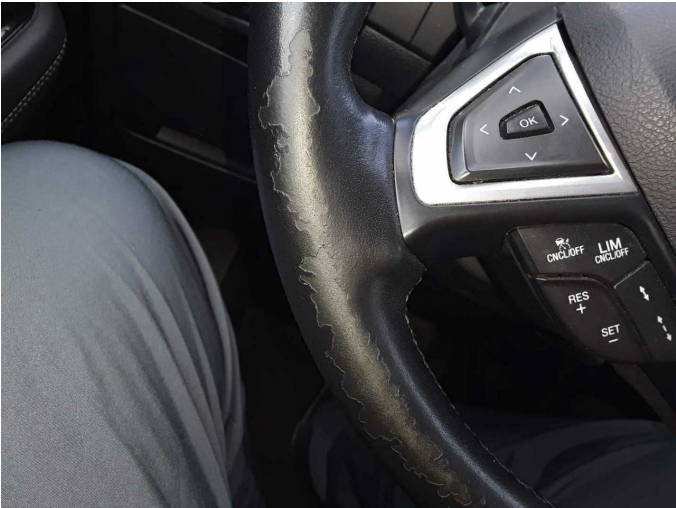
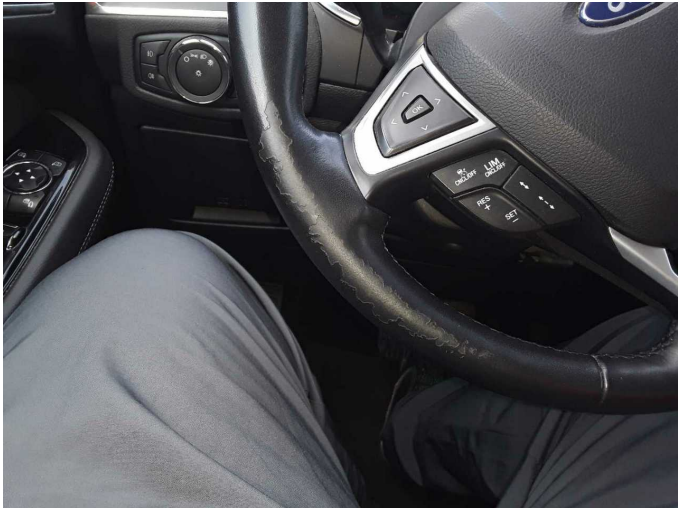
| No. | Component group | Description |
|---|---|---|
| 1 | Steering system | Steering wheel - Damaged - Smart repair |

Damage 1: Steering system: Steering wheel - Damaged - Smart repair

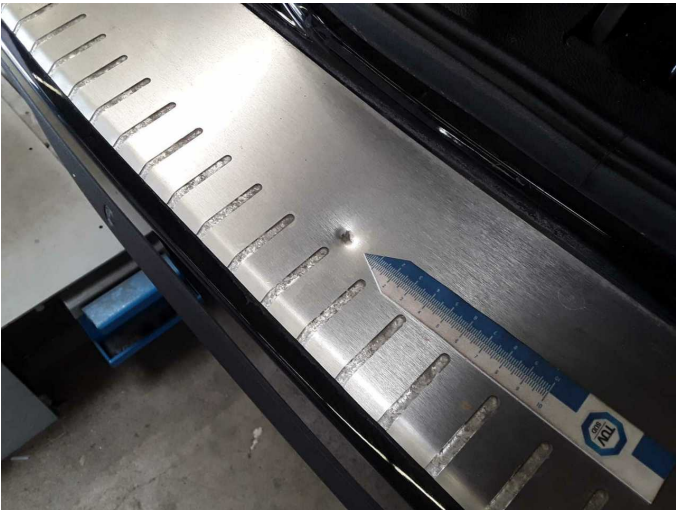
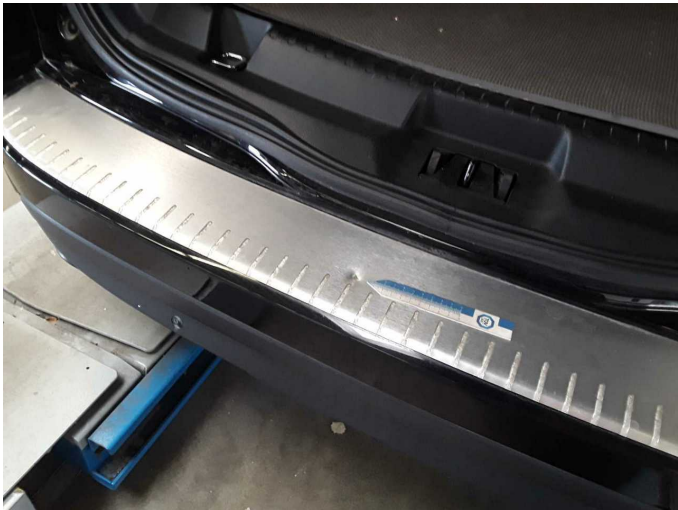
| No. | Component group | Description |
|---|---|---|
| 2 | Rear bumper | Cover - bumper - rear - Damaged - Replace |

Damage 2: Rear bumper: Cover - bumper - rear - Damaged - Replace

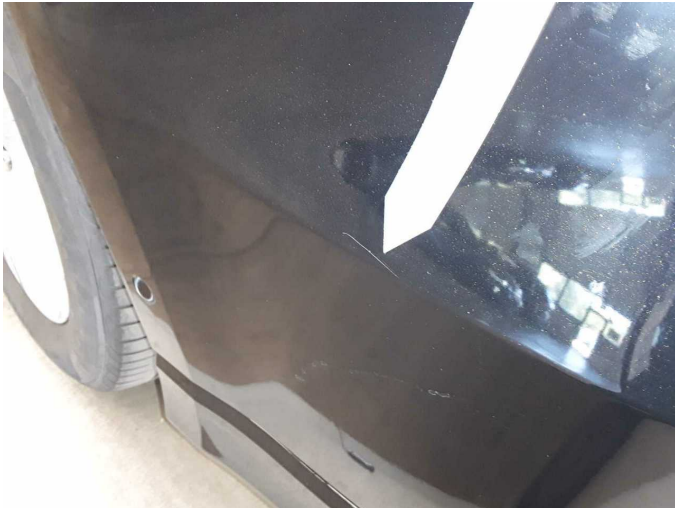
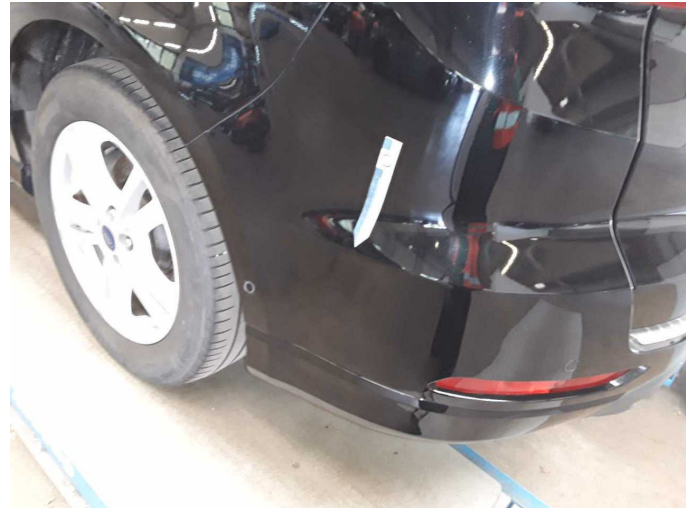
| No. | Component group | Description |
|---|---|---|
| 3 | Rear bumper | Rear bumper - Scratch(es) - Smart repair |

**Damage 3:** Rear bumper: Rear bumper - Scratch(es) - Smart repair

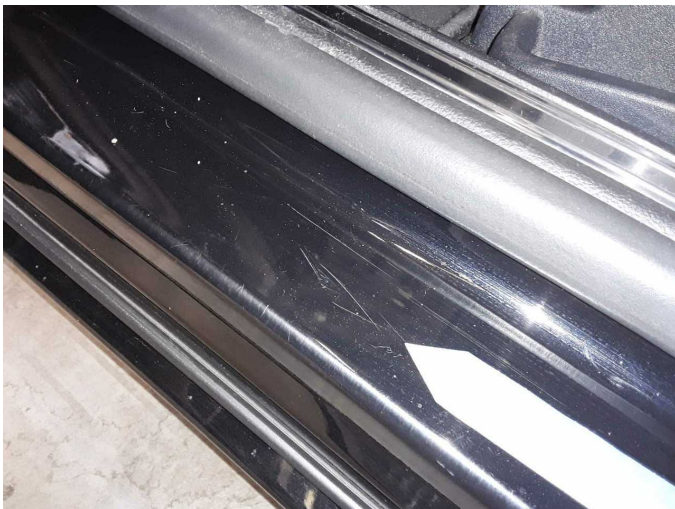
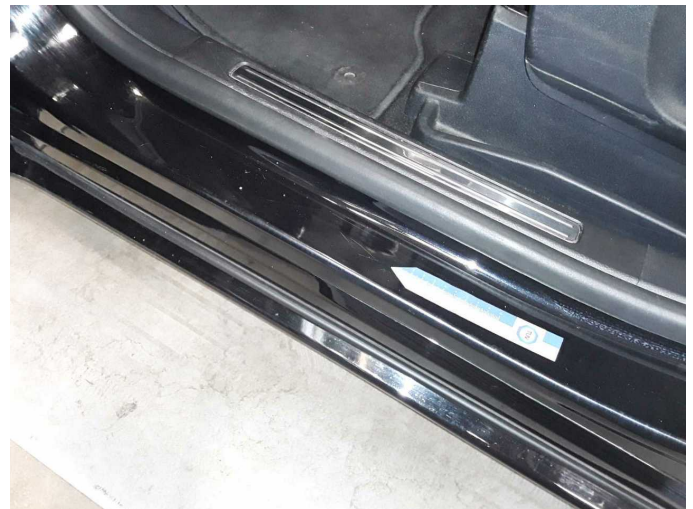
| No. | Component group | Description |
|---|---|---|
| 4 | Sill - left side | Sill - Scratch(es) - Smart repair |

**Damage 4:** Sill - left side: Sill - Scratch(es) - Smart repair

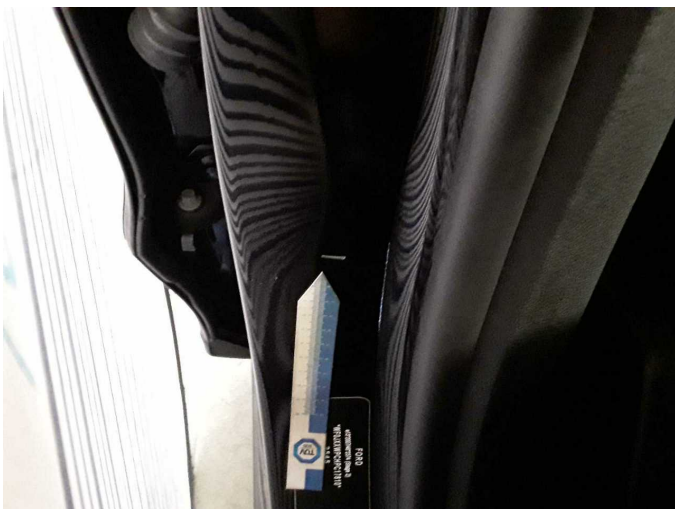
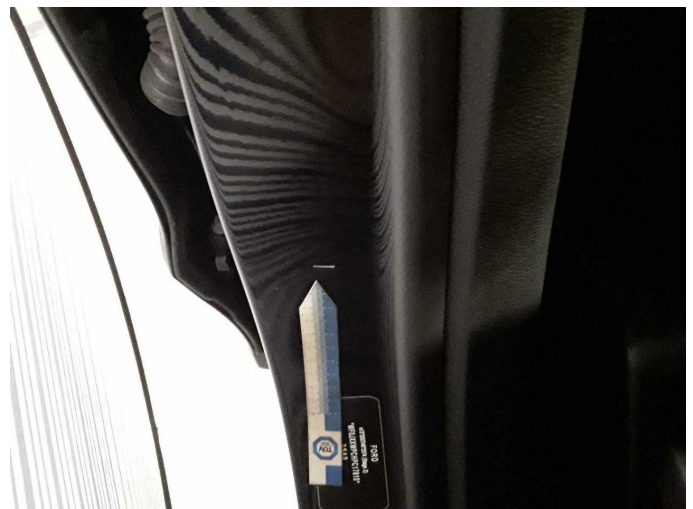
| No. | Component group | Description |
|---|---|---|
| 5 | Body | B-pillar - right side - Dent / paintcoat damage - Smart repair |

**Damage 5:** Body: B-pillar - right side - Dent / paintcoat damage - Smart repair

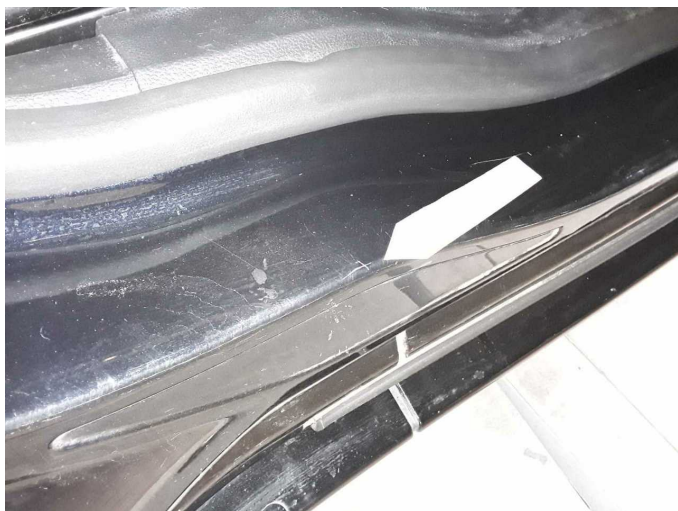
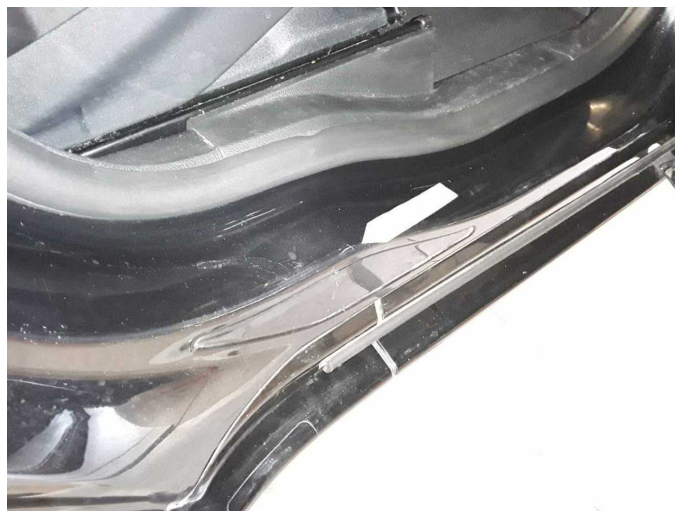
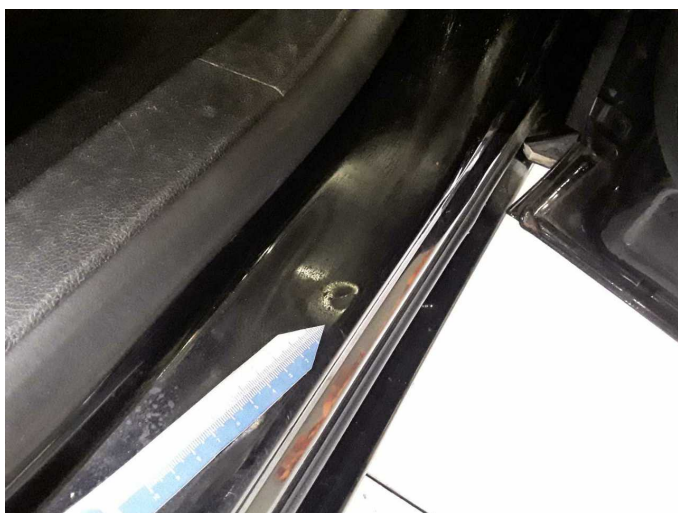
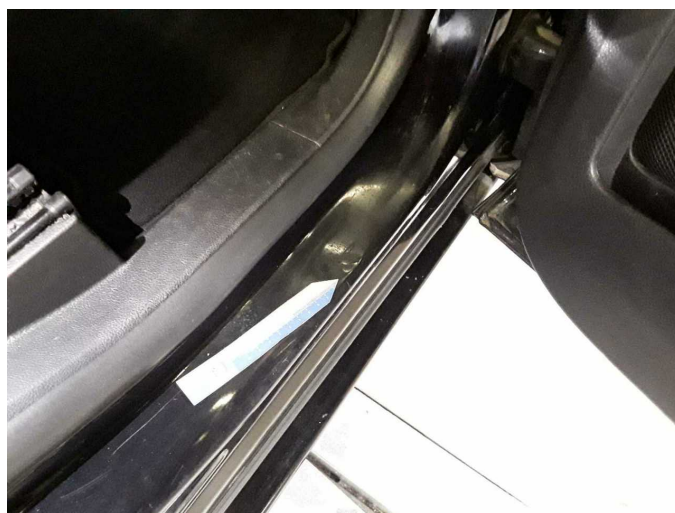
| No. | Component group | Description |
|---|---|---|
| 6 | Side panel - rear right side | Sill - Dent / paintcoat damage - Smart repair |

**Damage 6:** Side panel - rear right side: Sill - Dent / paintcoat damage - Smart repair

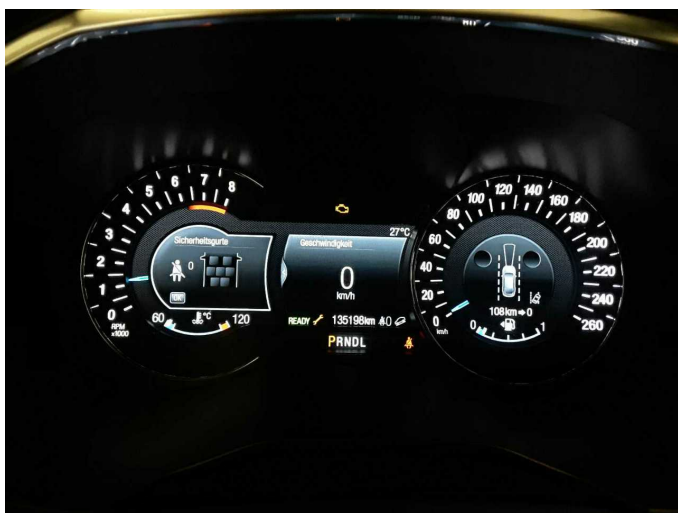
| No. | Component group | Description |
|---|---|---|
| 7 | Instrument panel | Indicator light (Motorkontrollleuchte) - on - Perform diagnosis |

**Damage 7:** Instrument panel: Indicator light (Motorkontrollleuchte) - on - Perform diagnosis

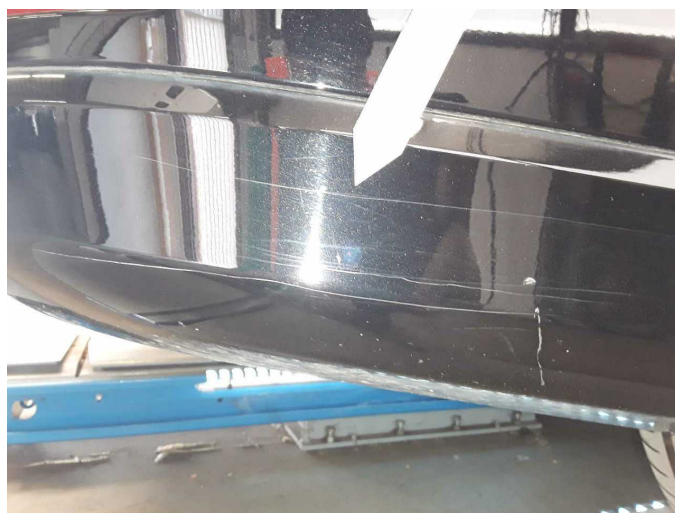
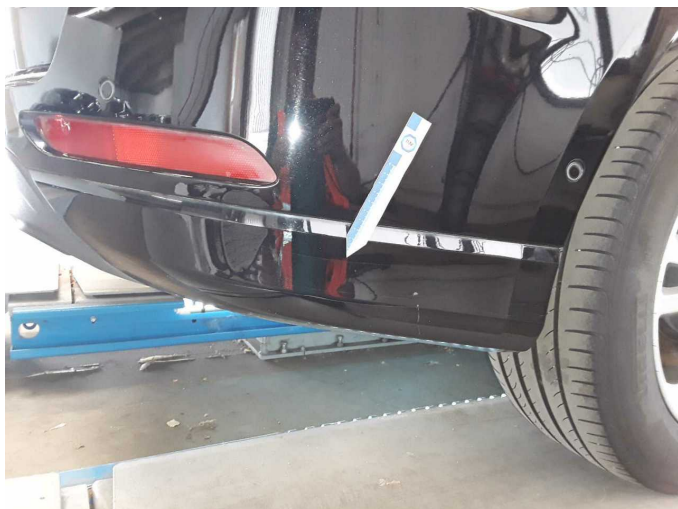
| No. | Component group | Description |
|---|---|---|
| 8 | Rear bumper | Rear bumper - Scratch(es) - Paint |

**Damage 8:** Rear bumper: Rear bumper - Scratch(es) - Paint

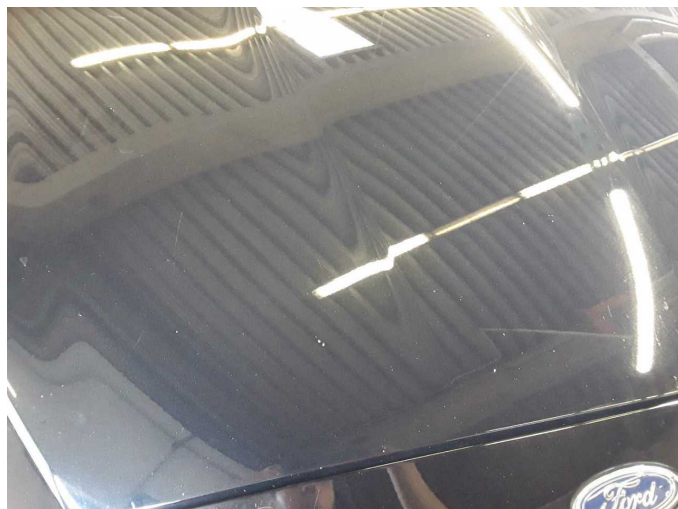
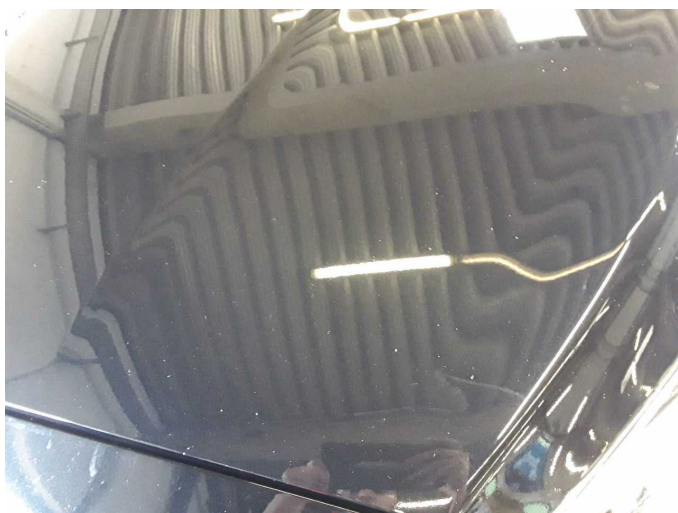
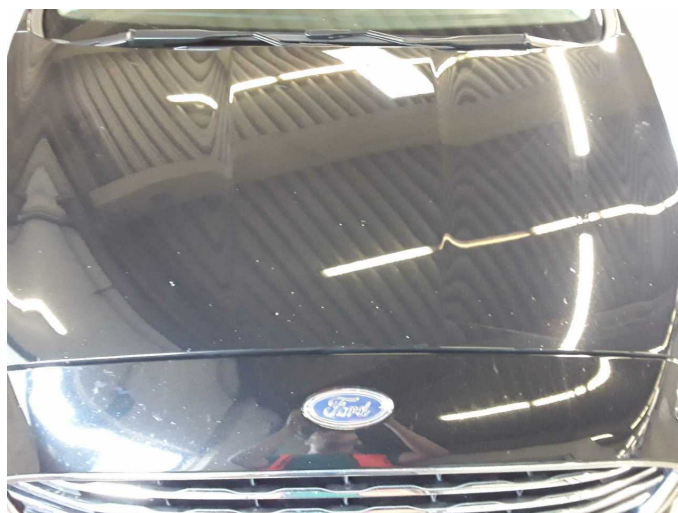
| No. | Component group | Description |
|---|---|---|
| 9 | Bonnet | Bonnet - Stone chips - Paint |

**Damage 9:** Bonnet: Bonnet - Stone chips - Paint

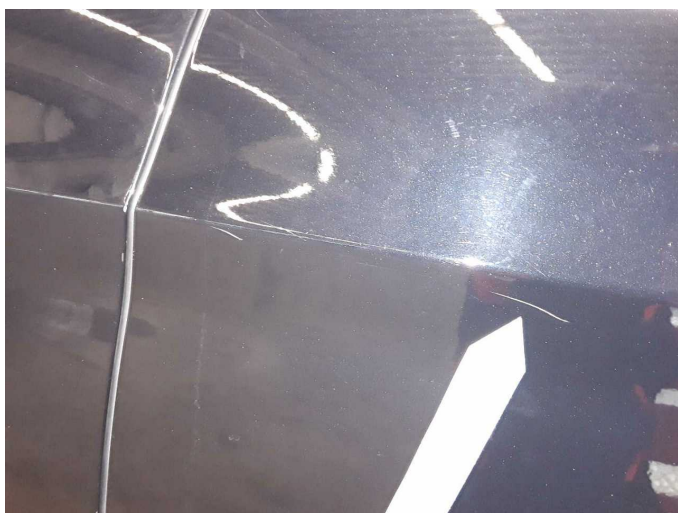
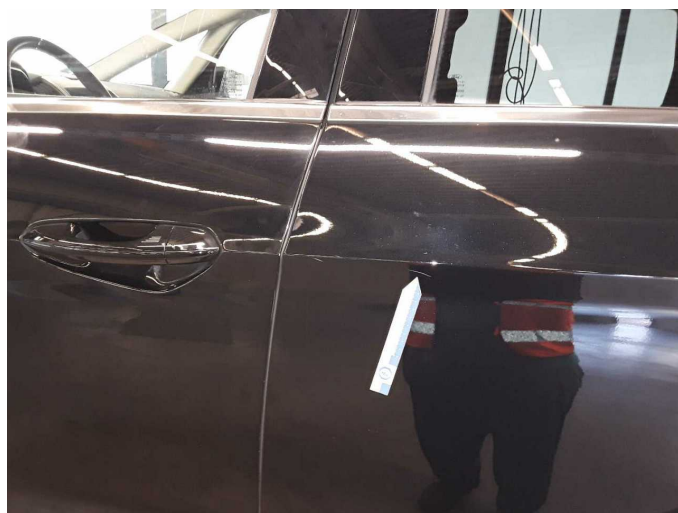
| No. | Component group | Description |
|---|---|---|
| 10 | Door - rear left side | Door - Scratch(es) - Paint |

**Damage 10:** Door - rear left side: Door - Scratch(es) - Paint

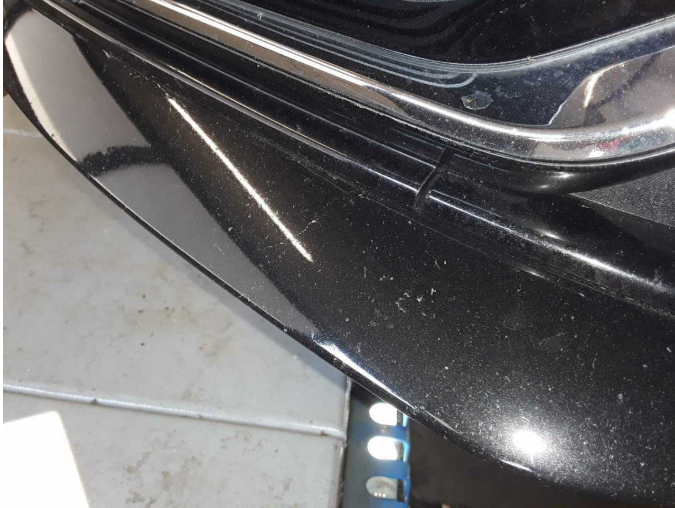
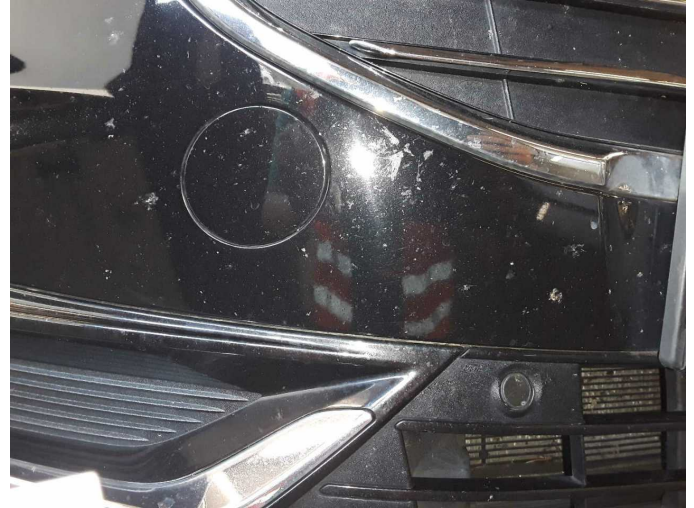
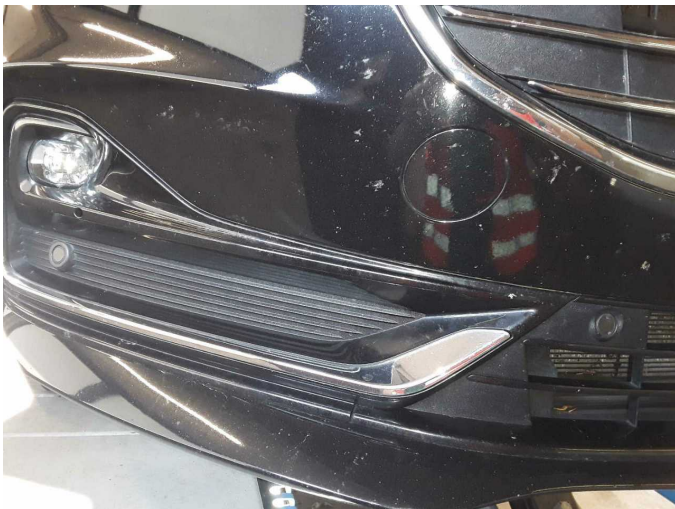
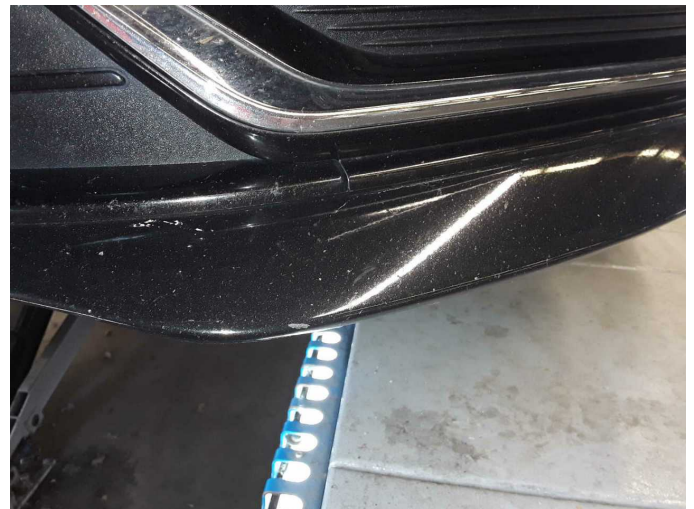
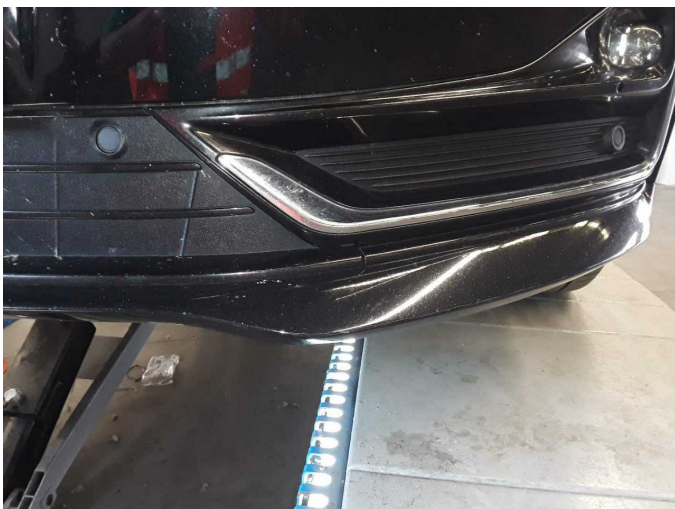
| No. | Component group | Description |
|---|---|---|
| 11 | Front bumper | Front bumper - Stone chips - Paint |

**Damage 11:** Front bumper: Front bumper - Stone chips - Paint
