Expertise

Protocol number: 45864321
Order No. / Reference: 26494647
Inspection date: 10 Jun 2026

Manufacturer: Opel

Model: Grandland 1.5 D Automatik Elegance

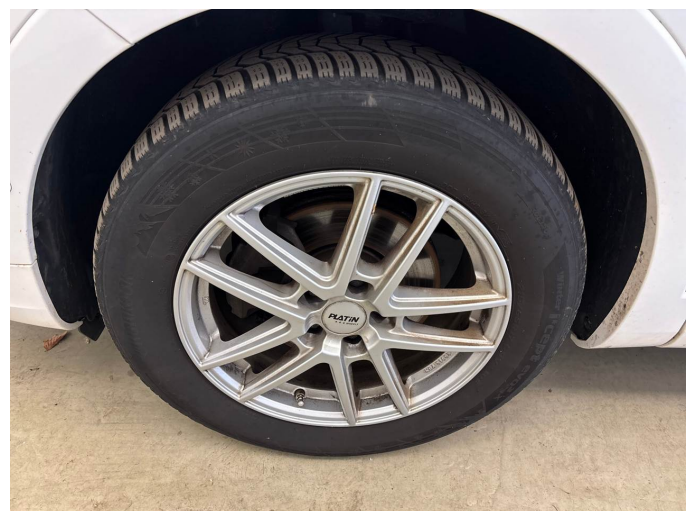
Figure 12: Mounted tyres

#	Tyre size	Type of tyre	Manufacturer	Tread depth
1)	215/65 R17 99V	Winter tyres on Light alloy	Hankook	3mm / 3mm
2)	215/65 R17 99V	Winter tyres on Light alloy	Hankook	5mm / 5mm

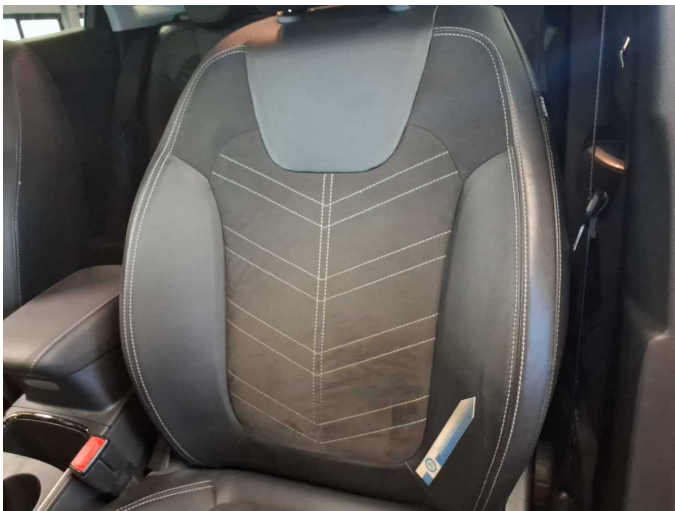
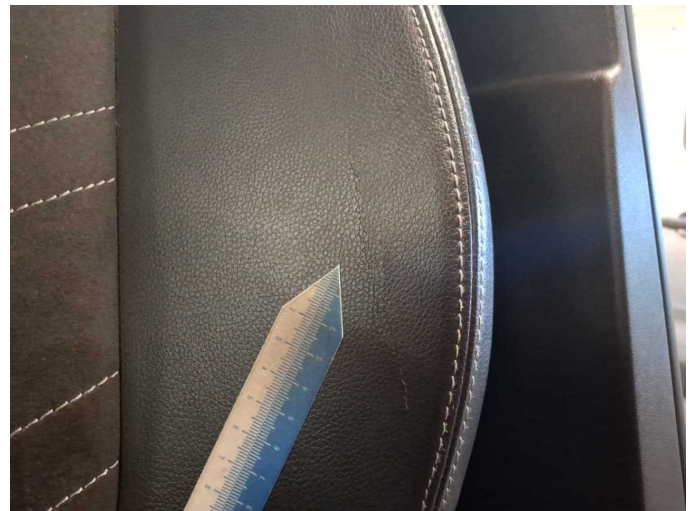
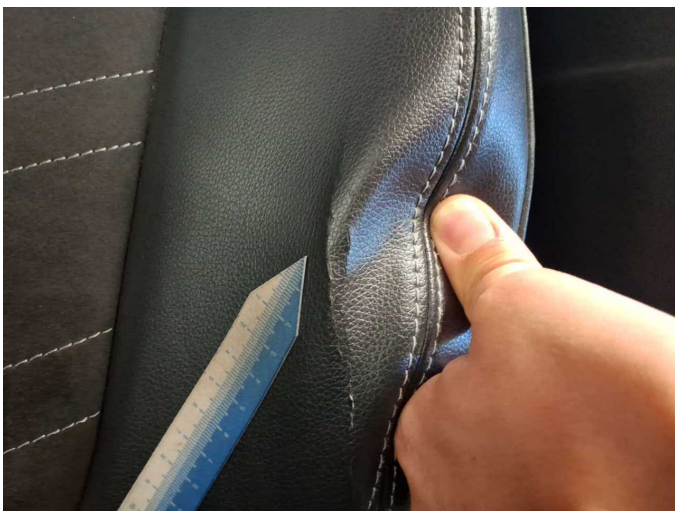
Damage 2: Seat - front: Backrest cover - left side - Broken / torn - Smart repair

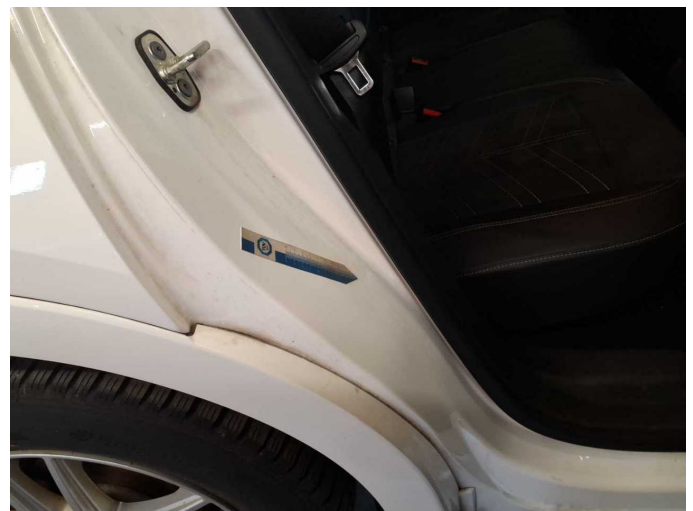
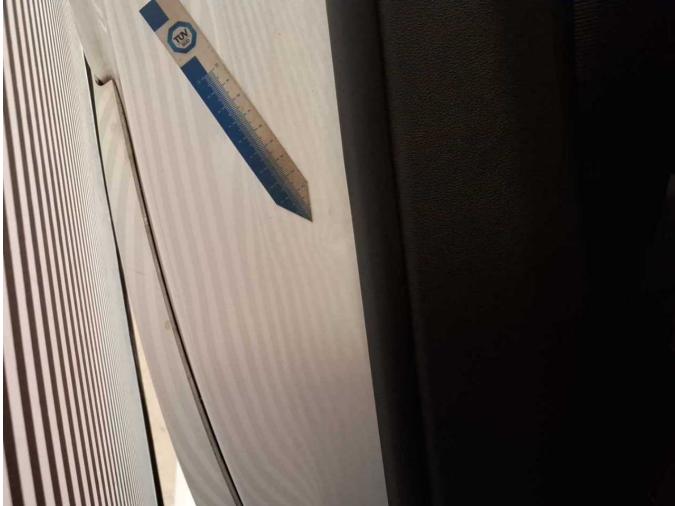
Damage 3: Side panel - rear right side: Sill - dent(s) - Smooth repair work

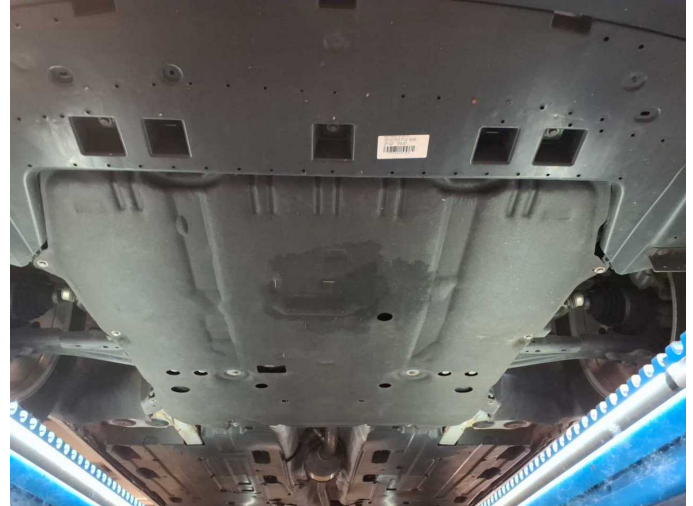
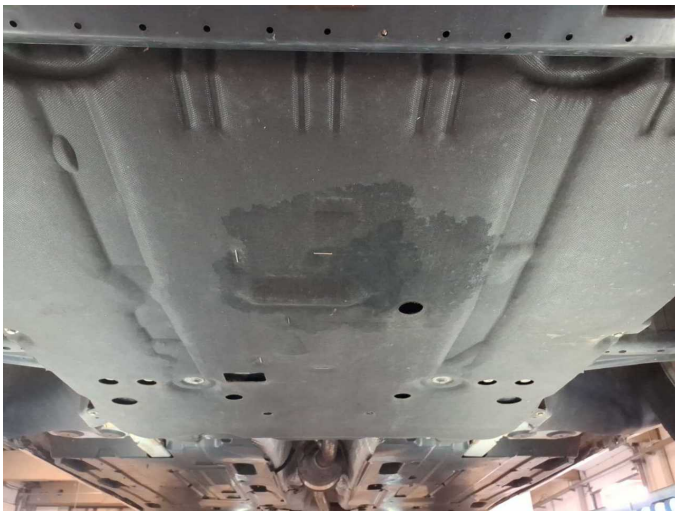
Damage 4: Engine: Engine (Motor/Getriebe) - Leaking - Perform diagnosis

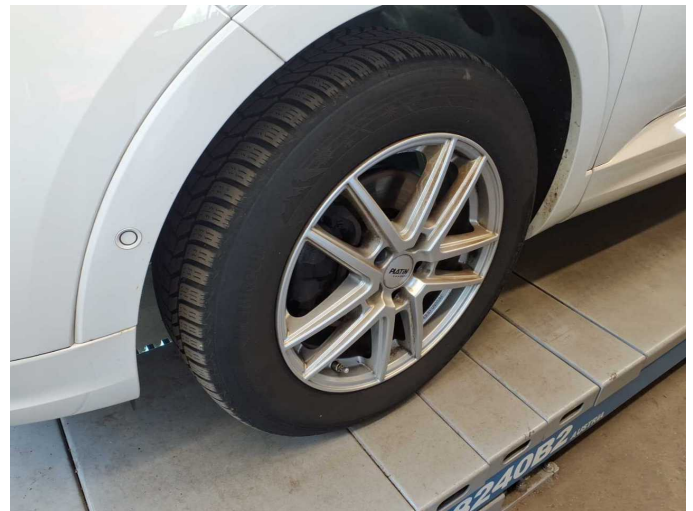
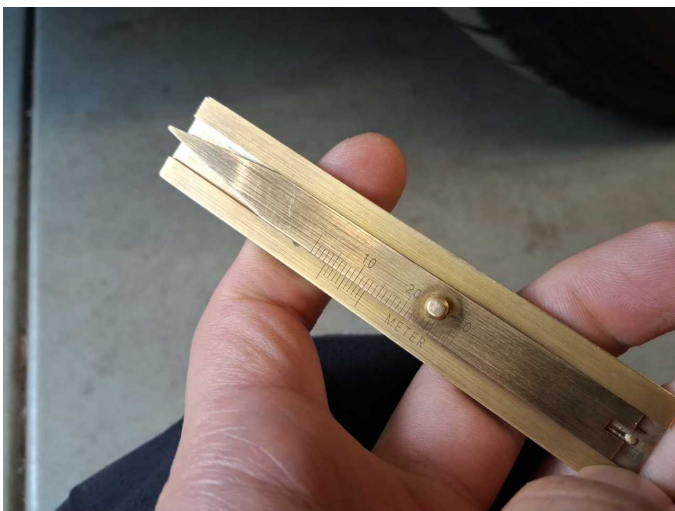
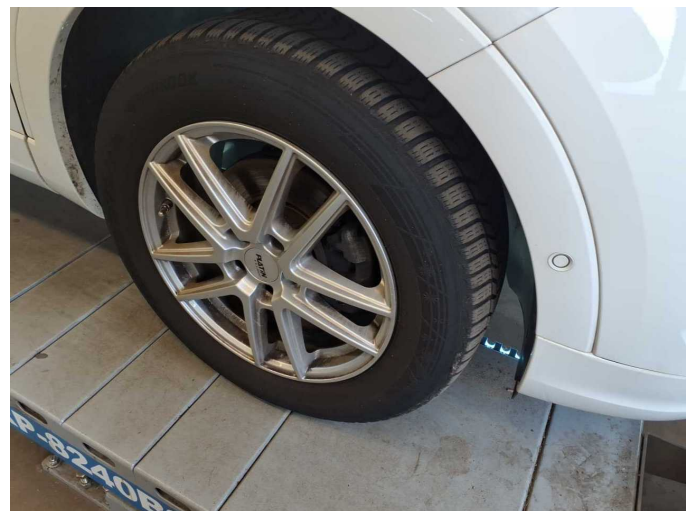
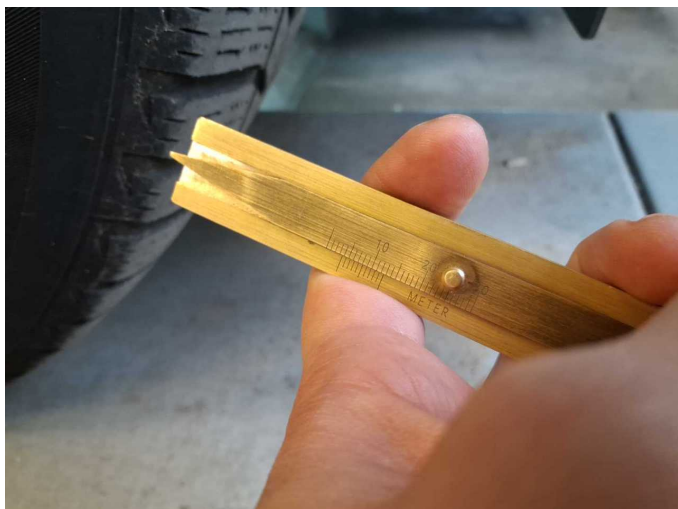
Damage 5: Wheel / tyres: Tyre - front - Does not meet the leasing specifications - Replace
