## Expertise

Protocol number: 45948306  
Order No. / Reference: 26323326  
Inspection date: 15 Jun 2026

Manufacturer: Skoda

Model: Superb Combi 2.0 TDI 4x4 DSG Scout

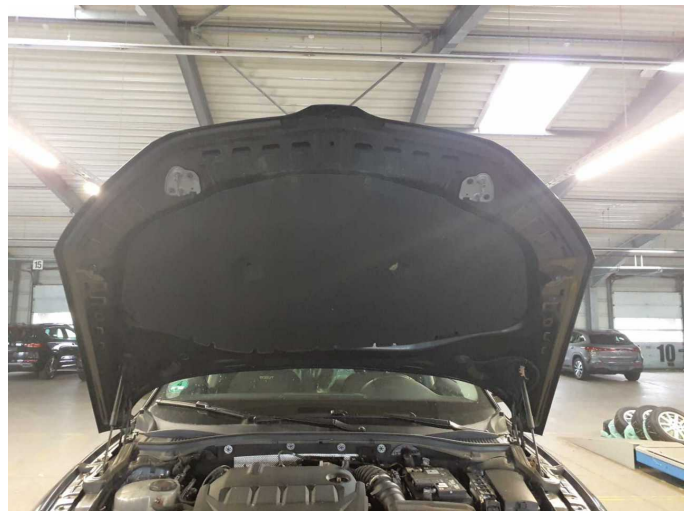
Damage 1: Bonnet: Insulation lining - Damage caused by marten / rodent  
- Replace

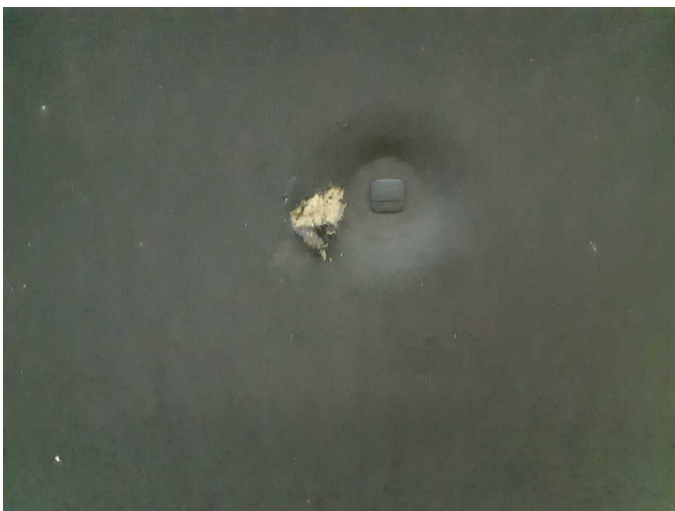
Damage 1: Bonnet: Insulation lining - Damage caused by marten / rodent  
- Replace

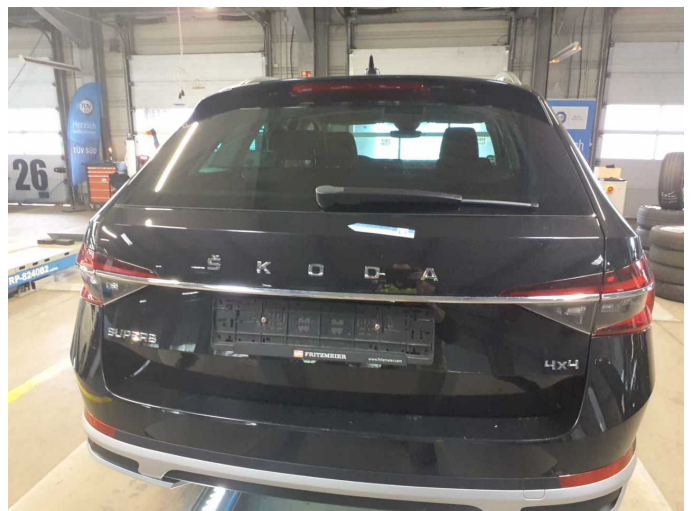
Damage 2: Boot lid / rear door: Boot lid - dent(s) - Smooth repair work

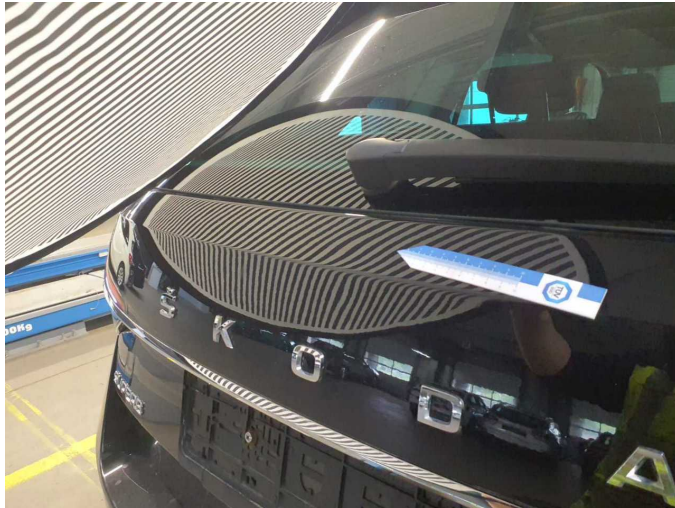
**Damage 2:** Boot lid / rear door: Boot lid - dent(s) - Smooth repair work

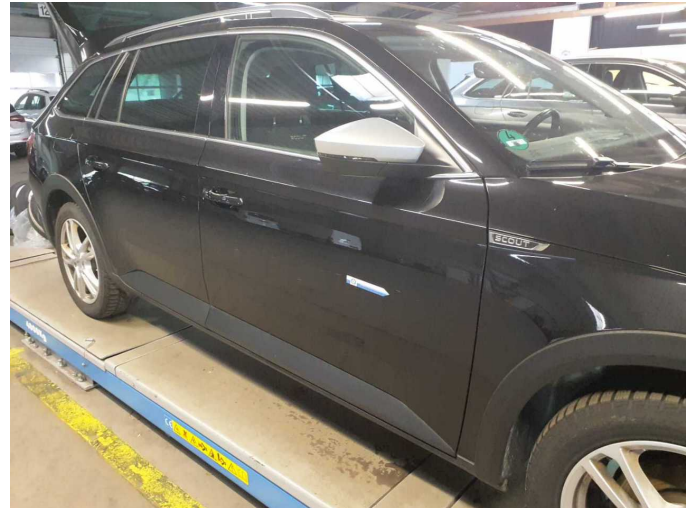
**Damage 3:** Door - front right side: Door - Scratched - Paint

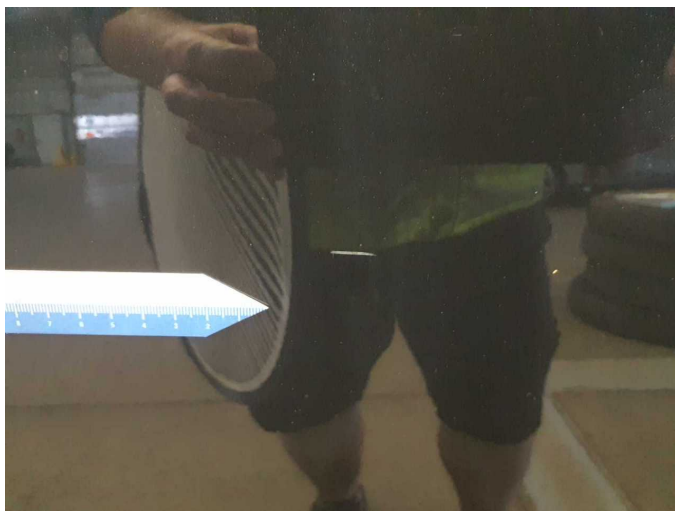
**Damage 3:** Door - front right side: Door - Scratched - Paint

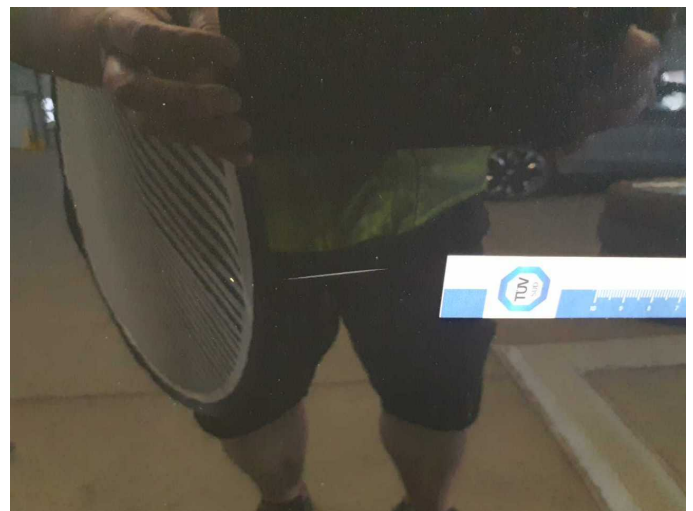
**Damage 3:** Door - front right side: Door - Scratched - Paint

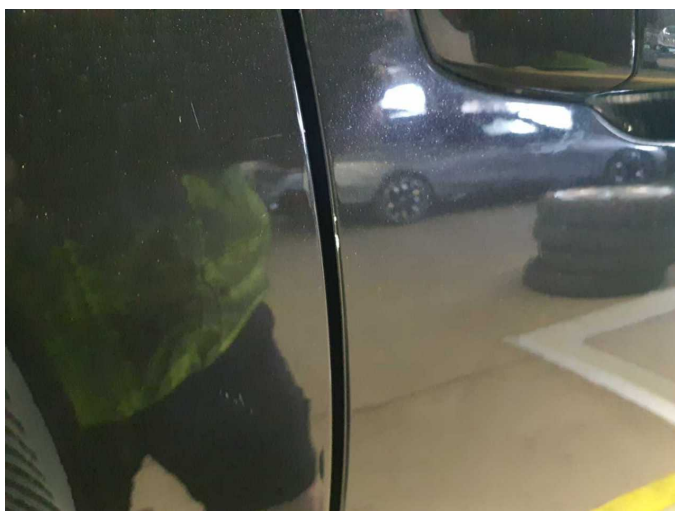
**Damage 3:** Door - front right side: Door - Scratched - Paint

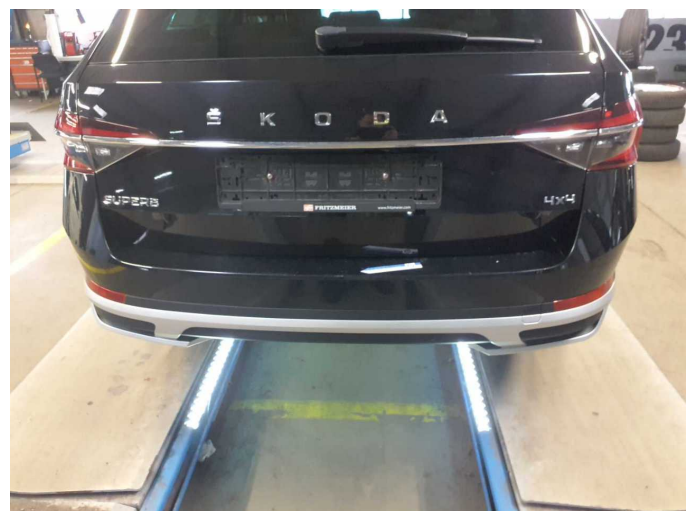
**Damage 4:** Rear bumper: Rear bumper - Scratched - Paint

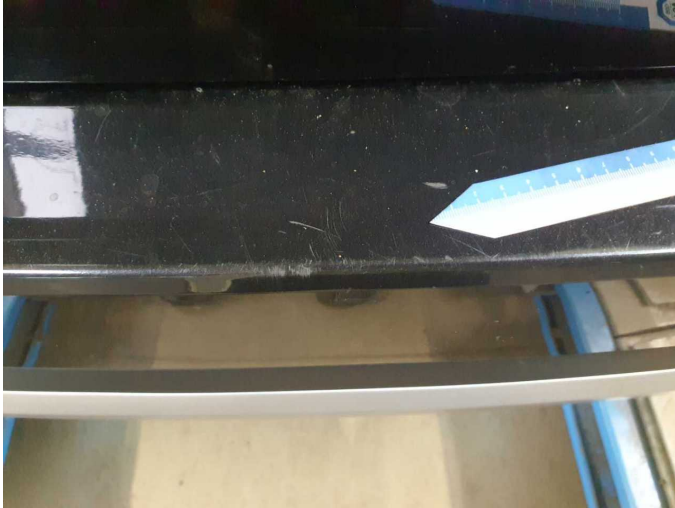
**Damage 4:** Rear bumper: Rear bumper - Scratched - Paint

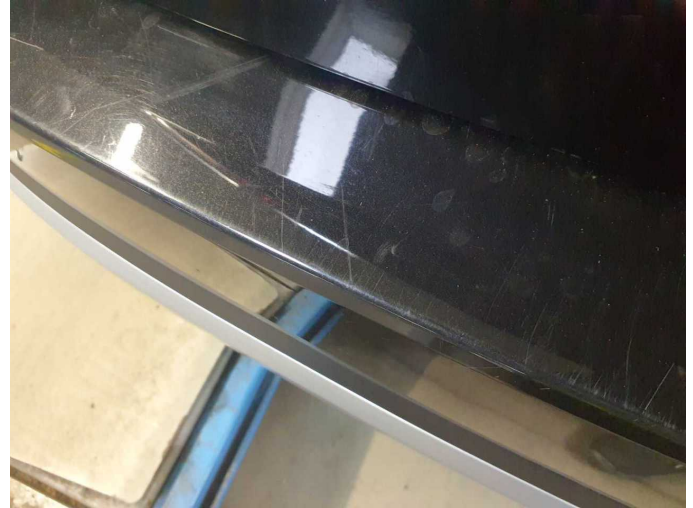
**Damage 4:** Rear bumper: Rear bumper - Scratched - Paint

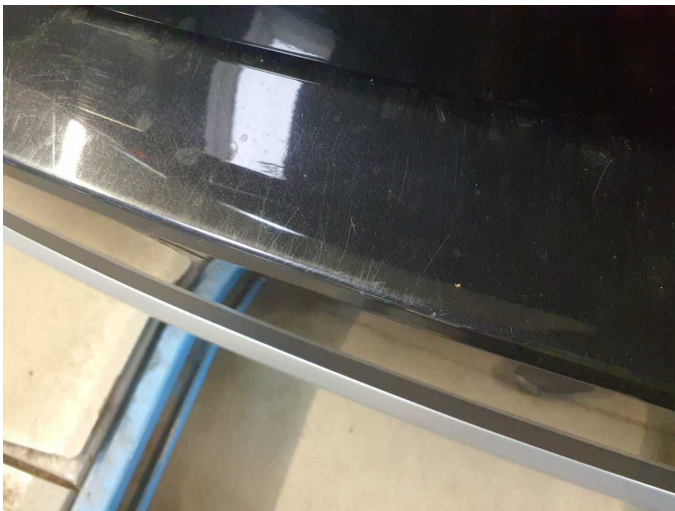
**Damage 4:** Rear bumper: Rear bumper - Scratched - Paint

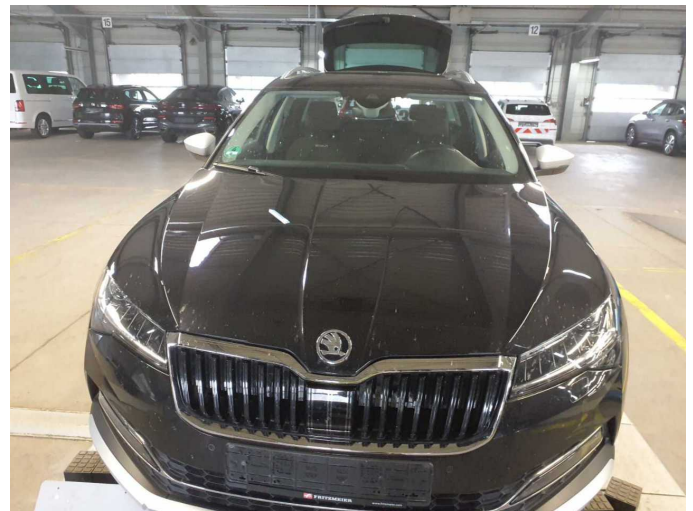
**Damage 5:** Bonnet: Bonnet - Dent / paintcoat damage - Paint

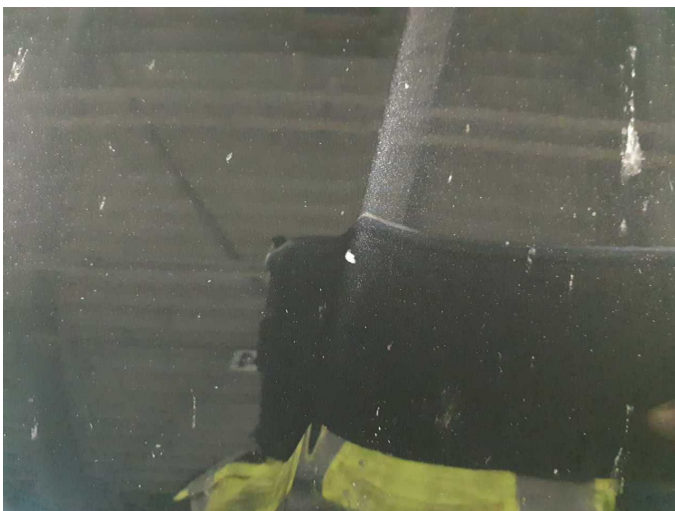
**Damage 5:** Bonnet: Bonnet - Dent / paintcoat damage - Paint

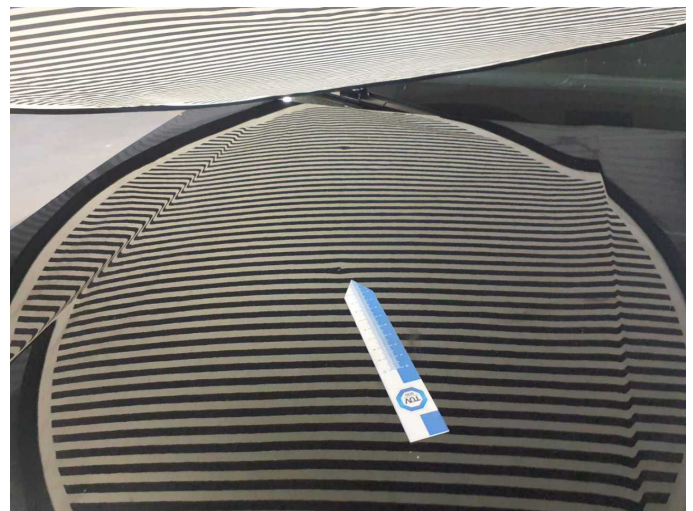
**Damage 5:** Bonnet: Bonnet - Dent / paintcoat damage - Paint

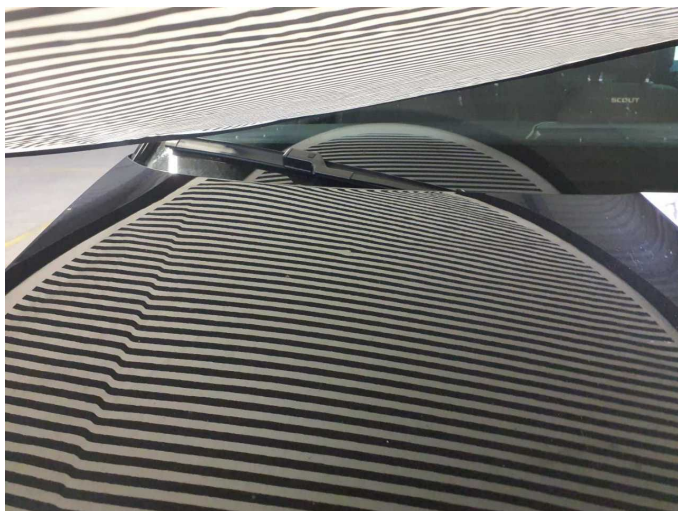
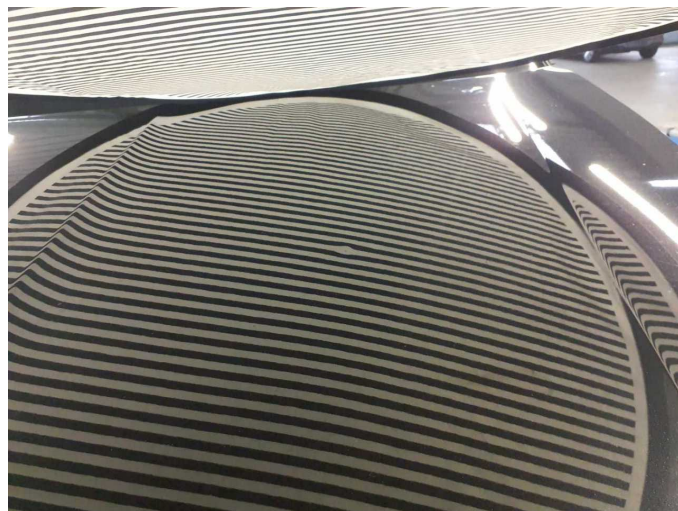
**Damage 5:** Bonnet: Bonnet - Dent / paintcoat damage - Paint

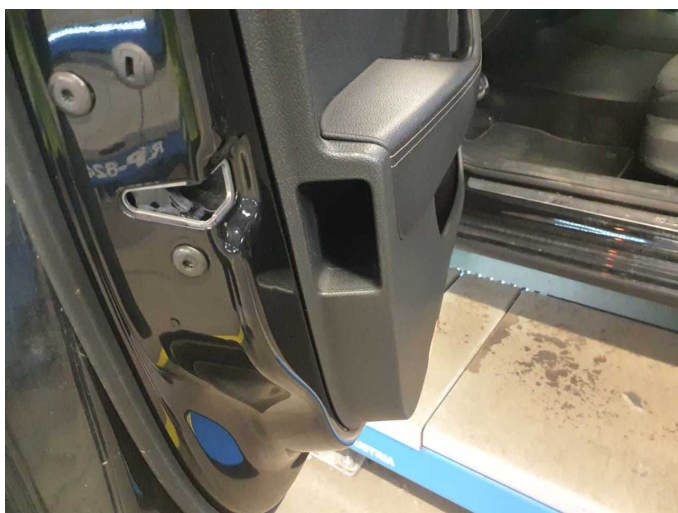
**Missing part 1:** Equipment: Umbrella - Missing - Replace
