Expertise

Protocol number: 45918232
Order No. / Reference: 26428488
Inspection date: 10 Jun 2026

Manufacturer: Opel

Model: Astra 1.5 D Automatik Business Edition

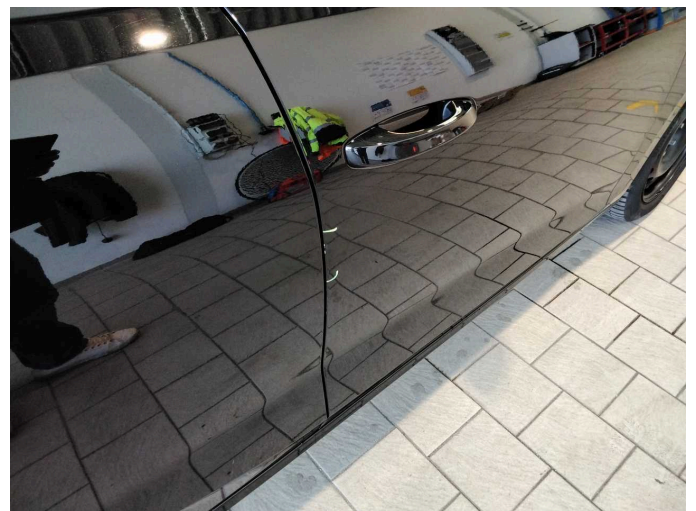
Damage 4: Door - front right side: Door edge - Scratch(es) - Smart repair

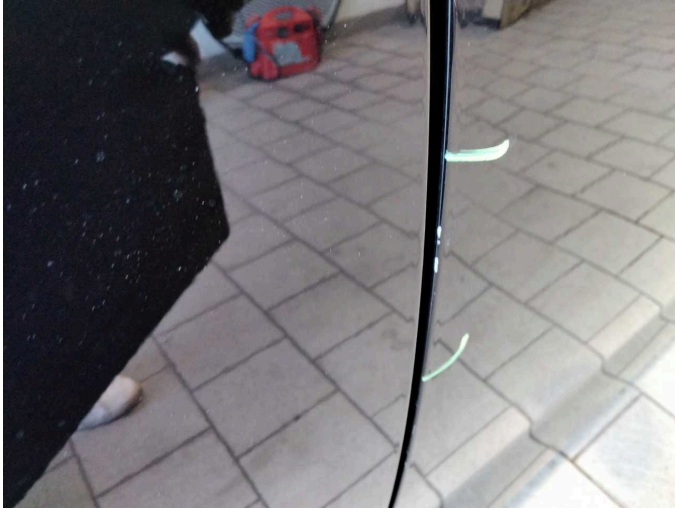
Damage 4: Door - front right side: Door edge - Scratch(es) - Smart repair

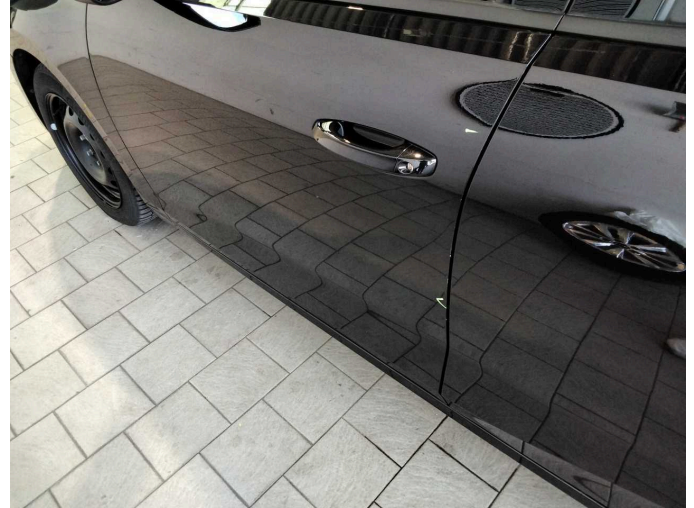
Damage 5: Door - front left side: Door edge - Scratch(es) - Smart repair

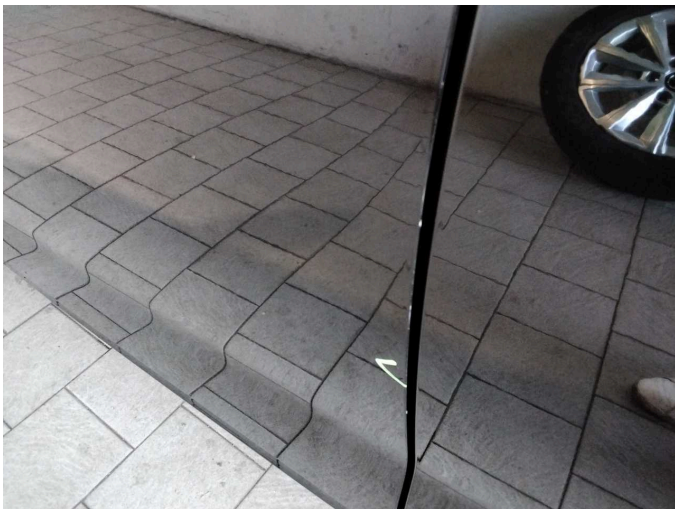
Damage 5: Door - front left side: Door edge - Scratch(es) - Smart repair

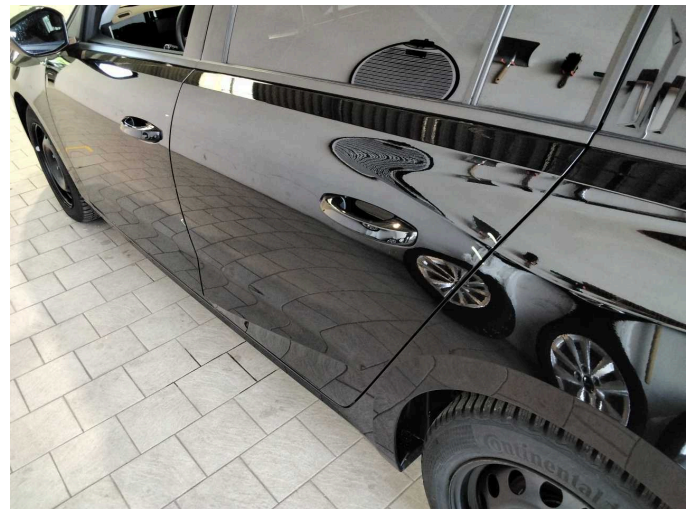
Damage 6: Door - rear left side: Door edge - Scratch(es) - Smart repair

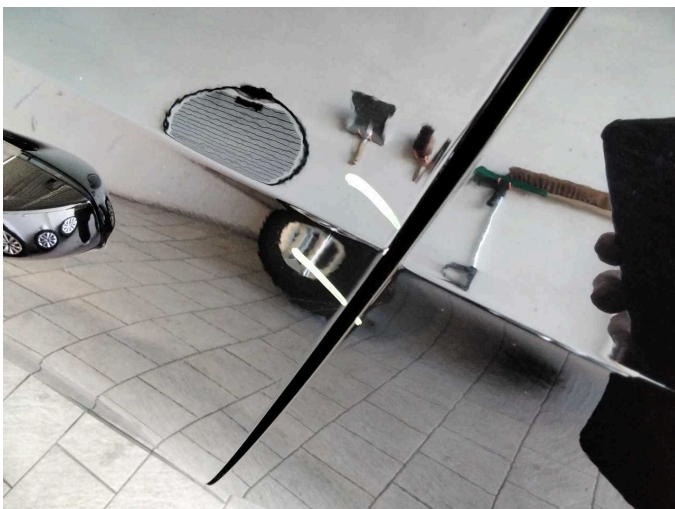
Damage 6: Door - rear left side: Door edge - Scratch(es) - Smart repair

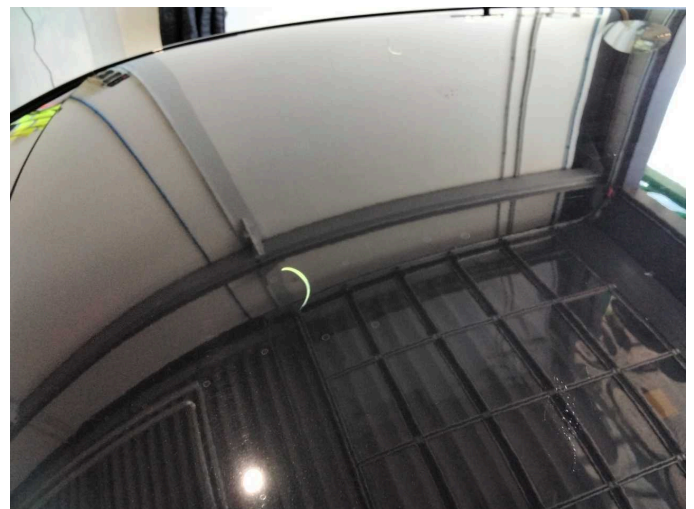
Damage 7: Roof: Roof - dent(s) - Smooth repair work

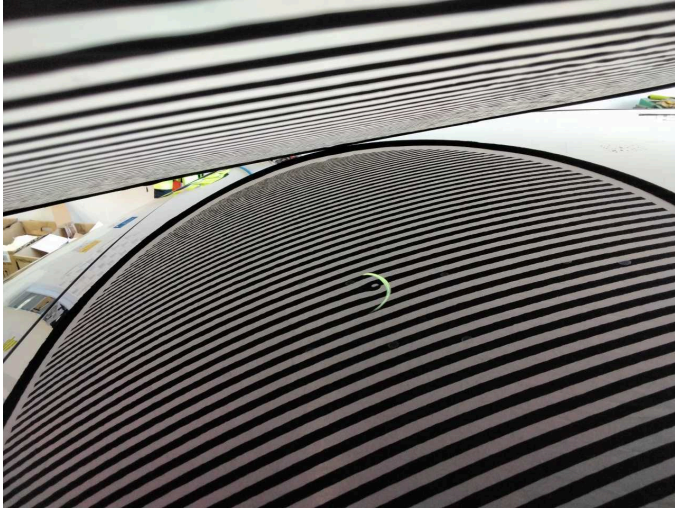
Damage 7: Roof: Roof - dent(s) - Smooth repair work

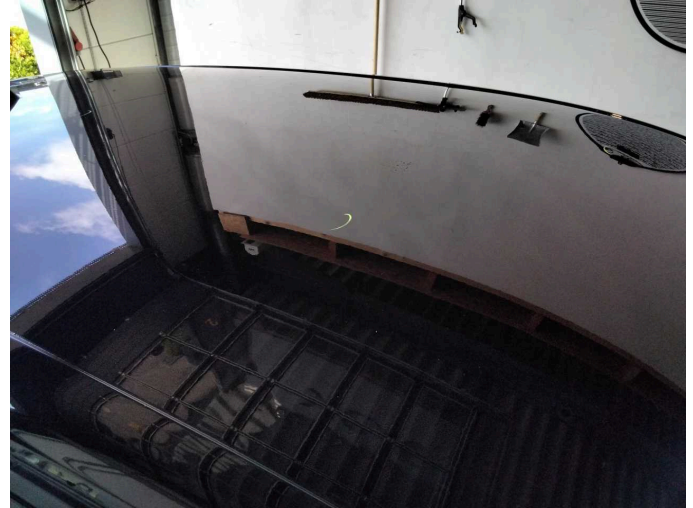
Damage 7: Roof: Roof - dent(s) - Smooth repair work

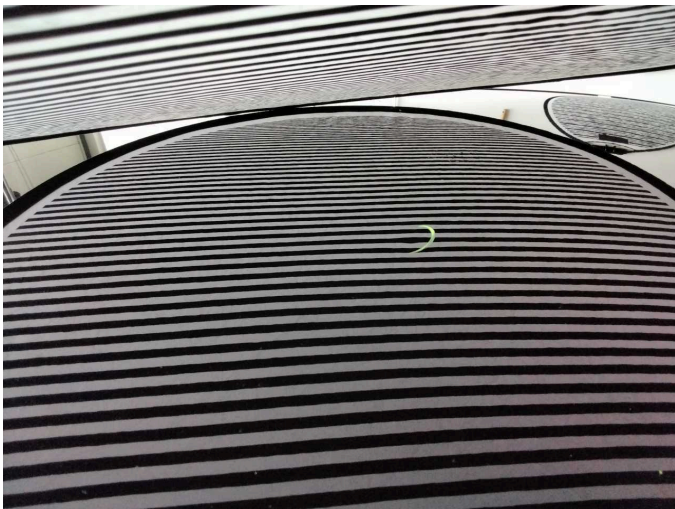
Damage 7: Roof: Roof - dent(s) - Smooth repair work

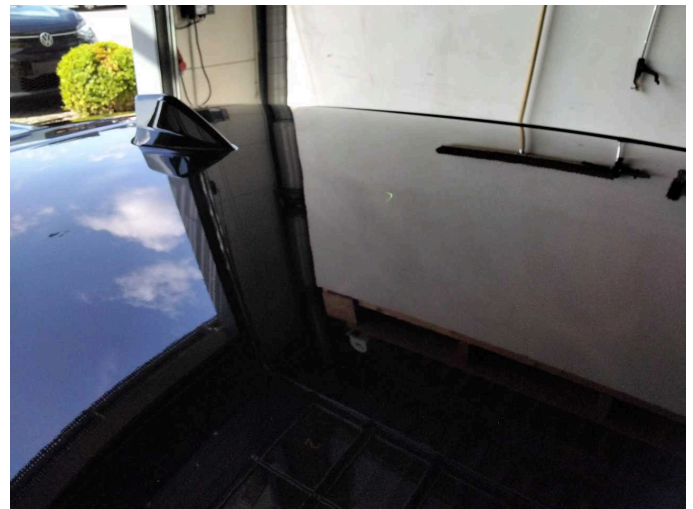
Damage 7: Roof: Roof - dent(s) - Smooth repair work

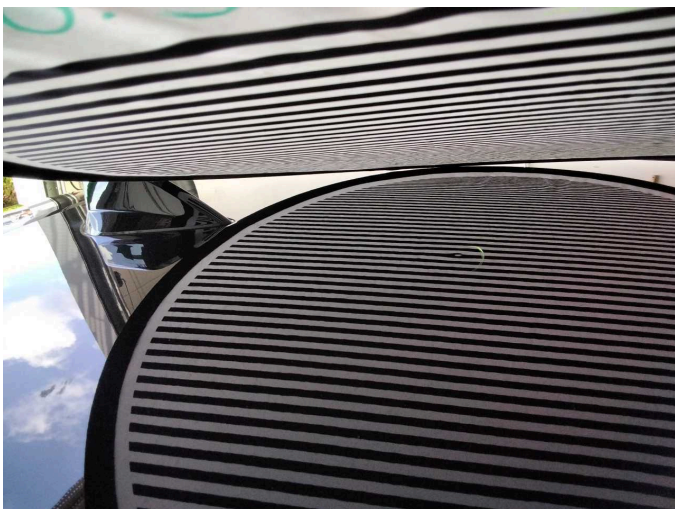
Damage 7: Roof: Roof - dent(s) - Smooth repair work

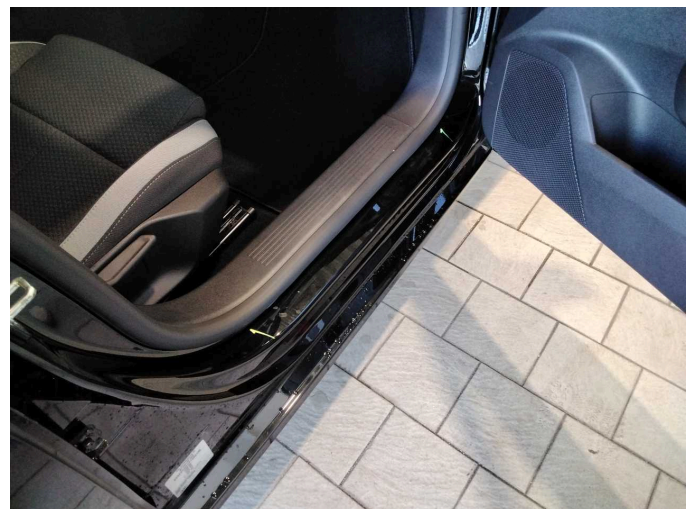
Damage 8: Sill - right side: Sill - Scratch(es) - Smart repair

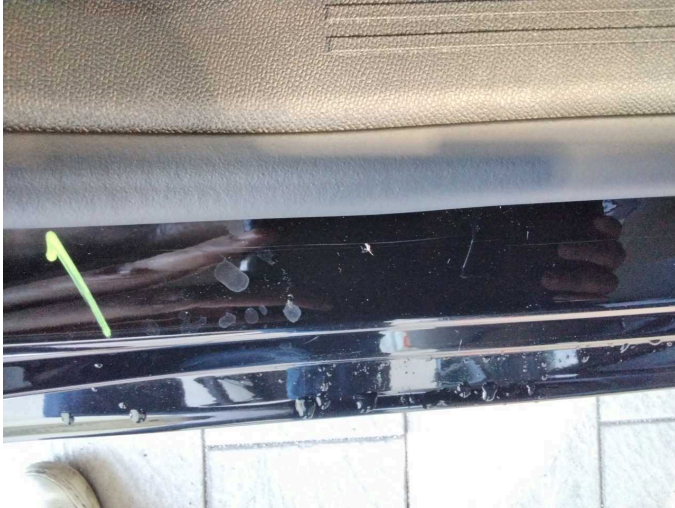
Damage 8: Sill - right side: Sill - Scratch(es) - Smart repair

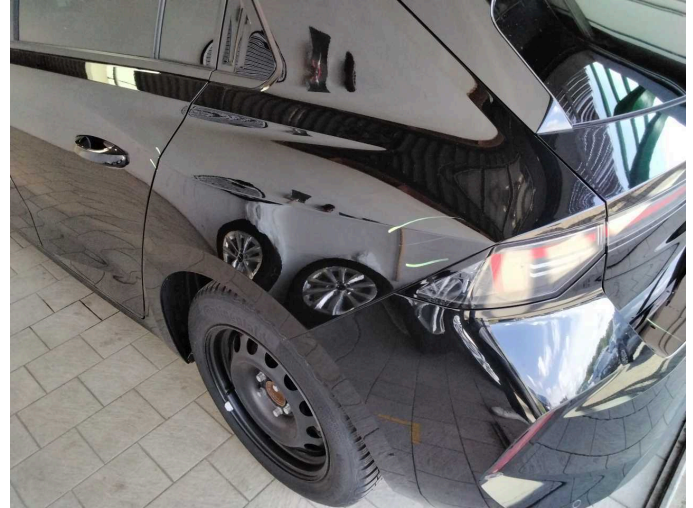
Damage 9: Side panel - rear left side: Side panel - Scratch(es) - Smart repair

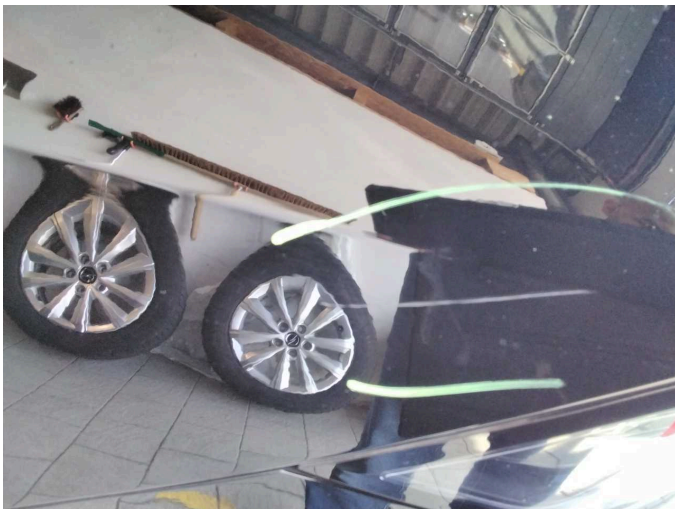
Damage 9: Side panel - rear left side: Side panel - Scratch(es) - Smart repair

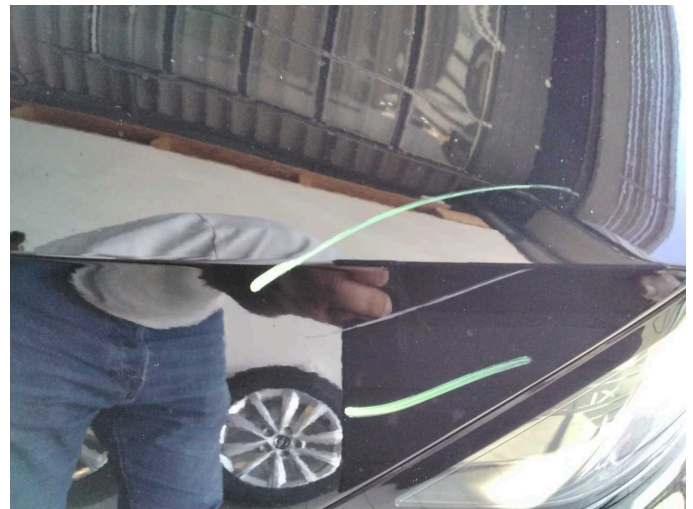
Damage 9: Side panel - rear left side: Side panel - Scratch(es) - Smart repair

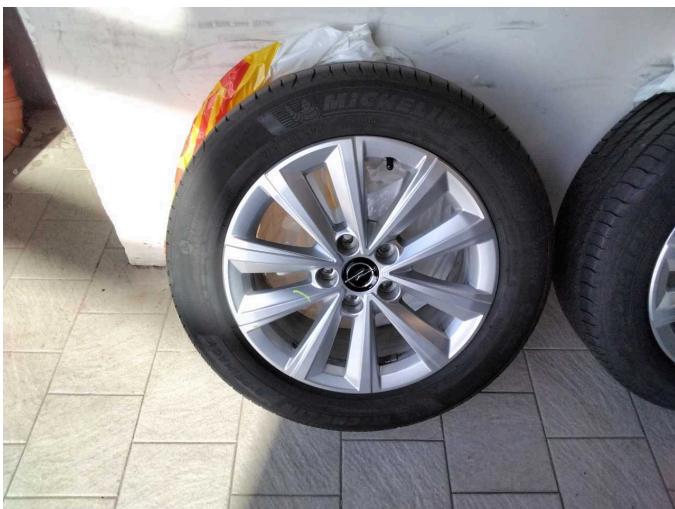
Damage 10: 2nd wheel set: 1 alloy rim - Scratch(es) - Smart repair

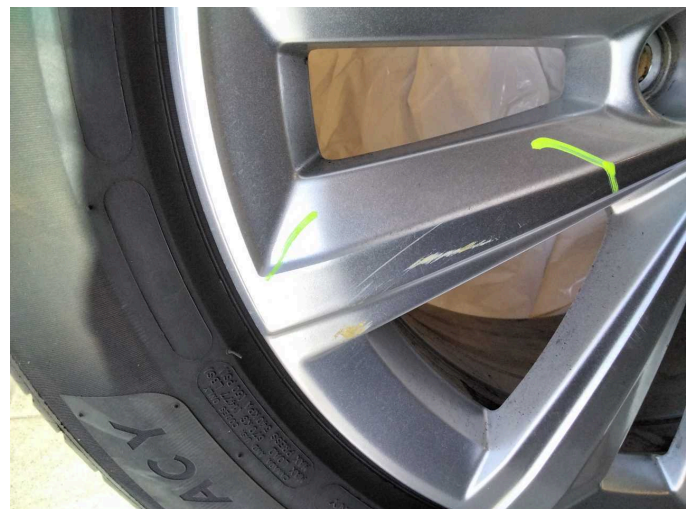
Damage 10: 2nd wheel set: 1 alloy rim - Scratch(es) - Smart repair

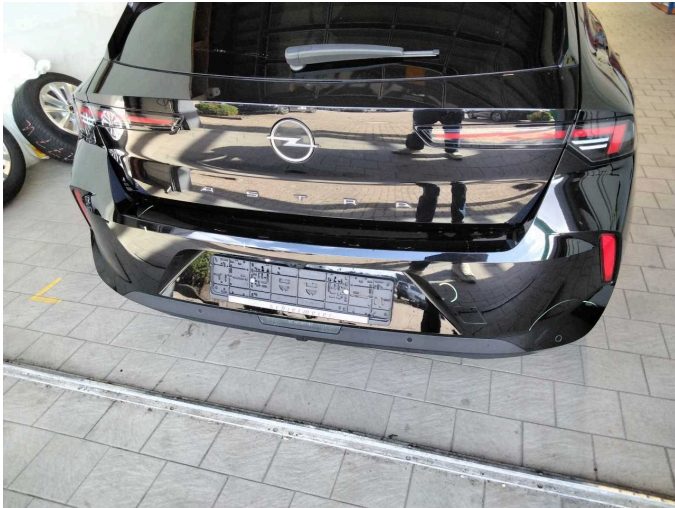
Damage 11: Rear bumper: Rear bumper - Scratch(es) - Paint

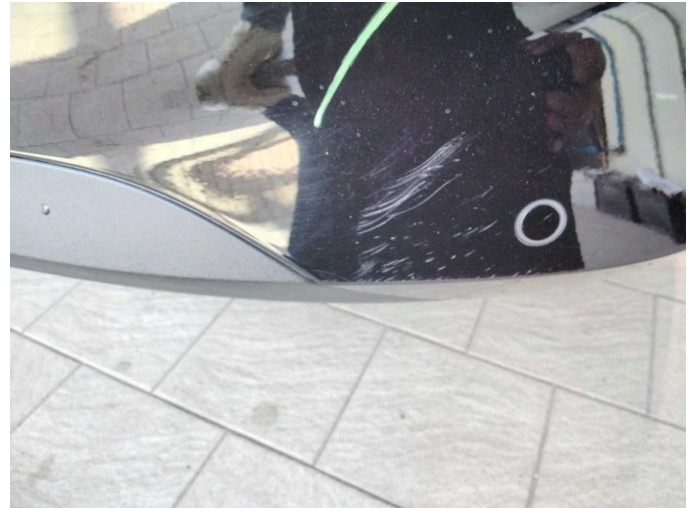
Damage 11: Rear bumper: Rear bumper - Scratch(es) - Paint

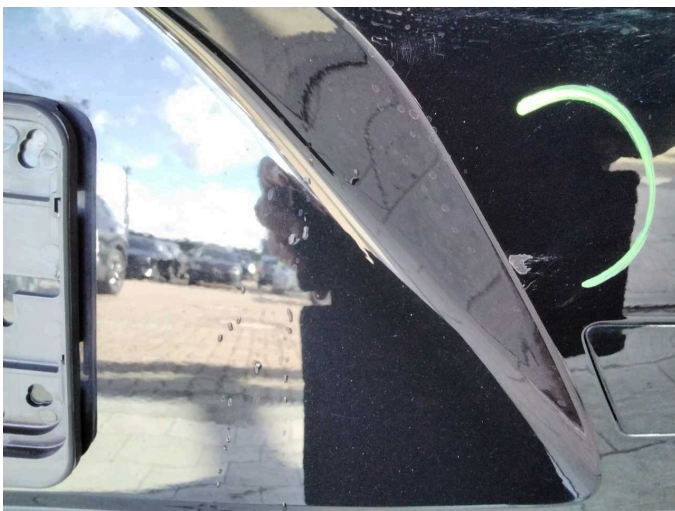
Damage 11: Rear bumper: Rear bumper - Scratch(es) - Paint

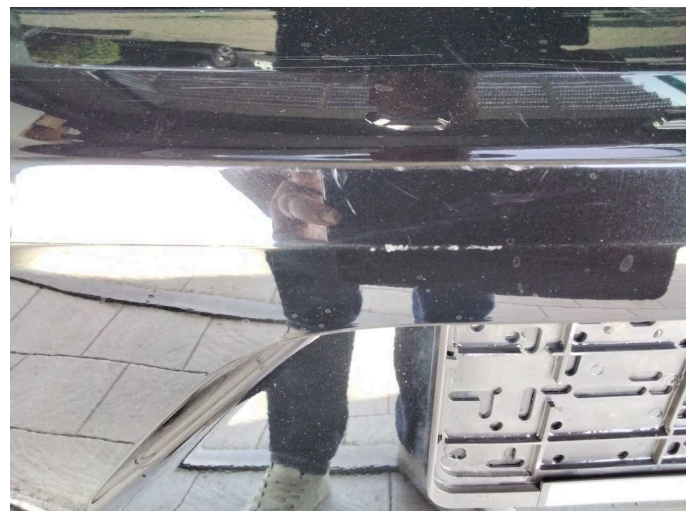
Damage 11: Rear bumper: Rear bumper - Scratch(es) - Paint

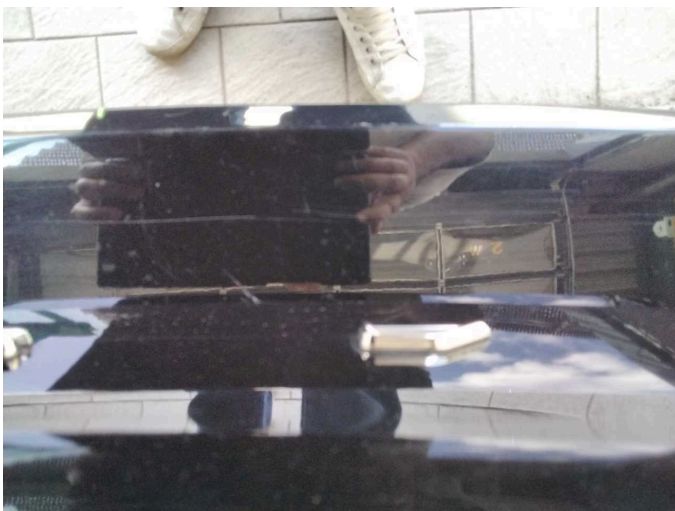
Damage 11: Rear bumper: Rear bumper - Scratch(es) - Paint

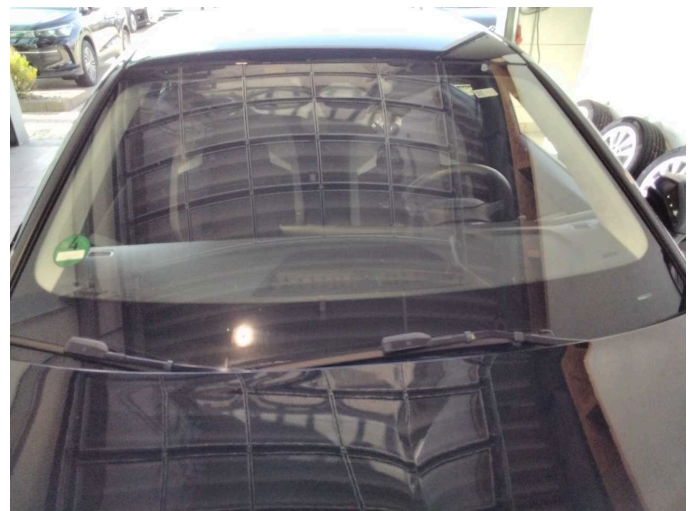
Wear and tear 1: Vehicle glazing: Windscreen - Stone chips - No deduction

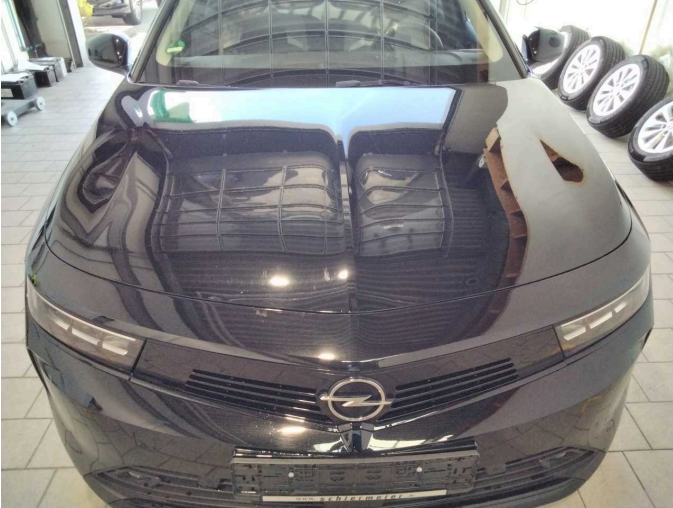
Wear and tear 2: Bonnet: Bonnet - Stone chips - No deduction

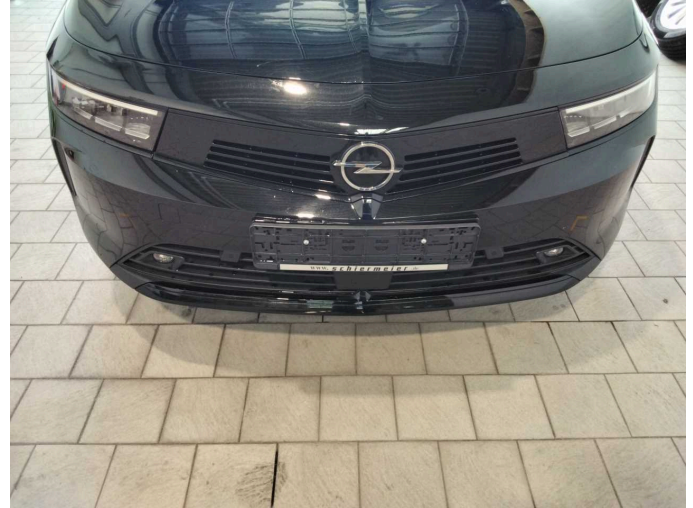
Wear and tear 3: Front bumper: Front bumper - Stone chips - No deduction

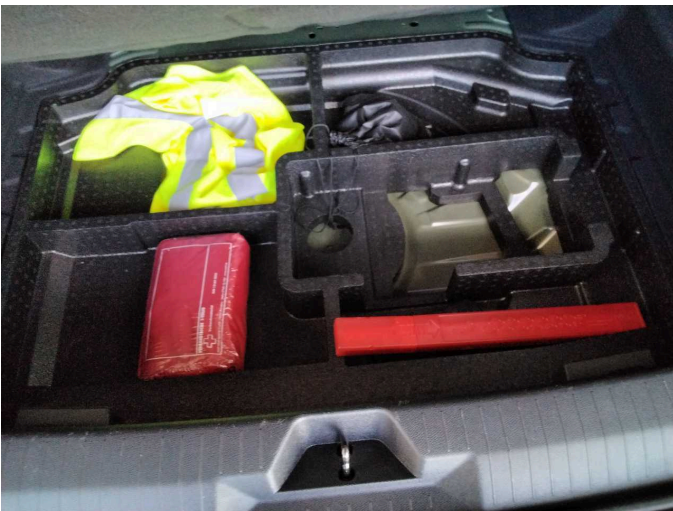
Missing part 2: Equipment: Tirefit complete - Missing - Replace
