## Expertise

Protocol number: 46152819  
Order No. / Reference: 26538920  
Inspection date: 25 Jun 2026

Model: Focus Turnier 1.5 EcoBlue Start-Stopp-System Aut. TITANIUM

VIN: WF0PXXGCHPPE77016

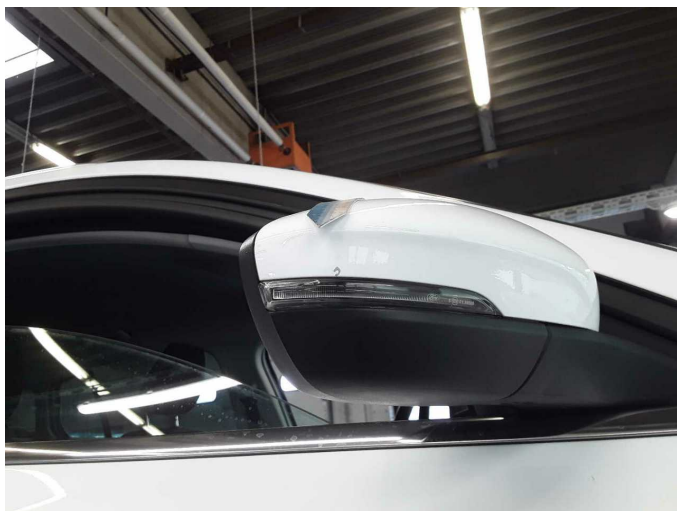
Damage 1: Wing mirror - right side: Cap - Scratch(es) - Smart repair

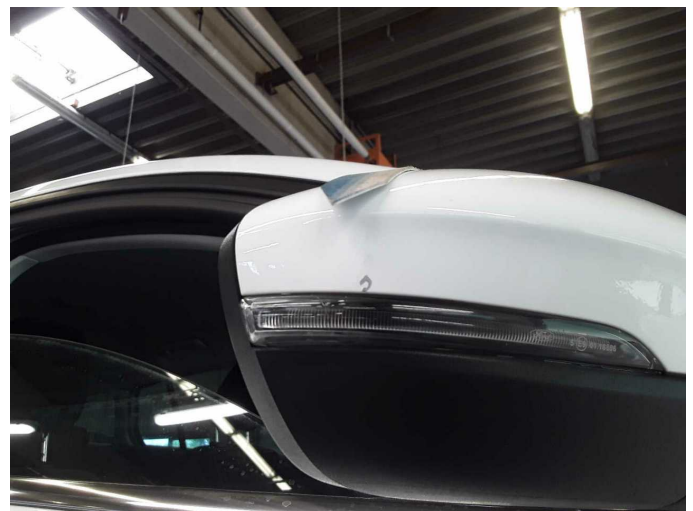
Damage 1: Wing mirror - right side: Cap - Scratch(es) - Smart repair

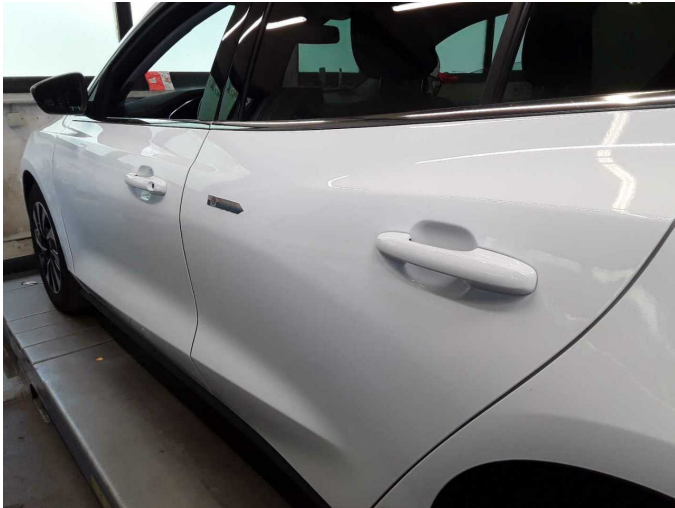
**Damage 2:** Door - rear left side: Door - dent(s) - Smooth repair work

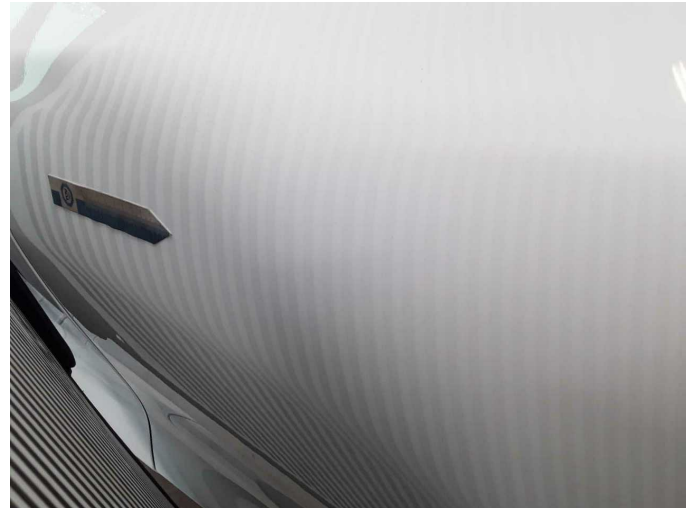
**Damage 2:** Door - rear left side: Door - dent(s) - Smooth repair work

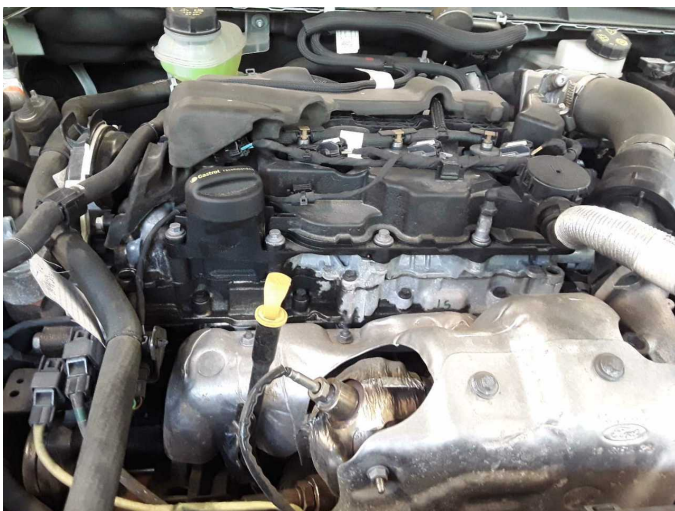
**Damage 3:** Engine: Engine - Leaking - Diagnosed and repair if necessary

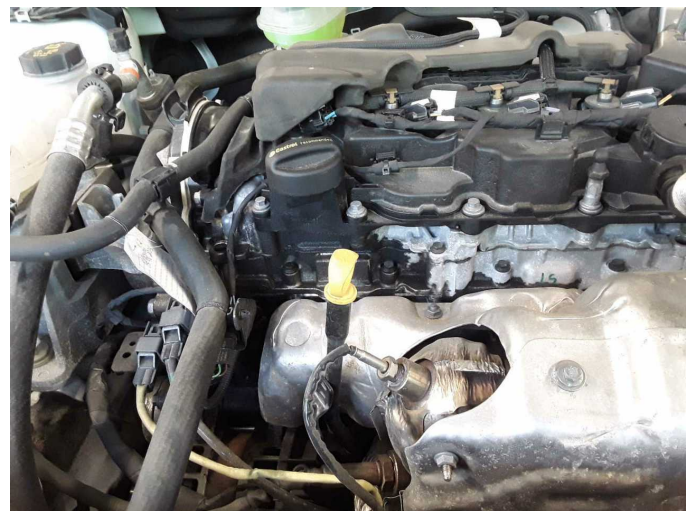
**Damage 3:** Engine: Engine - Leaking - Diagnosed and repair if necessary

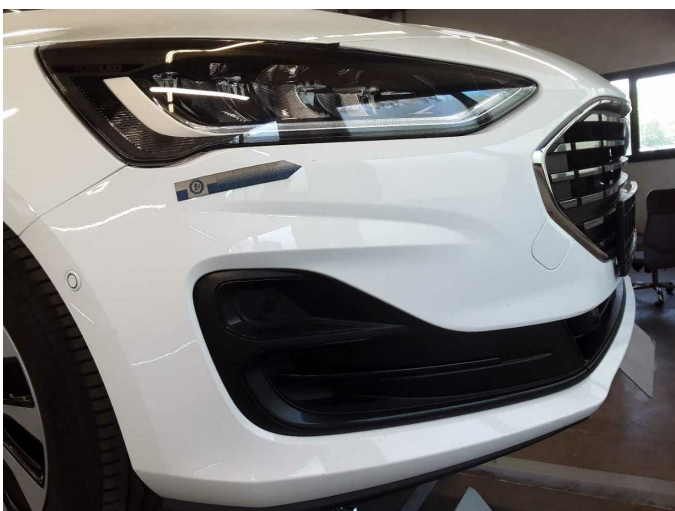
**Wear and tear 1:** Front bumper: Front bumper - Stone chips - No deduction

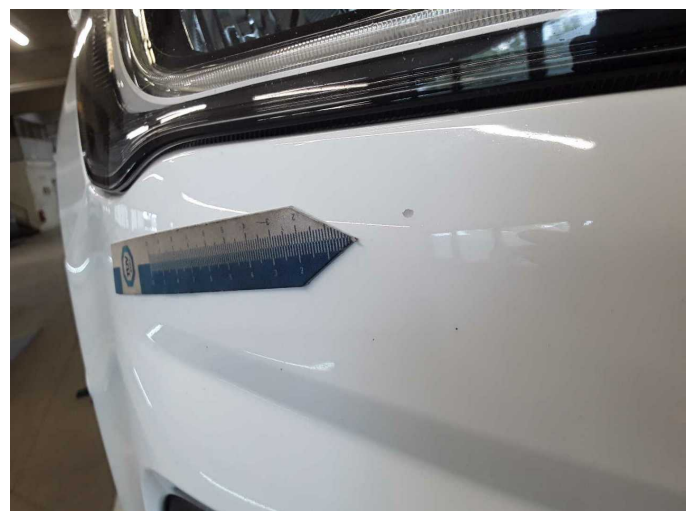
**Wear and tear 1:** Front bumper: Front bumper - Stone chips - No deduction

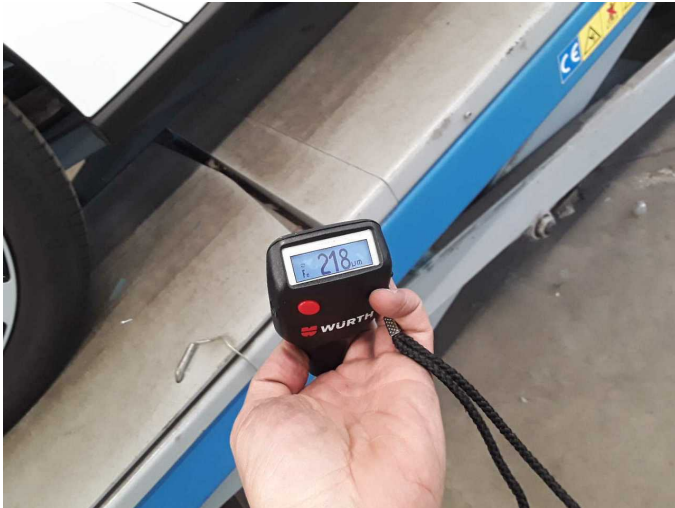
No.	Repainting
1	Boot lid / rear door, Side panel - rear right side, Door - rear right side, Professionally carried out, Invoice of repair done Non-existent

Repainting 1: Boot lid / rear door, Side panel - rear right side, Door - rear right side

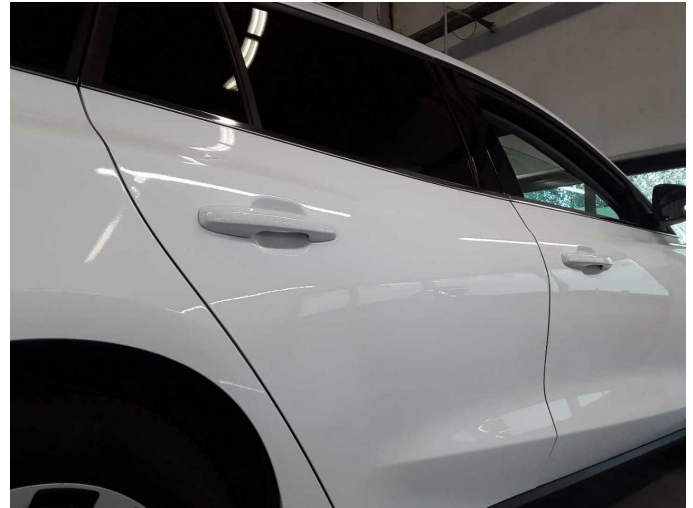
Repainting 1: Boot lid / rear door, Side panel - rear right side, Door - rear right side

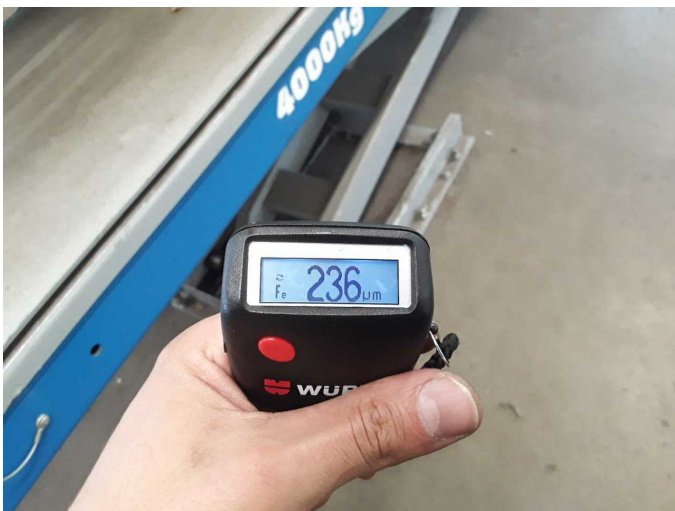
Repainting 1: Boot lid / rear door, Side panel - rear right side, Door - rear right side

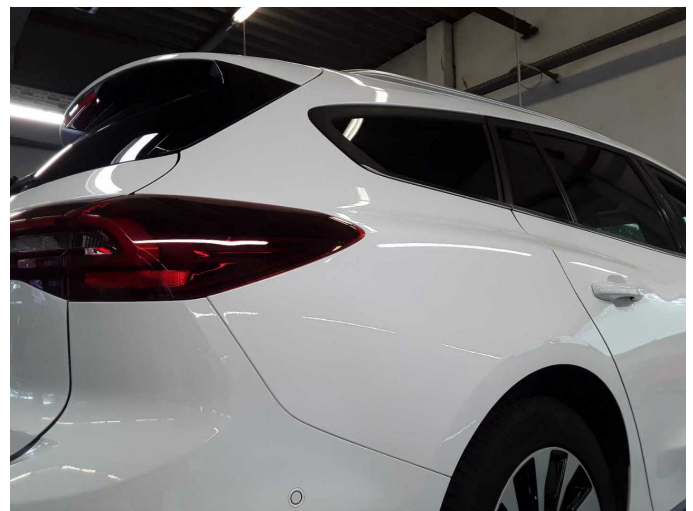
Repainting 1: Boot lid / rear door, Side panel - rear right side, Door - rear right side

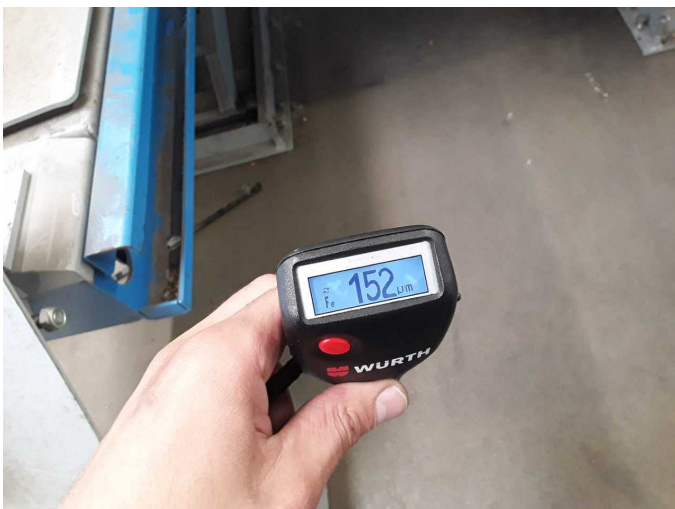
Repainting 1: Boot lid / rear door, Side panel - rear right side, Door - rear right side

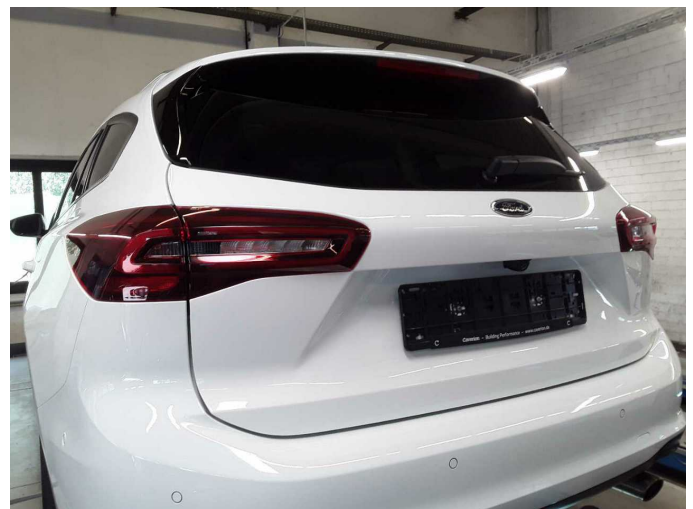
Repainting 1: Boot lid / rear door, Side panel - rear right side, Door - rear right side
