Expertise

Protocol number: 46458749  
Order No. / Reference: 26642153  
Inspection date: 9 Jul 2026

Manufacturer: MAN

Model: TGE 3.140 4X2F SB

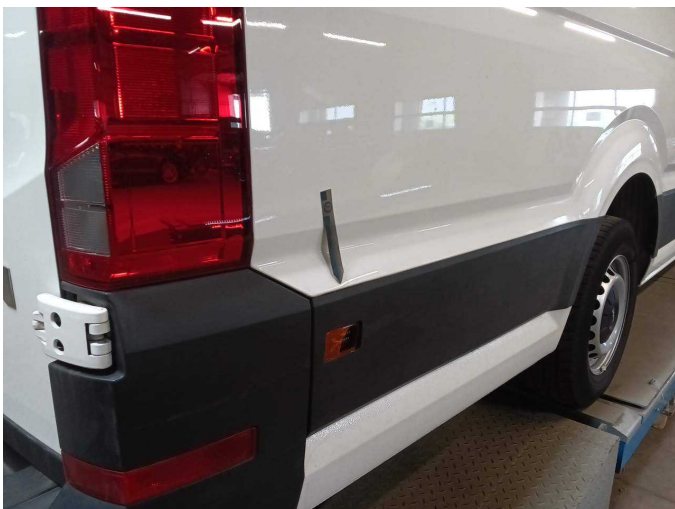
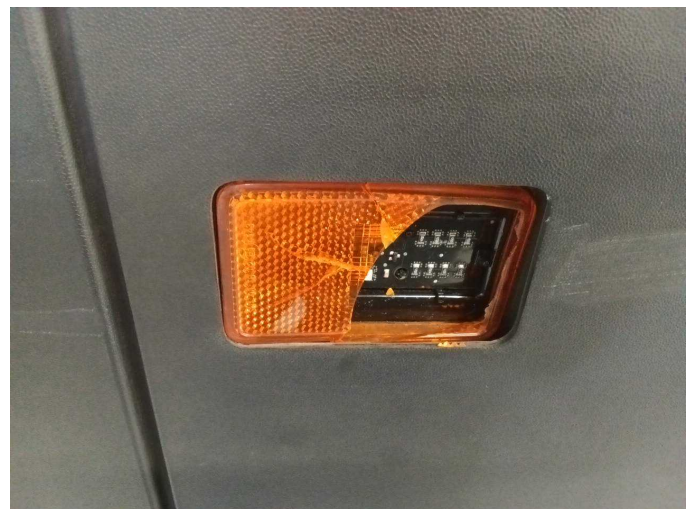
| No. | Component group | Description |
|---|---|---|
| 1 | Indicator - front | Indicator lamp - rear right side - Broken / torn - Replace |

**Damage 1:** Indicator - front: Indicator lamp - rear right side - Broken / torn - Replace

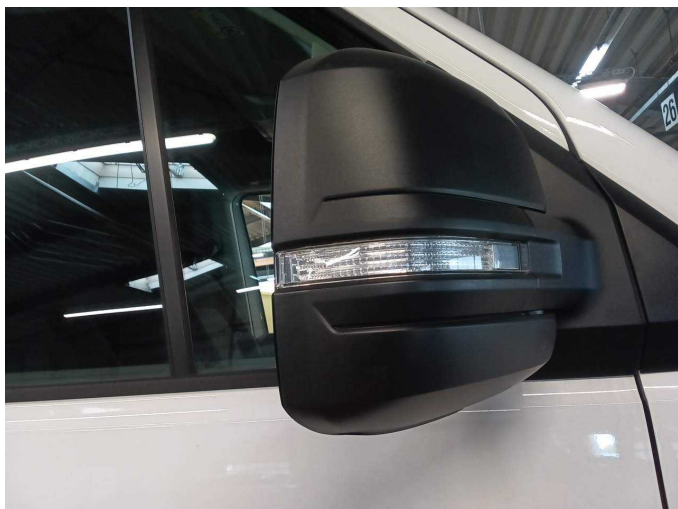
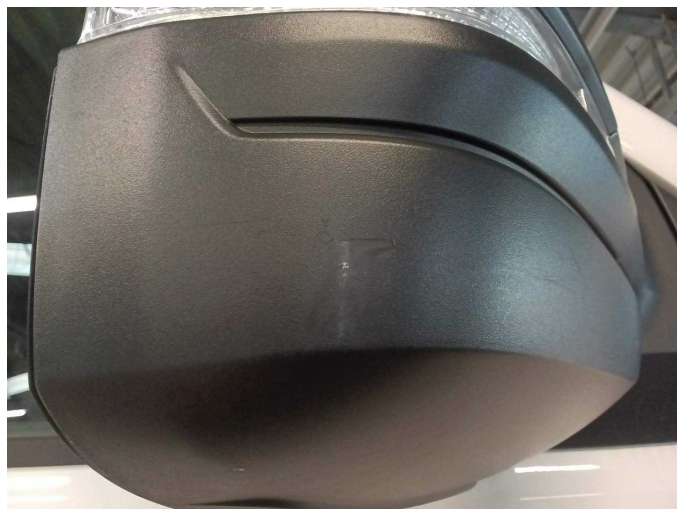
| No. | Component group | Description |
|---|---|---|
| 2 | Wing mirror - right side | Mirror housing - Scratch(es) - Loss in value |

**Damage 2:** Wing mirror - right side: Mirror housing - Scratch(es) - Loss in value

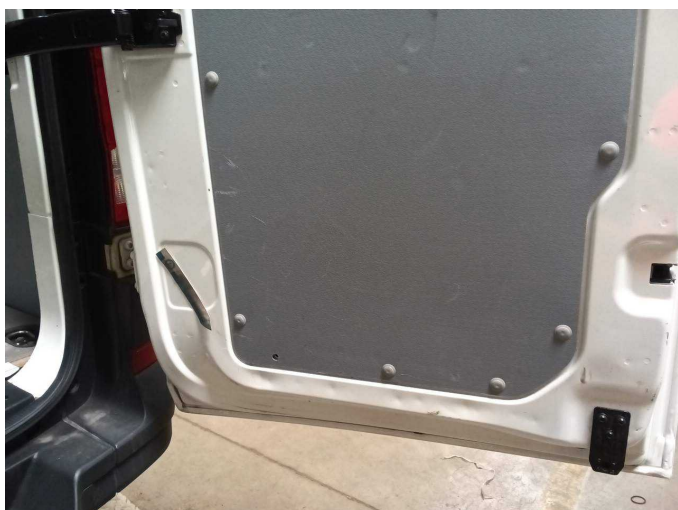
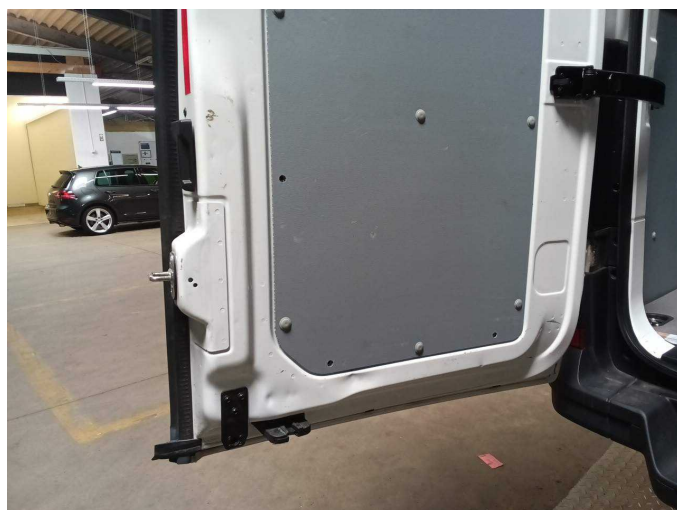
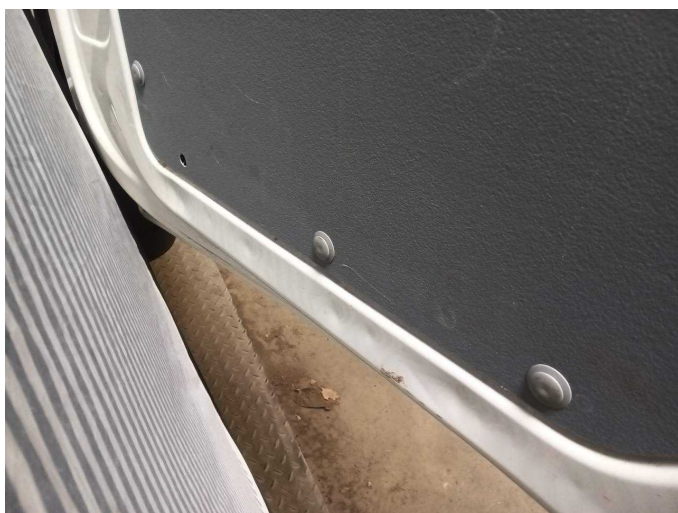
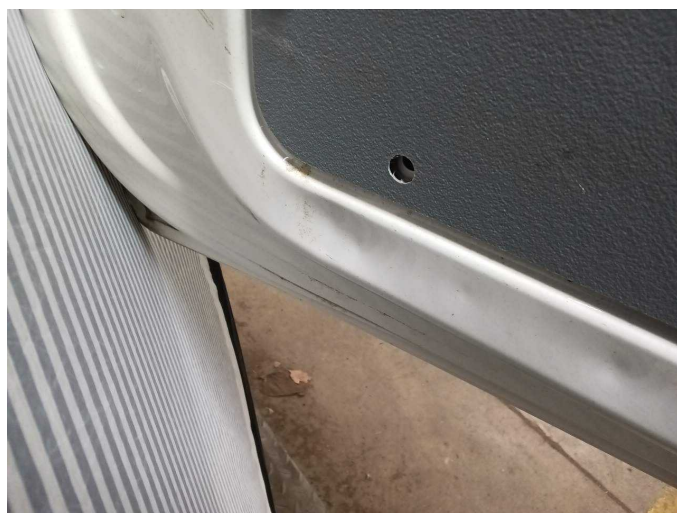
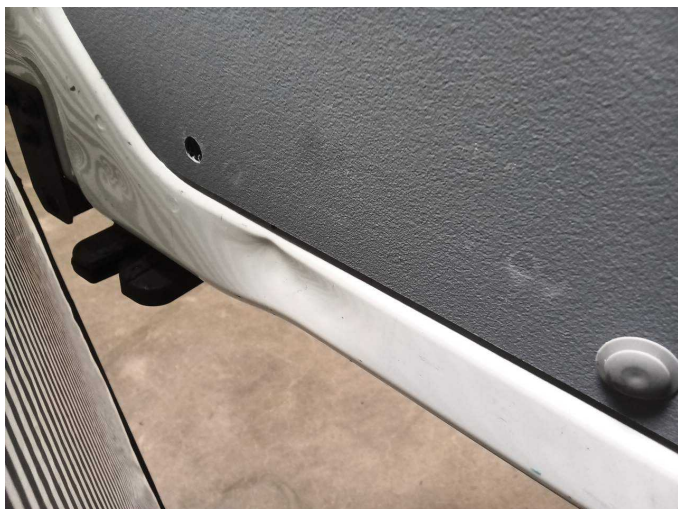
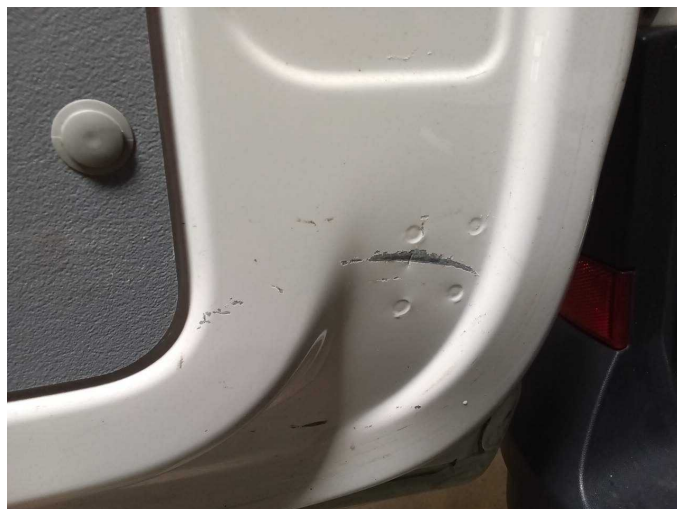
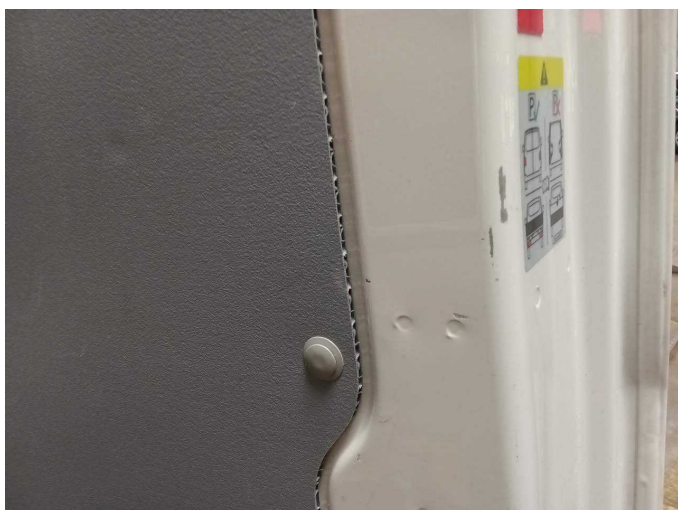
| No. | Component group | Description |
|---|---|---|
| 3 | Boot lid / rear door | Boot lid (innen) - Dent / paintcoat damage - Loss in value |

**Damage 3:** Boot lid / rear door: Boot lid (innen) - Dent / paintcoat damage - Loss in value

**Damage 3:** Boot lid / rear door: Boot lid (innen) - Dent / paintcoat damage  
- Loss in value

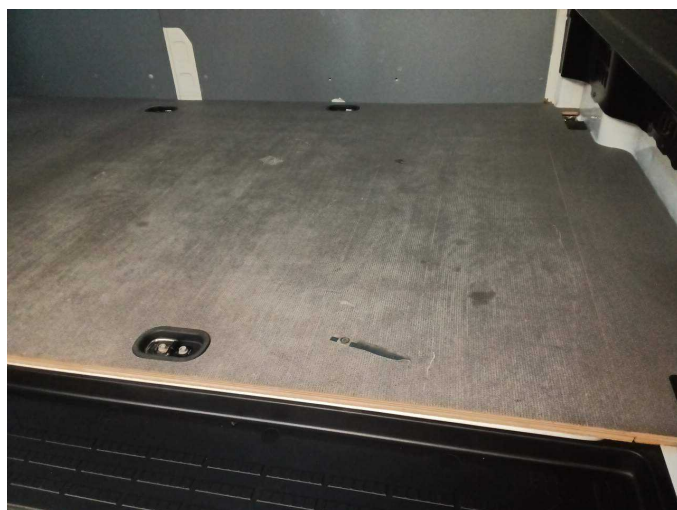
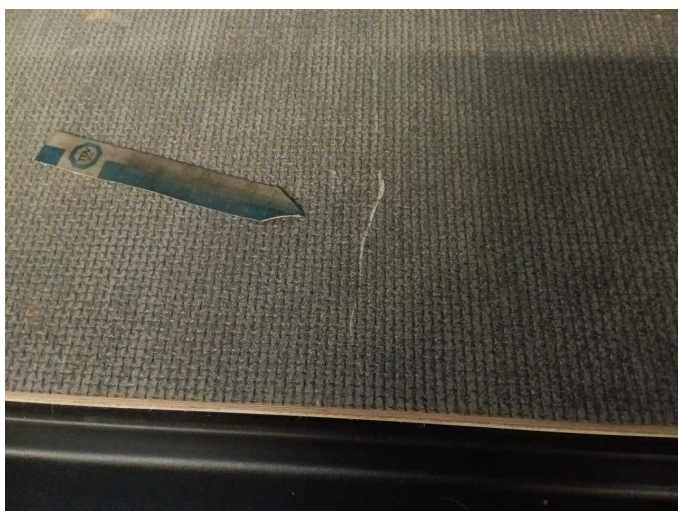
| No. | Component group | Description |
|---|---|---|
| 1 | Interior | Cargo area floor - Scratch(es) - No deduction |

**Wear and tear 1:** Interior: Cargo area floor - Scratch(es) - No deduction

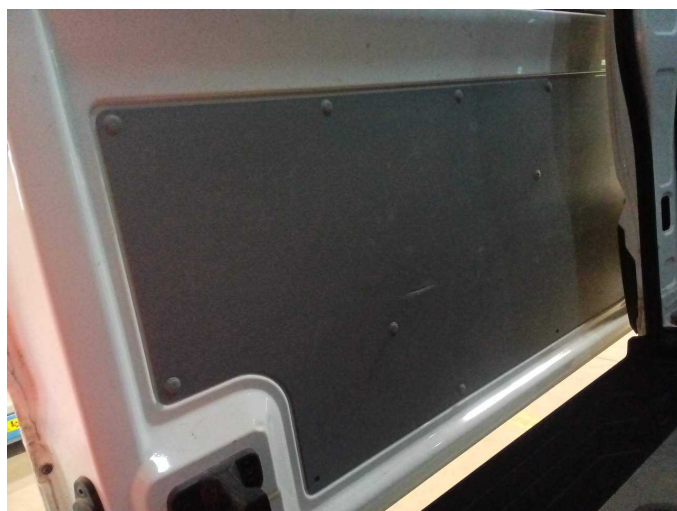
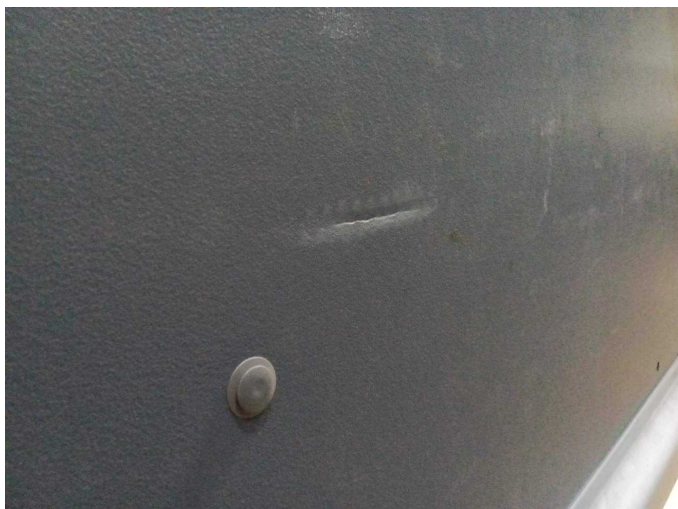
| No. | Component group | Description |
|---|---|---|
| 2 | Trim / covers | Door trim - rear right side - Scratch(es) - No deduction |

**Wear and tear 2:** Trim / covers: Door trim - rear right side - Scratch(es) -  
No deduction
