Expertise

Protocol number: 46192403
Order No. / Reference: 26154489
Inspection date: 22 Jun 2026

Manufacturer: Mercedes-Benz

Model: Vito 116 CDI Tourer Extralang Aut. PRO

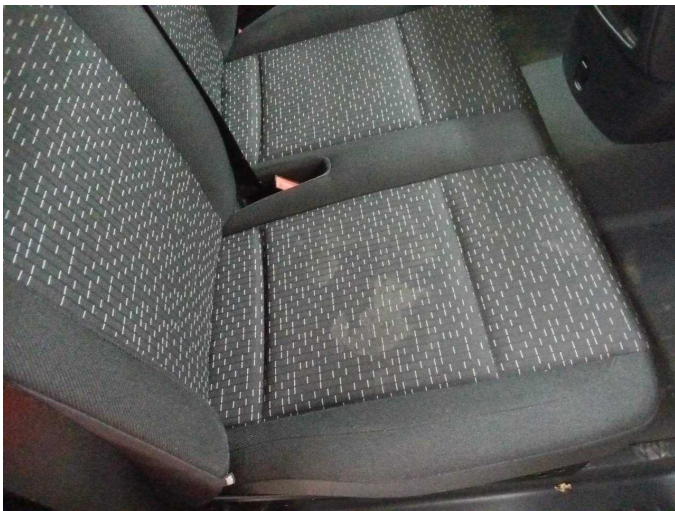
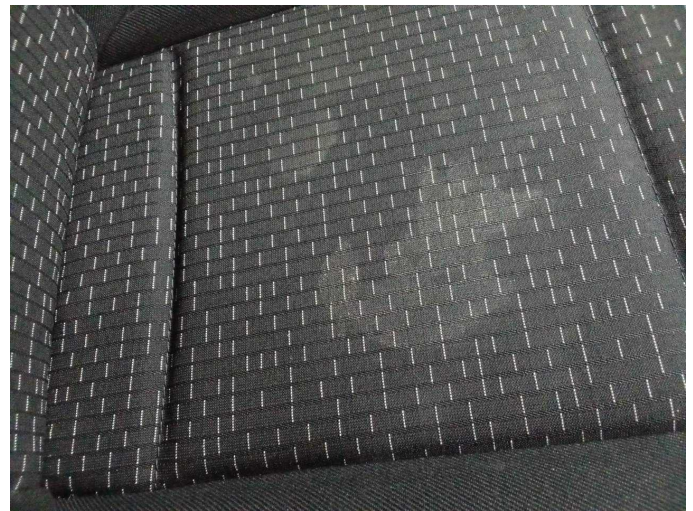
Damage 1: Seat - front: Seat cover - right side - Clean

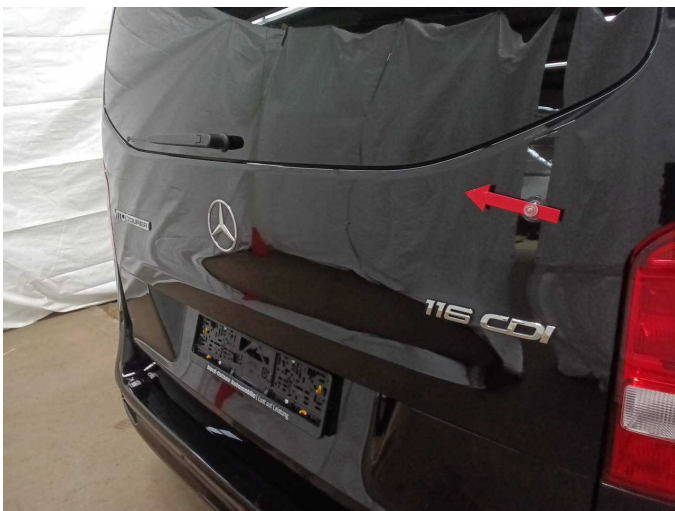
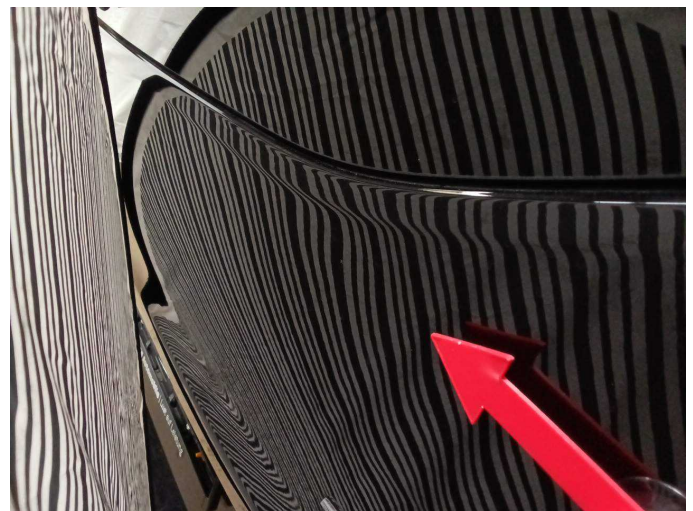
Damage 2: Boot lid / rear door: Boot lid - dent(s) - Smooth repair work

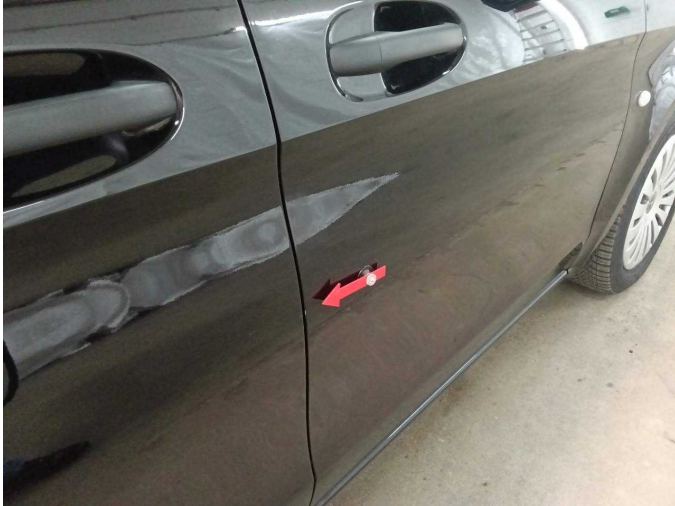
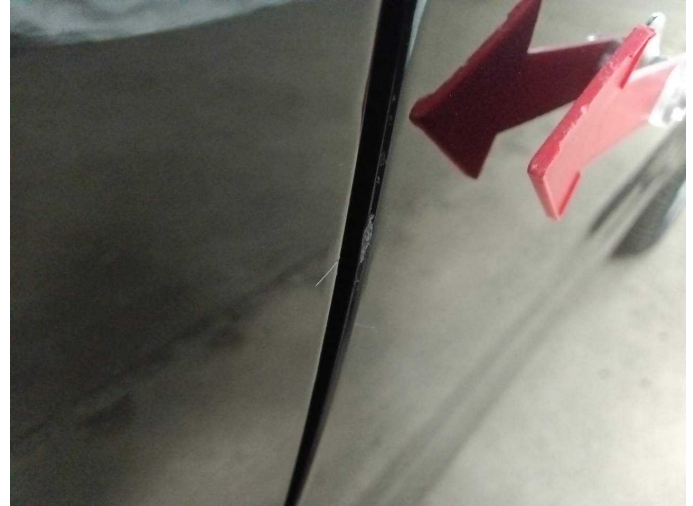
Damage 3: Door - front right side: Door edge - Scratch(es) - Smart repair

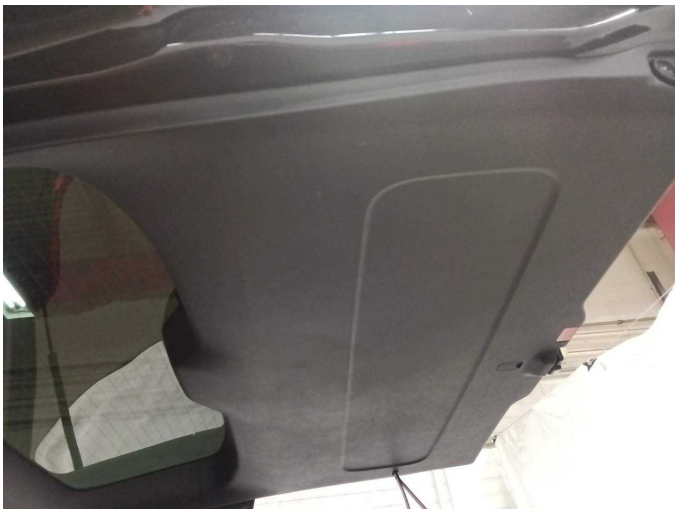
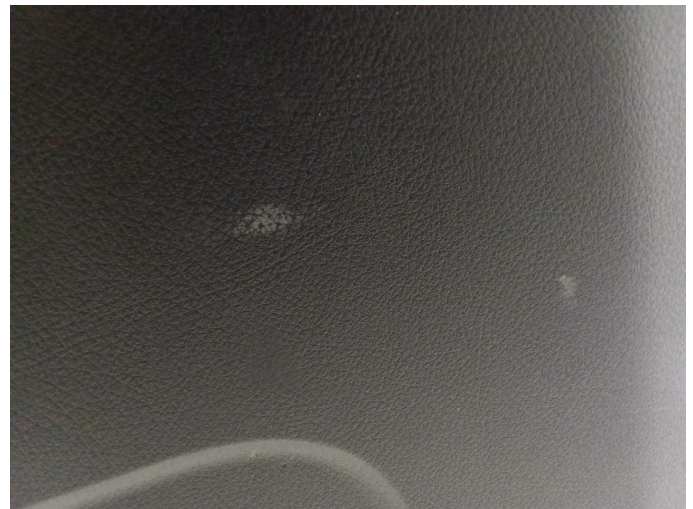
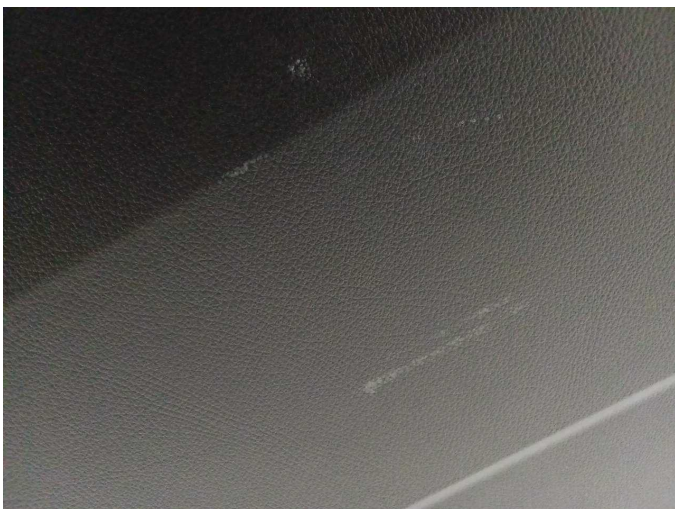
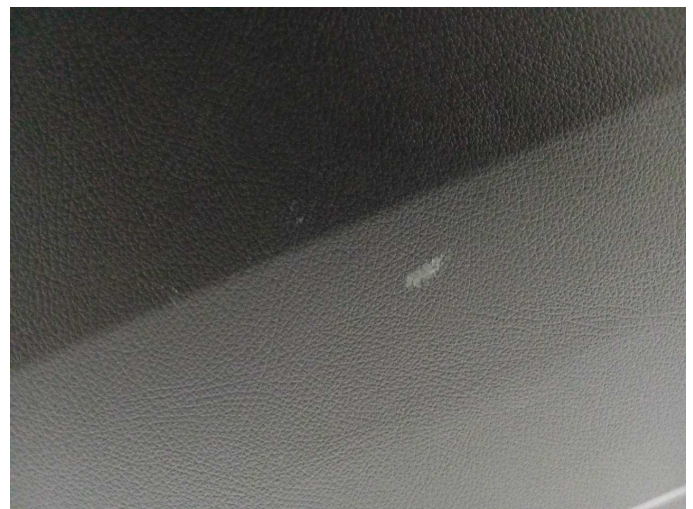
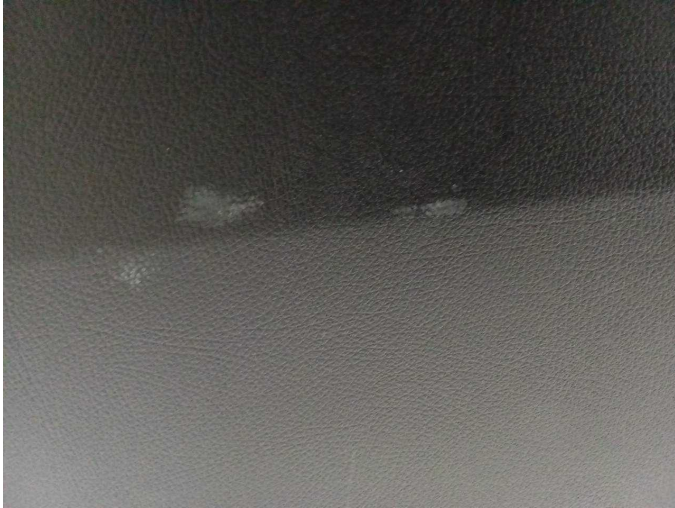
Damage 4: Trim / covers: Boot lid - interior trim - Scratched - Loss in value

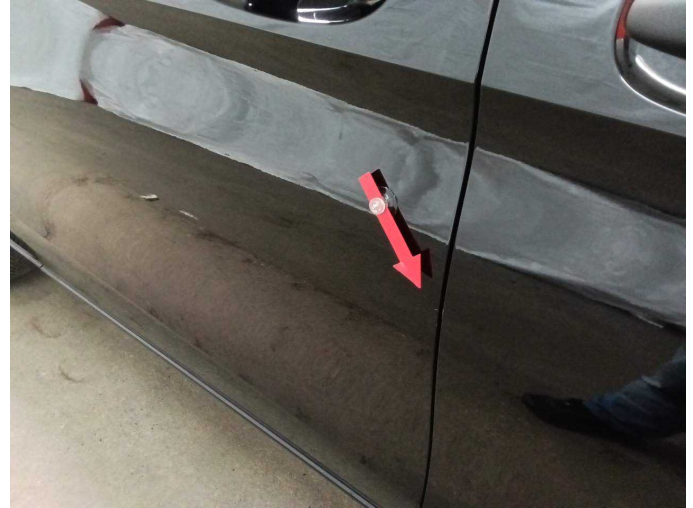
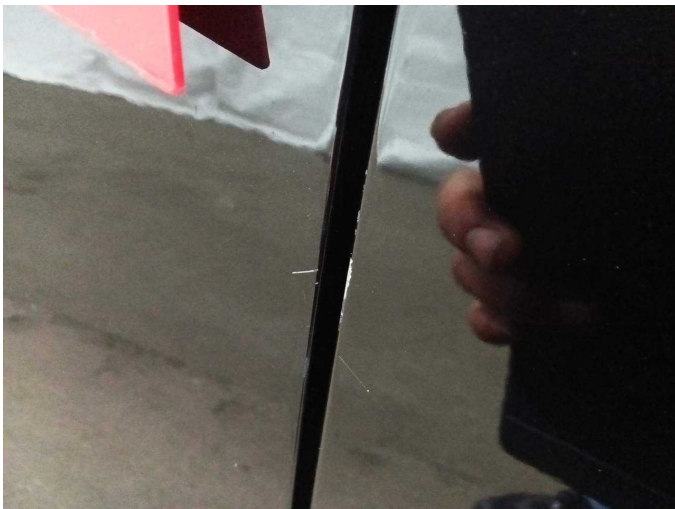
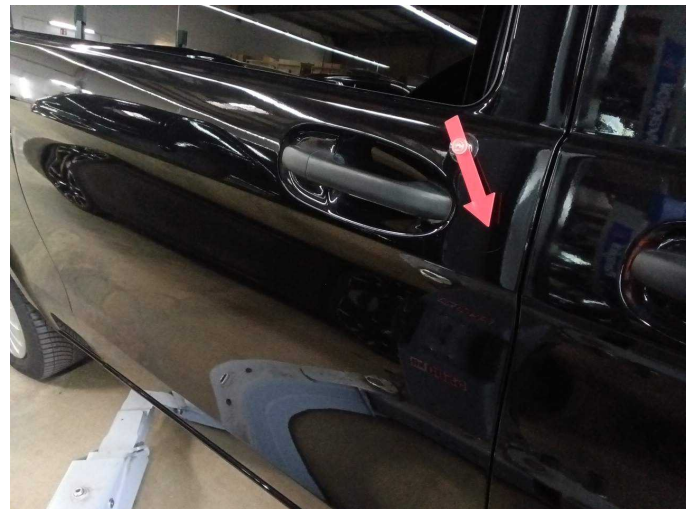
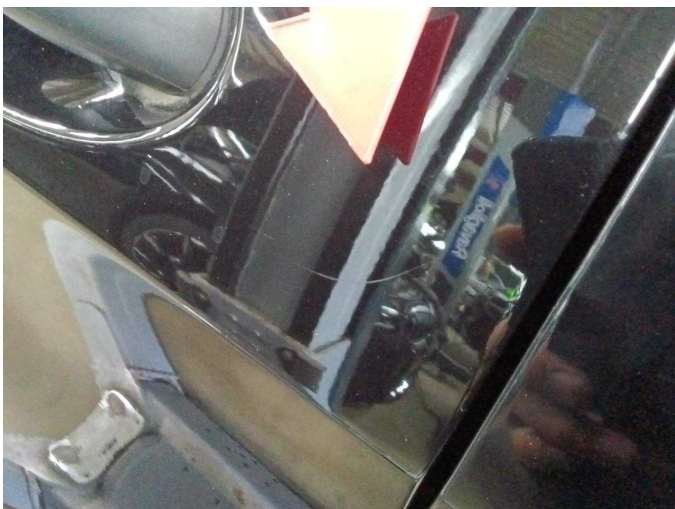
Damage 5: Sliding door, right: Sliding door - Scratch(es) - Smart repair

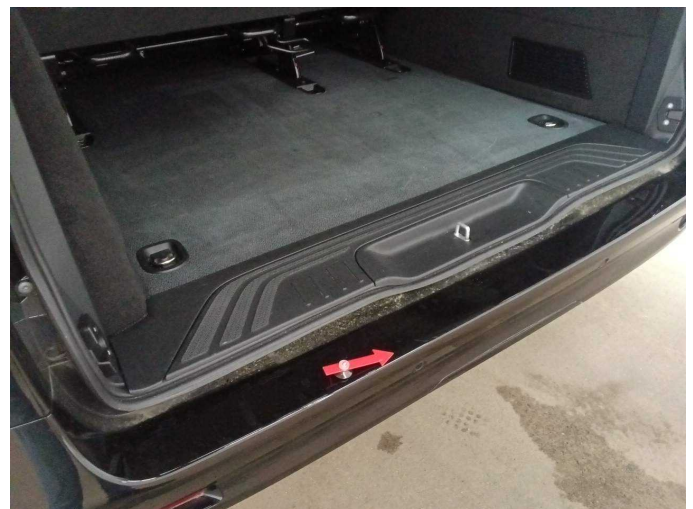
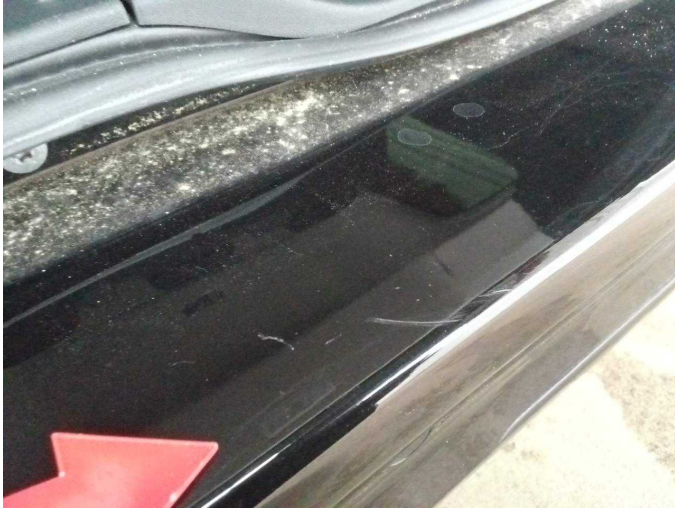
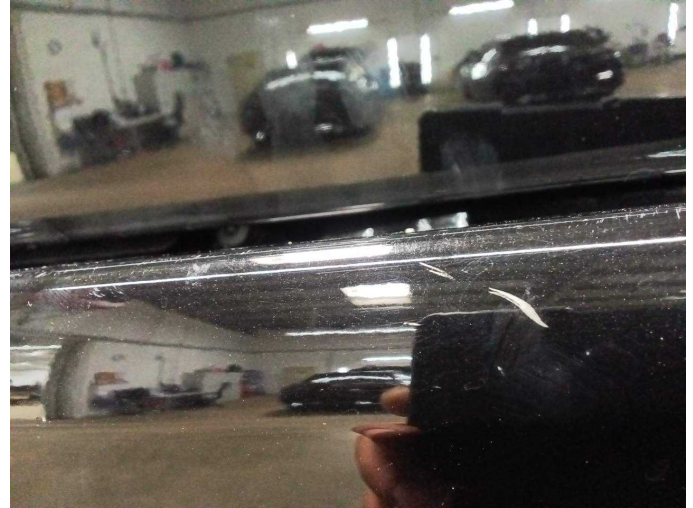
Damage 6: Rear bumper: Rear bumper - Scratched - Paint

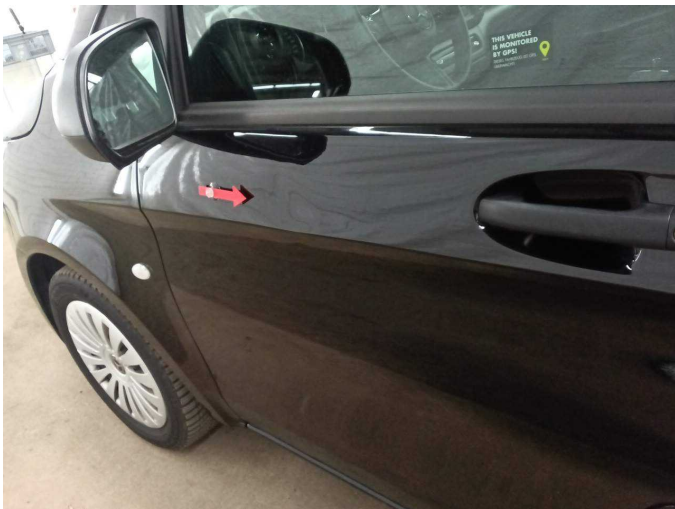
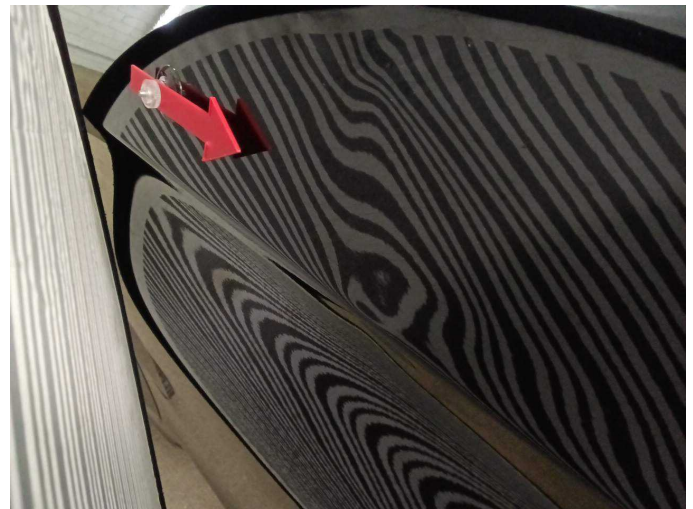
Damage 7: Door - front left side: Door - dent(s) - Repair and paint

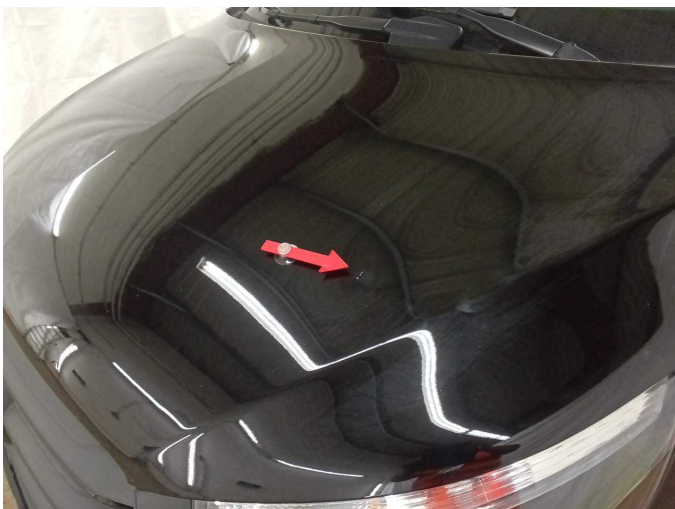
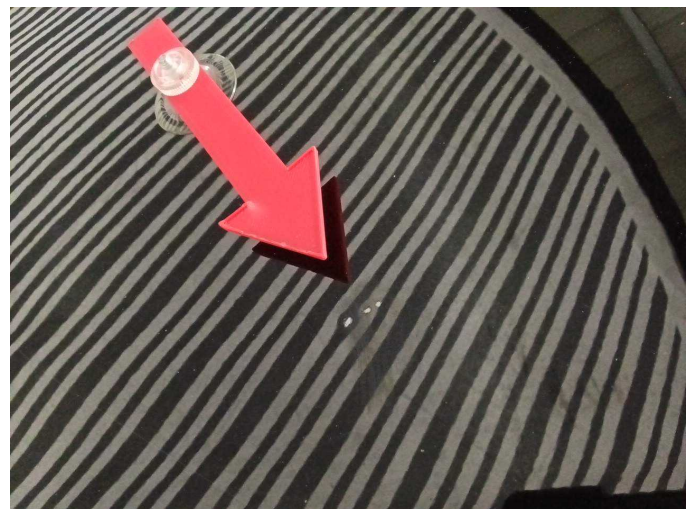
Damage 8: Bonnet: Bonnet - Dent / paintcoat damage - Repair and paint
