## Expertise

Protocol number: 45411137  
Order No. / Reference: 26258388  
Inspection date: 12 May 2026

Model: Vito 116 CDI Kasten Extralang HA Aut. PRO

VIN: W1VVLCEZ3T4536176

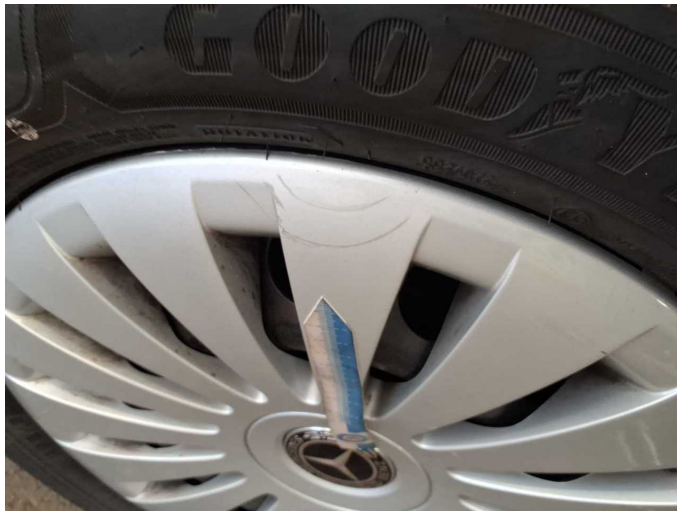
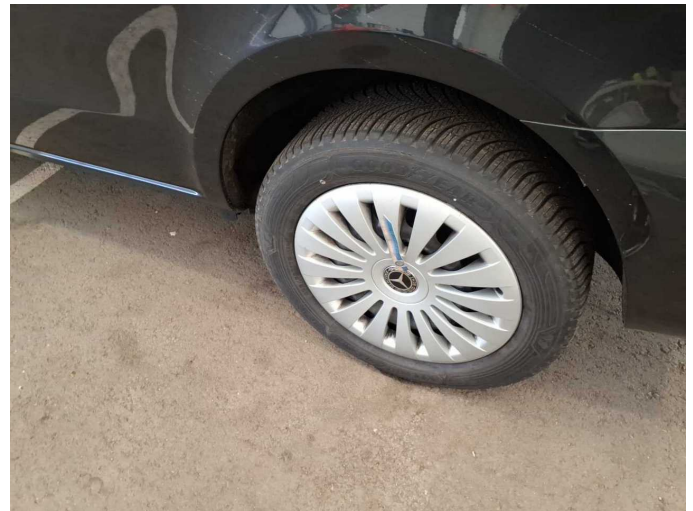
Damage 1: Wheel / tyres: Wheel cover - rear left side - Scratch(es) - Replace

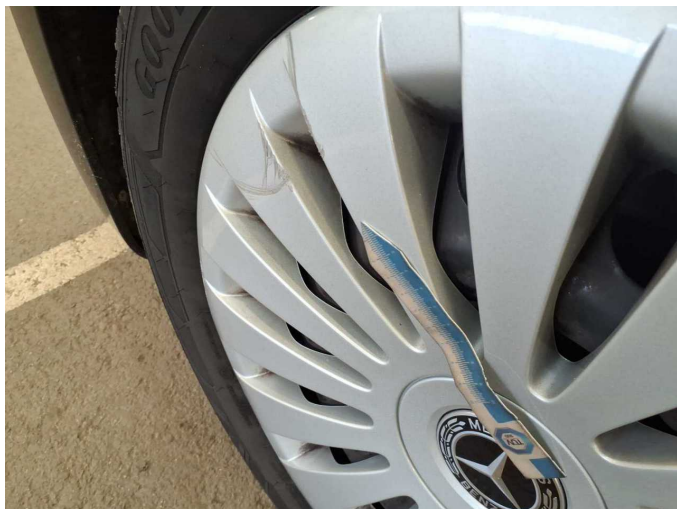
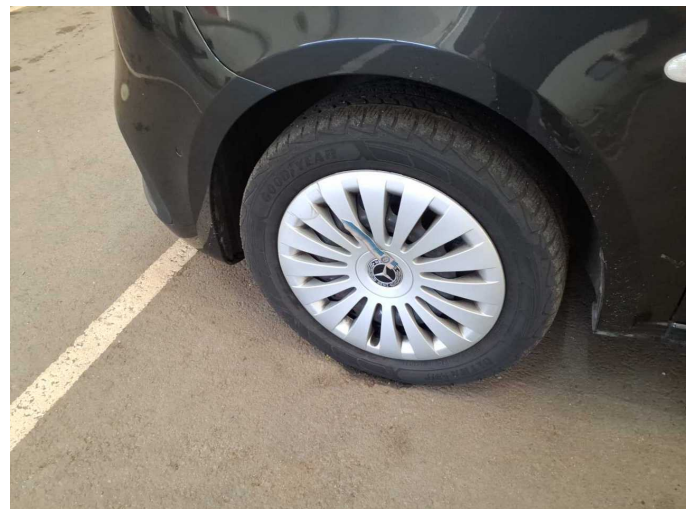
Damage 2: Wheel / tyres: Wheel cover - front left side - Scratch(es) - Replace

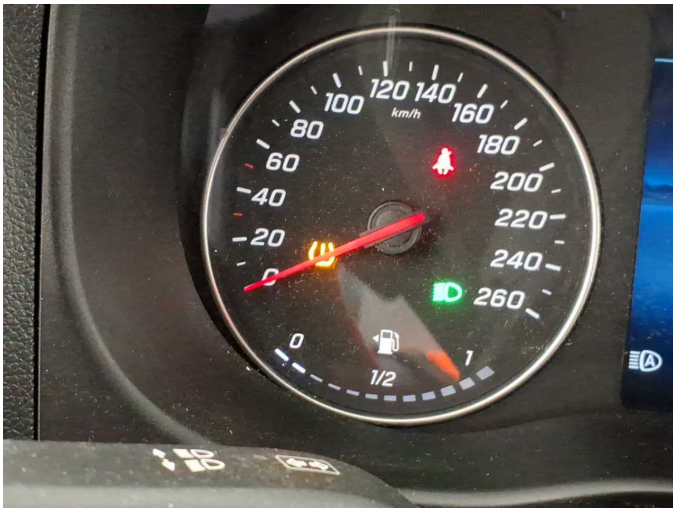
**Damage 3:** Instrument panel: Indicator light (Reifendruck Kontrollleuchte) - on - Perform diagnosis

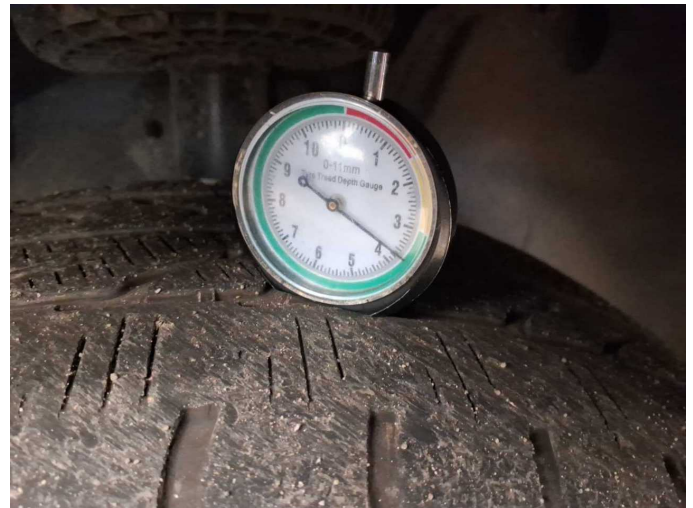
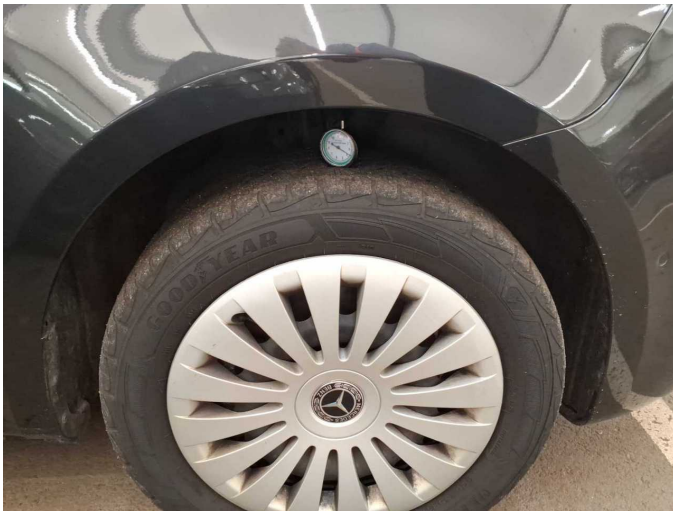
**Damage 4:** Wheel / tyres: Tyre - front right side - Does not meet the leasing specifications - Replace

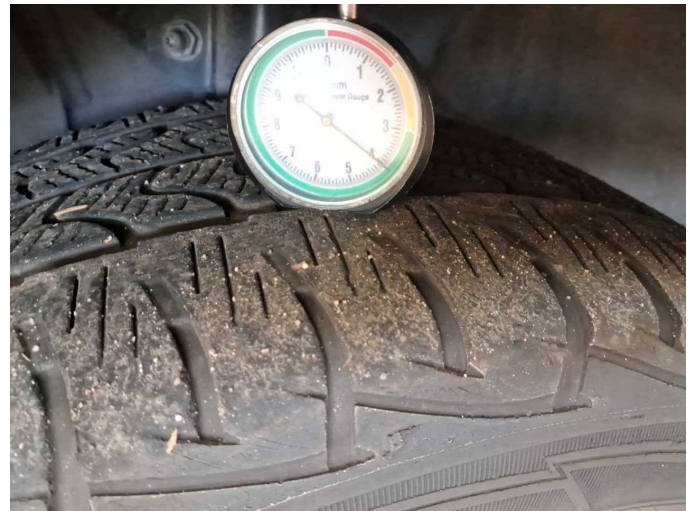
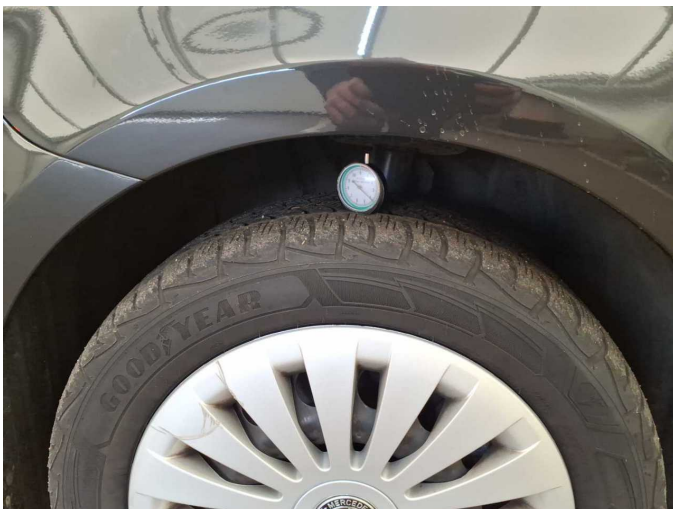
**Damage 5:** Wheel / tyres: Tyre - front left side - Does not meet the leasing specifications - Replace

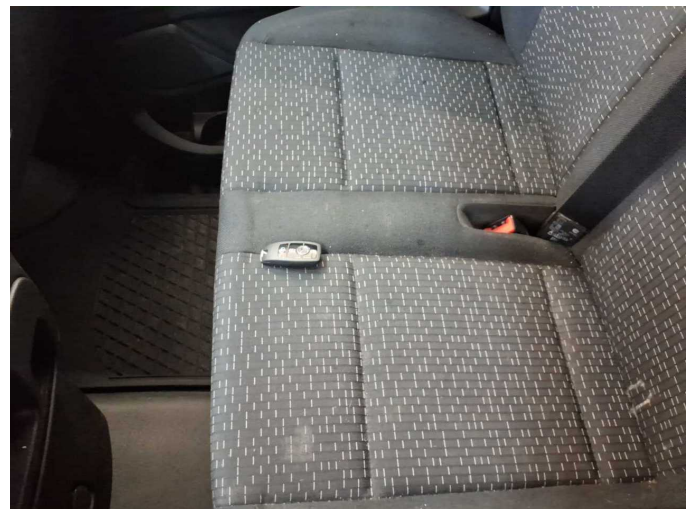
**Missing part 1:** Equipment: Vehicle key (laut Auftraggeber vorhanden) - Missing - Replace
