Expertise

Protocol number: 46004139
Order No. / Reference: 26451761
Inspection date: 16 Jun 2026

Manufacturer: Opel

Model: Vivaro 2.0 D Cargo L EHZ Autm. Elegance

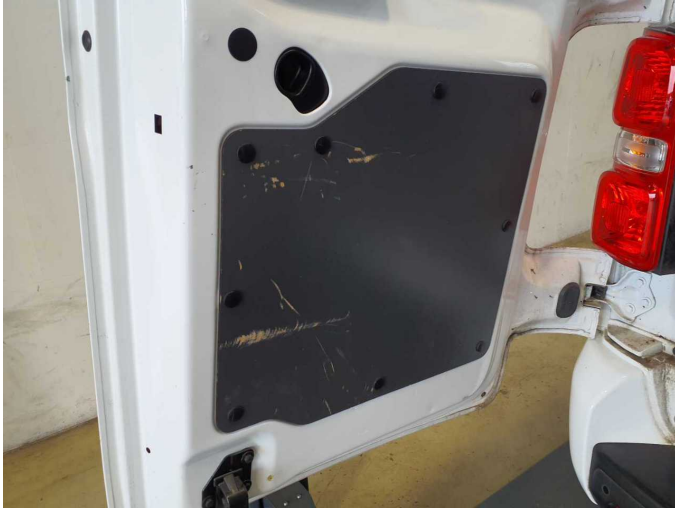
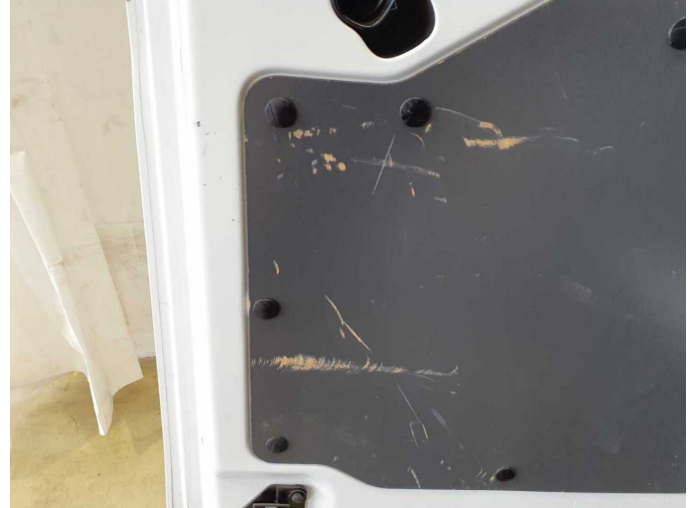
Damage 3: Trim / covers: Door trim - rear left side - Scratch(es) - Loss in value

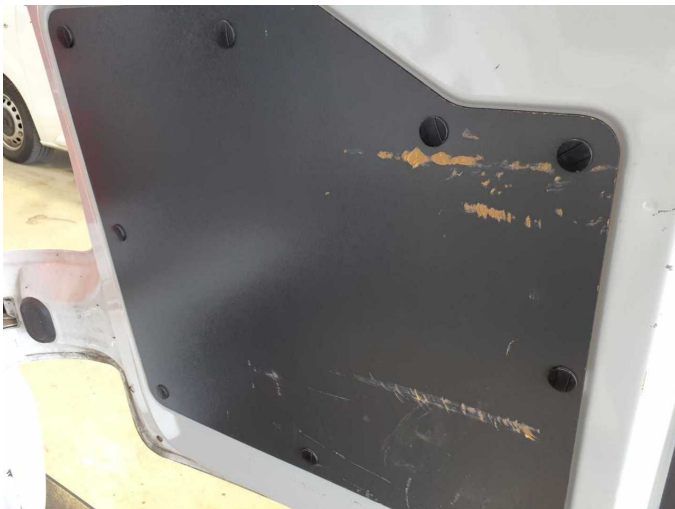
Damage 4: Trim / covers: Door trim - rear right side - Scratch(es) - Loss in value

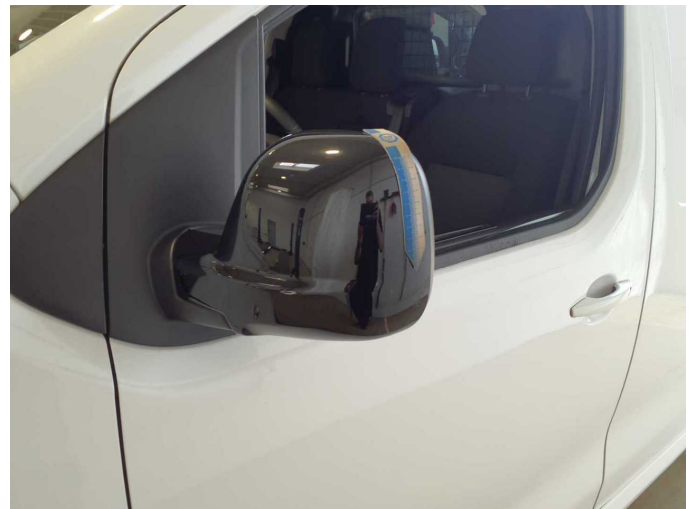
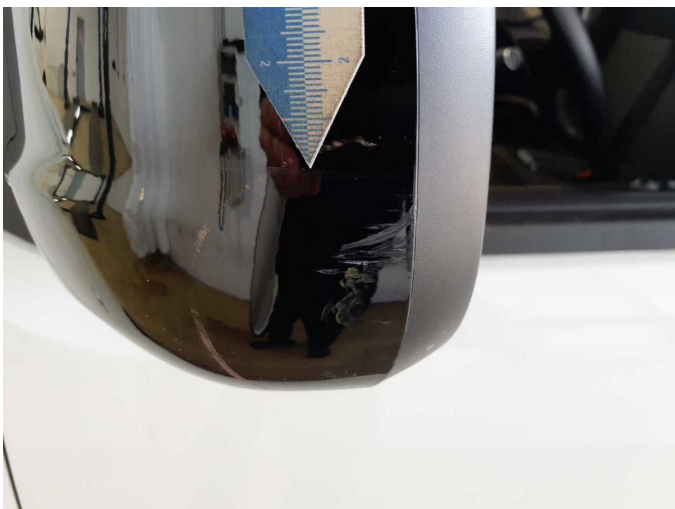
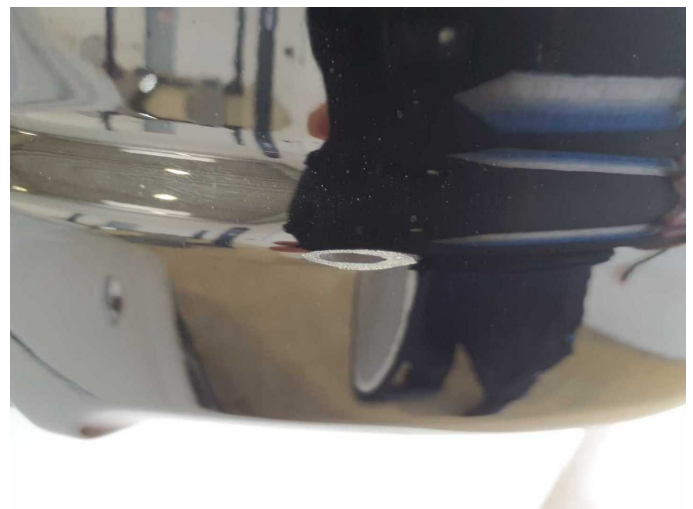
Damage 5: Wing mirror - left side: Cap - Scratch(es) - Repaired

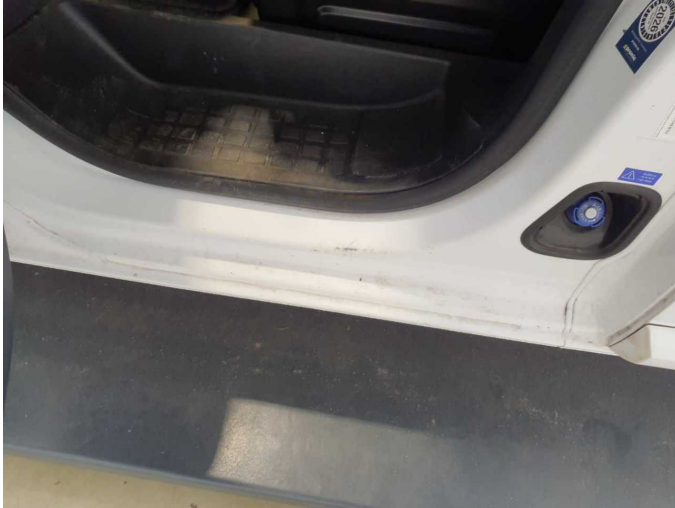
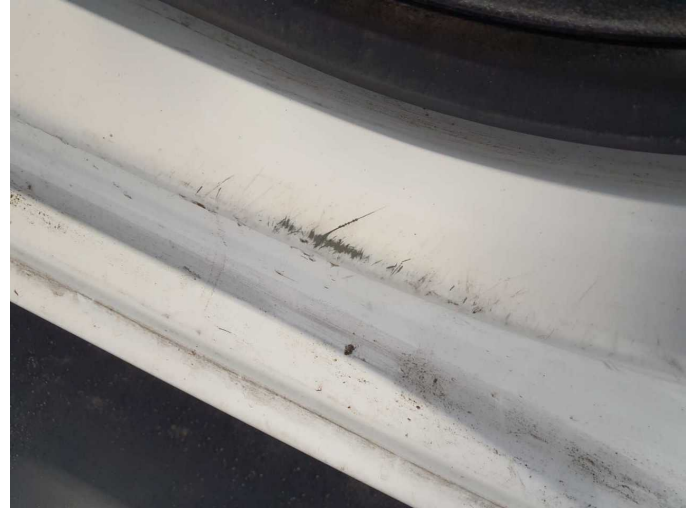
Damage 6: Sill - left side: Sill - Scratch(es) - Smart repair

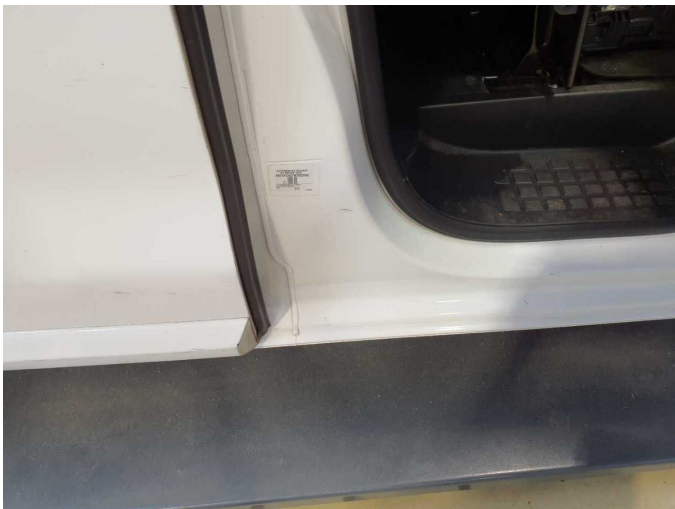
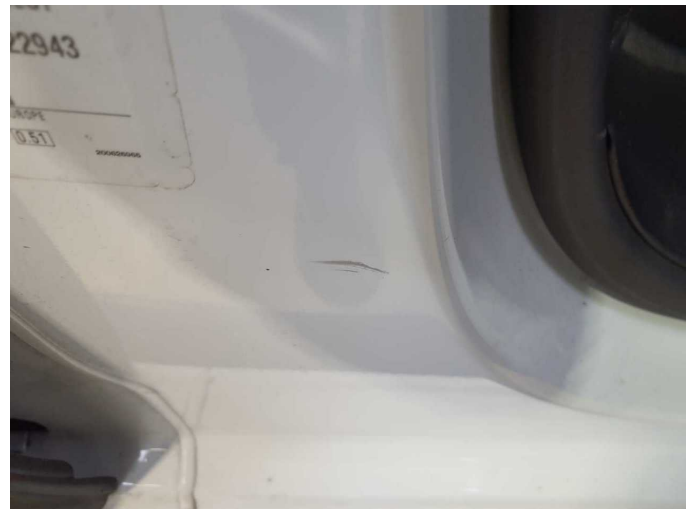
Damage 7: Sill - right side: Sill - Dent / paintcoat damage - Smart repair

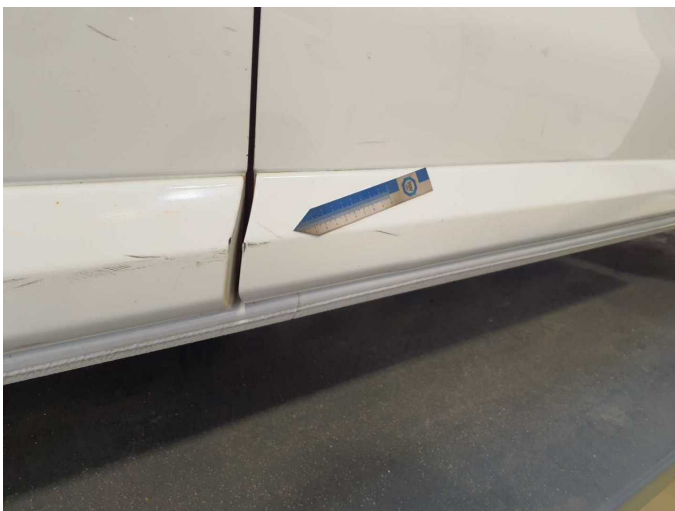
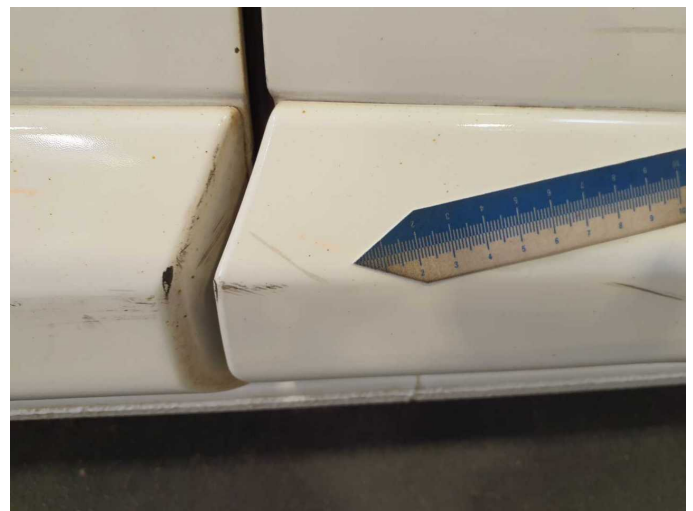
Damage 8: Door - front right side: Brightware - lower - Scratch(es) - Smart repair

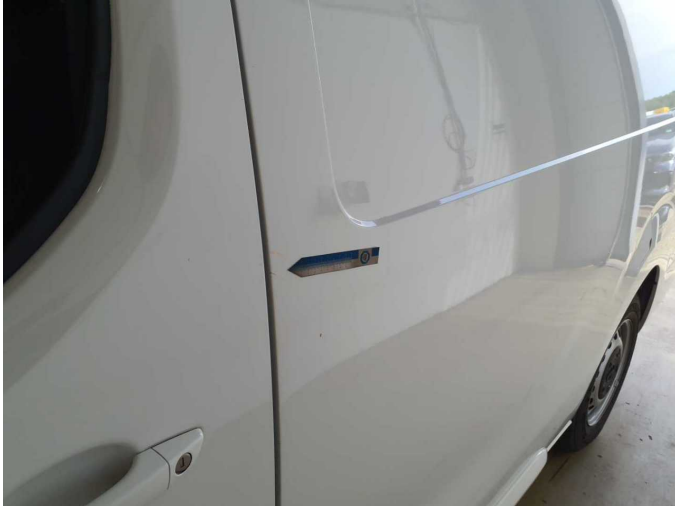
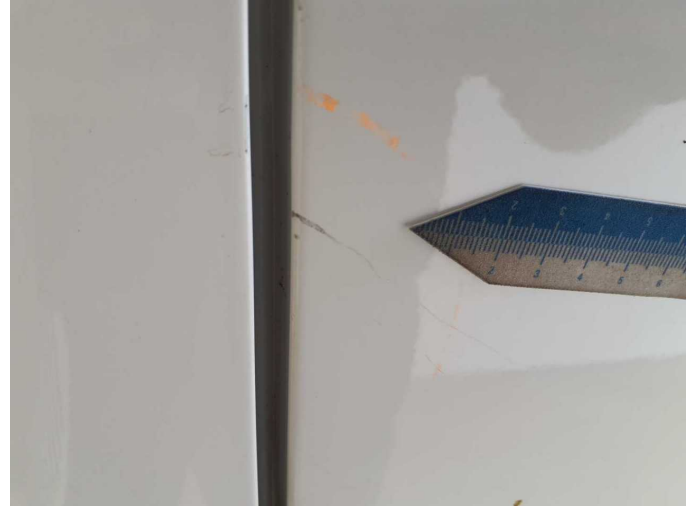
Damage 9: Side panel - rear left side: Side panel - Scratch(es) - Smart repair

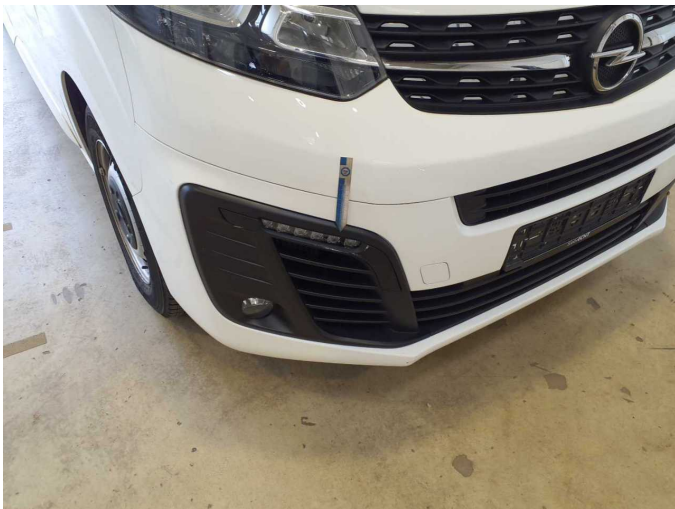
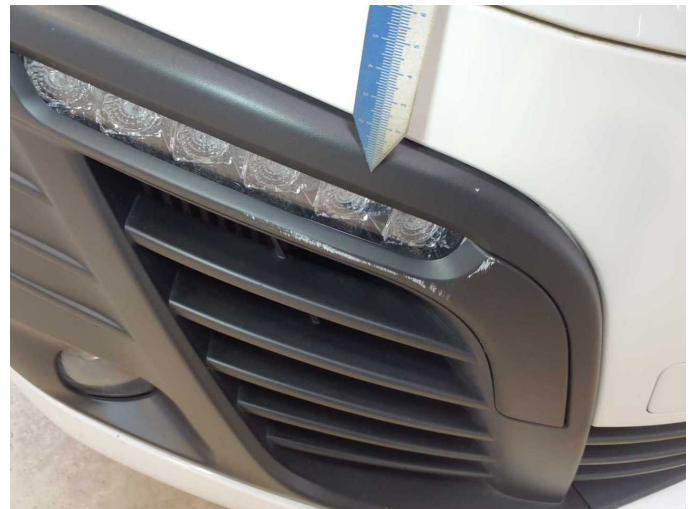
Damage 10: Trim / covers: Trim / covers - Scratch(es) - Smart repair

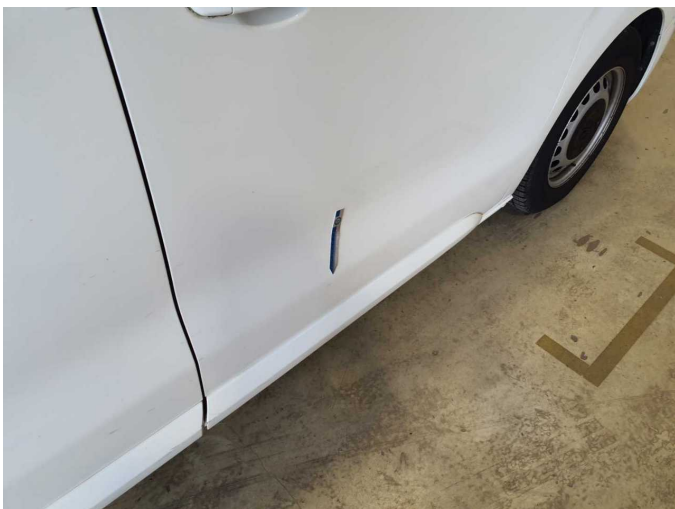
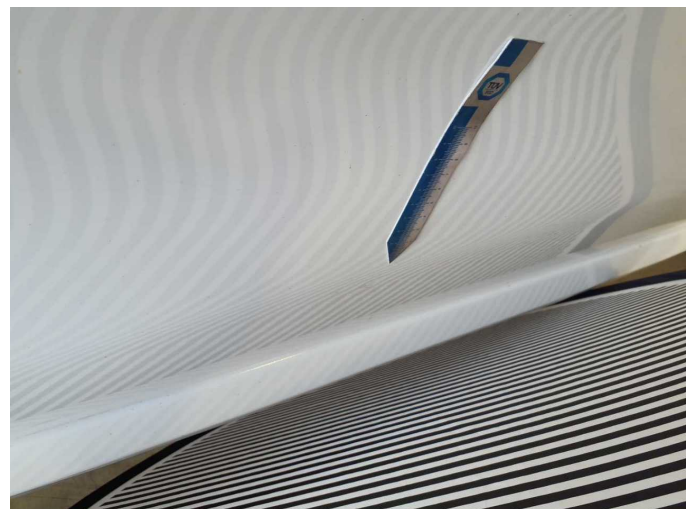
Damage 11: Door - front right side: Door - Dent / paintcoat damage - Smart repair

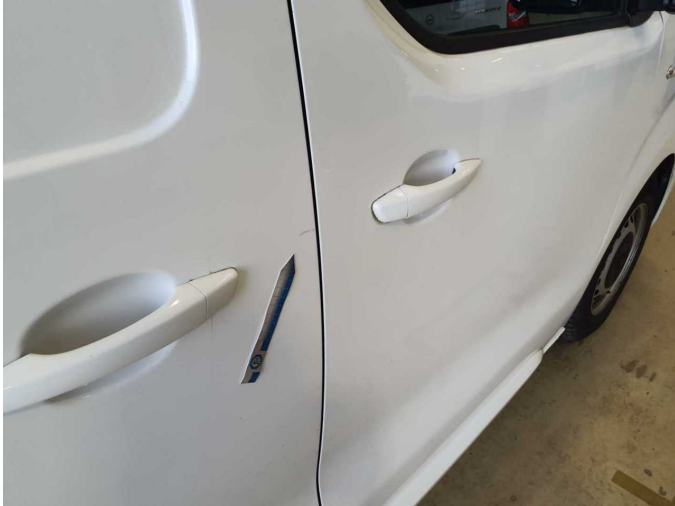
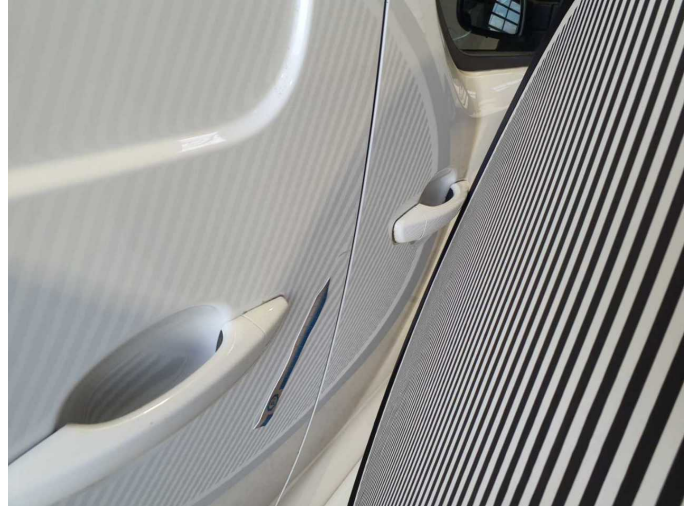
Damage 12: Sliding door, right: Sliding door - Dent / paintcoat damage - Smart repair

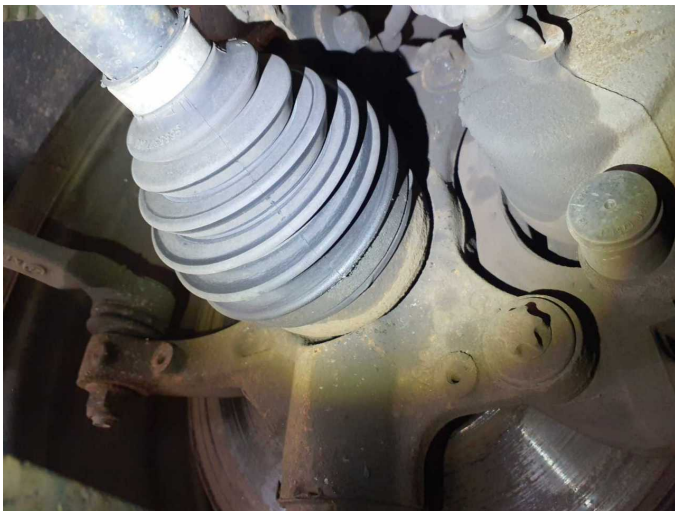
Damage 13: Drive train: Sleeve prop shaft - front left side - Broken / torn - Replace

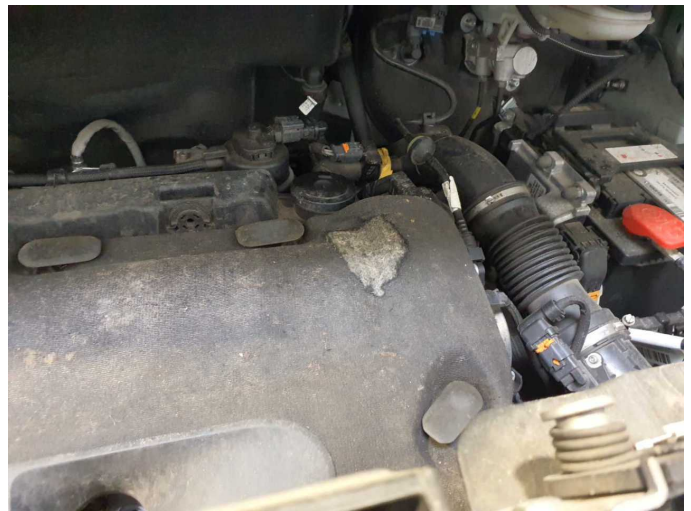
Damage 14: Engine: Engine cover - Broken / torn - Replace

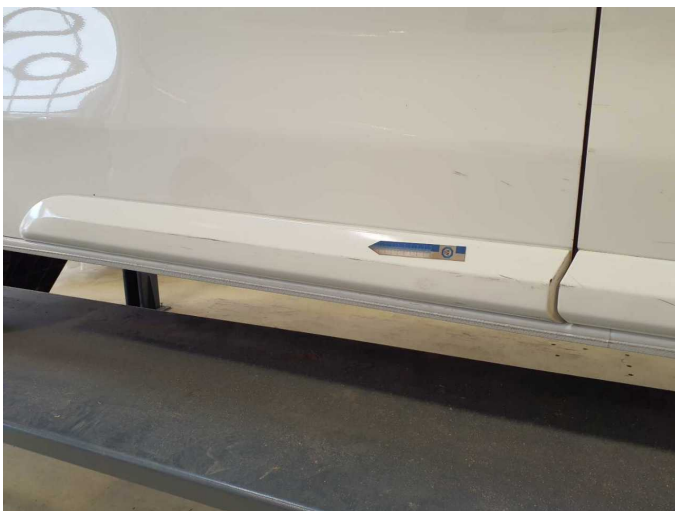
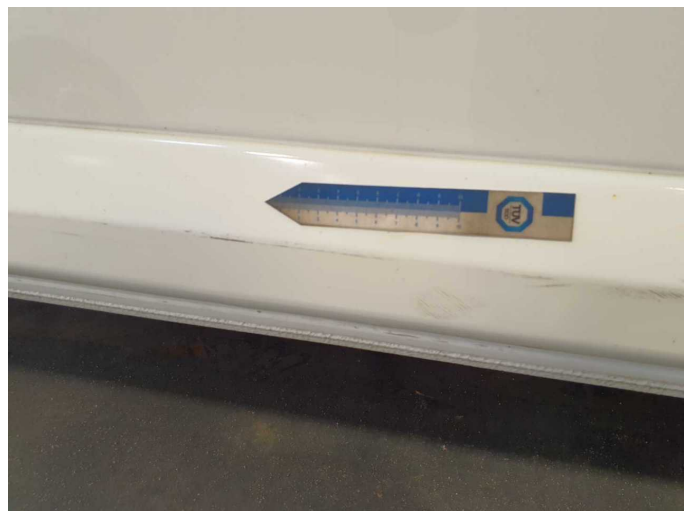
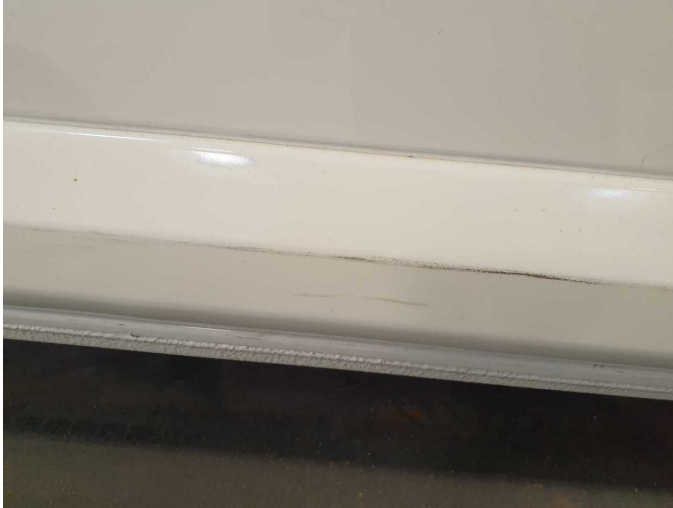
15	Door - rear right side	Brightware - lower - Scratch(es) - Paint
16	Rear bumper	Bumper - rear right side (Eckteil) - Broken / torn - Replace
17	Front bumper	Front bumper - Dent / paintcoat damage - Repair and paint

Damage 15: Door - rear right side: Brightware - lower - Scratch(es) - Paint

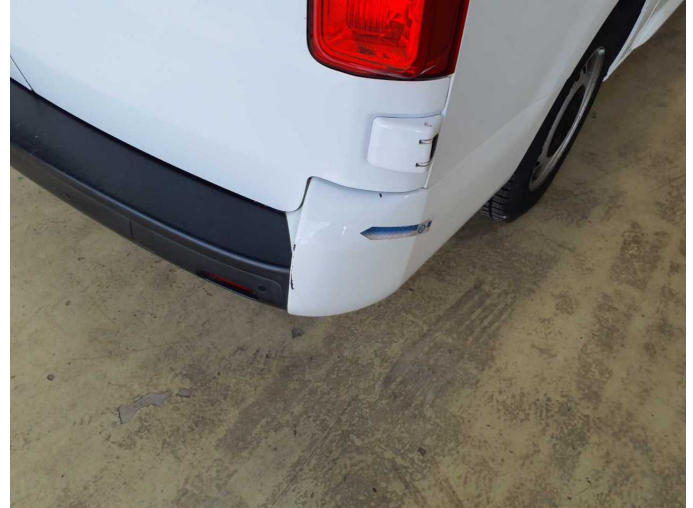
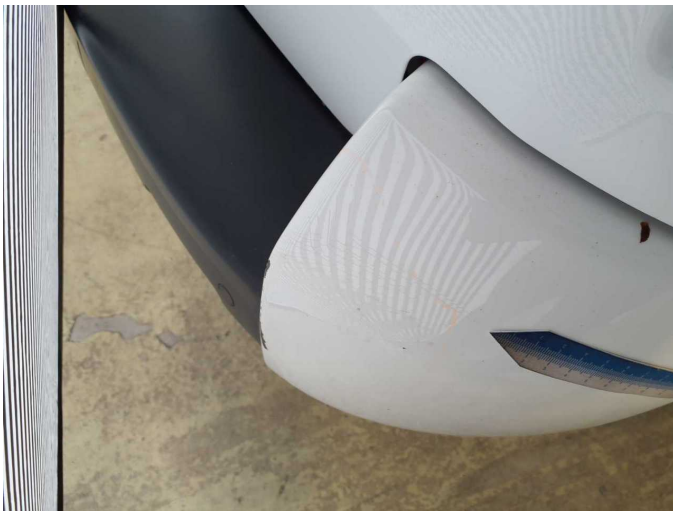
Damage 16: Rear bumper: Bumper - rear right side (Eckteil) - Broken / torn - Replace

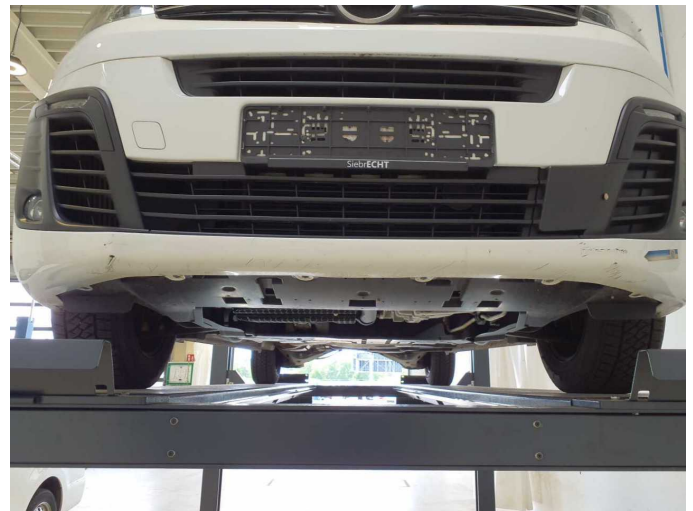
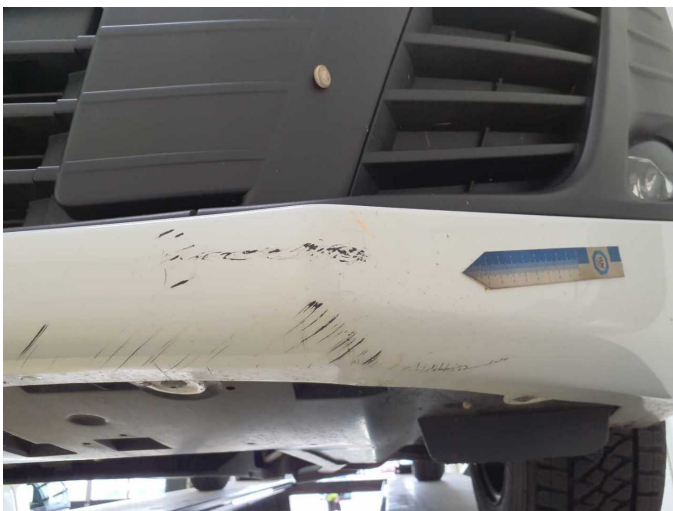
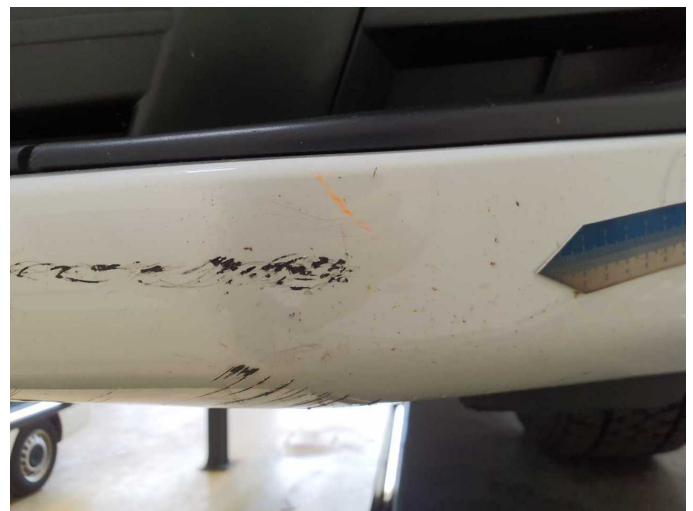
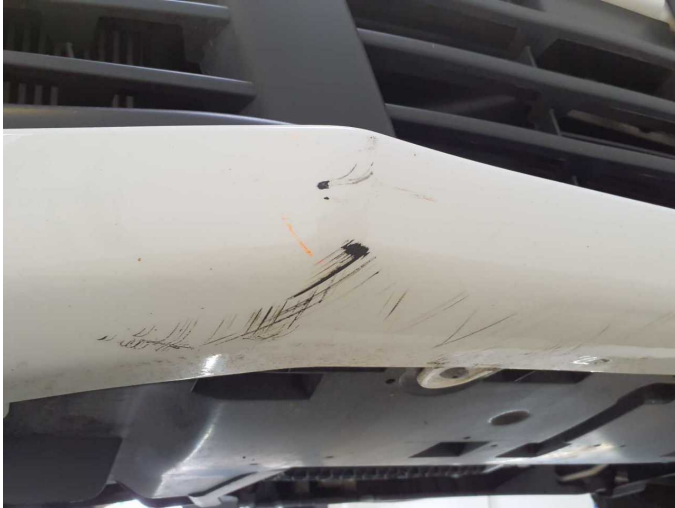
Damage 17: Front bumper: Front bumper - Dent / paintcoat damage - Repair and paint
