Expertise

Protocol number: 46094432  
Order No. / Reference: 26617003  
Inspection date: 23 Jun 2026

Manufacturer: Ford

Model: Focus Turnier 1.5 EcoBlue Start-Stopp-System Aut. TITANIUM

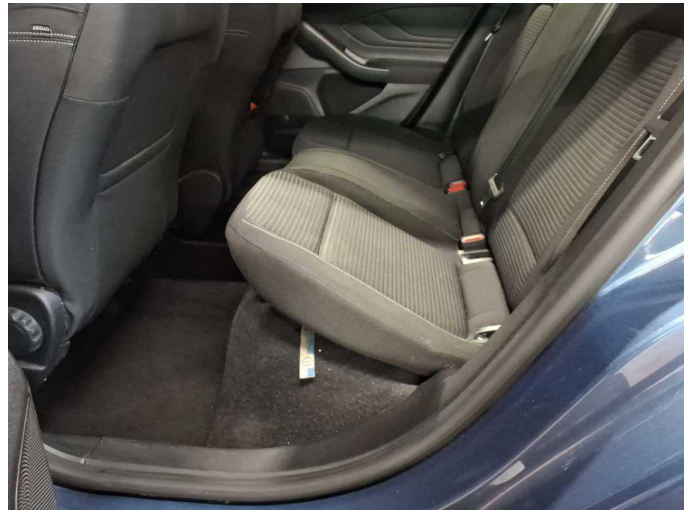
| No. | Component group | Description |
|---|---|---|
| 1 | Seat - rear | Seat upholstery - 3 seater bench (Mehrkosten möglich) - Loose - Perform diagnosis |

**Damage 1:** Seat - rear: Seat upholstery - 3 seater bench (Mehrkosten möglich) - Loose - Perform diagnosis

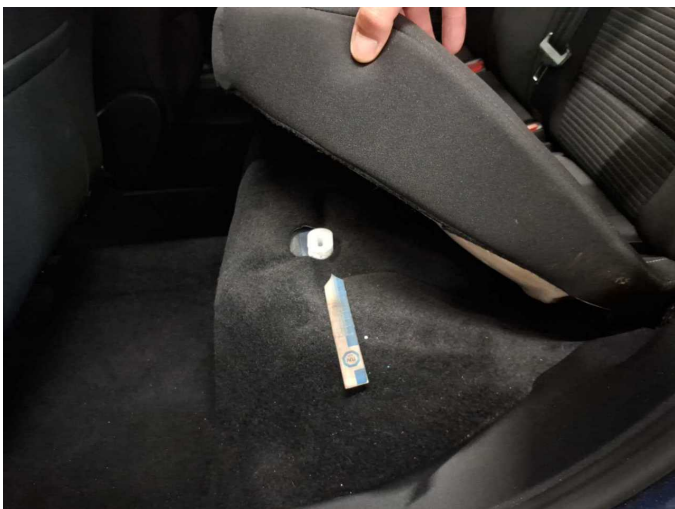
**Damage 1:** Seat - rear: Seat upholstery - 3 seater bench (Mehrkosten möglich) - Loose - Perform diagnosis

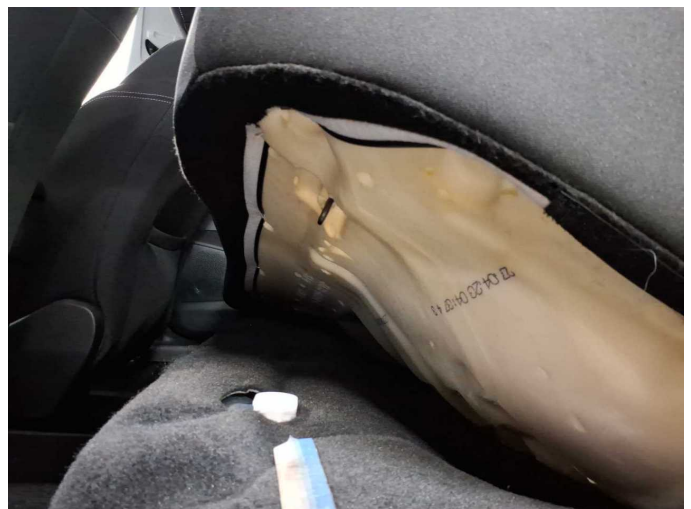
**Damage 1:** Seat - rear: Seat upholstery - 3 seater bench (Mehrkosten möglich) - Loose - Perform diagnosis

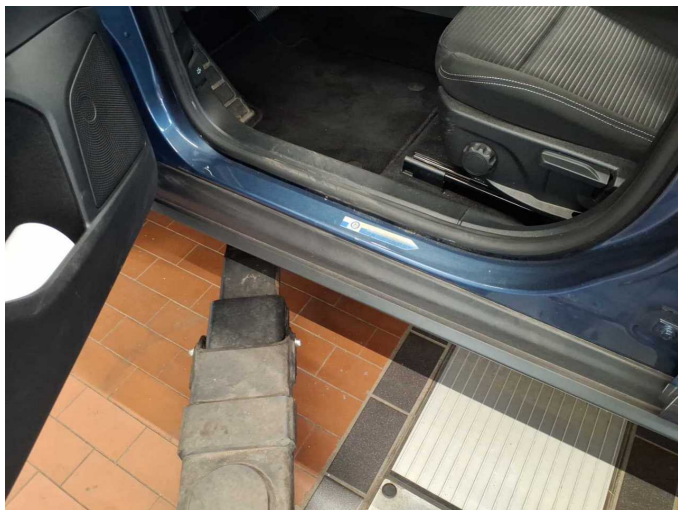
| No. | Component group | Description |
|---|---|---|
| 2 | Sill - left side | Sill (Vorne) - Scratch(es) - Smart repair |

**Damage 2:** Sill - left side: Sill (Vorne) - Scratch(es) - Smart repair

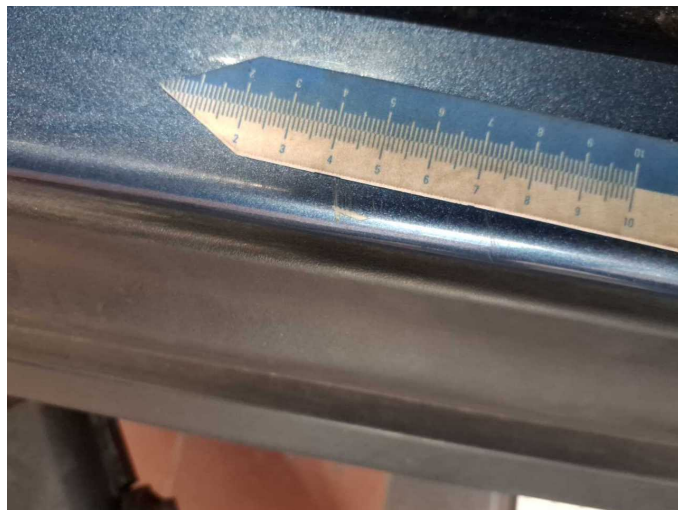
**Damage 2:** Sill - left side: Sill (Vorne) - Scratch(es) - Smart repair

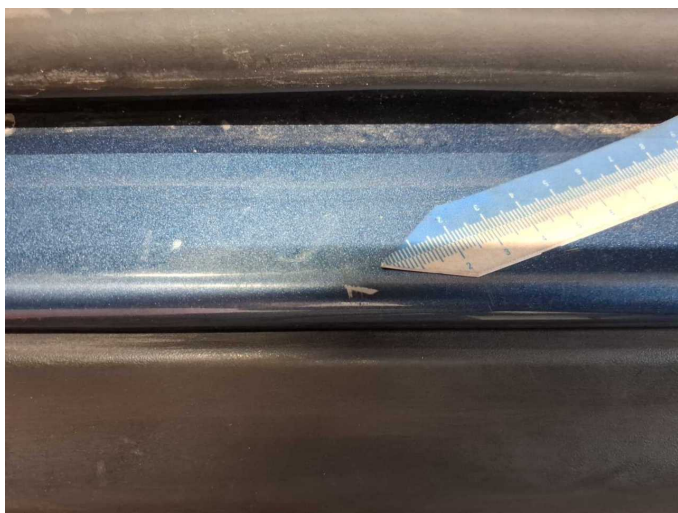
**Damage 2:** Sill - left side: Sill (Vorne) - Scratch(es) - Smart repair

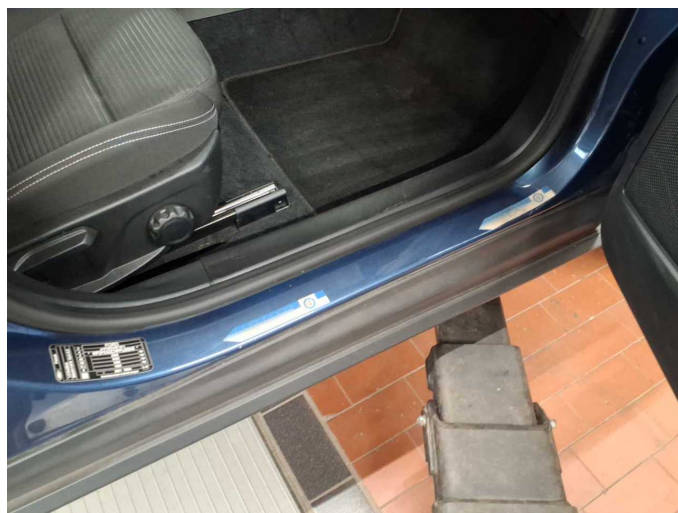
| No. | Component group | Description |
|---|---|---|
| 3 | Sill - right side | Sill (Vorne) - Scratch(es) - Smart repair |

**Damage 3:** Sill - right side: Sill (Vorne) - Scratch(es) - Smart repair

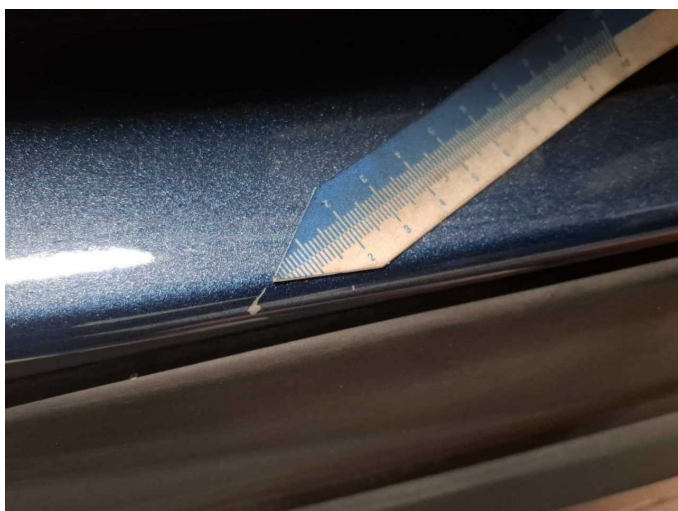
**Damage 3:** Sill - right side: Sill (Vorne) - Scratch(es) - Smart repair

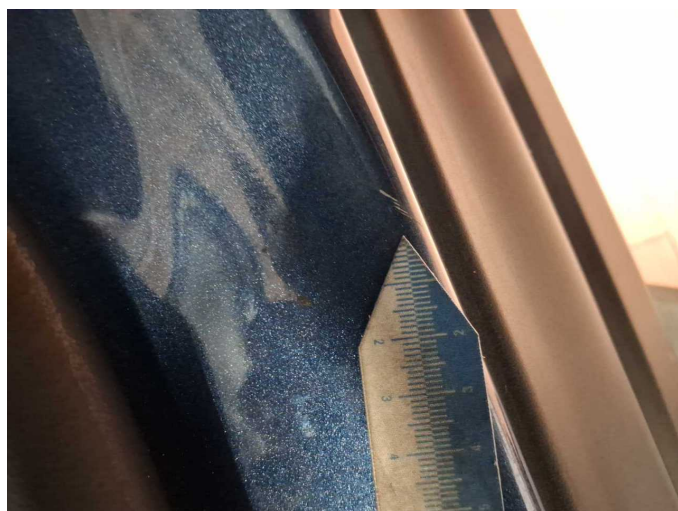
**Damage 3:** Sill - right side: Sill (Vorne) - Scratch(es) - Smart repair

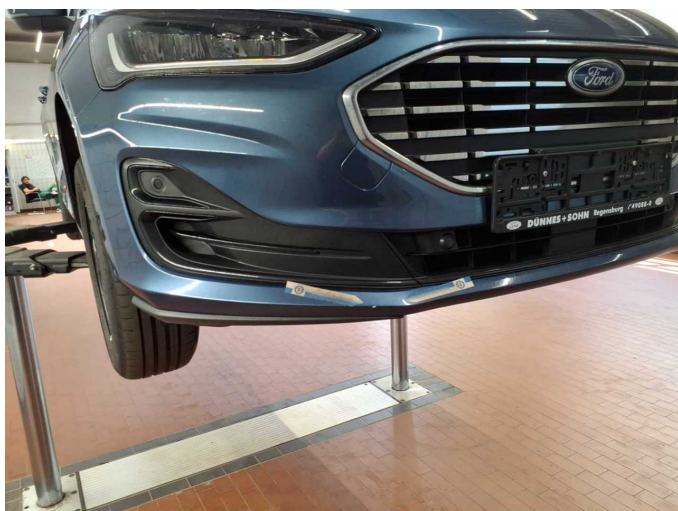
| No. | Component group | Description |
|---|---|---|
| 4 | Front bumper | Front bumper - Scratched - Smart repair |

**Damage 4:** Front bumper: Front bumper - Scratched - Smart repair

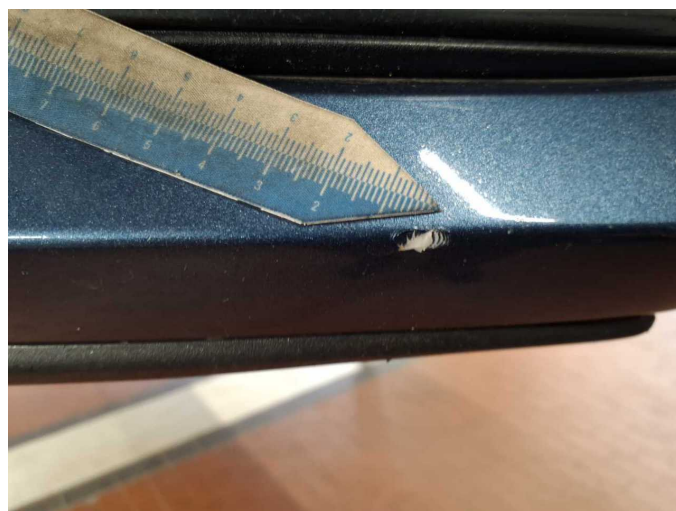
**Damage 4:** Front bumper: Front bumper - Scratched - Smart repair

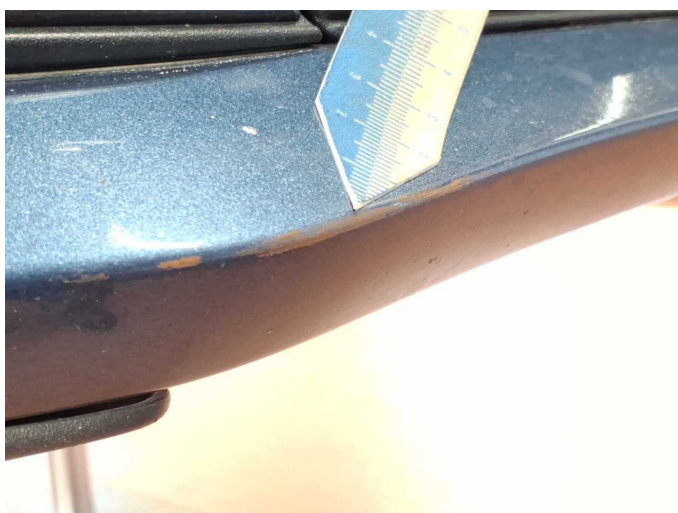
**Damage 4:** Front bumper: Front bumper - Scratched - Smart repair

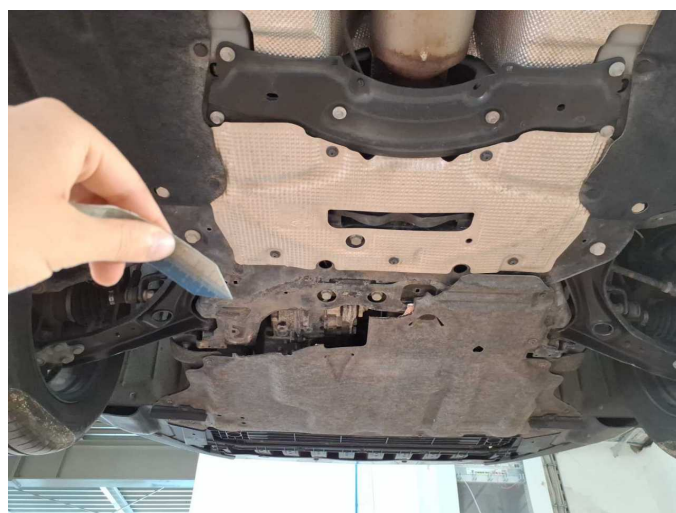
| No. | Component group | Description |
|---|---|---|
| 5 | Engine | Engine cowling - lower - Broken / torn - Replace |

**Damage 5:** Engine: Engine cowling - lower - Broken / torn - Replace

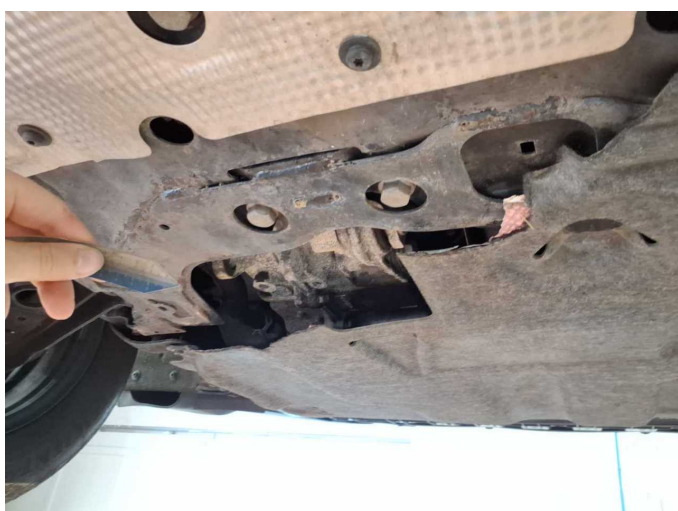
**Damage 5:** Engine: Engine cowling - lower - Broken / torn - Replace

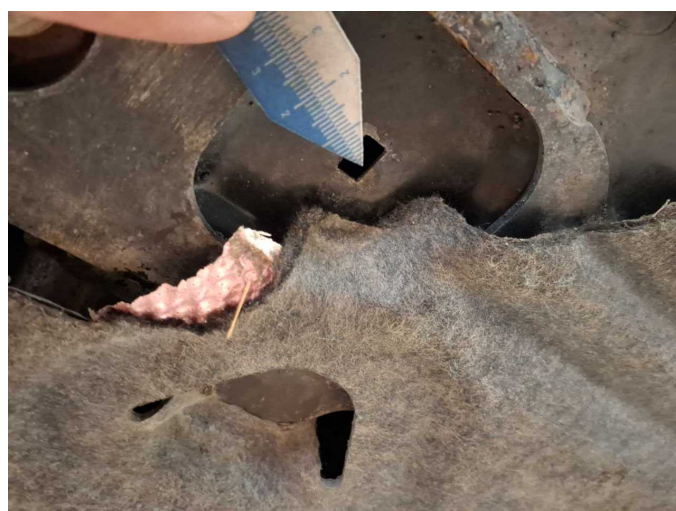
**Damage 5:** Engine: Engine cowling - lower - Broken / torn - Replace

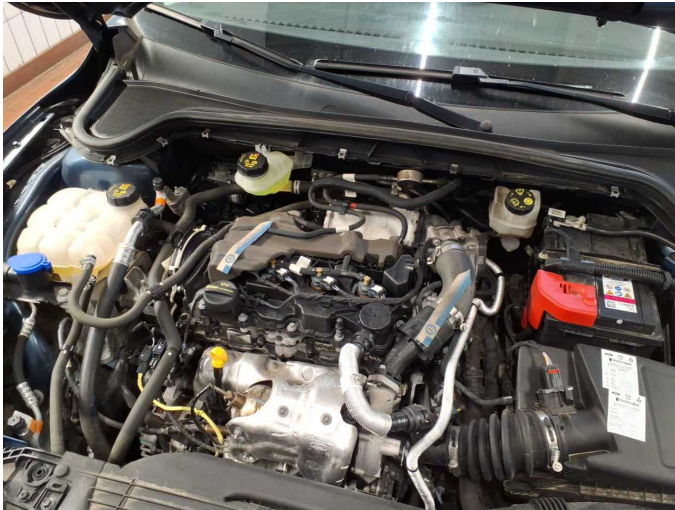
| No. | Component group | Description |
|---|---|---|
| 6 | Engine | Hose turbocharger (+ Isolierung Motor & Dämmmatte Motorhaube) - Damage caused by marten / rodent - Replace |

**Damage 6:** Engine: Hose turbocharger (+ Isolierung Motor & Dämmmatte Motorhaube) - Damage caused by marten / rodent - Replace

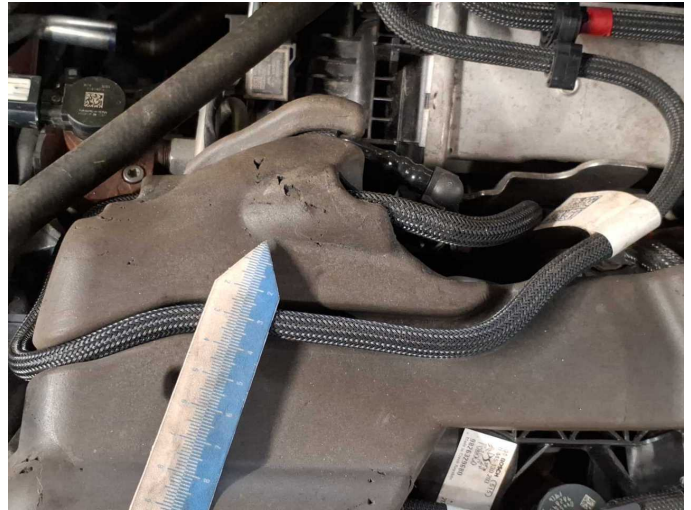
**Damage 6:** Engine: Hose turbocharger (+ Isolierung Motor & Dämmmatte Motorhaube) - Damage caused by marten / rodent - Replace

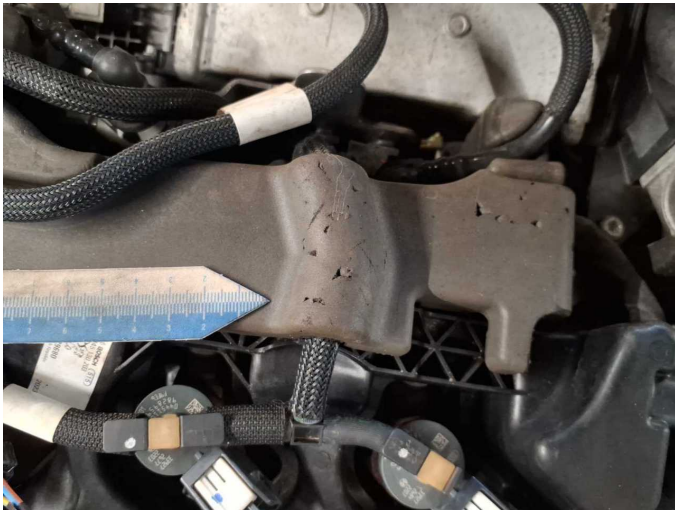
**Damage 6:** Engine: Hose turbocharger (+ Isolierung Motor & Dämmmatte Motorhaube) - Damage caused by marten / rodent - Replace

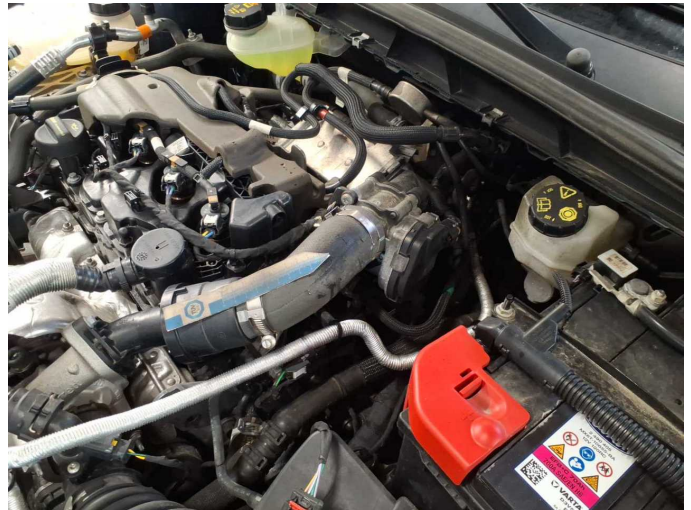
**Damage 6:** Engine: Hose turbocharger (+ Isolierung Motor & Dämmmatte Motorhaube) - Damage caused by marten / rodent - Replace

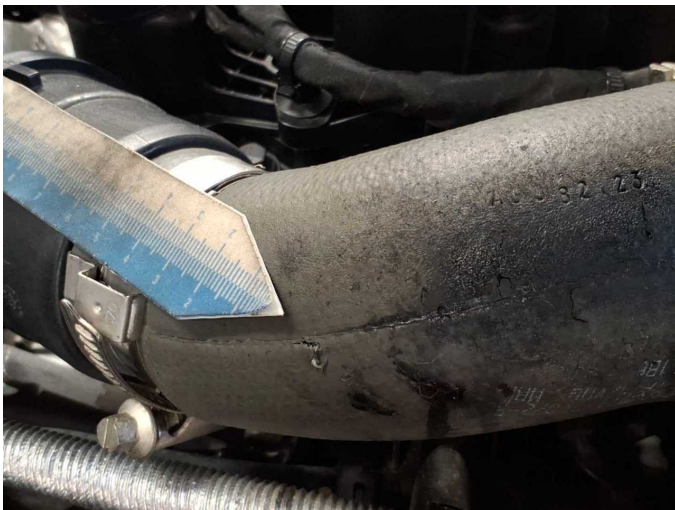
**Damage 6:** Engine: Hose turbocharger (+ Isolierung Motor & Dämmmatte Motorhaube) - Damage caused by marten / rodent - Replace

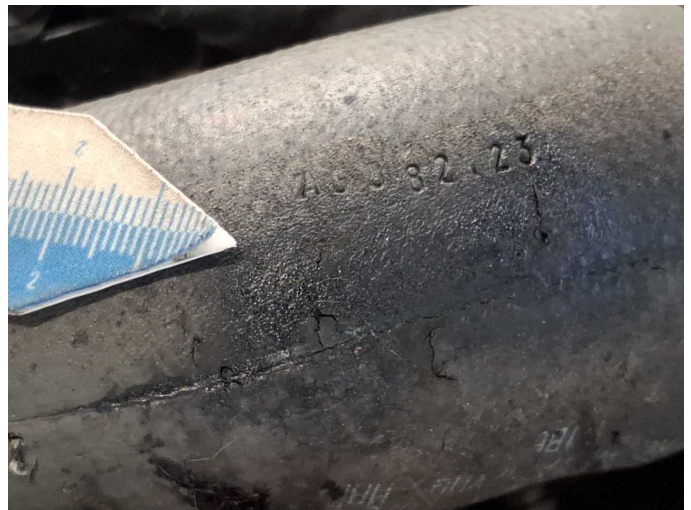
**Damage 6:** Engine: Hose turbocharger (+ Isolierung Motor & Dämmmatte Motorhaube) - Damage caused by marten / rodent - Replace

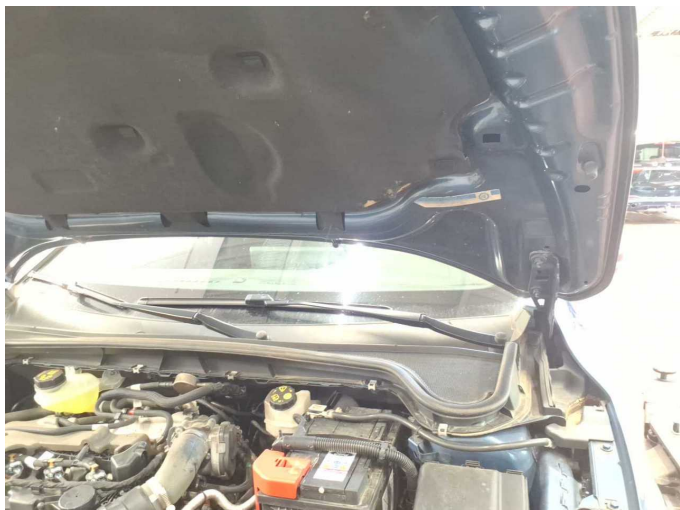
**Damage 6:** Engine: Hose turbocharger (+ Isolierung Motor & Dämmmatte Motorhaube) - Damage caused by marten / rodent - Replace

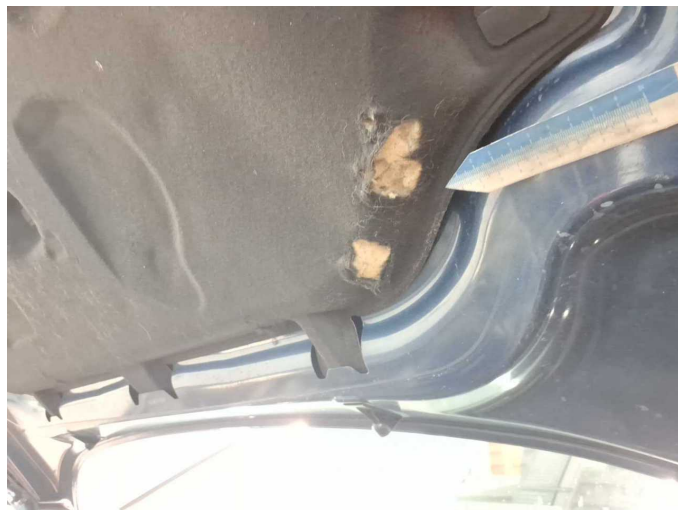
**Damage 6:** Engine: Hose turbocharger (+ Isolierung Motor & Dämmmatte Motorhaube) - Damage caused by marten / rodent - Replace

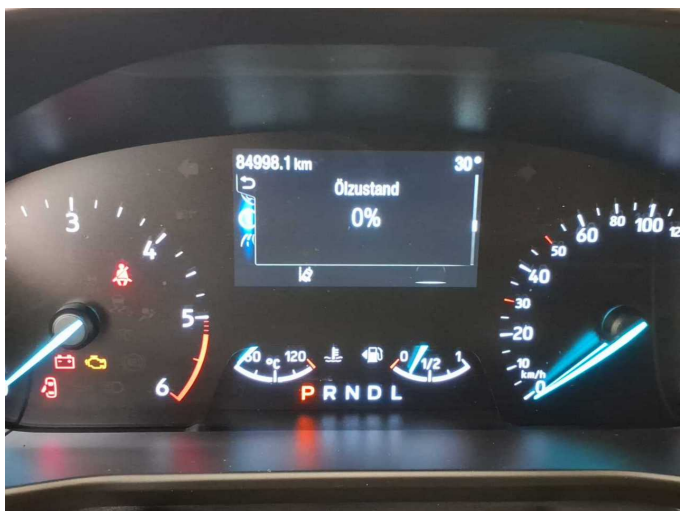
| No. | Component group | Description |
|---|---|---|
| 7 | Misc. | Inspection / maintenance - Due - Perform |

**Damage 7:** Misc.: Inspection / maintenance - Due - Perform

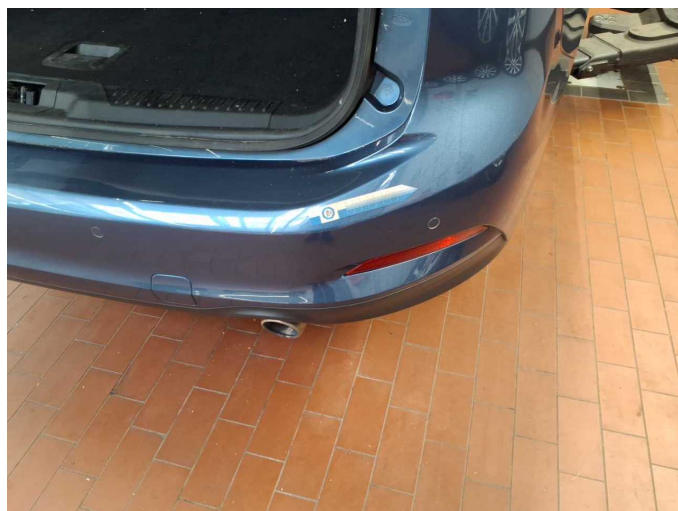
| No. | Component group | Description |
|---|---|---|
| 7 | Rear bumper | Rear bumper - Scratch(es) - Cover / polish |

**Wear and tear 7:** Rear bumper: Rear bumper - Scratch(es) - Cover / polish

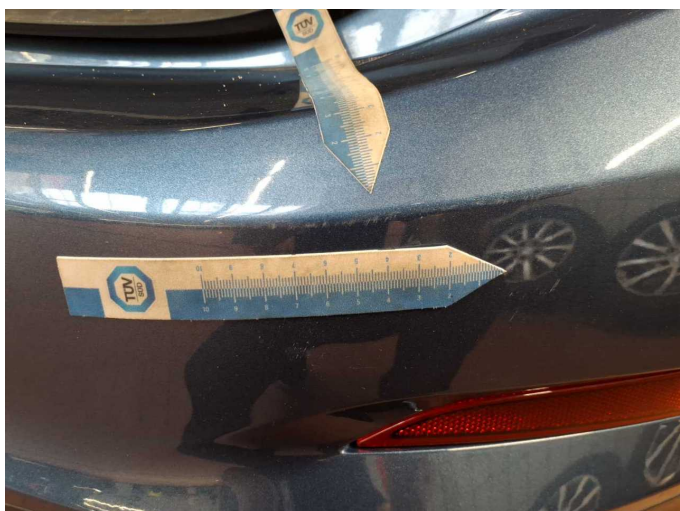
**Wear and tear 7:** Rear bumper: Rear bumper - Scratch(es) - Cover / polish

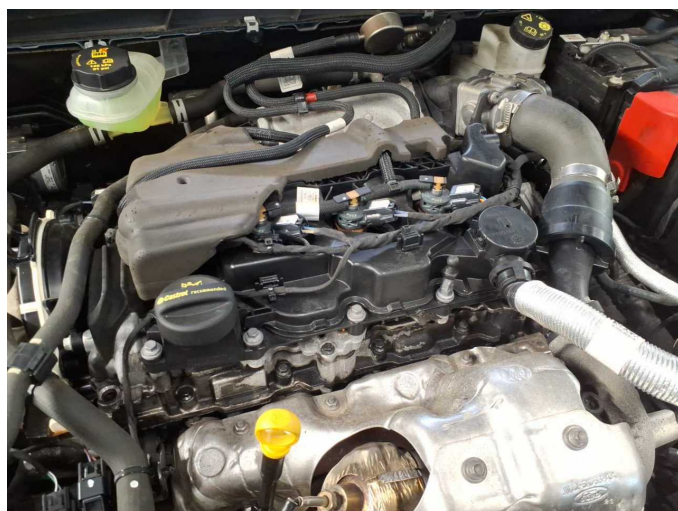
Engine - Engine cover

**Missing part 2:** Engine: Engine cover - Missing - Replace
