Expertise

Protocol number: 46382987  
Order No. / Reference: 26555092  
Inspection date: 7 Jul 2026

Manufacturer: Ford

Model: S-Max 2.0 EcoBlue Allrad Aut. TITANIUM

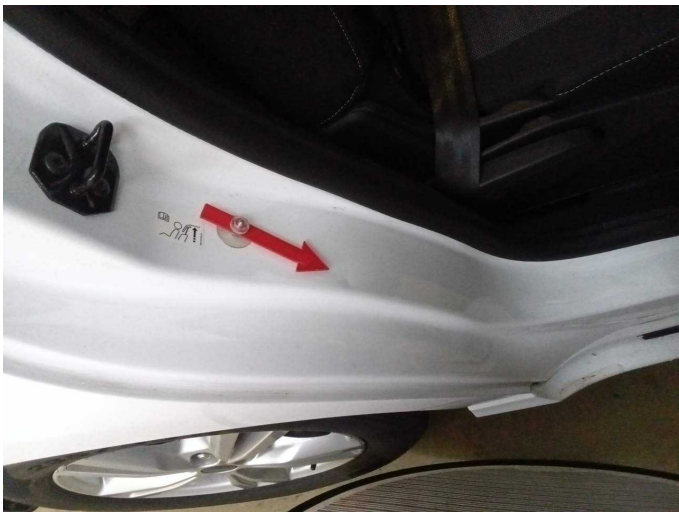
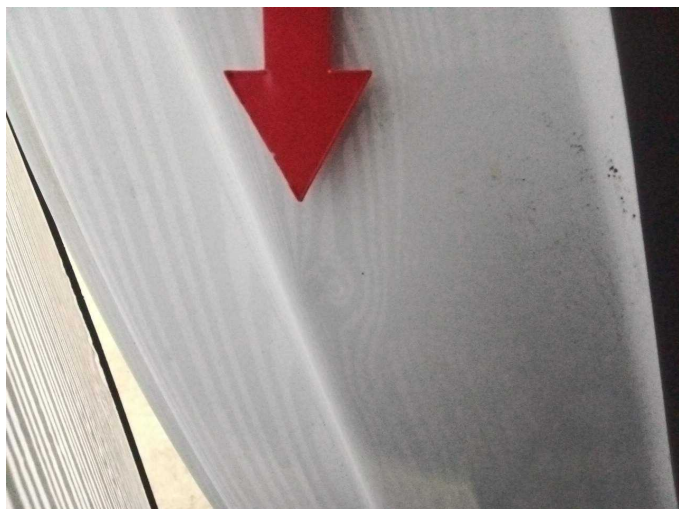
| No. | Component group | Description |
|---|---|---|
| 2 | Side panel - rear right side | Sill - dent(s) - Smooth repair work |

Damage 2: Side panel - rear right side: Sill - dent(s) - Smooth repair work

**Damage 2:** Side panel - rear right side: Sill - dent(s) - Smooth repair work

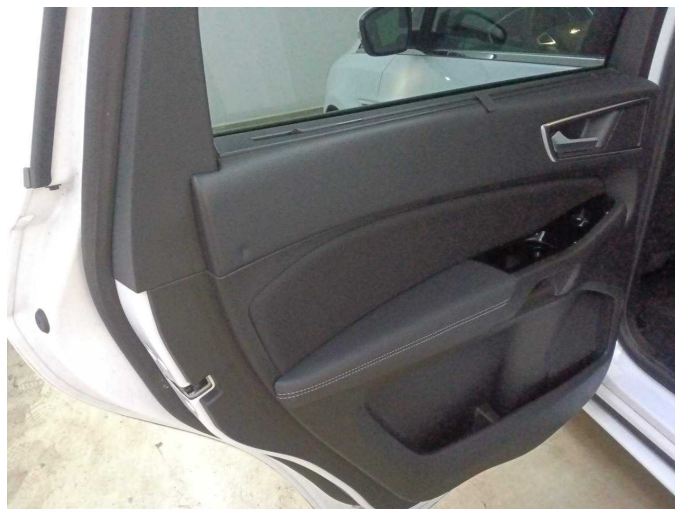
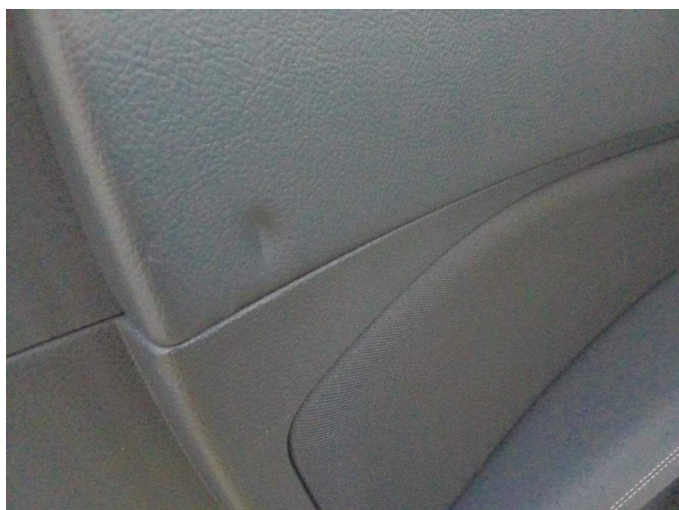
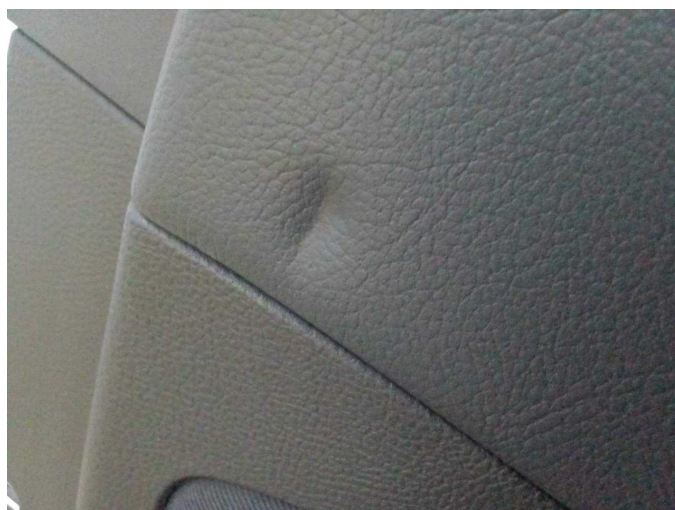
| No. | Component group | Description |
|---|---|---|
| 3 | Trim / covers | Door trim - rear left side - dent(s) - Smart repair |

**Damage 3:** Trim / covers: Door trim - rear left side - dent(s) - Smart repair

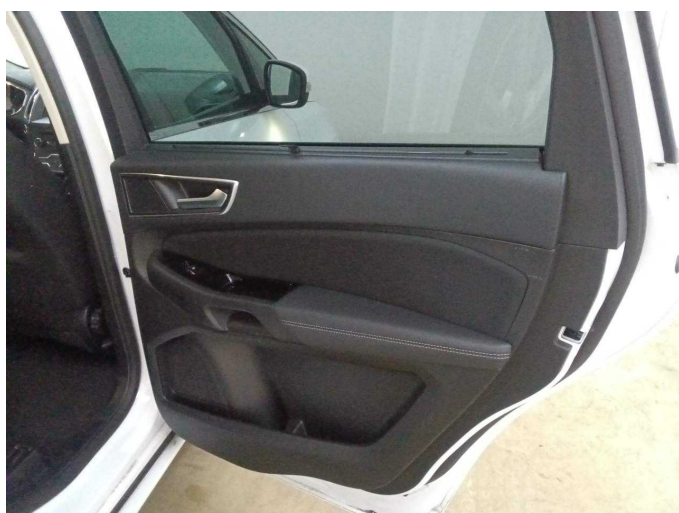
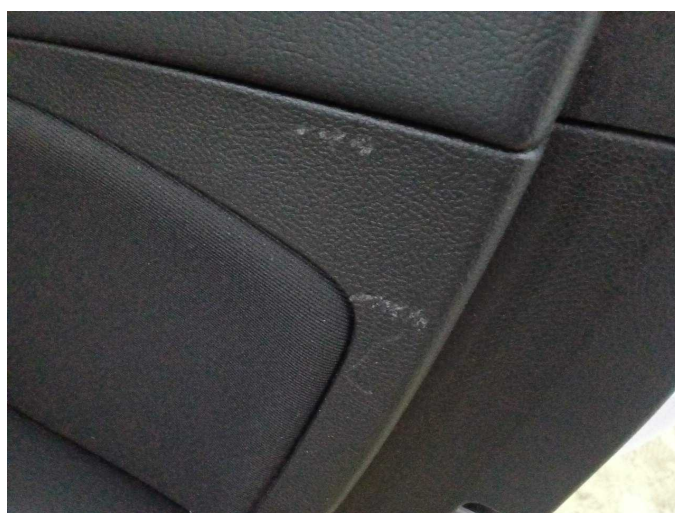
| No. | Component group | Description |
|---|---|---|
| 4 | Trim / covers | Door trim - rear right side - Scratched - Smart repair |

**Damage 4:** Trim / covers: Door trim - rear right side - Scratched - Smart repair

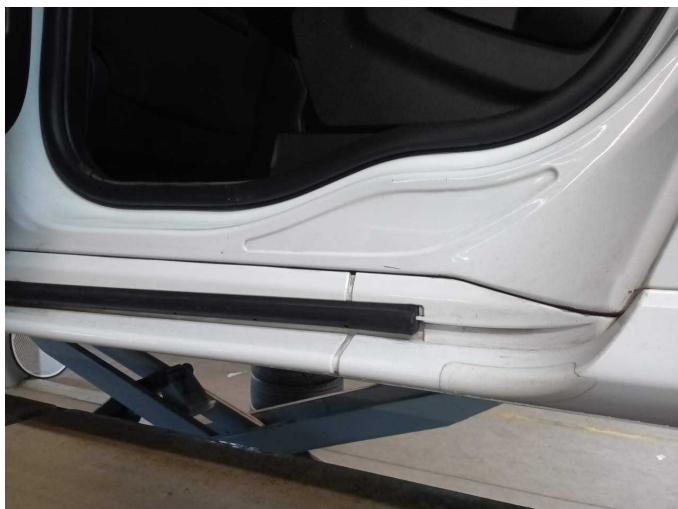
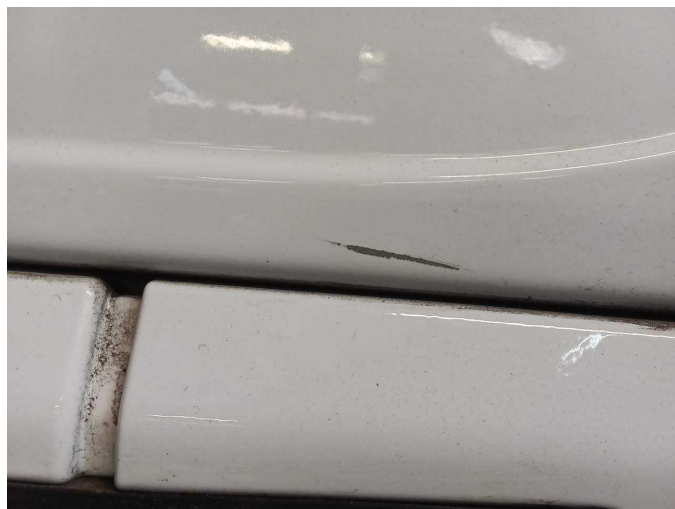
| No. | Component group | Description |
|---|---|---|
| 5 | Sill - left side | Sill - Scratch(es) - Smart repair |

**Damage 5:** Sill - left side: Sill - Scratch(es) - Smart repair

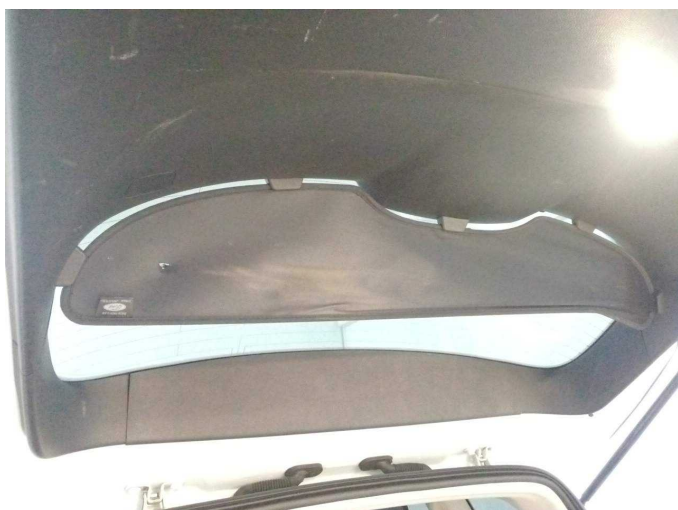
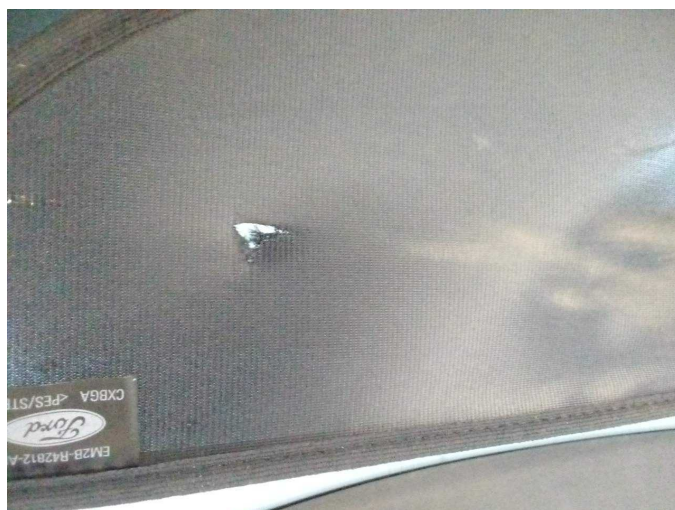
| No. | Component group | Description |
|---|---|---|
| 6 | Misc. | Misc. (Sonnenblende Heck) - Holes - Replace |

**Damage 6:** Misc.: Misc. (Sonenblende Heck) - Holes - Replace

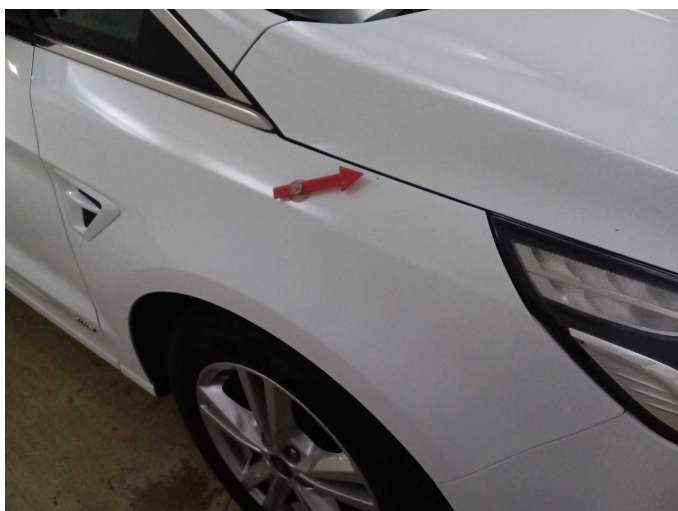
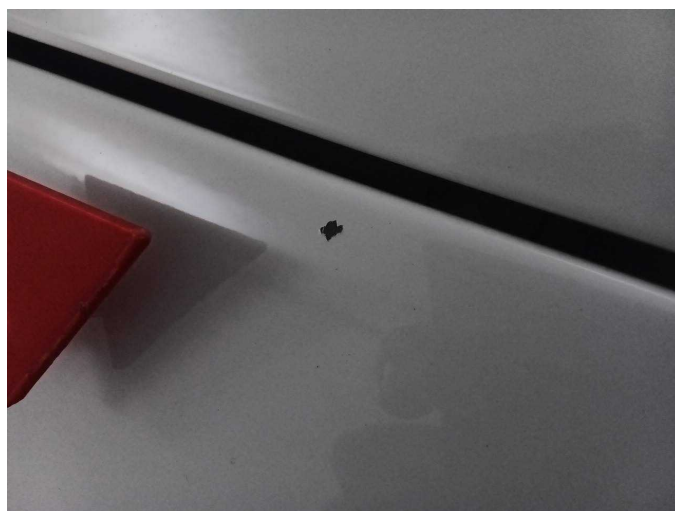
| No. | Component group | Description |
|---|---|---|
| 7 | Mudguard - right side | Mudguard - right side - Stone chips - Smart repair |

**Damage 7:** Mudguard - right side: Mudguard - right side - Stone chips - Smart repair

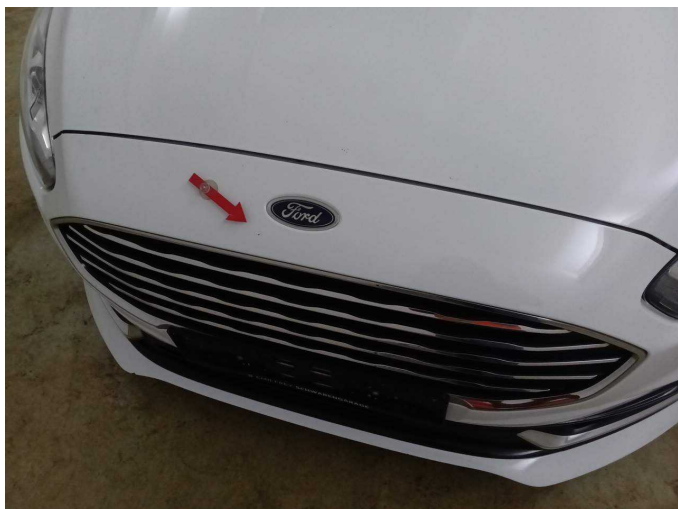
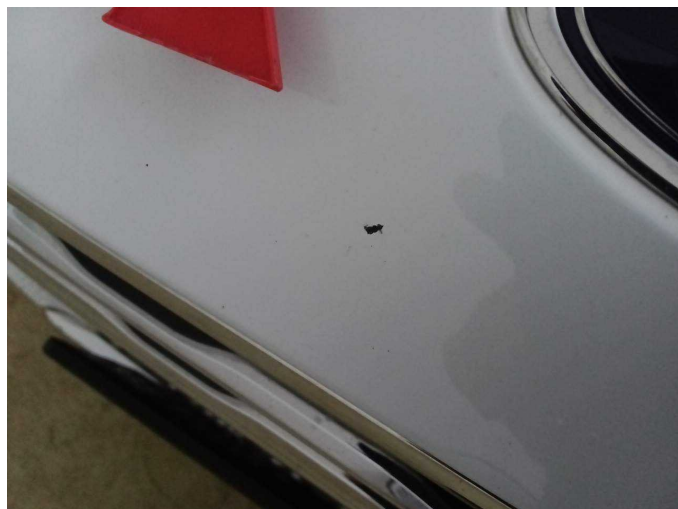
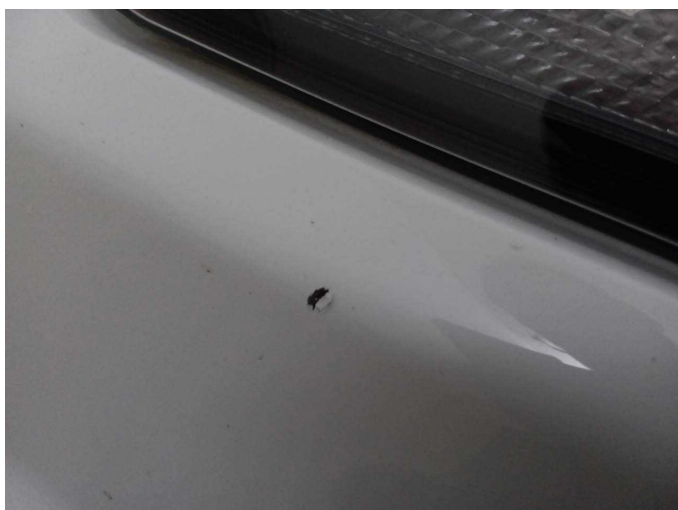
| No. | Component group | Description |
|---|---|---|
| 8 | Front bumper | Front bumper - Stone chips - Smart repair |

**Damage 8:** Front bumper: Front bumper - Stone chips - Smart repair

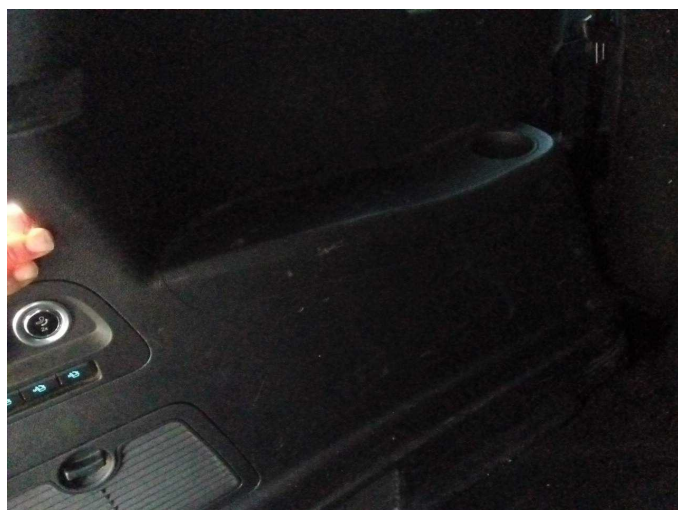
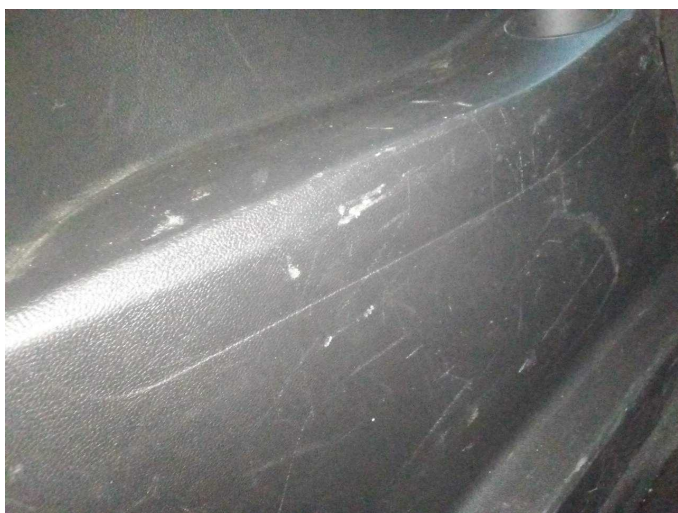
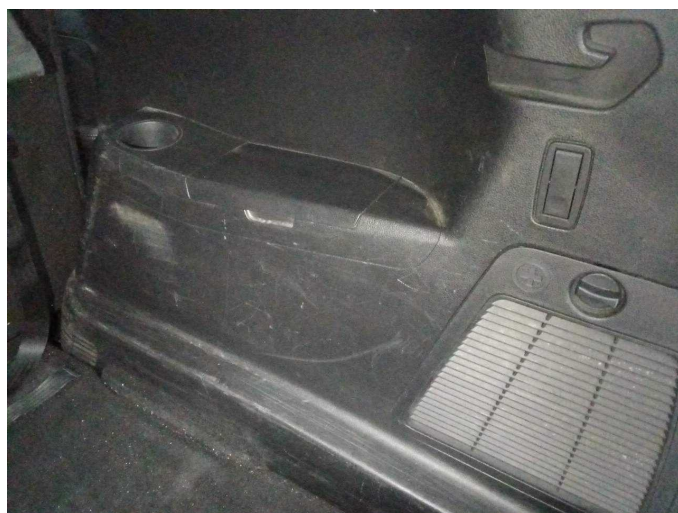
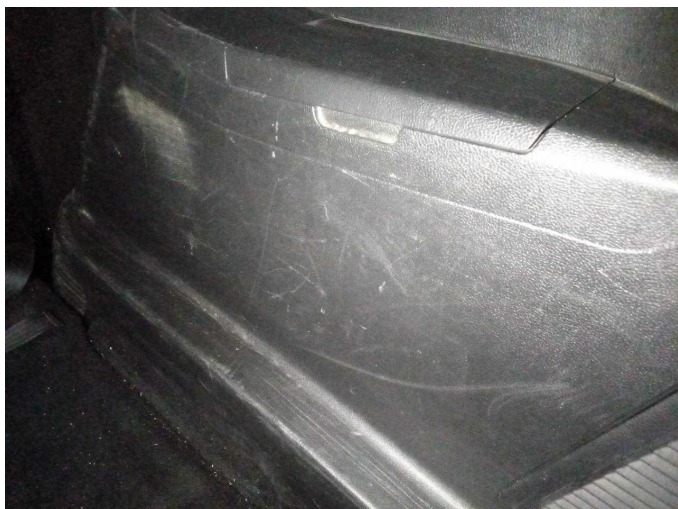
| No. | Component group | Description |
|---|---|---|
| 9 | Trim / covers | Boot lining - Scratched - Loss in value |

**Damage 9:** Trim / covers: Boot lining - Scratched - Loss in value

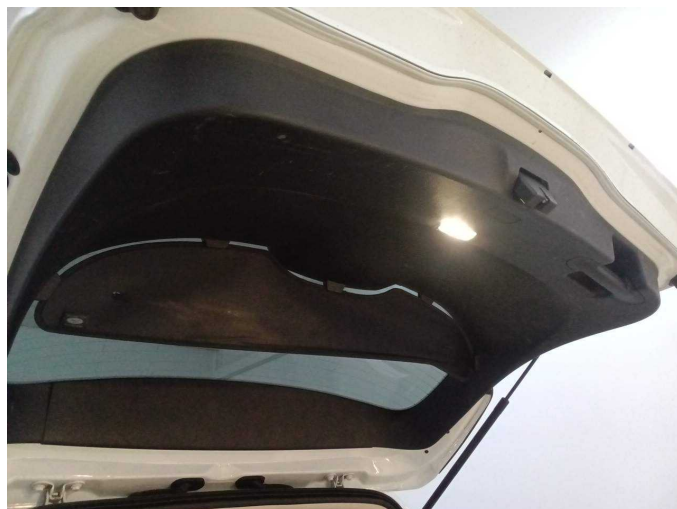
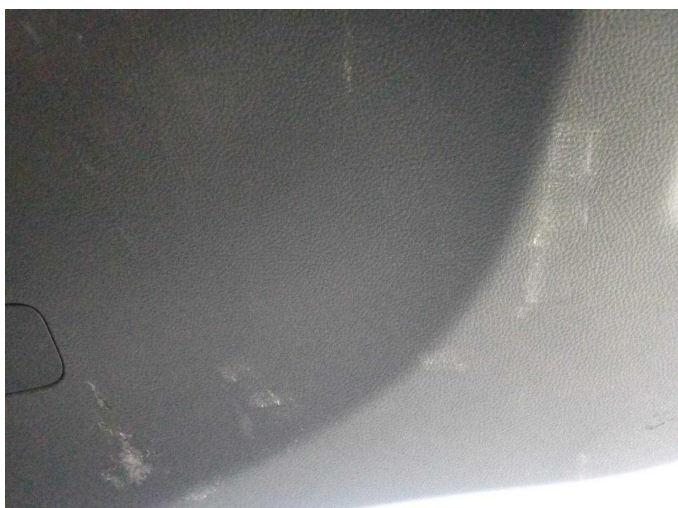
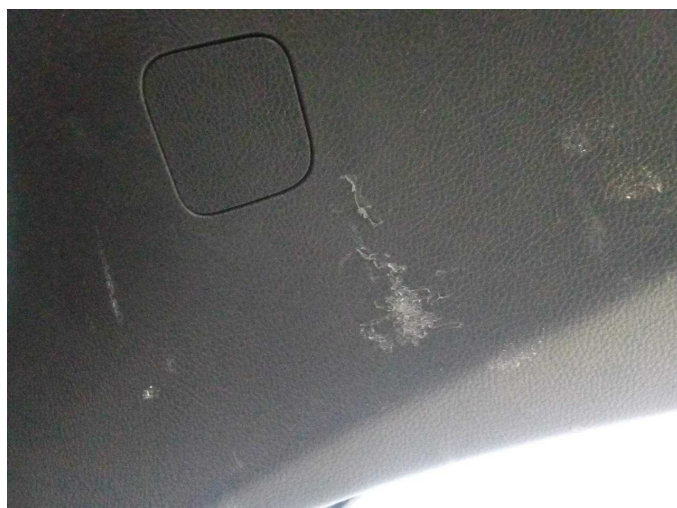
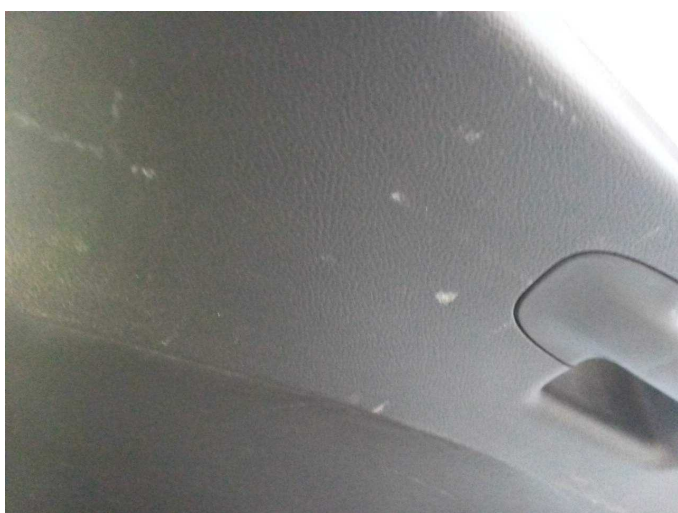
| No. | Component group | Description |
|---|---|---|
| 10 | Trim / covers | Boot lid - interior trim - Scratched - Replace |

**Damage 10:** Trim / covers: Boot lid - interior trim - Scratched - Replace

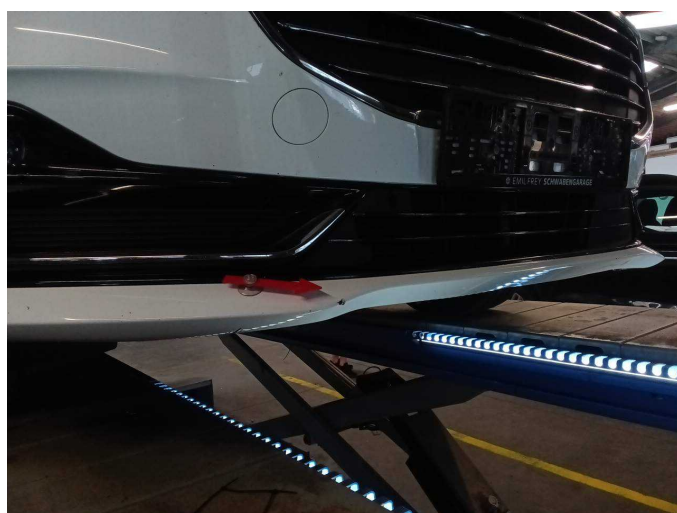
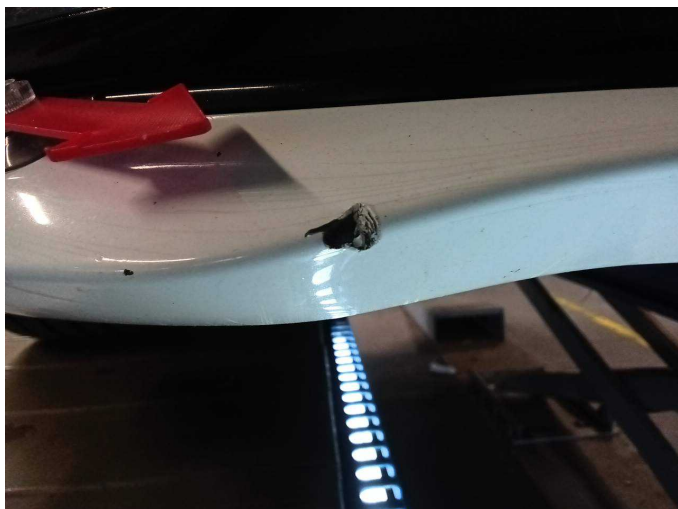
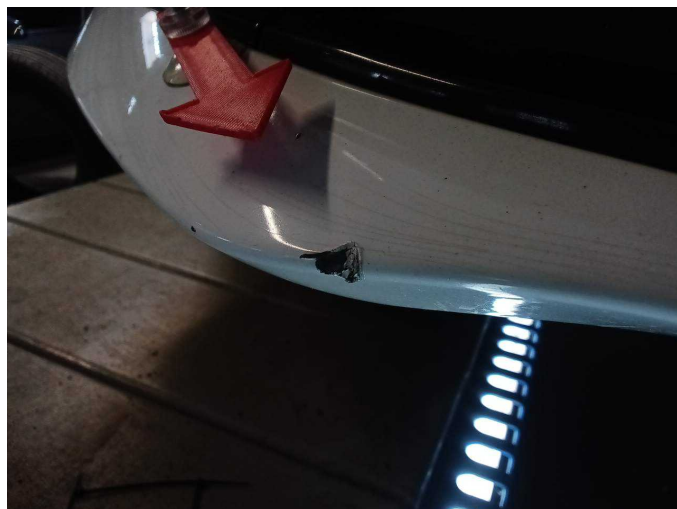
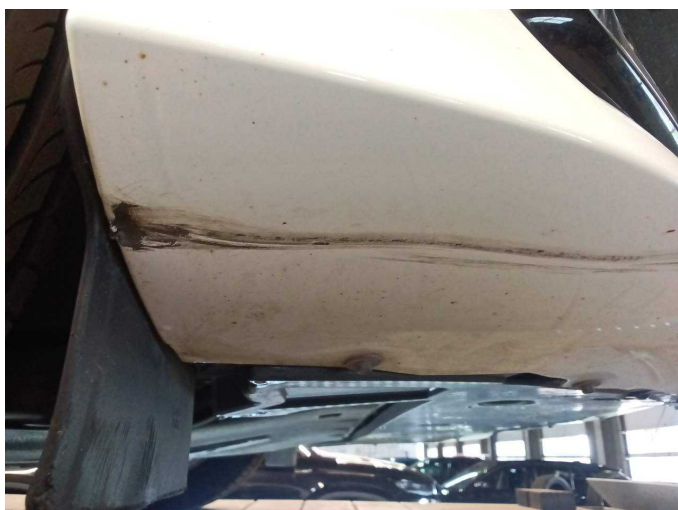
| No. | Component group | Description |
|---|---|---|
| 11 | Front bumper | Spoiler - Scratched - Repair and paint |

**Damage 11:** Front bumper: Spoiler - Scratched - Repair and paint

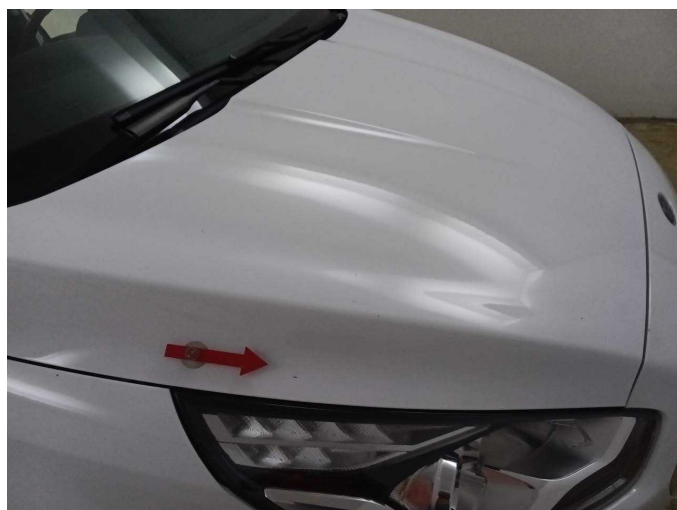
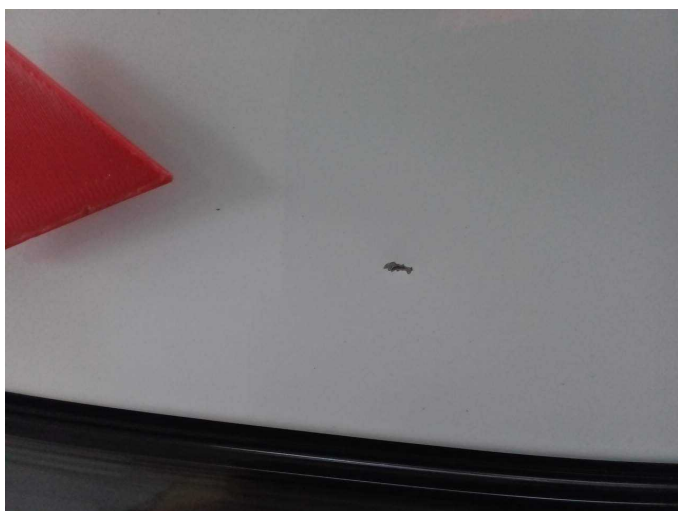
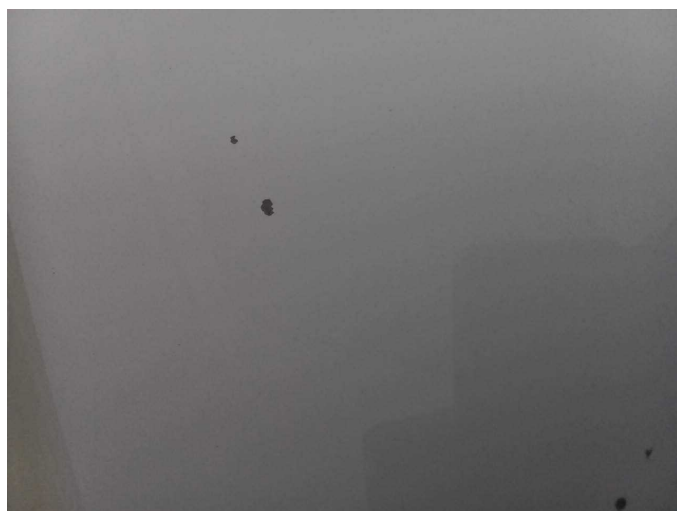
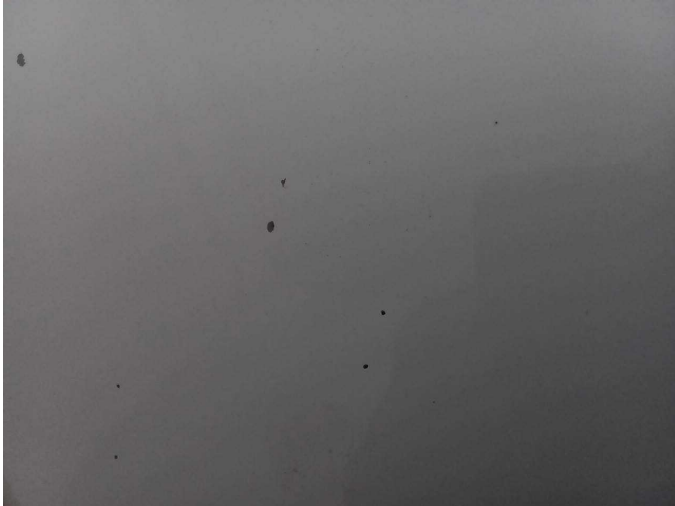
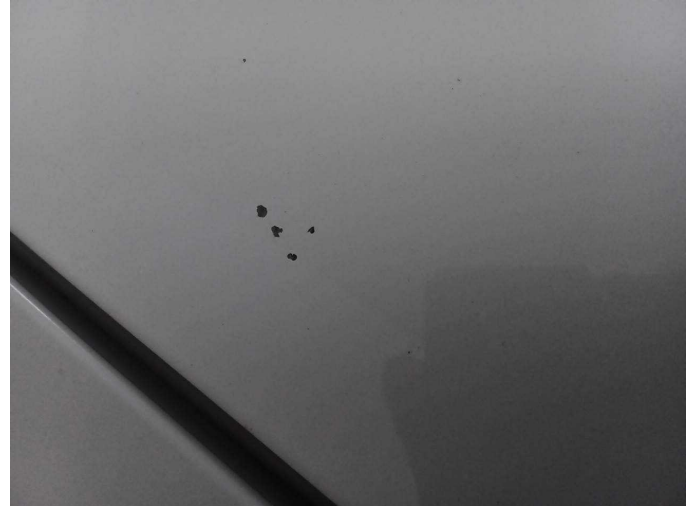
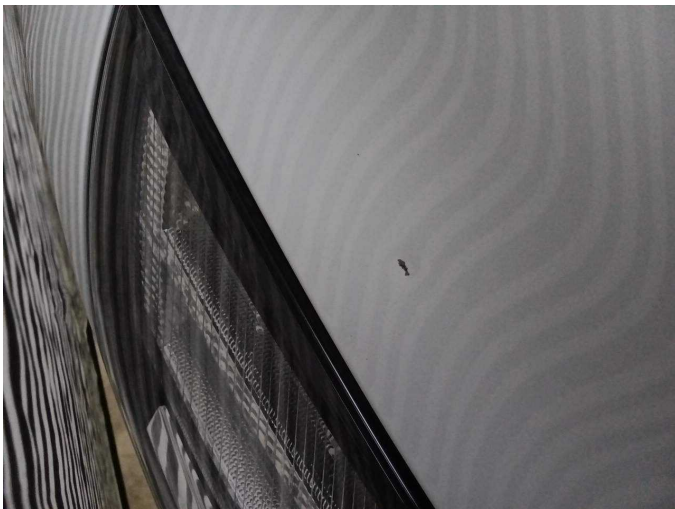
| No. | Component group | Description |
|---|---|---|
| 12 | Bonnet | Bonnet - Dent / paintcoat damage - Repair and paint |

**Damage 12:** Bonnet: Bonnet - Dent / paintcoat damage - Repair and paint

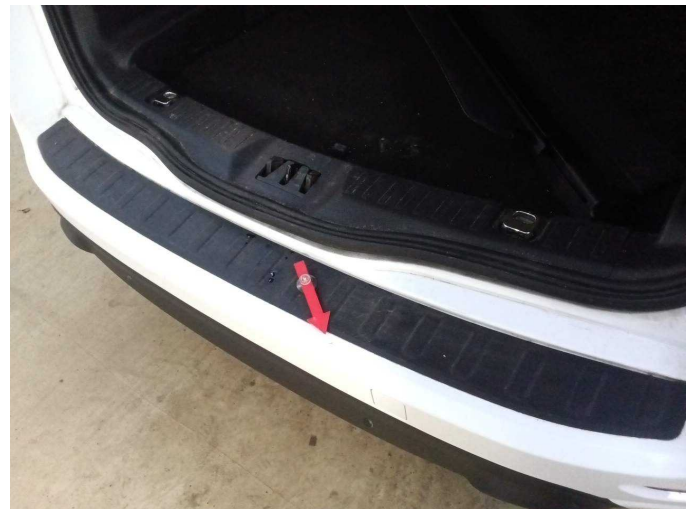
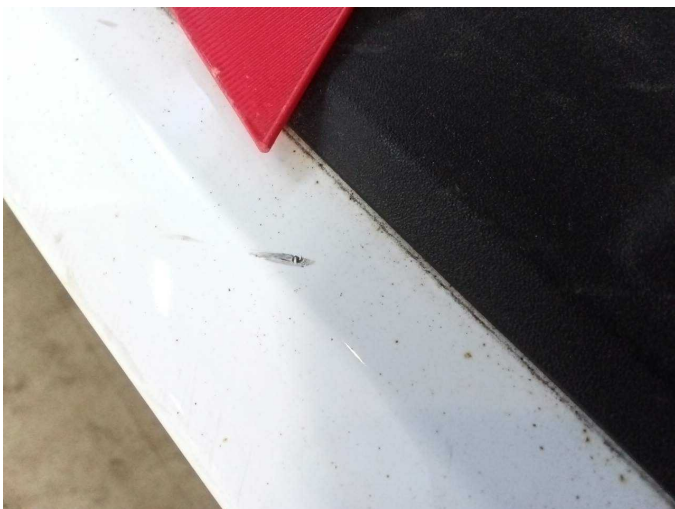
| No. | Component group | Description |
|---|---|---|
| 1 | Rear bumper | Rear bumper - Scratch(es) - No deduction |

**Wear and tear 1:** Rear bumper: Rear bumper - Scratch(es) - No deduction

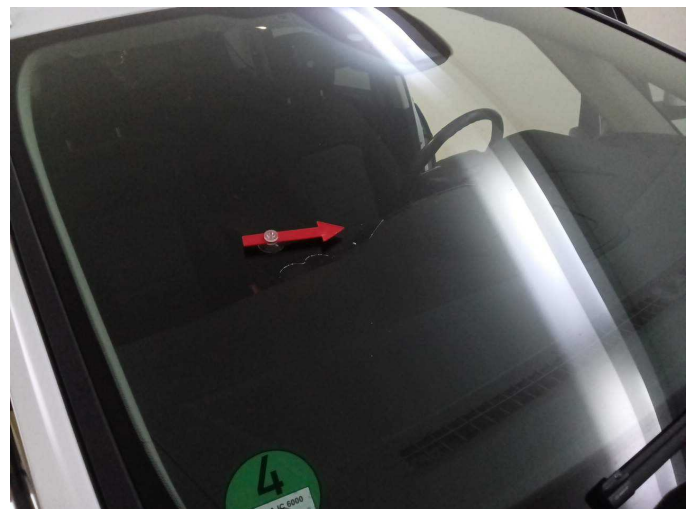
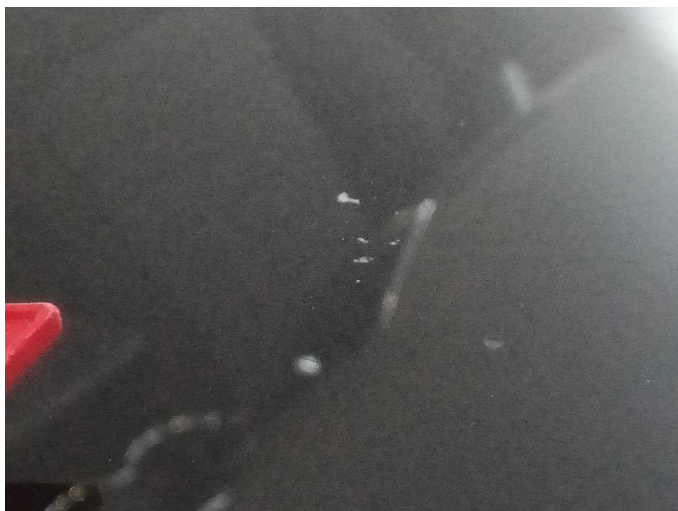
| No. | Component group | Description |
|---|---|---|
| 2 | Vehicle glazing | Windscreen - Stone chips - No deduction |

**Wear and tear 2:** Vehicle glazing: Windscreen - Stone chips - No deduction
