Expertise

Protocol number: 46467331  
Order No. / Reference: 26703104  
Inspection date: 9 Jul 2026

Manufacturer: Ford

Model: Focus Turnier 1.5 EcoBlue Start-Stopp-System Aut.  
COOL&CONNECT

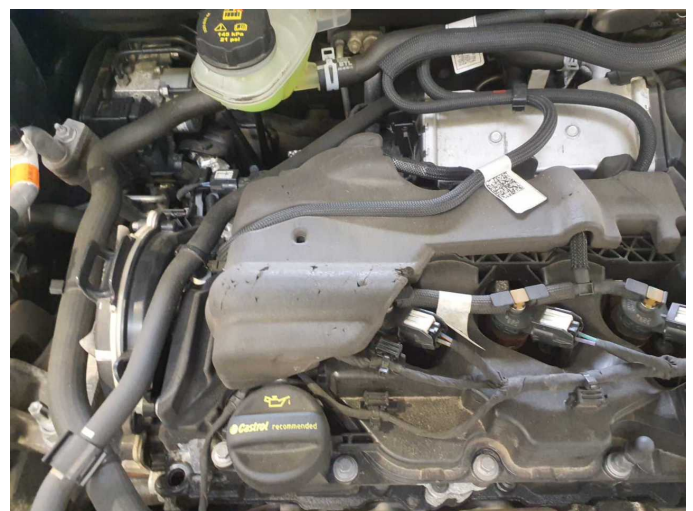
| No. | Component group | Description |
|---|---|---|
| 2 | Engine | Engine cover - Damage caused by marten / rodent - Replace |

**Damage 2:** Engine: Engine cover - Damage caused by marten / rodent - Replace

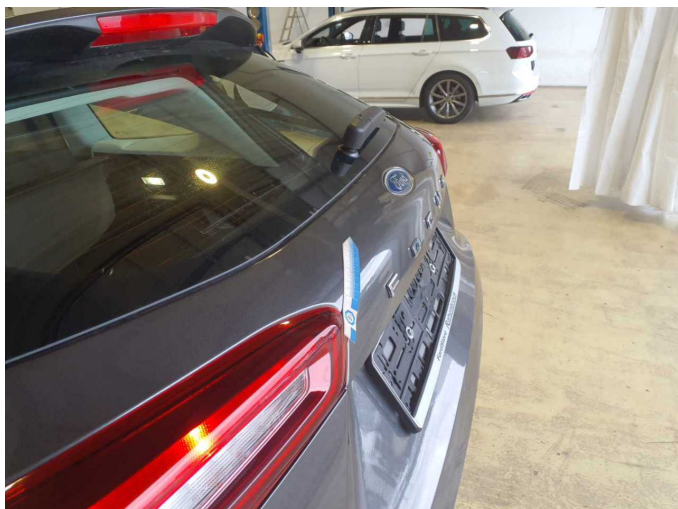
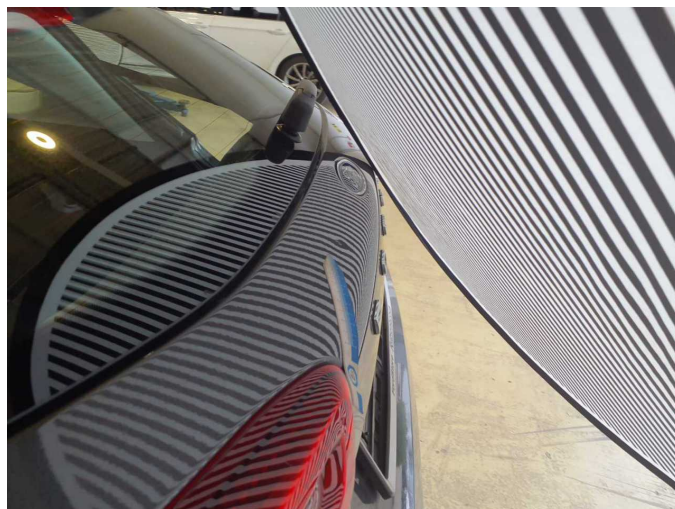
| No. | Component group | Description |
|---|---|---|
| 3 | Boot lid / rear door | Boot lid - dent(s) - Smooth repair work |

**Damage 3:** Boot lid / rear door: Boot lid - dent(s) - Smooth repair work

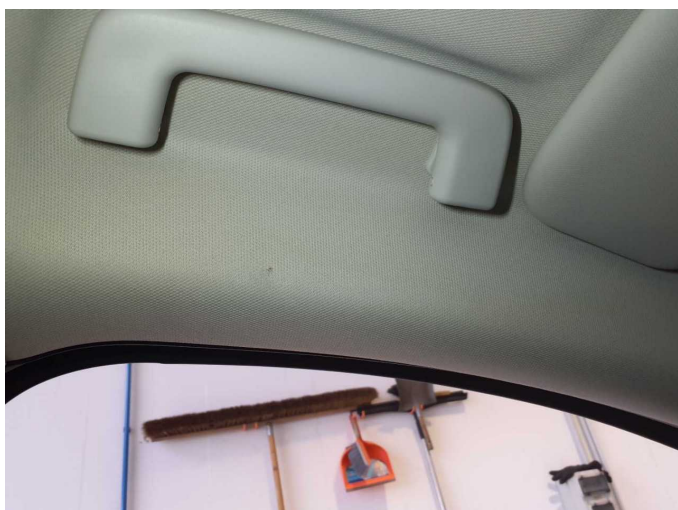
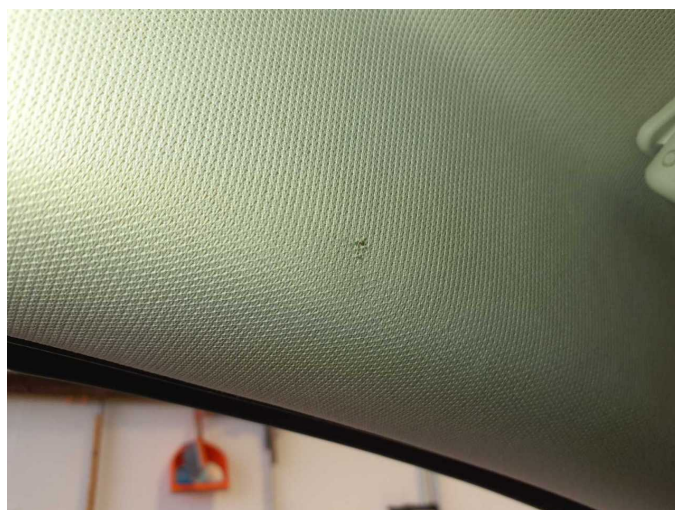
| No. | Component group | Description |
|---|---|---|
| 4 | Trim / covers | Roof lining - Scratch(es) - Smart repair |

**Damage 4:** Trim / covers: Roof lining - Scratch(es) - Smart repair

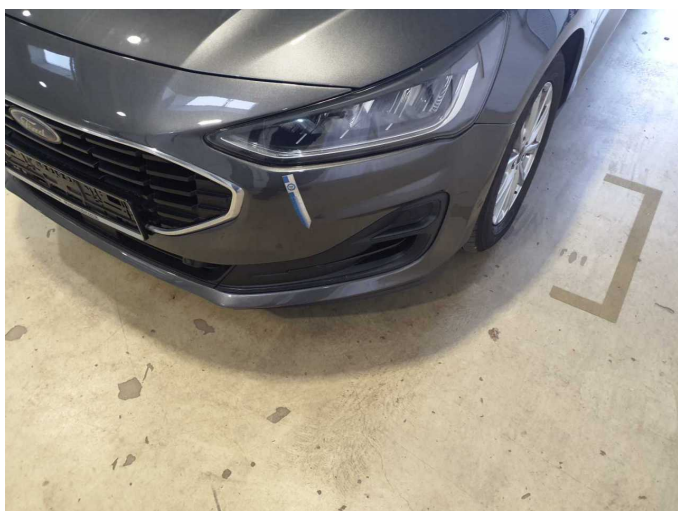
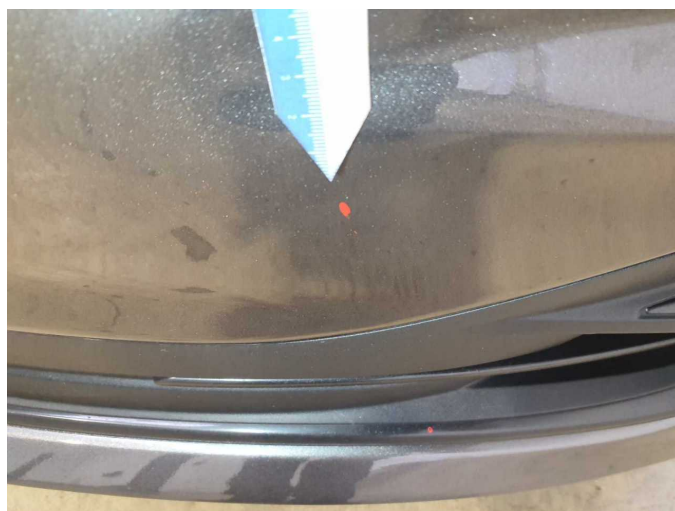
| No. | Component group | Description |
|---|---|---|
| 5 | Front bumper | Front bumper - Scratch(es) - Smart repair |

**Damage 5:** Front bumper: Front bumper - Scratch(es) - Smart repair

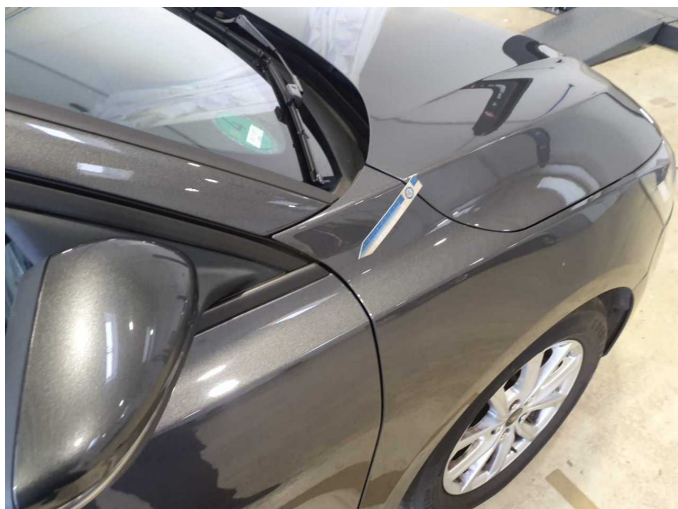
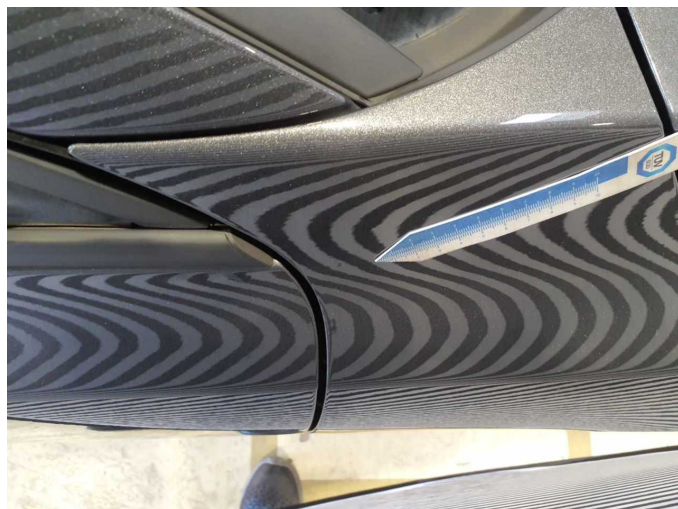
| No. | Component group | Description |
|---|---|---|
| 6 | Mudguard - right side | Mudguard - right side (Einschlüsse, Mehrkosten sind Möglich) - Unprofessionally repaired - Smart repair |

| Roof rail - left side | 181 µm | Mudguard - right side | 173 µm |

**Damage 6:** Mudguard - right side: Mudguard - right side (Einschlüsse, Mehrkosten sind Möglich) - Unprofessionally repaired - Smart repair

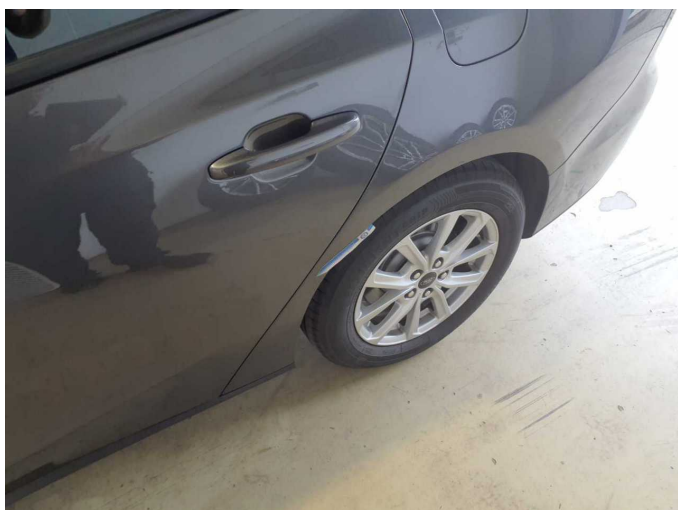
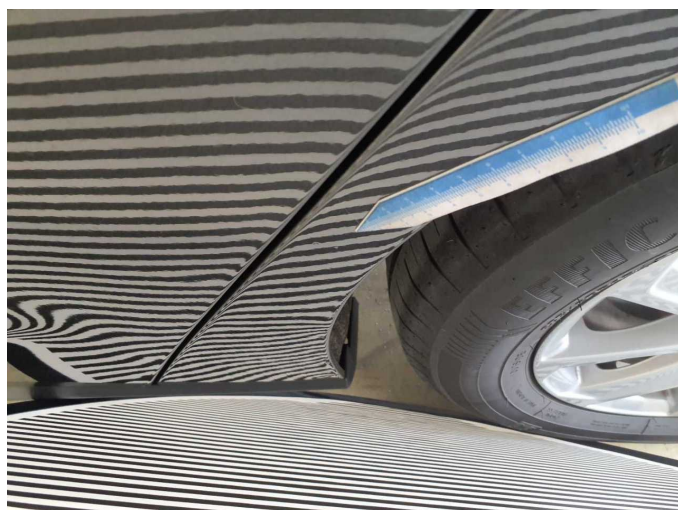
| No. | Component group | Description |
|---|---|---|
| 7 | Side panel - rear left side | Side panel (Einschlüsse, Mehrkosten sind Möglich) - Unprofessionally repaired - Smart repair |

| Bonnet | 320 µm | Side panel - rear left side | 594 µm |

**Damage 7:** Side panel - rear left side: Side panel (Einschlüsse, Mehrkosten sind Möglich) - Unprofessionally repaired - Smart repair

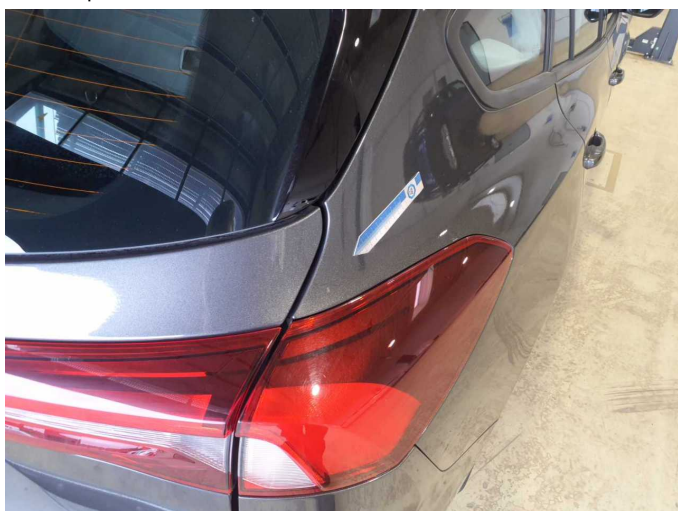
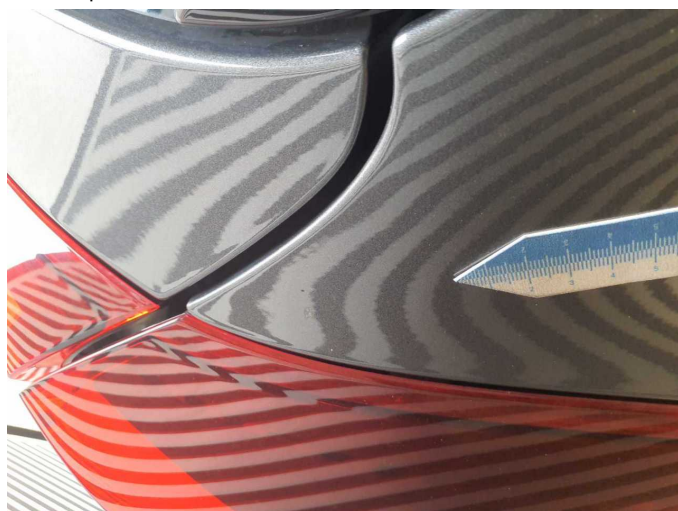
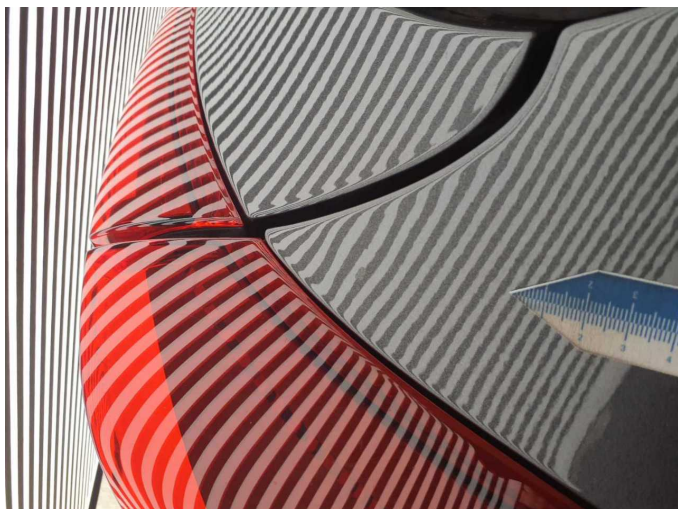
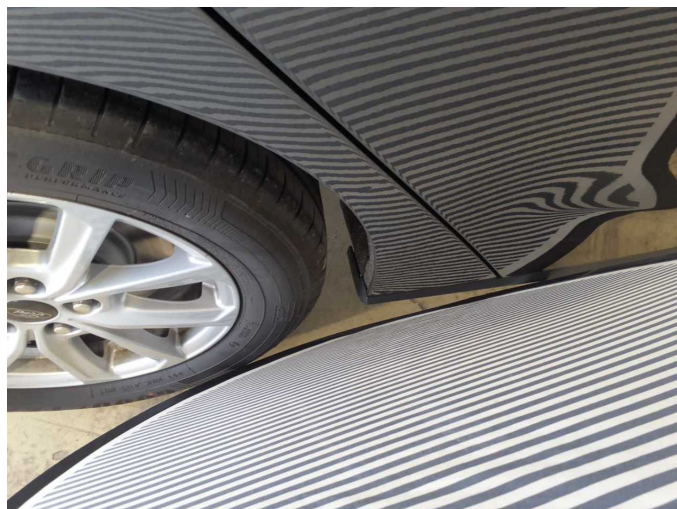
| No. | Component group | Description |
|---|---|---|
| 8 | Side panel - rear right side | Side panel (Einschlüsse, Mehrkosten sind Möglich) - Unprofessionally repaired - Smart repair |

| Side panel - rear right side | 302 µm | Door - rear left side | 180 µm |

**Damage 8:** Side panel - rear right side: Side panel (Einschlüsse, Mehrkosten sind Möglich) - Unprofessionally repaired - Smart repair

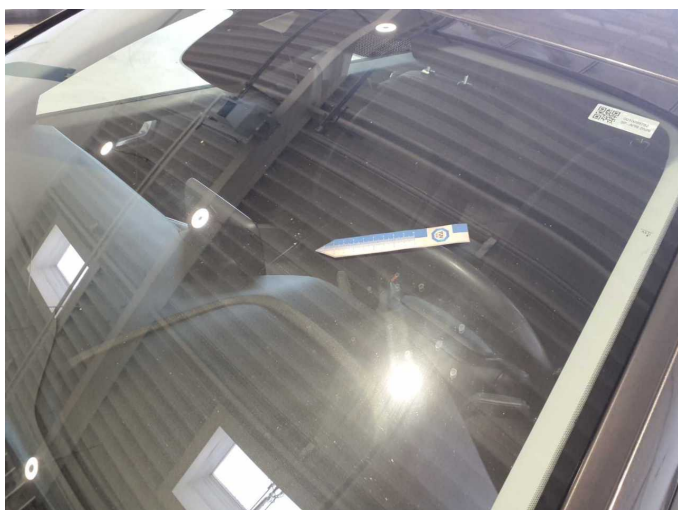
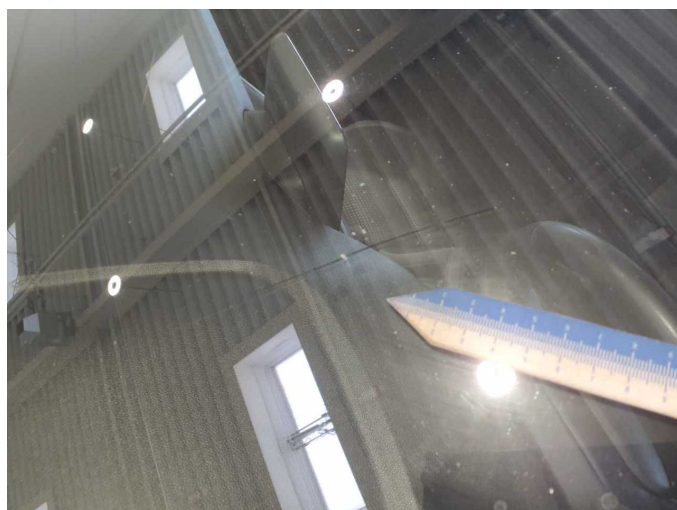
| No. | Component group | Description |
|---|---|---|
| 9 | Vehicle glazing | Windscreen - Broken / torn - Replace |

**Damage 9:** Vehicle glazing: Windscreen - Broken / torn - Replace

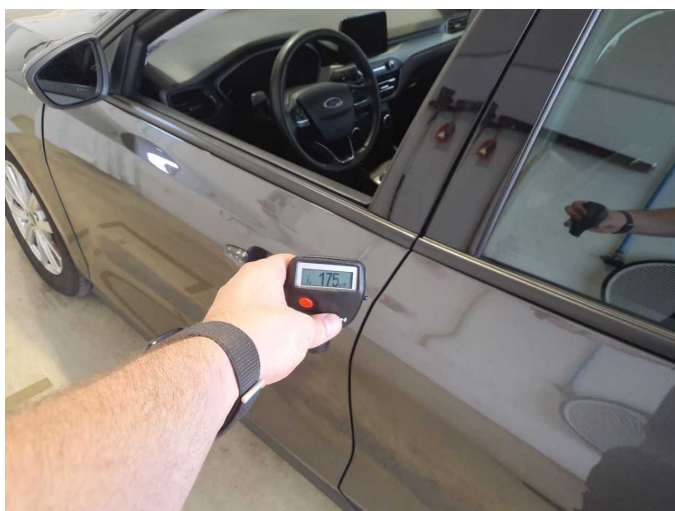
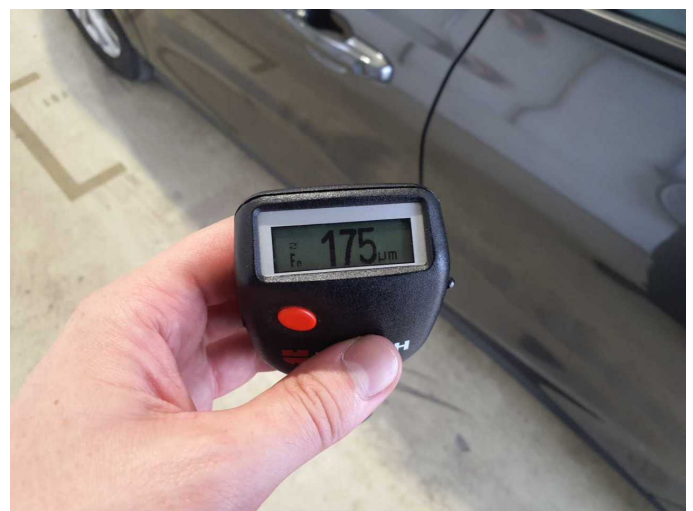
**Repainting 4: Door - front left side**

| Door - front left side | 175 µm | | |
