Expertise

Protocol number: 46563853  
Order No. / Reference: 26689447  
Inspection date: 16 Jul 2026

Manufacturer: Skoda  
VIN: TMBGF7NY8PF050222

Model: Enyaq Coupe iV RS

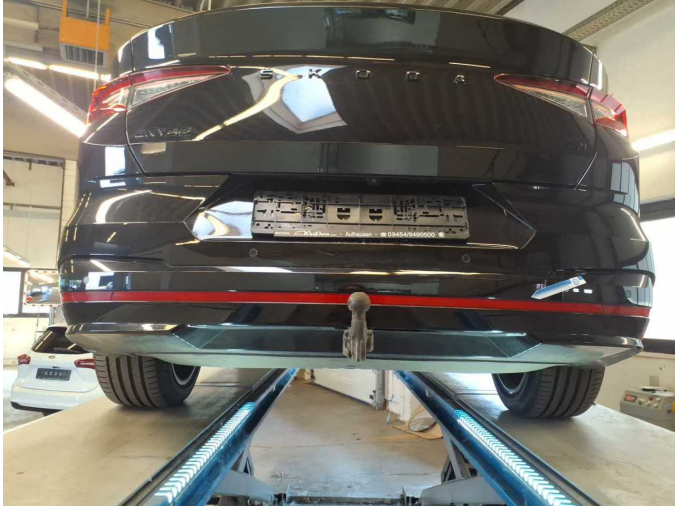
| No. | Component group | Description |
|---|---|---|
| 1 | Rear bumper | Spoiler - Scratched - Smart repair |

**Damage 1:** Rear bumper: Spoiler - Scratched - Smart repair

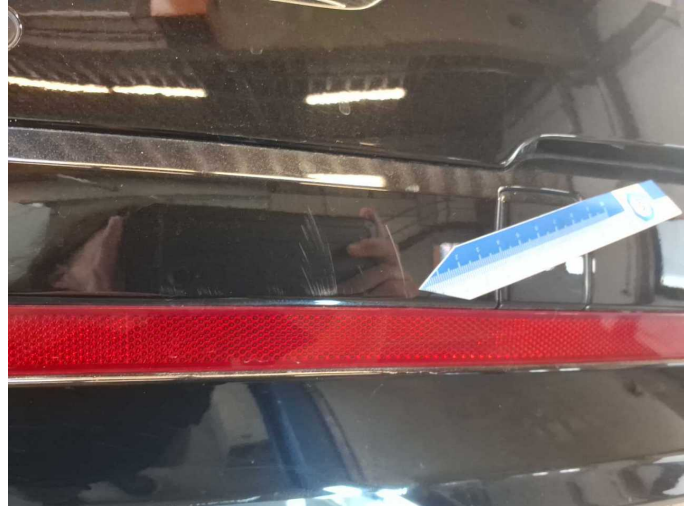
**Damage 1:** Rear bumper: Spoiler - Scratched - Smart repair

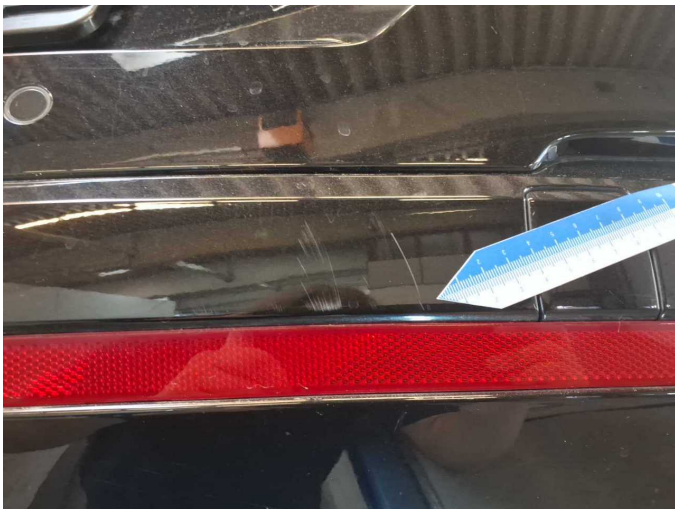
**Damage 1:** Rear bumper: Spoiler - Scratched - Smart repair

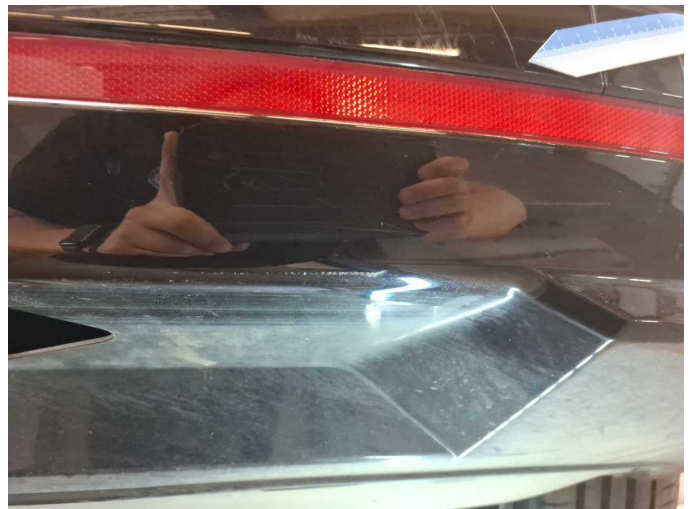
**Damage 1:** Rear bumper: Spoiler - Scratched - Smart repair

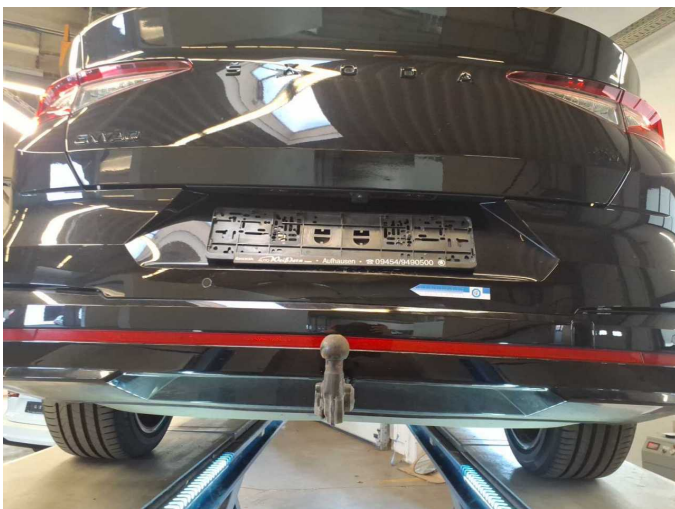
| No. | Component group | Description |
|---|---|---|
| 2 | Rear bumper | Rear bumper - Scratched - Smart repair |

**Damage 2:** Rear bumper: Rear bumper - Scratched - Smart repair

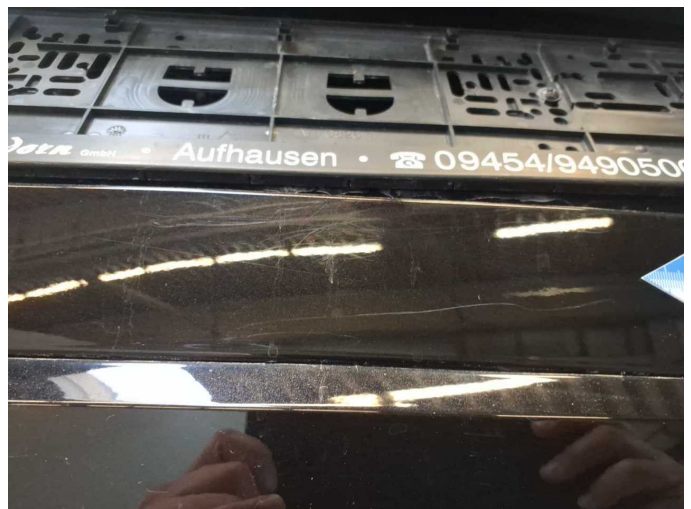
**Damage 2:** Rear bumper: Rear bumper - Scratched - Smart repair

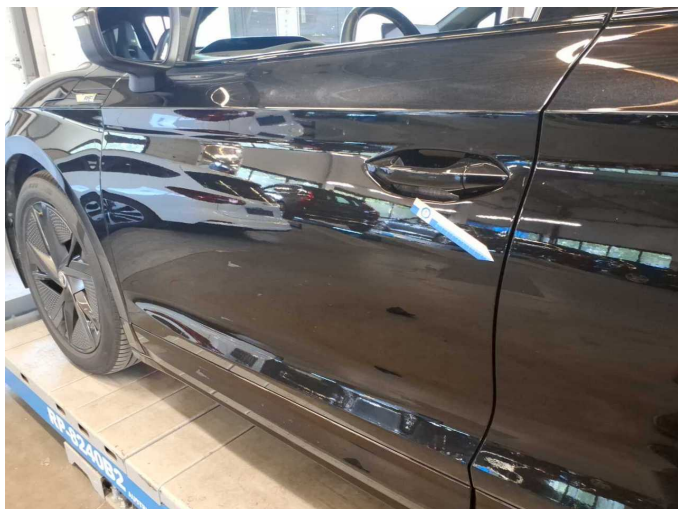
| No. | Component group | Description |
|---|---|---|
| 3 | Door - front left side | Door edge - Scratched - Smart repair |

**Damage 3:** Door - front left side: Door edge - Scratched - Smart repair

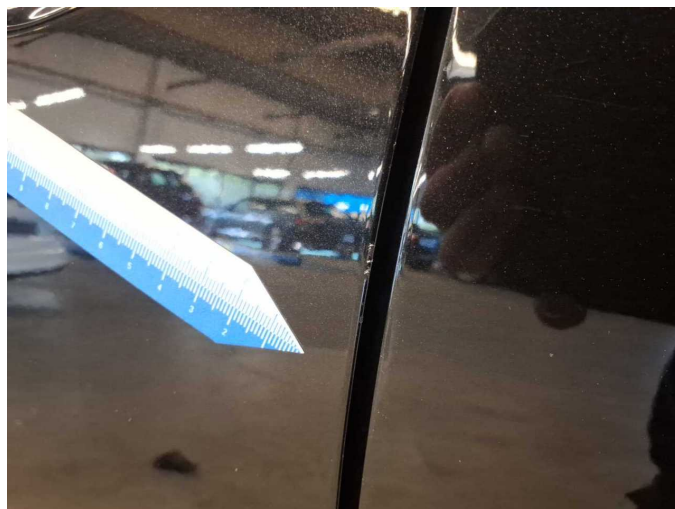
**Damage 3:** Door - front left side: Door edge - Scratched - Smart repair

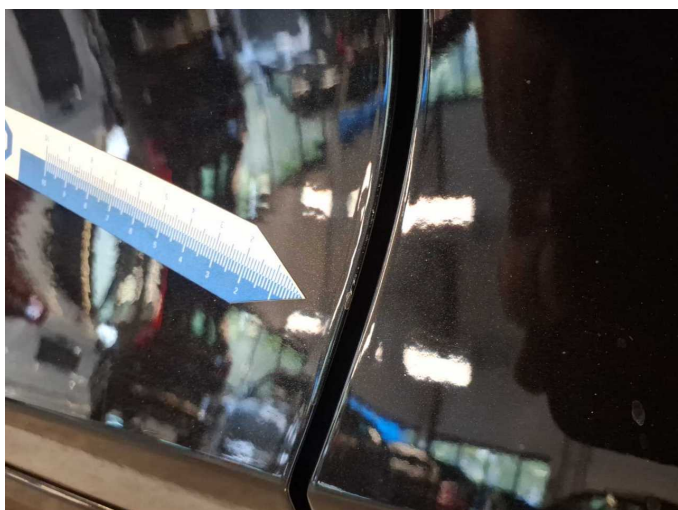
**Damage 3:** Door - front left side: Door edge - Scratched - Smart repair

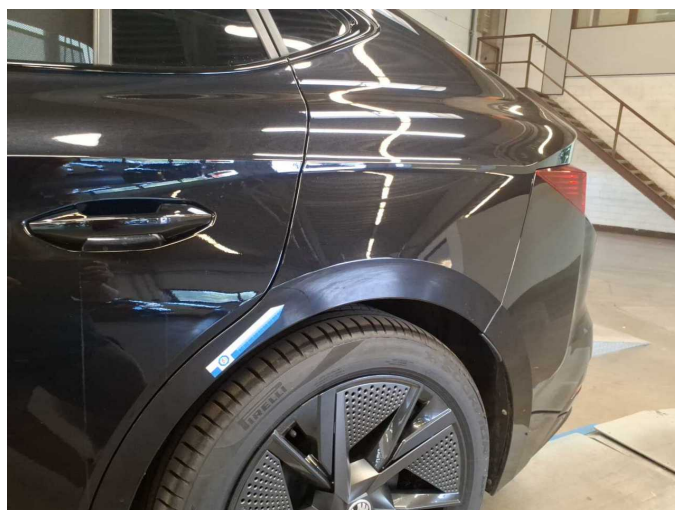
| No. | Component group | Description |
|---|---|---|
| 4 | Side panel - rear left side | Side panel (Aufpolieren) - Scratched - Smart repair |

**Damage 4:** Side panel - rear left side: Side panel (Aufpolieren) - Scratched - Smart repair

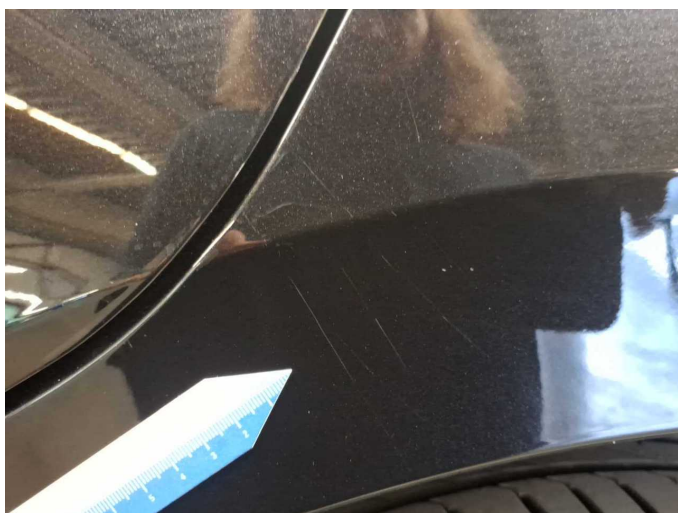
**Damage 4:** Side panel - rear left side: Side panel (Aufpolieren) - Scratched - Smart repair

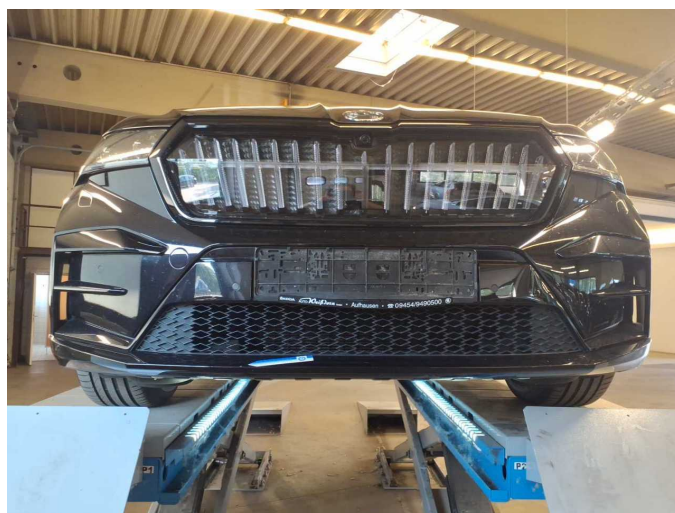
| No. | Component group | Description |
|---|---|---|
| 1 | Front bumper | Front bumper - Stone chips - No deduction |

**Wear and tear 1:** Front bumper: Front bumper - Stone chips - No deduction

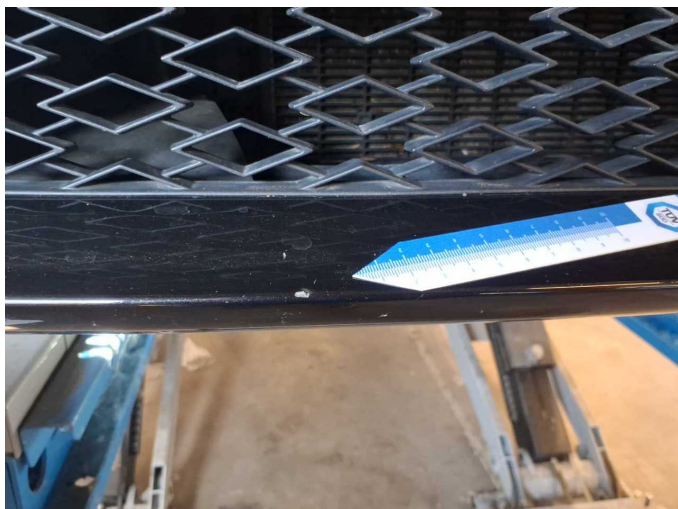
**Wear and tear 1:** Front bumper: Front bumper - Stone chips - No deduction

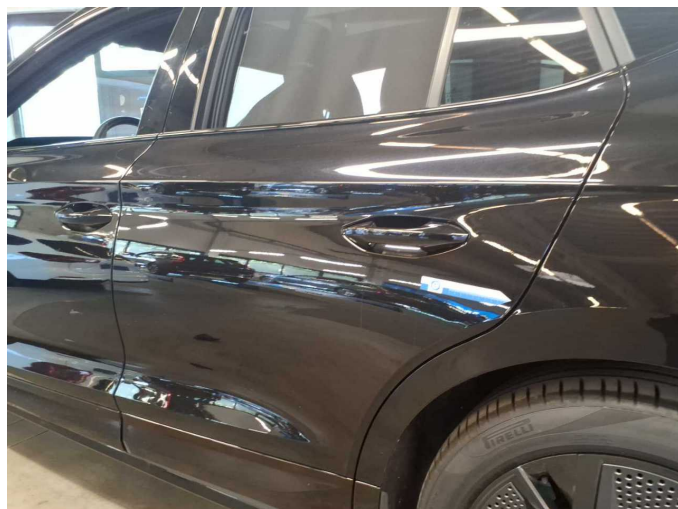
| No. | Component group | Description |
|---|---|---|
| 2 | Door - rear left side | Door edge - Scratched - No deduction |

**Wear and tear 2:** Door - rear left side: Door edge - Scratched - No deduction

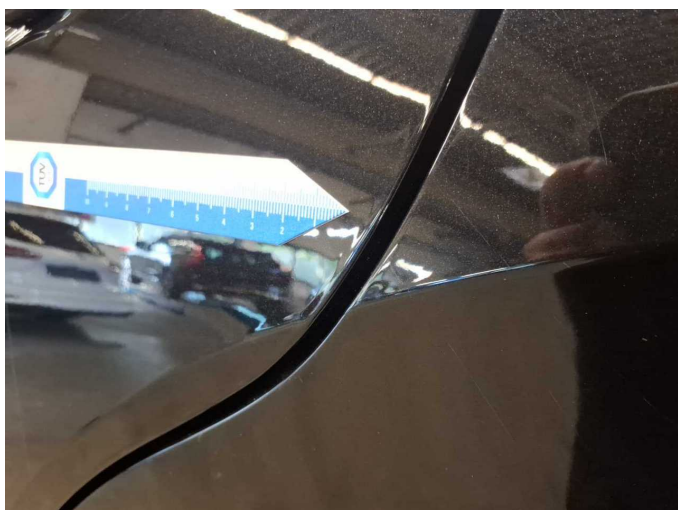
**Wear and tear 2:** Door - rear left side: Door edge - Scratched - No deduction

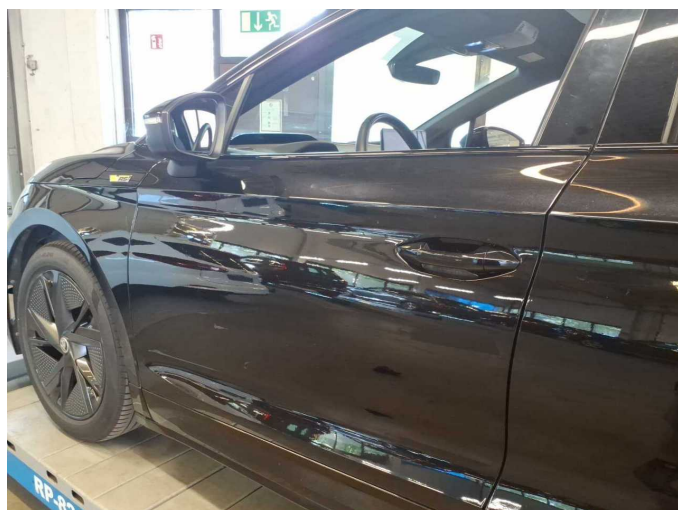
| No. | Repainting |
|---|---|
| 1 | Door - front left side |

| Door - front left side | 179 µm |

**Repainting 1:** Door - front left side

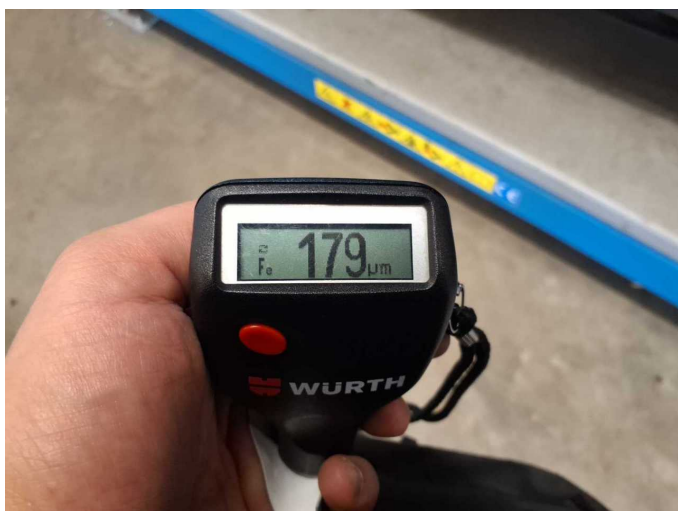
**Repainting 1:** Door - front left side
