## Expertise

Protocol number: 45529990  
Order No. / Reference: 26335487  
Inspection date: 19 May 2026

Manufacturer: Skoda

Model: Kodiaq 2.0 TDI 4x4 DSG Style

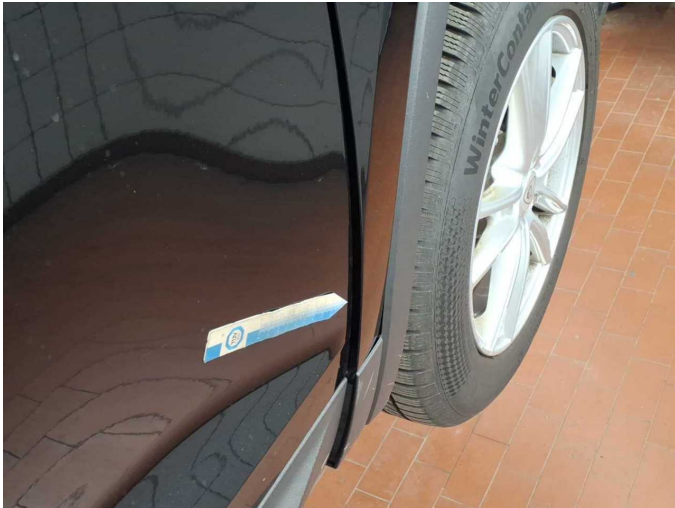
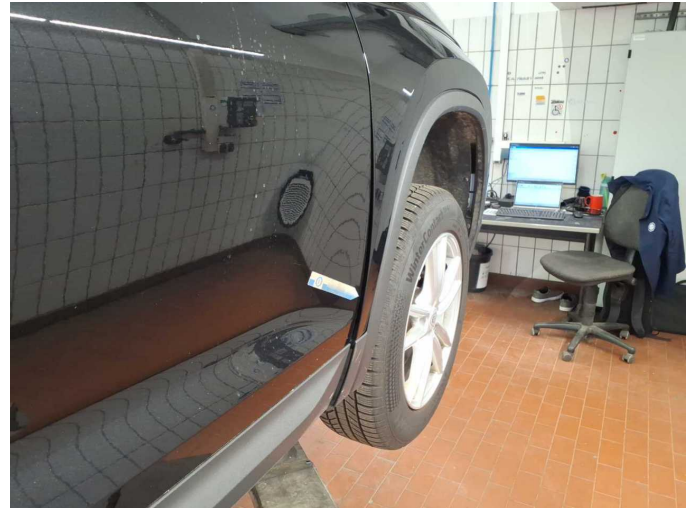
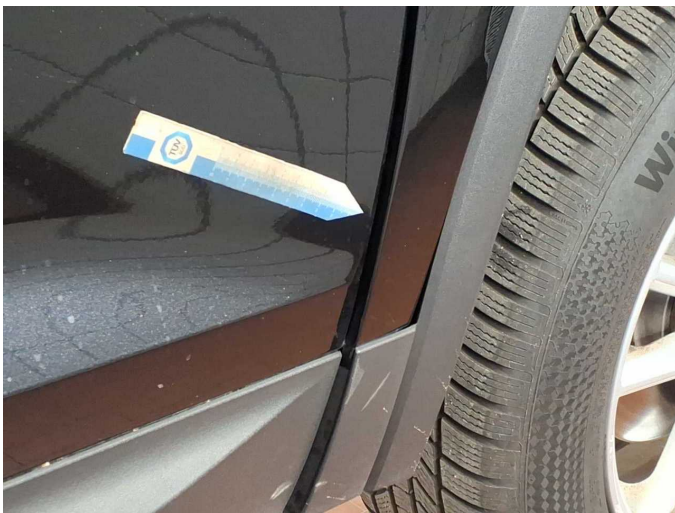
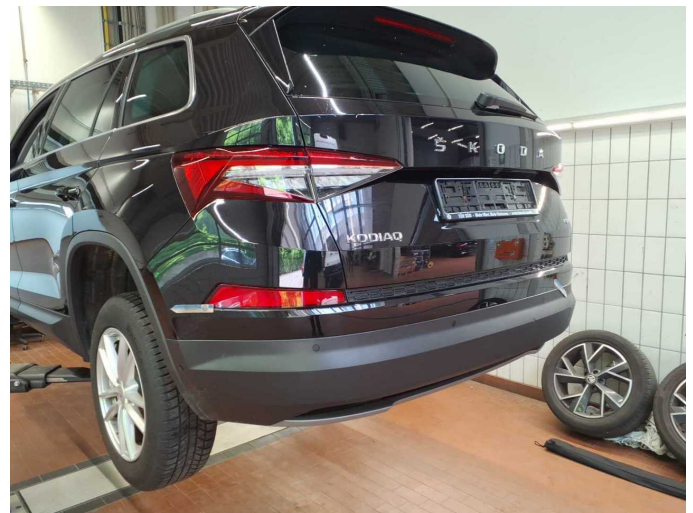
**Damage 2:** Mudguard - right side: Mudguard - right side (Mehrkosten möglich) - Malposition - Un- / install

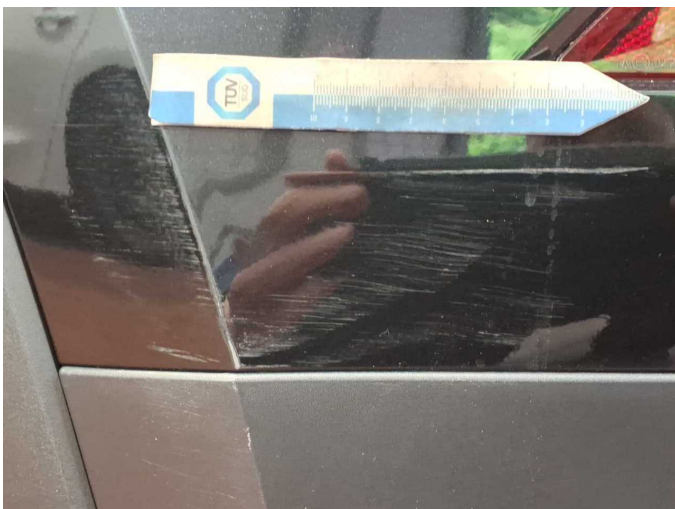
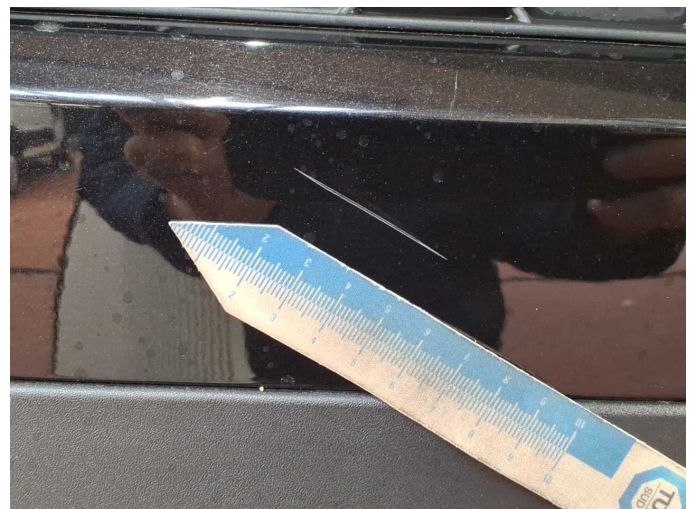
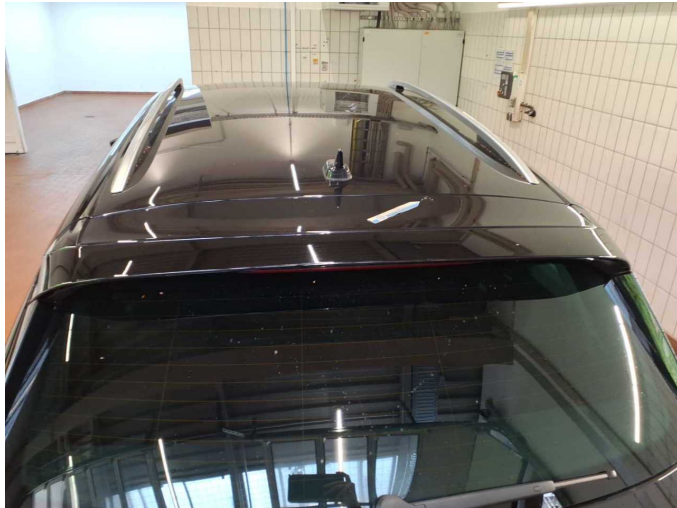
**Damage 3:** Rear bumper: Rear bumper - Scratched - Paint

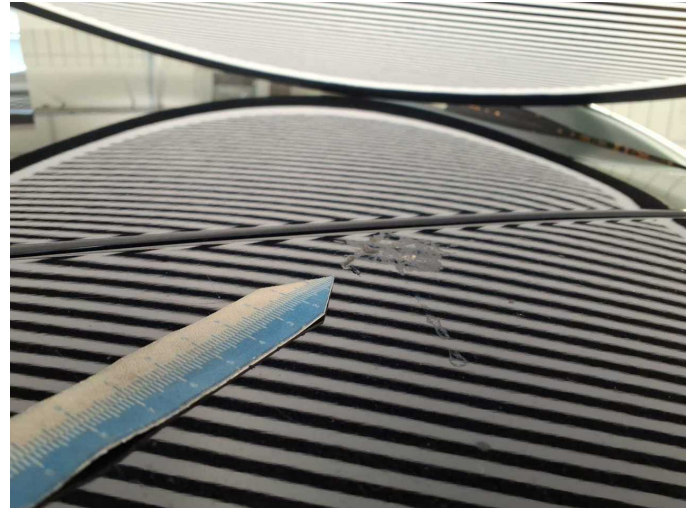
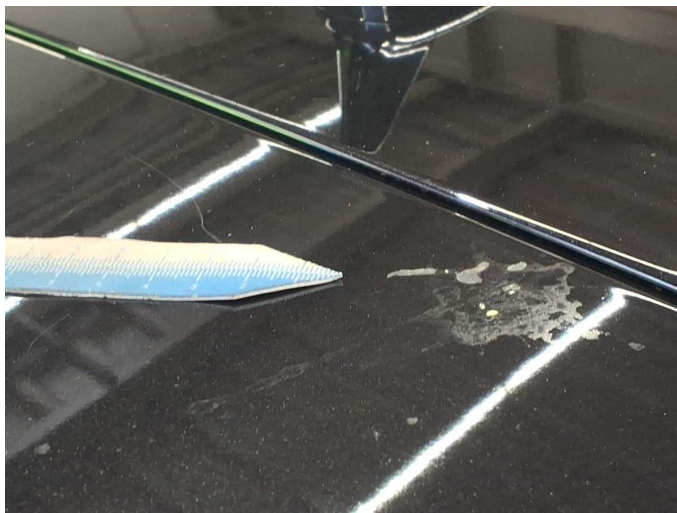
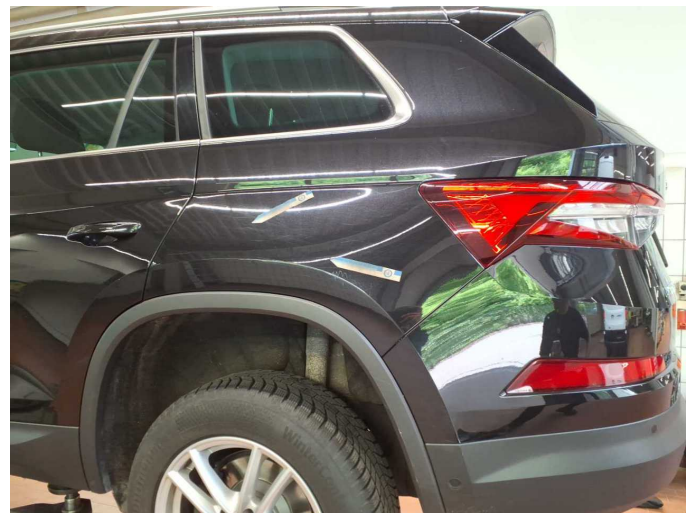
**Damage 4:** Boot lid / rear door: Boot lid (verätzt) - Paint defect - Paint

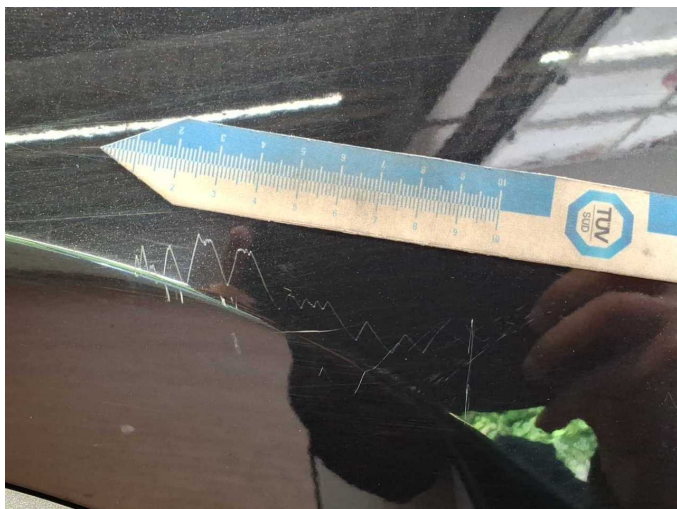
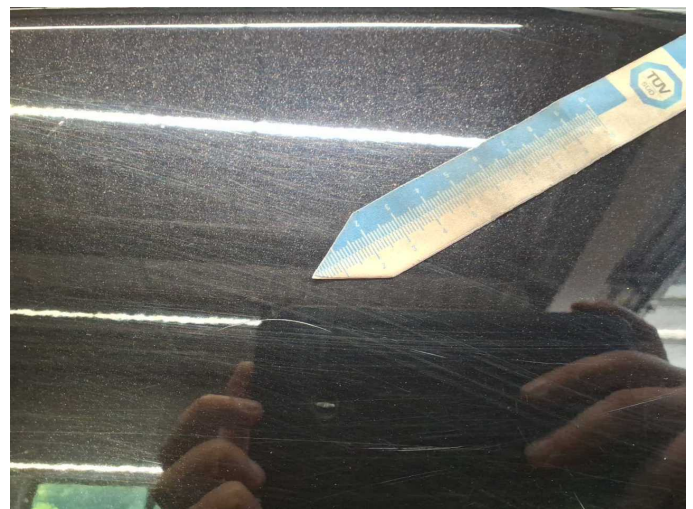
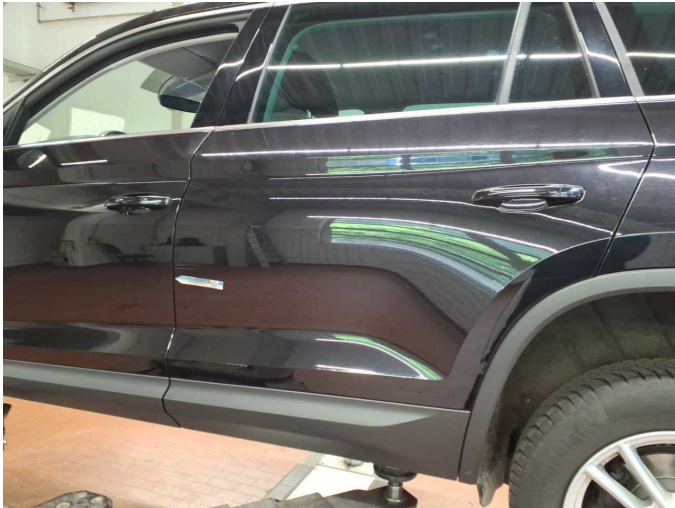
**Damage 5:** Side panel - rear left side: Side panel - Scratch(es) - Paint

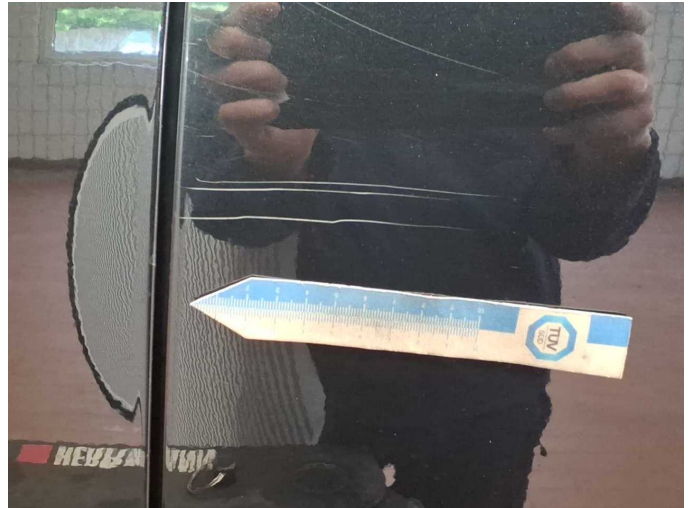
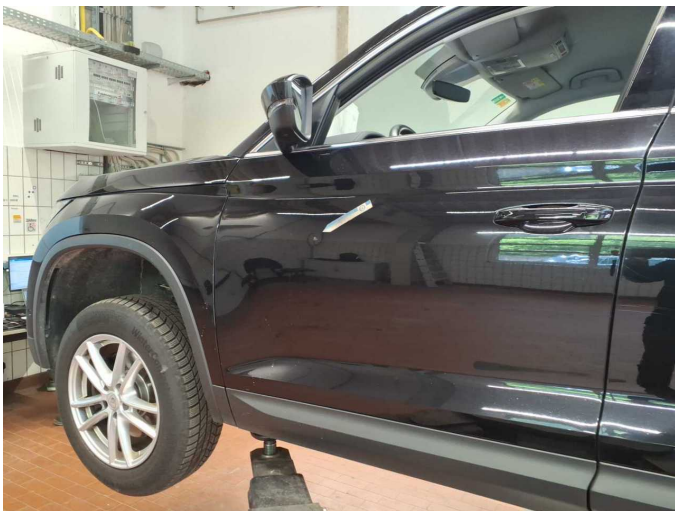
**Damage 6:** Door - rear left side: Door - Scratch(es) - Paint

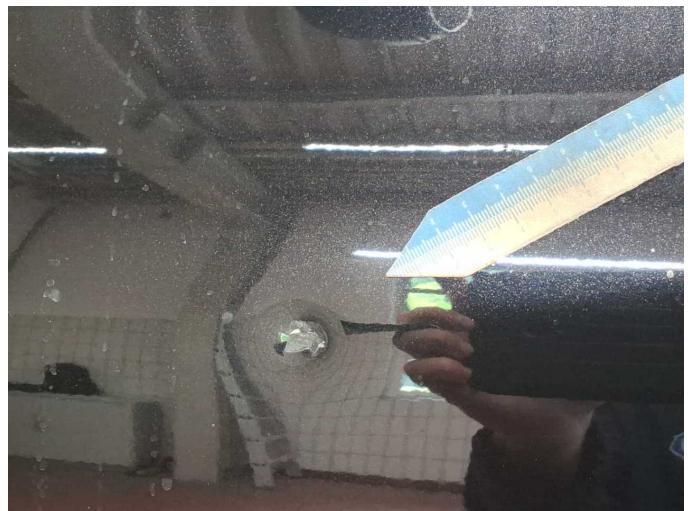
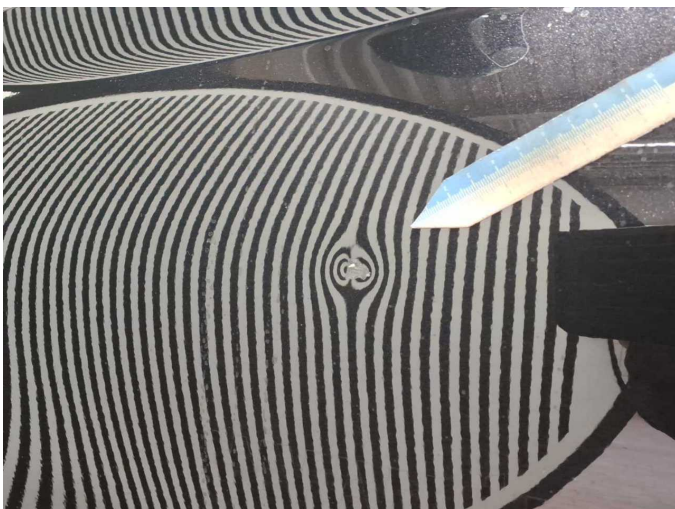
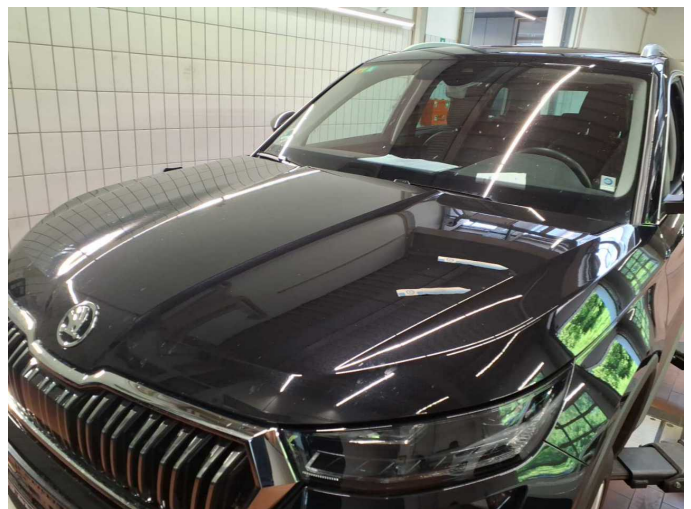
**Damage 7:** Door - front left side: Door - Dent / paintcoat damage - Repair and paint

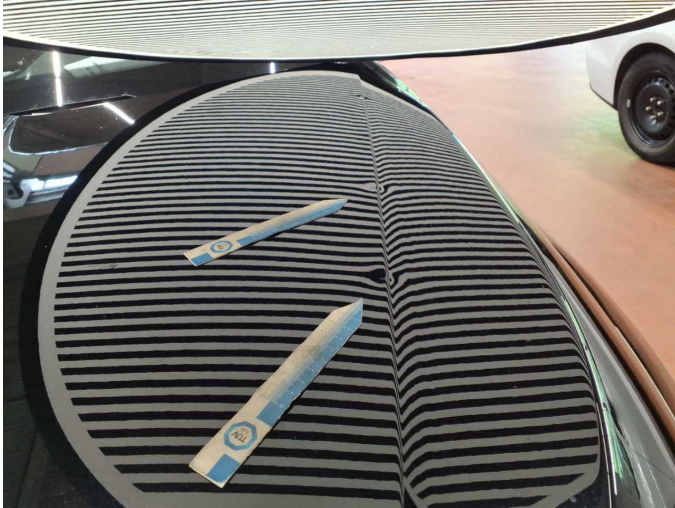
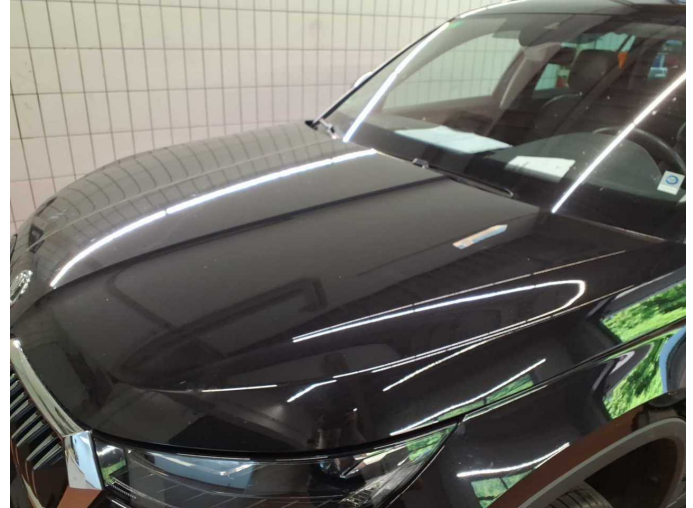
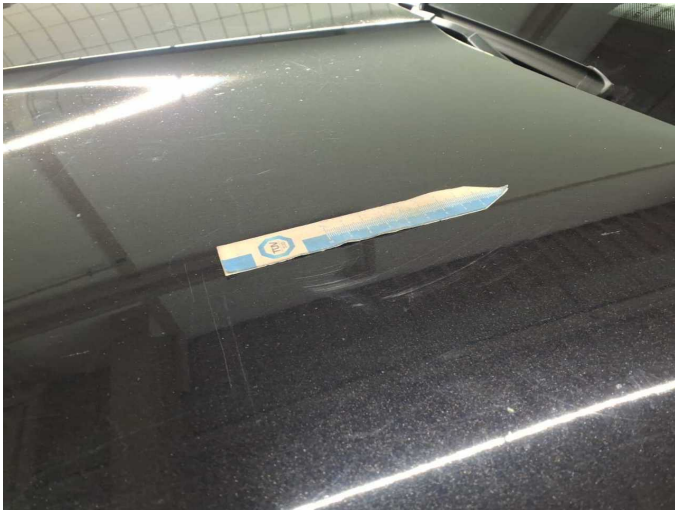
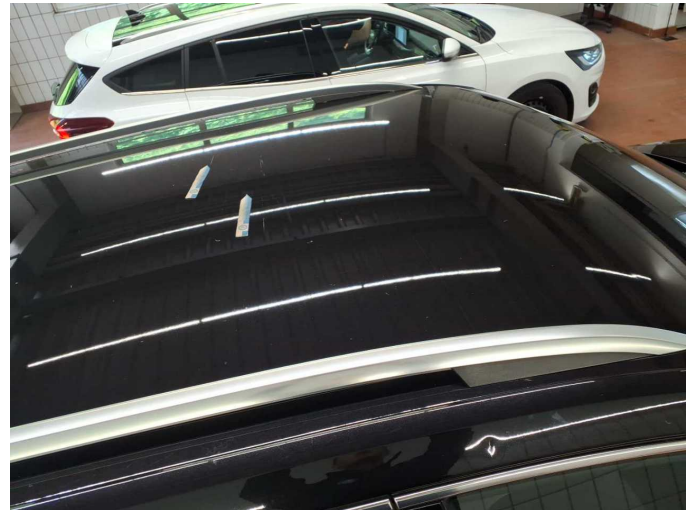
**Damage 8:** Bonnet: Bonnet (+ Kratzer) - Stone chips - Repair and paint

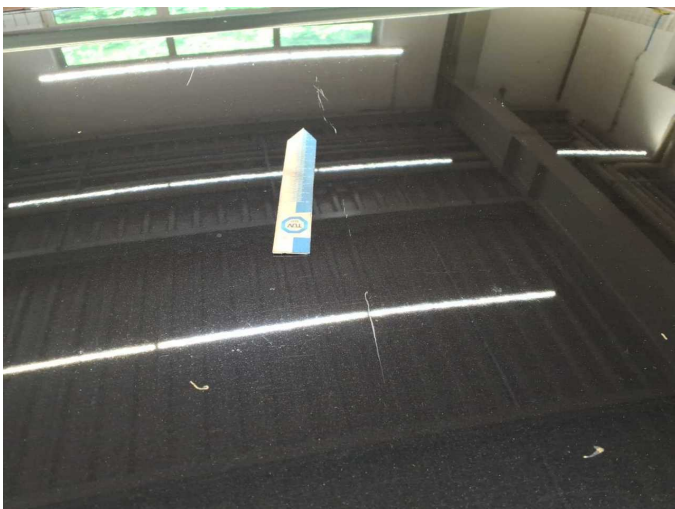
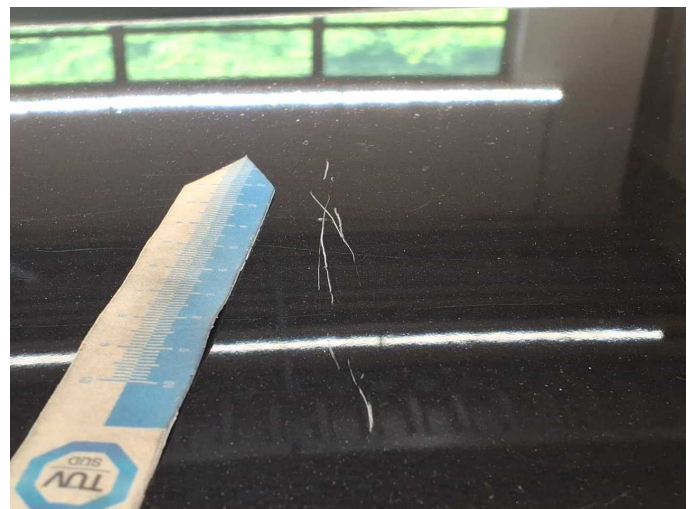
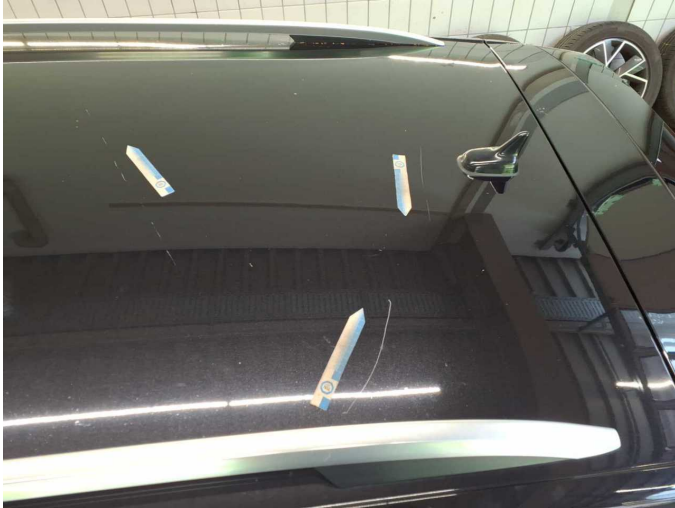
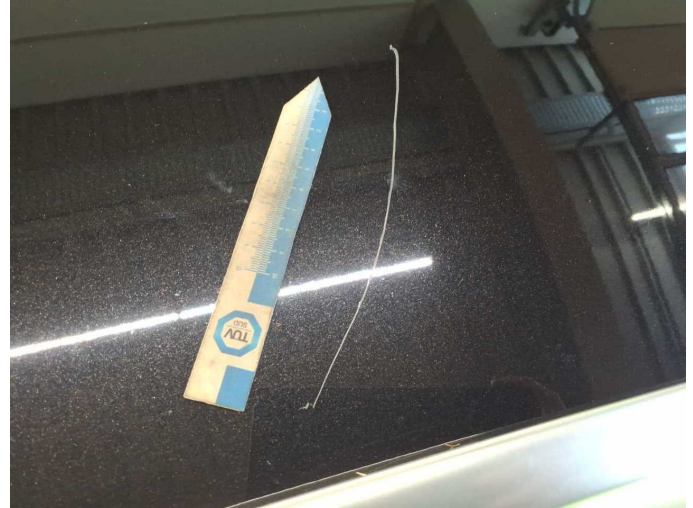
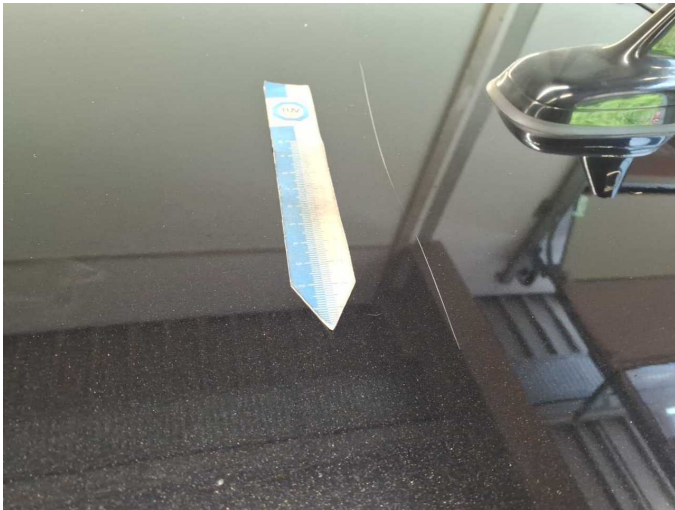
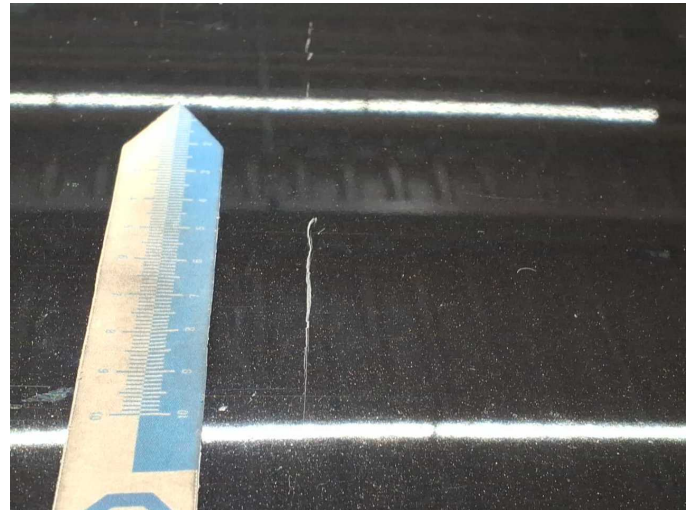
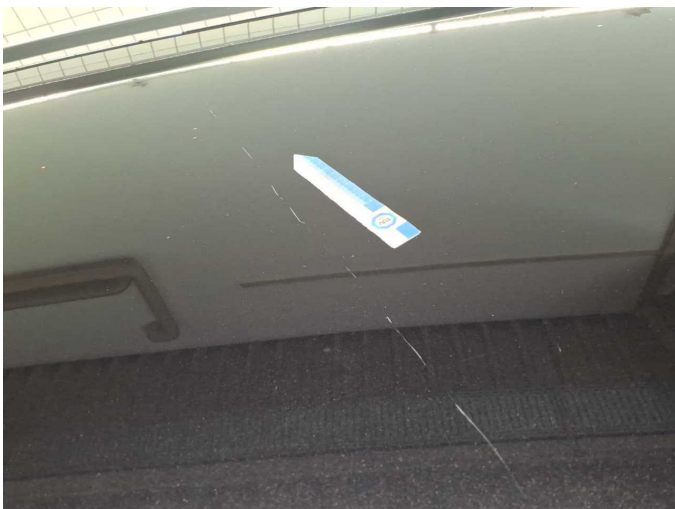
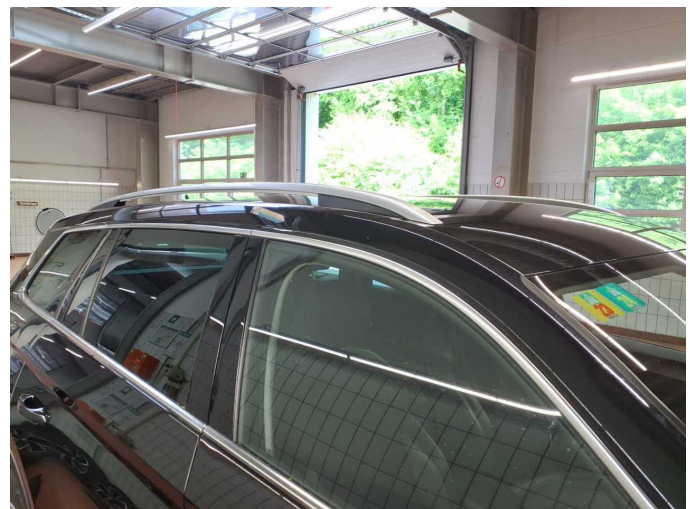
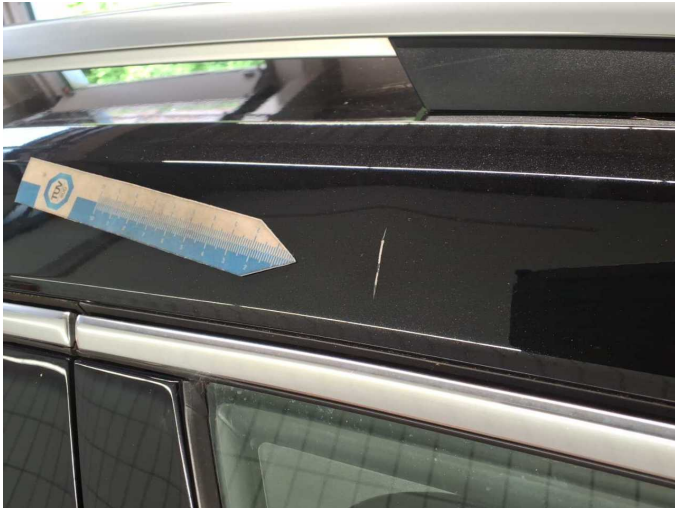
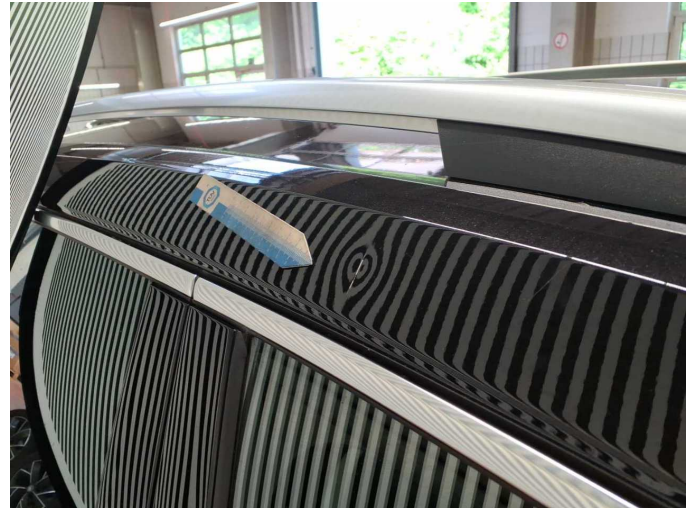
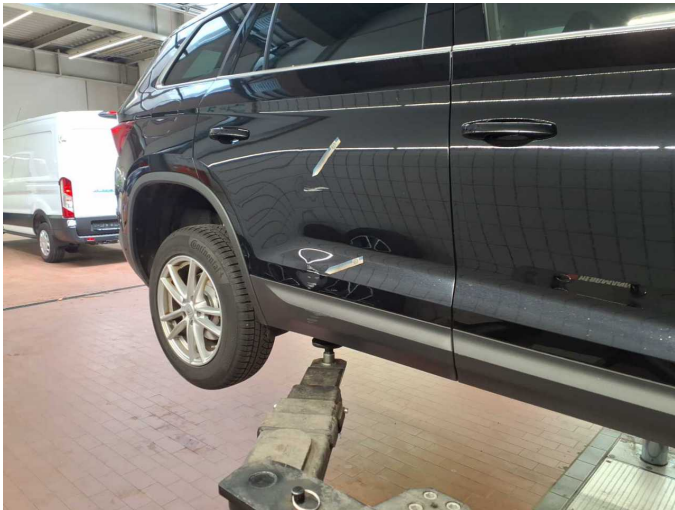
**Damage 9:** Roof: Roof (+ Dachholm re.) - Dent / paintcoat damage - Repair and paint

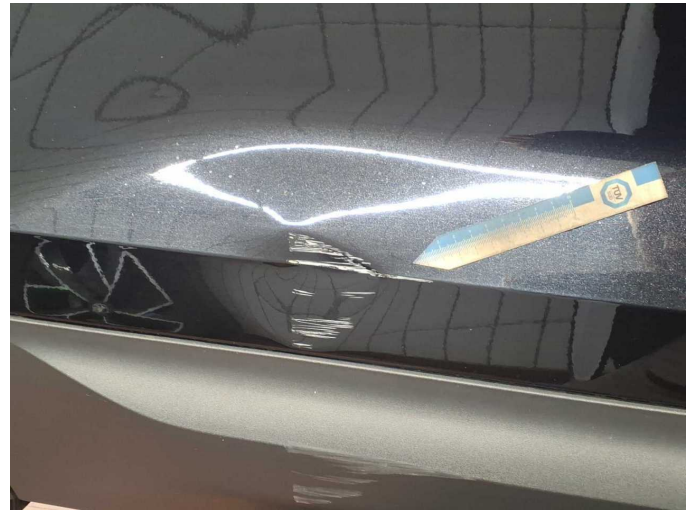
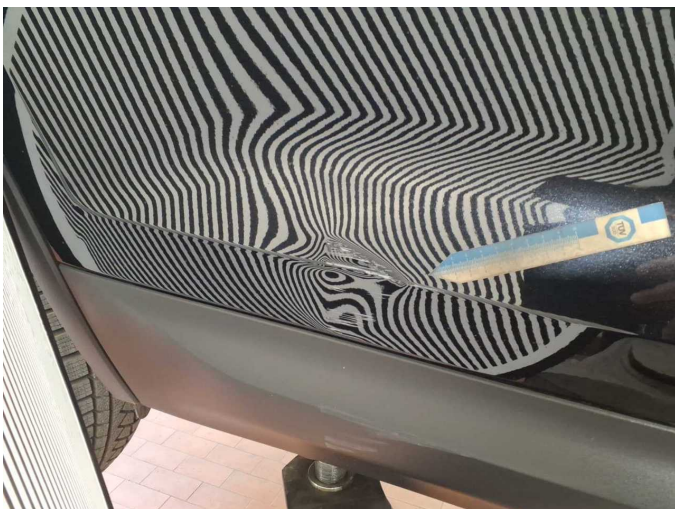
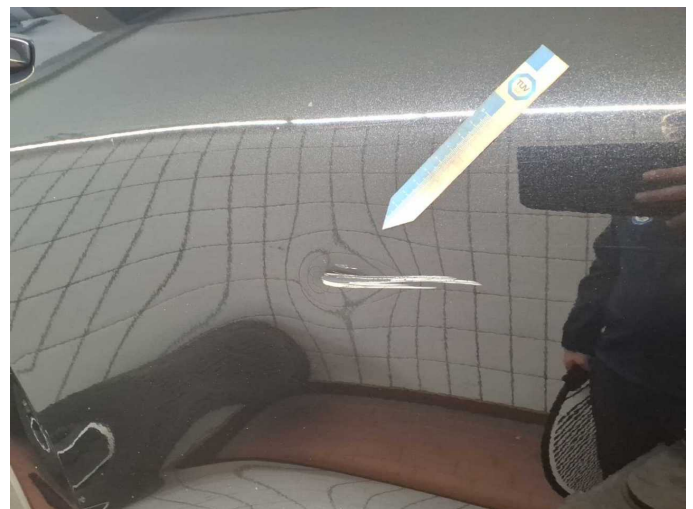
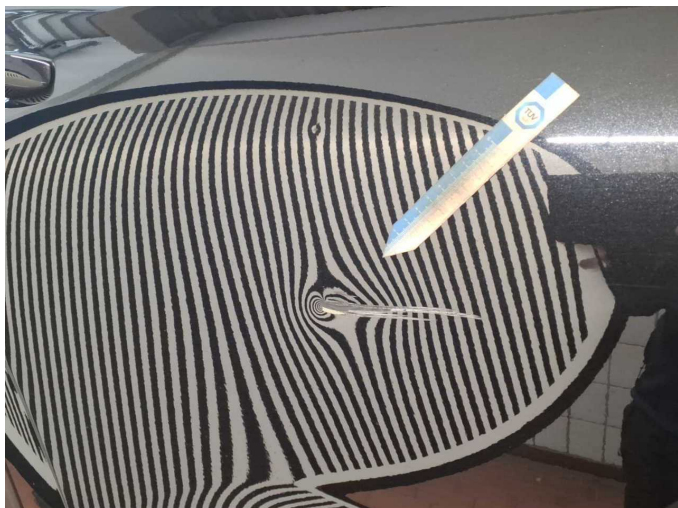
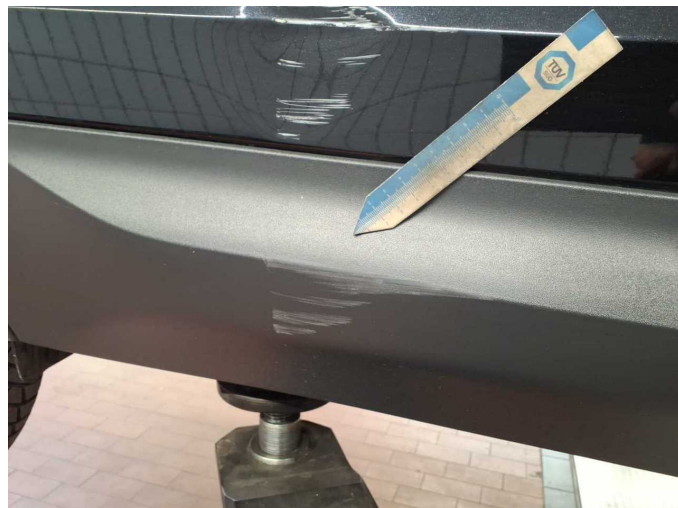
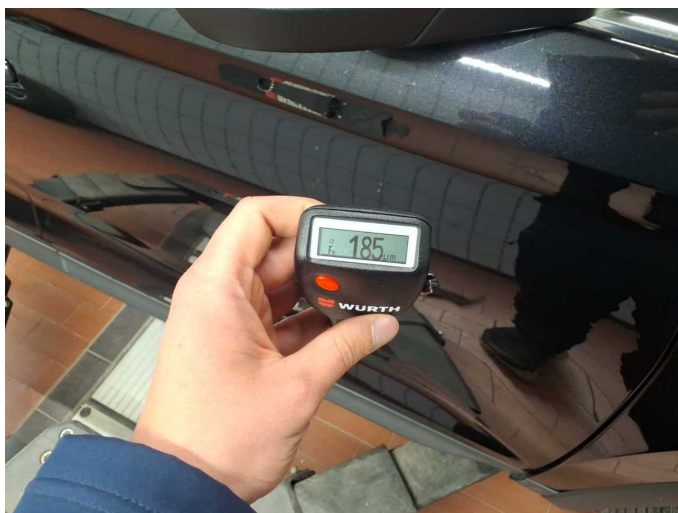
**Damage 10:** Door - rear right side: Door (+ Zierleiste unten erneuer) - Deformed - Replace
