## Expertise

Protocol number: 45878975  
Order No. / Reference: 26494935  
Inspection date: 15 Jan 2026

Manufacturer: Volkswagen

Model: Touran 2.0 TDI SCR DSG Highline

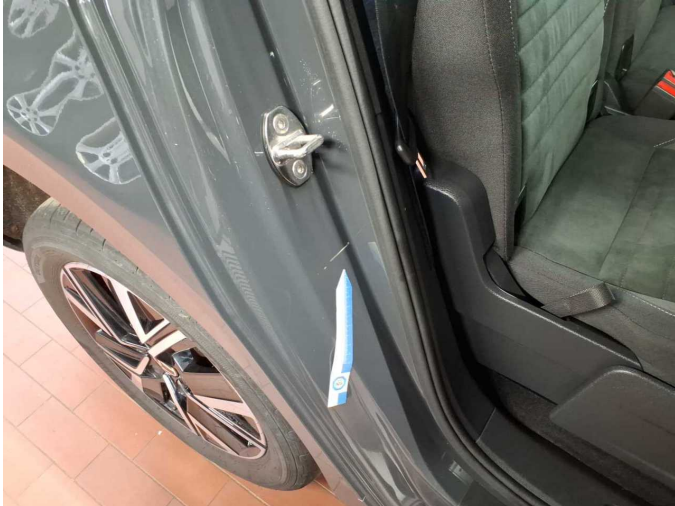
**Damage 1:** Side panel - rear right side: Sill - Scratch(es) - Smart repair

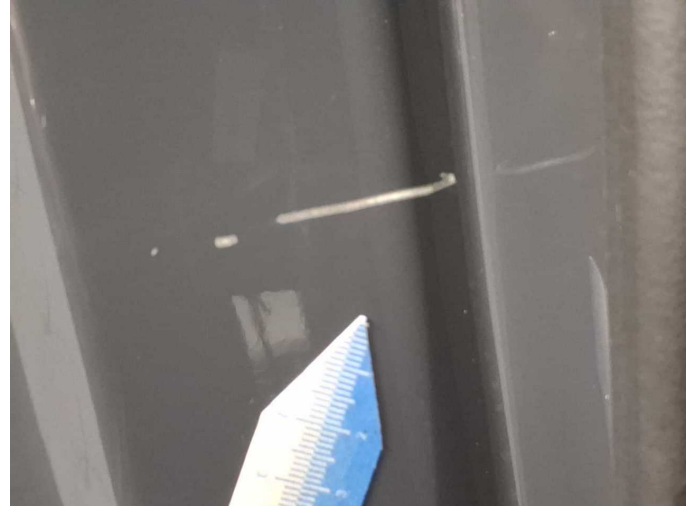
**Damage 1:** Side panel - rear right side: Sill - Scratch(es) - Smart repair

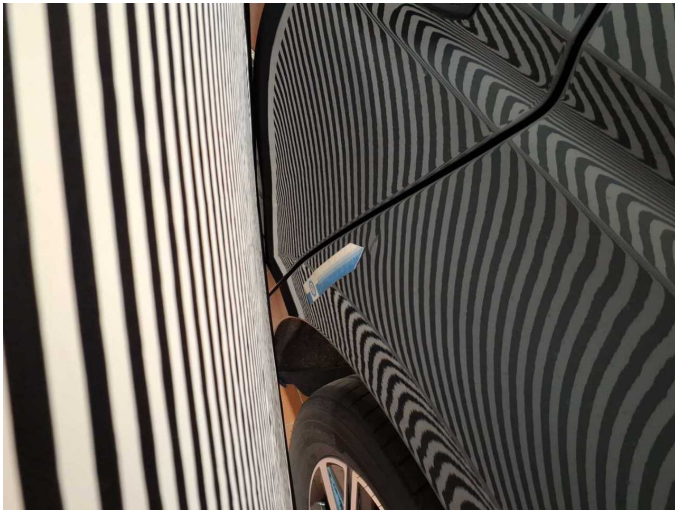
**Damage 2:** Side panel - rear left side: Side panel - Dent / paintcoat damage - Smart repair

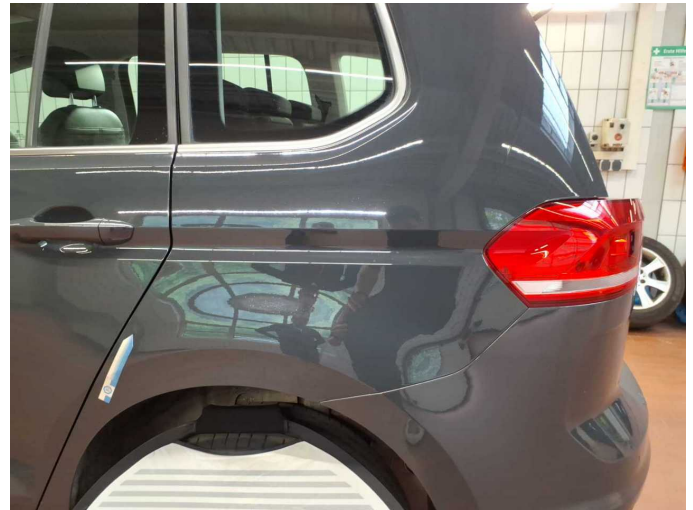
**Damage 2:** Side panel - rear left side: Side panel - Dent / paintcoat damage - Smart repair

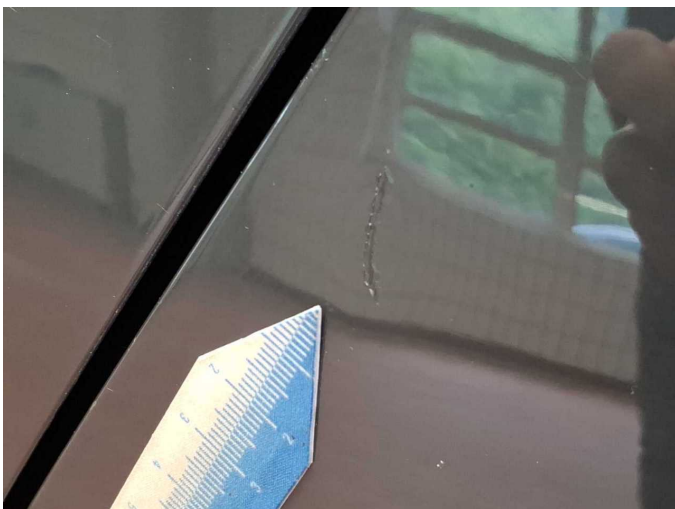
**Damage 2:** Side panel - rear left side: Side panel - Dent / paintcoat damage - Smart repair

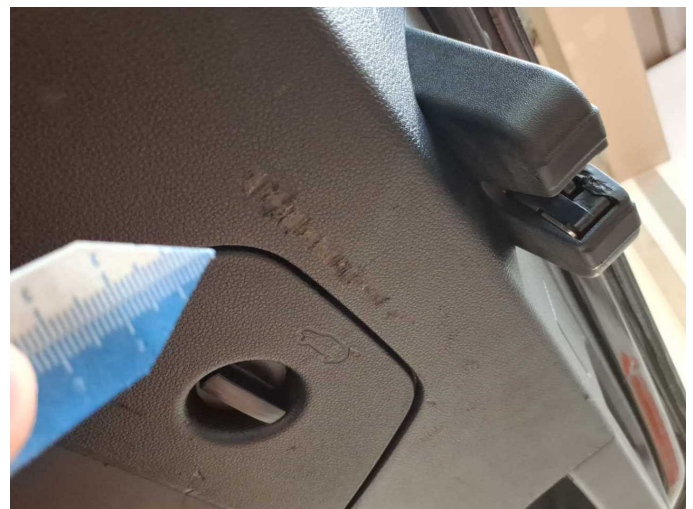
**Damage 3:** Trim / covers: Boot lid - interior trim - Scratched - Replace

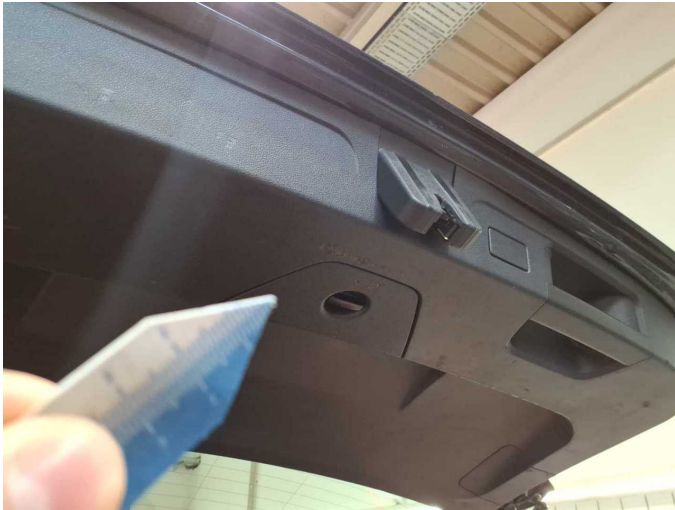
**Damage 3:** Trim / covers: Boot lid - interior trim - Scratched - Replace

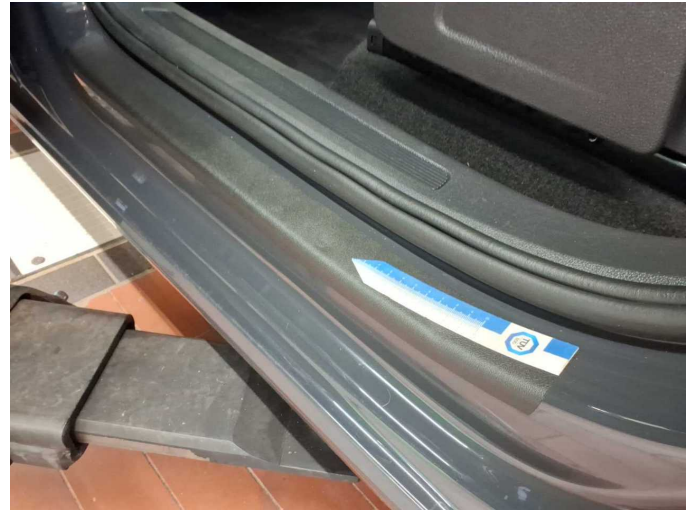
**Damage 4:** Side panel - rear left side: Sill (Folie überklebt dellen/ Lackschaden) - Dent / paintcoat damage - Repair and paint

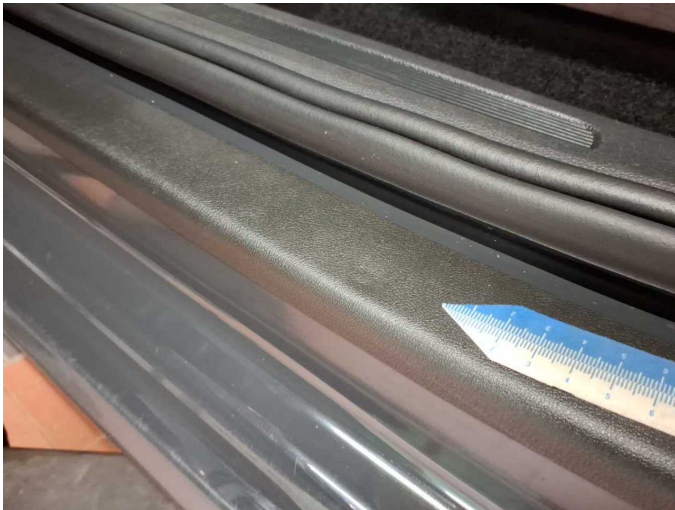
**Damage 4:** Side panel - rear left side: Sill (Folie überklebt dellen/ Lackschaden) - Dent / paintcoat damage - Repair and paint

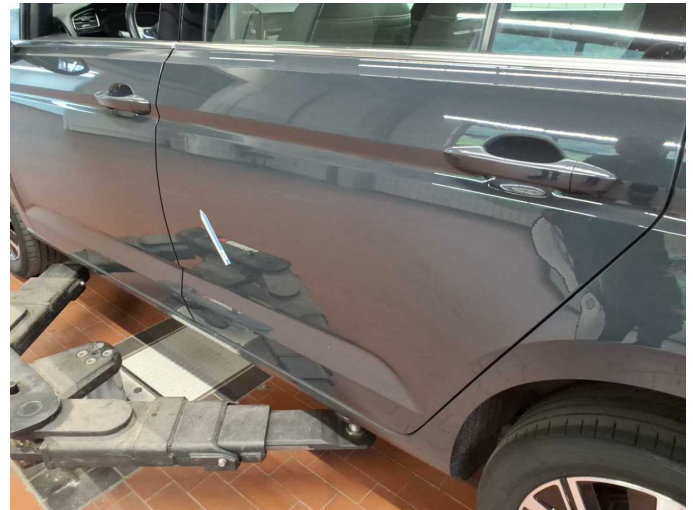
**Damage 5:** Door - rear left side: Door - Dent / paintcoat damage - Repair and paint

Reparaturfreigabe: Schadenposition 5

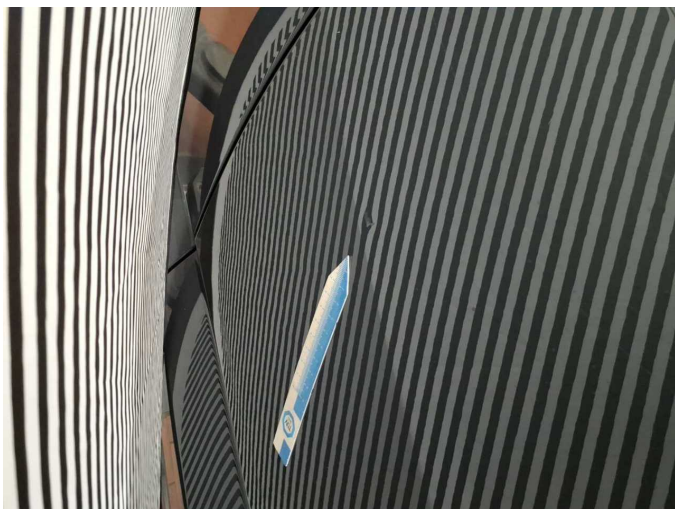
**Damage 5:** Door - rear left side: Door - Dent / paintcoat damage - Repair and paint

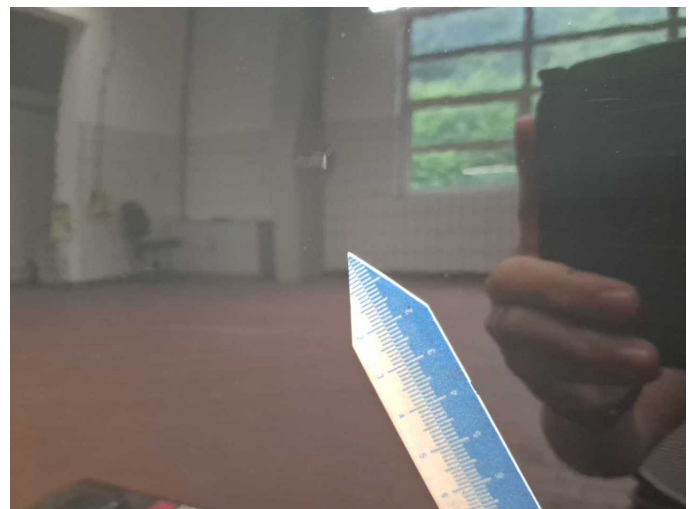
**Damage 5:** Door - rear left side: Door - Dent / paintcoat damage - Repair and paint

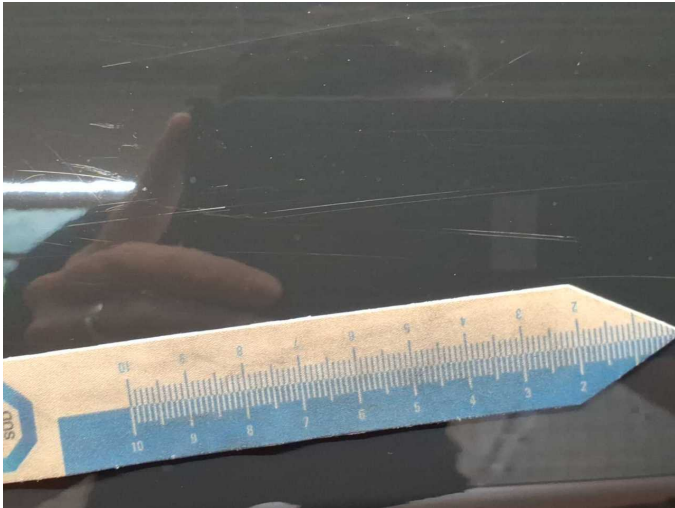
**Damage 5:** Door - rear left side: Door - Dent / paintcoat damage - Repair and paint

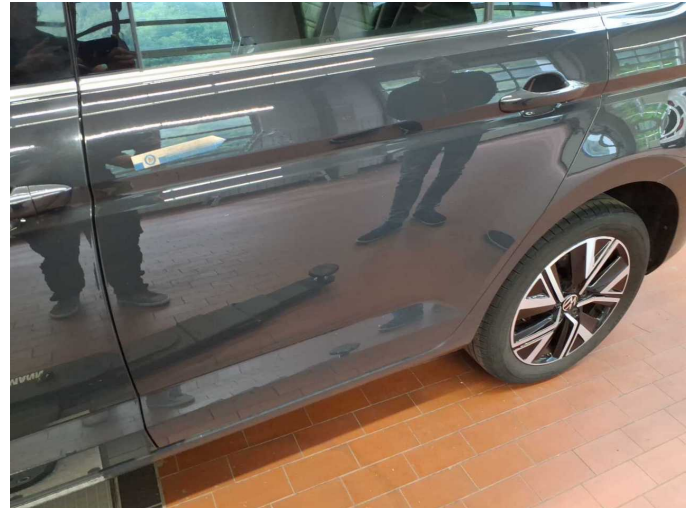
**Damage 5:** Door - rear left side: Door - Dent / paintcoat damage - Repair and paint

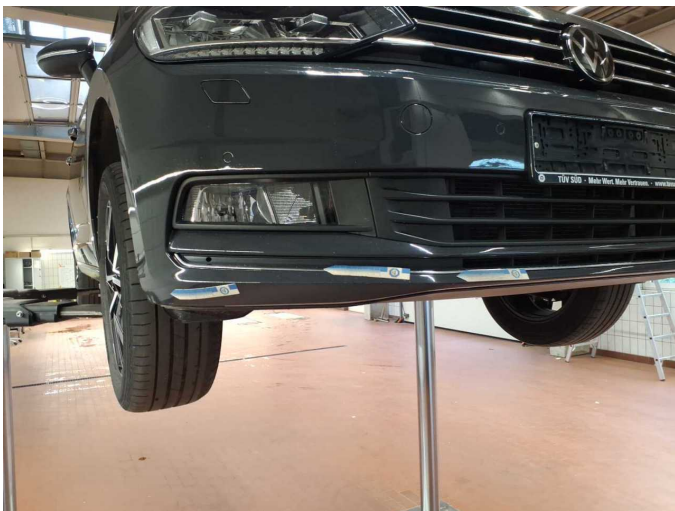
**Damage 6:** Front bumper: Front bumper - Scratched - Paint

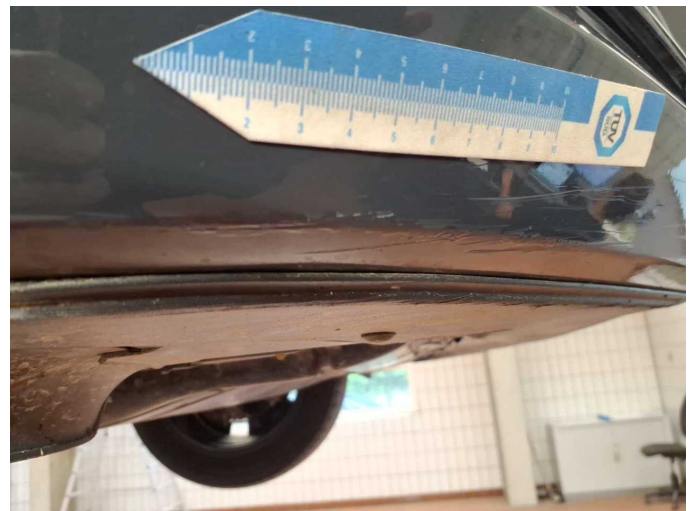
**Damage 6:** Front bumper: Front bumper - Scratched - Paint

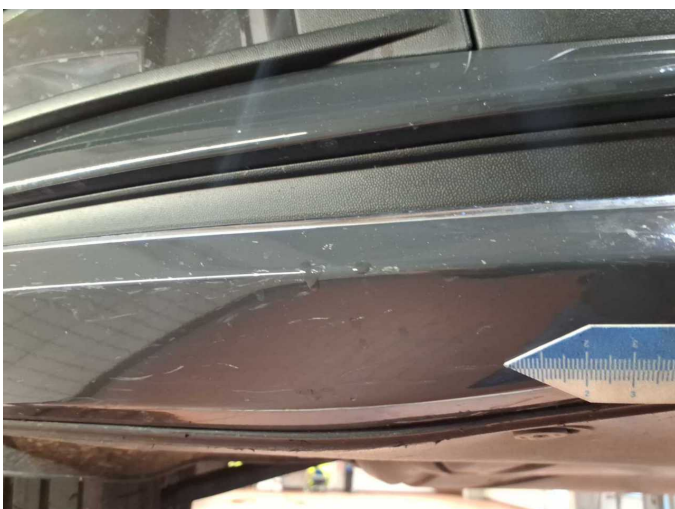
**Damage 6:** Front bumper: Front bumper - Scratched - Paint

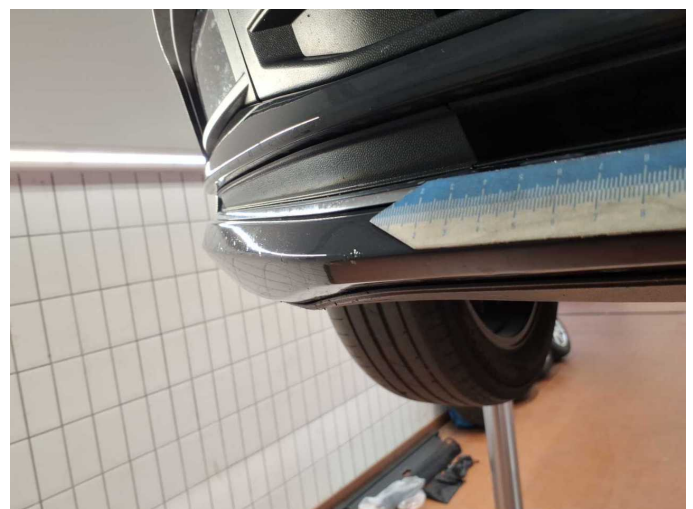
**Damage 6:** Front bumper: Front bumper - Scratched - Paint

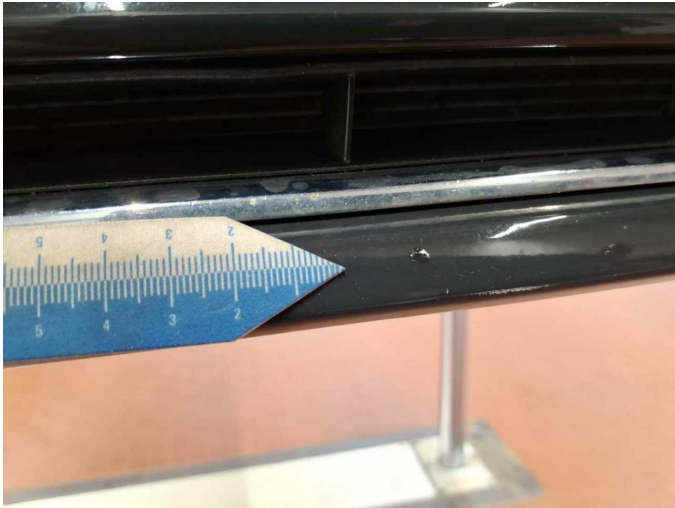
**Damage 6:** Front bumper: Front bumper - Scratched - Paint

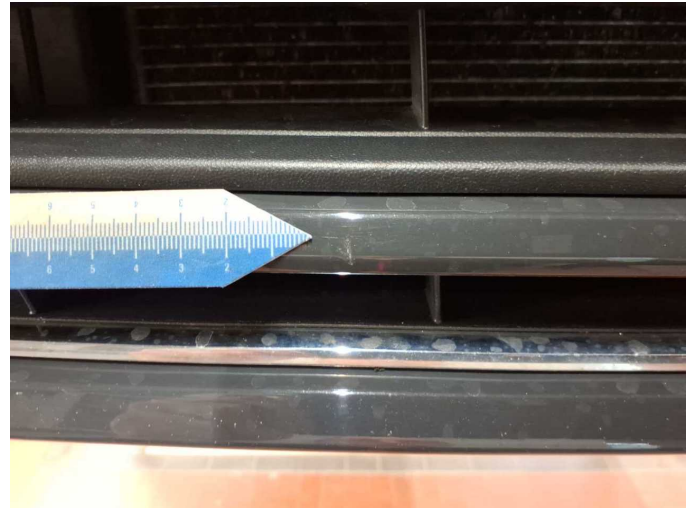
**Damage 6:** Front bumper: Front bumper - Scratched - Paint

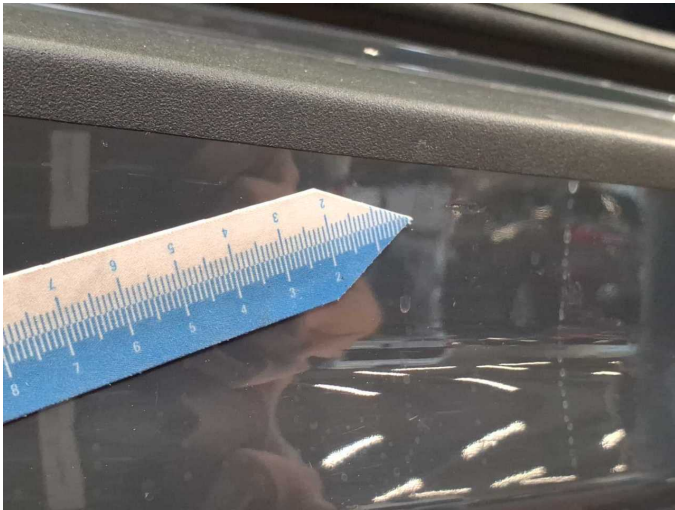
**Damage 7:** Rear bumper: Rear bumper - Dent / paintcoat damage - Repair and paint

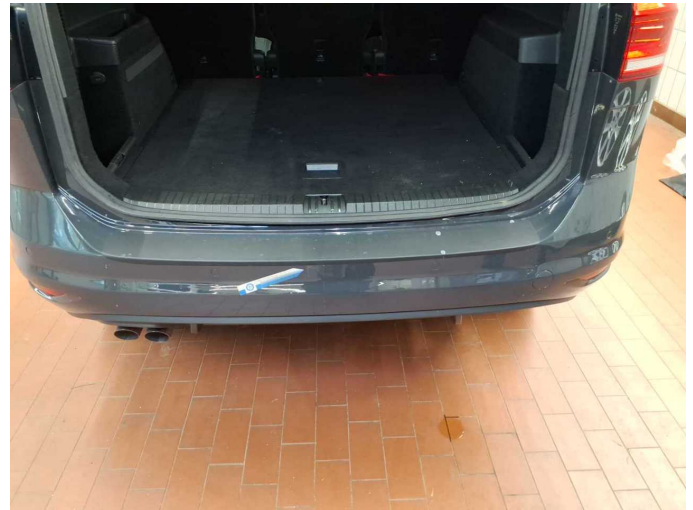
**Damage 7:** Rear bumper: Rear bumper - Dent / paintcoat damage - Repair and paint

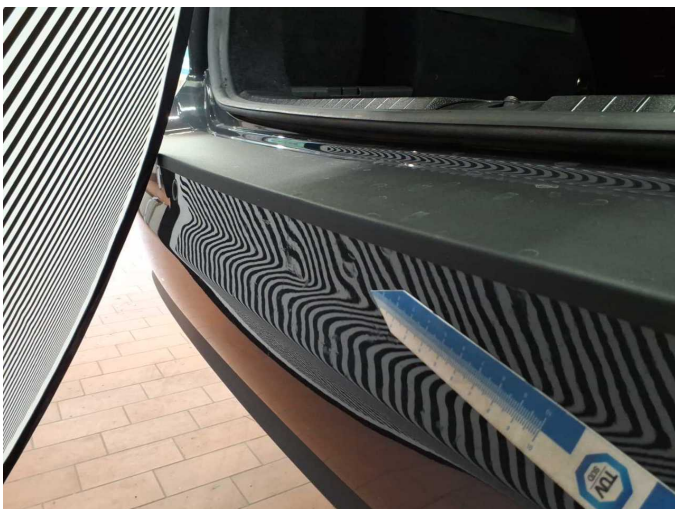
**Damage 7:** Rear bumper: Rear bumper - Dent / paintcoat damage - Repair and paint

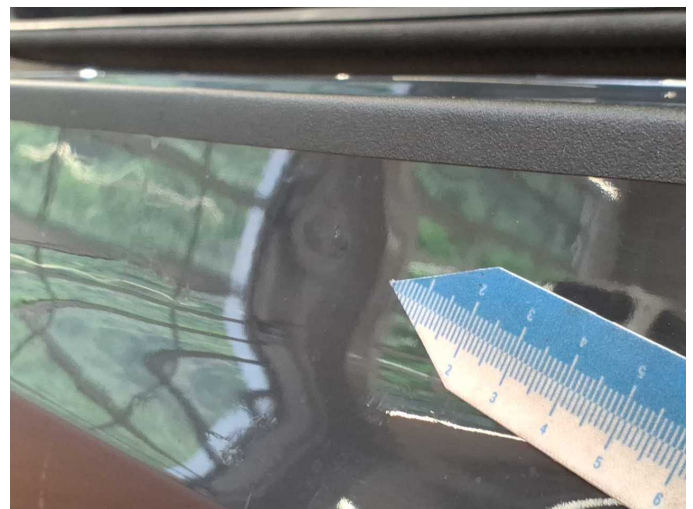
**Damage 7:** Rear bumper: Rear bumper - Dent / paintcoat damage - Repair and paint

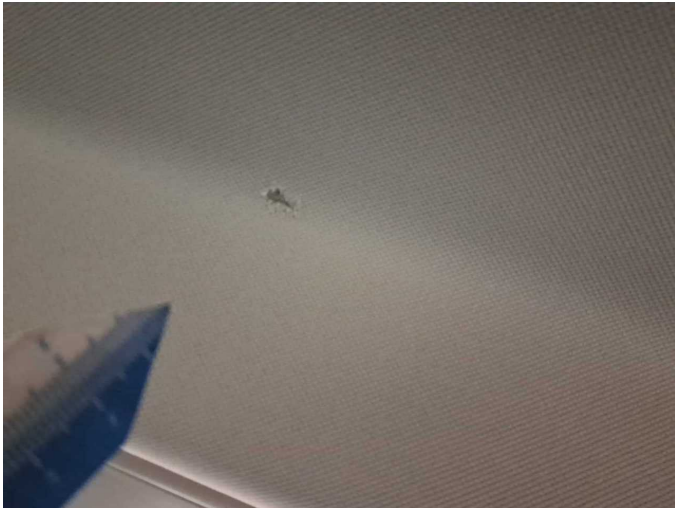
**Damage 8:** Trim / covers: Roof lining - Scratch(es) - Replace

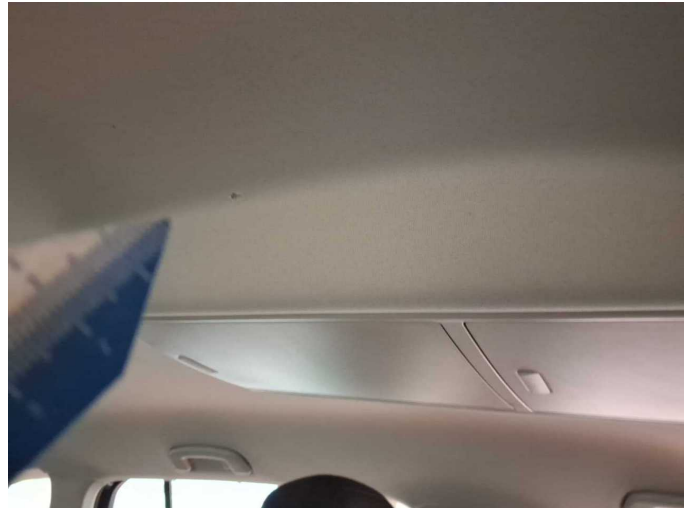
**Damage 8:** Trim / covers: Roof lining - Scratch(es) - Replace

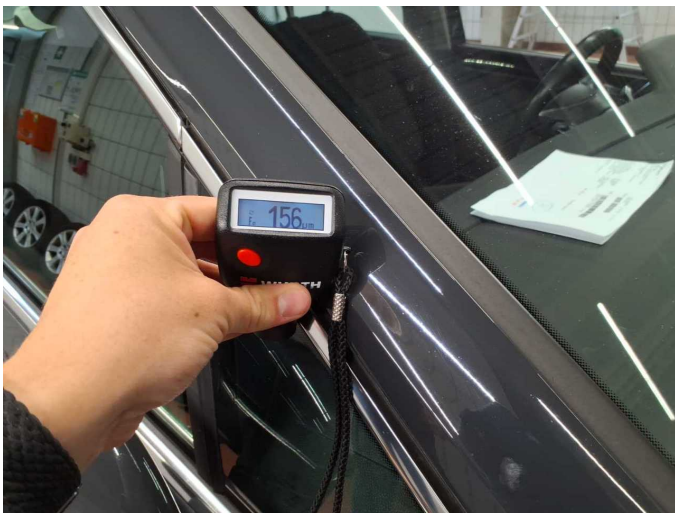
**Repainting 1:** Roof rail - right side

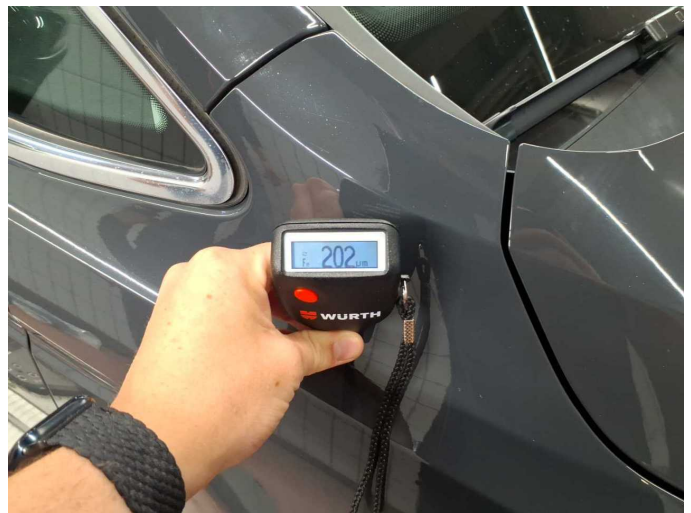
**Repainting 2:** Mudguard - right side

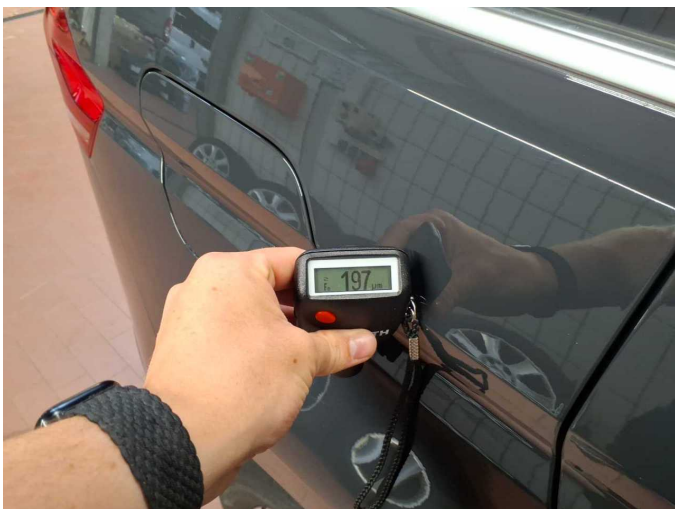
**Repainting 3:** Side panel - rear right side

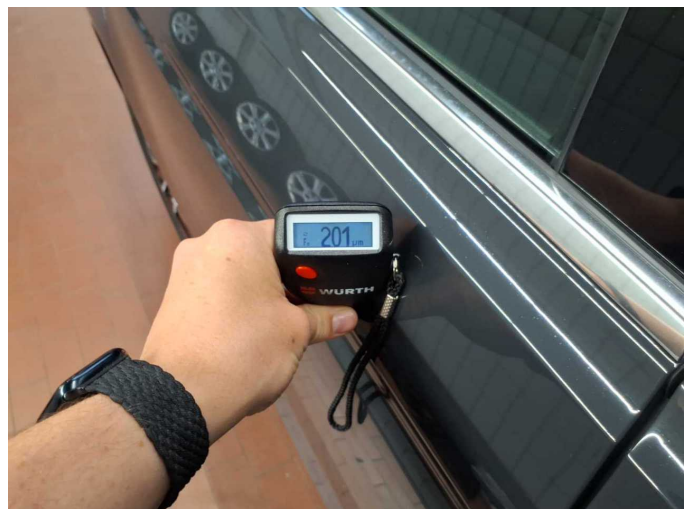
**Repainting 4:** Door - rear right side

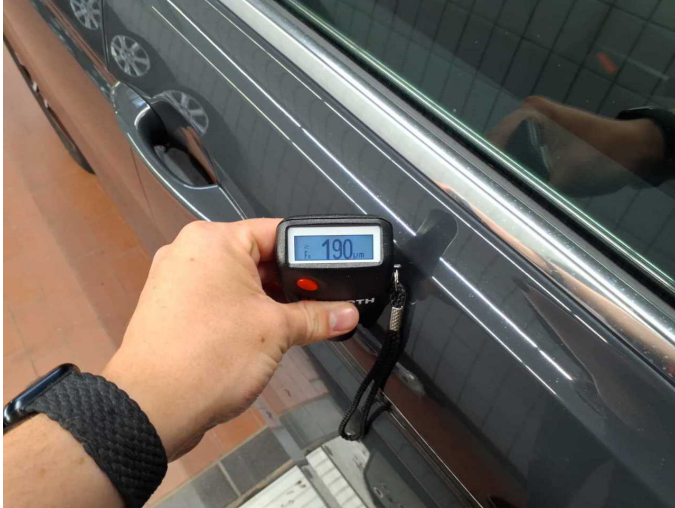
**Repainting 5:** Door - front right side
