Expertise

Protocol number: 46740280  
Order No. / Reference: 26804302  
Inspection date: 27 Jul 2026

Manufacturer: Volkswagen

Model: Transporter T6.1 4MOTION Lang

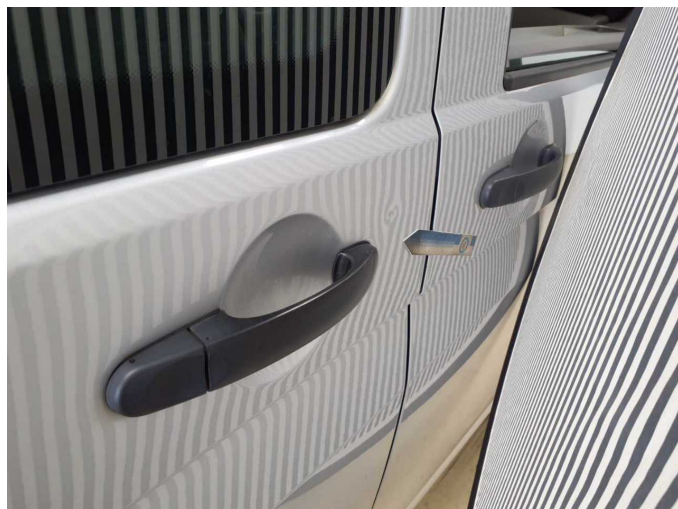
| No. | Component group | Description |
|---|---|---|
| 2 | Sliding door, right | Sliding door - Dent / paintcoat damage - Smart repair |

**Damage 2:** Sliding door, right: Sliding door - Dent / paintcoat damage - Smart repair

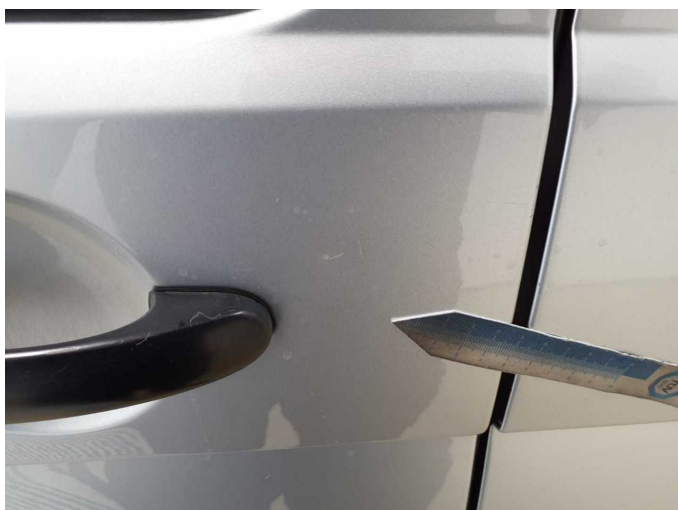
**Damage 2:** Sliding door, right: Sliding door - Dent / paintcoat damage - Smart repair

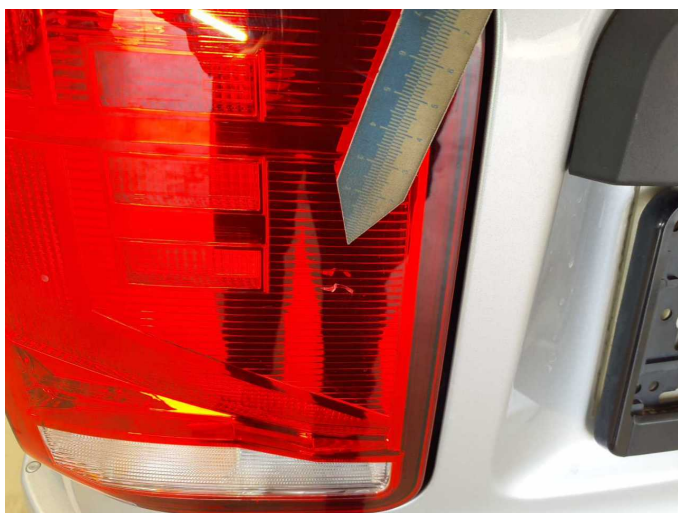
| No. | Component group | Description |
|---|---|---|
| 3 | Tail light | Tail lamp - left side - Scratch(es) - Replace |

**Damage 3:** Tail light: Tail lamp - left side - Scratch(es) - Replace

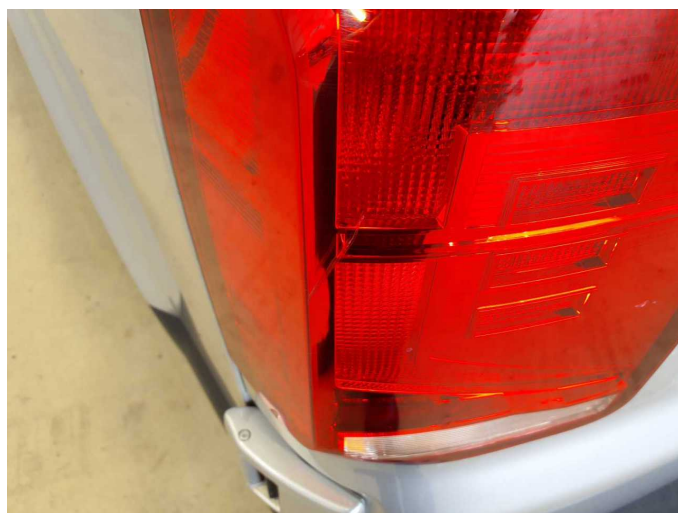
**Damage 3:** Tail light: Tail lamp - left side - Scratch(es) - Replace

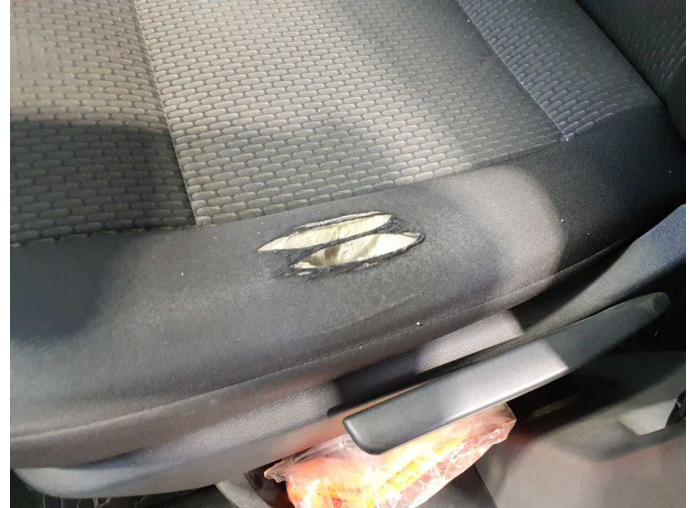
| No. | Component group | Description |
|---|---|---|
| 4 | Seat - front | Seat cover - left side (Inklusive polster) - Broken / torn - Replace |

**Damage 4:** Seat - front: Seat cover - left side (Inklusive polster) - Broken / torn - Replace

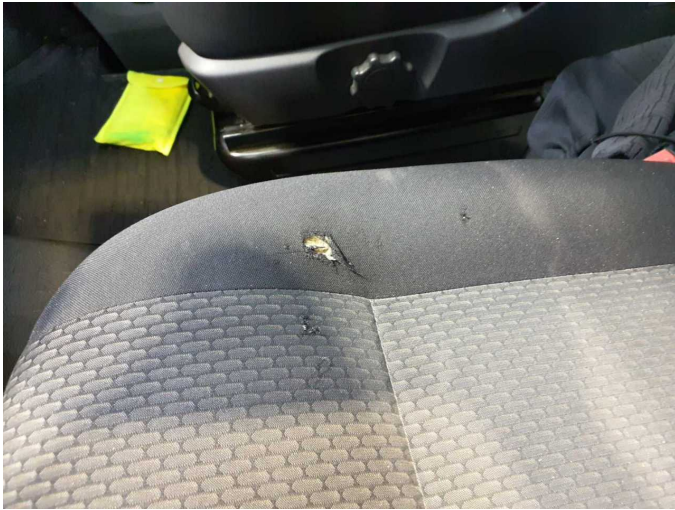
**Damage 4:** Seat - front: Seat cover - left side (Inklusive polster) - Broken / torn - Replace

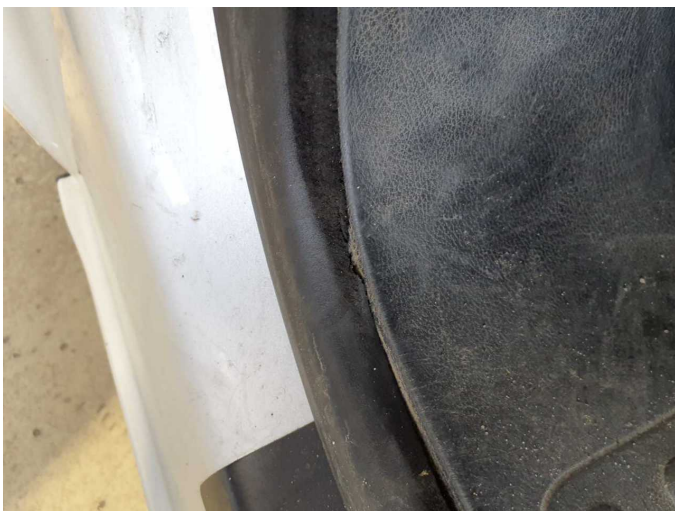
| No. | Component group | Description |
|---|---|---|
| 5 | Door - front left side | Door seal - Broken / torn - Replace |

**Damage 5:** Door - front left side: Door seal - Broken / torn - Replace

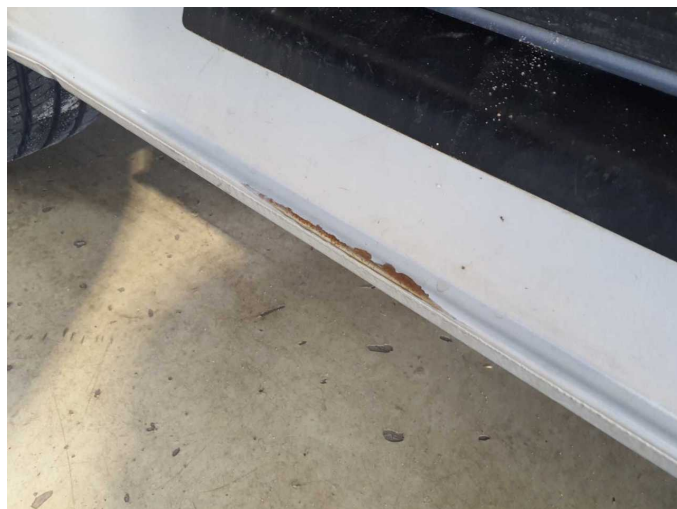
| No. | Component group | Description |
|---|---|---|
| 7 | Sill - left side | Sill - Corrosion - Repair and paint |

**Damage 7:** Sill - left side: Sill - Corrosion - Repair and paint

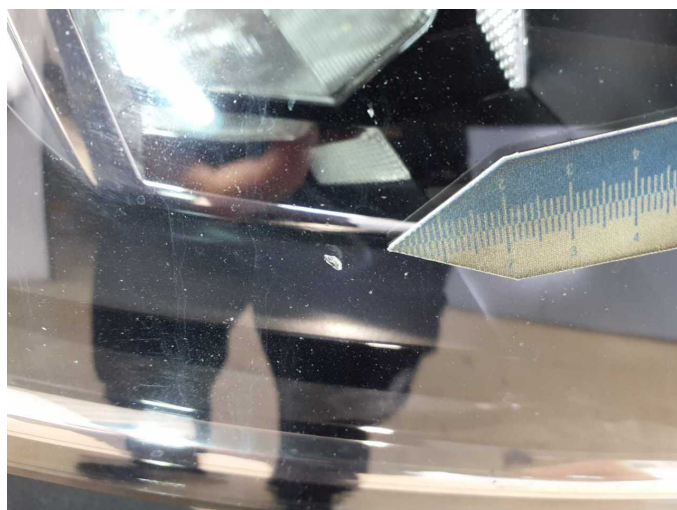
| No. | Component group | Description |
|---|---|---|
| 8 | Headlight | Headlight - right side - Stone chips - Replace |

**Damage 8:** Headlight: Headlight - right side - Stone chips - Replace

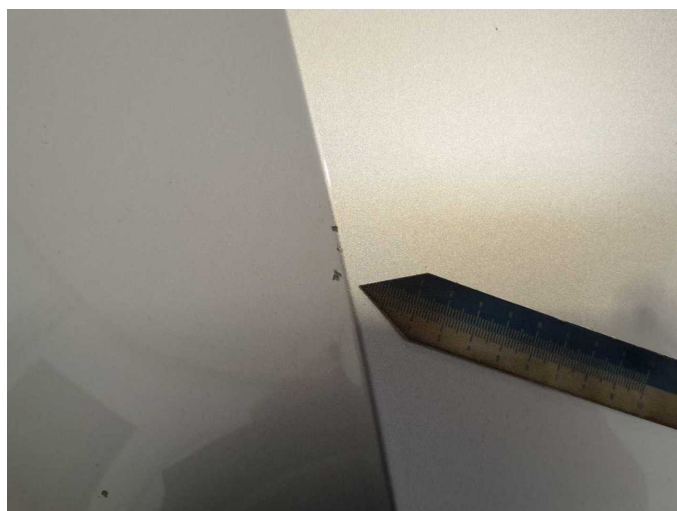
| No. | Component group | Description |
|---|---|---|
| 9 | Bonnet | Bonnet - Scratch(es) - Paint |

**Damage 9:** Bonnet: Bonnet - Scratch(es) - Paint

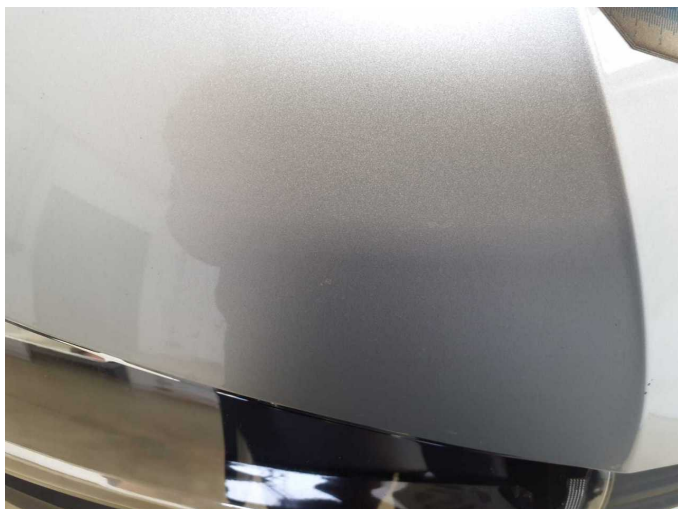
**Damage 9:** Bonnet: Bonnet - Scratch(es) - Paint

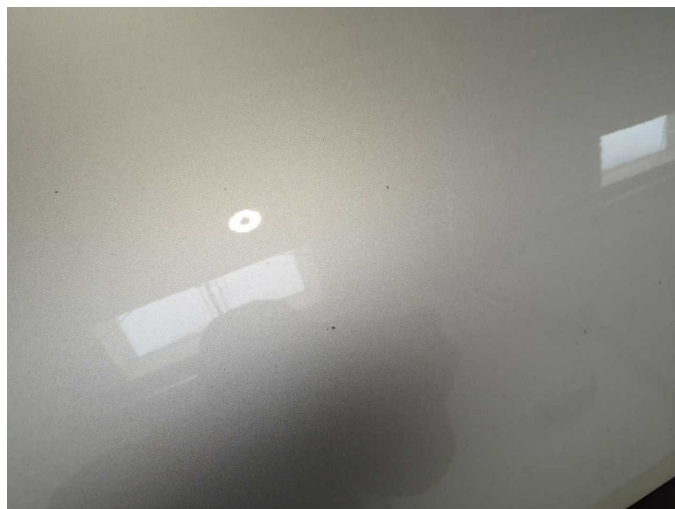
**Damage 9:** Bonnet: Bonnet - Scratch(es) - Paint

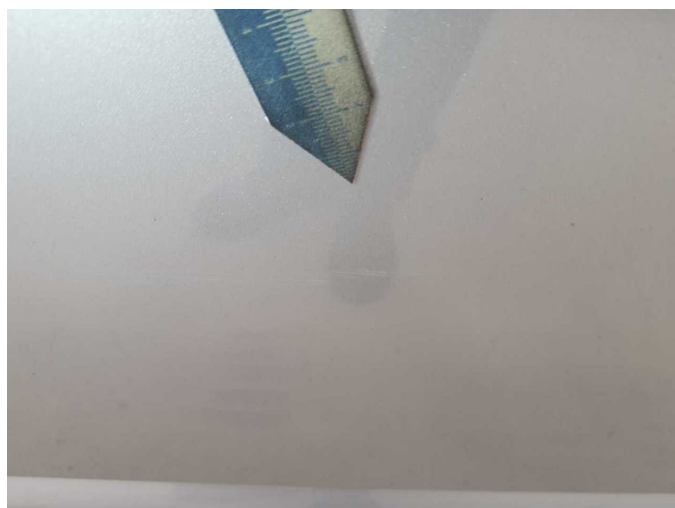
| No. | Component group | Description |
|---|---|---|
| 10 | Door - front right side | Door - Scratch(es) - Paint |

**Damage 10:** Door - front right side: Door - Scratch(es) - Paint

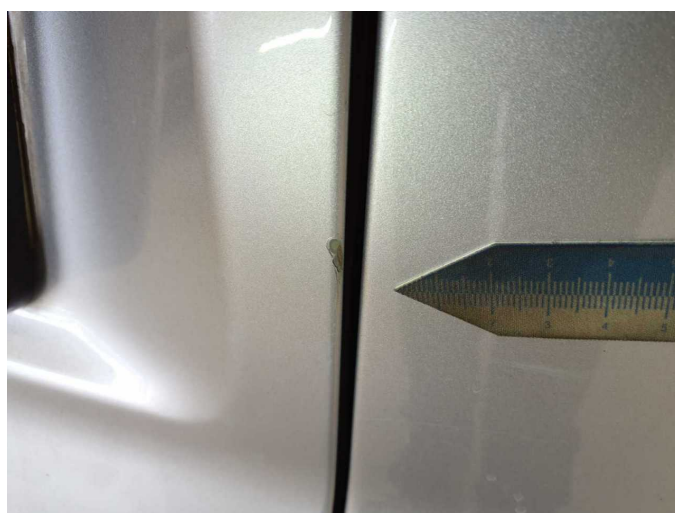
| No. | Component group | Description |
|---|---|---|
| 11 | Boot lid / rear door | Rear door - left side - Corrosion - Repair and paint |

**Damage 11:** Boot lid / rear door: Rear door - left side - Corrosion - Repair and paint

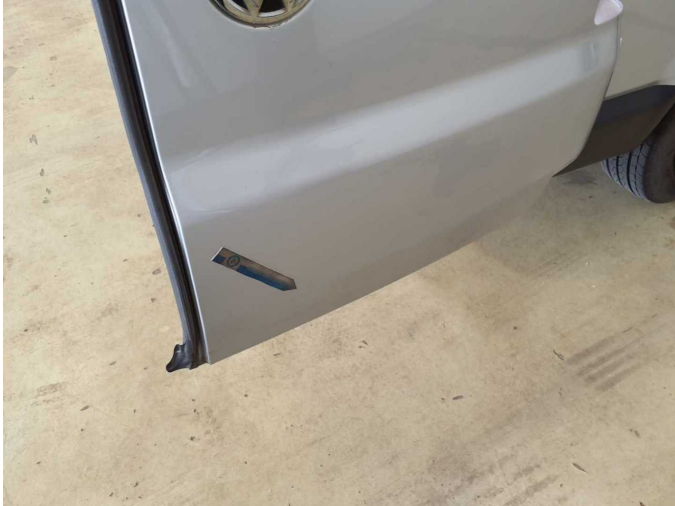
**Damage 11:** Boot lid / rear door: Rear door - left side - Corrosion - Repair and paint

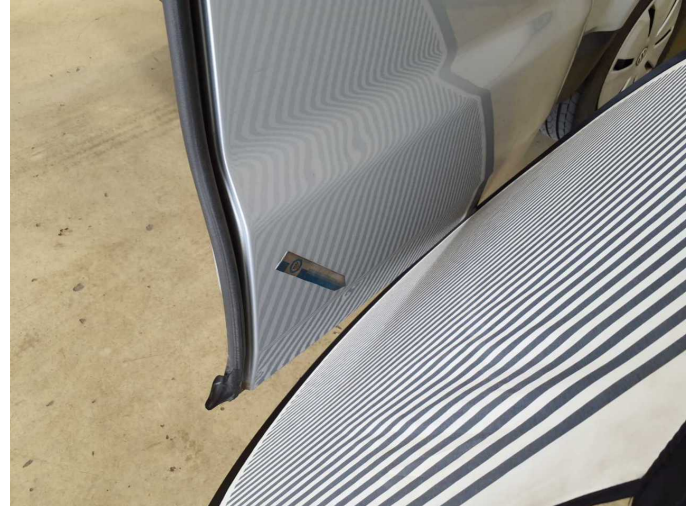
| No. | Component group | Description |
|---|---|---|
| 12 | Boot lid / rear door | Rear door - right side - Dent / paintcoat damage - Repair and paint |

**Damage 12:** Boot lid / rear door: Rear door - right side - Dent / paintcoat damage - Repair and paint

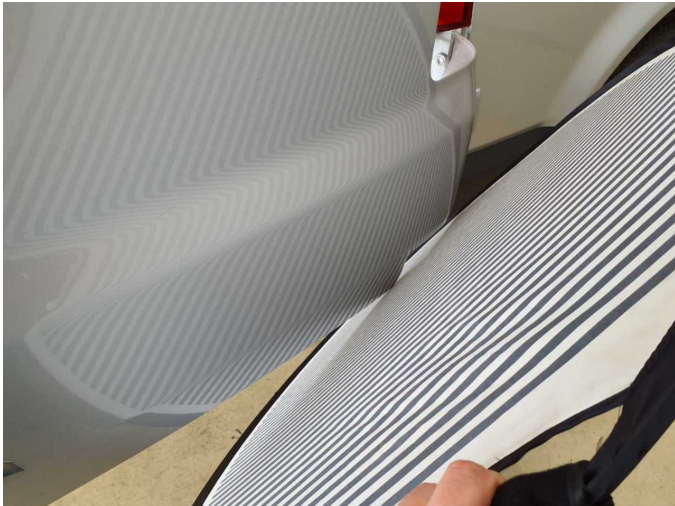
**Damage 12:** Boot lid / rear door: Rear door - right side - Dent / paintcoat damage - Repair and paint

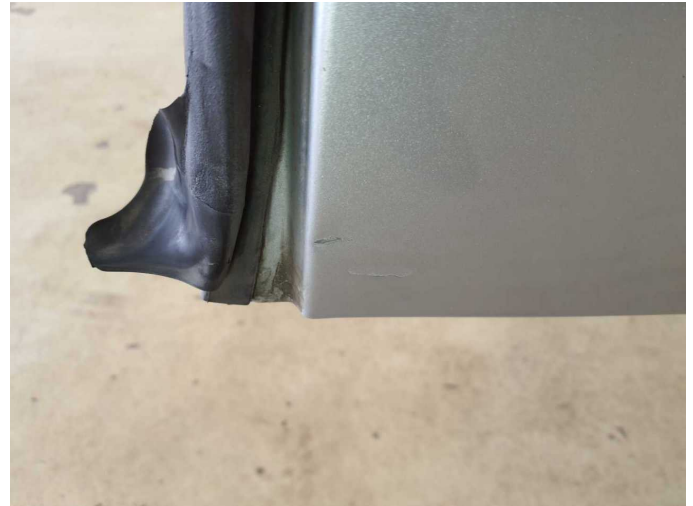
**Damage 12:** Boot lid / rear door: Rear door - right side - Dent / paintcoat damage - Repair and paint

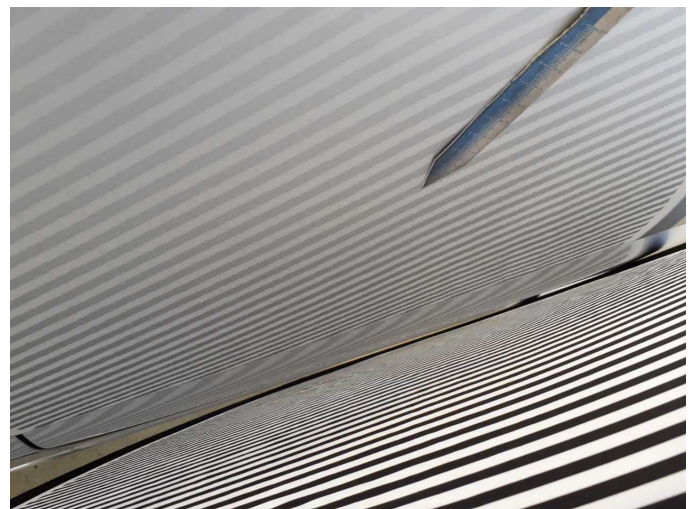
| No. | Component group | Description |
|---|---|---|
| 13 | Side panel - rear left side | Side panel (Einschlüsse) - Unprofessionally repaired - Repair and paint |

- Winterradsatz ist kein Bestandteil des Auslieferungsumfangs.
- Das Fahrzeug befand sich zum Besichtigungszeitpunkt in nicht fachgerecht reparierten Zustand. Schadenausweitung möglich, Zusatzkosten können entstehen.

**Damage 13:** Side panel - rear left side: Side panel (Einschlüsse) - Unprofessionally repaired - Repair and paint

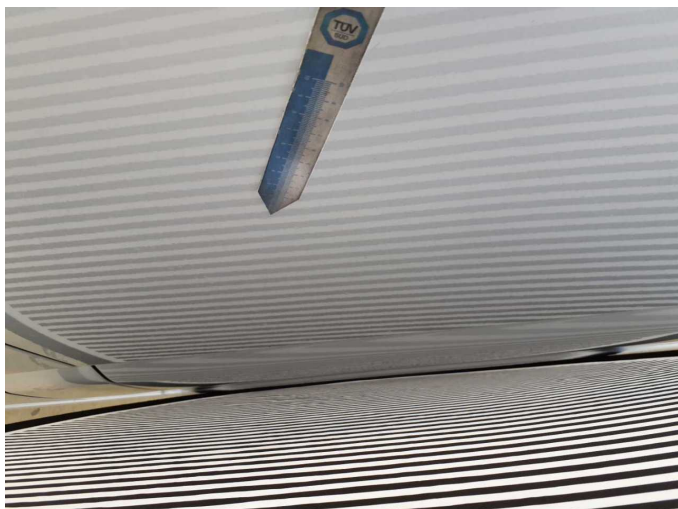
**Damage 13:** Side panel - rear left side: Side panel (Einschlüsse) - Unprofessionally repaired - Repair and paint

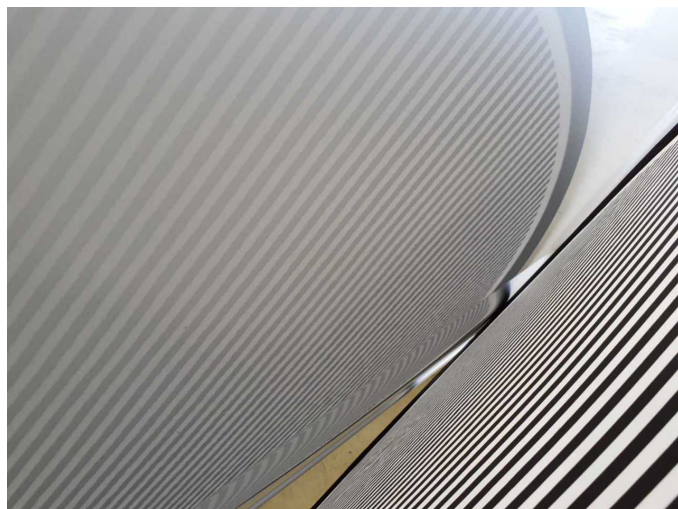
**Damage 13:** Side panel - rear left side: Side panel (Einschlüsse) - Unprofessionally repaired - Repair and paint

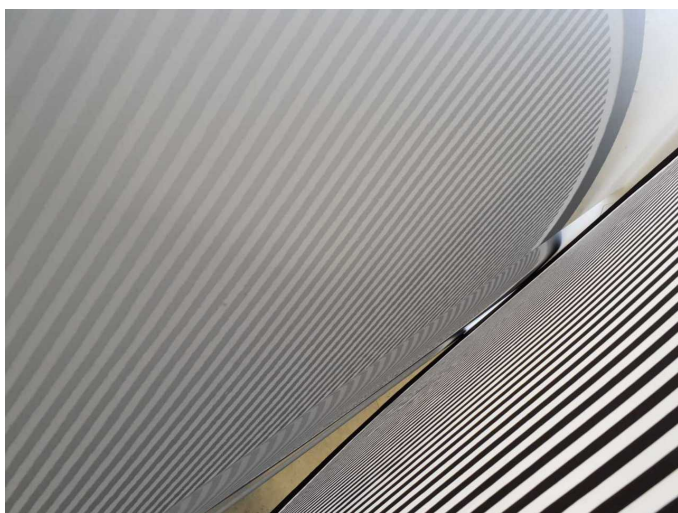
**Damage 13:** Side panel - rear left side: Side panel (Einschlüsse) - Unprofessionally repaired - Repair and paint

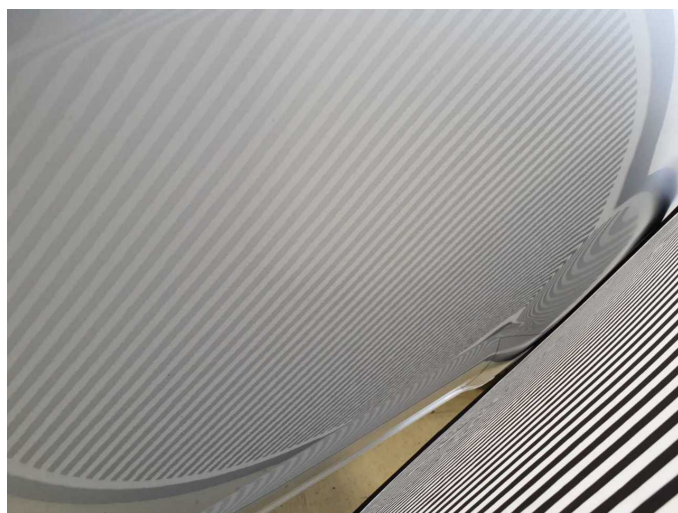
**Damage 13:** Side panel - rear left side: Side panel (Einschlüsse) - Unprofessionally repaired - Repair and paint

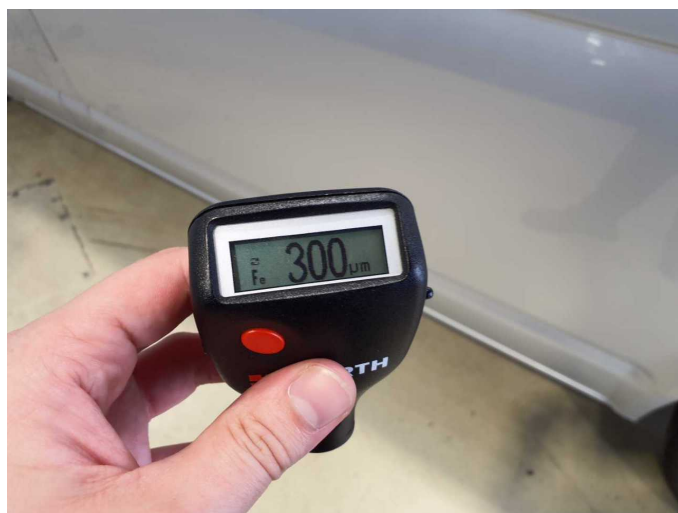
| No. | Repainting |
|---|---|
| 1 | Side panel - rear left side, Unprofessionally carried out, Invoice of repair done Non-existent |

Side panel - rear left side 300 µm |

**Repainting 1:** Side panel - rear left side
