## Expertise

Protocol number: 46134684  
Order No. / Reference: 26349239  
Inspection date: 28 May 2026

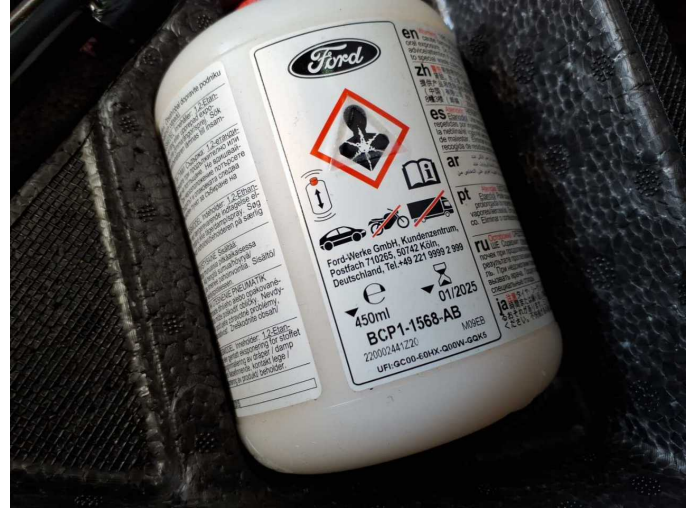
Damage 1: Equipment: Tirefit filler - Expired - Replace

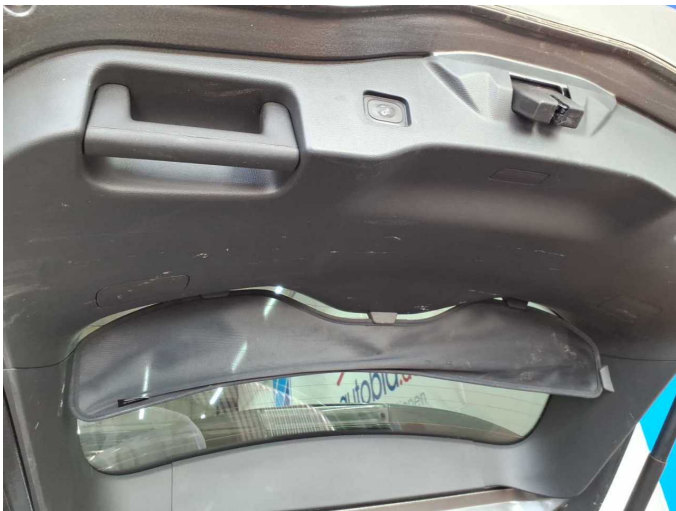
Damage 2: Trim / covers: Boot lid - interior trim - Scratch(es) - Loss in value

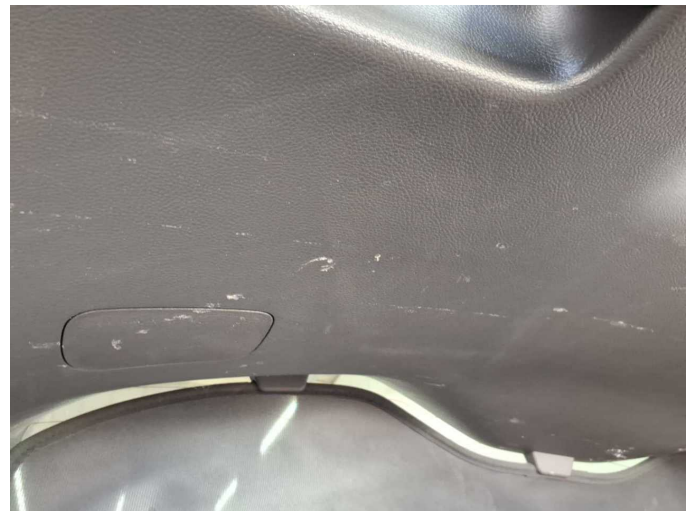
Damage 2: Trim / covers: Boot lid - interior trim - Scratch(es) - Loss in value

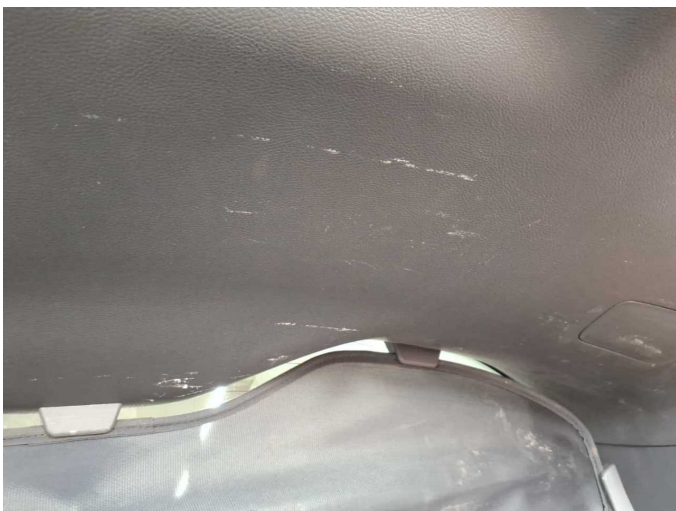
Damage 2: Trim / covers: Boot lid - interior trim - Scratch(es) - Loss in value

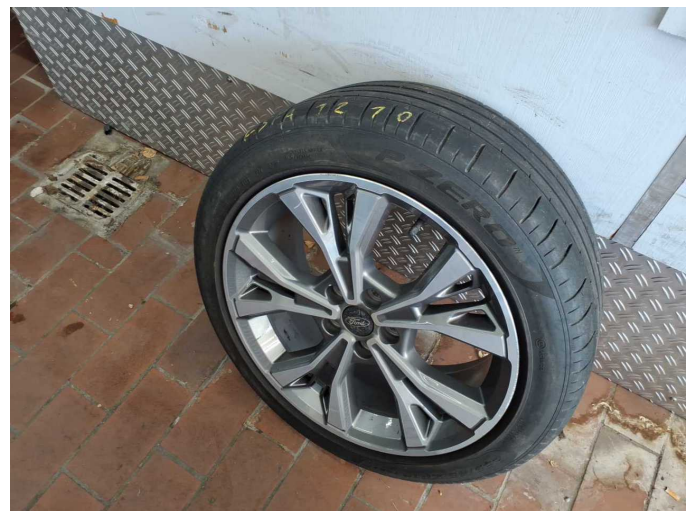
Damage 3: 2nd wheel set: 1 alloy rim - Scratch(es) - Loss in value

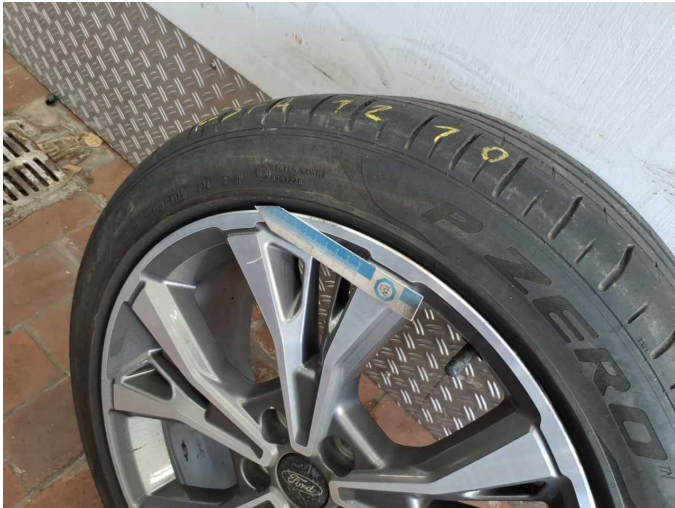
**Damage 3:** 2nd wheel set: 1 alloy rim - Scratch(es) - Loss in value

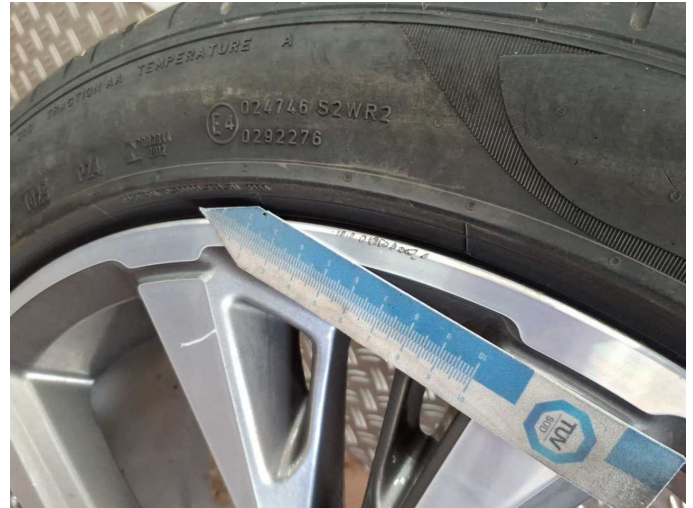
**Damage 3:** 2nd wheel set: 1 alloy rim - Scratch(es) - Loss in value

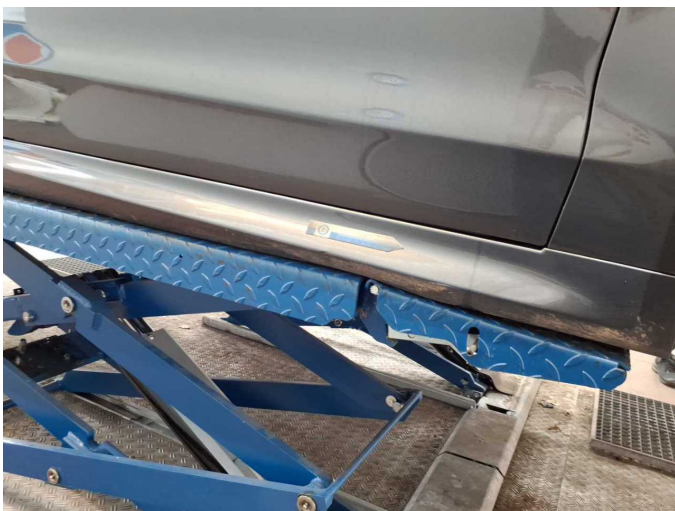
**Damage 4:** Sill - right side: Trim - Deformed - Loss in value

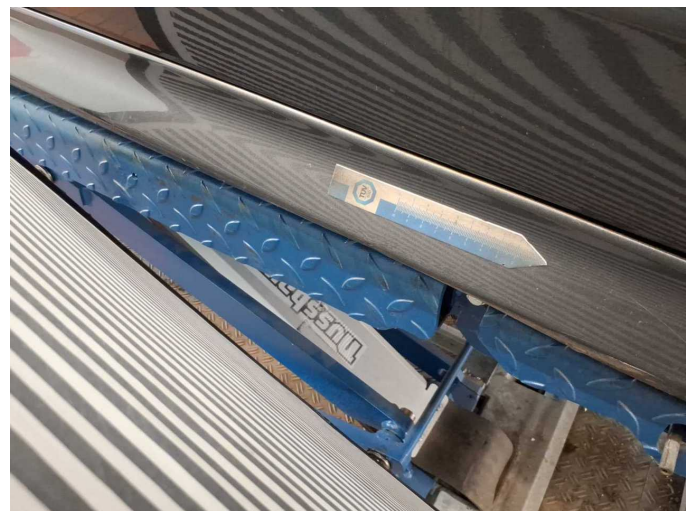
**Damage 4:** Sill - right side: Trim - Deformed - Loss in value

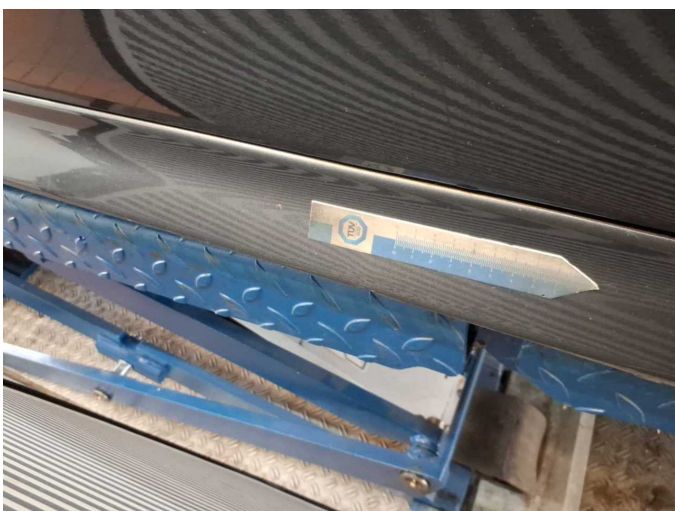
**Damage 4:** Sill - right side: Trim - Deformed - Loss in value

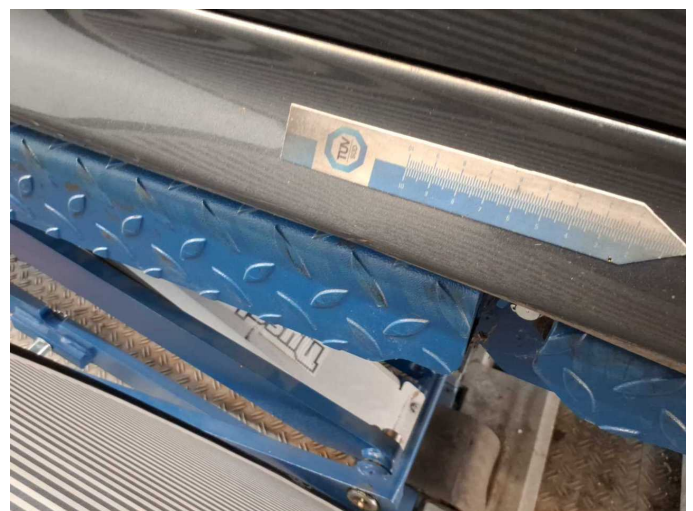
**Damage 4:** Sill - right side: Trim - Deformed - Loss in value

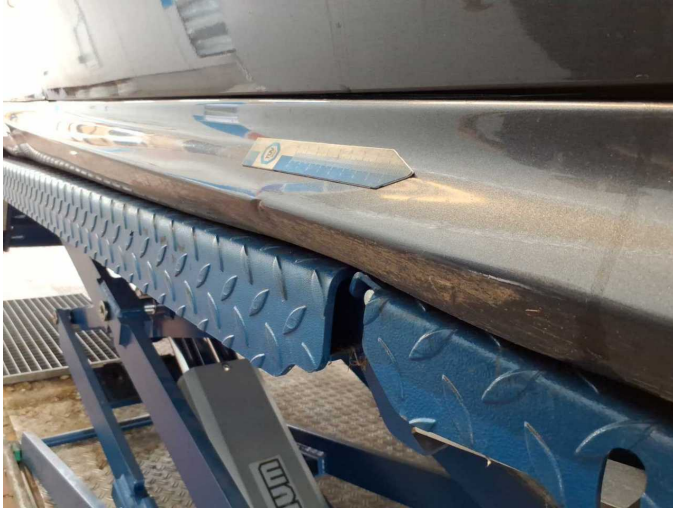
**Damage 4:** Sill - right side: Trim - Deformed - Loss in value

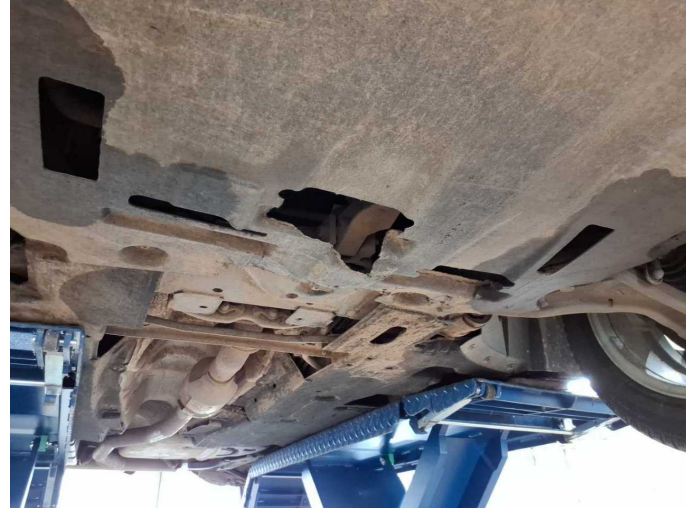
**Damage 5:** Body: Underbody panelling - Broken / torn - Replace

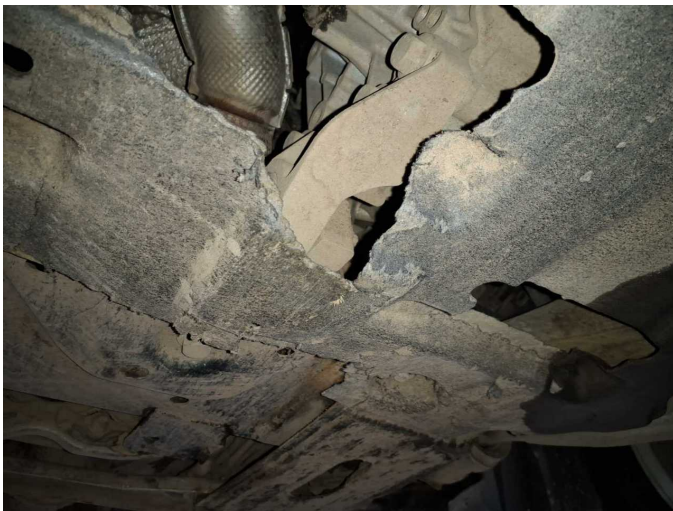
**Damage 5:** Body: Underbody panelling - Broken / torn - Replace

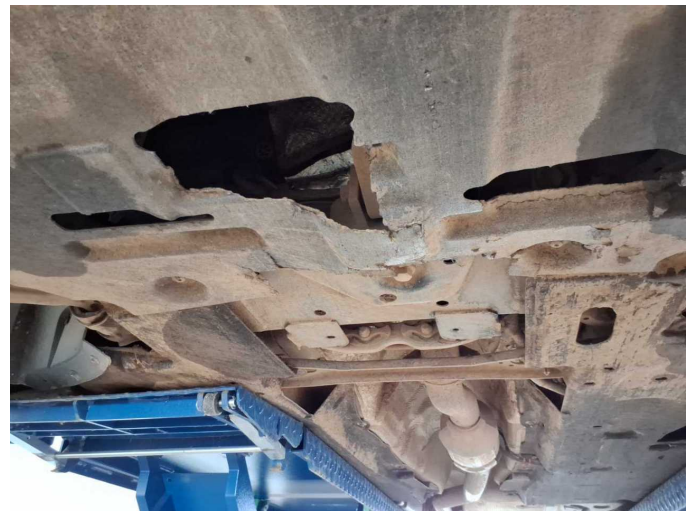
**Damage 5:** Body: Underbody panelling - Broken / torn - Replace

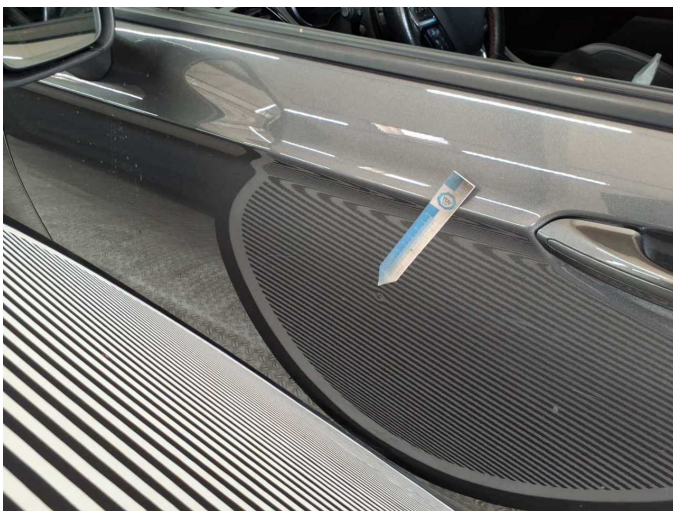
**Damage 6:** Door - front left side: Door (+ Kratzer) - Dent / paintcoat damage - Paint

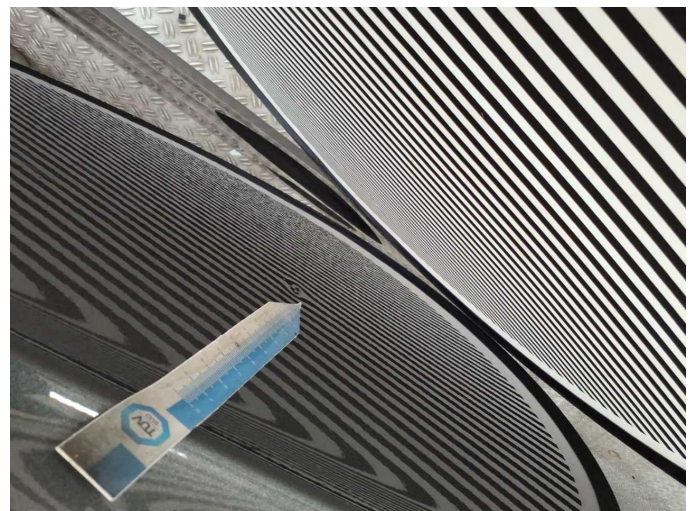
**Damage 6:** Door - front left side: Door (+ Kratzer) - Dent / paintcoat damage - Paint

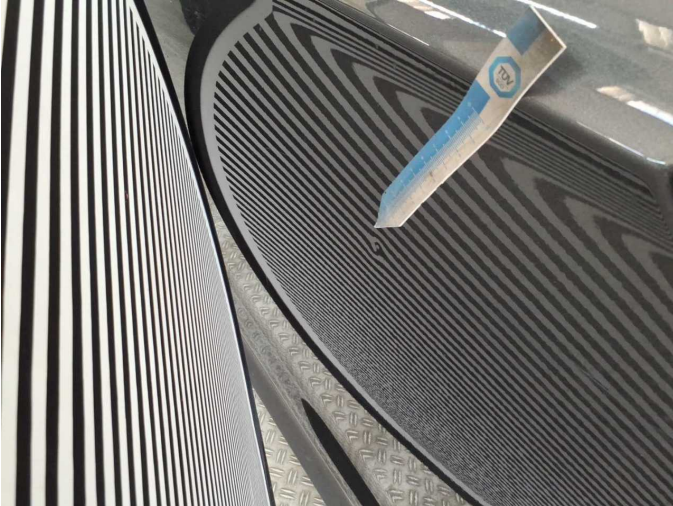
**Damage 6:** Door - front left side: Door (+ Kratzer) - Dent / paintcoat damage - Paint

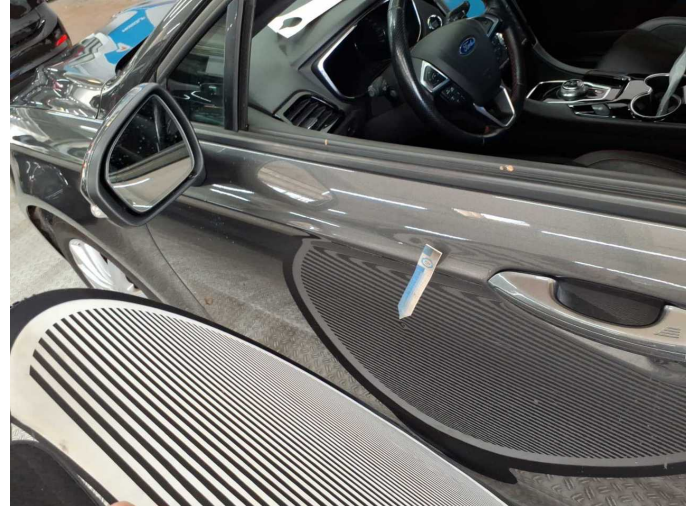
**Damage 6:** Door - front left side: Door (+ Kratzer) - Dent / paintcoat damage - Paint

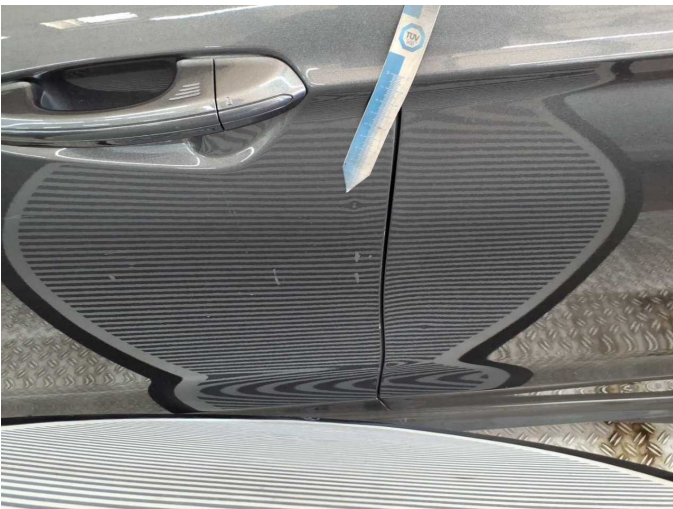
**Damage 6:** Door - front left side: Door (+ Kratzer) - Dent / paintcoat damage - Paint

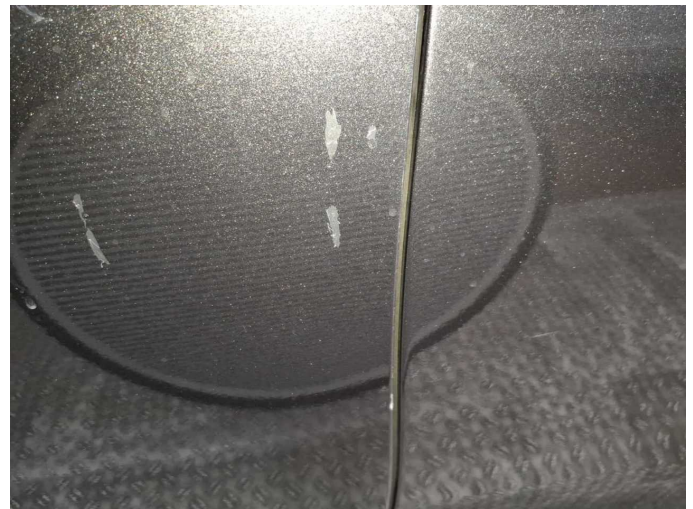
**Damage 6:** Door - front left side: Door (+ Kratzer) - Dent / paintcoat damage - Paint

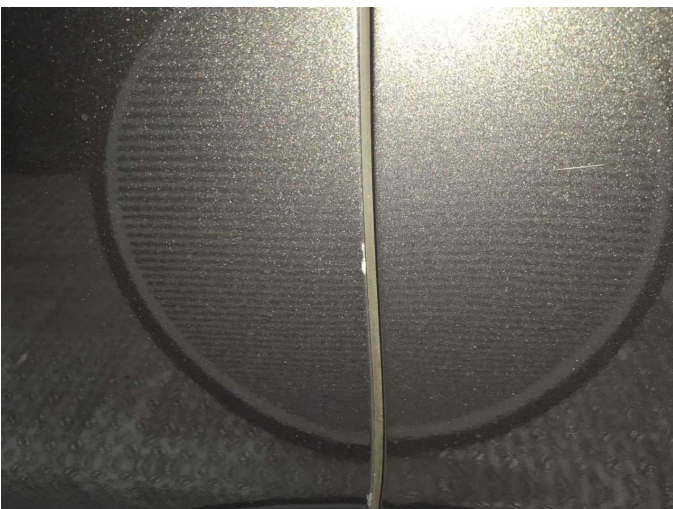
**Damage 6:** Door - front left side: Door (+ Kratzer) - Dent / paintcoat damage - Paint

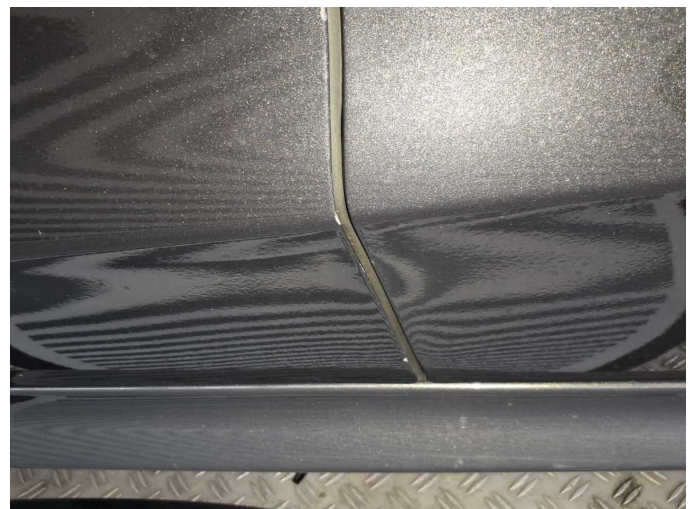
**Damage 6:** Door - front left side: Door (+ Kratzer) - Dent / paintcoat damage - Paint

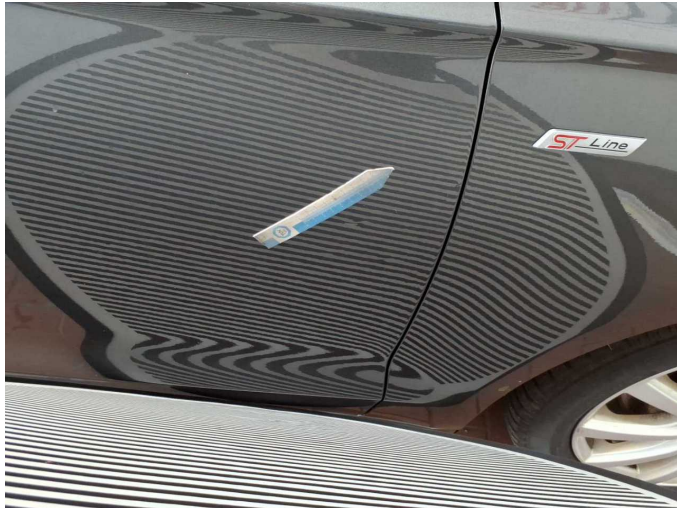
**Damage 7:** Door - front right side: Door - Unprofessionally repaired - Paint

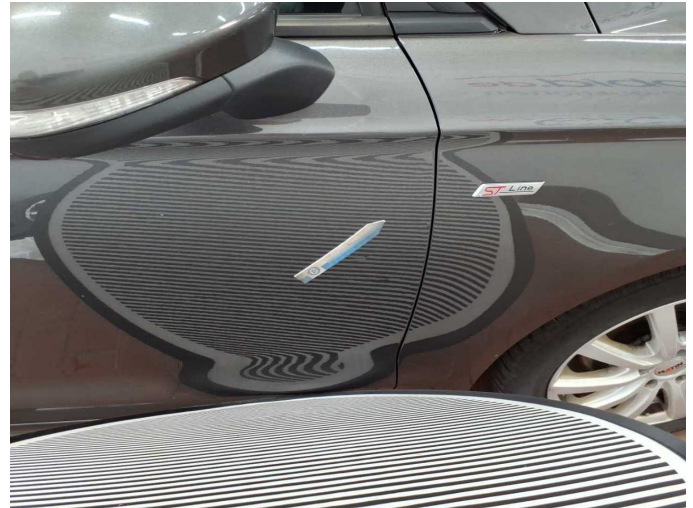
**Damage 7:** Door - front right side: Door - Unprofessionally repaired - Paint

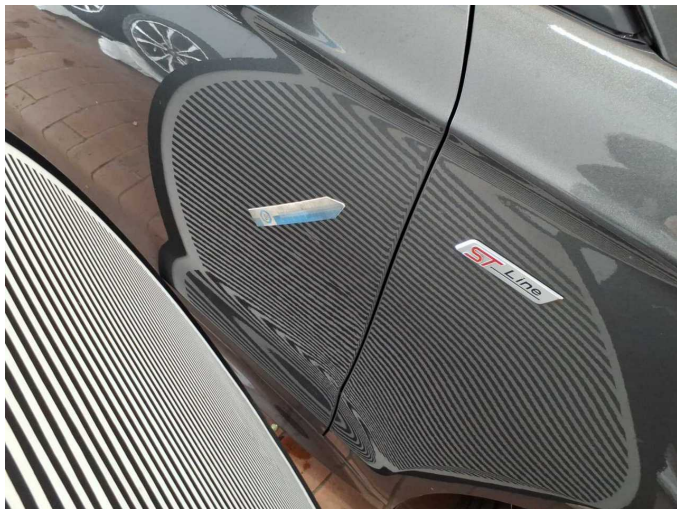
**Damage 7:** Door - front right side: Door - Unprofessionally repaired - Paint

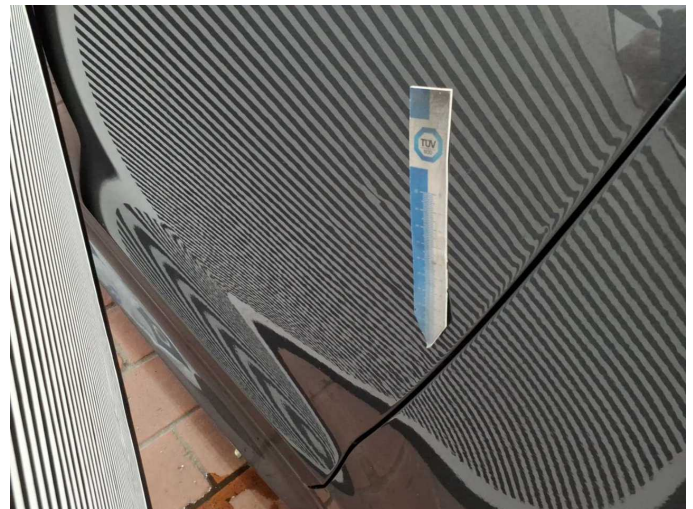
**Damage 7:** Door - front right side: Door - Unprofessionally repaired - Paint

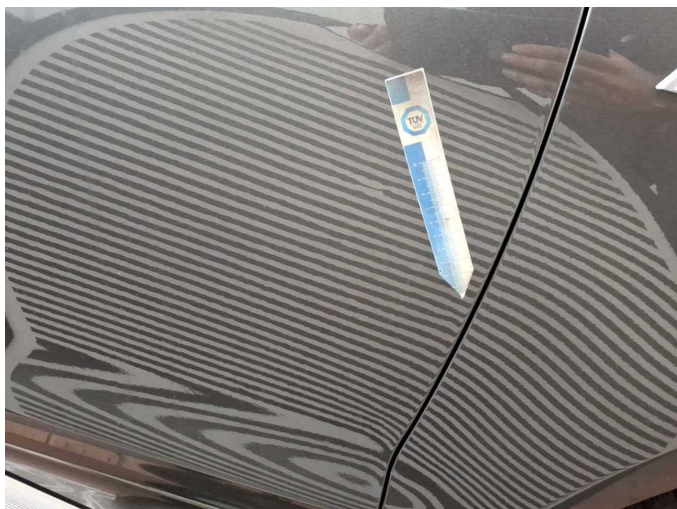
**Damage 7:** Door - front right side: Door - Unprofessionally repaired - Paint

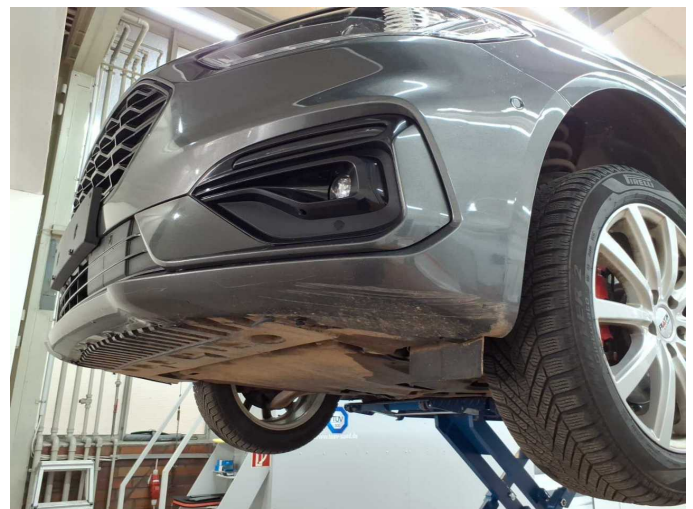
**Damage 8:** Front bumper: Front bumper - Scratched - Paint

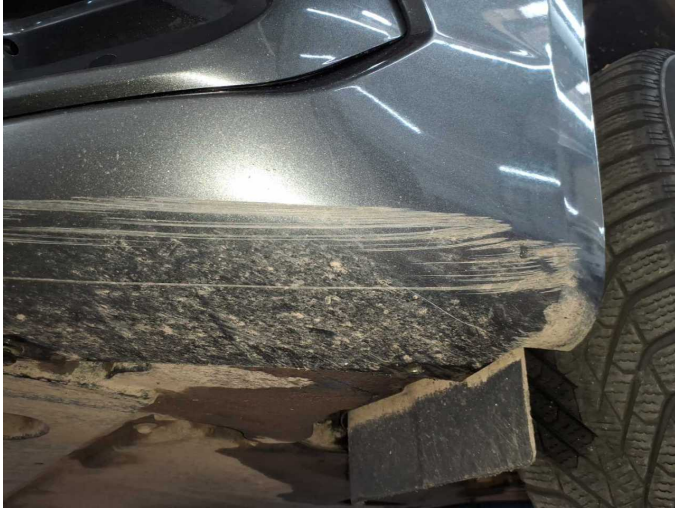
**Damage 8:** Front bumper: Front bumper - Scratched - Paint

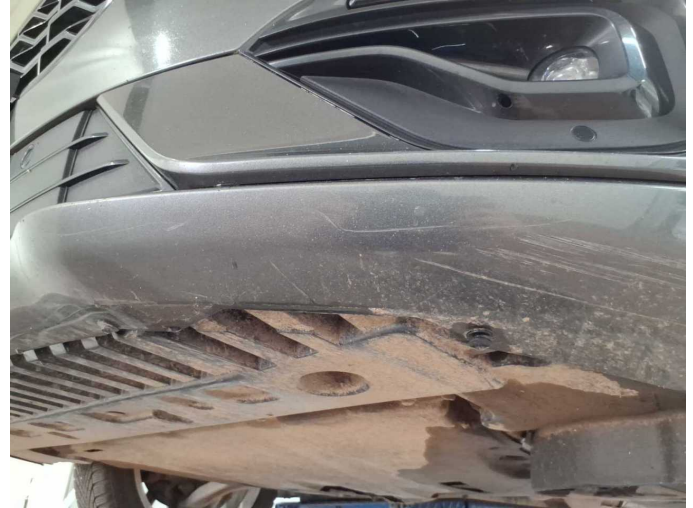
**Damage 8:** Front bumper: Front bumper - Scratched - Paint

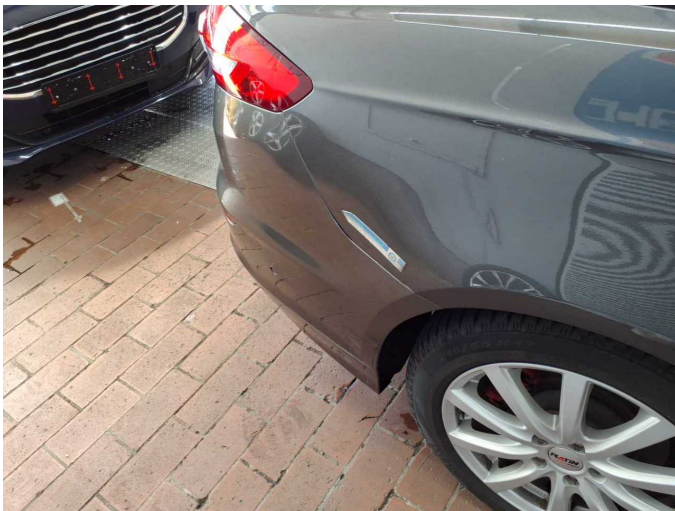
**Damage 9:** Rear bumper: Rear bumper - Scratch(es) - Paint

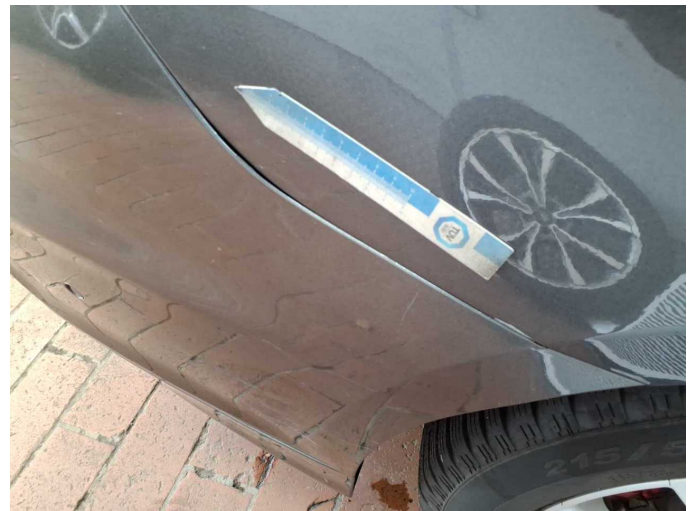
**Damage 9:** Rear bumper: Rear bumper - Scratch(es) - Paint

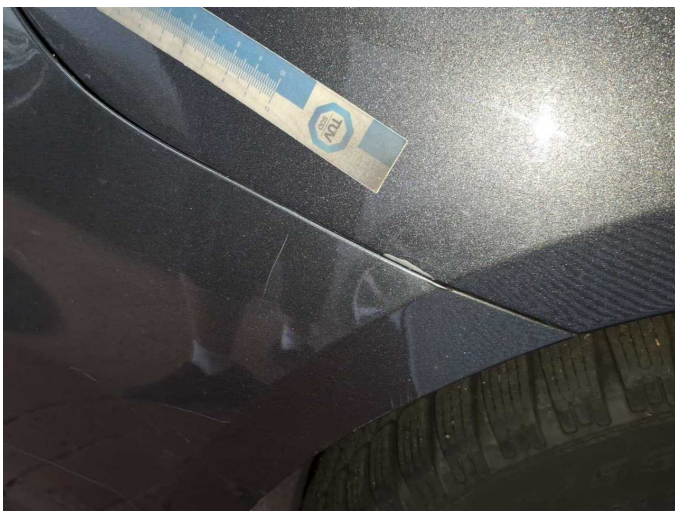
**Damage 9:** Rear bumper: Rear bumper - Scratch(es) - Paint

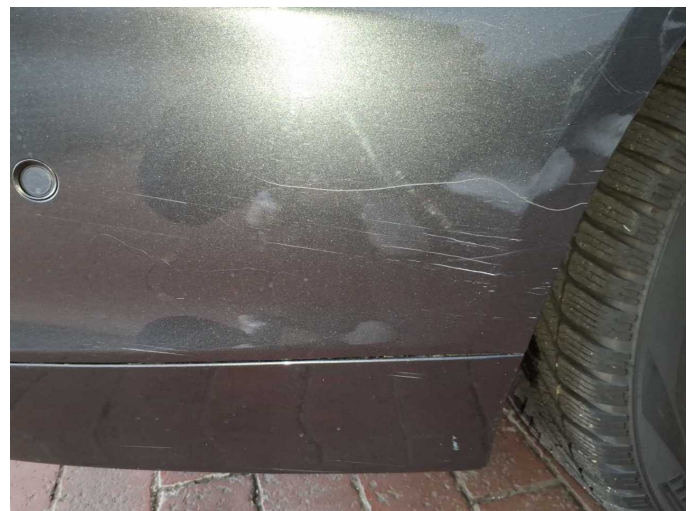
**Damage 9:** Rear bumper: Rear bumper - Scratch(es) - Paint

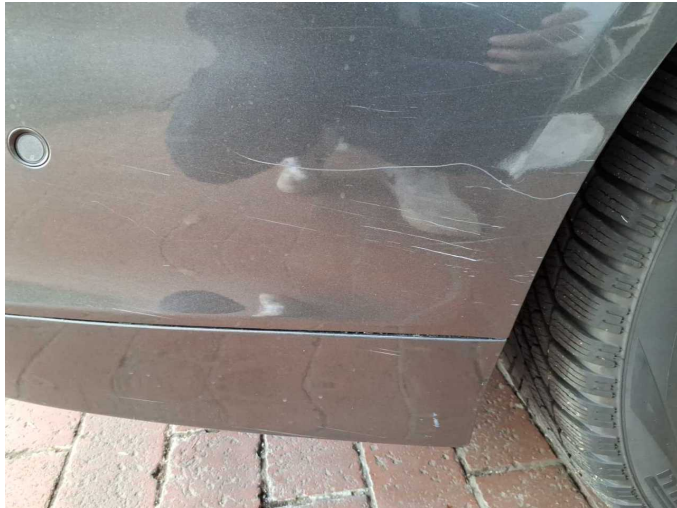
**Damage 9:** Rear bumper: Rear bumper - Scratch(es) - Paint

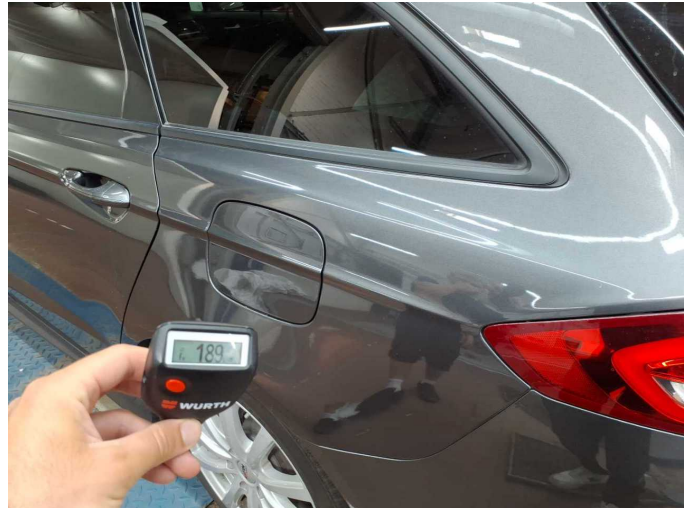
**Repainting 1:** Roof rail - left side, Side panel - rear left side, Door - rear right side
