Expertise

Protocol number: 46269172
Order No. / Reference: 26461196
Inspection date: 1 Jul 2026

Model: Kodiaq 2.0 TDI 4x4 DSG Style

VIN: TMBLJ7NS6P8032606

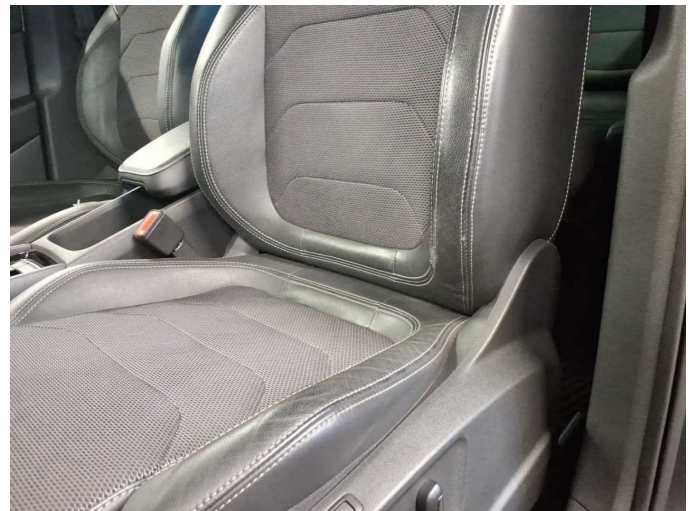
Damage 2: Seat - front: Seat cover - left side (Wange) - Abrasion - Smart repair

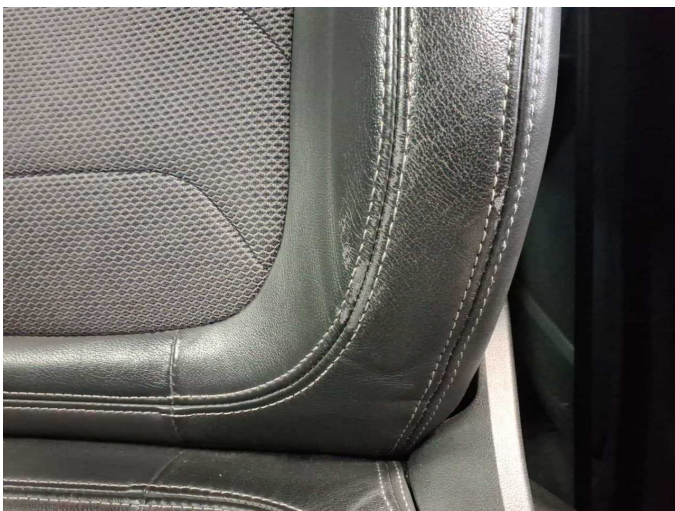
Damage 2: Seat - front: Seat cover - left side (Wange) - Abrasion - Smart repair

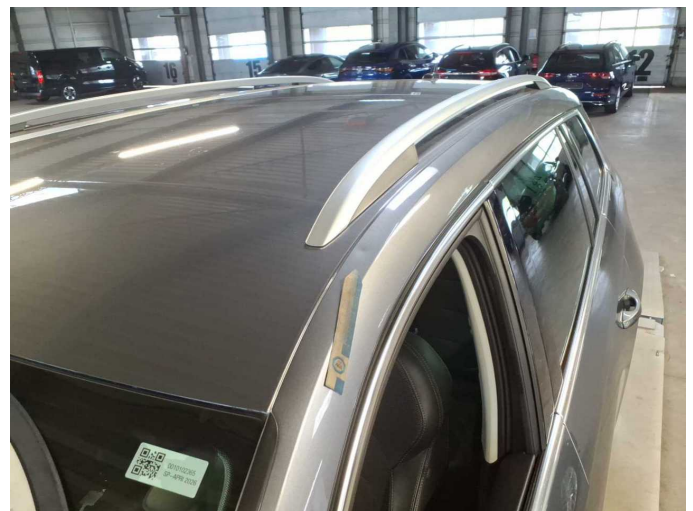
Damage 3: Roof: Roof rail - left side - dent(s) - Smooth repair work

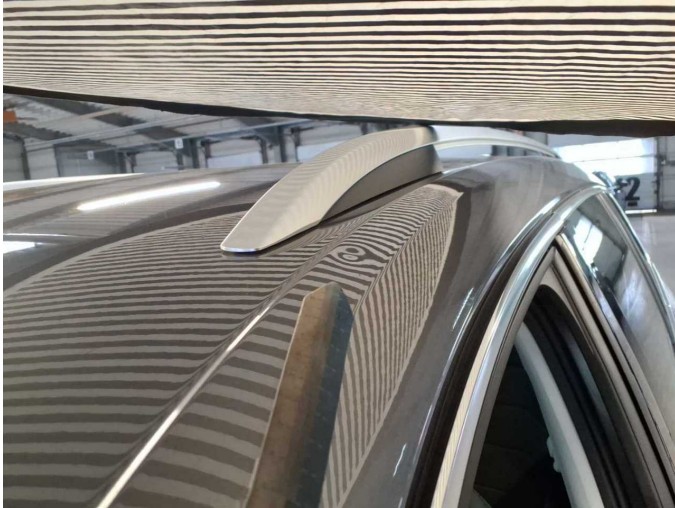
Damage 3: Roof: Roof rail - left side - dent(s) - Smooth repair work

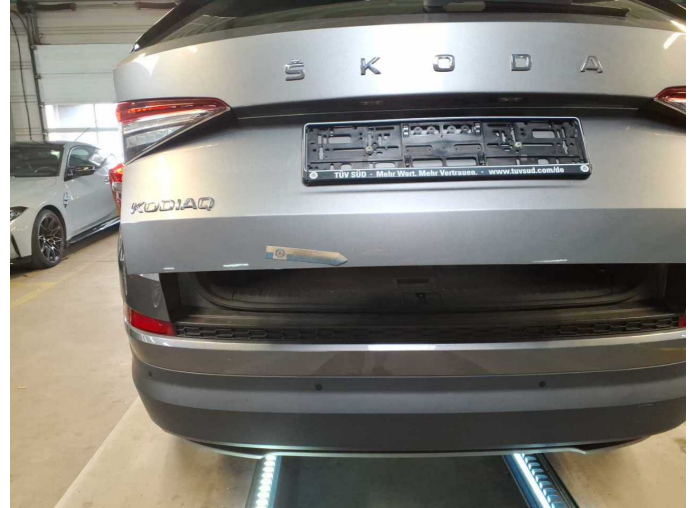
Damage 4: Boot lid / rear door: Boot lid (Rostpickel) - Paint defect - Smart repair

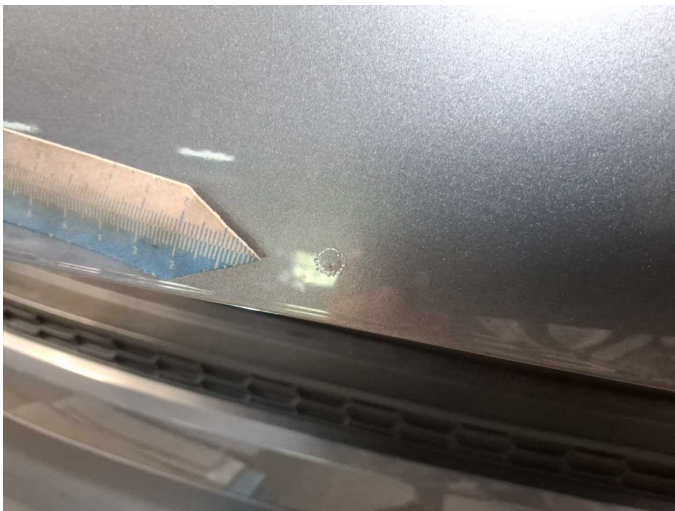
Damage 4: Boot lid / rear door: Boot lid (Rostpickel) - Paint defect - Smart repair

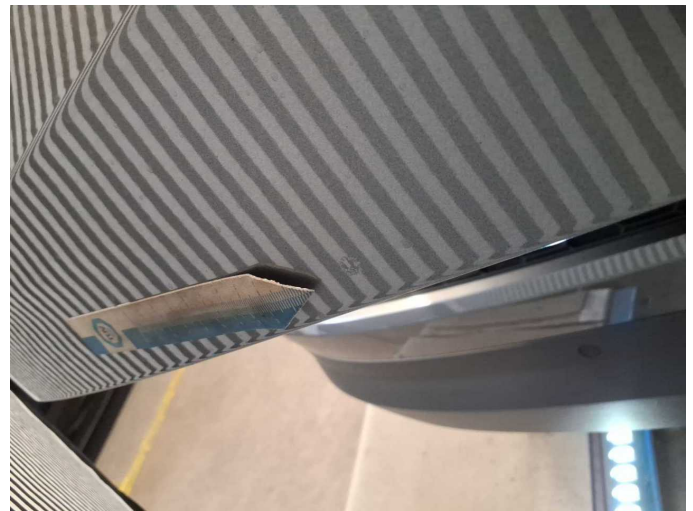
Damage 4: Boot lid / rear door: Boot lid (Rostpickel) - Paint defect - Smart repair

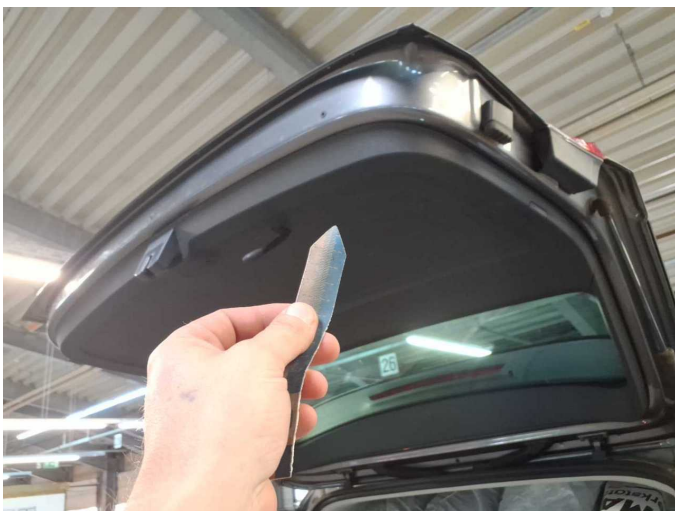
Damage 5: Trim / covers: Boot lid - interior trim (Materialabtrag) - Scratched - Replace

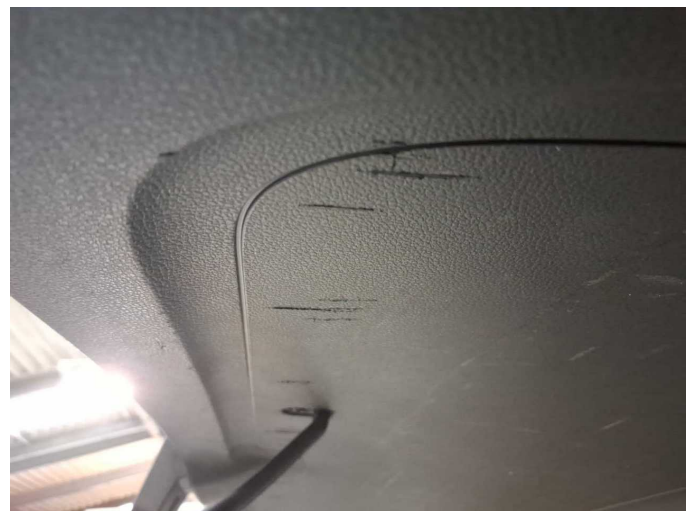
Damage 5: Trim / covers: Boot lid - interior trim (Materialabtrag) - Scratched - Replace

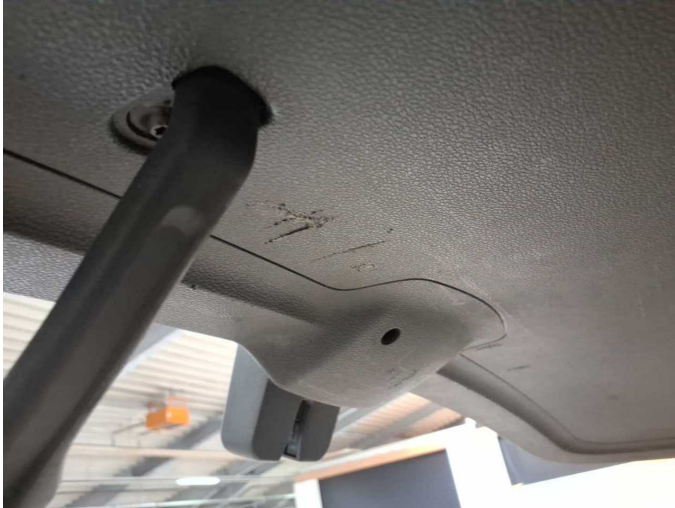
Damage 5: Trim / covers: Boot lid - interior trim (Materialabtrag) - Scratched - Replace

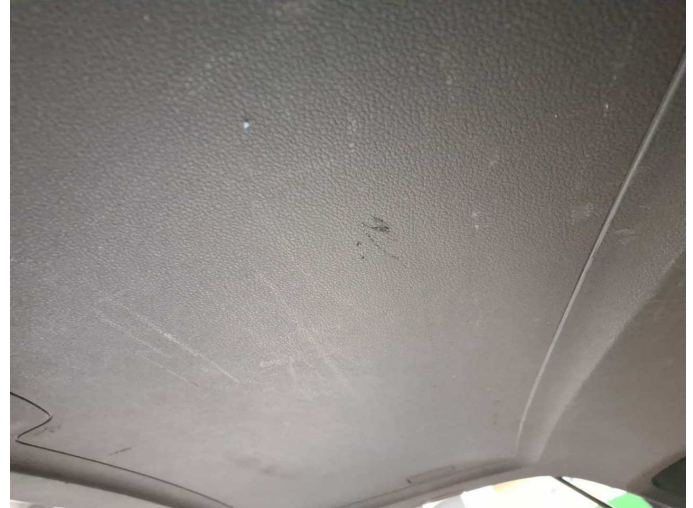
Damage 5: Trim / covers: Boot lid - interior trim (Materialabtrag) - Scratched - Replace

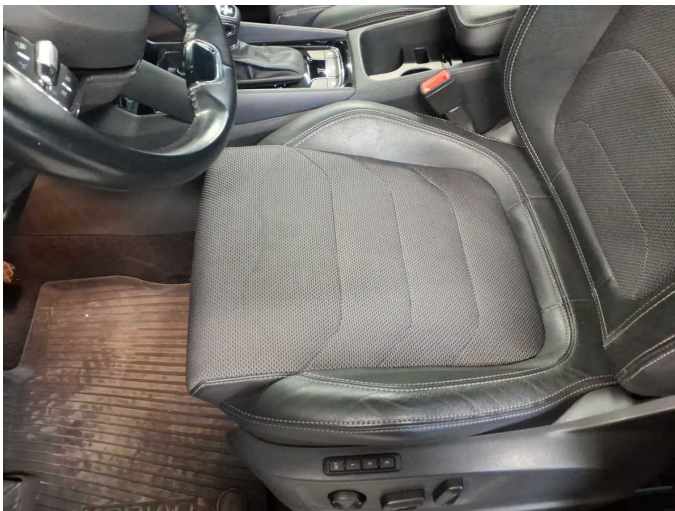
Damage 6: Seat - front: Seat cover - left side (+ Rechts, Flecken) - Soiled - Clean

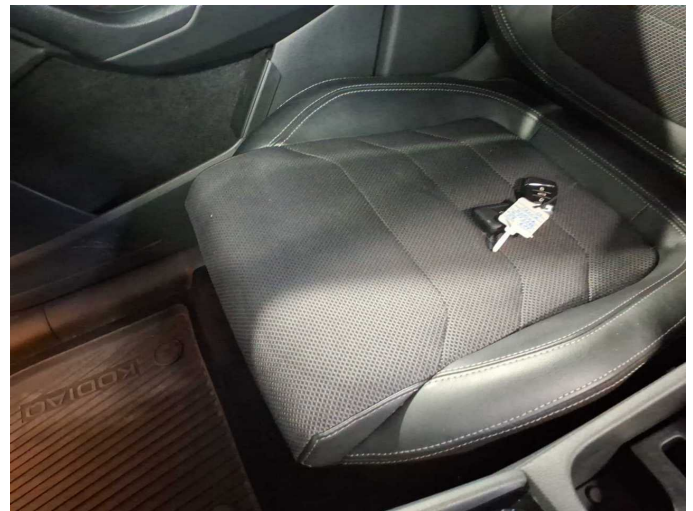
Damage 6: Seat - front: Seat cover - left side (+ Rechts, Flecken) - Soiled - Clean

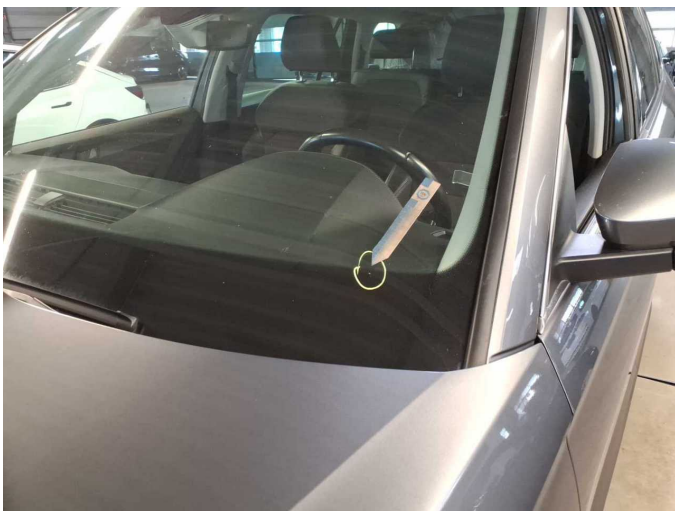
Damage 7: Vehicle glazing: Windscreen (Rissbildung) - Stone chips - Replace

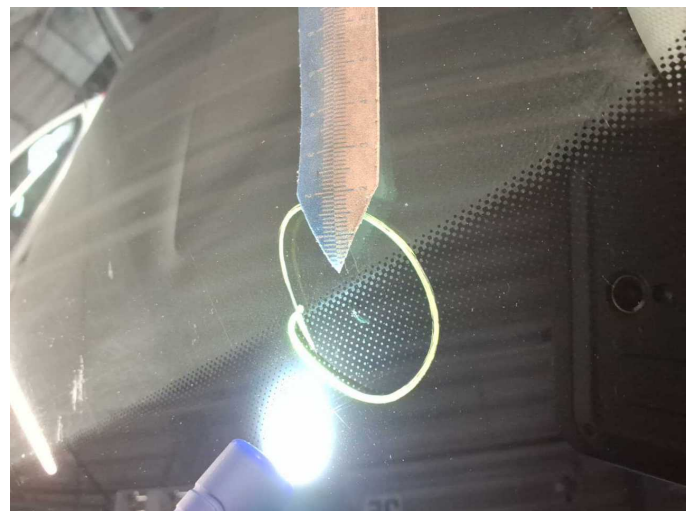
Damage 7: Vehicle glazing: Windscreen (Rissbildung) - Stone chips - Replace

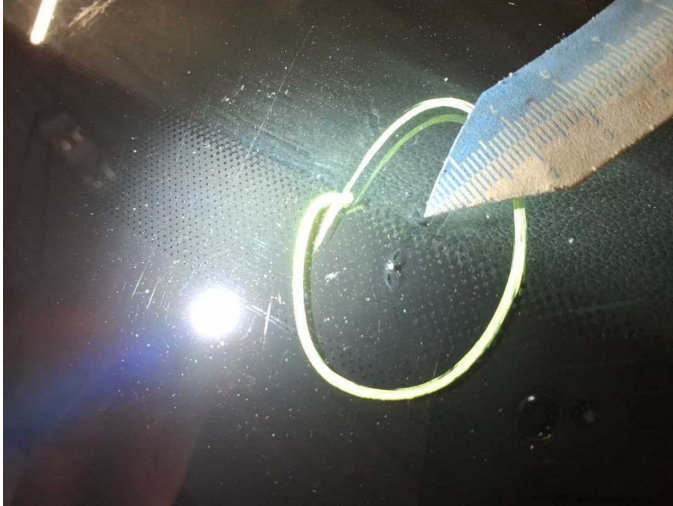
Damage 7: Vehicle glazing: Windscreen (Rissbildung) - Stone chips - Replace

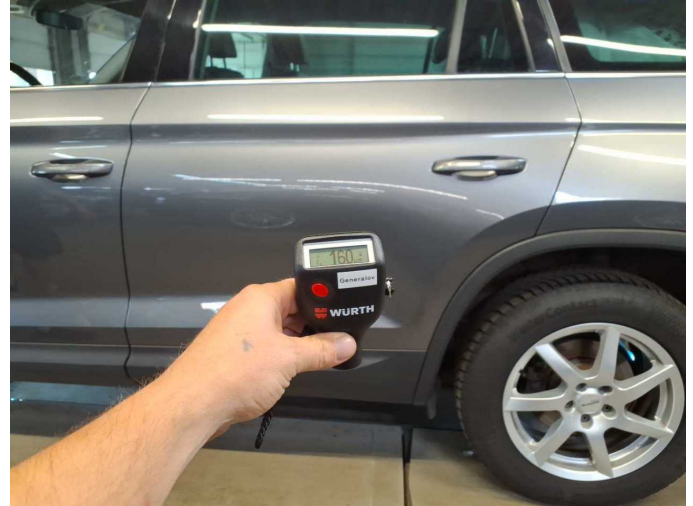
Door - rear left side	160 µm	Door - rear right side	206 µm
Door - front left side	180 µm	Door - front right side	160 µm

Repainting 1: Door - rear left side

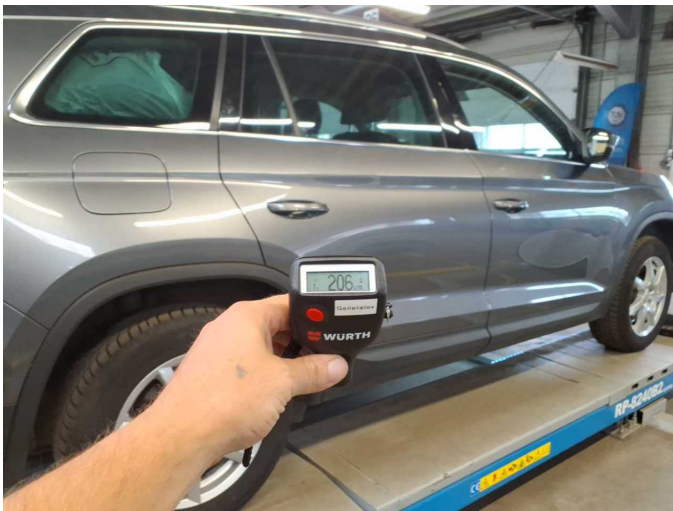
Repainting 2: Door - rear right side

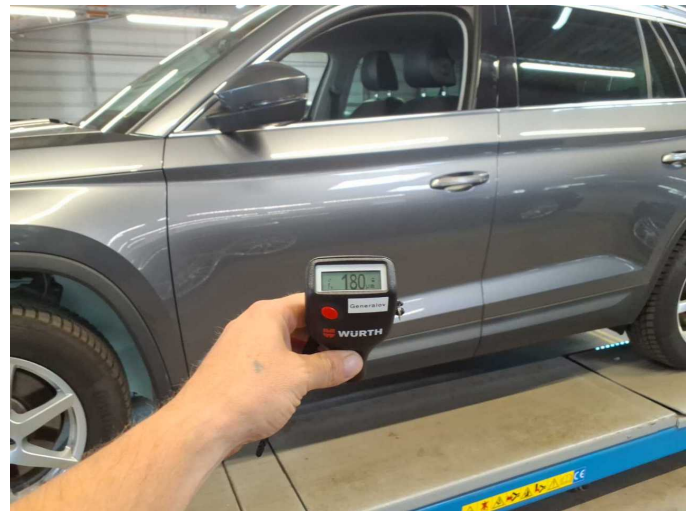
Repainting 3: Door - front left side

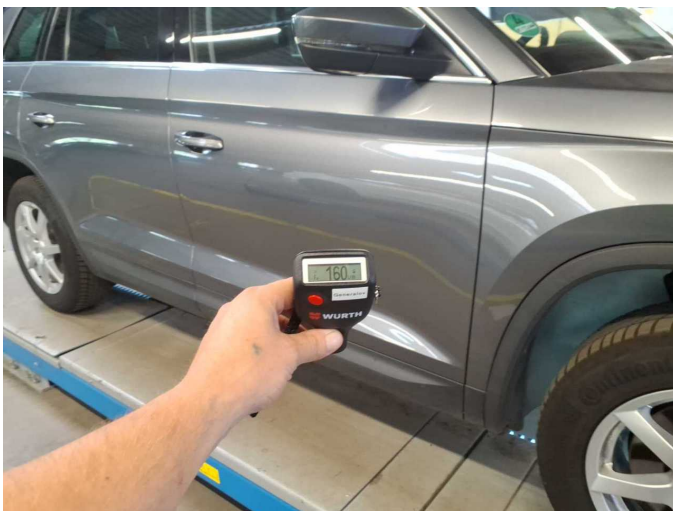
Repainting 4: Bumper front, Door - front right side
